GEOTECHNICAL REVIEW, DRAINAGE ASPECTS

MAIN EMBANKMENT DAM

TAILINGS STORAGE FACILITY

MT. POLLEY PROJECT, BRITISH COLUMBIA

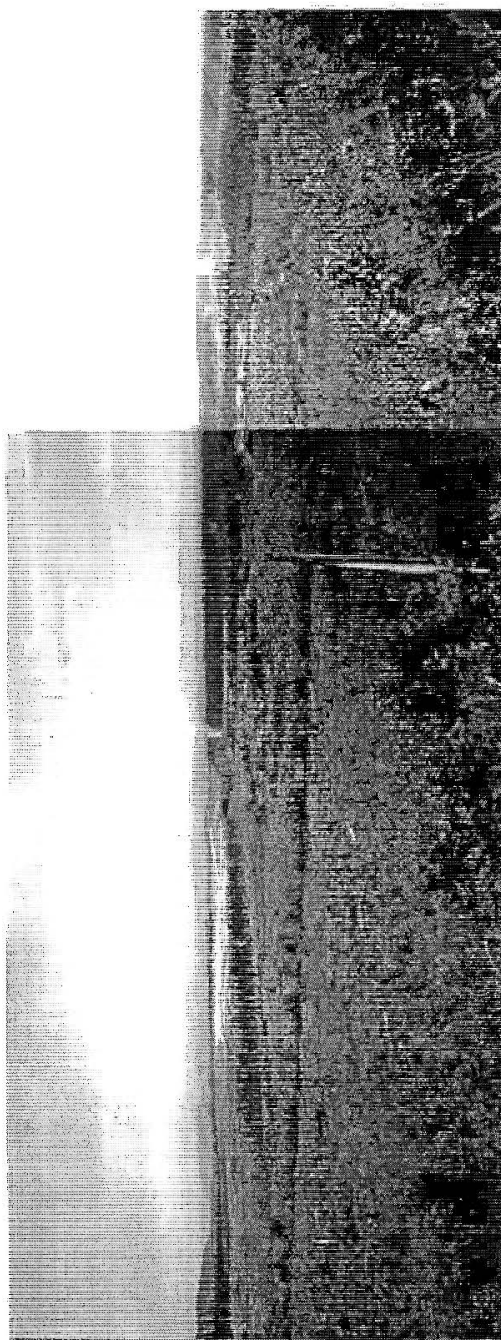
Photo 1
Overall View of Tailings Storage Facility Site
from West Side, Looking South-East towards
Main Embankment Area.

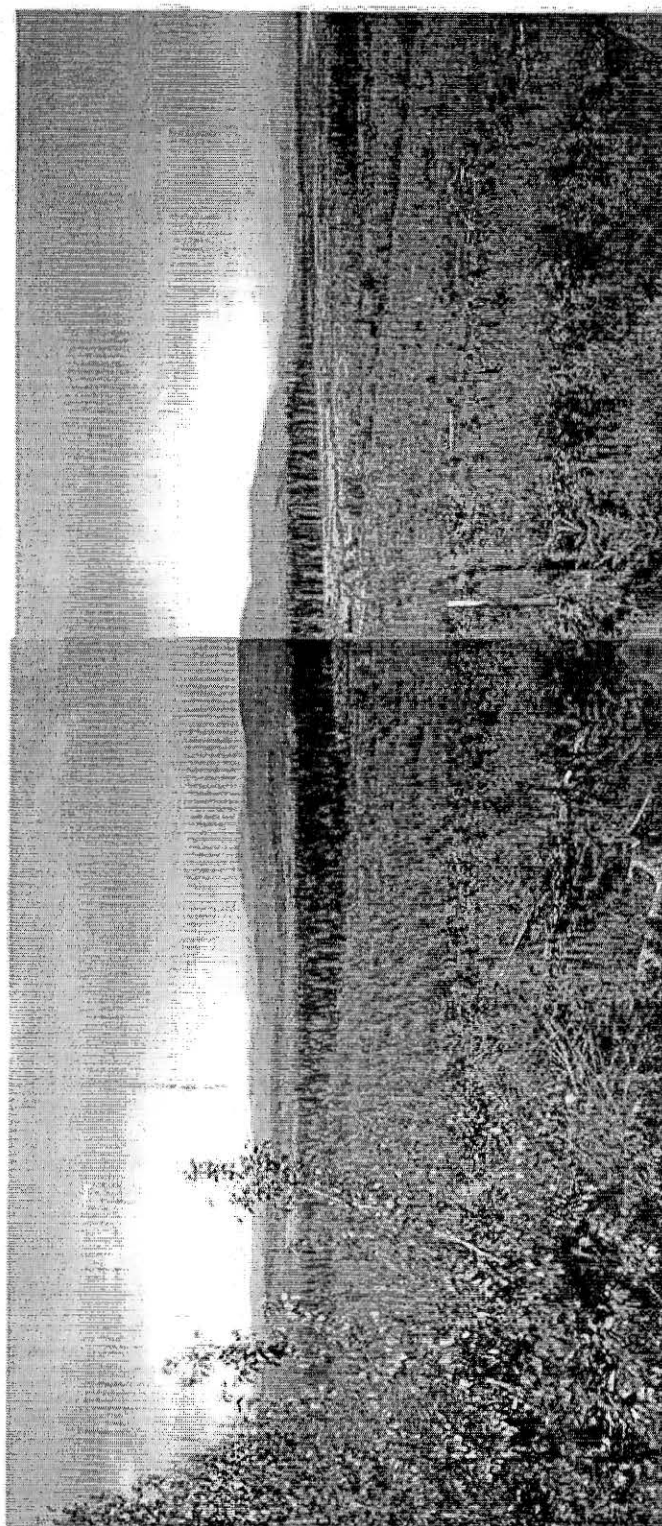
Photo 2. As for Photo 1 but Looking North towards
Perimeter Embankment Area

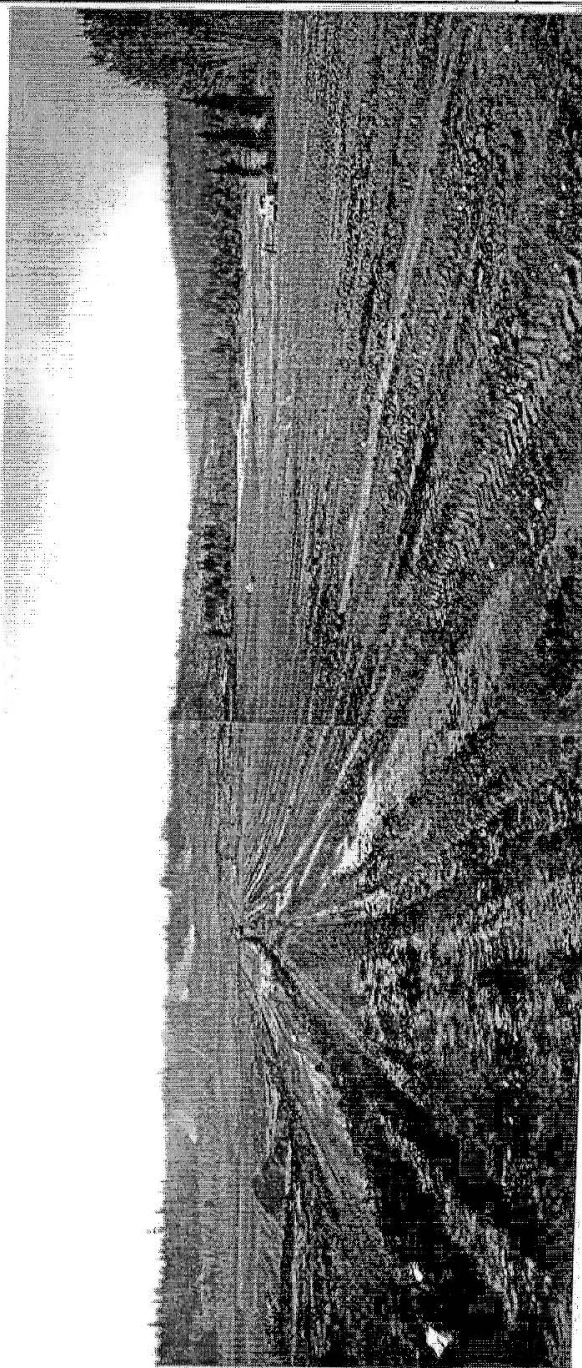
Photo 3. Base of Stage 1b of Main Embankment. Looking North-East

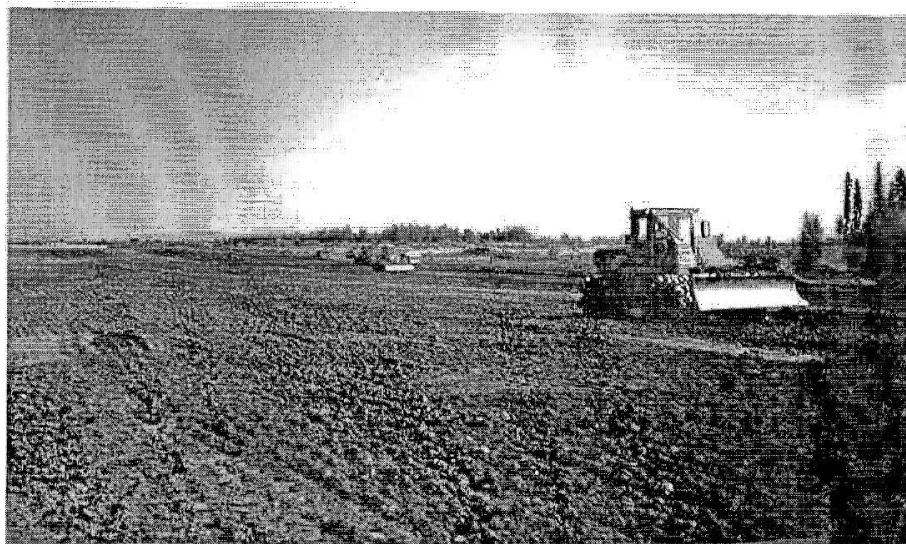
Photo 4. Base of Stage 1b of Main Embankment. Looking South-West.

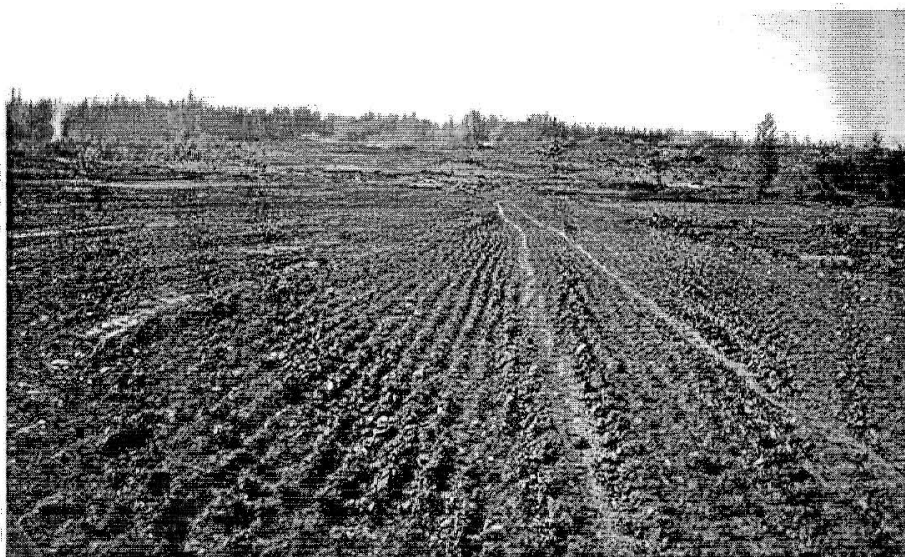
Photo 5. Base of Stage 1b of Main Embankment and Adjoining Basin Liner. Looking South-West.

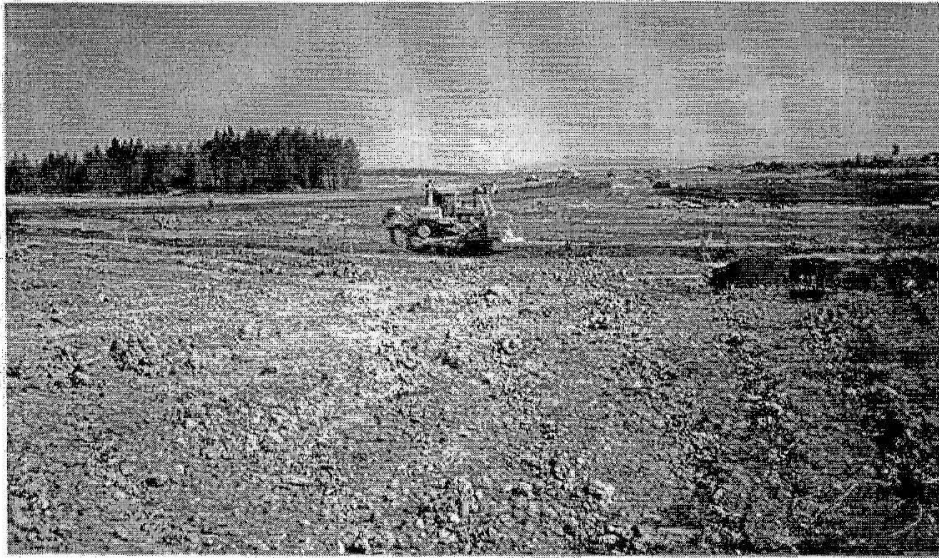
Photo 6. Base of Zone B of Stage 1b of Main Embankment near Seepage Collection Pond. Looking North-East.

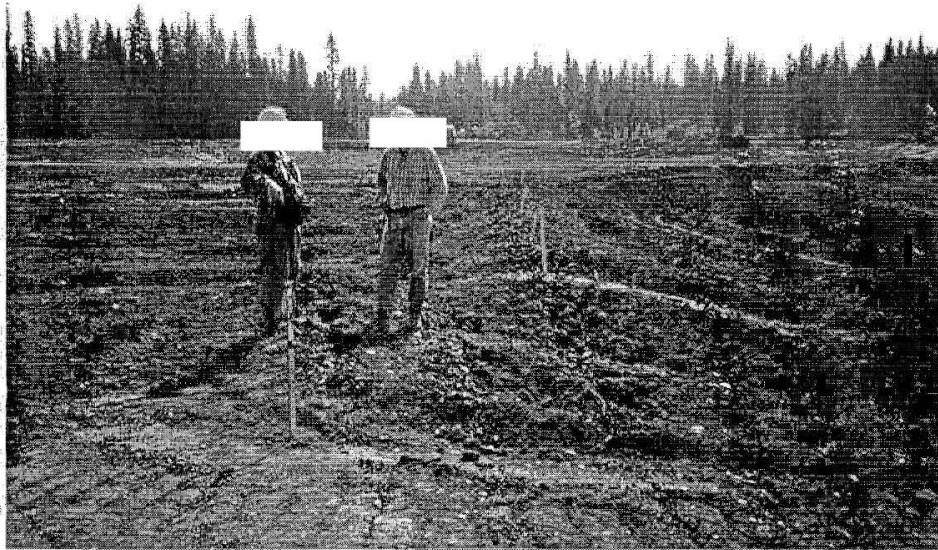
Photo 7. Base of Zone B of Stage 1b of Main Embankment. A Foundation Drain visible. Looking South-East.

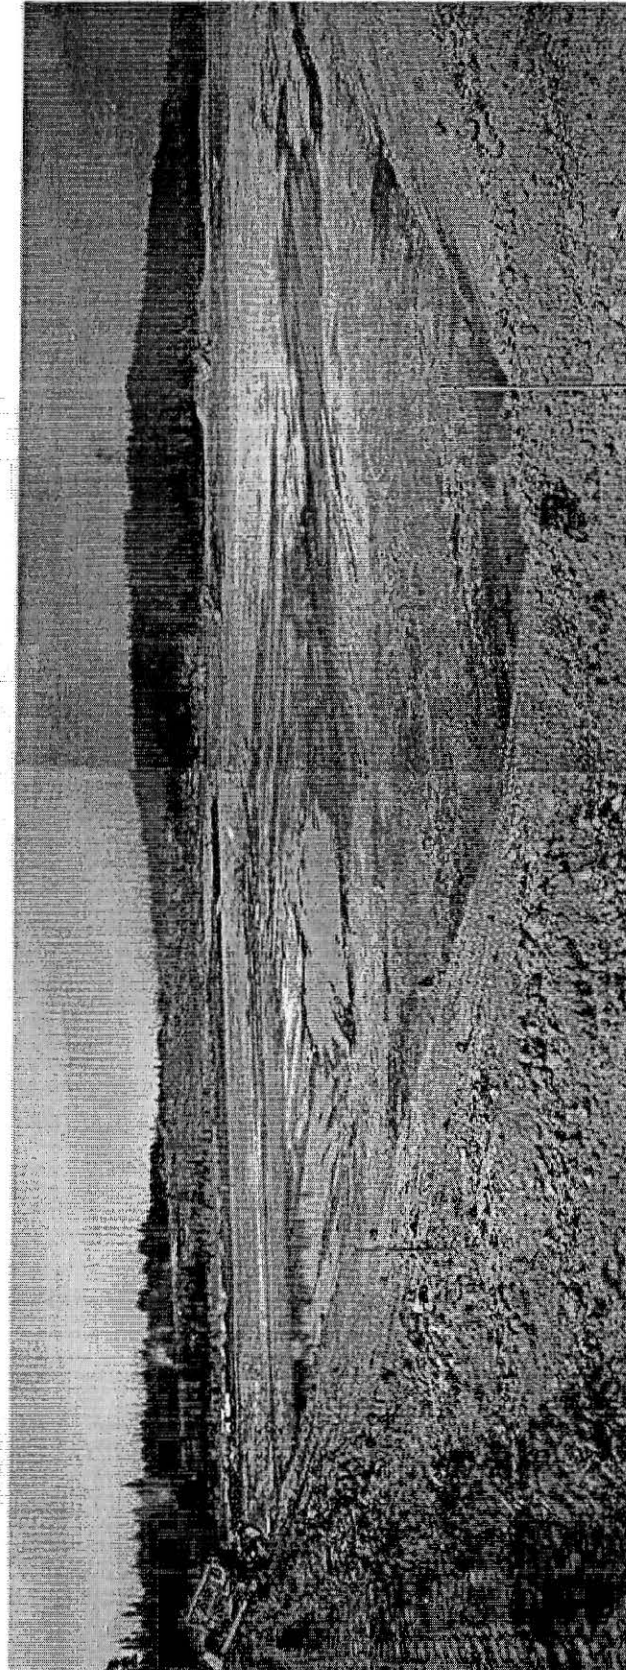
Photo 8. Panoramic View of Main Embankment Seepage
Collection Point. Looking West.

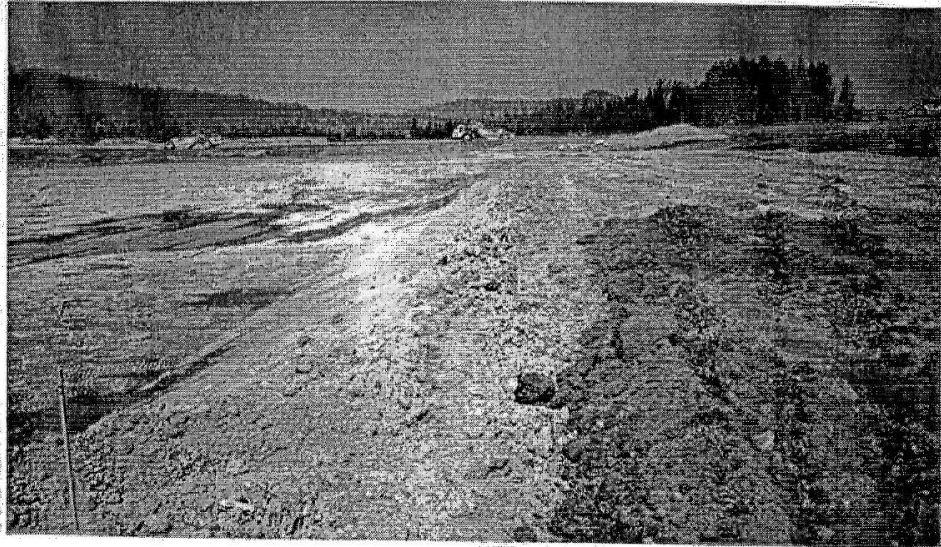
Photo 9. East Side of Main Embankment Seepage Collection Pond. Looking North.

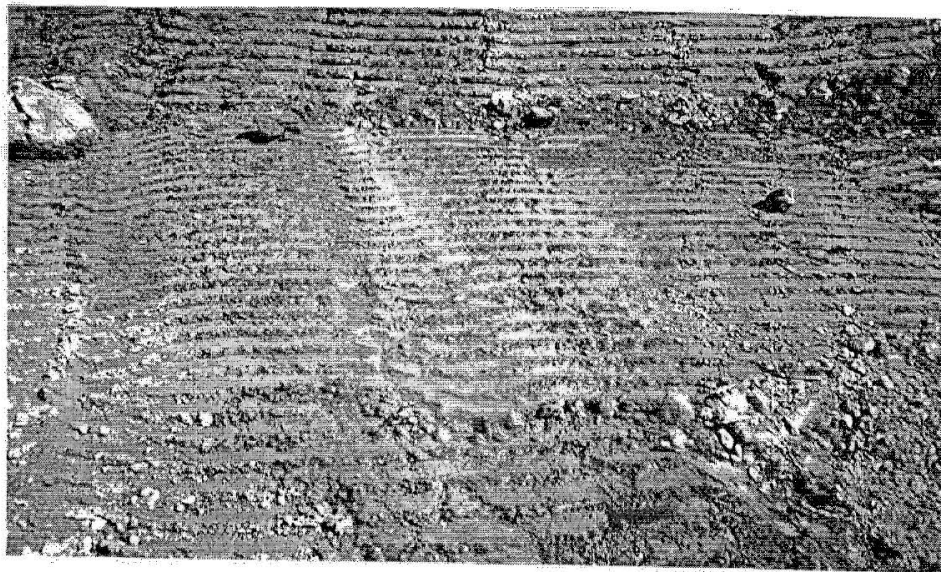
Photo 10. Base of Main Embankment Seepage Collection Pond near South-East Corner.

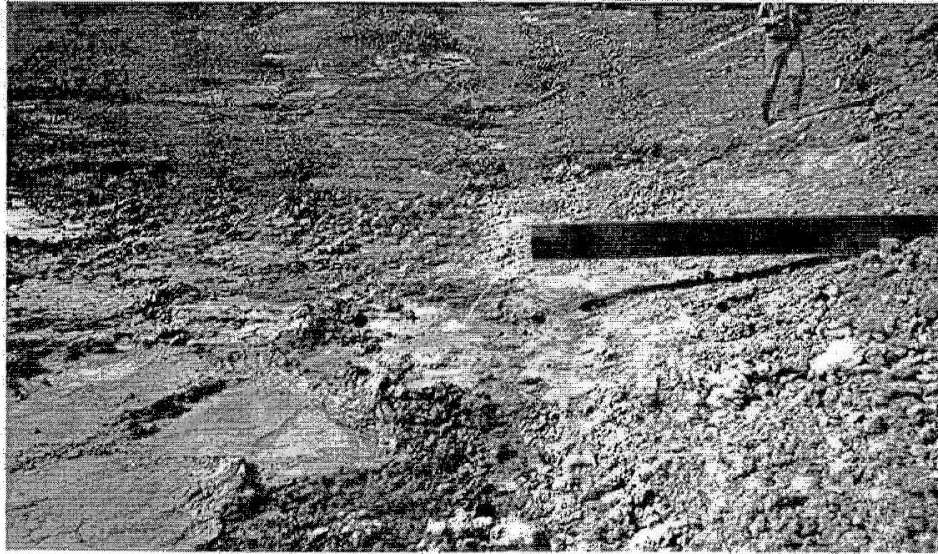
Photo 11. Outlet from Drain Monitoring Sump Discharging into Main Embankment Seepage Collection Pond.

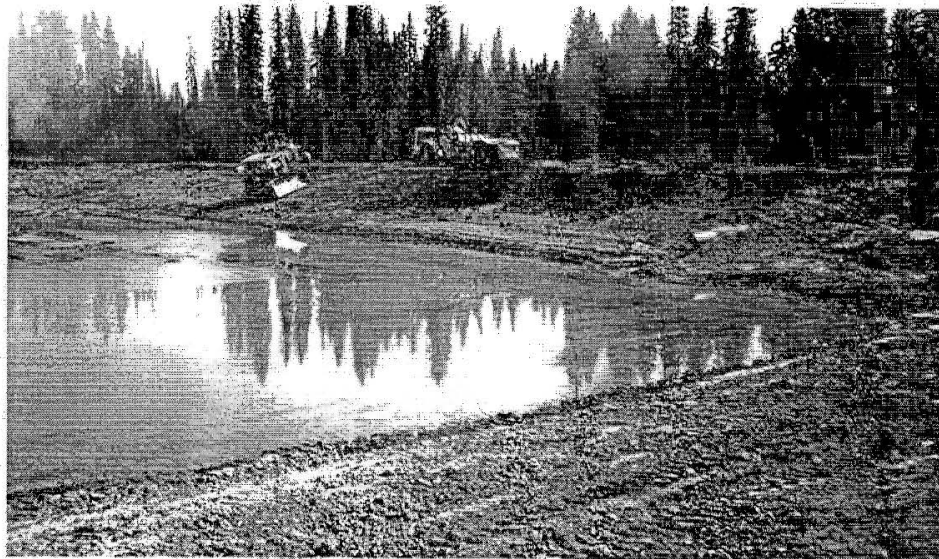
Photo 12. Decant from Main Embankment Seepage Collection Pond in South-West Corner.

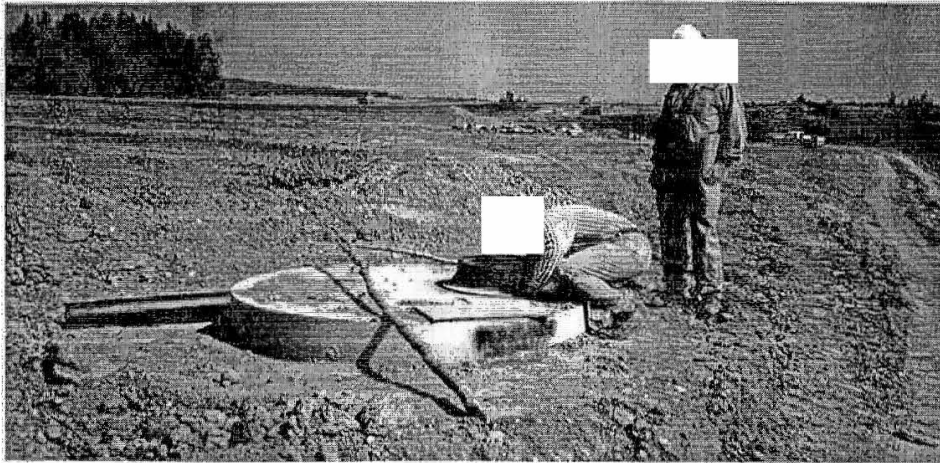
Photo 13. Top of Drain Monitoring Sump at Main Embankment.

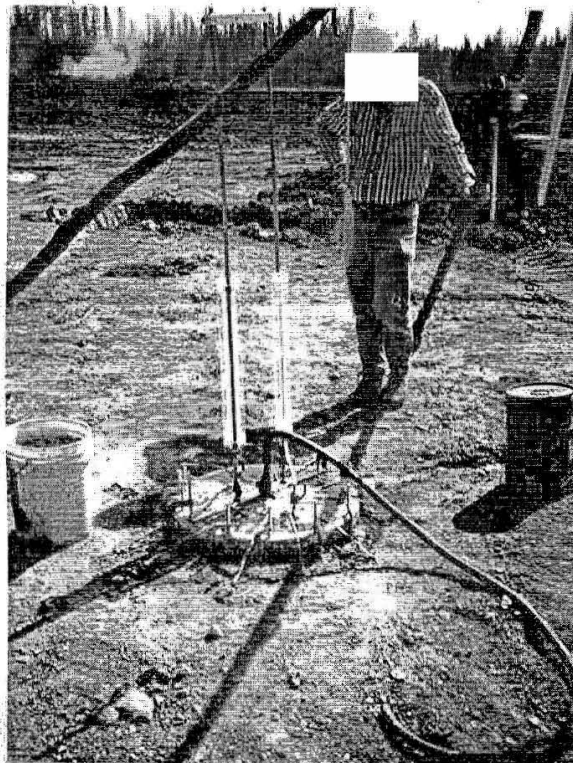
Photo 14. View of Field Air Entry Permeameter Testing of Basin Liner.

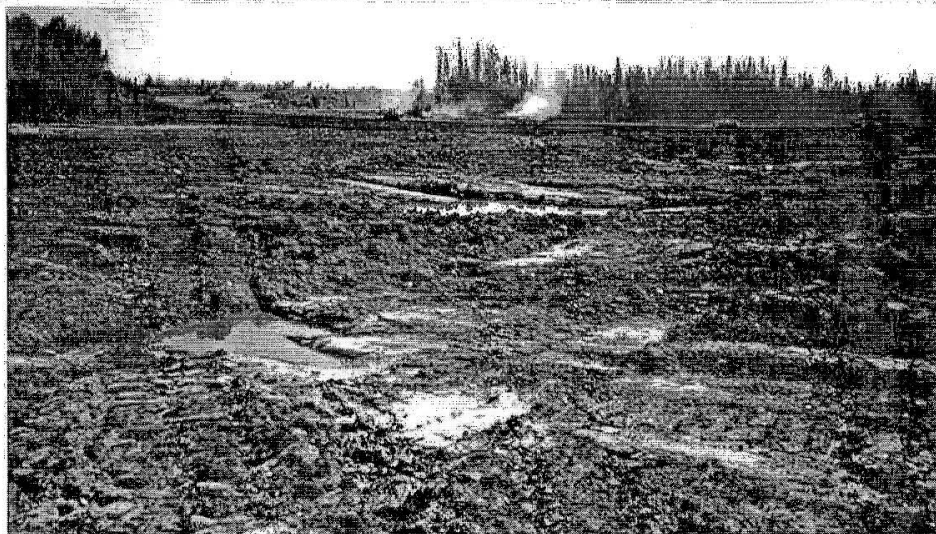
Photo 15. Surface of Basin Liner. Looking East.

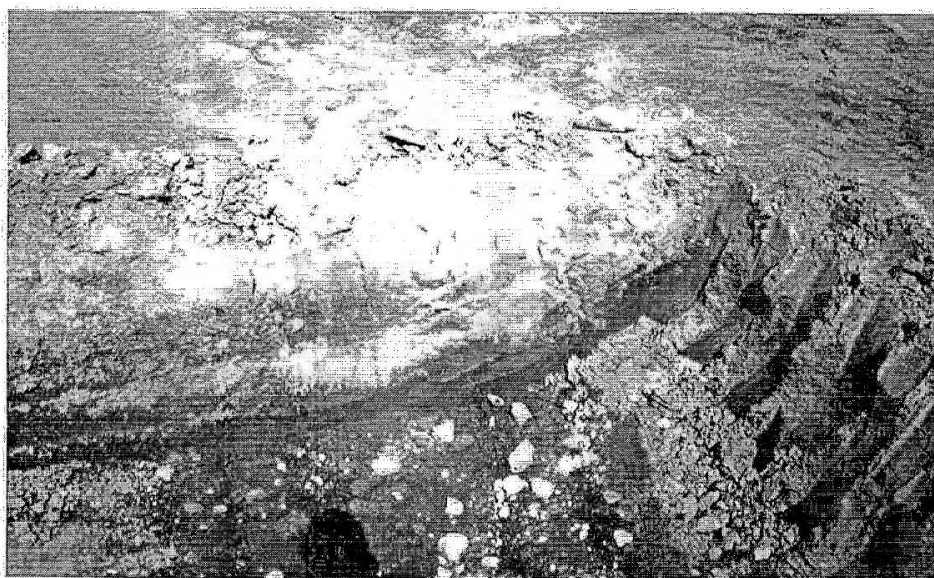
Photo 16. Exploration Trench Near South-West Edge of Basin Liner.

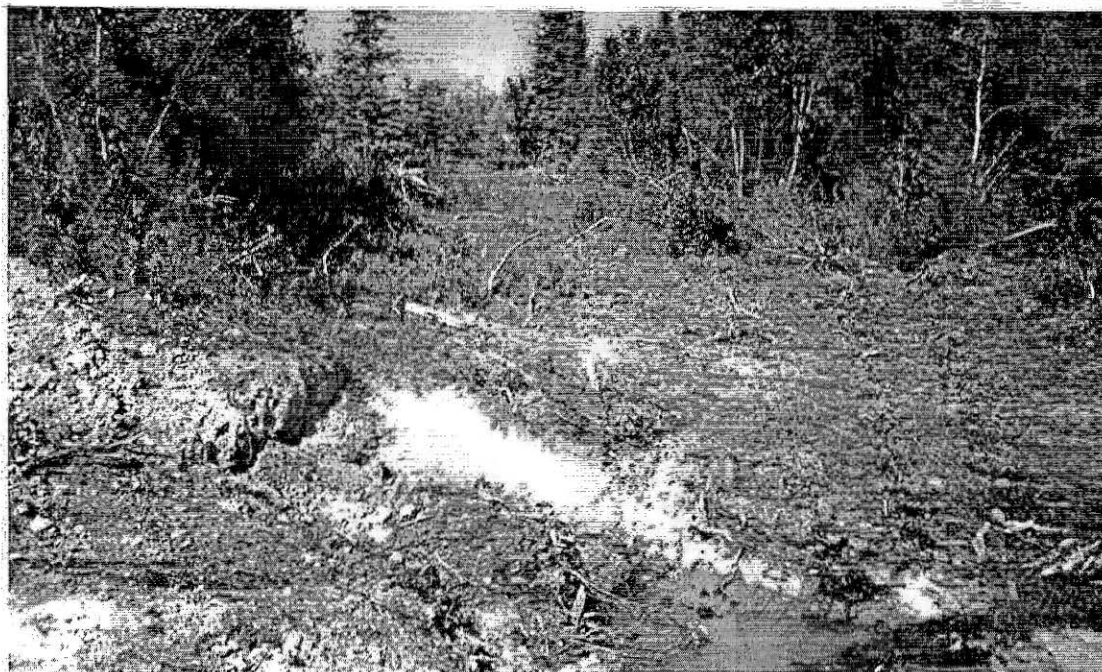
The till cap appears to have been completely removed locally in the base of the Reclaim Barge Channel (Ref. 9.8 and Photo 19, Appendix I). It was also recommended that these local areas be checked and sealed, as required. Similarly the local area, (probably a former stream bed) at the upstream edge of the Basin Liner. (Photo 17 in Appendix I).

Photo 17. Previous Stream and Trail of Juncture with West Edge of Basin Liner. Looking North-West.

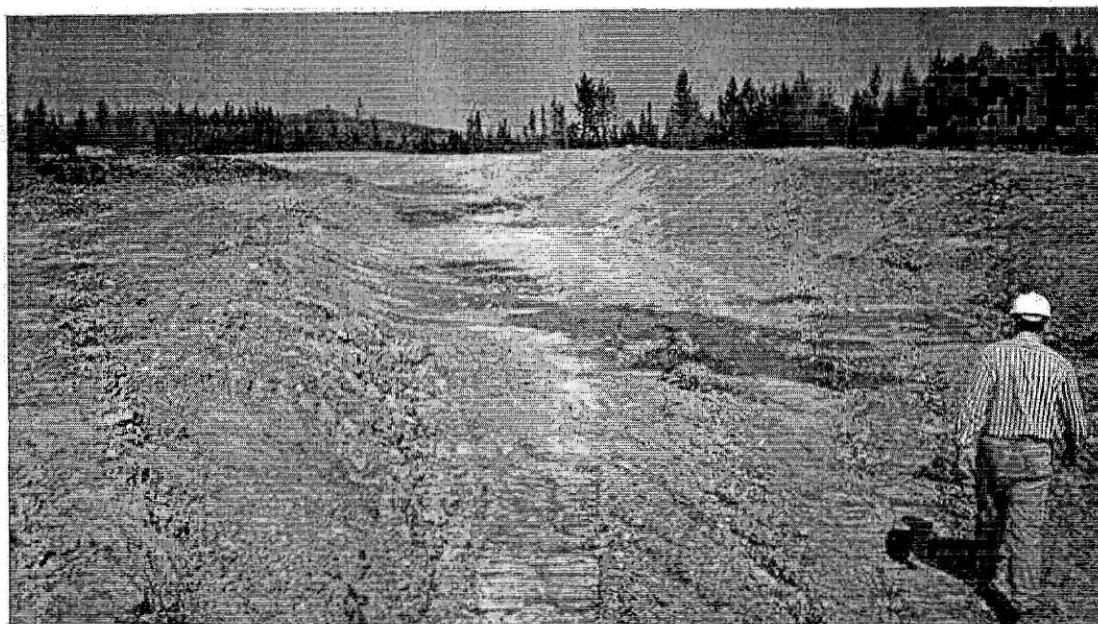
Photo 18. South end of Reclaim Barge Channel. Looking North-West.

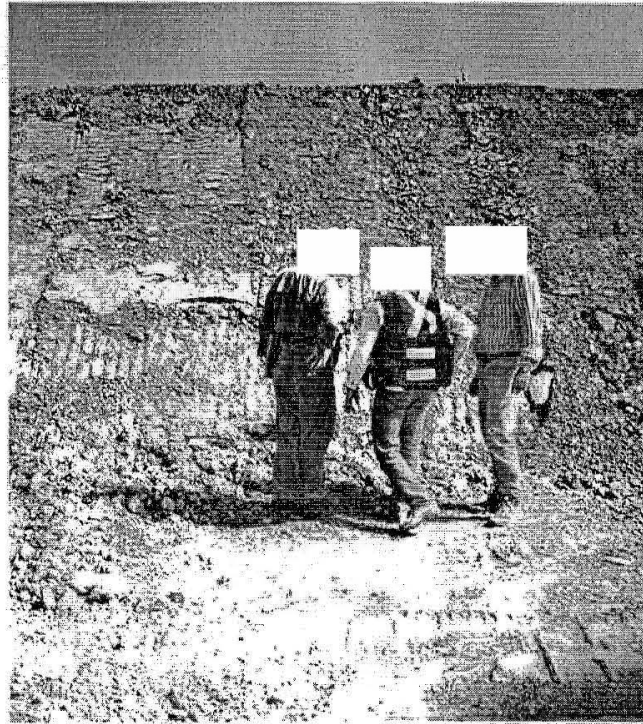
Photo 19. Exposure in base of Reclaim Barge Channel, East Side, Near South end.

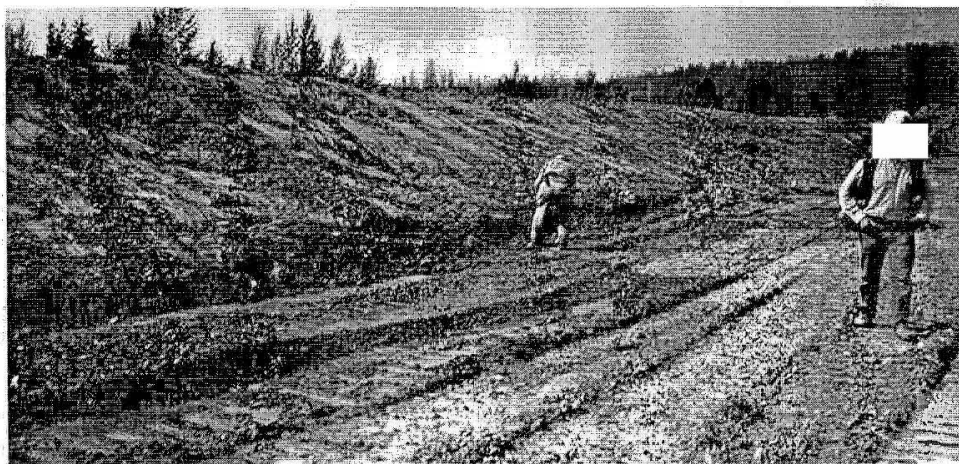
Photo 20. North Side of Reclaim Barge Channel at About Mid-Length.

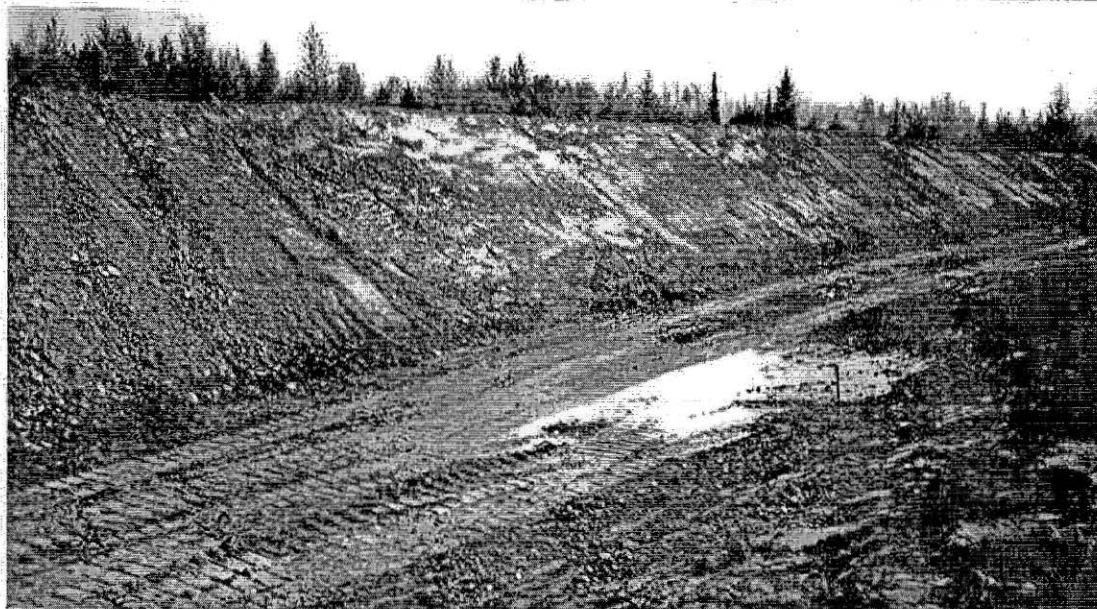
Photo 21. As for Photo 20 but at a Location Further West.

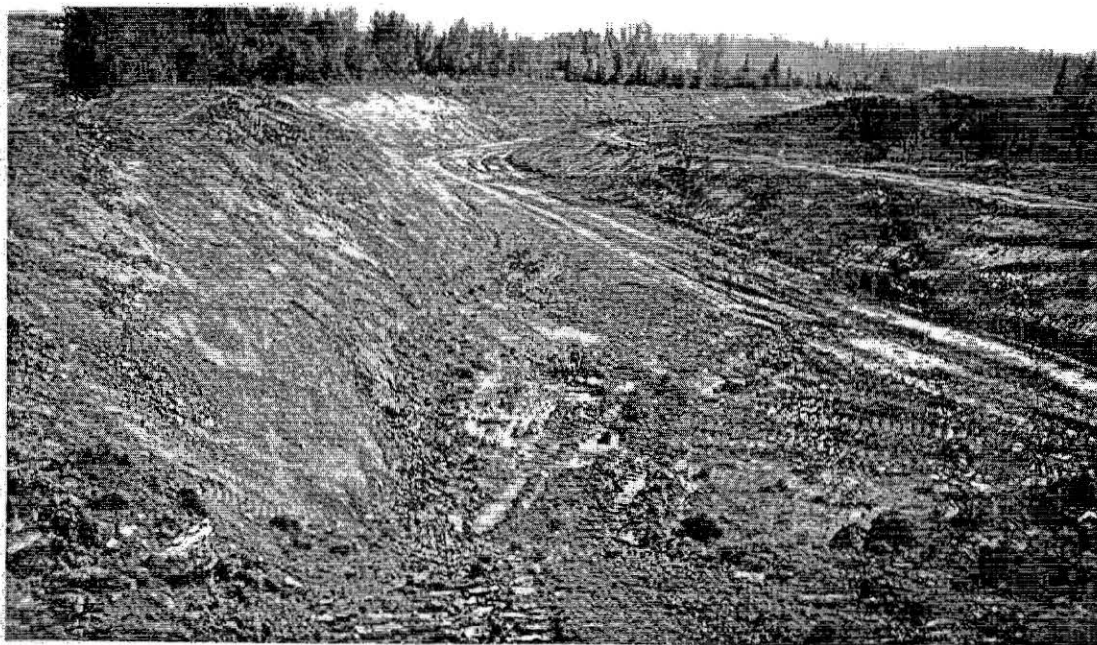
Photo 22. West End of Reclaim Barge Channel at the Time.
Looking East Towards Main Embankment.

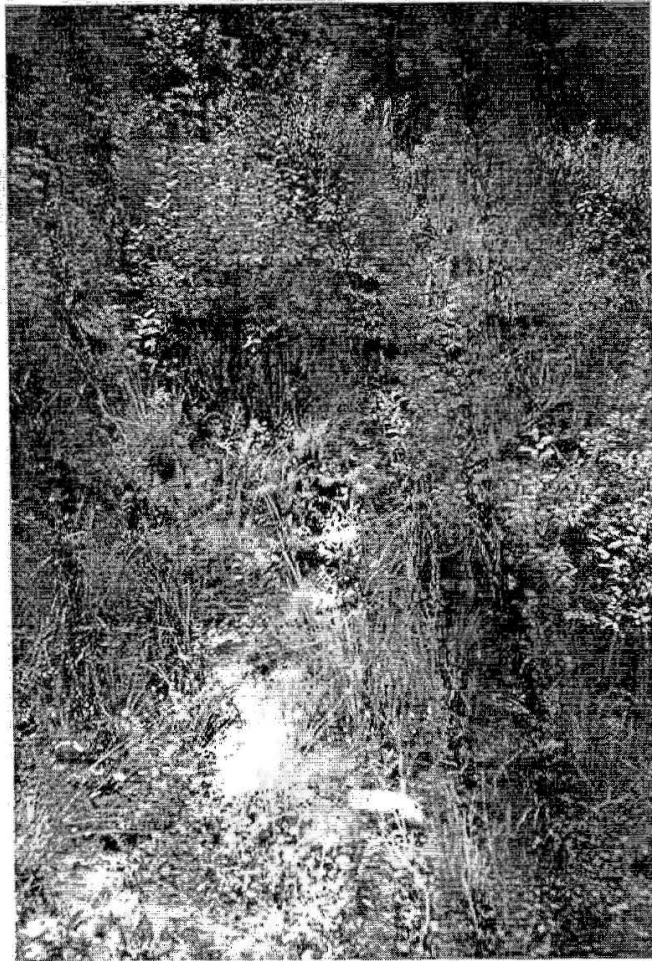
Photo 23. Flow from a Cased Borehole Near Junction of West Perimeter Road and Proposed South Embankment.
