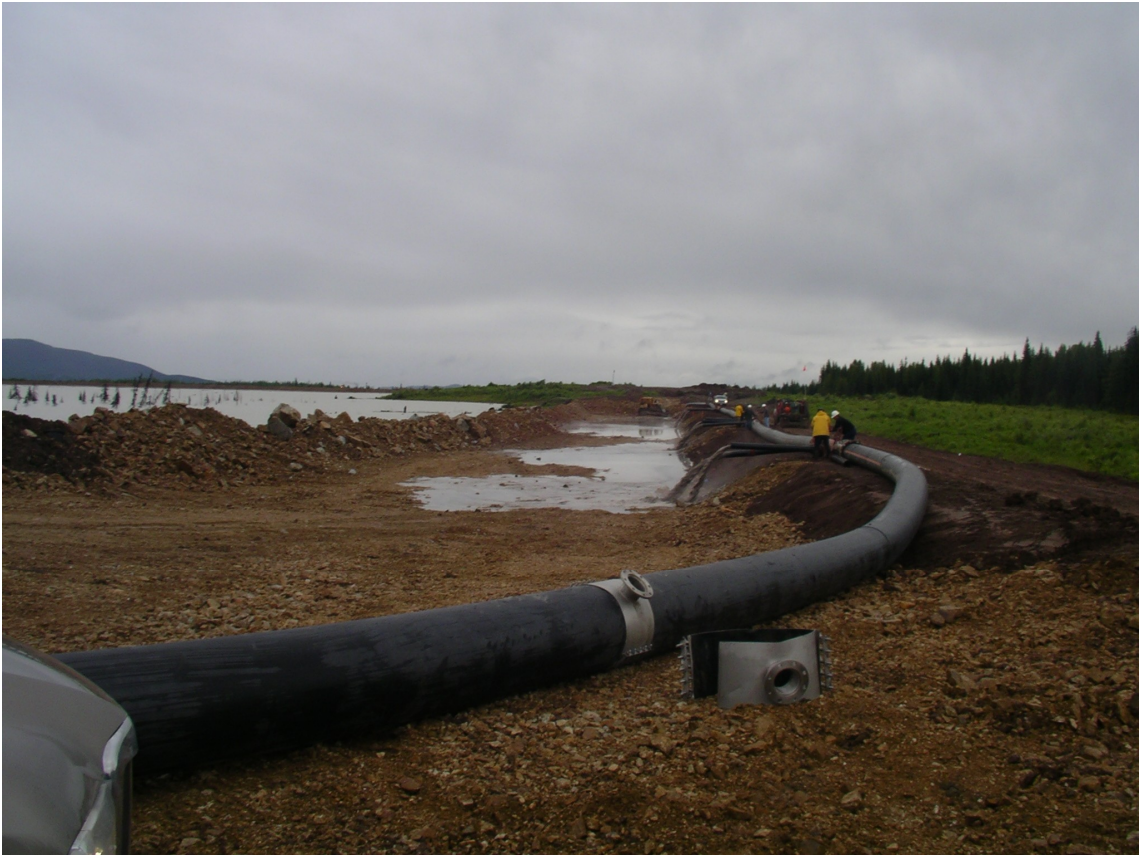
Figure 1: South embankment June 21, 2005

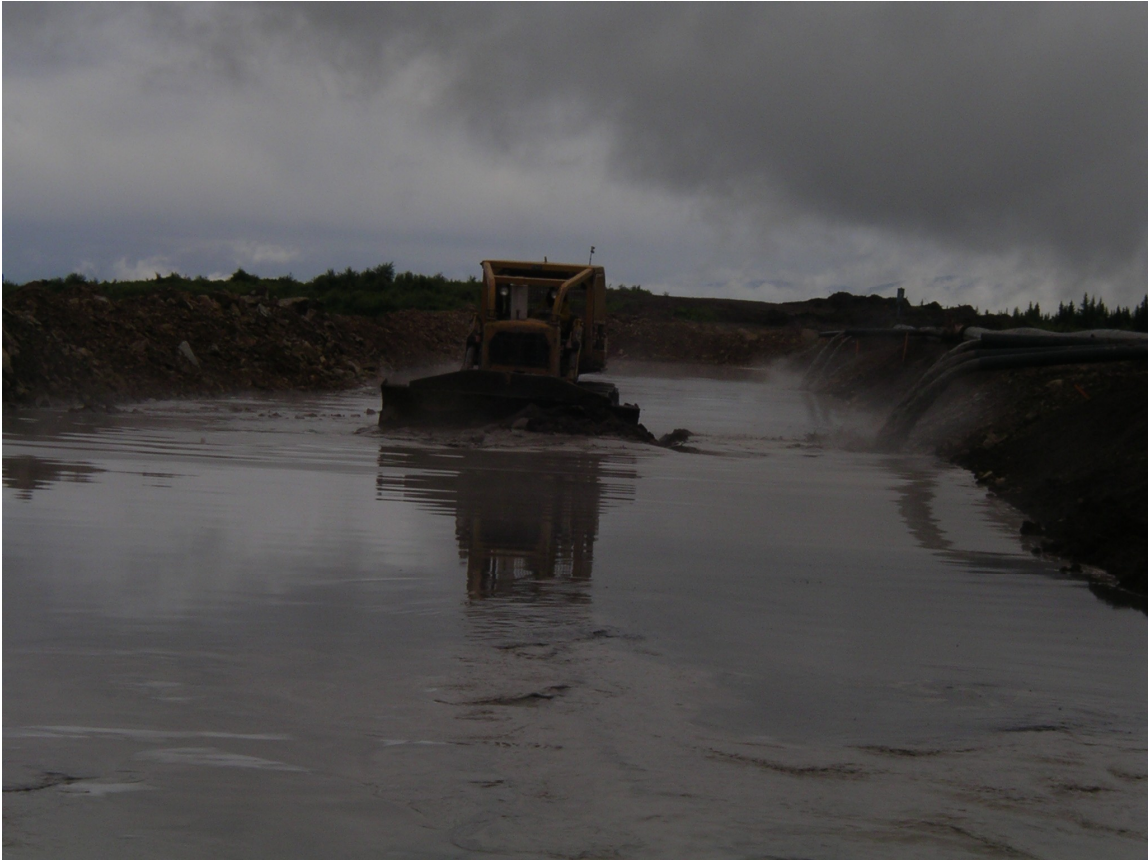
Figure 2: Day 1 of the Trial

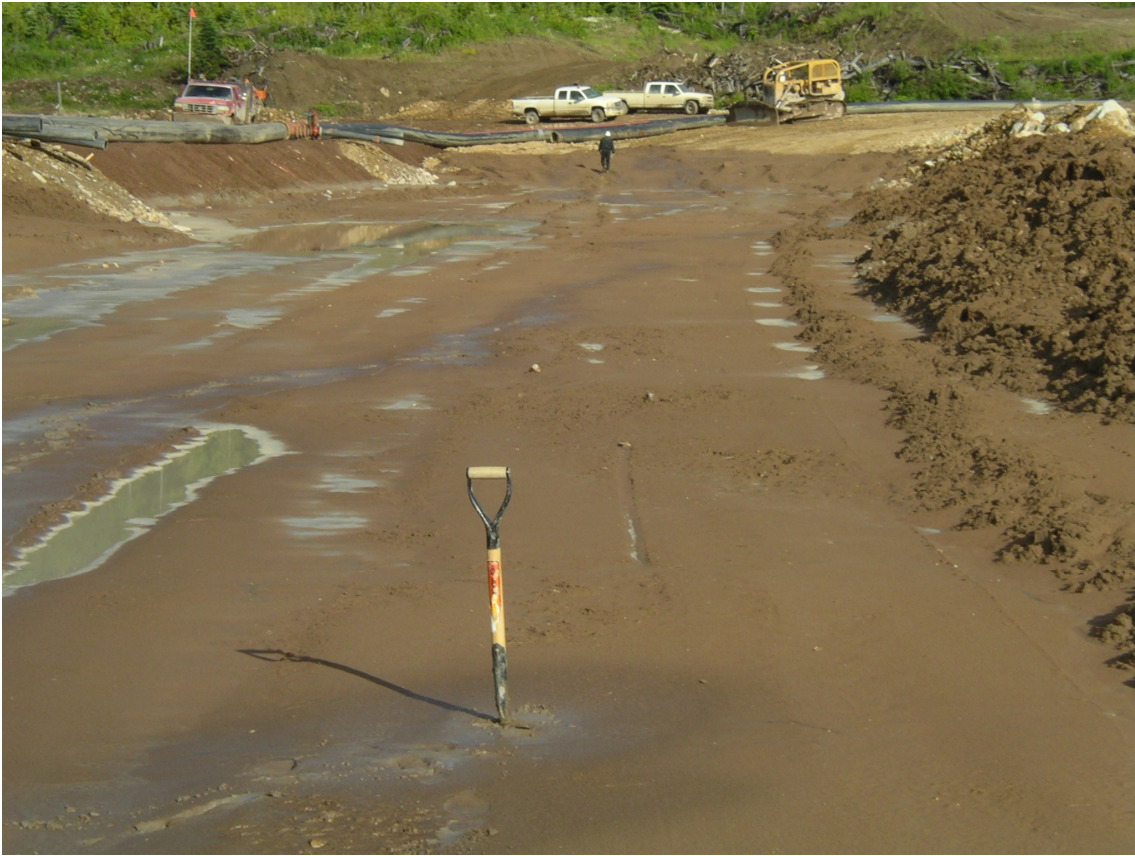
Figure 3: 1 foot of sand in 7.5 hours
