Our Reference: VA101-1/10-A.01
 Continuity Nbr.: V5-1042

Re: Slope Stability Analysis

A stability analysis was completed on the Main and Perimeter Embankments for the Mount Polley Tailings Storage Facility. MPMC feels they cannot economically place enough Zone C to the ultimate toe up to 948m elevation by summer 2006. The solution to this problem is to place as much Zone C as possible on the Perimeter Embankment, and continue placing till using Zone U as a running surface on the Main Embankment.

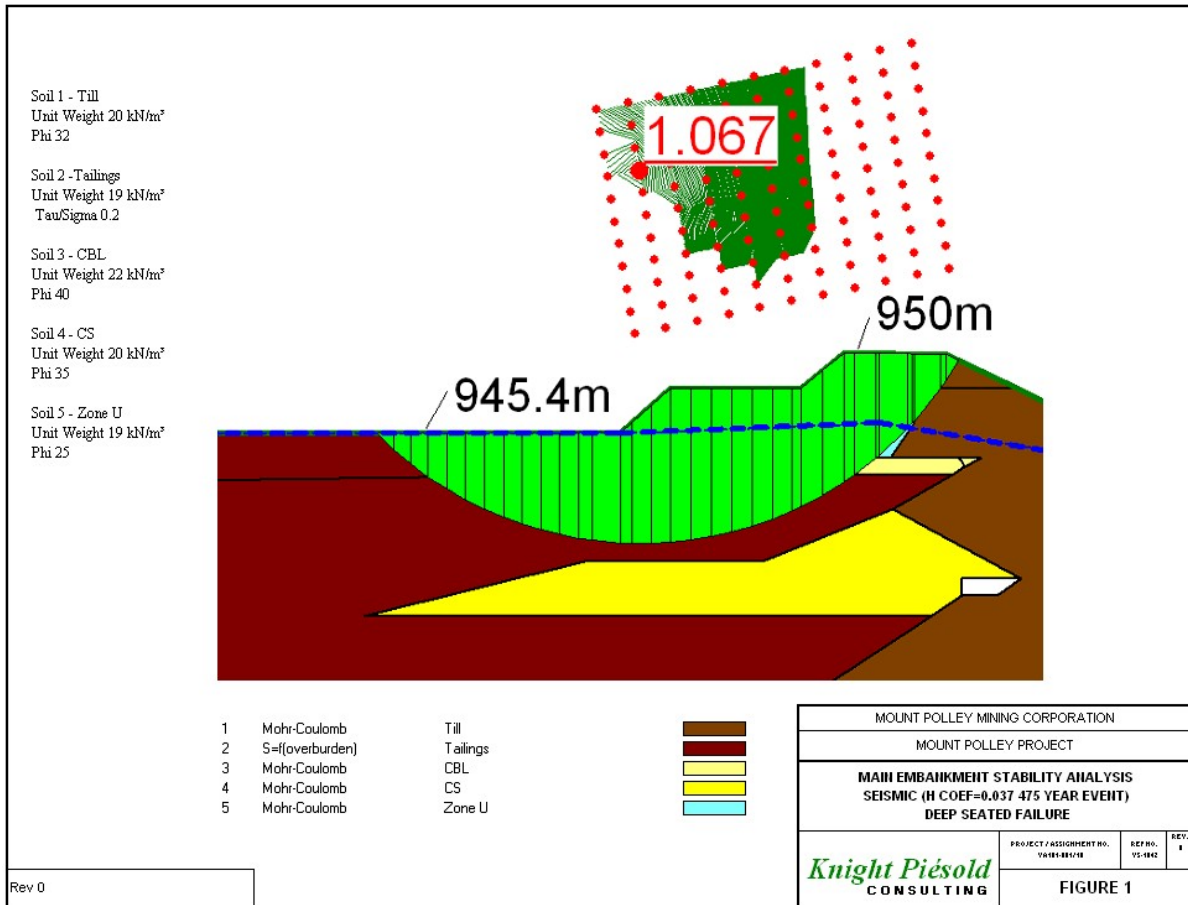
- The proposed design change will be safe statically for Stage 5 and in the long term.
- The proposed design change will be able to withstand a 1 in 475 year seismic event assuming that the liquefaction does not occur in the tailings.

- Due to the nature of the tailings it is expected that liquefaction will occur during a seismic event. The assumed design Tau/Sigma ratio of the tailings when liquefaction occurs is 0.05. This analysis indicates a factor of safety less than 1. This means **the dam will fail during a seismic event if liquefaction occurs while the freeboard is high** (if you deviate from the design by building a modified centerline core construction of 2:1 rather than 0.5:1). However, as the tailings rise, this risk is significantly reduced. In other words, as soon as Zone U construction is completed there is a high risk of failure. As the tailings rise up to the design freeboard level there is a low risk of failure due to a seismic event.
