**GEOTECHNICAL REVIEW, DRAINAGE ASPECTS**

**MAIN EMBANKMENT DAM**

**TAILINGS STORAGE FACILITY**

**MT. POLLEY PROJECT, BRITISH COLUMBIA**

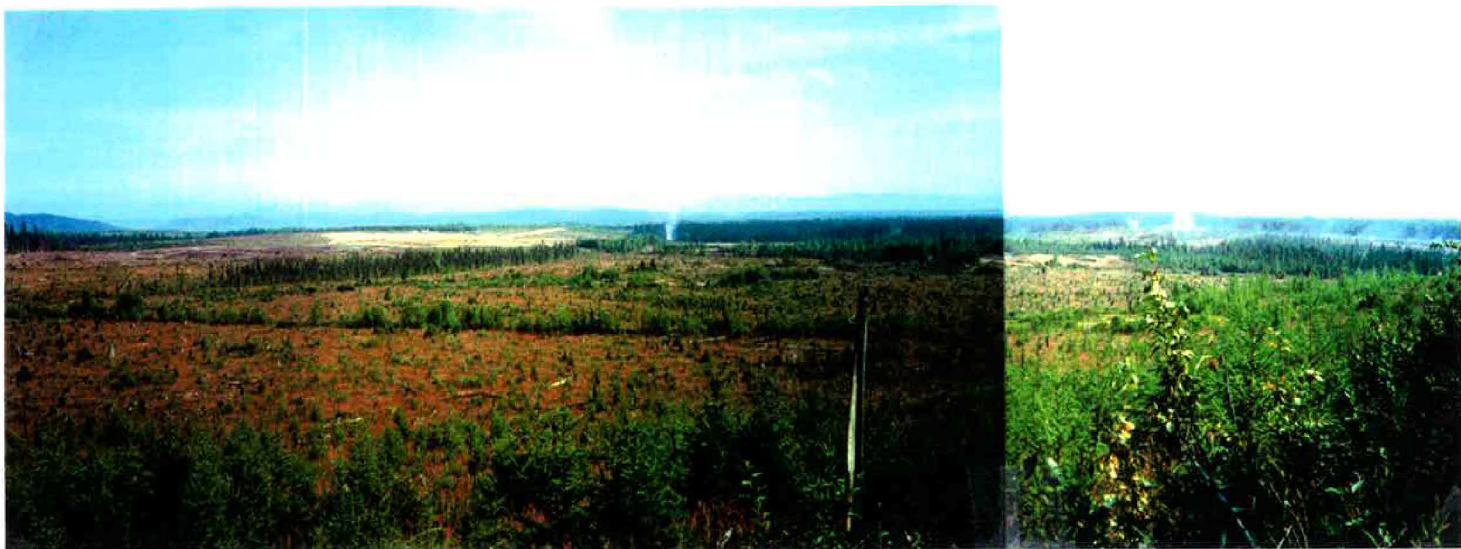
**Photo 1**

- (i) Photos 1 and 2 are taken from the high ground at about the Westerly limit of the Tailings Area at final elevation.
- (ii) The base of Stage Ib of the Main Embankment Dam is shown under construction in Photos 3 to 5, inclusive. The Basin liner already in place is visible in the right hand side of Photos 3 and 5.
- (iii) The base of Zone B of Stage Ib of the Main Embankment Dam is visible in Photos 6 and 7.
- (iv) Part of an embankment foundation drain can be seen in Photo 7.
- (v) Overall views of the Seepage Collection Pond are given in Photos 8 and 9. These show that excavation has been for the most part in the upper glacial till formation, with occasional exposures of a bluish-grey material which is

Overall View of Tailings Storage Facility Site  
from West Side, Looking South-East towards  
Main Embankment Area.

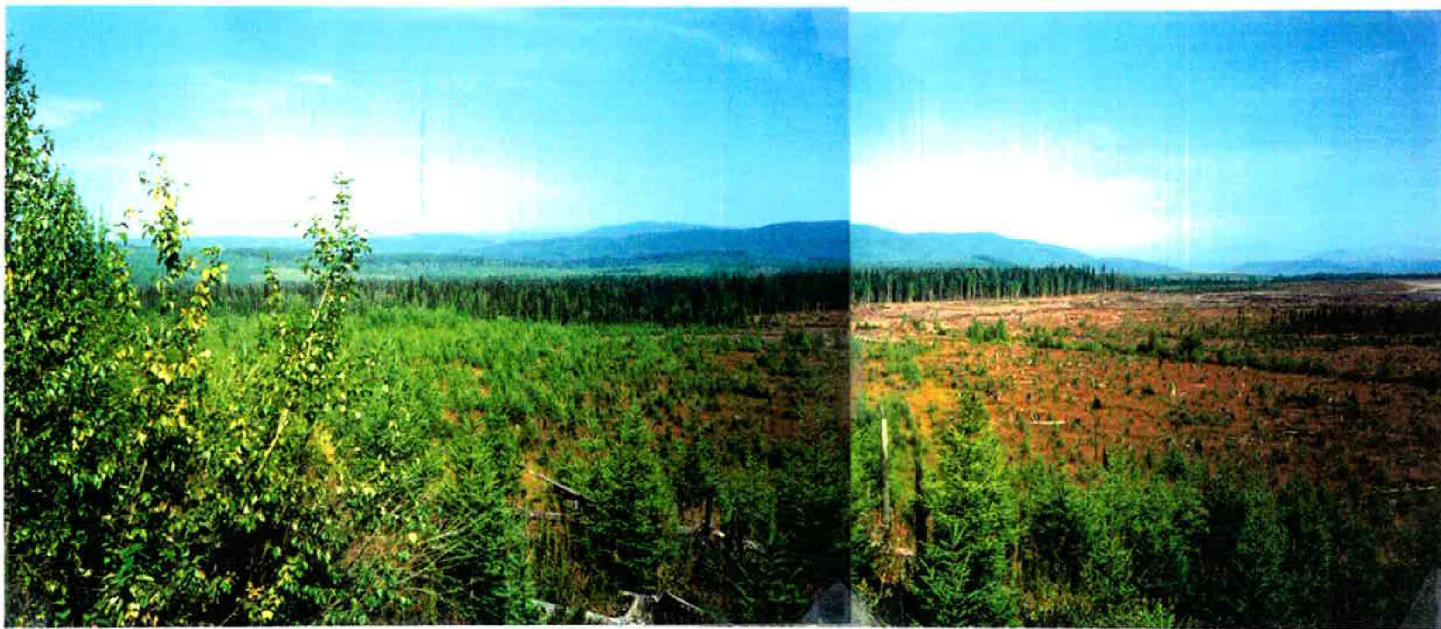
**Photo 2.** As for Photo 1 but Looking North towards  
Perimeter Embankment Area

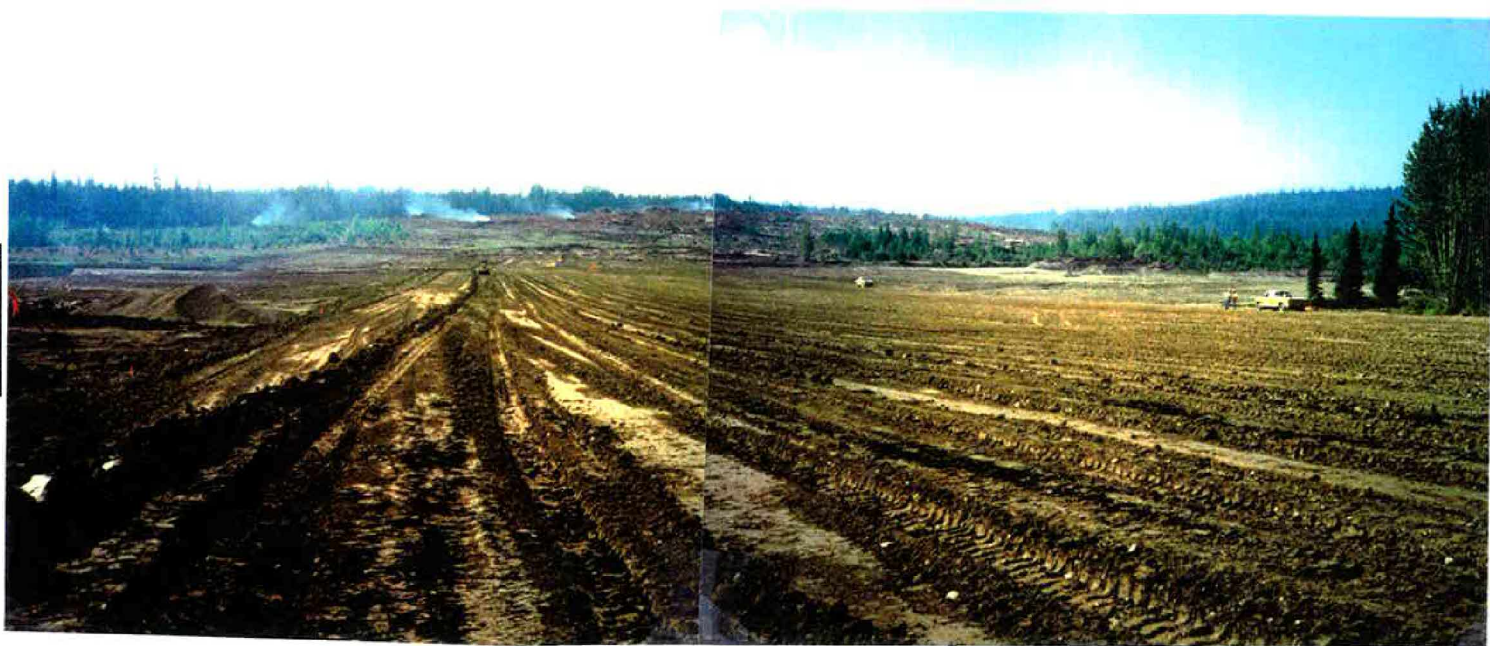
**Photo 3.** Base of Stage 1b of Main Embankment. Looking North-East

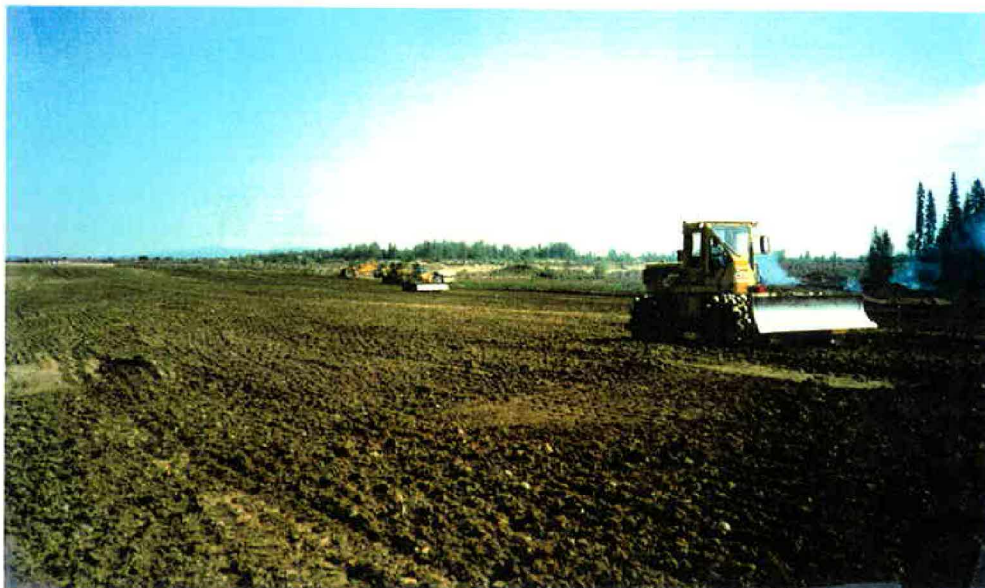
**Photo 4.** Base of Stage 1b of Main Embankment. Looking South-West.

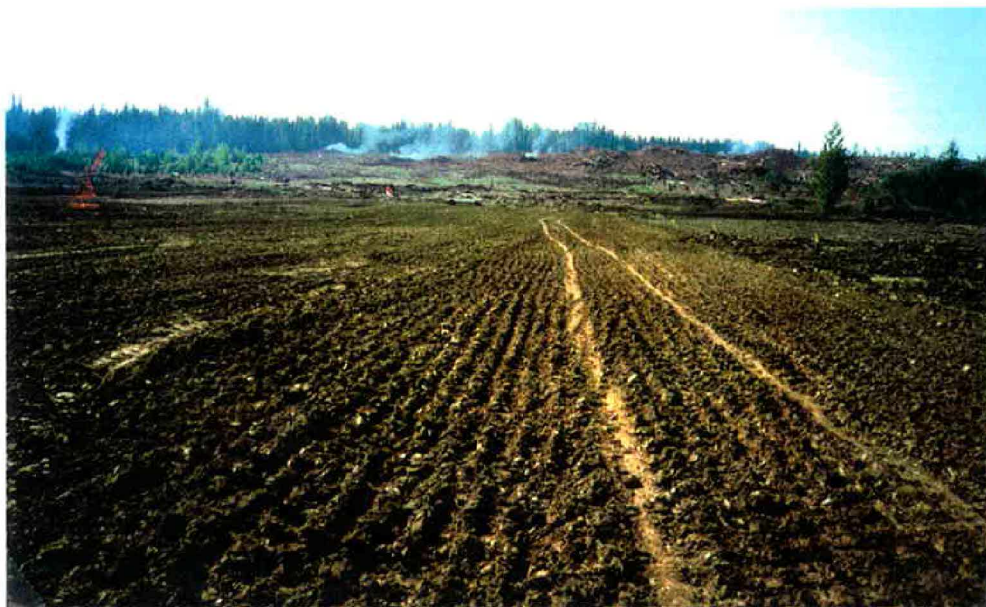
**Photo 5.** Base of Stage 1b of Main Embankment and Adjoining Basin Liner. Looking South-West.

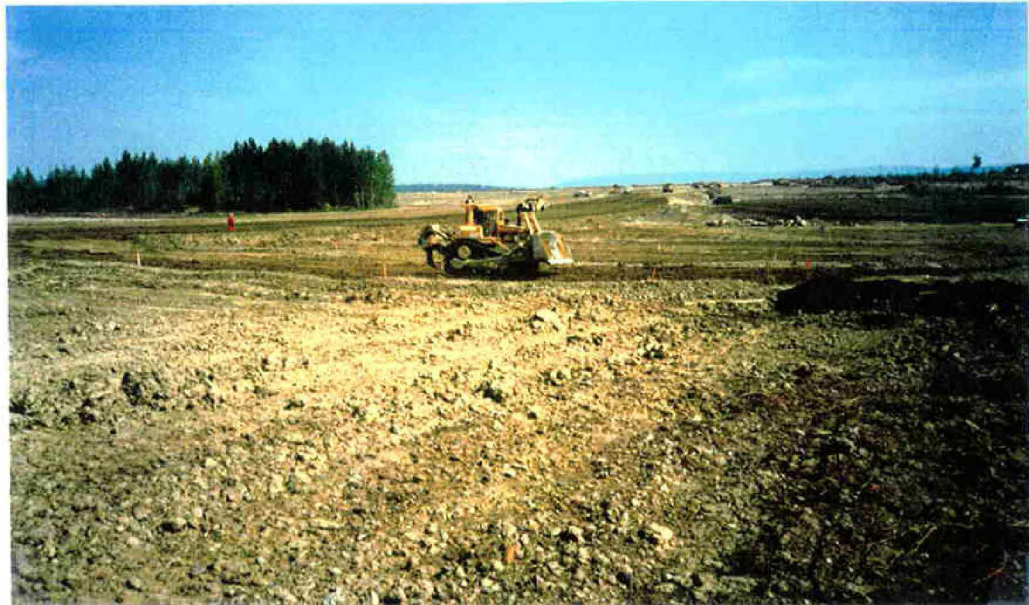
**Photo 6.** Base of Zone B of Stage 1b of Main Embankment near Seepage Collection Pond. Looking North-East.

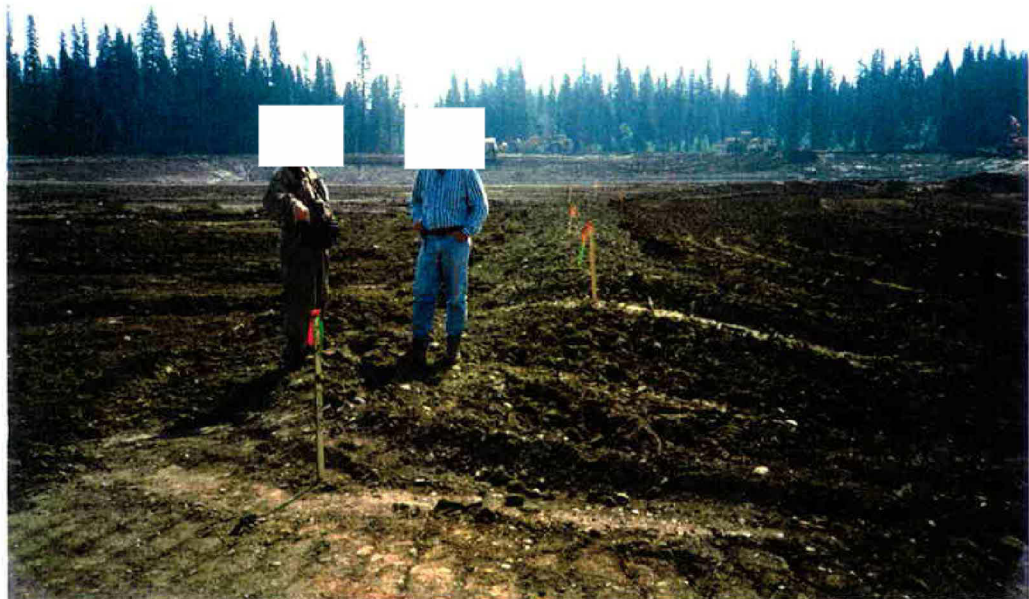
**Photo 7.** Base of Zone B of Stage 1b of Main Embankment. A Foundation Drain visible. Looking South-East.

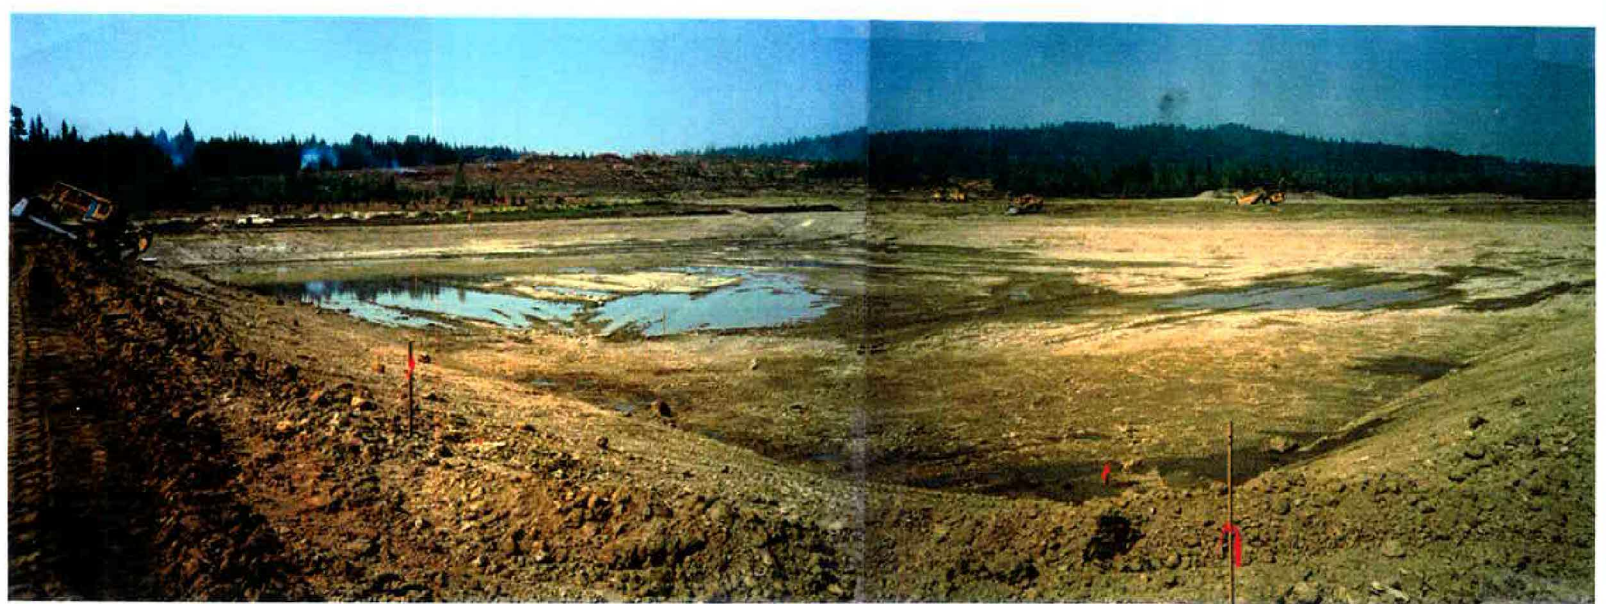
**Photo 8.** Panoramic View of Main Embankment Seepage Collection Point. Looking West.

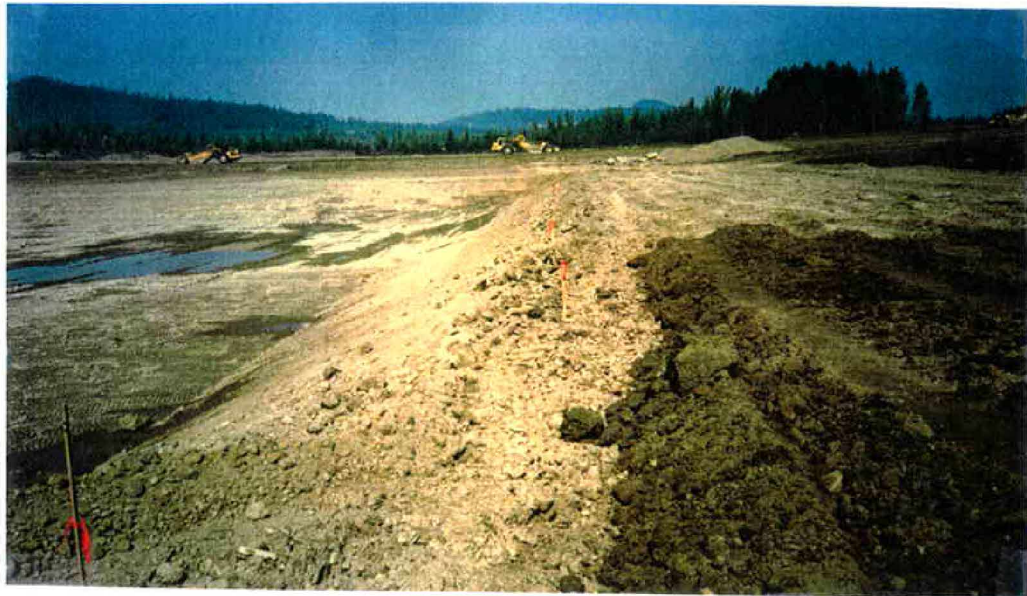
**Photo 9.** East Side of Main Embankment Seepage Collection Pond. Looking North.

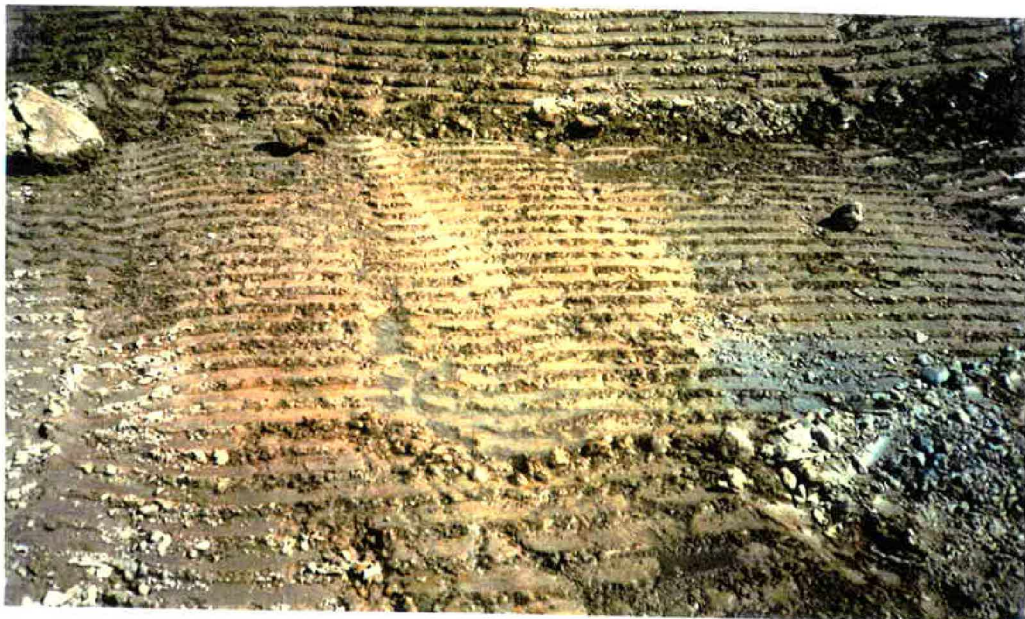
**Photo 10.** Base of Main Embankment Seepage Collection Pond near South-East Corner.

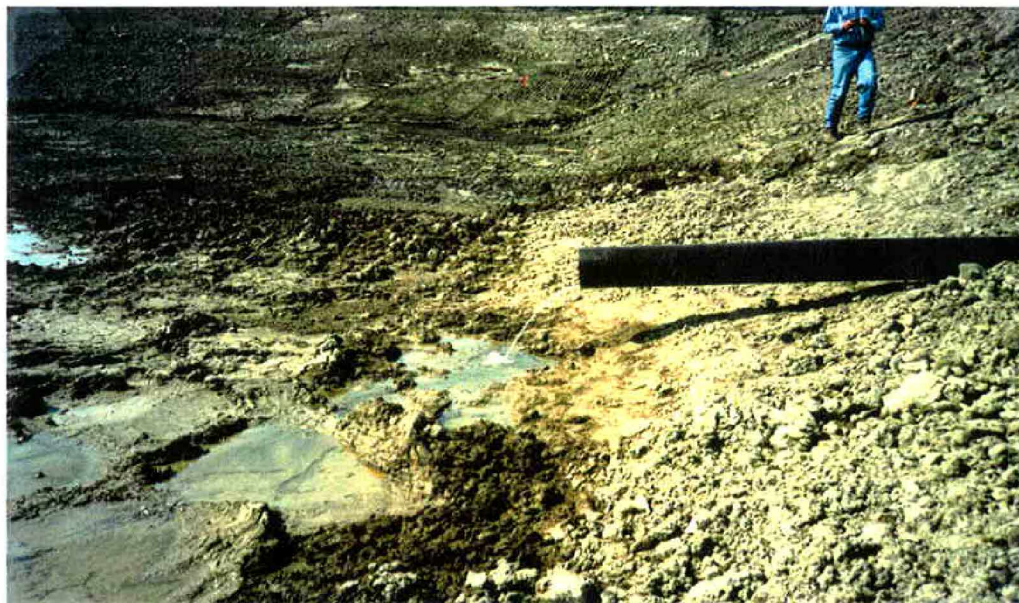
**Photo 11.** Outlet from Drain Monitoring Sump Discharging into Main Embankment Seepage Collection Pond.

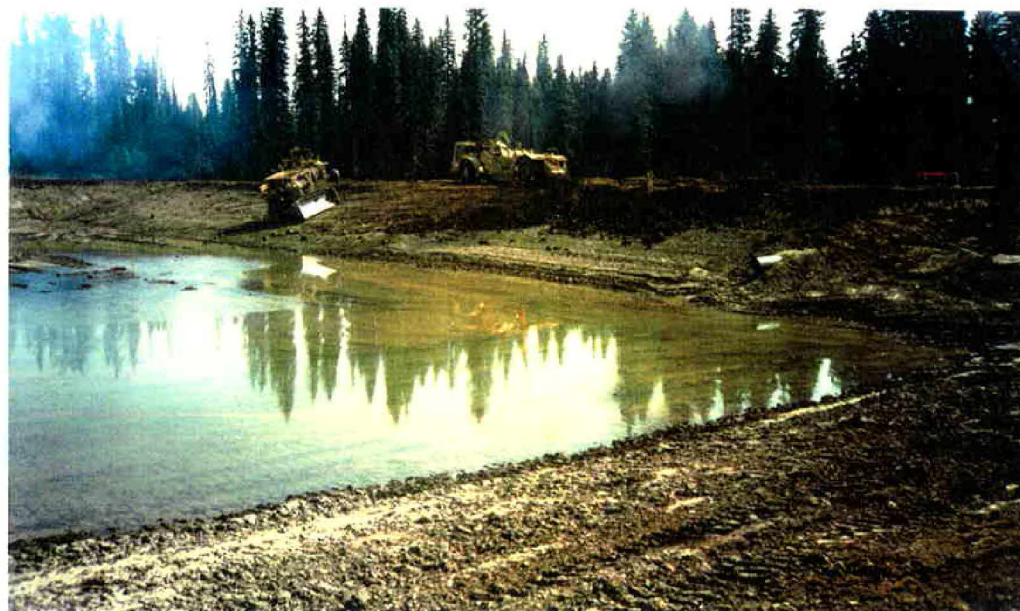
**Photo 12.** Decant from Main Embankment Seepage Collection Pond in South-West Corner.

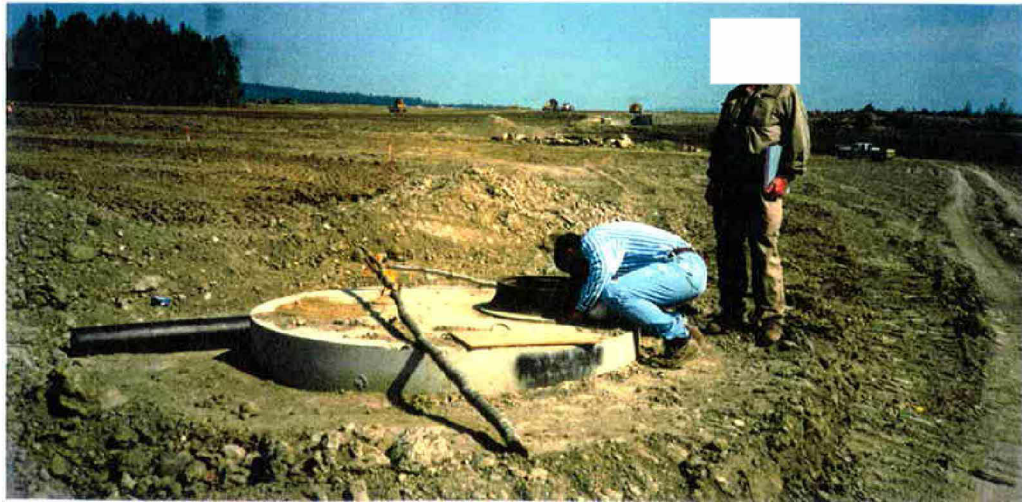
**Photo 13.** Top of Drain Monitoring Sump at Main Embankment.

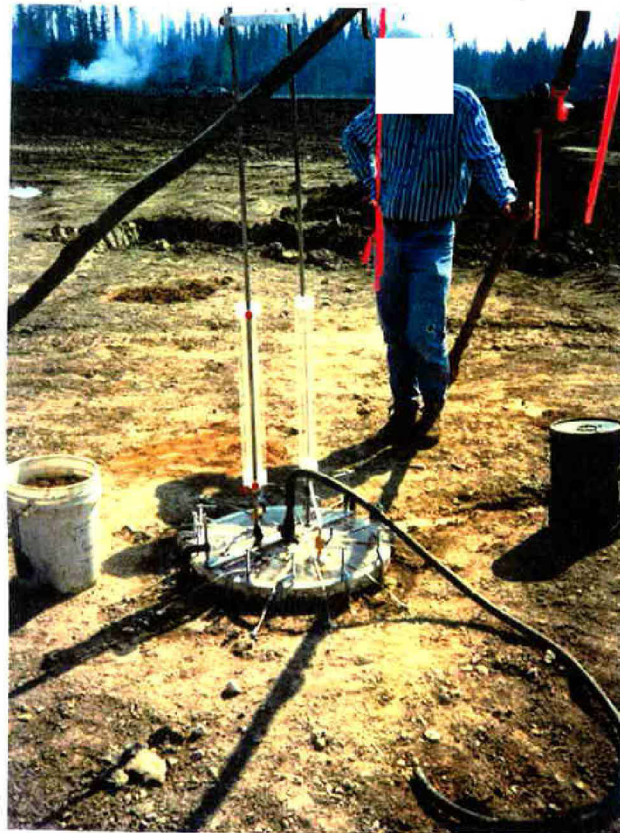
**Photo 14.** View of Field Air Entry Permeameter Testing of Basin Liner.

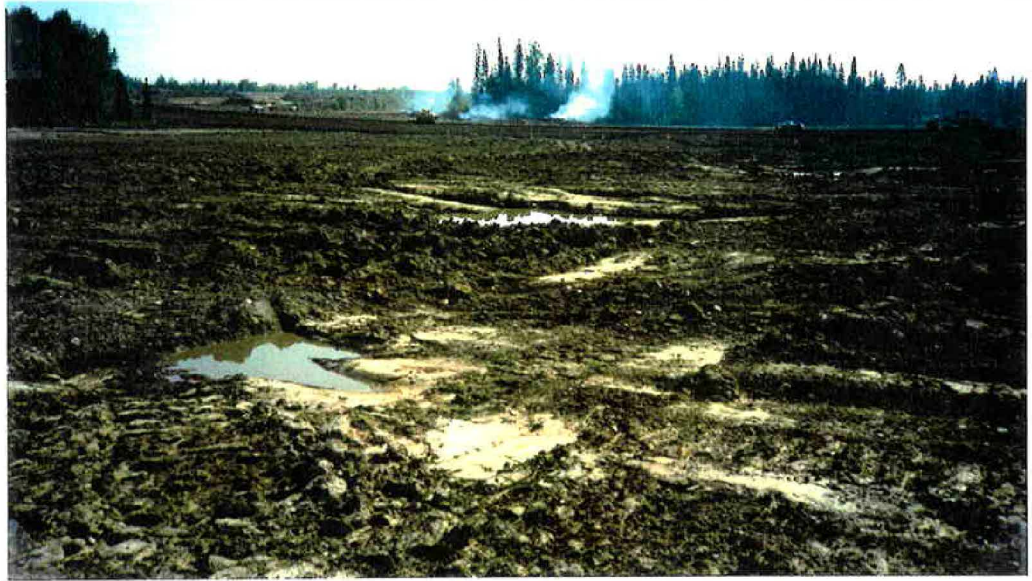
**Photo 15.** Surface of Basin Liner. Looking East.

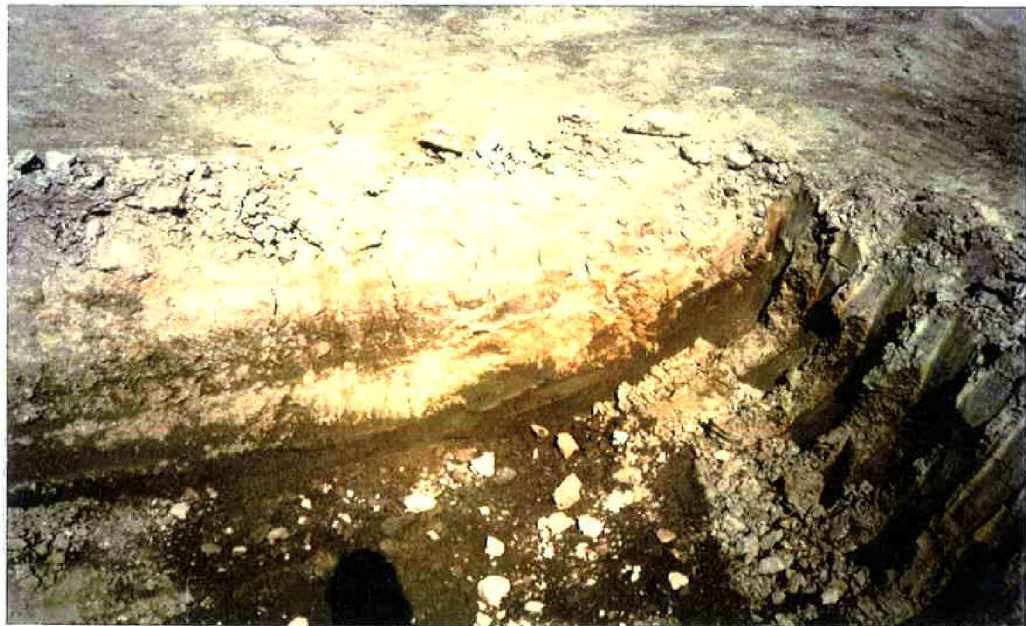
**Photo 16.** Exploration Trench Near South-West Edge of Basin Liner.

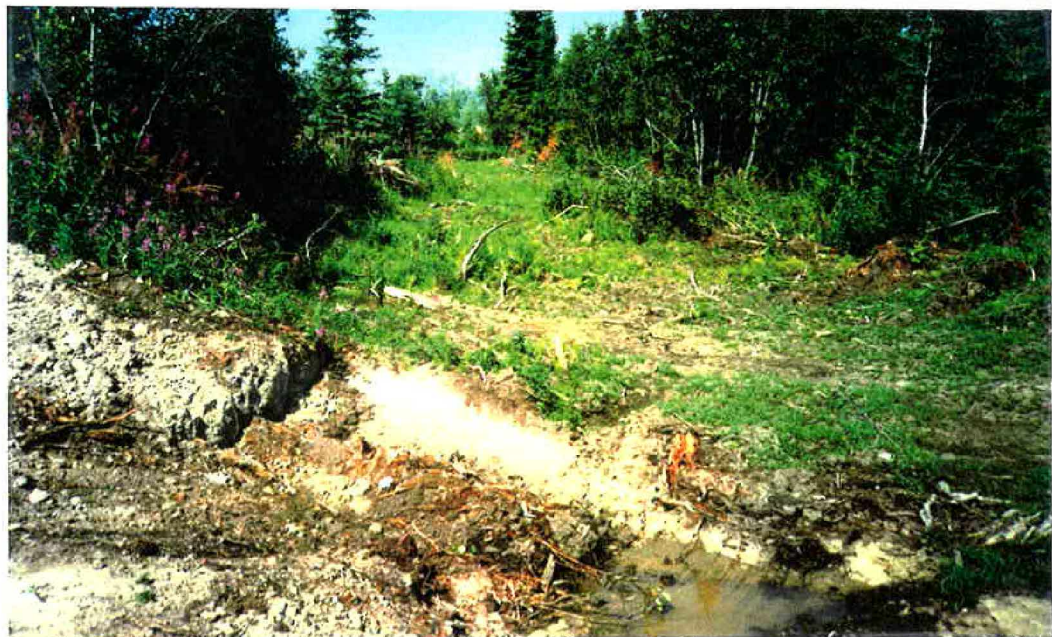
The till cap appears to have been completely removed locally in the base of the Reclaim Barge Channel (Ref. 9.8 and Photo 19, Appendix I). It was also recommended that these local areas be checked and sealed, as required. Similarly the local area, (probably a former stream bed) at the upstream edge of the Basin Liner. (Photo 17 in Appendix I).

**Photo 17.** Previous Stream and Trail of Juncture with West Edge of Basin Liner. Looking North-West.

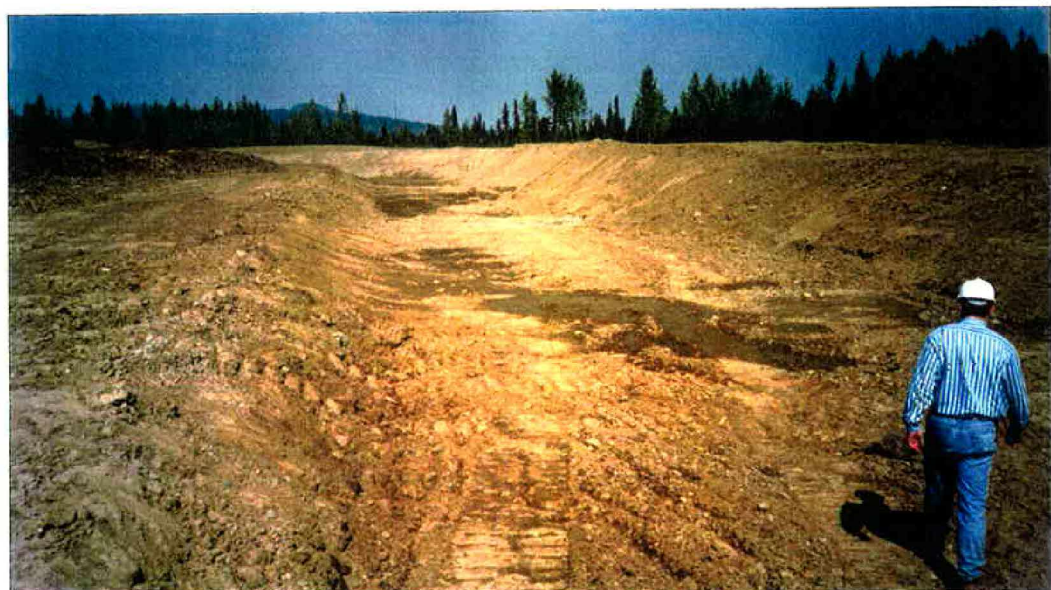
**Photo 18.** South end of Reclaim Barge Channel. Looking North-West.

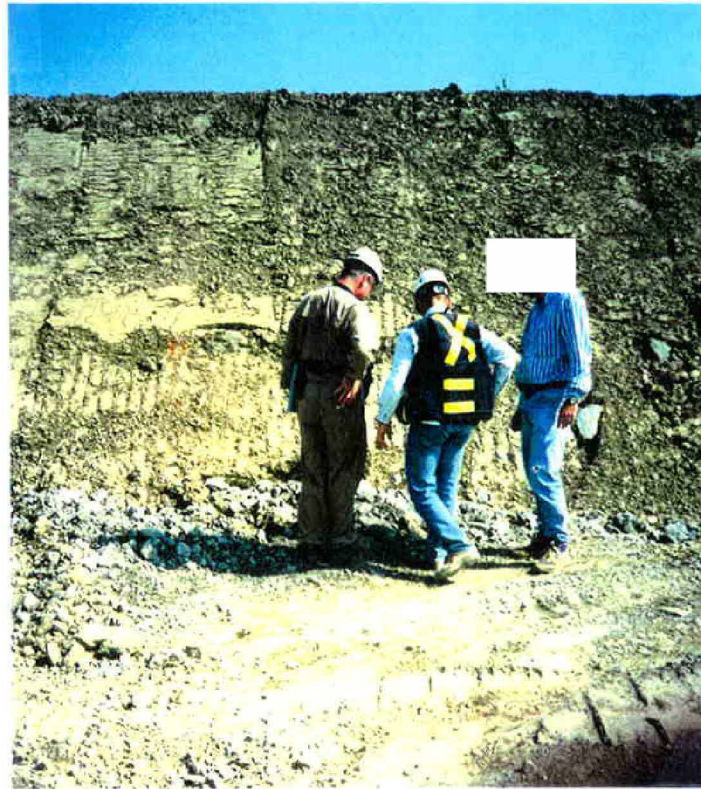
**Photo 19.** Exposure in base of Reclaim Barge Channel, East Side, Near South end.

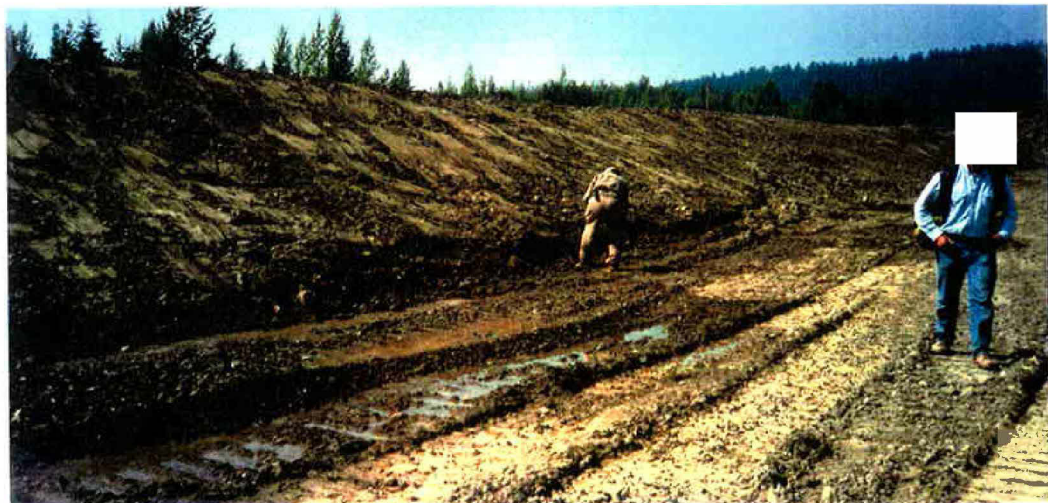
**Photo 20.** North Side of Reclaim Barge Channel at About Mid-Length.

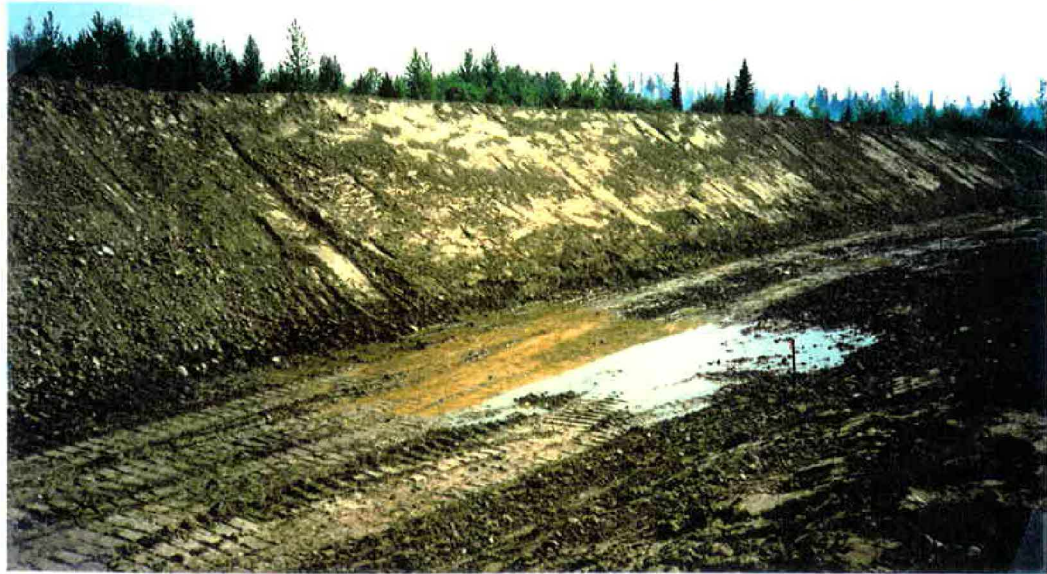
**Photo 21.** As for Photo 20 but at a Location Further West.

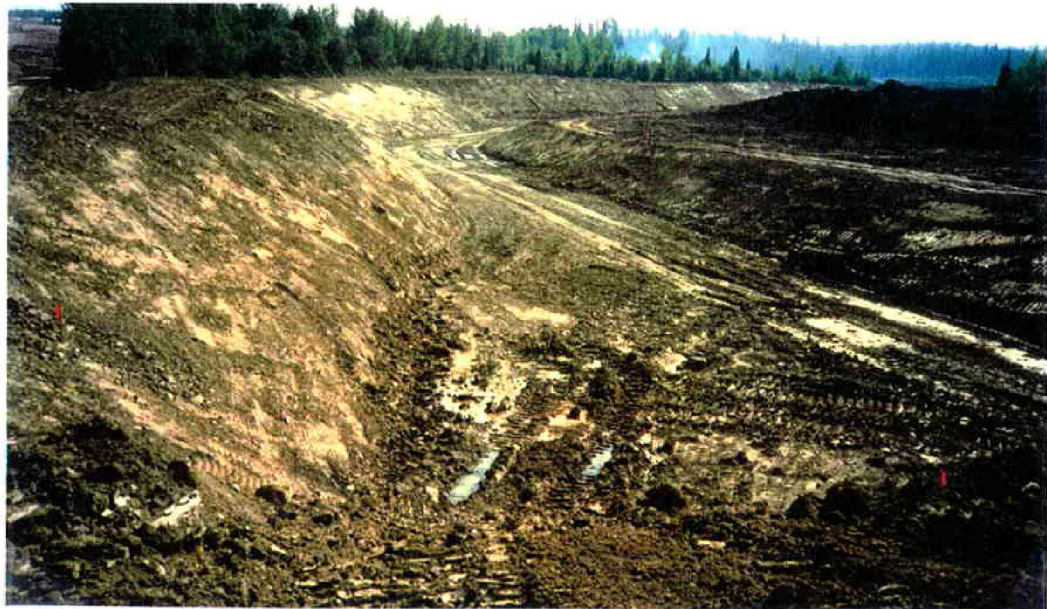
**Photo 22.** West End of Reclaim Barge Channel at the Time.  
Looking East Towards Main Embankment.

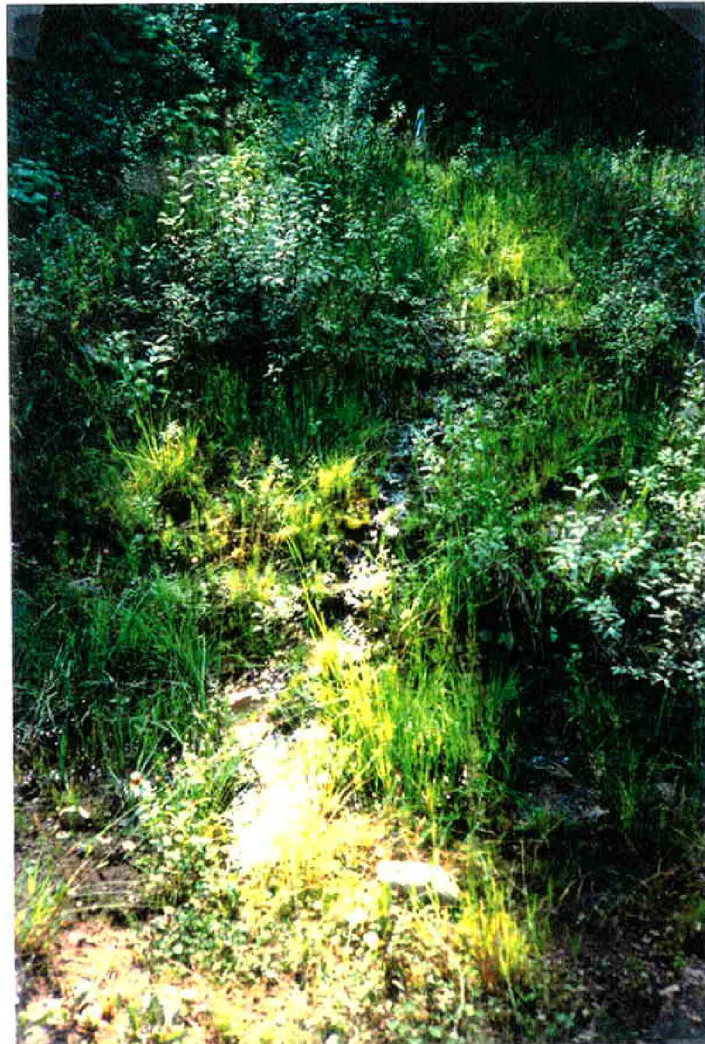
**Photo 23.** Flow from a Cased Borehole Near Junction of West Perimeter Road and Proposed South Embankment.
