**MOUNT POLLEY MINING CORPORATION  
MOUNT POLLEY MINE**

**TAILINGS STORAGE FACILITY  
REPORT ON 2009 ANNUAL INSPECTION**

VA101-1/27-1  
Rev 1  
January 5, 2010

**TAILINGS STORAGE FACILITY  
REPORT ON 2009 ANNUAL INSPECTION  
(REF. NO. VA101-1/27-1)**

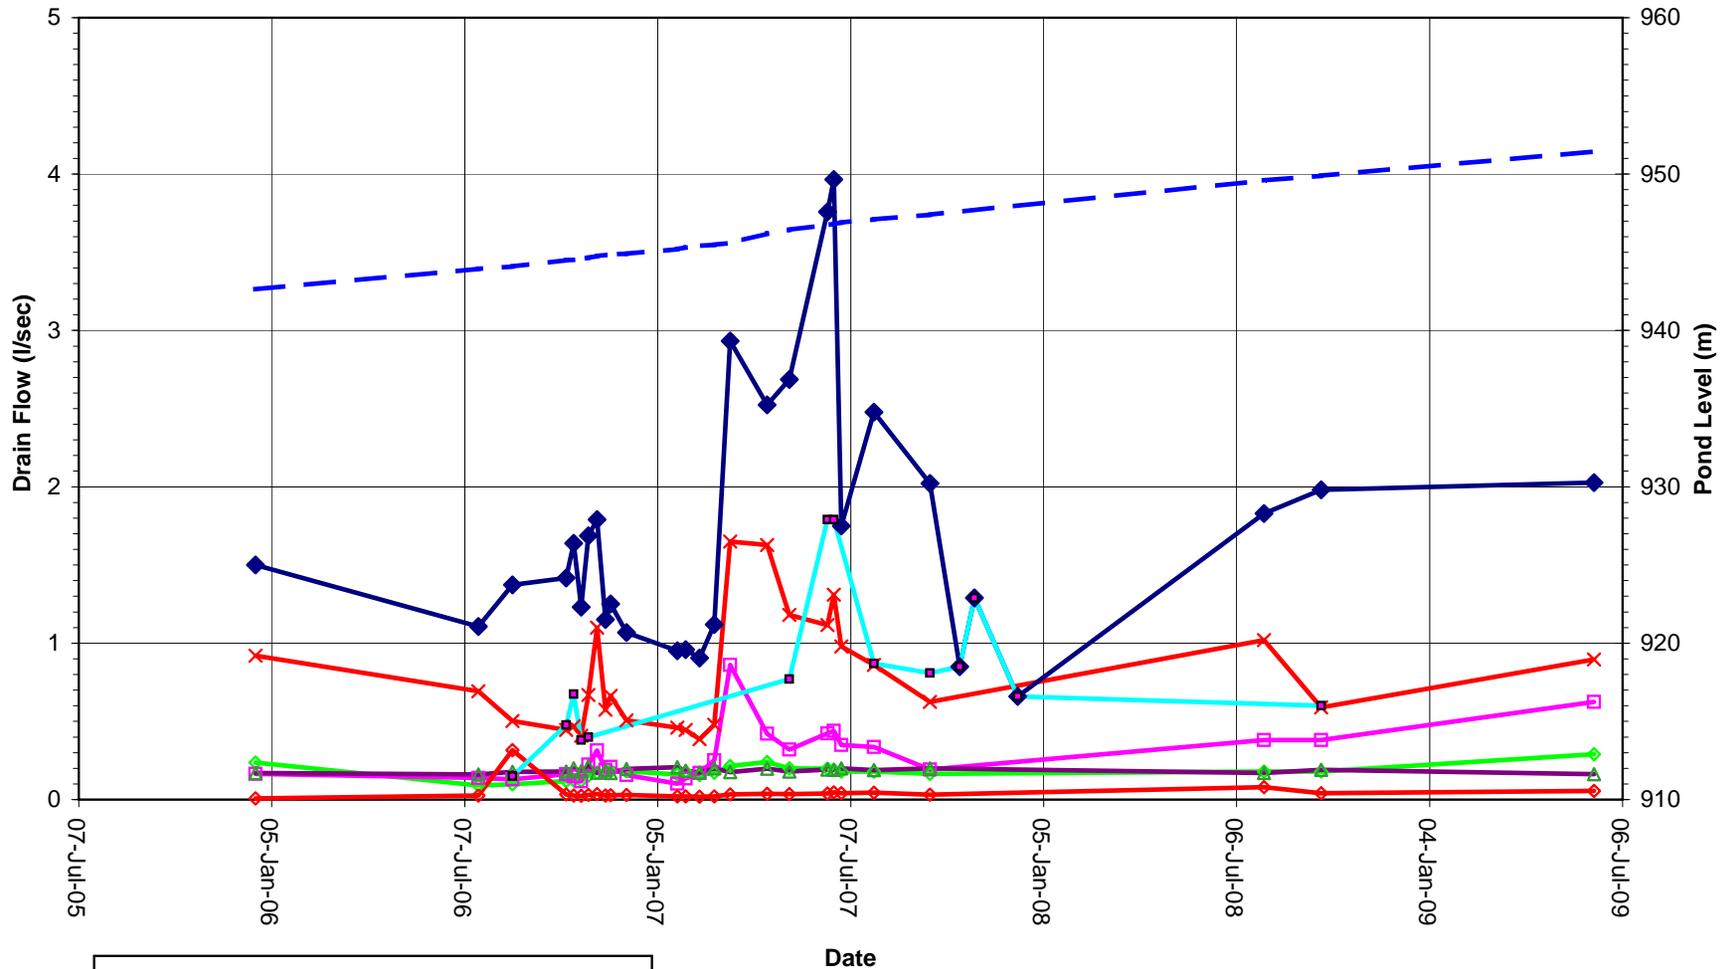
MOUNT POLLEY MINING CORPORATION	
MOUNT POLLEY MINE	
TAILINGS STORAGE FACILITY MAIN EMBANKMENT FOUNDATION DRAIN FLOWS	
	P/A NO. VA101-1/27
	REF NO. 1
<b>FIGURE 3.1</b>	
	REV 0

Water from the foundation drains and upstream toe drains flows into the seepage collection ponds where it is temporarily stored prior to being pumped back into the TSF. The flow rates for the foundation drains are shown on Figure 3.1. The flow rates for the upstream toe drains are shown on Figure 3.2. The total flows from foundation drains FD-1 to FD-5 have remained fairly constant during the past year at approximately 2.0 l/s. The flows from the upstream toe drains fluctuate throughout the year in response to the tailings deposition location and the tailings pond location. The flow from the Main Embankment upstream toe drain, as measured in June 2009, was approximately 11 l/s, which is slightly less than the same flows measured in 2008. The flow from the Perimeter Embankment upstream toe drain, as measured in June 2009, was approximately 8 l/s, which is consistent with the measured flows from 2008.

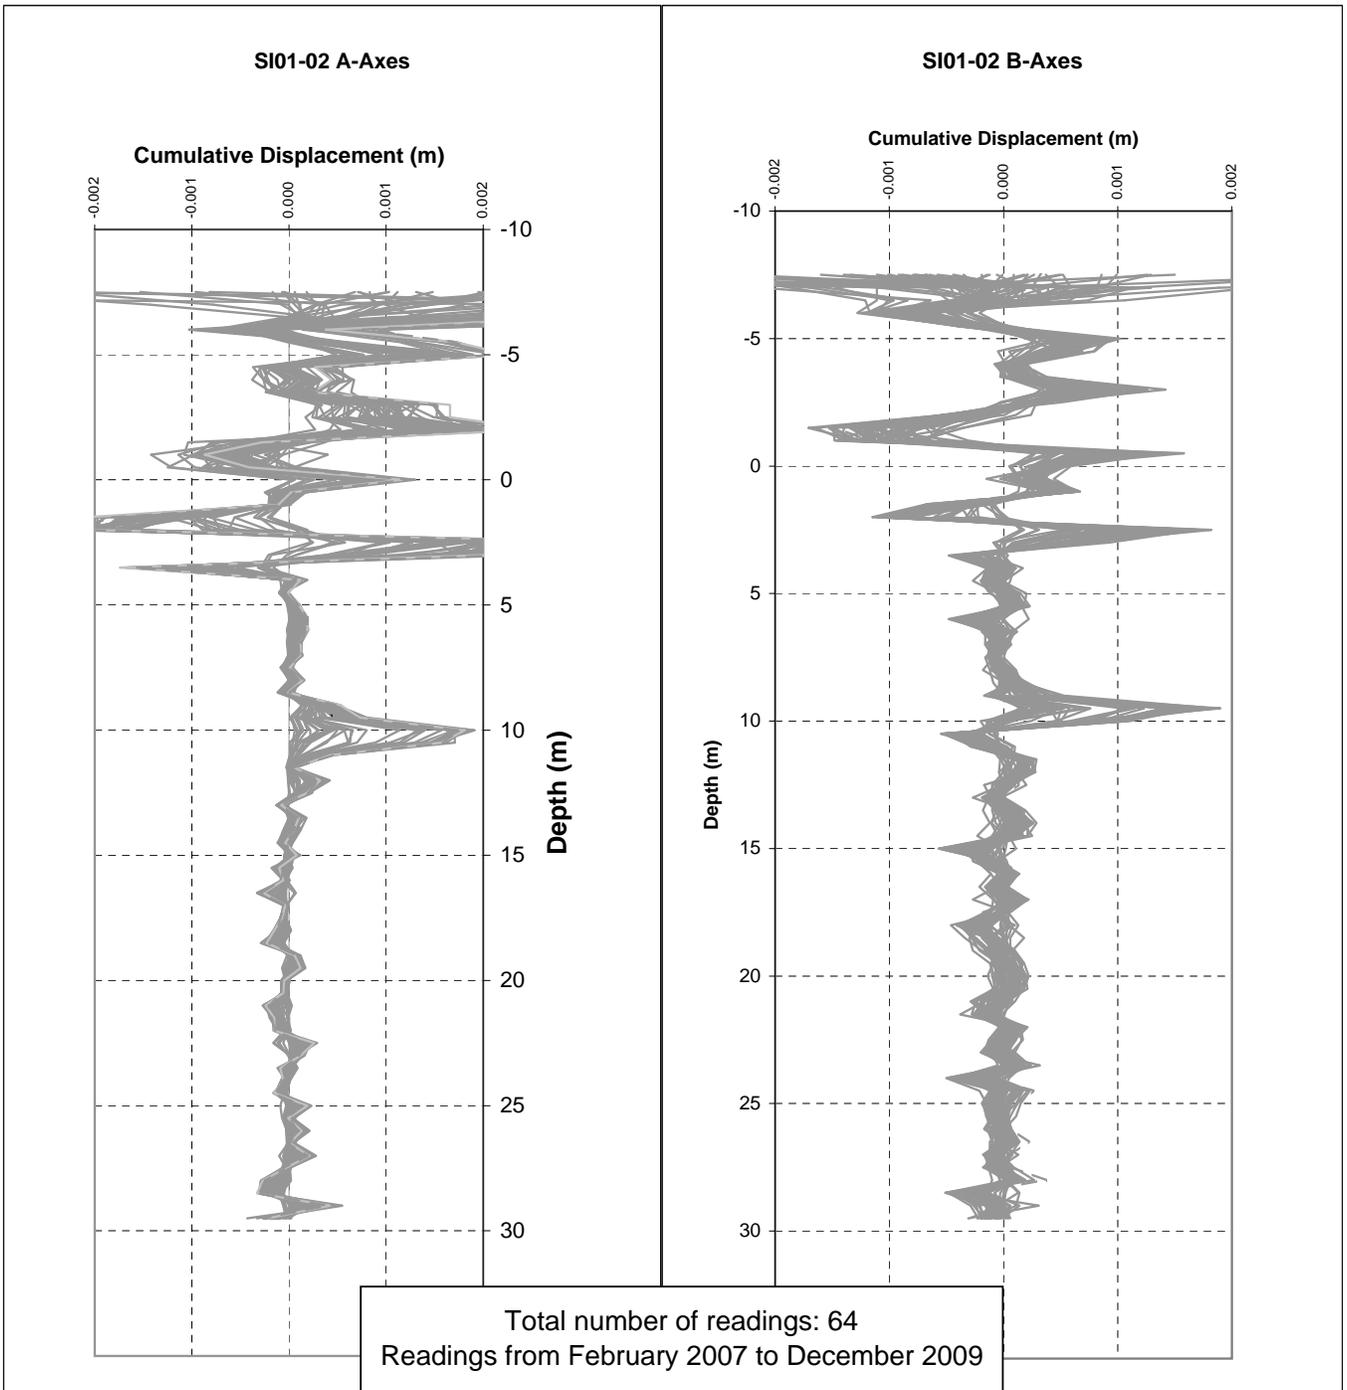
MOUNT POLLEY MINING CORPORATION	
MOUNT POLLEY MINE	
<b>DOWN HOLE INCLINOMETER DISPLACEMENT SI01-02</b>	
<i><b>Knight Piésold</b></i> CONSULTING	P/A NO. VA101-1/27
<b>FIGURE B.1</b>	REF NO. 1
	REV 0

The TSF instrumentation currently consists of four slope inclinometers installed at the Main Embankment and 62 operating vibrating wire piezometers installed in the Main, Perimeter and South Embankments. The piezometers monitor the pore pressures in the foundation materials, embankment fill materials, the tailings mass and the embankment drains. There have been no significant deviations in the inclinometers and no unexpected or anomalous pore pressures reading in the vibrating wire piezometers. However, inclinometer SI01-02 is showing slight deviations at an approximate depth of 10 m below ground in the lacustrine silts. This is being closely monitored by MPMC who have increased the monitoring frequency of the inclinometers to weekly. MPMC has also expanded the buttress at the Main Embankment as a result of the measured displacements in SI01-02.

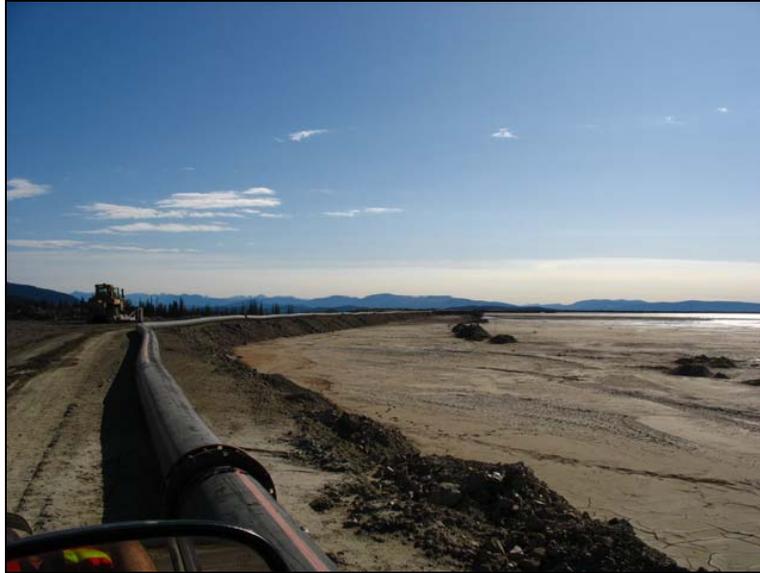
**PHOTO 1** – Tailings beach development on the Perimeter Embankment

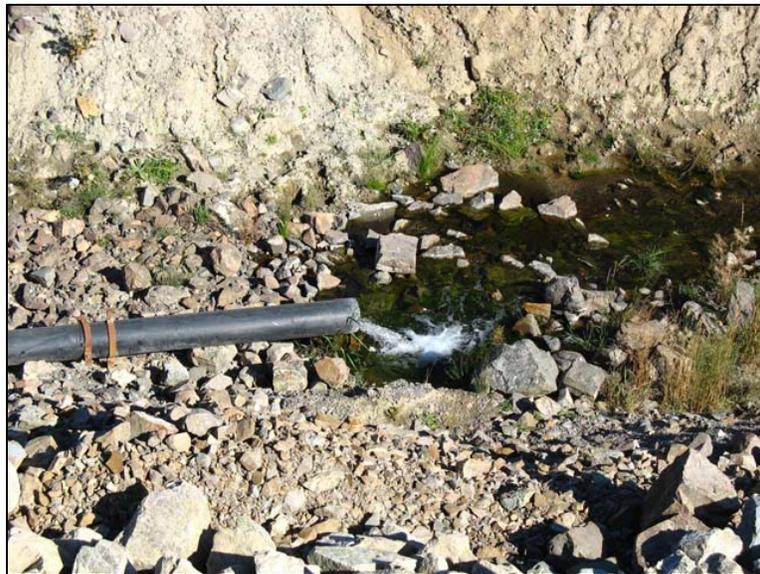
**PHOTO 2** – Perimeter Embankment Toe Drain flow.

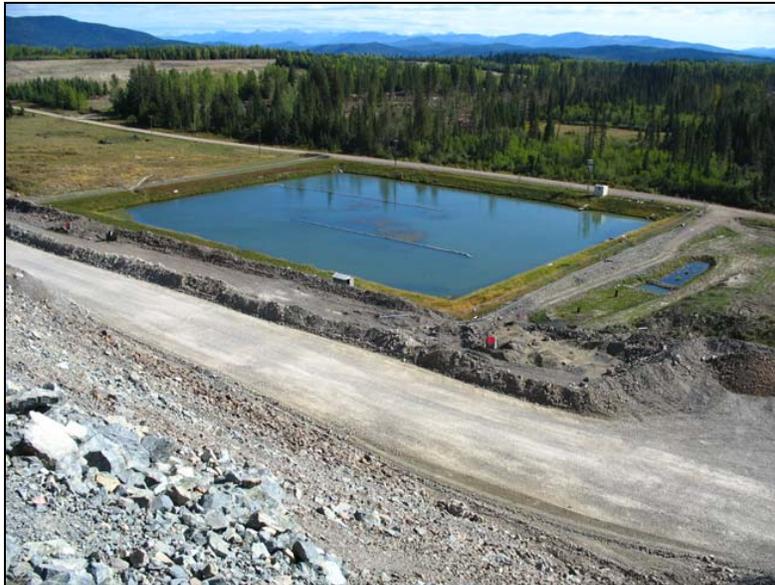
runoff. The seepage collection ponds were observed to be in good condition with no observed erosion activity.

**PHOTO 3** – Main Embankment Seepage Collection Pond

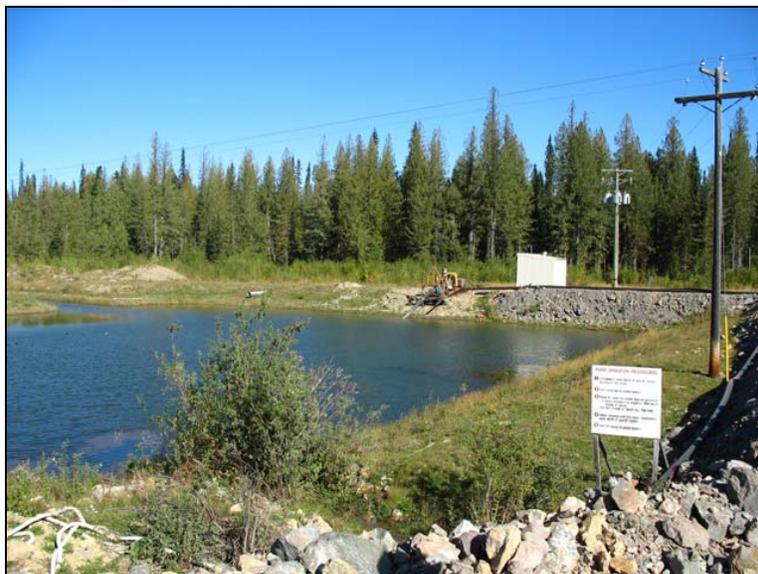
**PHOTO 6** – Perimeter Embankment Seepage Collection Pond

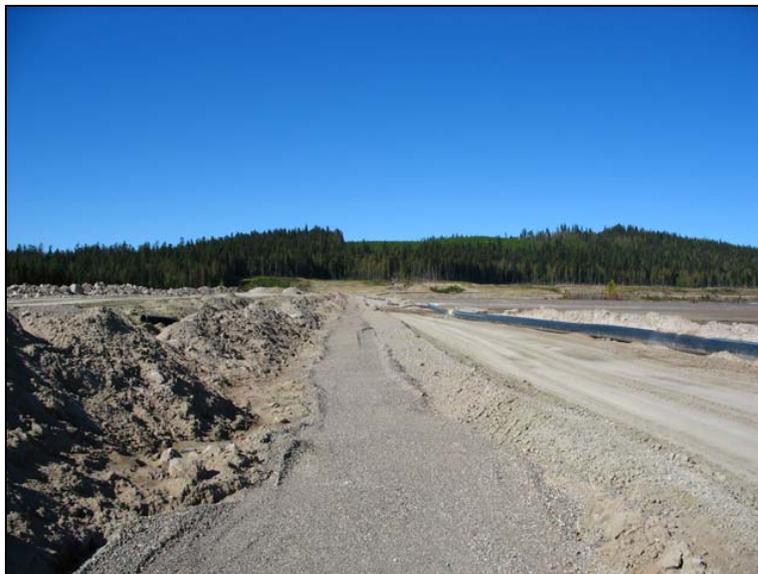
**PHOTO 7** – South Embankment upstream toe drain.

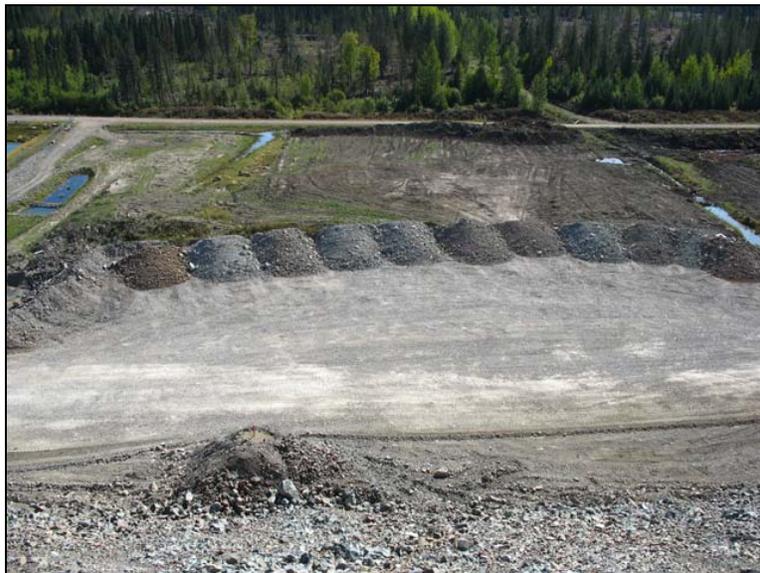
**PHOTO 9** – Buttress construction at the Main Embankment.

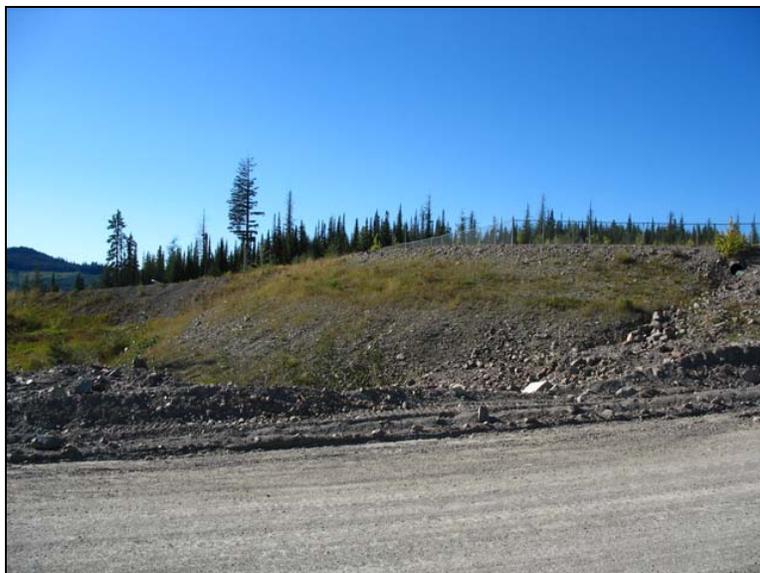
Surface water from the Mill Site Area is routed into the Mill Site Sump where it is transferred to the TSF via the tailings pipeline. The embankments at the Mill Site Sump were observed to be in good condition, and no cracks, seepage or slumping was noted. The emergency overflow culvert was clear of obstructions.

**PHOTO 10** – Mill Site Sump Embankment

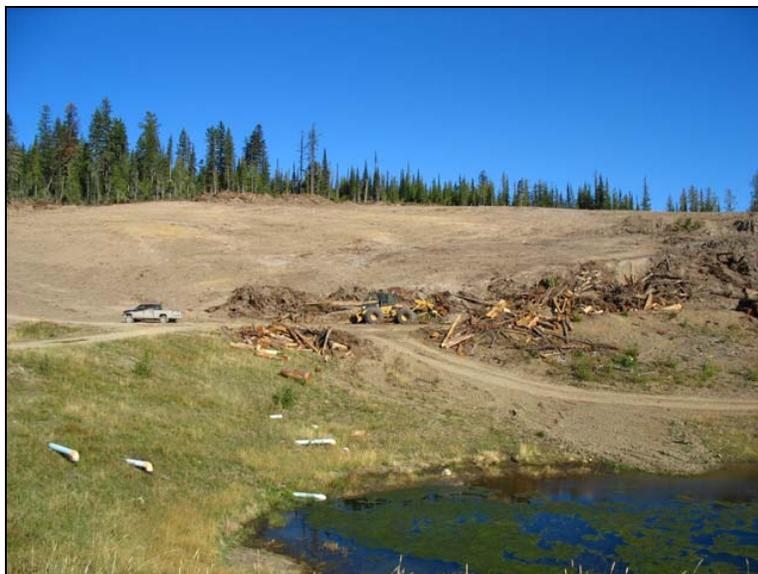
The Southeast Sediment Pond is no longer in service and runoff that previously reported to the Southeast Sediment Pond is now being routed to the Perimeter Embankment Seepage Collection Pond. The embankment at the Southeast Sediment Pond was observed to be in good condition.

**PHOTO 11** – Southeast Sediment Pond, west end showing outlet pipes

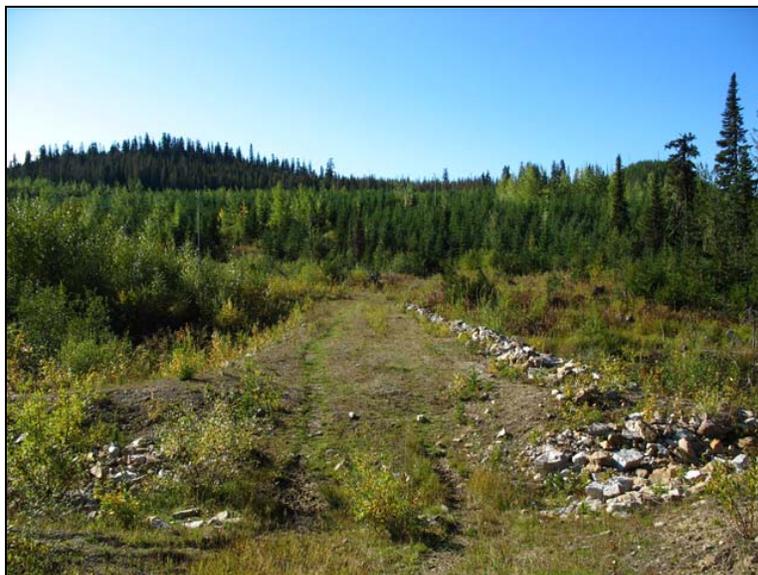
The South Bootjack Dam was observed to be in good condition at the time of the inspection. Observations include the following:

- The water level was low
- Both upstream and downstream fill slopes were in good condition, with no evidence of seepage or slumping
- No cracks were observed on the dam crest, and
- The spillway contained some minor vegetation, but was generally unobstructed.

**PHOTO 12** – South Bootjack Dam
