**MOUNT POLLEY MINING CORPORATION
MOUNT POLLEY MINE**

**TAILINGS STORAGE FACILITY
REPORT ON 2007 ANNUAL INSPECTION
(REF. NO. VA101-01/20-1)**

Knight Piésold Ltd.

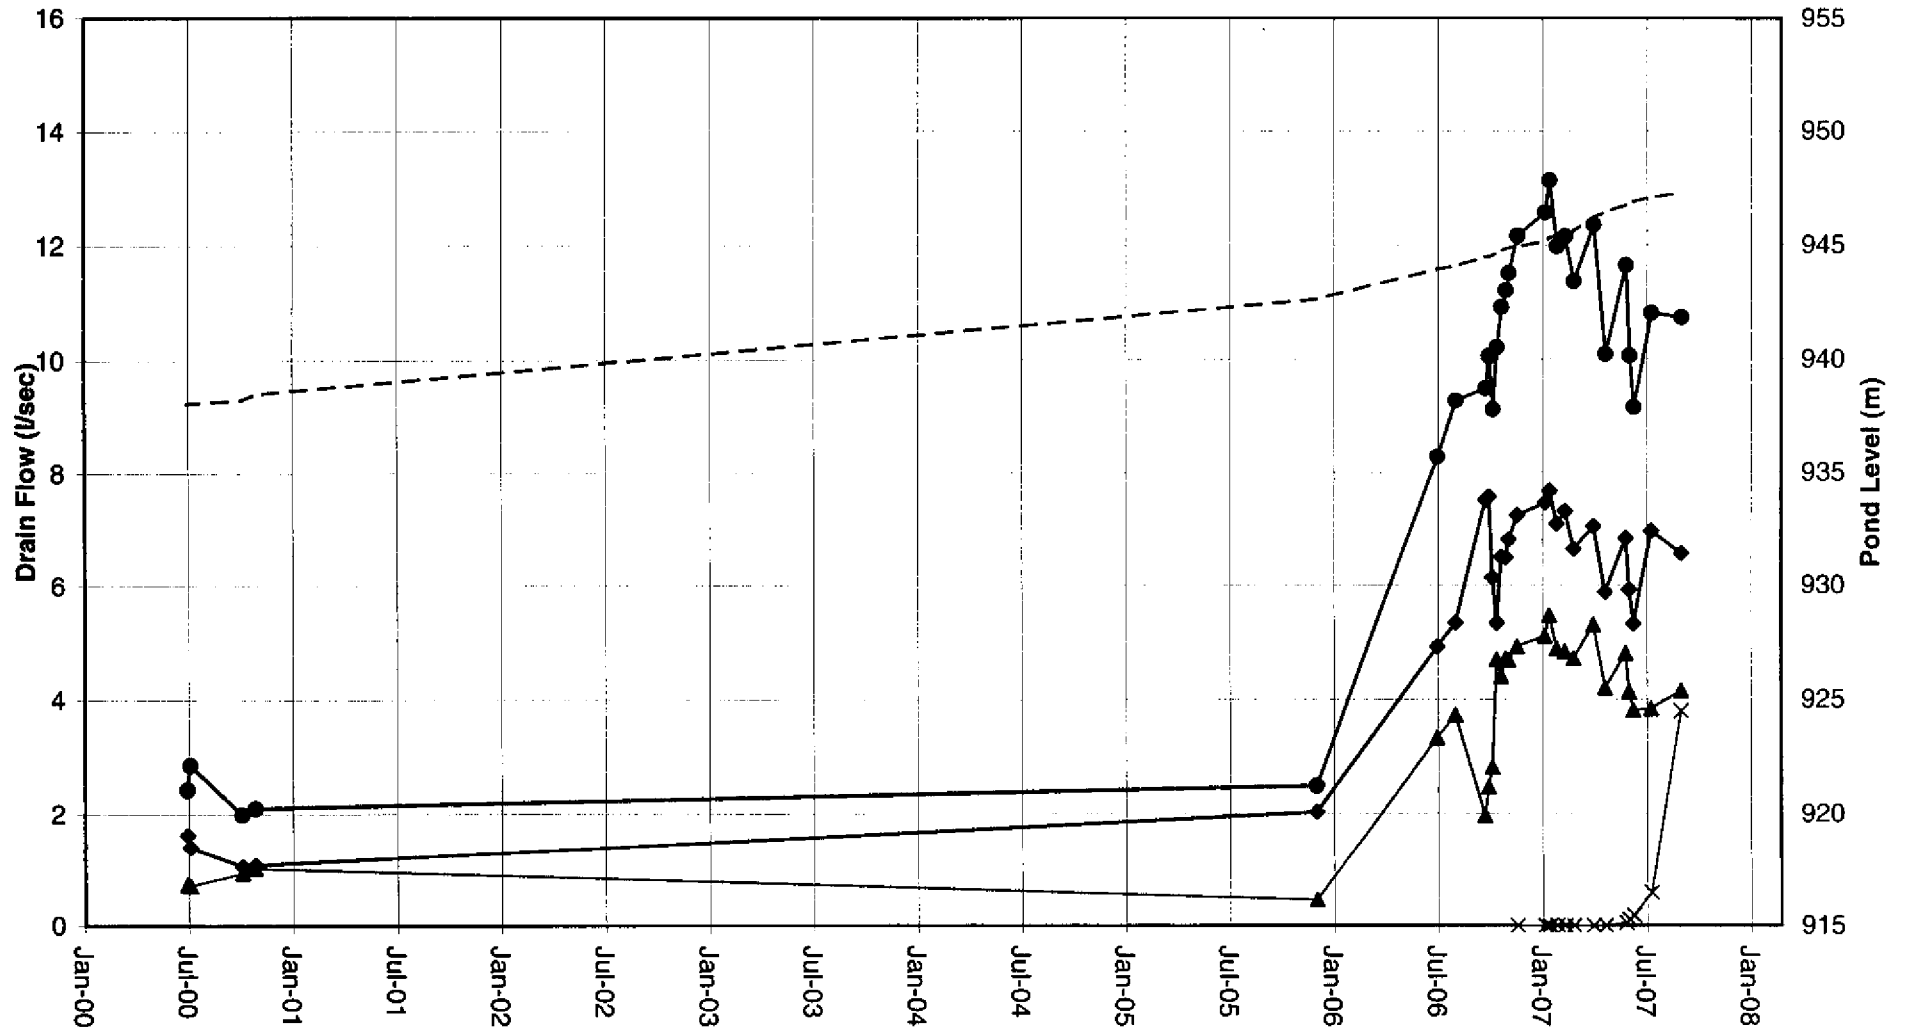
MOUNT POLLEY MINING CORPORATION	
MOUNT POLLEY MINE	
TAILINGS STORAGE FACILITY UPSTREAM TOE DRAIN FLOWS	
	PROJECT / ASSIGNMENT NO. VA 101-1/20
	REF NO. 1
FIGURE 3.1	
REV. 0

The flow rate from the upstream toe drains has increased in the last year as the tailings pond has increased in volume and is considerably closer to the embankments and the upstream toe drains than in previous years. The majority of the flow from the upstream toe drains is currently from the Main Embankment upstream toe drain; as the Perimeter Embankment upstream toe drain was installed in October 2006 and the first flows were not observed until July 2007. The total flow from the Main Embankment upstream toe drain was approximately 11 l/s at the time of the inspection with the flow from the

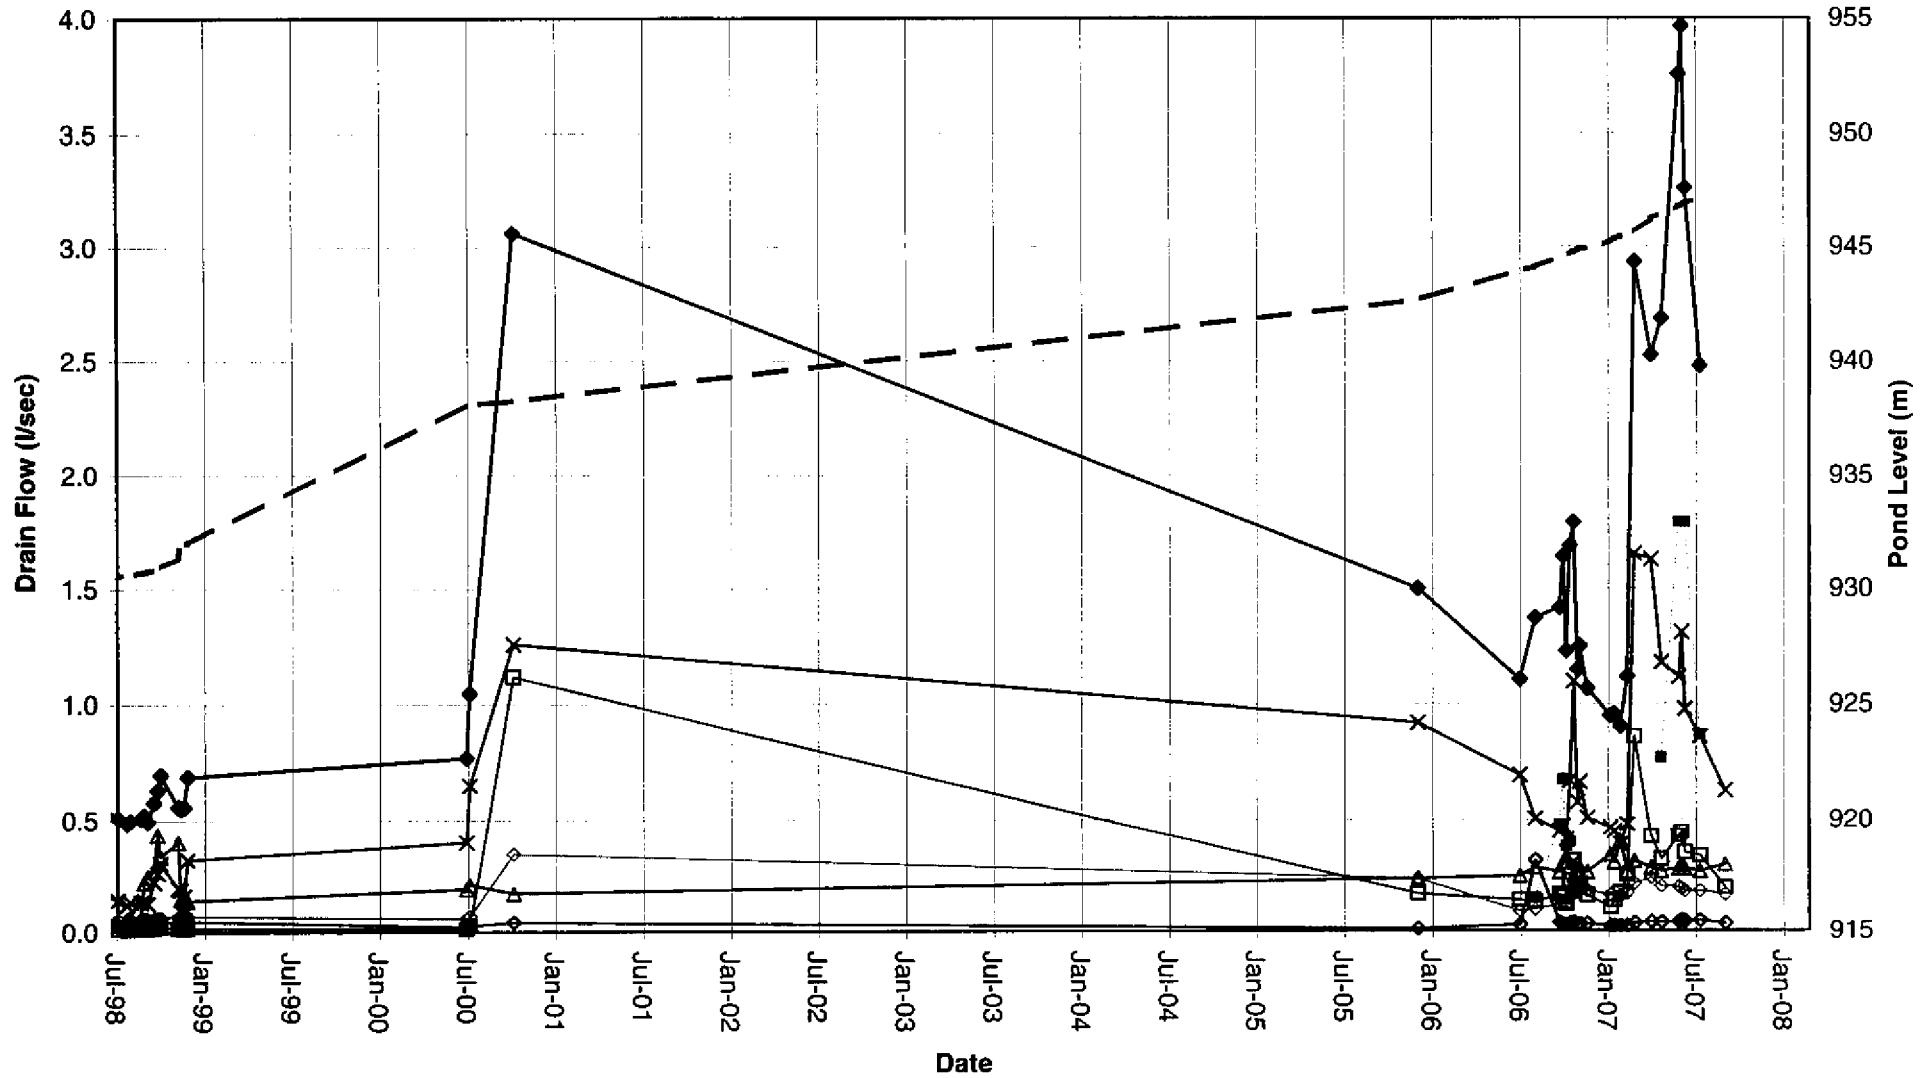
MOUNT POLLEY MINING CORPORATION	
MOUNT POLLEY MINE	
TAILINGS STORAGE FACILITY MAIN EMBANKMENT FOUNDATION DRAIN FLOWS	
	PROJECT / ASSIGNMENT NO. VA 101-1/20
	REF NO 1
FIGURE 3.2	
REV. 0

The total flows from the foundation drains have increased slightly in the last year, especially in foundation drain FD-5 and the ME Corner foundation drain, which are both located at the corner of the Main and South Embankments. The increased flows were most likely due to the lack of tailings beach development in this area, as the tailings embankment has only recently expanded to cover the gap between the Main and South Embankments and there was limited beach development in this area. The flow rates in these foundation drains appear to be declining as the tailings beach is developed in this area and the pond relocates away from the embankment. The flows from the foundation drains were clear.

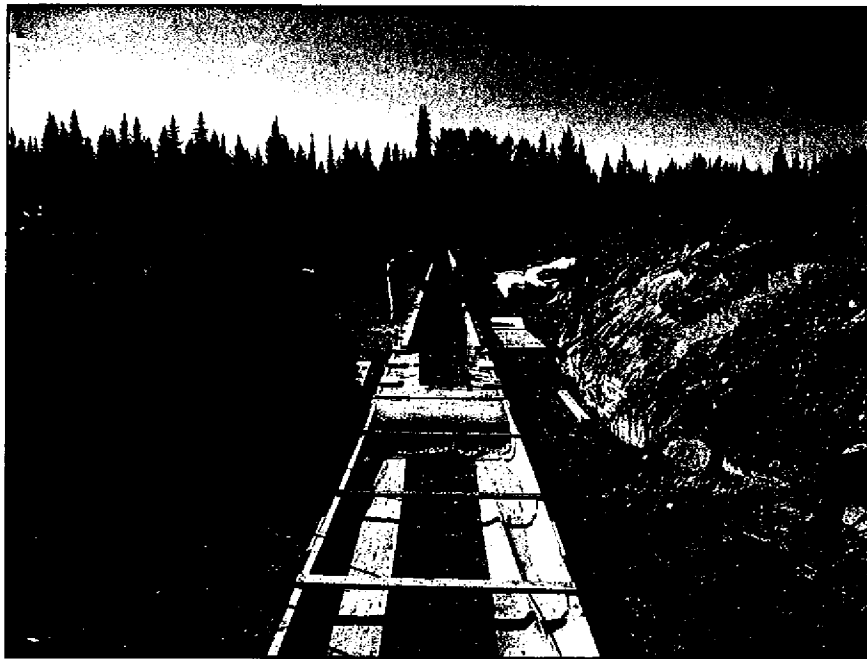
PHOTO 22 – South Embankment Concrete Encasement preparation.
