**MOUNT POLLEY MINING CORPORATION  
MOUNT POLLEY MINE**

**TAILINGS STORAGE FACILITY  
REPORT ON 2010 ANNUAL INSPECTION**

VA101-1/29-2  
Rev 1  
January 25, 2011

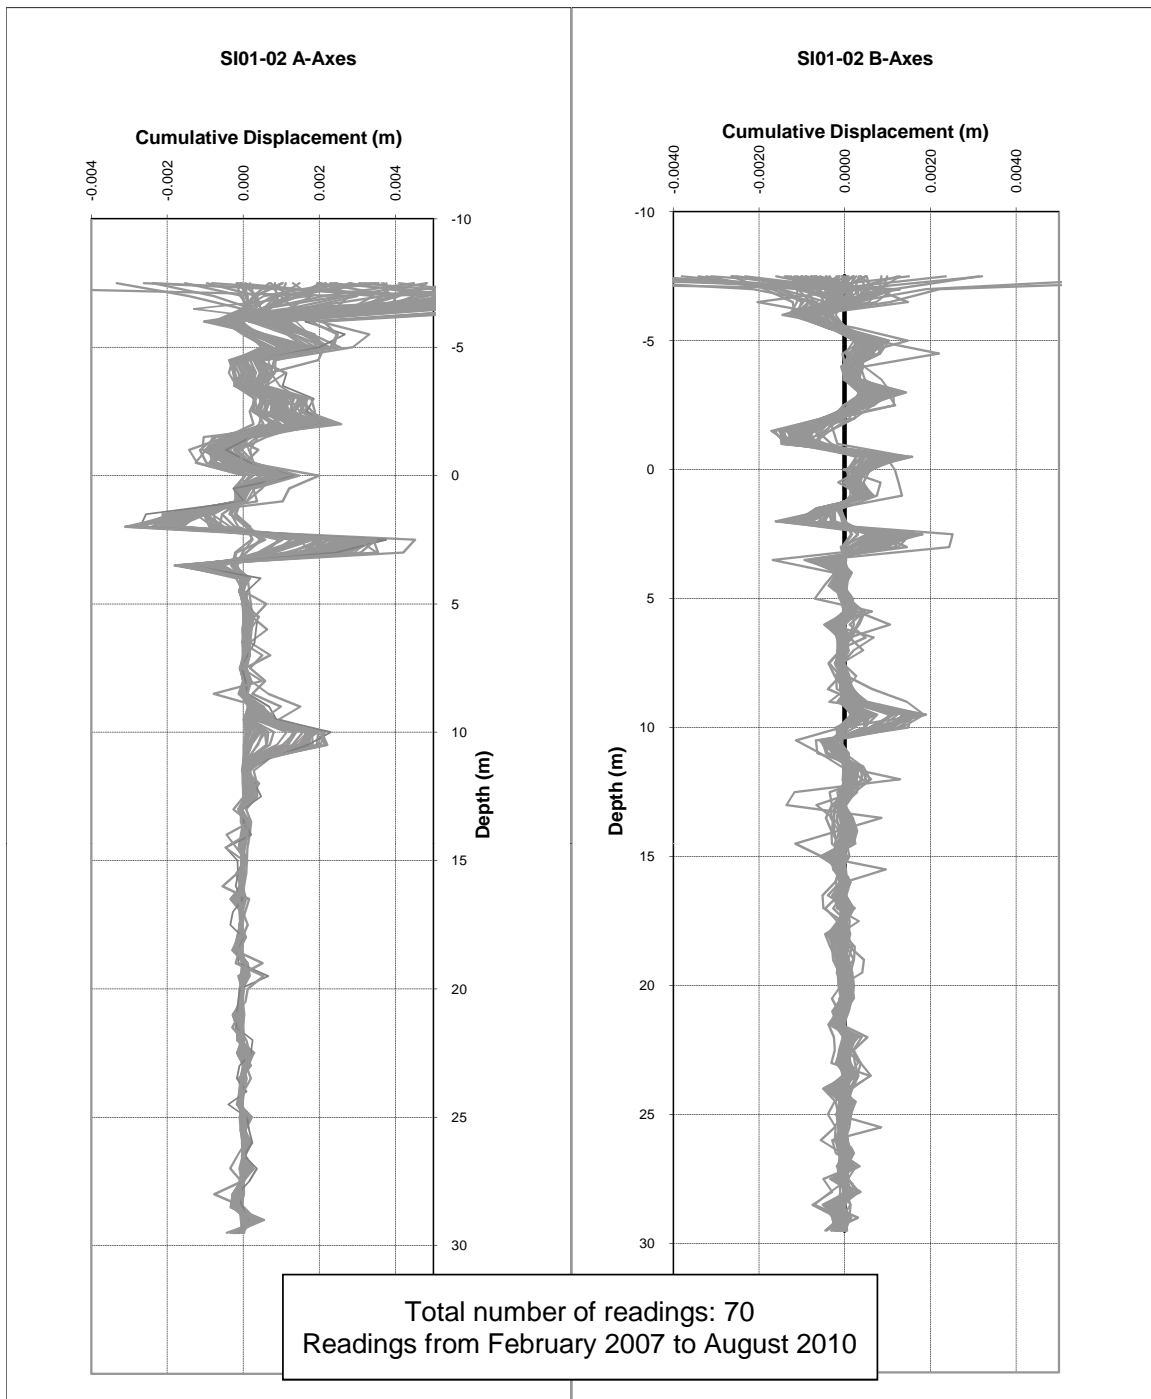
- Slight deviations measured in the lacustrine unit in Inclinator SI01-02 resulted in the recommendation for constructing a downstream buttress<sup>2</sup>. The results of the stability assessment recommended a buttress be constructed downstream of the Main Embankment to an elevation of 920 m for a crest elevation of 958 m, the crest elevation for the Stage 6b embankment. The Stage 6b buttress footprint, which extends to both sides of the Main Embankment Seepage Collection and Recycle Pond, is shown on Drawing VA101-1/29-210. The letter also recommended that the buttress be constructed prior to the commencement of the Stage 6b construction program, which did not happen.

MOUNT POLLEY MINING CORPORATION					
MOUNT POLLEY MINE					
TAILINGS STORAGE FACILITY STAGE 6B					
DOWN HOLE INCLINOMETER					
CUMULATIVE DISPLACEMENT SI01-02					
		<i>Knight Piésold</i>			
		CONSULTING			
0	30NOV'10	ISSUED WITH REPORT	GL	GIJ	KJB
REV	DATE	DESCRIPTION	PREP'D	CHK'D	APP'D
				P/A NO. VA101-1/29	REF NO. 2
				<b>FIGURE B4</b>	REV 0

*It is recommended that the Main Embankment buttress requirements and timing be re-evaluated as part of the Stage 7 design of the TSF.*

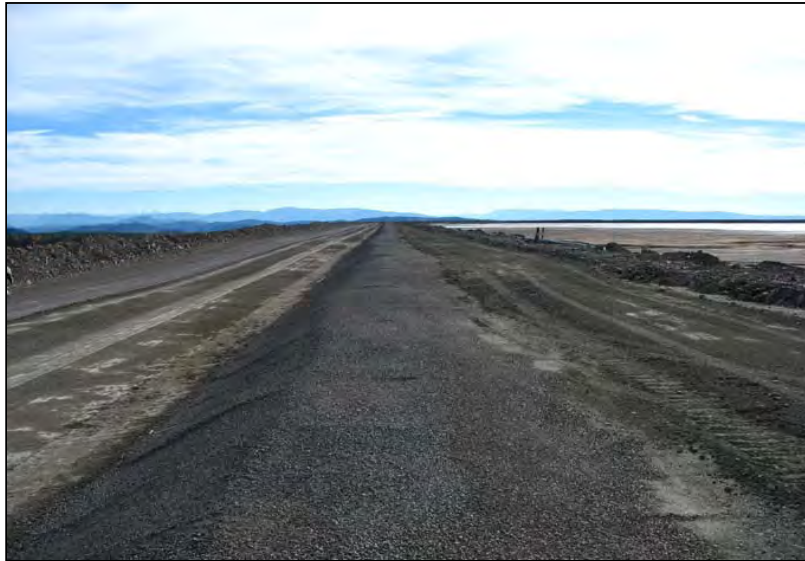
**PHOTO 1** – Perimeter Embankment Crest.

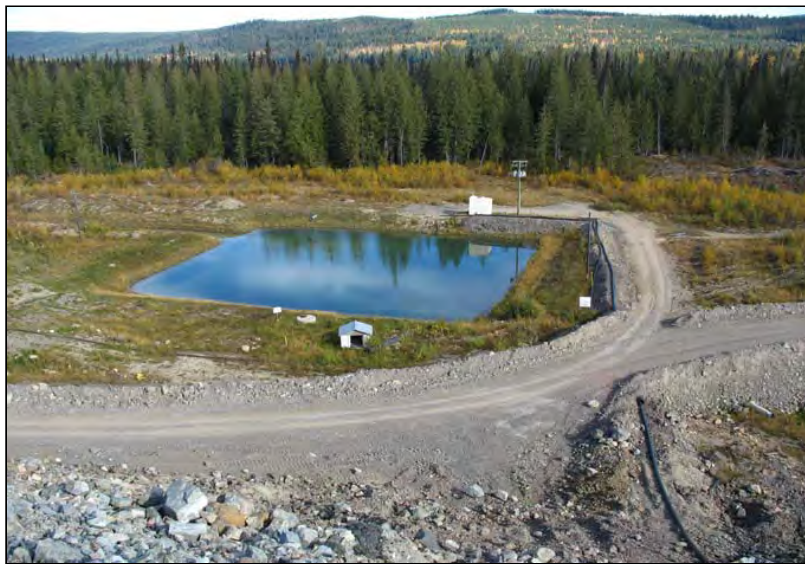
**PHOTO 2** – Perimeter Embankment Seepage Collection and Recycle Pond.

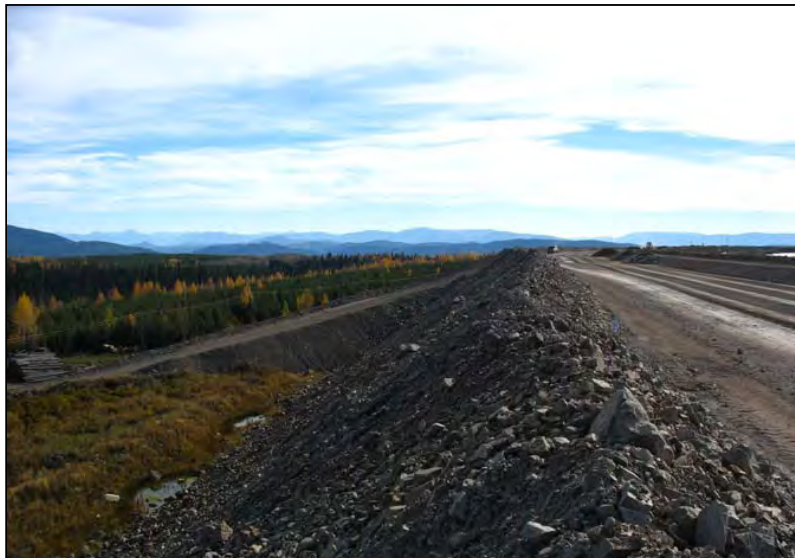
- A tension crack was observed at the Perimeter Embankment at an approximate chainage of 3+400. The tension crack is in the Zone C material at the downstream edge of the embankment crest. The tension crack was apparently identified two months earlier by the grader operator and was approximately 10 to 15 m long. The area has since been graded over but portions of the tension crack are still visible. The location of the tension crack in relation to the downstream slope is not an uncommon occurrence in rock slopes as the outer edge of the material typically receives less compaction effort. A tension crack does not necessarily indicate a plane of weakness in fill materials but it can't be ignored either. The tension crack is located on a section of the Perimeter Embankment located upstream of the Zone S borrow area.

**PHOTO 5** – Tension Crack Location at the Perimeter Embankment.

*It is recommended that a stability assessment be completed for this area to assess whether the borrow area configuration has any impact on the integrity of the current, and ultimate embankment section. It should also be noted that the identification of a tension crack, or any other abnormal observation at the tailings dam, should be reported to the design engineer immediately and prior to any remedial action being taken.*

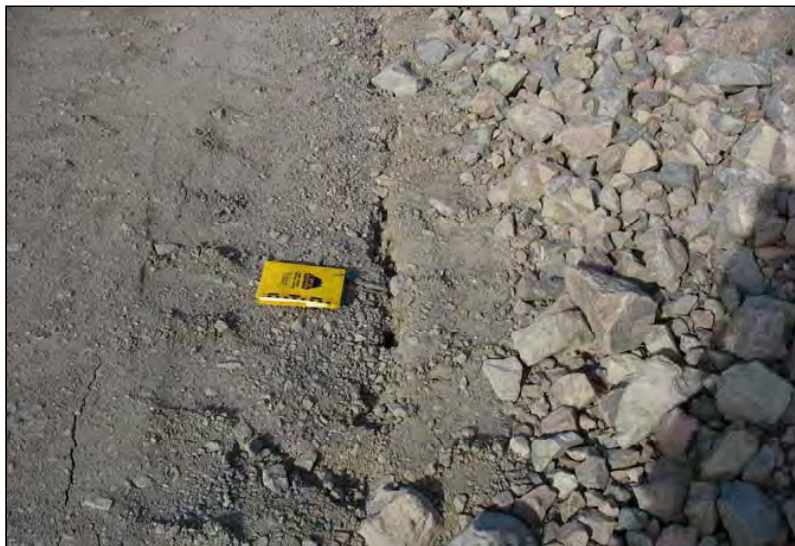
- The TSF embankments were observed to be in good condition, however, a tension crack was observed at the Perimeter Embankment on the downstream side of the crest in the Zone C rockfill material. Although this is likely the result of localized settlement in loosely compacted material along the downstream slope of the embankment, it is possible that there may be a relationship between the tension crack and the excavation of the glacial till borrow area immediately downstream. This should be evaluated as part of the Stage 7 design phase and any additional excavation within the borrow area should be reviewed and approved by the TSF design engineer.

**PHOTO 6** – Tension Crack at the Perimeter Embankment.

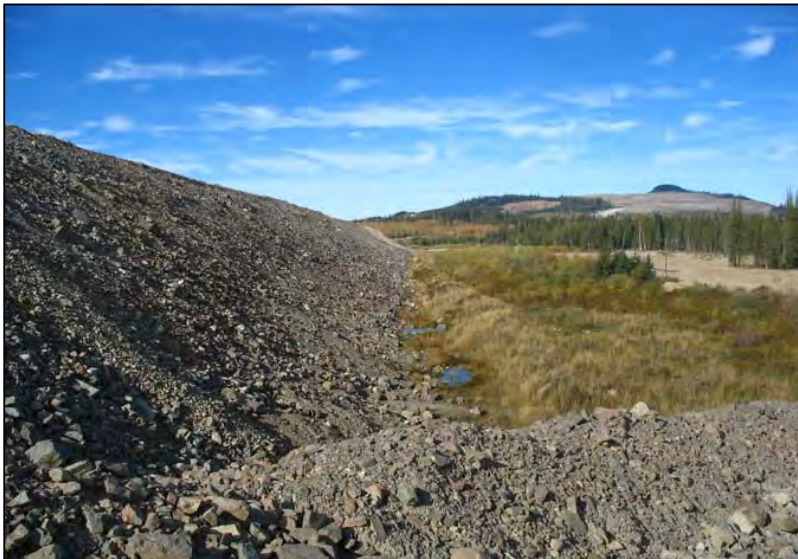
**PHOTO 7** – Downstream Slope of Perimeter Embankment.
