**Mount Polley Mine Project: Tailings Storage Facility  
2011 Geotechnical Site Investigation: Draft Report**

Likely, B.C.

**Mount Polley Mining Corporation**  
Likely, B.C.

14 February 2012

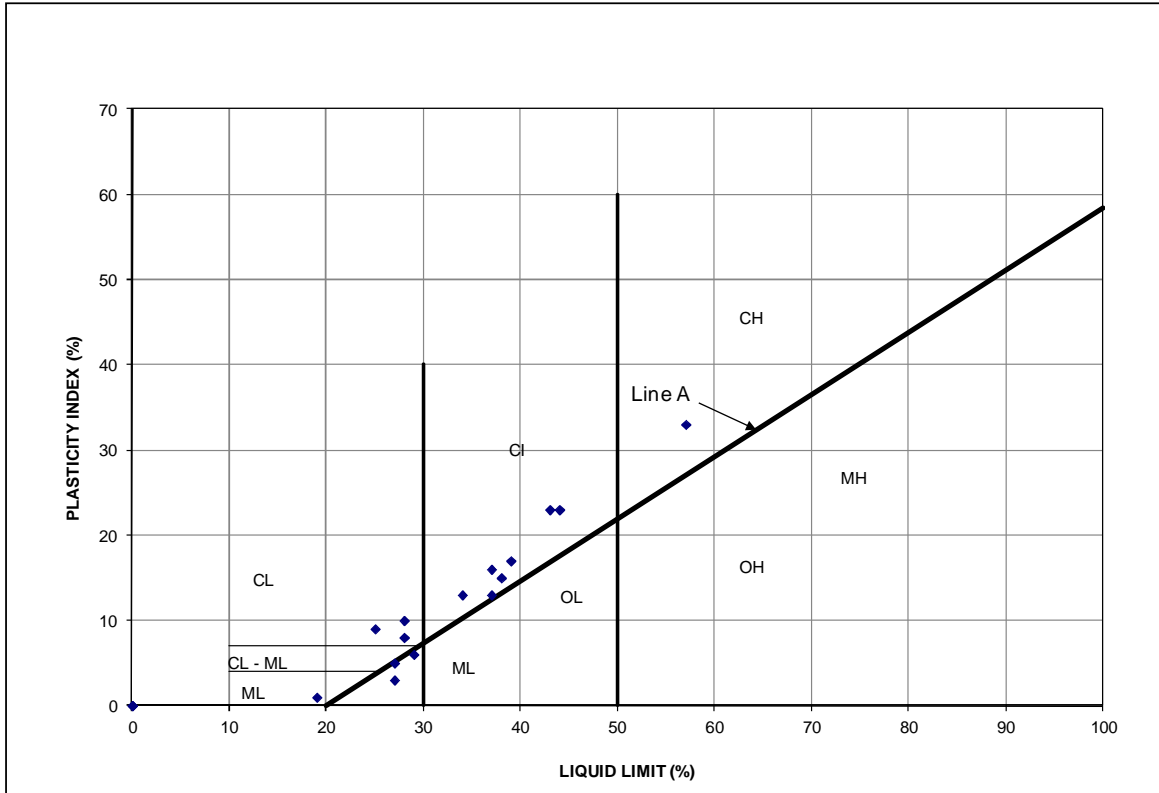
**Figure 3.2: Atterberg Limits Tests**

Atterberg limits testing of selected samples yielded plasticity indexes between, 0 and 33%, as shown on Figure 3.2. Samples tested from within the glaciolacustrine unit yielded results of 3% and 33%, the fines generally classifying as clay of low to intermediate plasticity (CL-CI). The highest plasticity index of 33%, fines classifying as a clay of high plasticity (CH), occurred in a sample from drill hole SI11-02 (Main Embankment) at a depth of approximately elevation 900.6m.
