**MOUNT POLLEY MINE  
Tailings Storage Facility  
2011 Construction**

**DRAFT As-Built Report and Annual Review**

15 March 2012

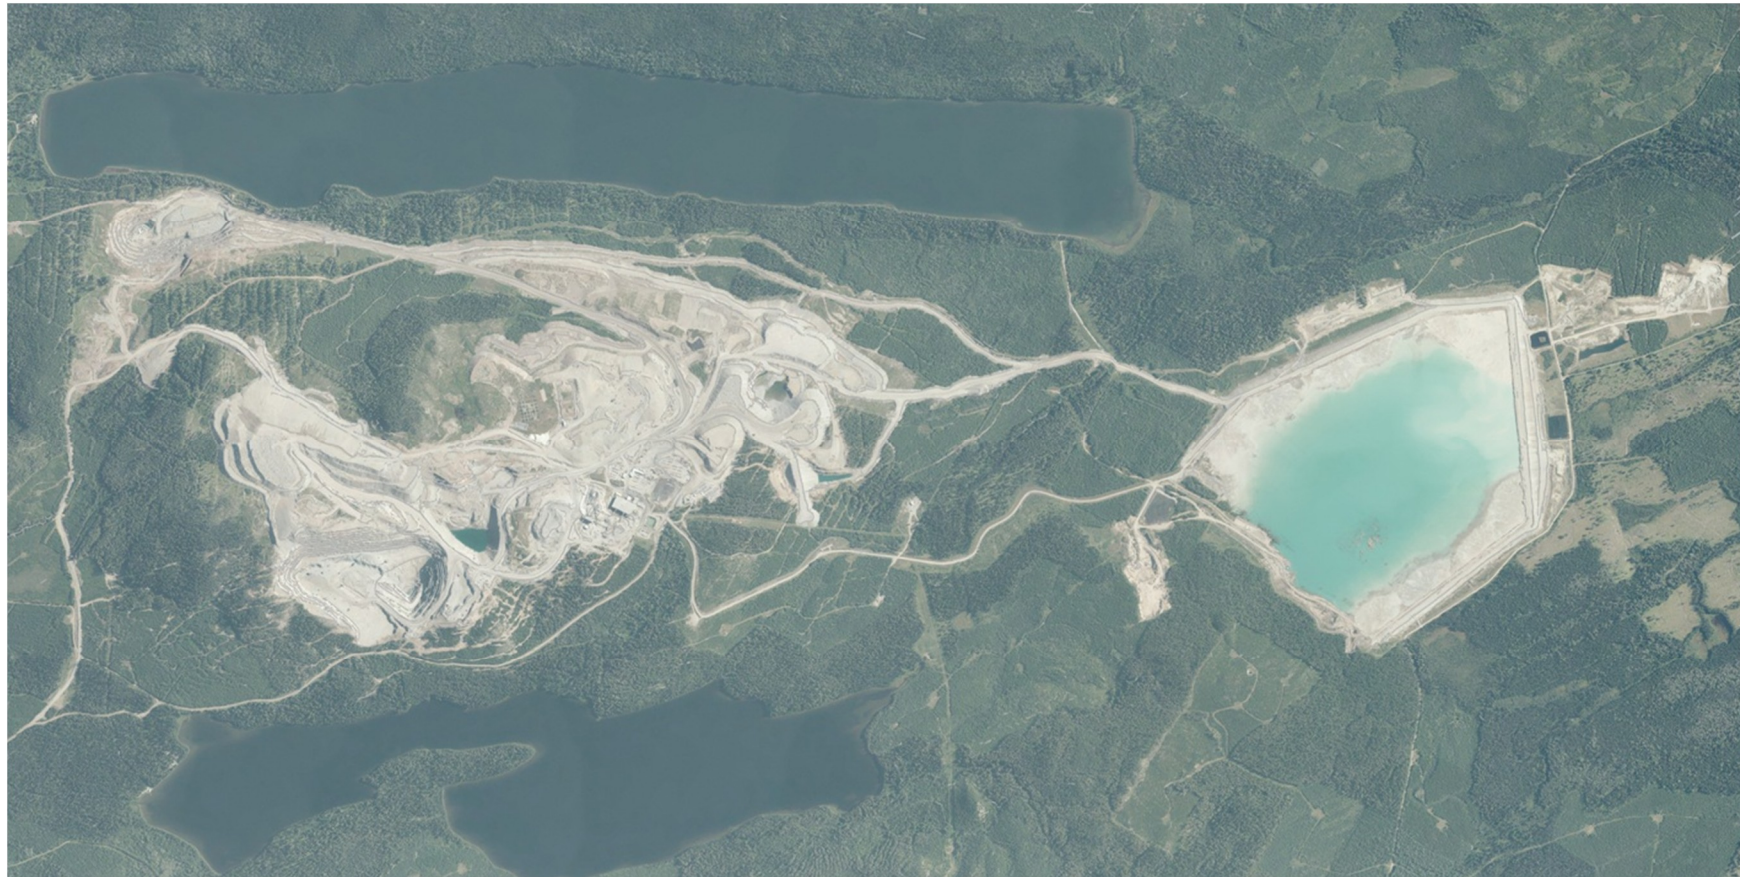
**Figure 1.1 Aerial View of Mine Site: 2011**

Drawing 2011AB.01 presents a plan of the as-built condition of the Mount Polley Mine site. Figure 1.1 shows an aerial view of the site from 2011.

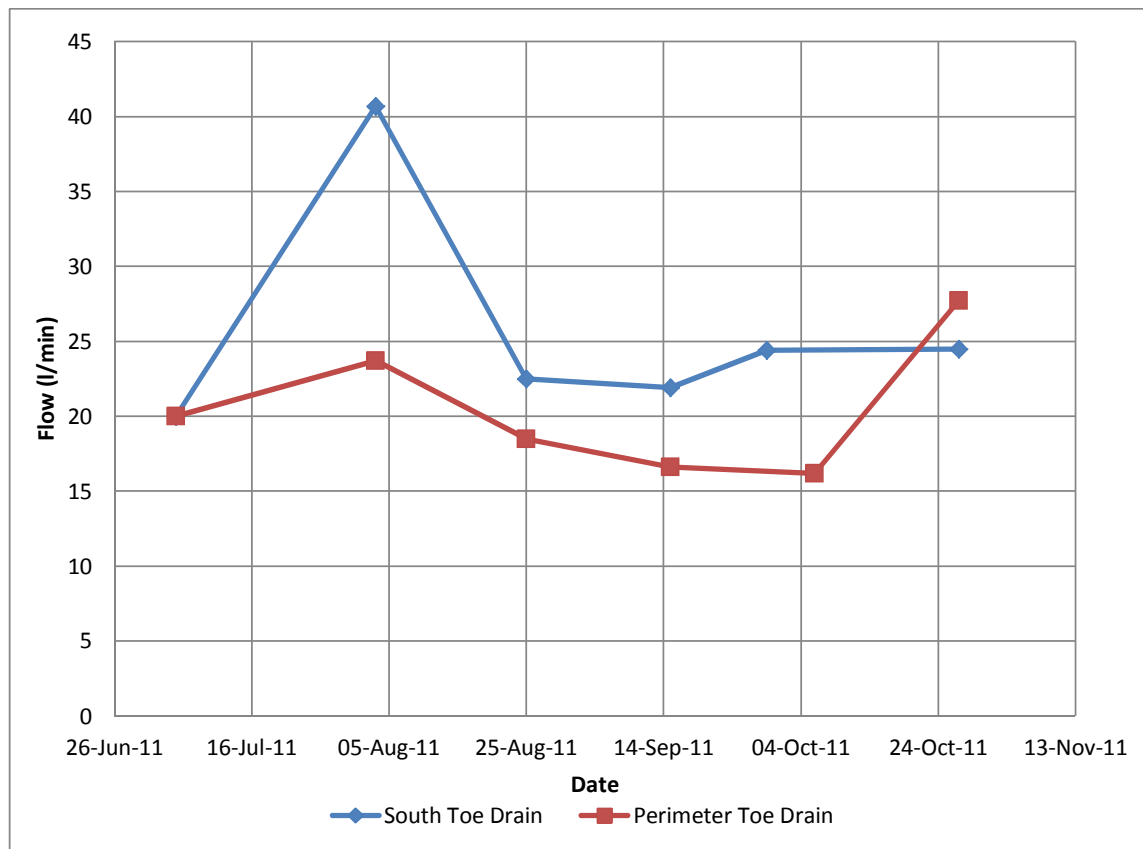
**Figure 2.2 2011 Collected Toe Drain Flow Rates**

Drain flows into the Main embankment require that the sediment control pond be pumped down to a low level to allow for safe entry into the sump. In 2011 Main embankment drain readings were not in compliance with the OMS manual requirements. MPMC is working to revise the monitoring system in an attempt to capture drain flow readings in compliance with the OMS requirements. Drain flows from the South and Perimeter embankments are read weekly as weather permits. The collected drain flow readings from 2011 are presented in Figure 2.2.

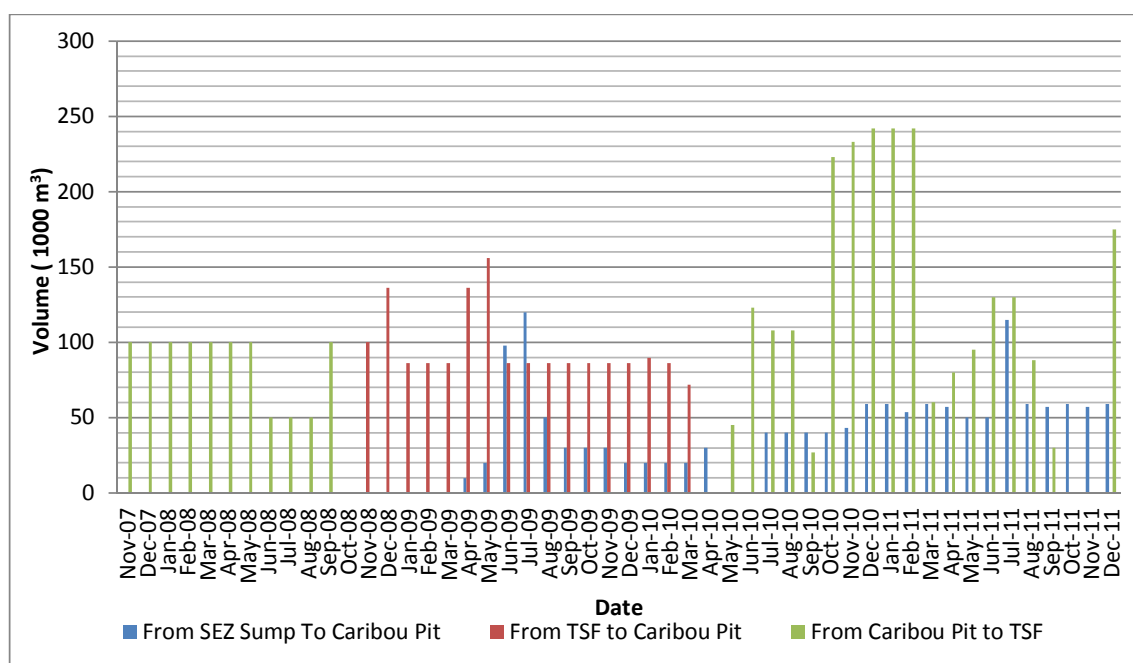
**Figure 7.1 Water Transfer**

AMEC understands that currently the total inflow from precipitation and surface runoff exceeds losses from evaporation. Thus, MPMC mine site is operating under a water surplus condition, with the surplus being stored in the TSF, the Caribou Pit and North East Zone Pit. In addition, to control and maintain required water balance, MPMC transfers water as needed. The volumes transferred are shown in Figure 7.1.

MPMC maintains the water balance for the impoundment and it has not been reviewed by AMEC. Integral component of any mine is the short and long term solid waste and water management. AMEC recommends that a review of the water balance be conducted during this upcoming year to confirm that the complex model is functioning as designed. The review of site water balance should include a stochastic analysis to evaluate the wet and dry precipitation conditions.

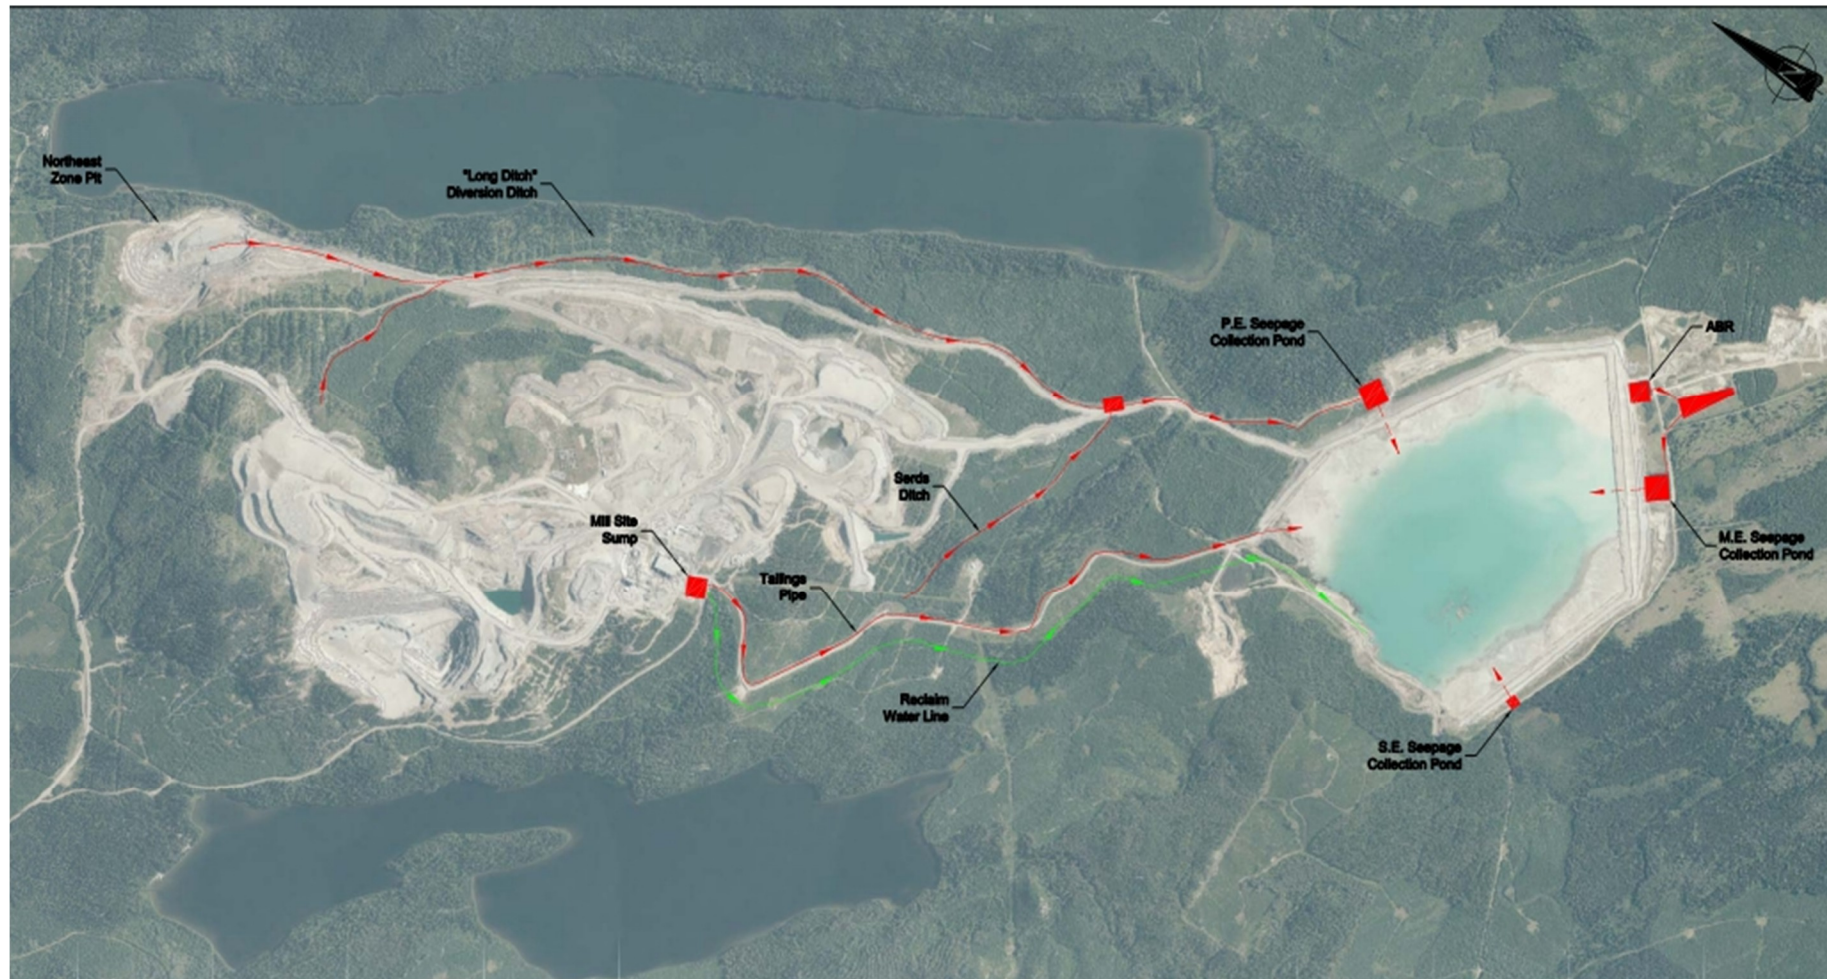
**Figure 7.2 Site Water Management Schematic**

- The Anaerobic Biological Reactor (ABR) receives to drain flow, and discharges out to a pond and to the Main Seepage Pond, where it is pumped back into the TSF.
- The Mill Site Sump is bled into the tailings line to the TSF.
- The reclaim water line runs adjacent to the tailings line, and transfers water from the barge to the booster station (not labelled) and to the mill.
- No toe drains were shown, but as described in Section 2.7 all drains report to the seepage collection ponds before being pumped back into the TSF.
