**MOUNT POLLEY MINE
Tailings Storage Facility
2011 Construction**

DRAFT As-Built Report and Annual Review

21 March 2012

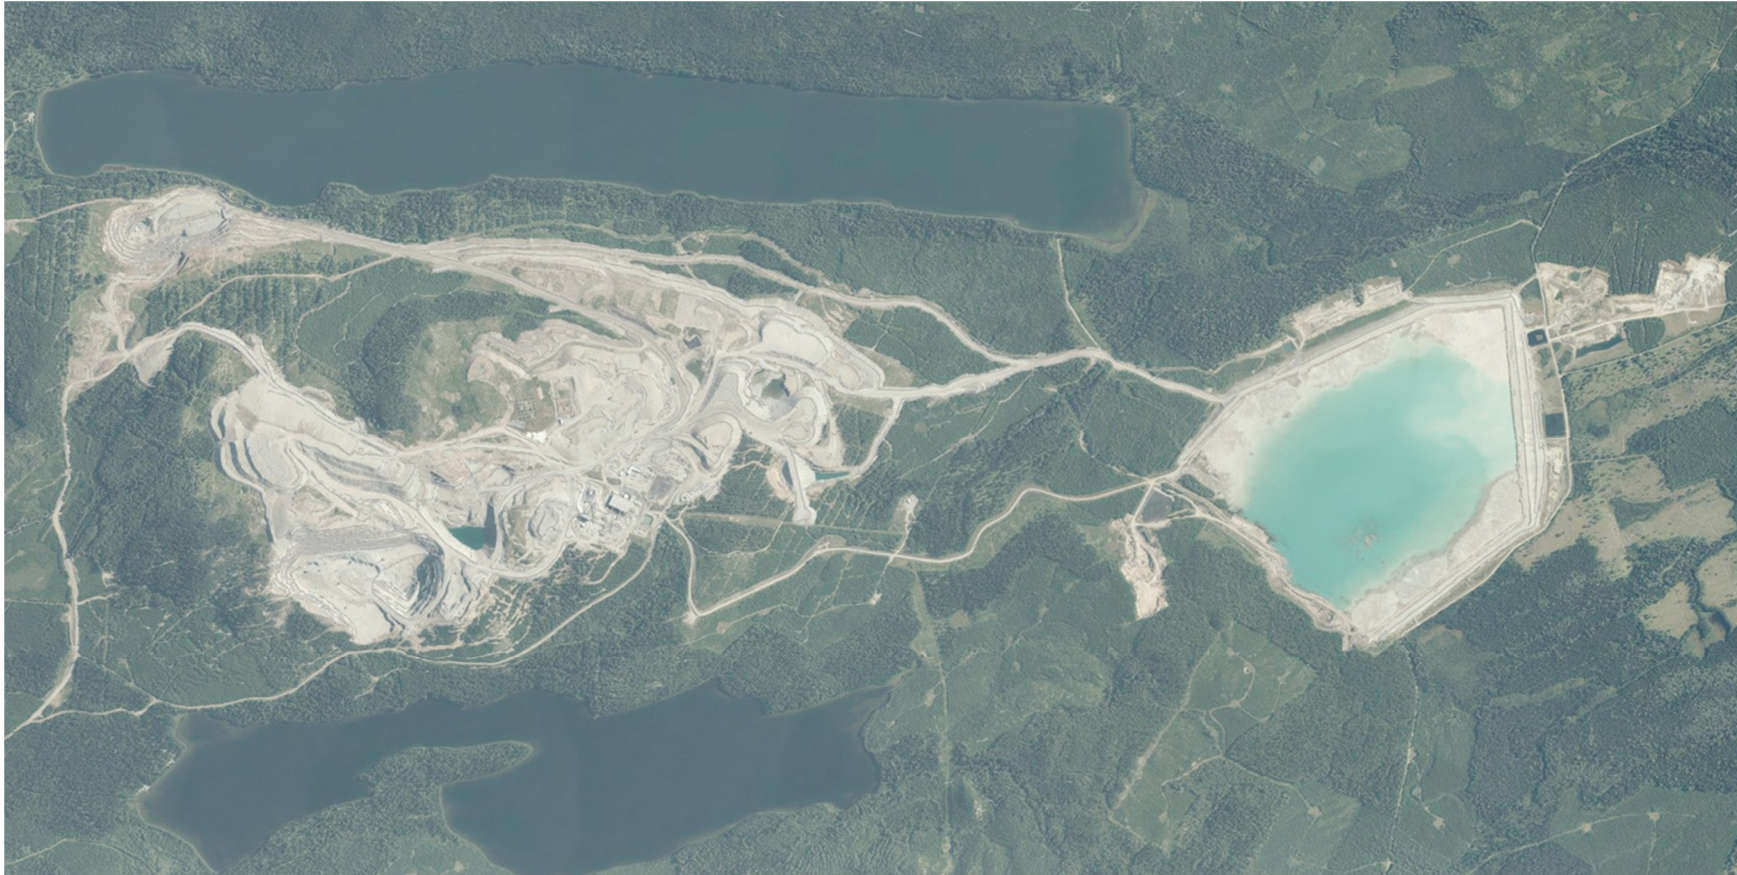
Figure 1.1 Aerial View of Mine Site: 2011

Drawing 2011AB.01 presents a plan of the as-built condition of the Mount Polley Mine site. Figure 1.1 shows an aerial view of the site from 2011.

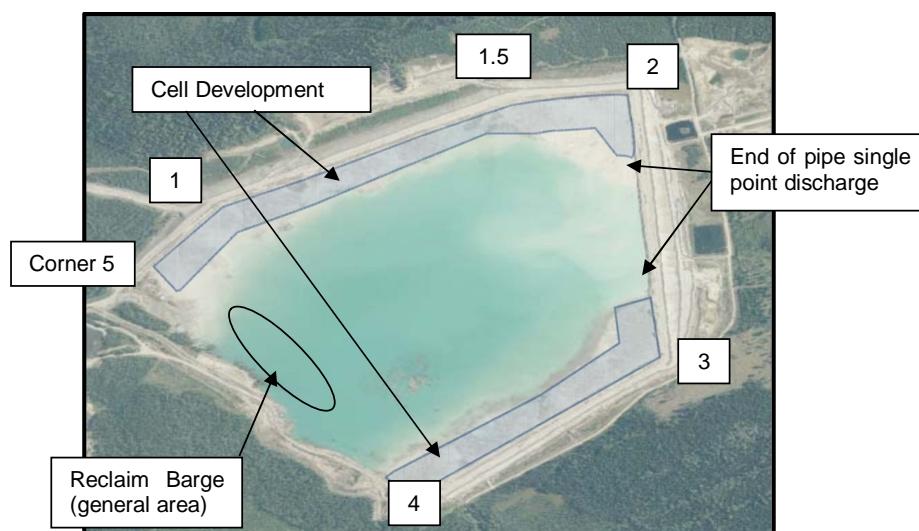
Figure 2.1 Tailings Discharge Plan

Tailings are transported from the mill to the impoundment via an approximately 7 km long HDPE pipeline. As shown in Figure 2.1, 2011 cell construction was carried out from corner 5 advancing along the Perimeter embankment to the Main embankment to about Sta. 24+00. Insufficient tailings line pressure prevents cell construction along the central portion of the Main embankment and single point discharge is employed (approximately Sta. 24+00) to facilitate the beach development. Discharge from Sta. 24+00 was maintained for about 3 weeks after which discharge was relocated to corner 4 for the resumption of cell development. Cellular development was employed along the South embankment and around corner 1 where single point discharge was resumed. The pipeline design flow is 20,000 tpd at about 35% solids by dry weight.

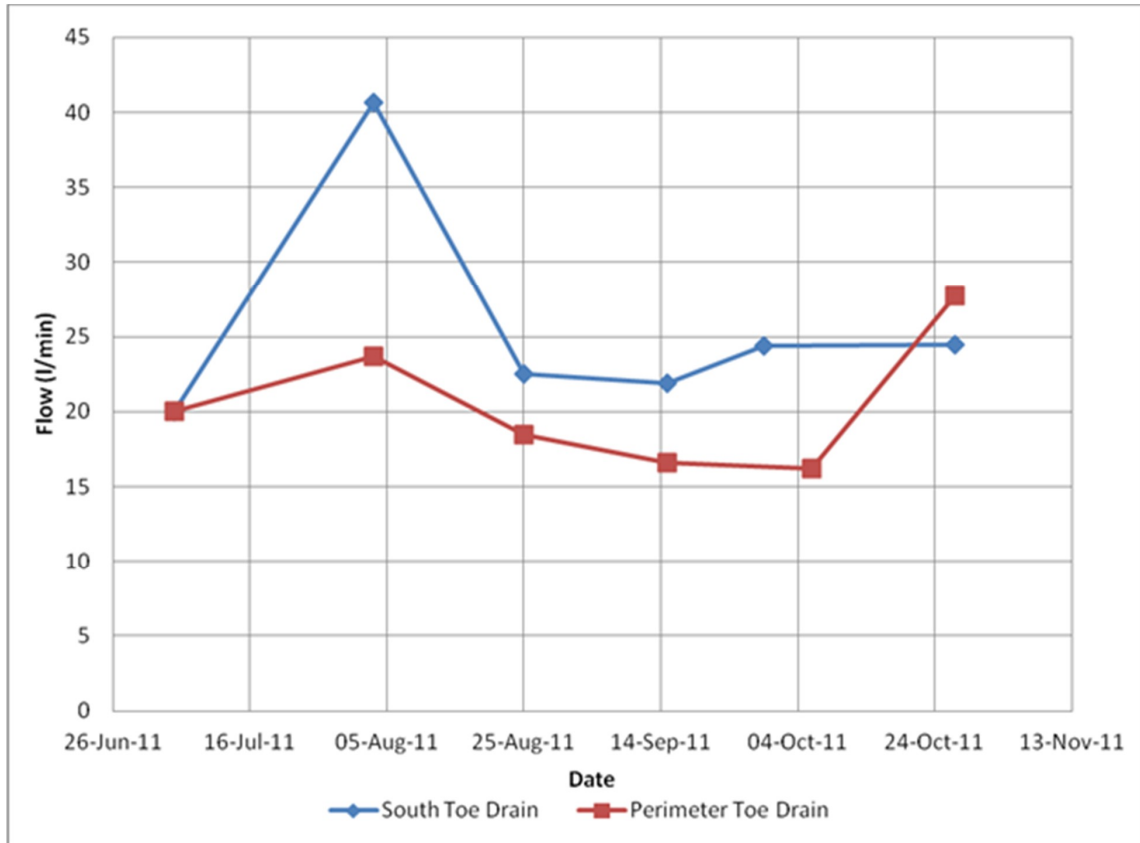
Figure 2.2 South and Perimeter Toe Drain Flow Readings – 2011

Measurement of drain flows into the Main Embankment requires that the sediment control pond be pumped down to a low level to allow for safe entry into the sump. In 2011 Main Embankment drain readings were not measured and MPMC was out of compliance with the OMS manual requirements. MPMC is working to revise the monitoring system in an attempt to capture drain flow readings in compliance with the OMS requirements. Frequency of drain flows from the South and Perimeter embankments varied from monthly to bi-weekly as weather permitted. South and Perimeter Embankment drain reading for 2011 are presented in Figure 2.2. There is no note of any turbidity observed in the drain water which indicates that the filters associated with the drains are operating as intended.

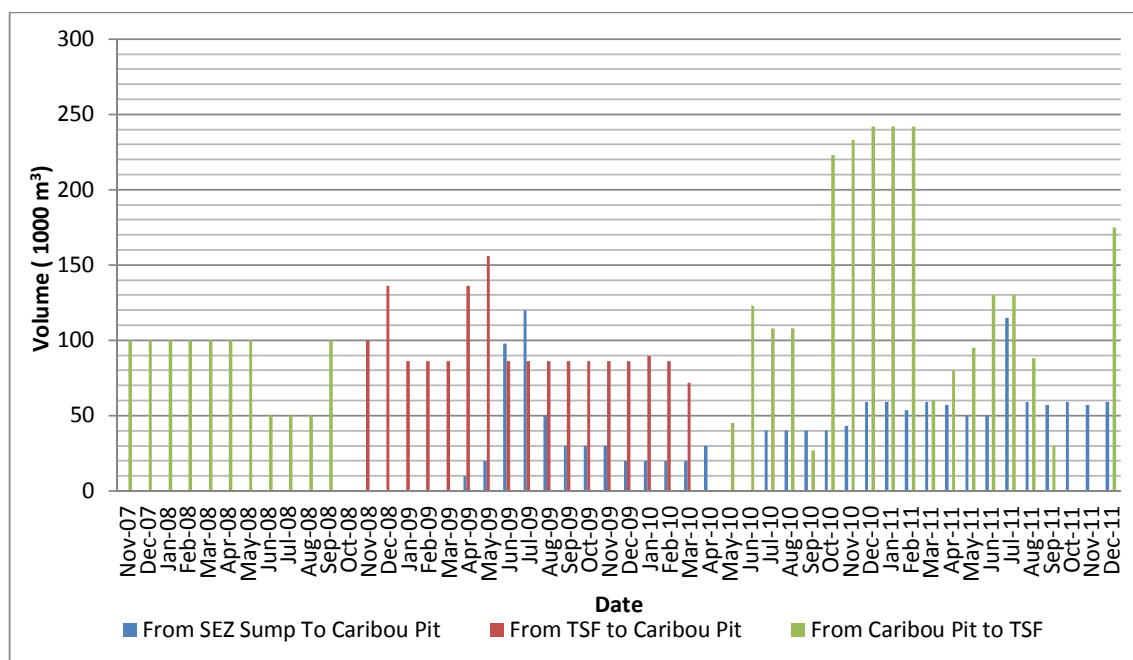
Figure 7.1: Water Transfer

It is AMEC's understanding that currently the total inflow from precipitation and surface runoff exceeds losses from evaporation and storage of water within the voids of deposited tailings. Thus, MPMC mine site is operating under a net annual water surplus condition, with the accumulating surplus being stored in the TSF, the Caribou Pit and North East Zone Pit. MPMC transfers water as needed between the TSF and the Caribou Pit, with the volumes transferred, as provided by MPMC, shown in Figure 7.1.
