**Mount Polley Mine Project: Tailings Storage Facility
2011 Geotechnical Site Investigation: Draft Report**

Likely, B.C.

Mount Polley Mining Corporation
Likely, B.C.

20 March 2012

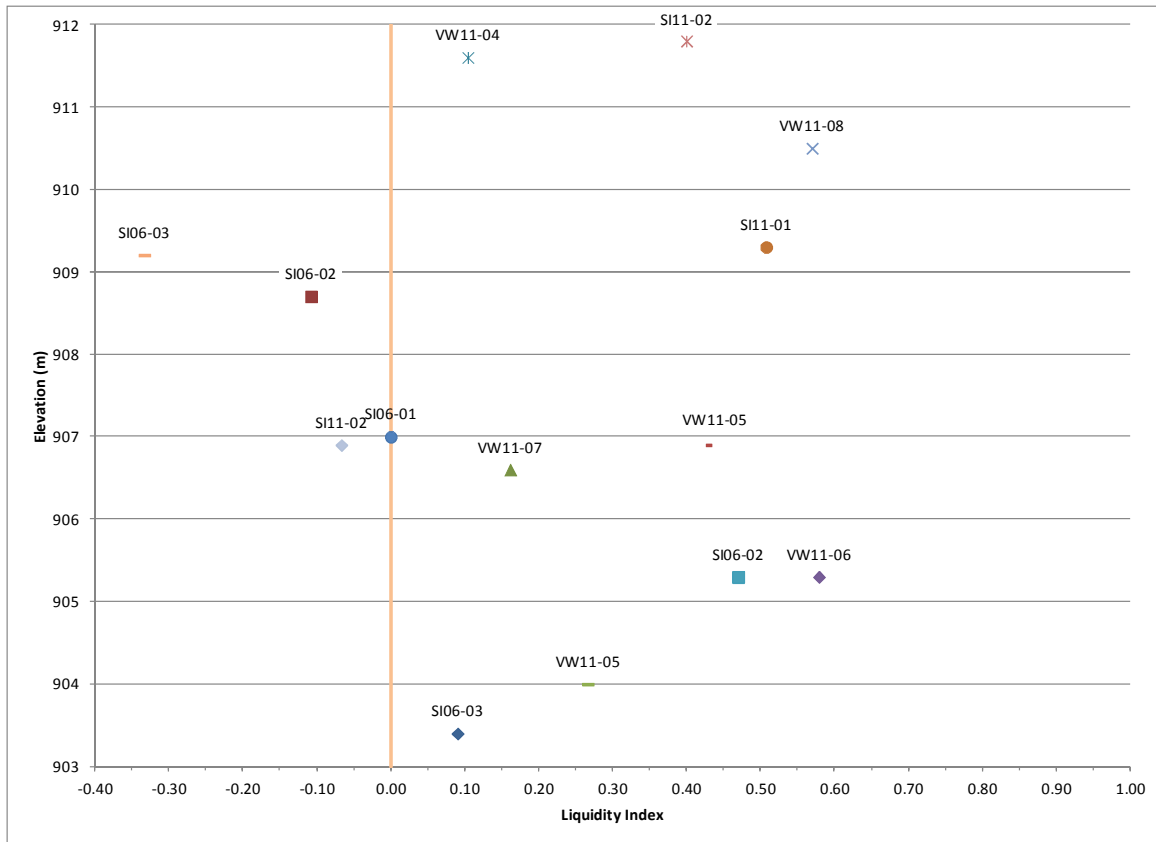
Figure 4.1: Elevation vs. Liquidity Index – Drill holes along Main Embankment

Figure 4.1 presents a plot of liquidity index results for various drill holes along the main embankment. The plot shows a number of samples with a liquidity index (LI) near zero (moisture content = plastic limit), which is typically consistent with an overconsolidated condition. For example, in VW11-04, testing of the silt GLU near elevation 911.5m (top of the unit) resulted in a LI equal to 0.1. (See Photo 4) This condition was also found to exist in several other locations along the Main Embankment from the 2011 investigation as well as earlier investigations. Table 4.2 presents a summary of available lab data for investigation holes located along the main embankment, 2011 and earlier. Note that some negative LI values were obtained, indicating natural moisture contents below the plastic limit.

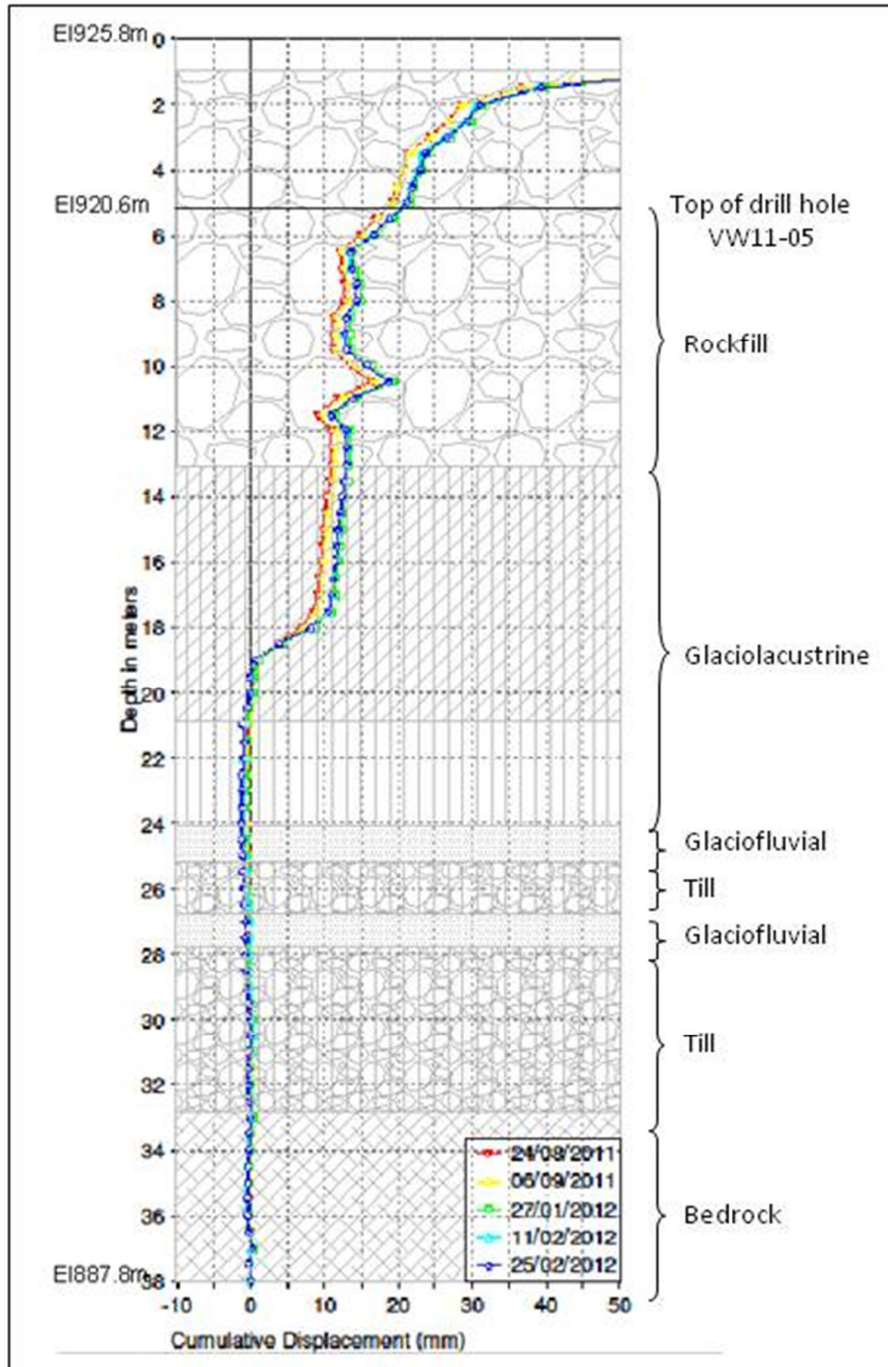
Figure 4.2: Cumulative Displacement vs. Depth (SI01-02) and VW11-05 stratigraphy

In summary, inclinometer data to date is consistent with the GLU comprising a competent foundation for the dams. This is no indication of pervasive pre-shearing nor is there indication there would be significant brittle behaviour upon shearing (loss of strength and, as a result, accelerated movements induced by shear strains).
