## **MOUNT POLLEY MINING CORPORATION**

## MOUNT POLLEY MINE

## TAILINGS STORAGE FACILITY 2012 ANNUAL REVIEW

DOCUMENT NO.:
 MP13-01

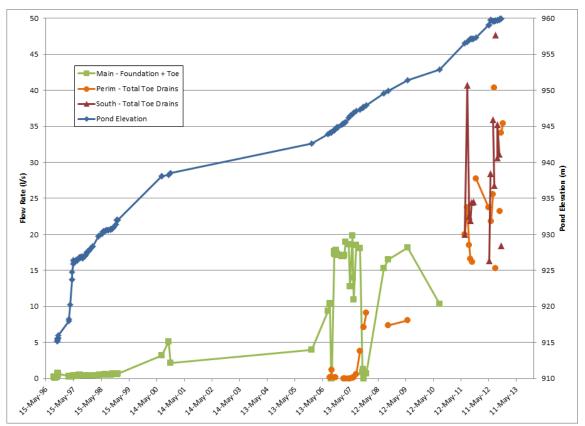
Figure 3-2. Drain Flow Readings.

widths, which are typically at a minimum immediately following the freshet, which is when spikes in drain flows are apparent. There appears to be a step increase in flow rate measured at the perimeter drain between 2009 and 2011, from approximately 8 l/s to ranging from 20 l/s to 50 l/s; this is likely in response to an increase in pond elevation.

There is no note of any turbidity observed in the drain water.

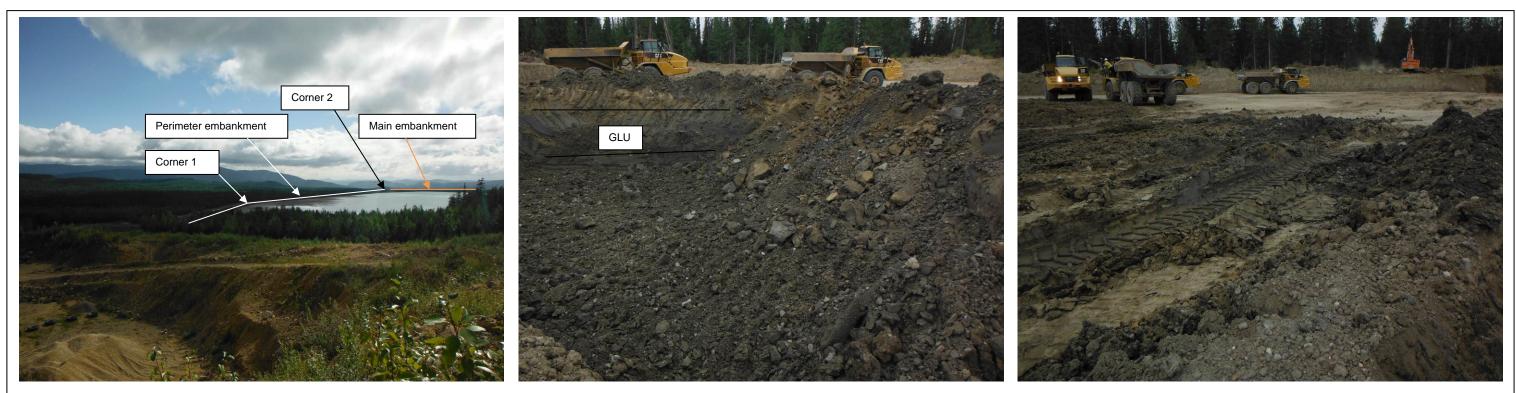
Photo 18: looking northeast at the Perimeter embankment and north end of Main embankment.

Photo 19: Glaciolacustrine unit (GLU) encountered in Perimeter borrow pit.

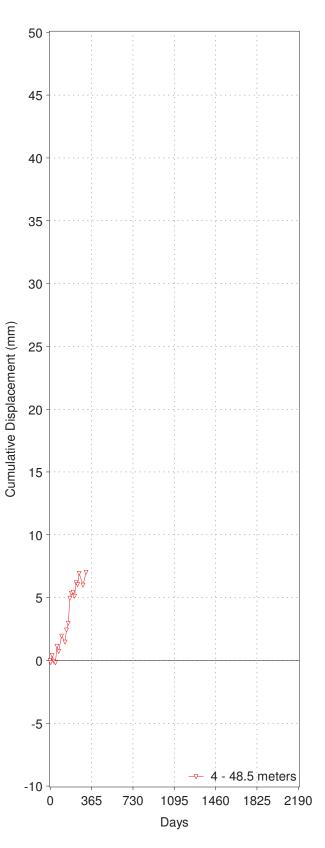
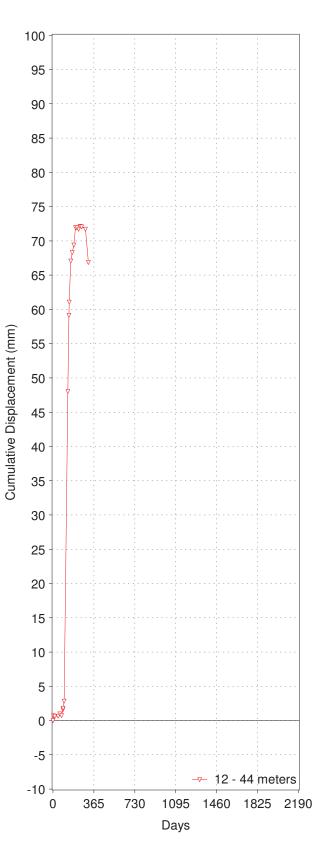
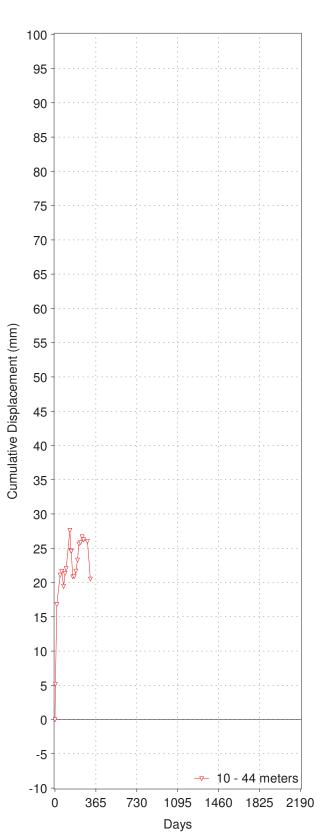
Mt. Polley Cumulative & Time Displacement SI11-04 A-Axis

SI11-04 has to date indicated an anomalous pattern of displacement suggestive of compression rather than net lateral displacement, although a faulty installation could be a contributor to the displacement pattern indicated. This slope inclinometer should be reinitialized when the compression displacement stabilizes. A replacement inclinometer was installed nearby in 2012, given concern that SI11-04 might soon become inoperative.
