**MOUNT POLLEY MINE
Tailings Storage Facility Stage 9
2013 As-Built Report**

Mount Polley Mining Corporation,
Likely, BC

February 2014
VM00560C

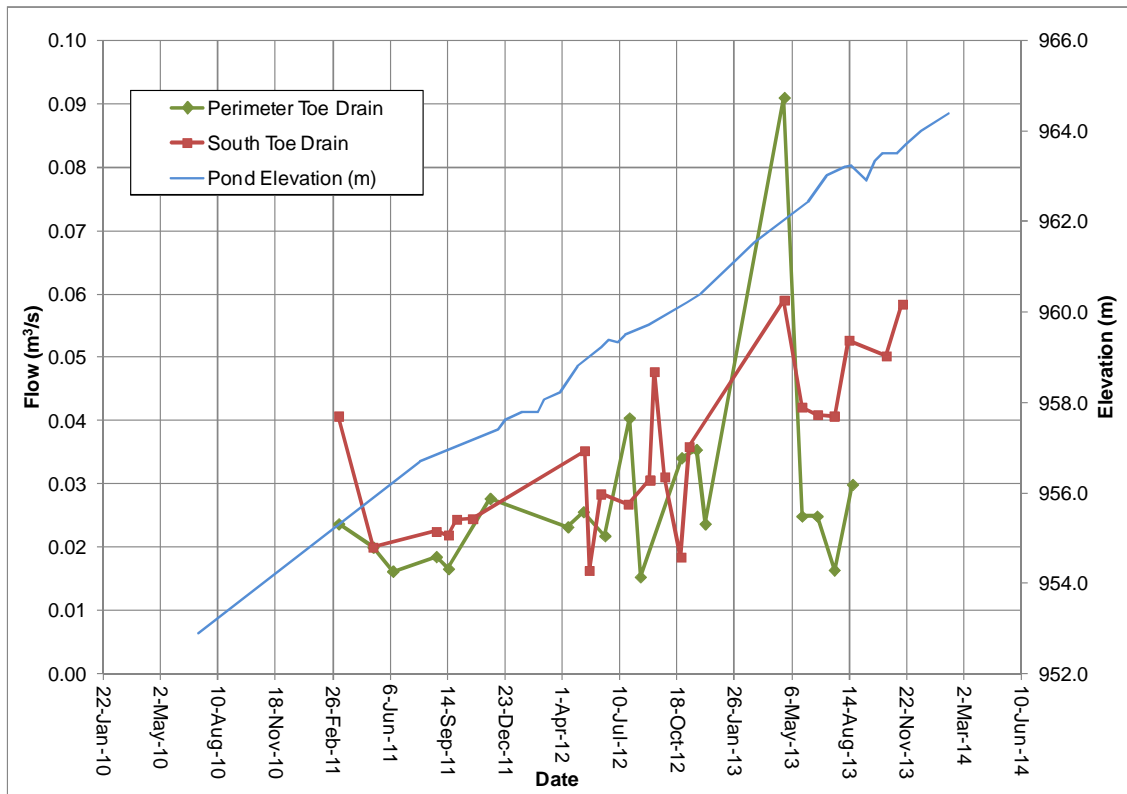
Figure 2.1: South and Perimeter Embankments Drain flow readings

Drain flows from the South and Perimeter embankments are read weekly as weather permits. These flow are typically influenced by the upstream sand cell placement. South and Perimeter Embankment drain flows measured since 2011 are illustrated below in Figure 2.1.
