**MOUNT POLLEY MINE
Tailings Storage Facility Stage 9
2013 As-Built and Annual Review Report**

Mount Polley Mining Corporation,
Likely, BC

AMEC Environment & Infrastructure,
a division of AMEC Americas Limited
Burnaby, BC

February 2014
VM00560C

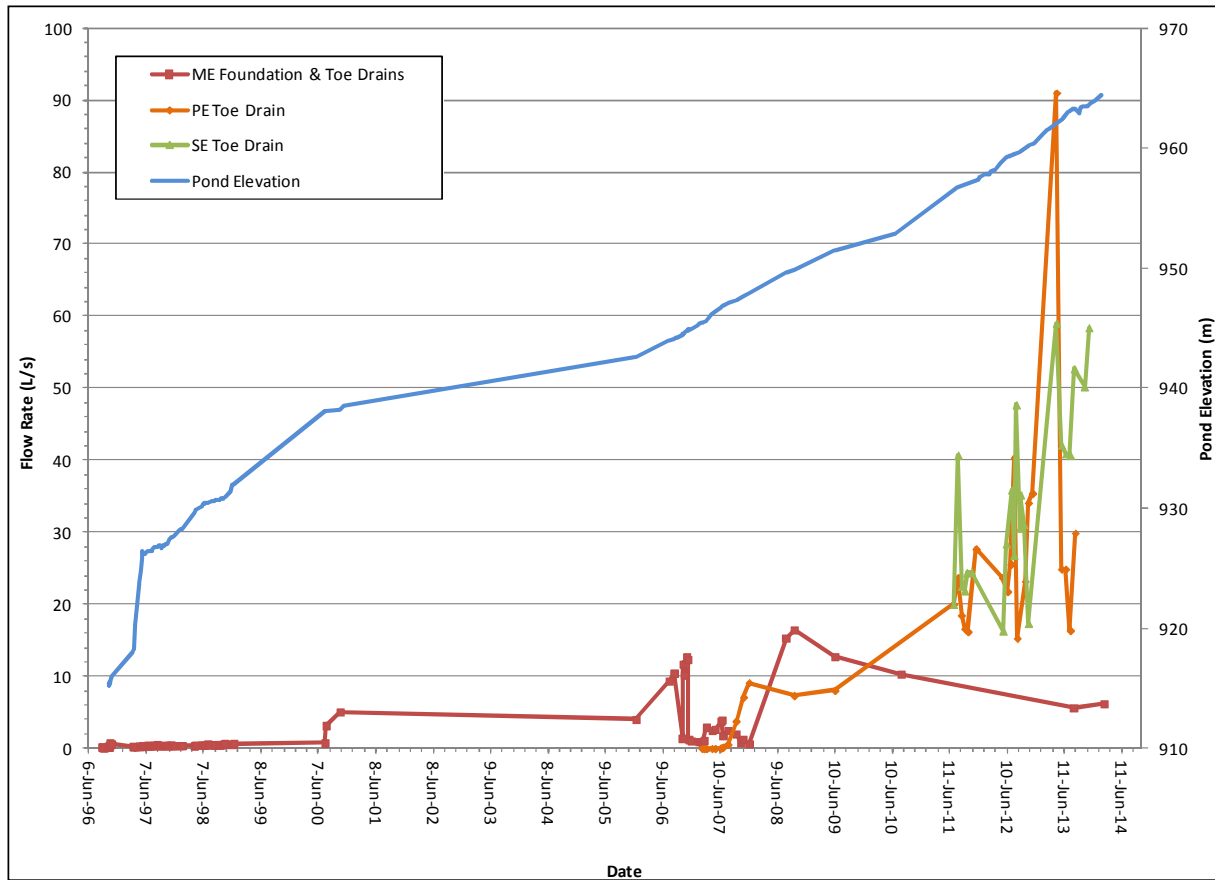
Figure 2.2: Main Embankment, Perimeter Embankment and South Embankment Drain Flow Readings

Flows from the upstream toe drain and foundation drains of the Main Embankment were historically measured at the sump located at the Main Embankment seepage collection pond, and are now measured at a manifold located at a water transfer station near the Main Embankment seepage collection pond (constructed as part of the discharge system installation completed in 2013). Upstream toe drains from the Perimeter Embankment and South Embankment discharge into ditches which carry the flow to their respective seepage collection ponds. Flow for the Perimeter Embankment and South Embankment are measured across the ditch profile as close to the end of the pipe as possible. Water from the upstream toe and foundation drains is recycled to the TSF, evaporated or discharged in accordance with permitted activities, the combination of which is dictated by the site water management strategy.
