FINAL REPORT

DAM SAFETY REVIEW

**Mount Polley Mine
Likely, British Columbia**

December 2006

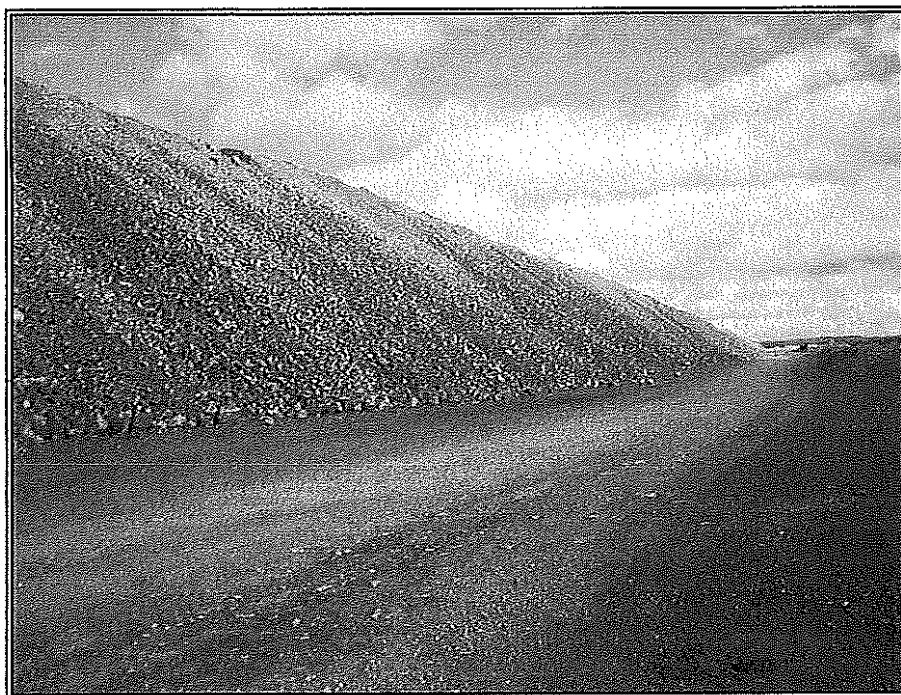
Photo 1: Main Embankment Shell – Looking Northeast

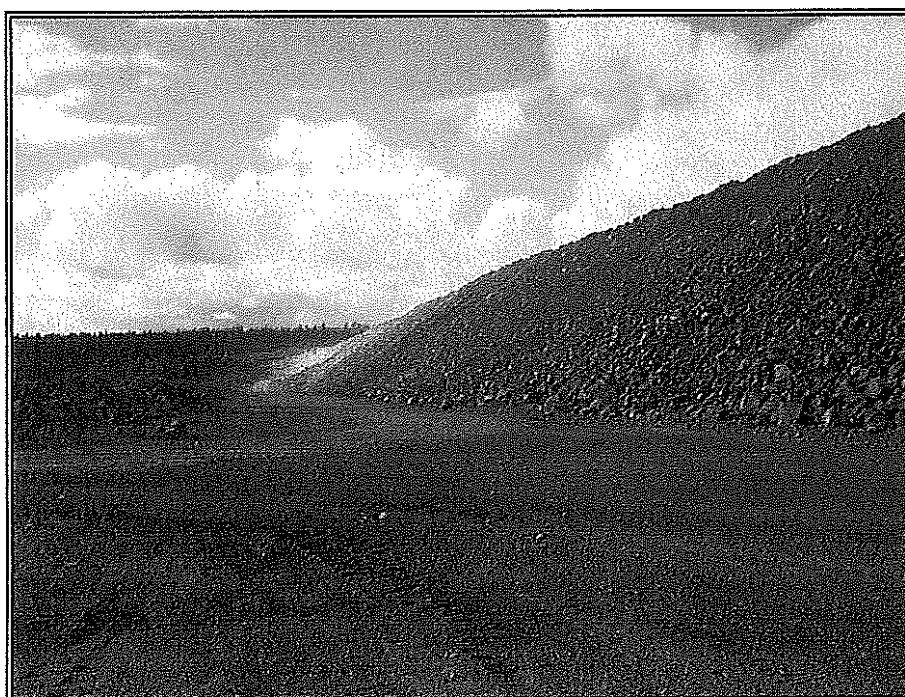
Photo 2: Main Embankment Shell – Looking Southwest

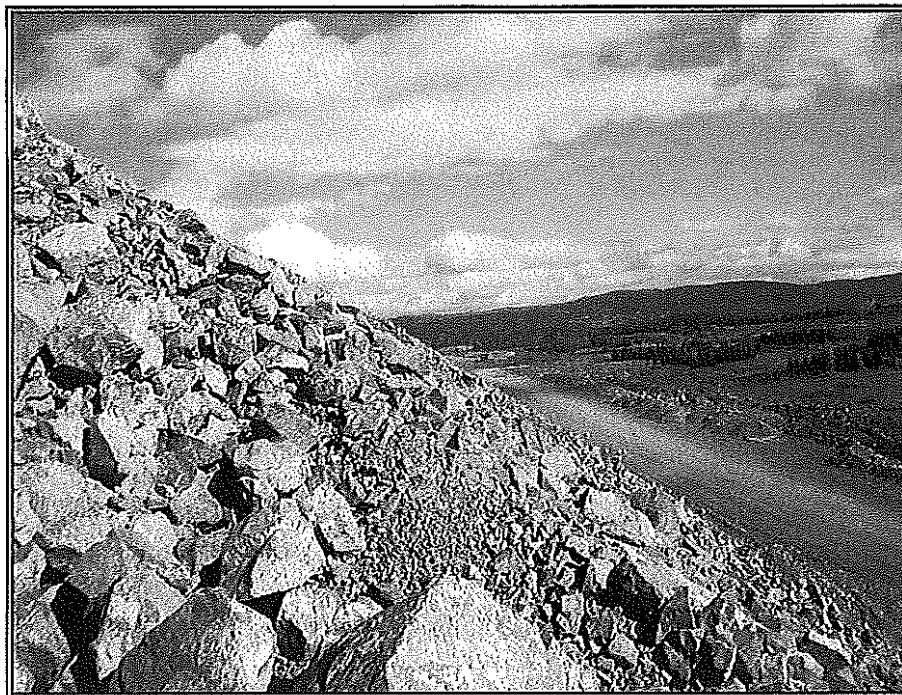
Photo 3: Nature of Main Embankment Rockfill

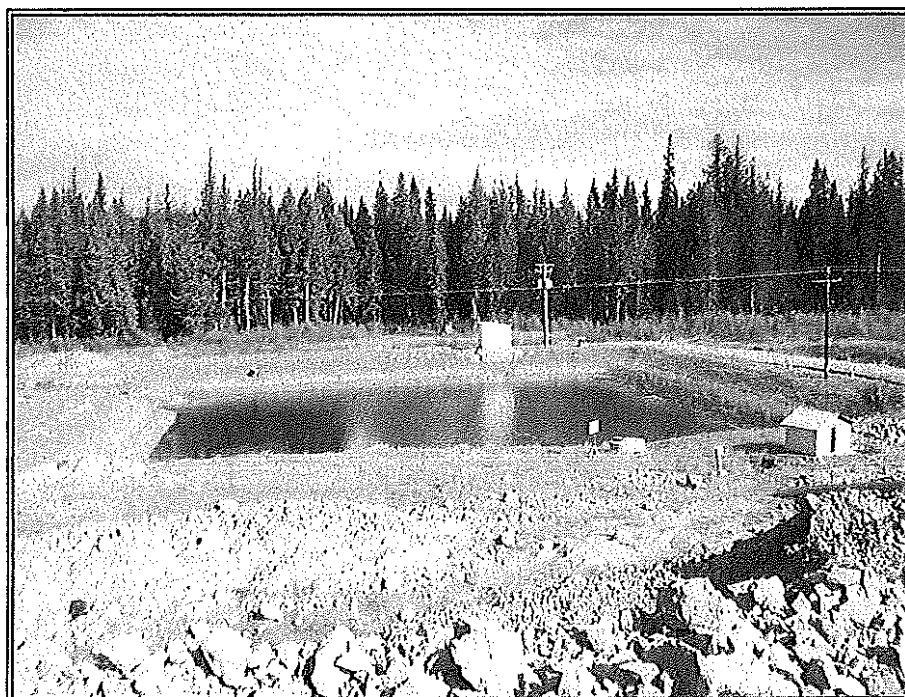
Photo 4: Main Embankment Seepage Collection

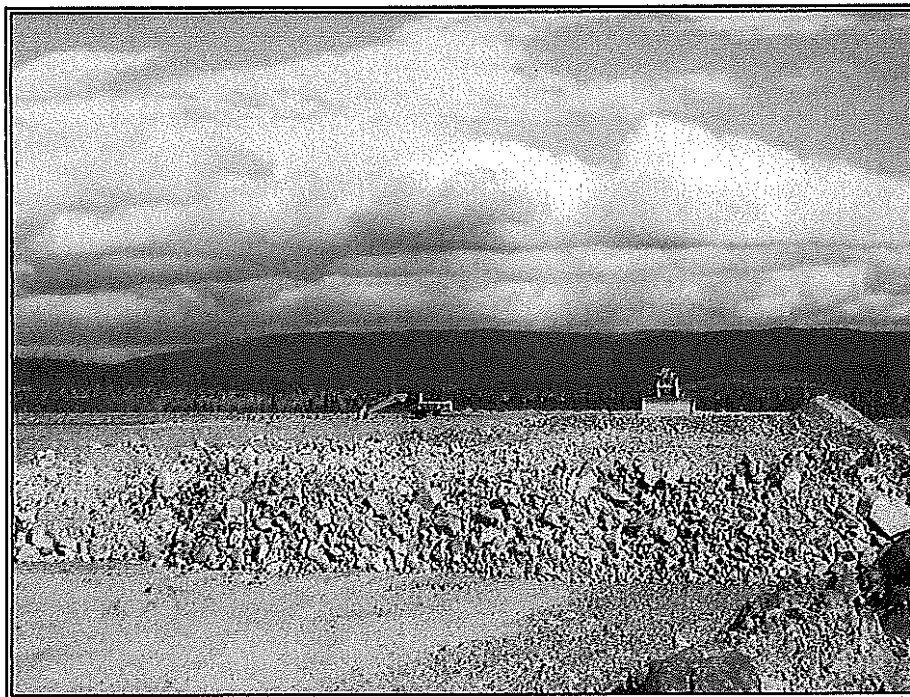
Photo 5: Construction on Main Embankment

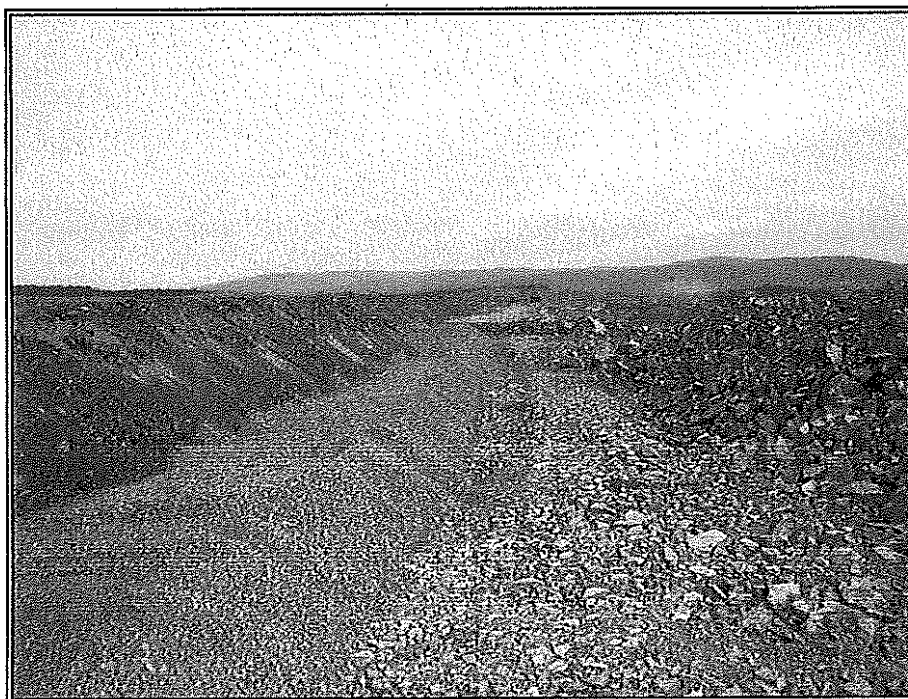
Photo 6: Zones of Main Embankment Dam

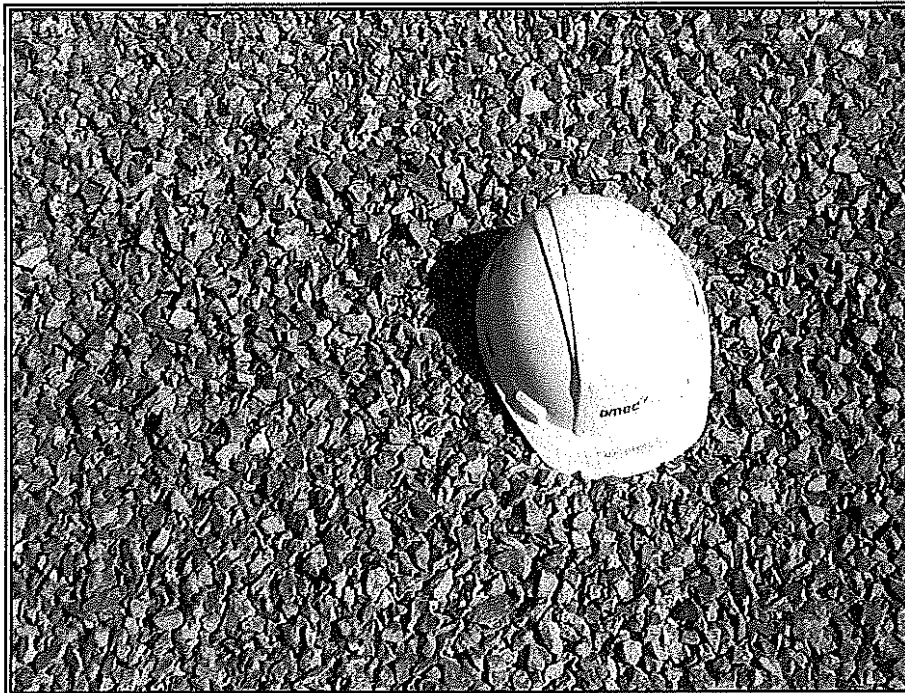
Photo 7: Main Embankment Transition Material

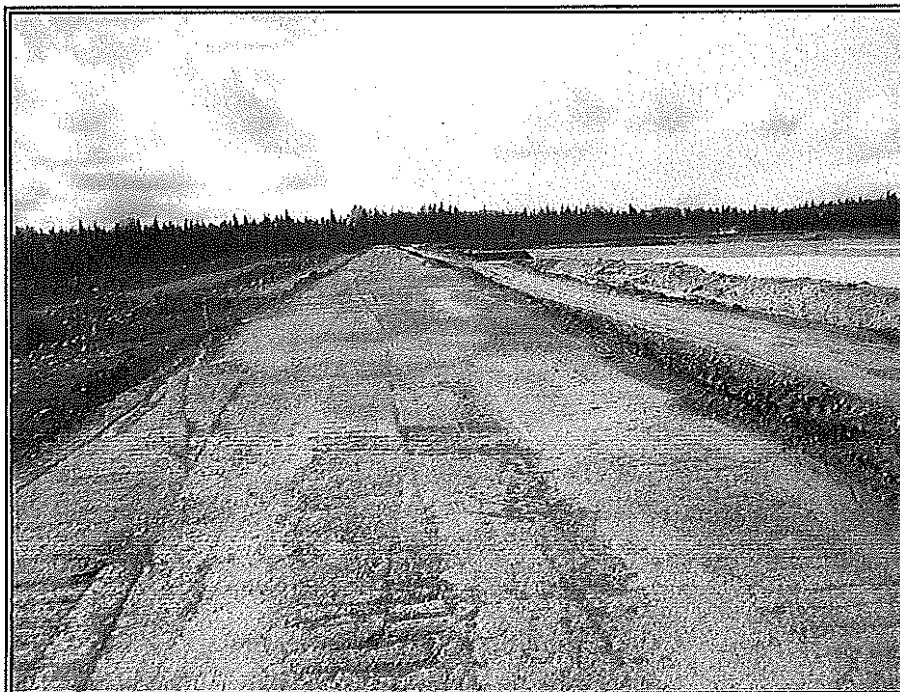
Photo 8: Main Embankment Compacted Core

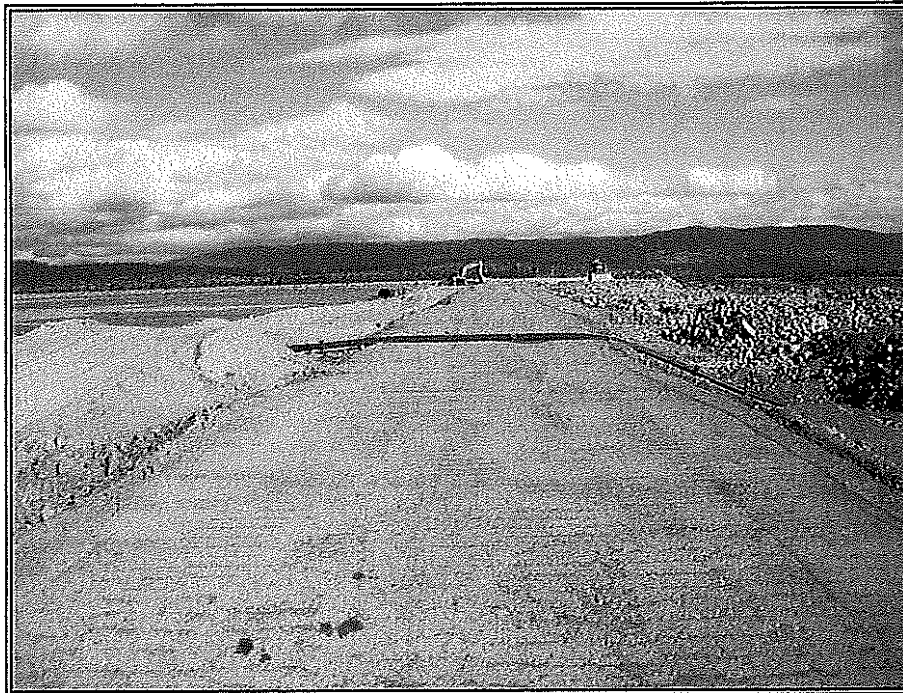
Photo 9: General Photograph of As-Built Robust Core

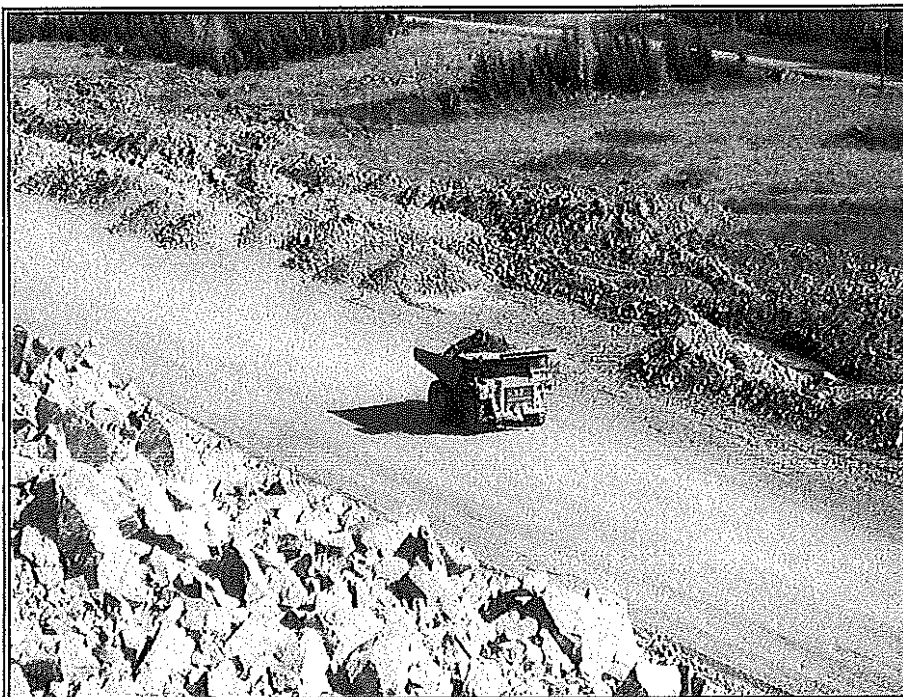
Photo 10: Haulage of Till from Borrow

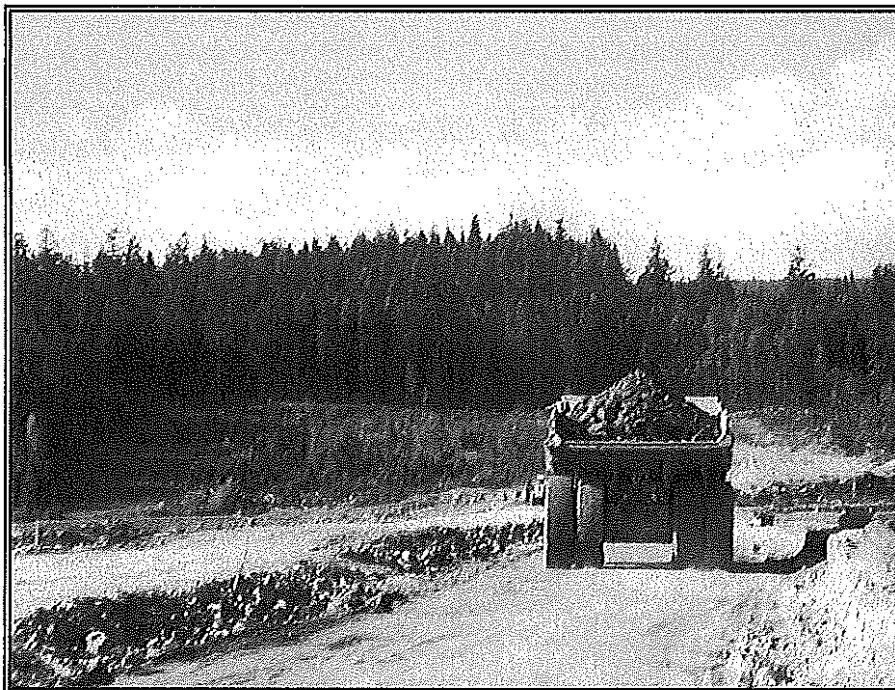
Photo 11: Till Haulage on South Embankment

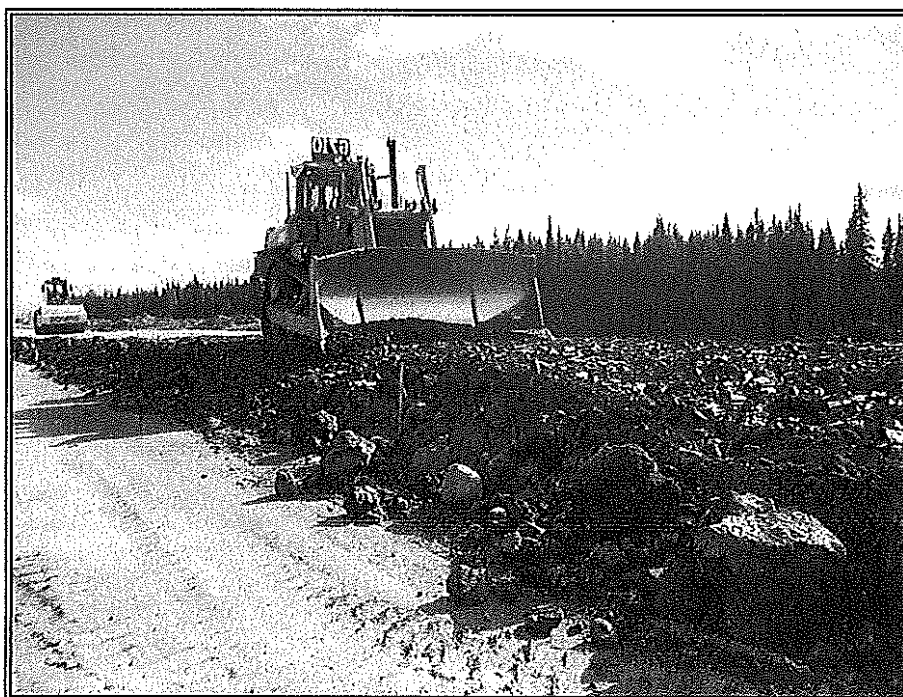
Photo 12: Placement of Till Core – South Embankment

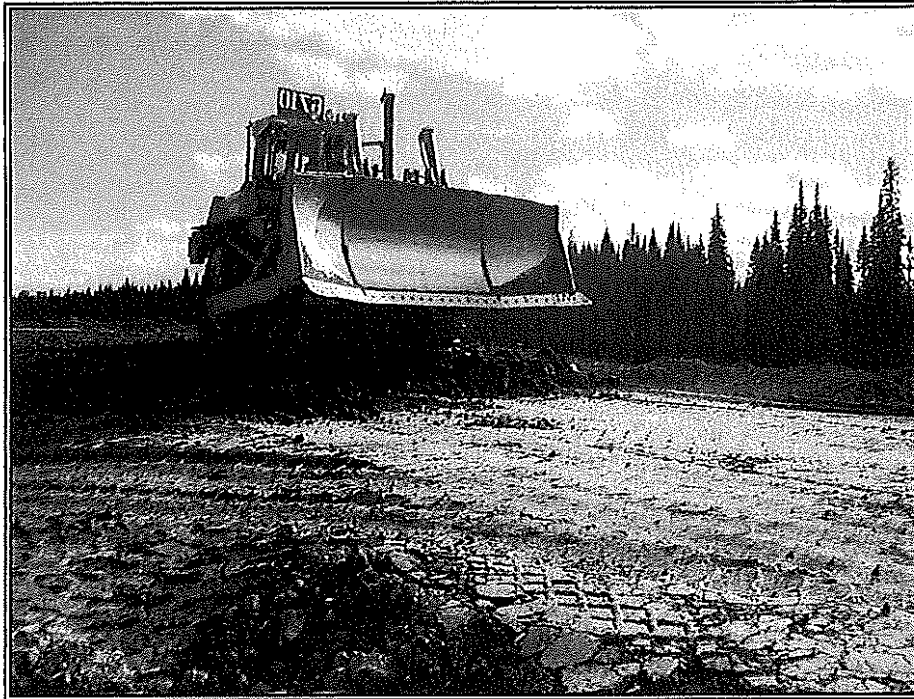
Photo 13: Compacted Till – South Embankment

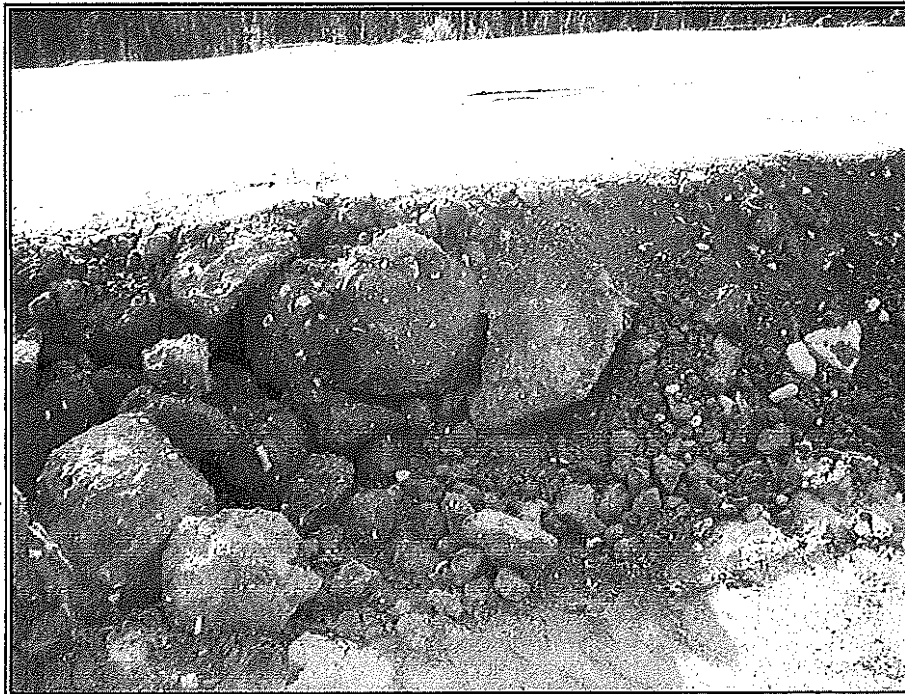
Photo 14: Compacted Till – South Embankment

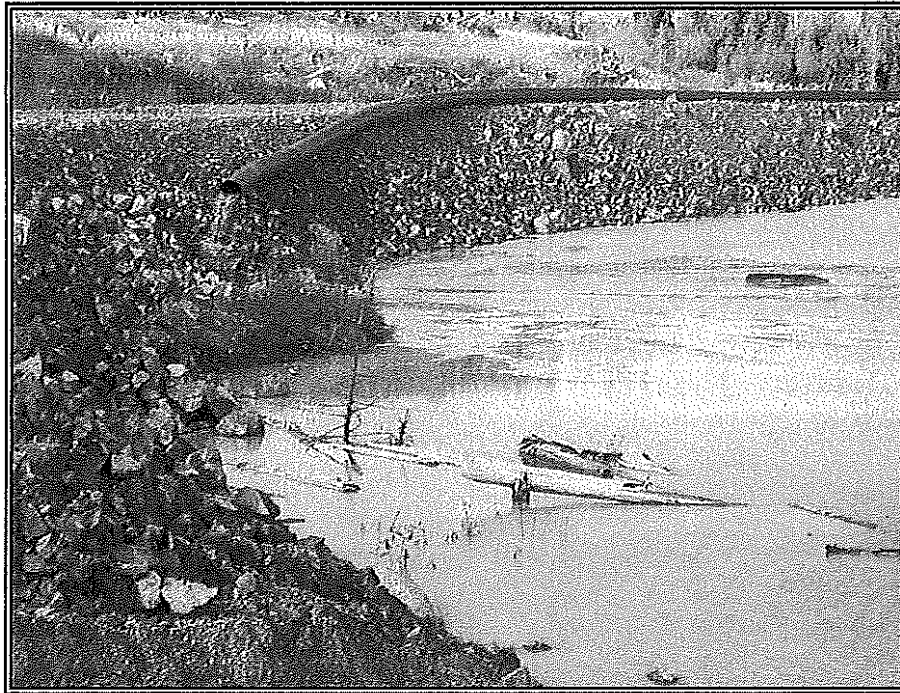
Photo 15: Tailings Overboarding at "Top" of Panel

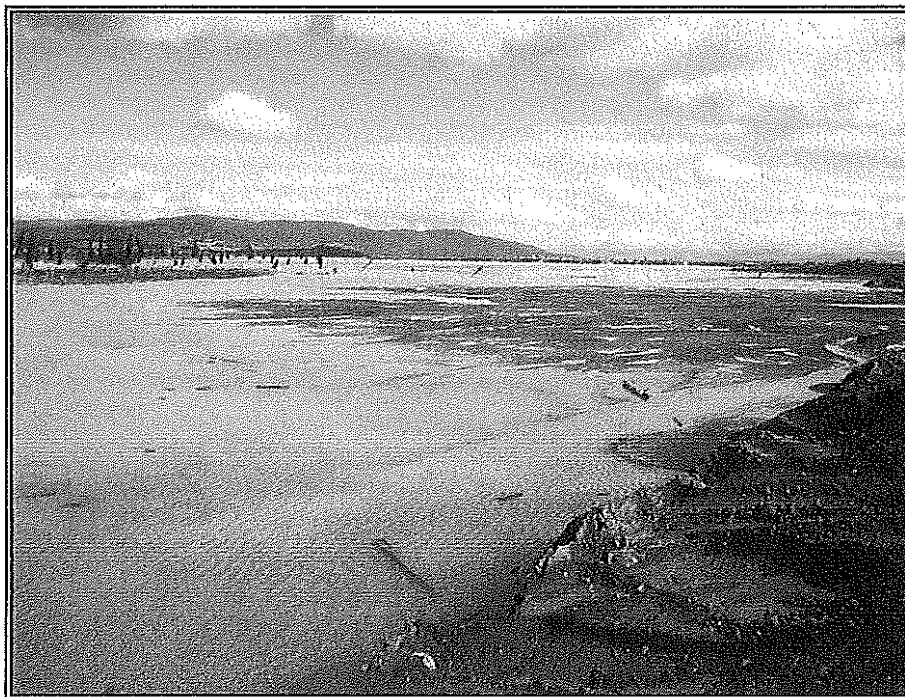
Photo 16: "Beach" Pondward of Deposition Location

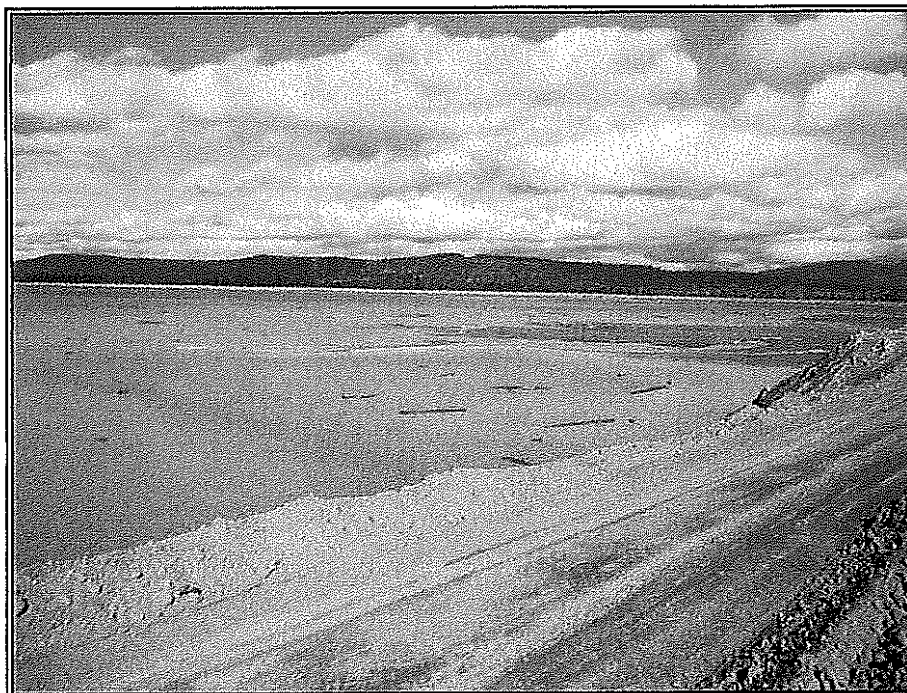
- **Dam Structures** – The three embankment dams all appeared in a good state of repair at the time of the DSR. There was no visual evidence of significant past issues (nor any documented). The lack of a tailings beach and inconsistency with beach profile and the closure concept for the TSF are notable but do not present immediate dam safety concerns. The lack of a beach profile consistent with closure objectives would address the lack of beach against the embankments and, for a number of reasons, should be addressed as soon as possible by the mine to avoid increased costs in this regard in the future. Again, however, dam safety is not a driving reason to address this lack of beach/positive beach profile.

Photo 17: Lack of Established Beach – Perimeter Embankment in Background

There is currently no surface discharge facility (spillway) and one will be required for closure (and is the prime reason why the current beaching practices should be modified to allow effective placement of a spillway). At other similar facilities in British Columbia, where there is no operating spillway, a longer duration PMF event than the 24 hour event has been used with the 24 hour duration being adopted for closure when there will be an appropriate spillway. This approach is recommended for the Mount Polley TSF.

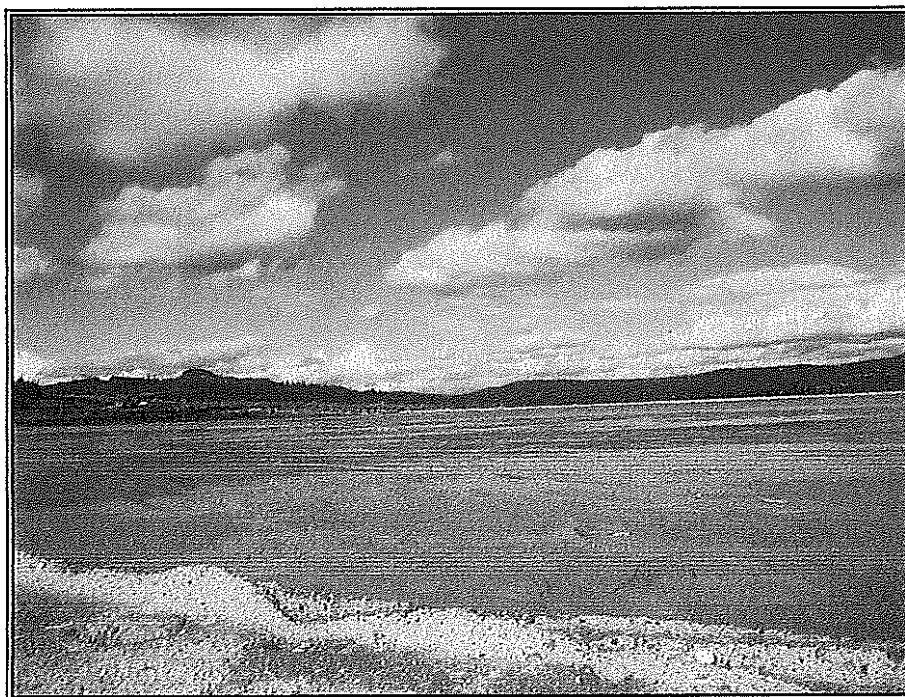
Photo 18: Minor Beach Development along Portion of Main Embankment

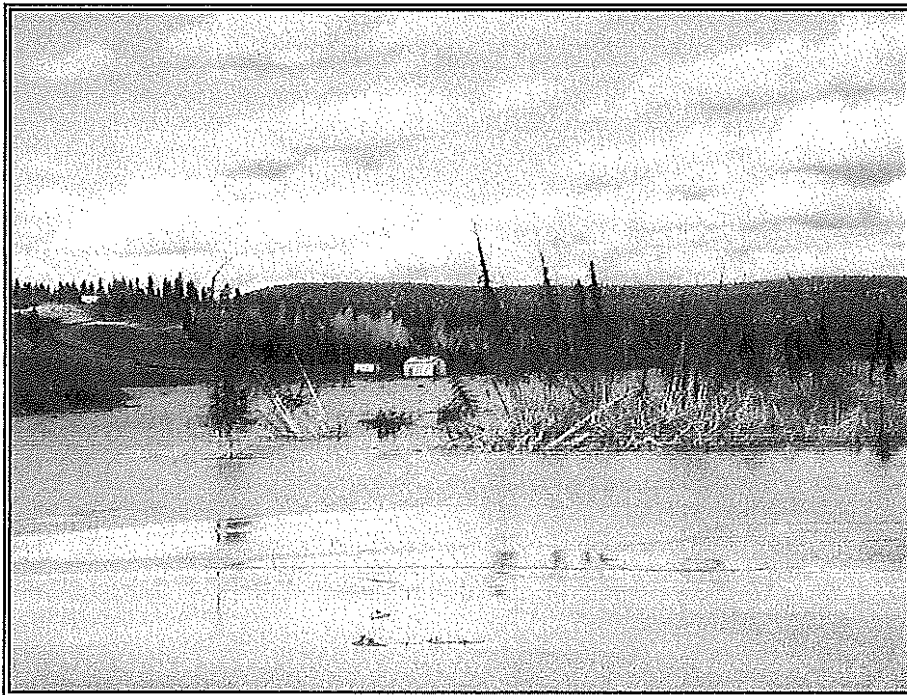
Photo 20: Tailings Water Reclaim Barge Location
