AMEC File No. VM00560

Date 14 June 2011

Subject **Mount Polley Mine Project
Tailings Storage Facility Instrumentation
Review and Recommendations**

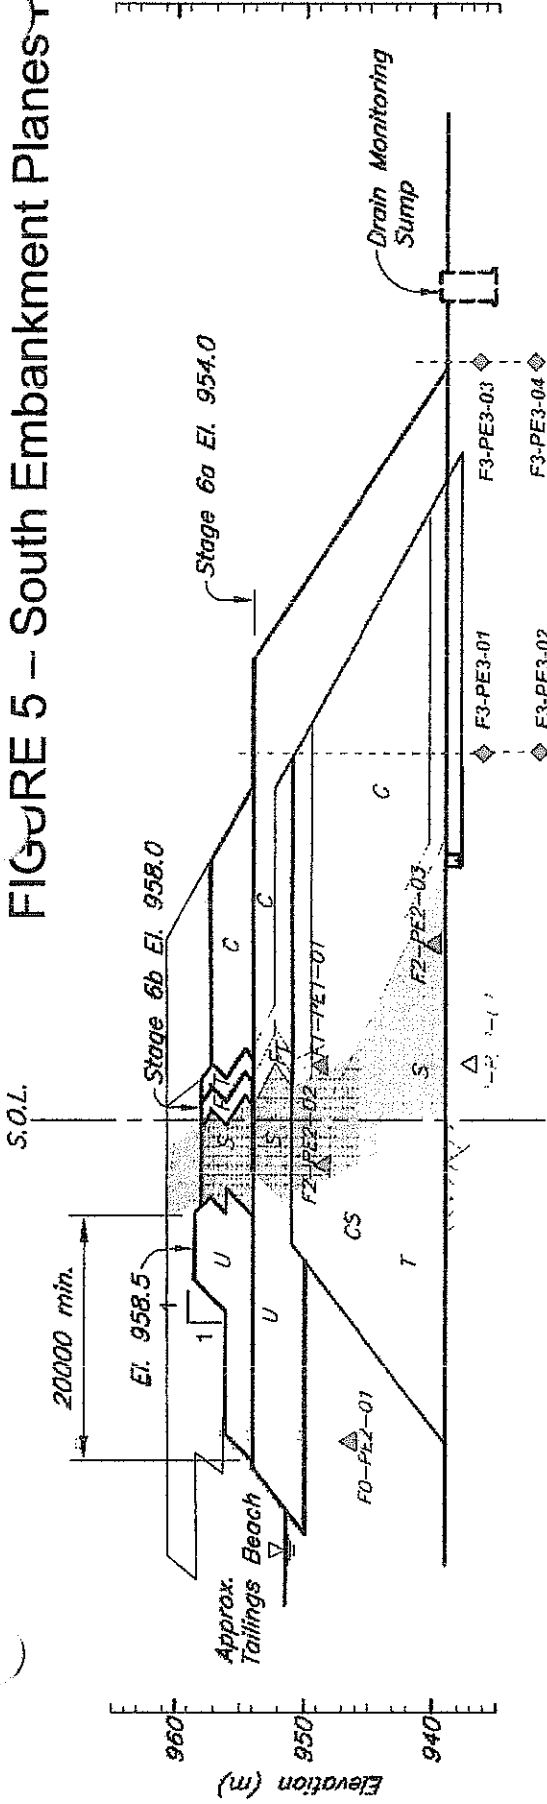
PLANE F/255

3. *South embankment foundation conditions:* AMEC's recent review of foundation conditions has revealed that very little information exists within the ultimate South embankment downstream toe area.

3. **South embankment foundation conditions:** South embankment foundation conditions will be investigated using both test pits and the sonic drill rig. Five test pits will be excavated by a CAT 320 or similar excavator in the downstream vicinity of the South embankment. Exposed soils within the test pits will be examined and characterised by the AMEC site engineer, with selected samples taken for potential laboratory testing. The sonic drill rig will complete two holes to bedrock or firm glacial till along the existing instrumentation plane F (Figure 5). Piezometers will be installed in each hole upon completion.

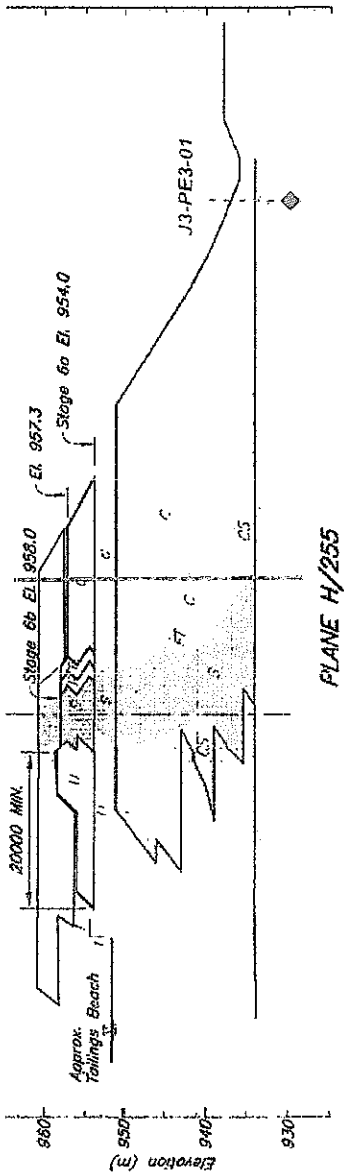
NEW PLANE "J" (at crack location, cross-section shown above is taken from plane H for illustrative purposes)

2. *Perimeter embankment crack:* The 2010 Dam Safety Inspection (KP, 2011) observed a crack at the eastern portion of the Perimeter embankment (at station 3+400 m) within the downstream rockfill shell. It is currently uncertain whether this crack is indicative of embankment slope movement (possibly related to till borrow excavation operations to the downstream, and/or foundation glaciolacustrine soils), or merely reflects localized rockfill settlement.

2. **Perimeter embankment crack:** At the location of the Perimeter embankment crack, foundation conditions will be investigated using a sonic drill rig to complete two holes to bedrock or firm glacial till. Holes will be located both on the embankment crest and adjacent to the downstream embankment toe at chainage 3+400 (i.e. the location of the observed crack). When complete, an inclinometer will be installed in the crest hole while a piezometer will be installed in the toe hole (at the locations shown in Figures 1 and 6). The inclinometer within the downstream rockfill shell will assist in determining the existence, extent, and rate of slope movements along this portion of the dam, and how such movements might be affected by downstream borrow excavation. The exposed faces within the till borrow pit to the downstream of the crack area will be inspected by the AMEC site engineer for any presence of glaciolacustrine soils.

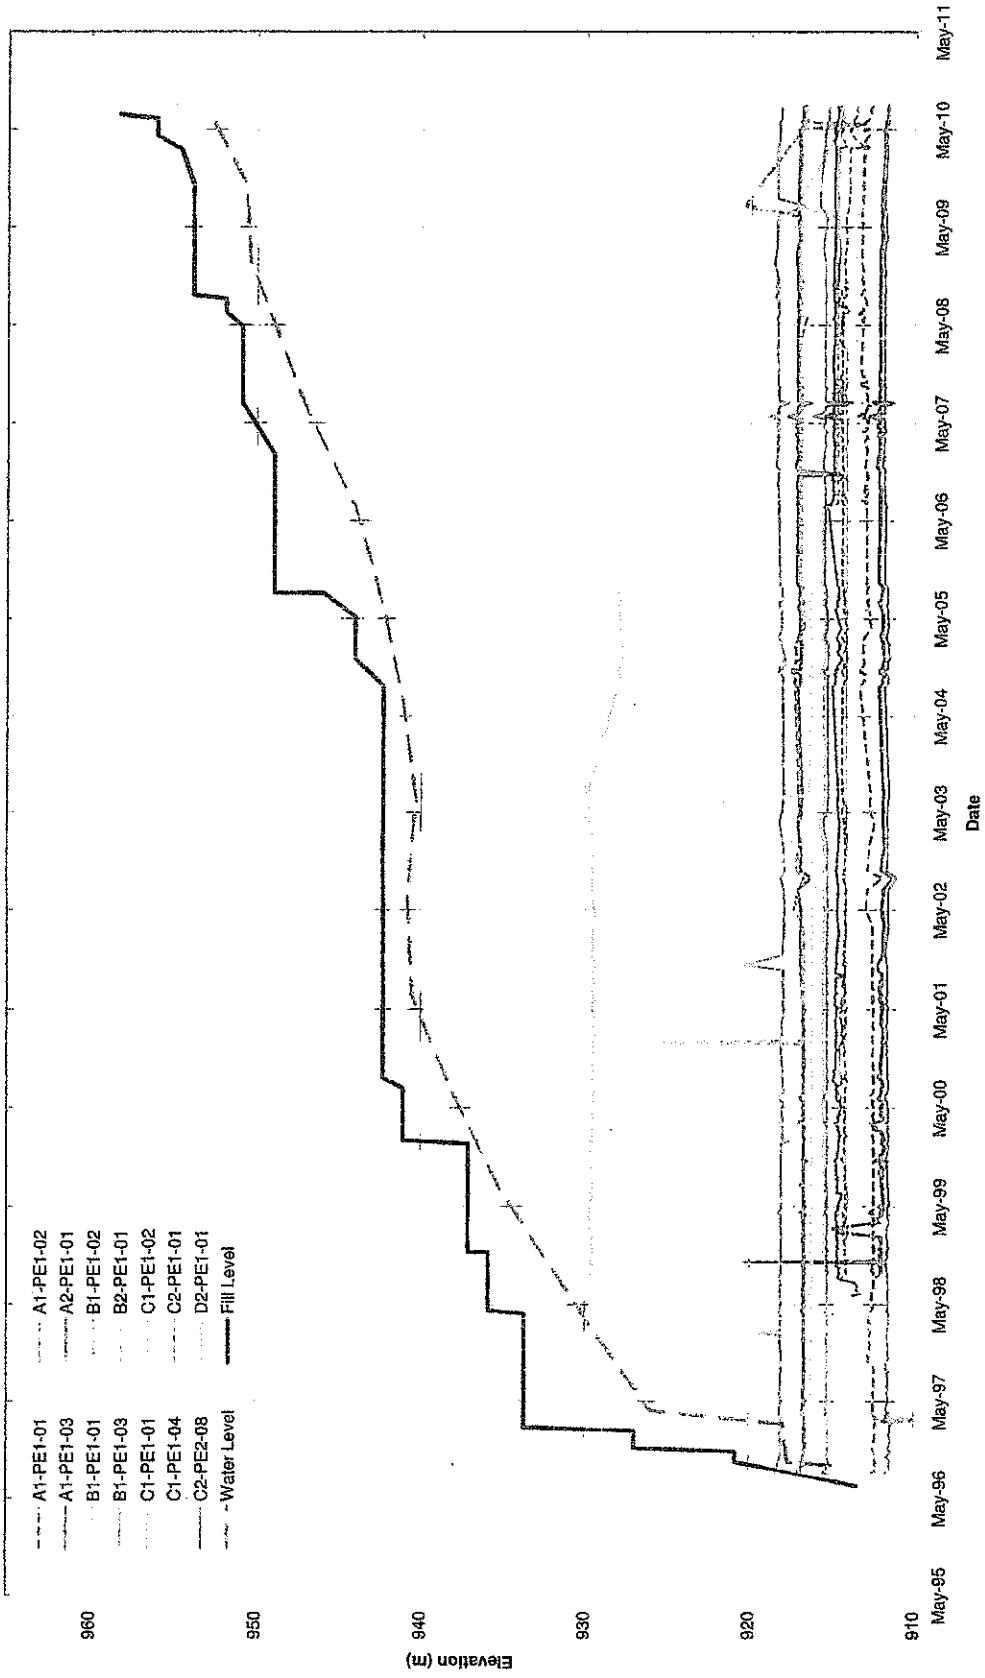
Figure 7: Drain Piezometers

Several drainage systems were installed within the Mount Polley TSF embankment. Foundation drains, downstream toe drains, and chimney drains were all instrumented with piezometers at various locations within the three TSF embankment sections. Figure 7 shows the historical data recorded in all drain system instruments. In general, piezometers show consistent overall flat-line trends over time (i.e. all continue to record their installation elevation even as water levels increased within the TSF). This agrees with the expectation that a functioning drainage system would not allow accumulation of water head.

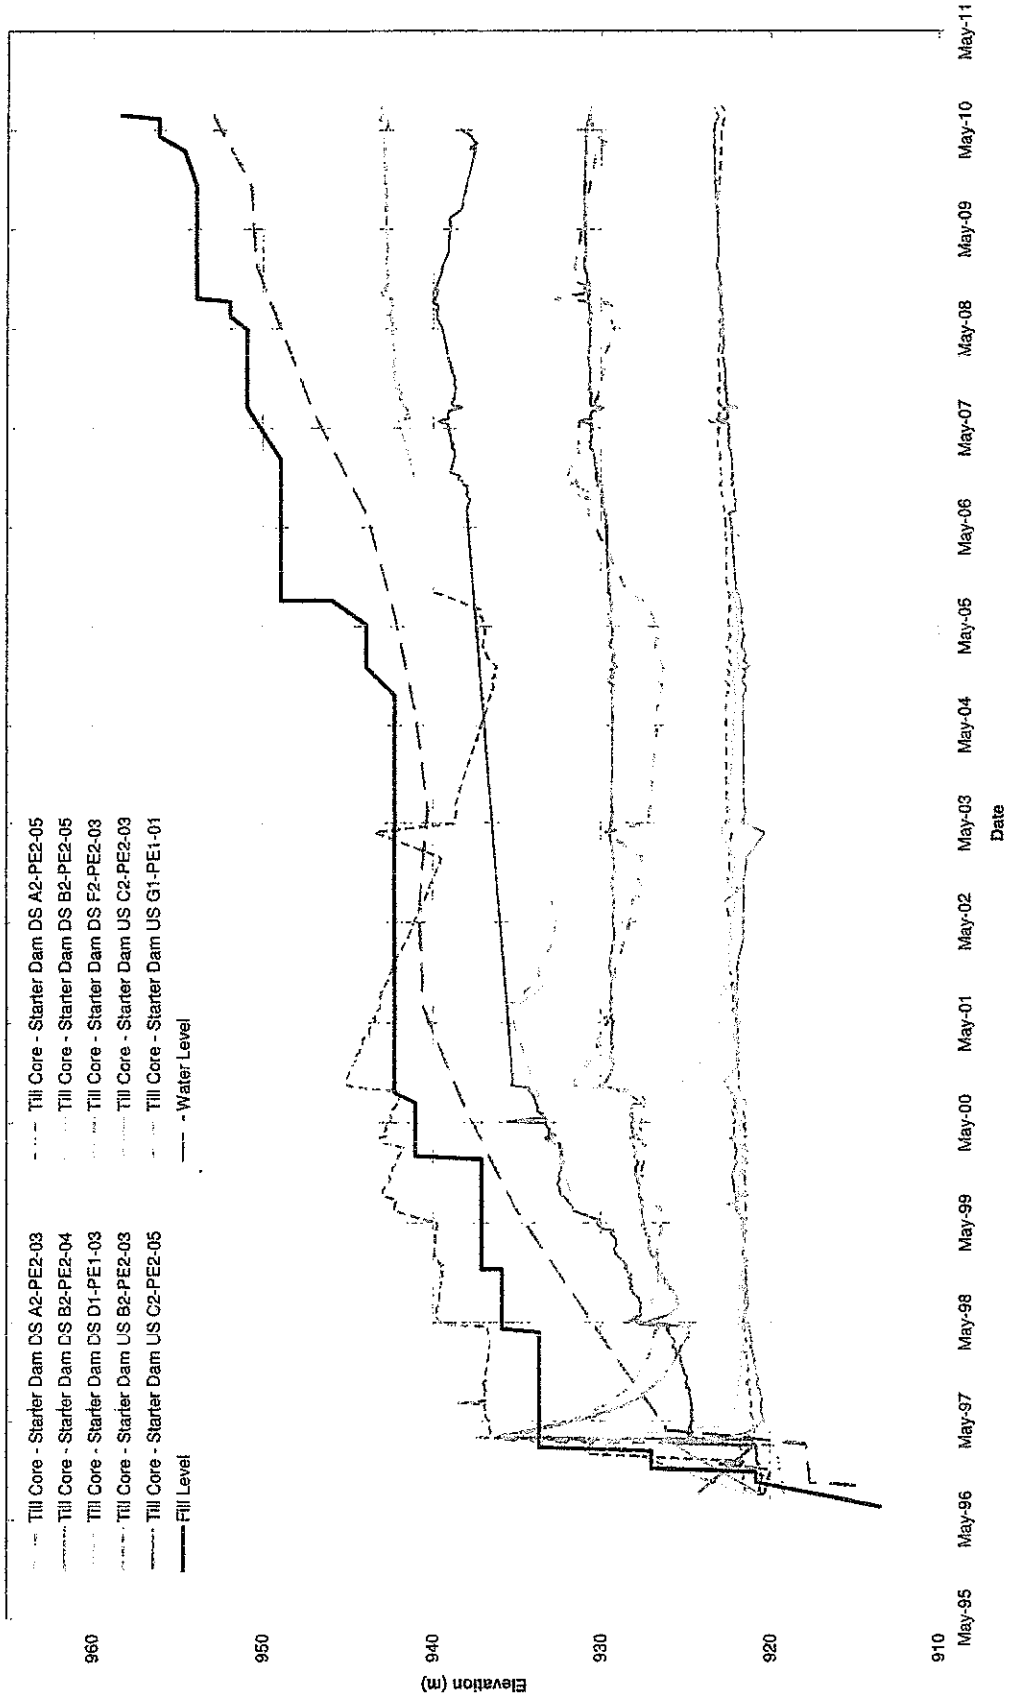
Figure 8: Till Core - Starter Dam Piezometers

Historical data from the Starter Dam piezometers (Figure 8) shows a general trend of sharply increasing pressures during the early timeframe when the overlying fill levels were low and construction equipment impacts were easily felt by nearby piezometers, in the form of construction-induced pore pressure response. The till fill piezometers show a long term trend of gradual pore pressure increase, with more significant transient pore pressure increases (due to construction of dam raises), and subsequent pore pressure declines, within the context of the long term increasing trend. With increasing time and greater depth of burial of the piezometer tips relative to the dam crest where raise construction occurs, the magnitude of transient pore pressure become more muted when compared to the absolute fill and water levels. All piezometers have recorded pressures less than the overlying fill levels since 2002. Currently, when compared to the overlying embankment fill levels, the five functioning piezometers in this region show pore pressure ratios⁵ (Ru) values of between 0 and 0.1. It can be seen in Figure 8

that pore pressures in all of the Starter Dam fill piezometers, as expressed in elevation head, are below the level of the tailings pond, and that the rate of the long term trend of increasing pressures is much lower than the overall rate of rise of the tailings pond. This is indicative of a downward hydraulic gradient, which can positively influence long-term embankment stability.

From a stability perspective, as evaluated in limit equilibrium stability analyses, it is the pore pressures registered in the till fill piezometers in the starter dam embankment that are of significance in terms of potential slip surface geometries yielding the lowest (i.e. most critical) factors of safety values in stability evaluations.

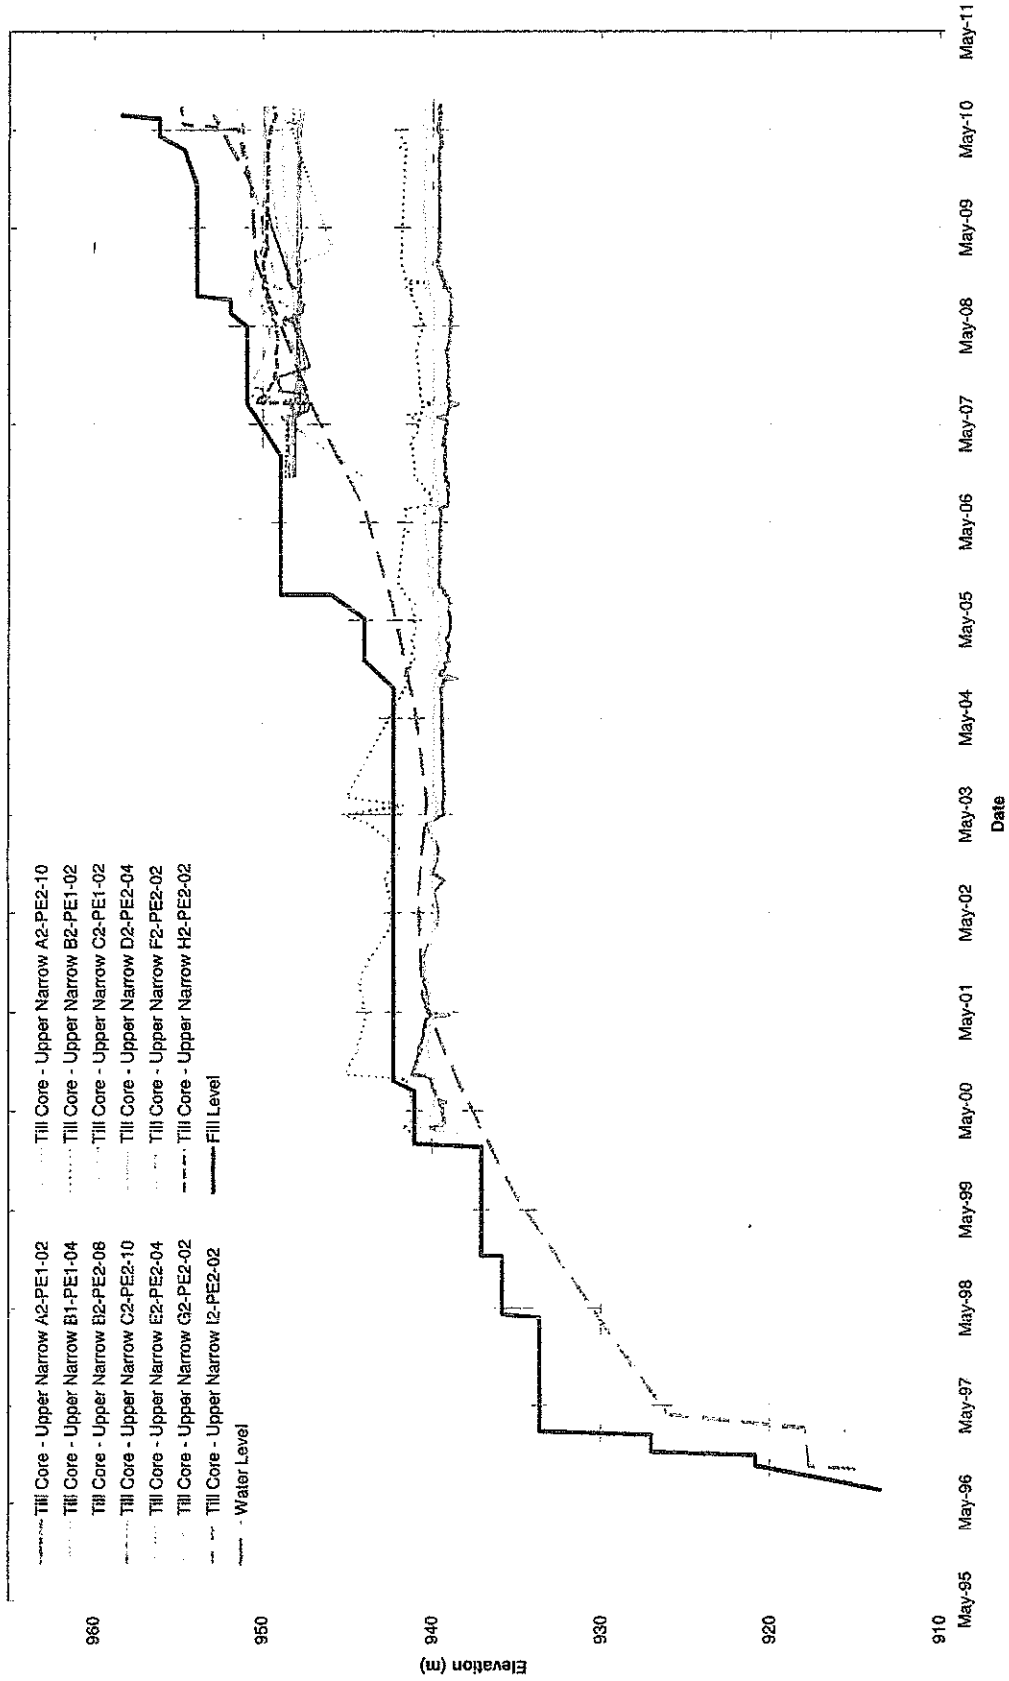
Figure 9: Till Core - Upper Narrow Section Piezometers

Those piezometers in the narrow, raised portion of the core (Figure 9) display similar general trends to the Starter Dam piezometers with initial sharp increases in recorded pressure as fill was placed in their immediate vicinity and lesser and more muted transient pressure responses to fill addition as their depth of burial increases. Figure 9 shows that, in the 2007 construction season, pore pressures in recently installed till fill piezometers actually registered pressure heads in excess of the tailings pond level, the pore pressures being governed by construction rather than the tailings pond level. Currently, when compared to the overlying embankment fill levels, the 9 functioning piezometers in the Main and Perimeter embankment central cores (i.e. above the starter dam embankment) show pore pressure ratios between 0 and 0.1. The two functioning piezometers within the South embankment core zone show elevated pore pressure ratio values of 0.2 to 0.3, with absolute measured pressure heads roughly reflecting the last measured pond level. Given their relative position within the embankment, it is expected that the till fill piezometers installed above the starter dam, in the central, narrower portion of the core, would be more responsive to the tailings pond level than those piezometers in the downstream portion of the till starter embankment.

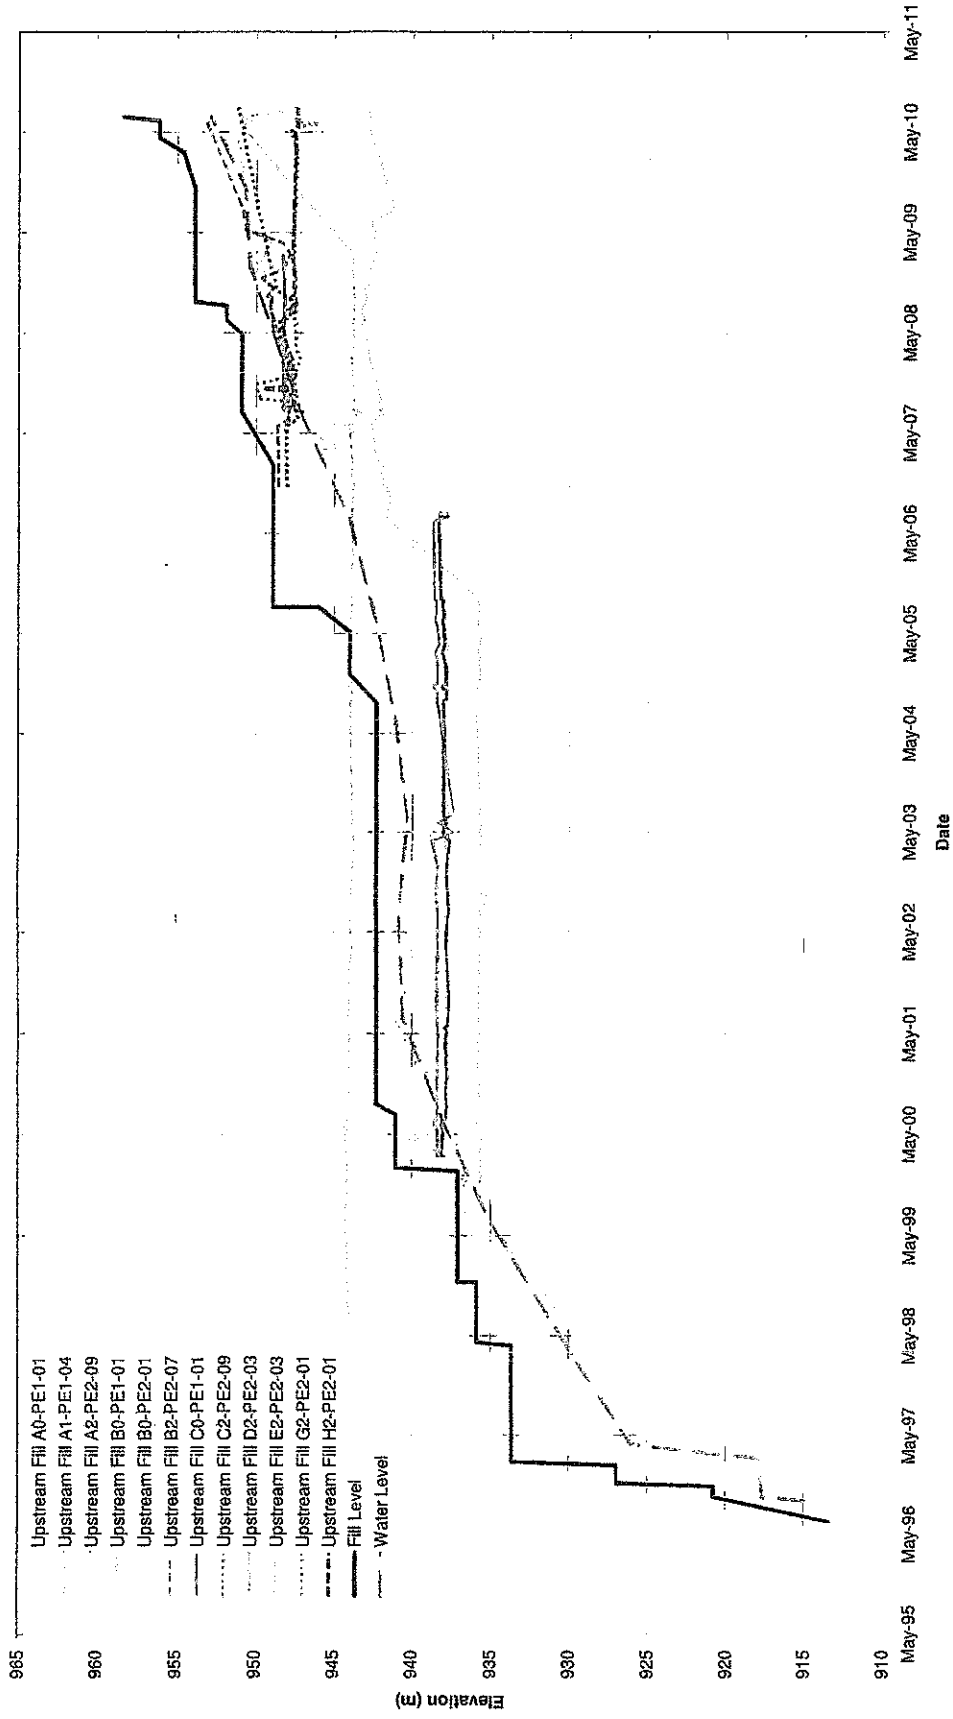
Figure 11: Upstream Fill Piezometers

Compacted tailings, rockfill, or till core materials have been used to form fills upstream of the core in the Mount Polley TSF embankments. Vibrating wire piezometer data exists for this variable fill unit from 12 piezometers installed in the Main and Perimeter embankments. One piezometer is shown for the South embankment, but no data is available. Historical data from the upstream fill piezometers (Figure 11) shows a variety of trends, likely reflecting the variety of materials used in construction. In general, pressure is observed to increase as fill and water levels increase. This is an expected result. Currently, when compared to the overlying embankment fill levels, the six functioning piezometers in this region show pore pressure ratios between 0 and 0.2. Two piezometers show pressure levels consistent with the measured pond level.

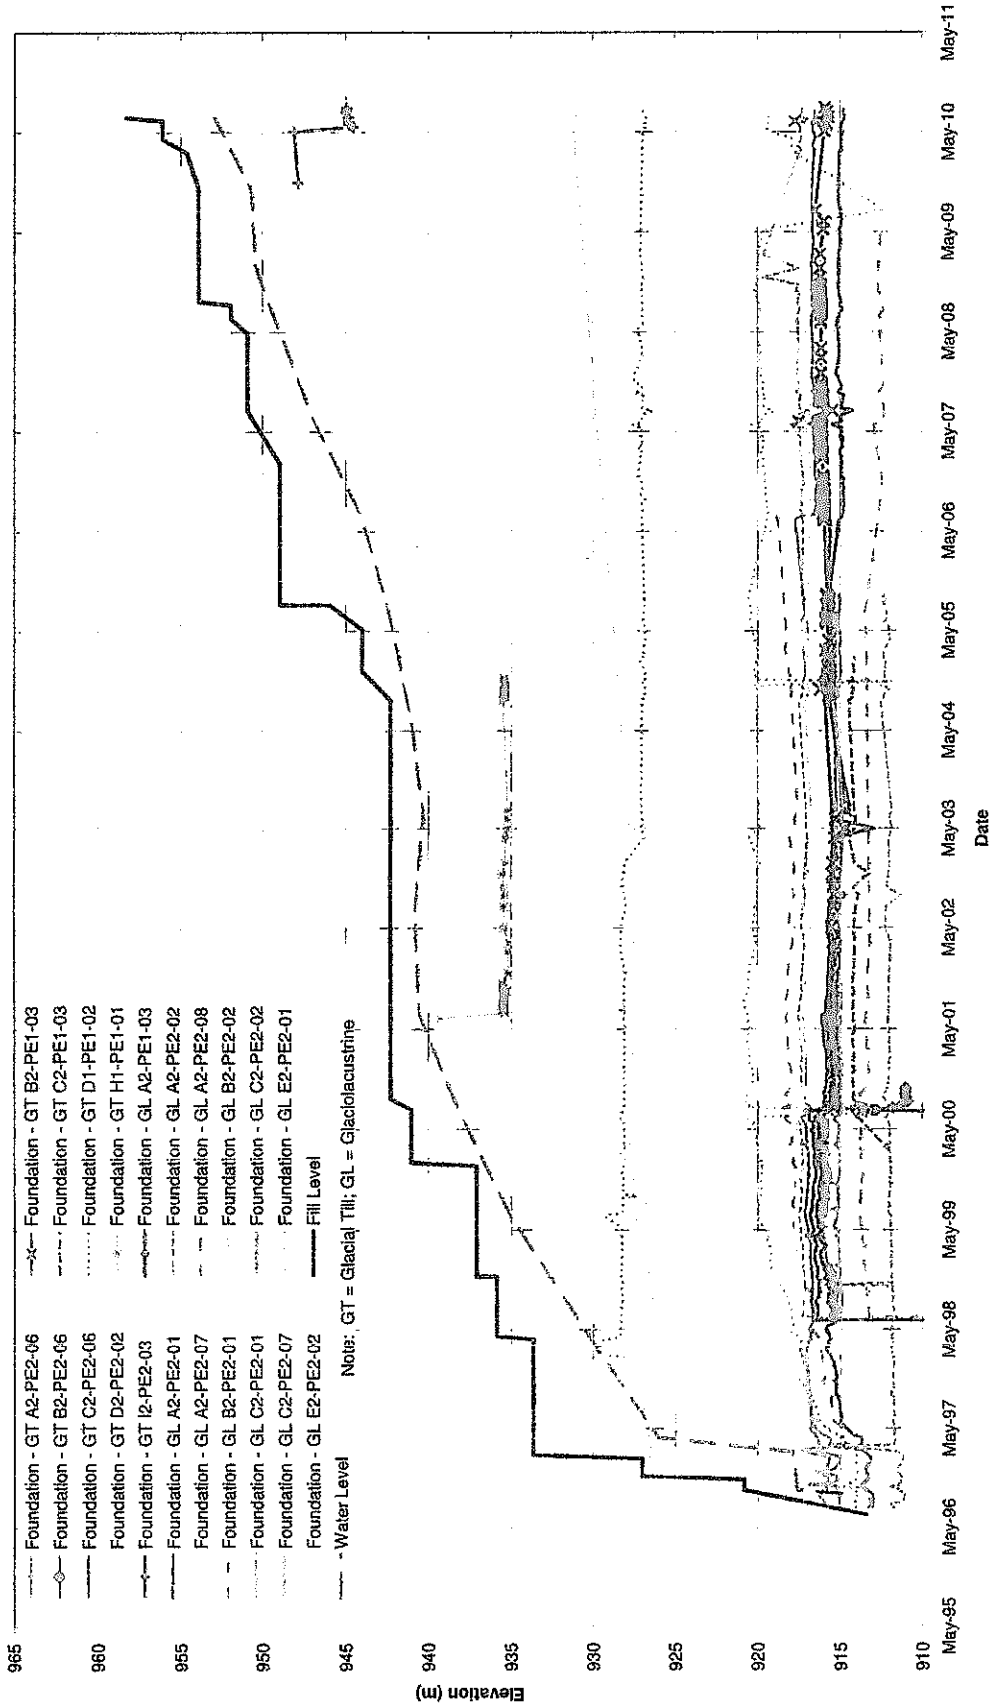
Figure 13: Foundation Piezometers

The foundation soils at all three TSF embankments have been instrumented with 22 piezometers installed within various soil units and at a variety of depths beneath the downstream portion of the embankments. Historical data from the foundation piezometers (Figure 13) shows a general trend of little to no response to dam construction (i.e. minimal indication of transient construction-induced pore pressures), nor to the rising level of the tailings pond. Currently, when compared to the overlying embankment fill levels, the nine functioning piezometers in this region show pore pressure ratios between 0 and 0.2. All functioning foundation piezometers show heads roughly equivalent to the ground surface elevation at their location. This indicates a combination of low seepage from the tailings impoundment and effective drainage of seepage that is occurring.

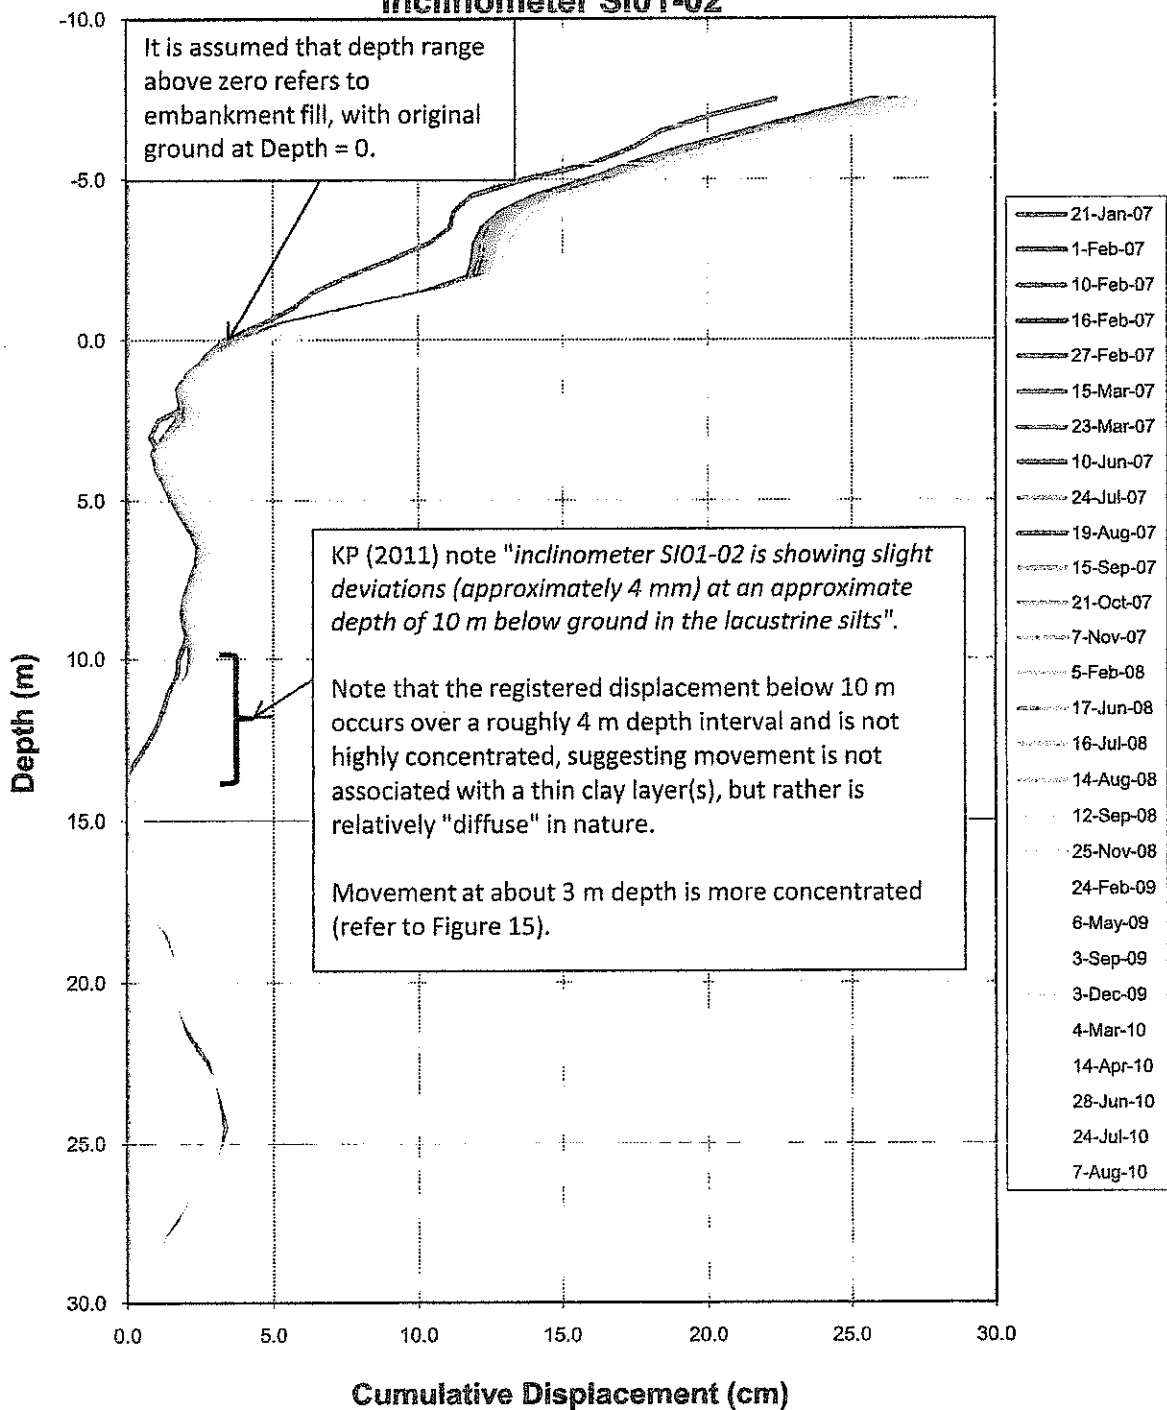
FIGURE 14
Cumulative Displacement vs. Depth
Inclinometer SI01-02

⁴ As stated in the KP report, "*inclinometer SI01-02 is showing slight deviations (approximately 4 mm) at an approximate depth of 10 m below ground in the lacustrine silts*". The zones of movement are indicated on Figures 14 and 15.

1. *Glaciolacustrine foundation soils:* The 2006 Dam Safety Review (AMEC, 2006) and 2010 Dam Safety Inspection (KP, 2011) both highlighted the significance of any potential of pre-sheared (i.e. low strength) planes within the glaciolacustrine soils present within the Mount Polley TSF foundation soils and recommended additional testing be undertaken to improve characterisation of these soils. Specifically, the concern would be associated with any laterally continuous, high plastic clay varves within the glaciolacustrine soils that, if pre-sheared to a low residual shear strength, would represent a weak planar feature within the foundation that would largely govern stability. Further, even if not pre-sheared, such clay varves could be driven to a low shear strength as a result of movements induced by the ongoing raising of the dam, thus making it important to monitor displacement patterns within these soils. It was movement (about 4 mm) within this foundation soil type noted by KP (2011) to have occurred in inclinometer SI01-02 (see Figures 14 and 15).

1. **Glaciolacustrine foundation soils:** The glaciolacustrine foundation soils of the Main embankment will be investigated using both test pits and the sonic drill rig. Five test pits will be excavated by a CAT 320 or similar excavator in the downstream vicinity of the Main embankment. Exposed soils within the test pits will be examined by the AMEC site engineer for incidence, thickness, and continuity of clay varves, and any signs of pre-shearing. The sonic drill rig will complete nine holes for the installation of piezometers and inclinometers in the downstream toe area of the Main embankment (Figures 2, 3, and 6). Holes will be drilled using the existing rockfill buttress as a platform. As previously noted, the sonic method will allow sample recovery for both detailed inspection and laboratory testing purposes.

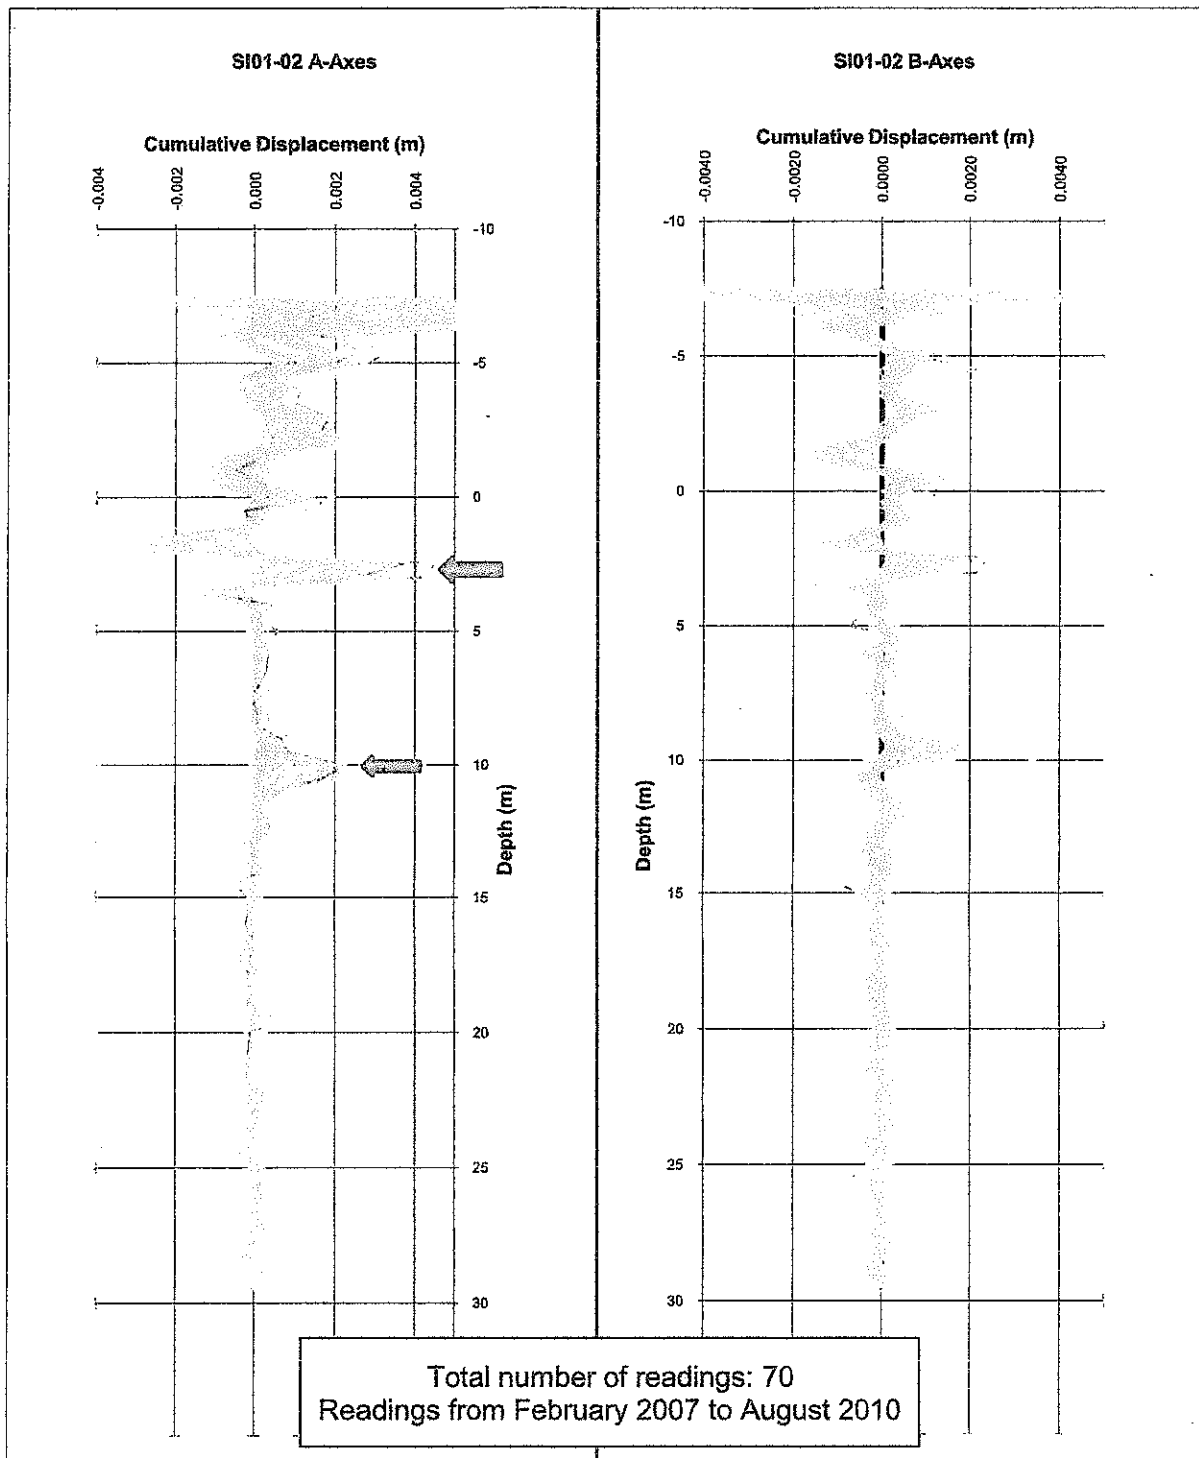
FIGURE 15

Block arrows indicate zones of inferred shear within the glaciolacustrine soils.
