**MEMO**

**Date:** July 30, 2014

**Project No.:** KX05414

**RE: MOUNT POLLEY MINE TAILINGS STORAGE FACILITY CORNER 5 REALIGNMENT TO CREST EL. 970 m**

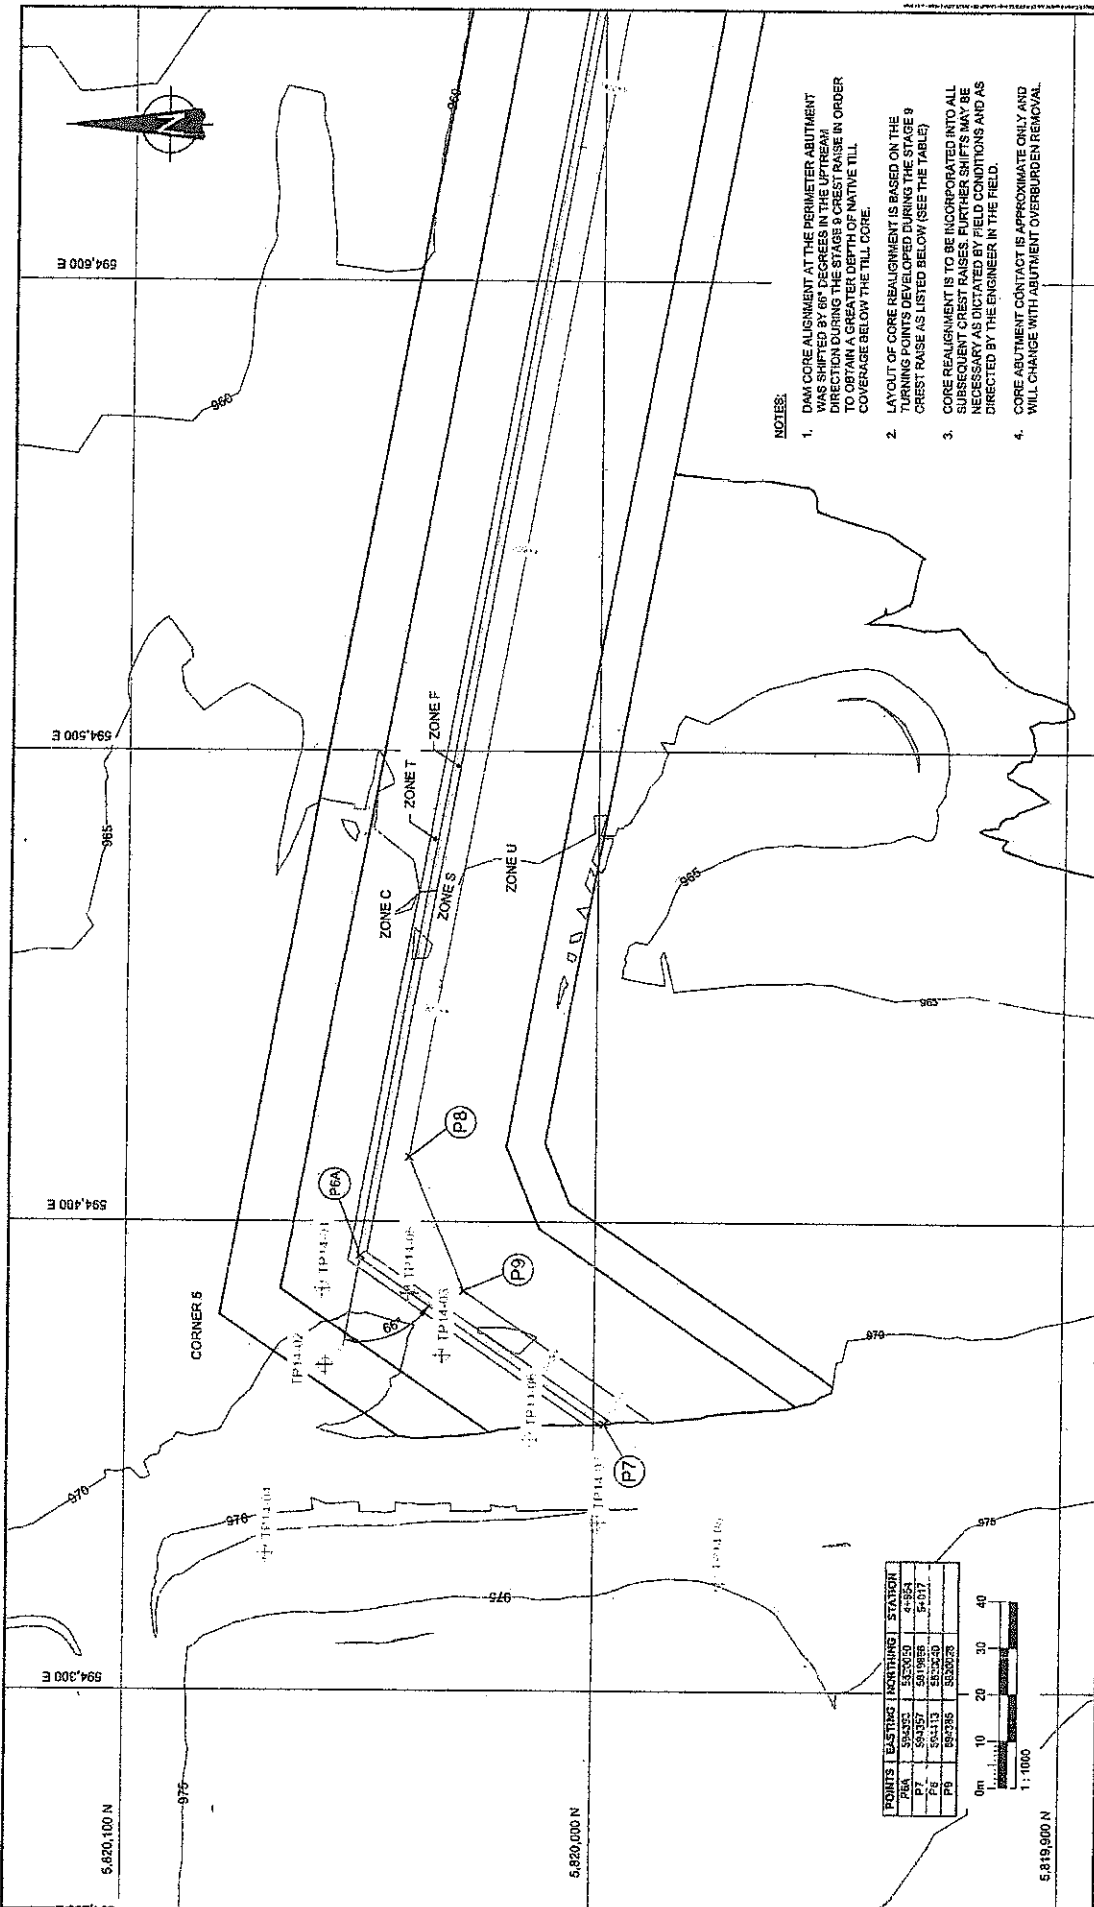
The test pits conducted in support of the realignment indicated that the till thickness increased from the current core location along the proposed realigned core.

AMEC understands that MPMC has decided to proceed with realignment of the dam to avoid existing unsuitable ground conditions encountered along the original design alignment that would necessitate detailed foundation preparation as outlined in Section 4.2 of the 2013 Construction Monitoring Manual<sup>1</sup>. To assist with the TSF realignment at corner 5 AMEC has provided new design points (P6A and P7) to be utilized during construction (refer to Figure 1). These points should enable MPMC to utilize the offsets currently in use for the perimeter embankment as shown in Figure 1.

The proposed core realignment rotates the original core counter-clockwise at stn.4+954 approximately 66°. To accommodate the sharp transition and maintain core integrity, the till core should be widened to the upstream side based on Points P8 and P9 (Figure 1) to an elevation of 970 m. The widened core in this area should be constructed on appropriately prepared and approved native till subgrade. The design of Corner 5 above 970 m will be the responsibility of others.
