## **FINAL REPORT**

### **DAM SAFETY REVIEW**

**Mount Polley Mine  
Likely, British Columbia**

**December 2006**

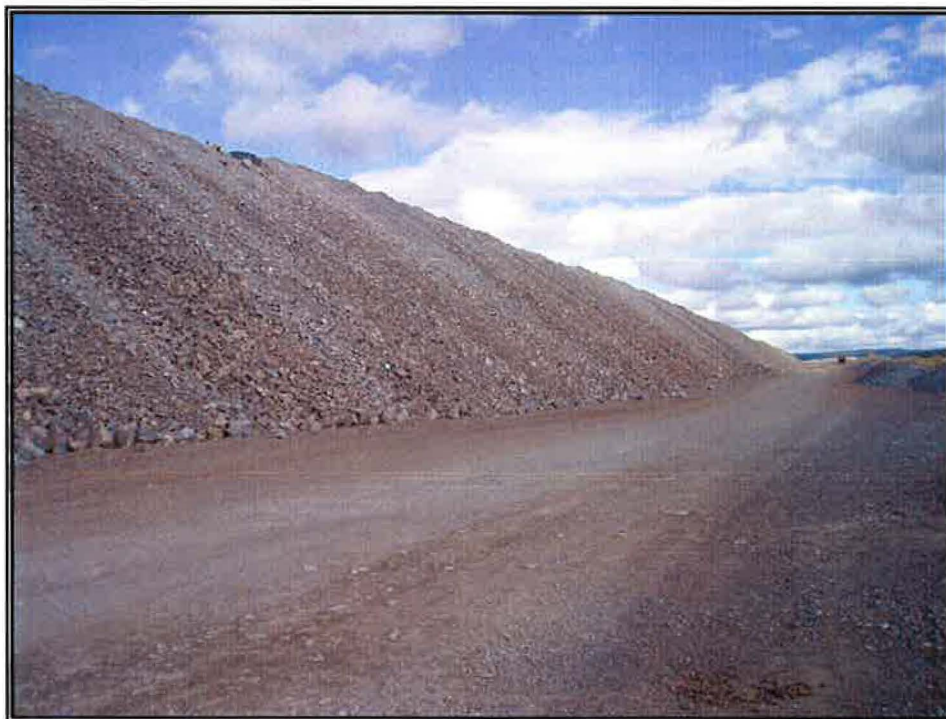
Photo 1: Main Embankment Shell – Looking Northeast

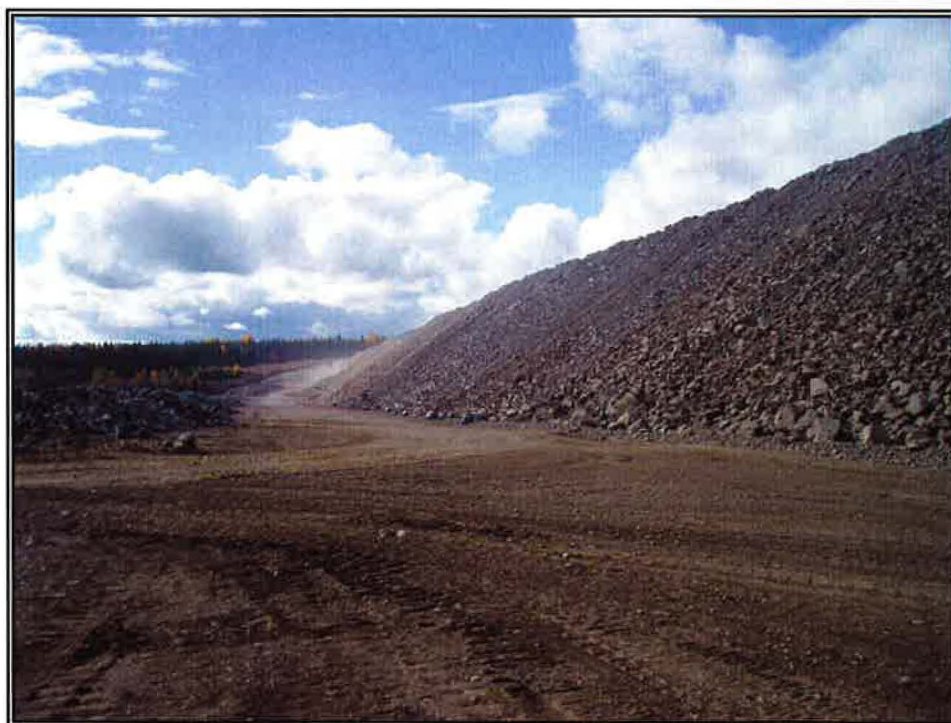
Photo 2: Main Embankment Shell – Looking Southwest

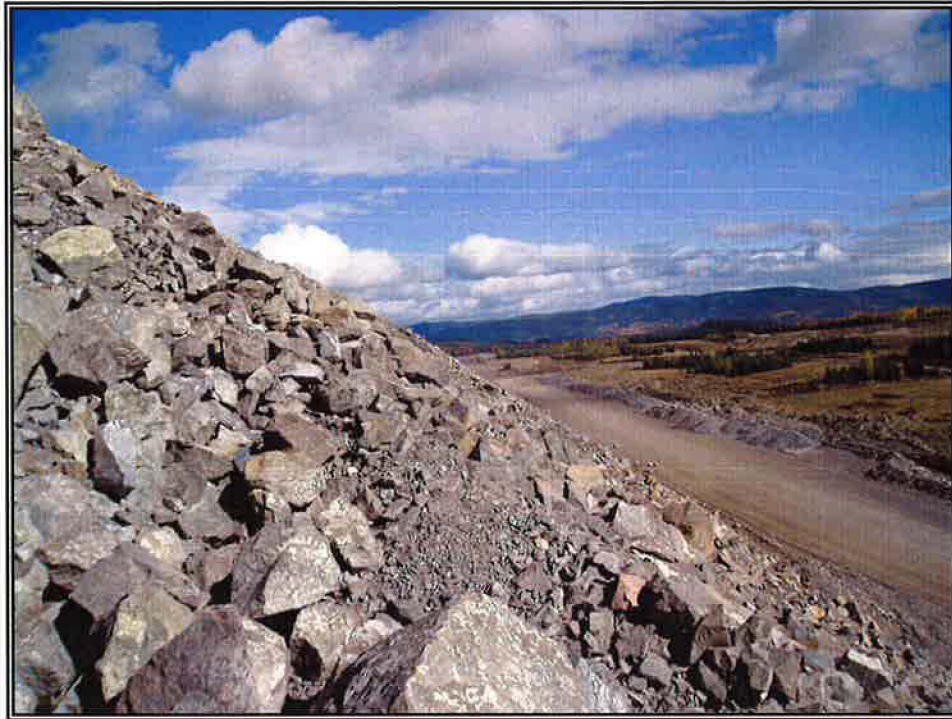
Photo 3: Nature of Main Embankment Rockfill

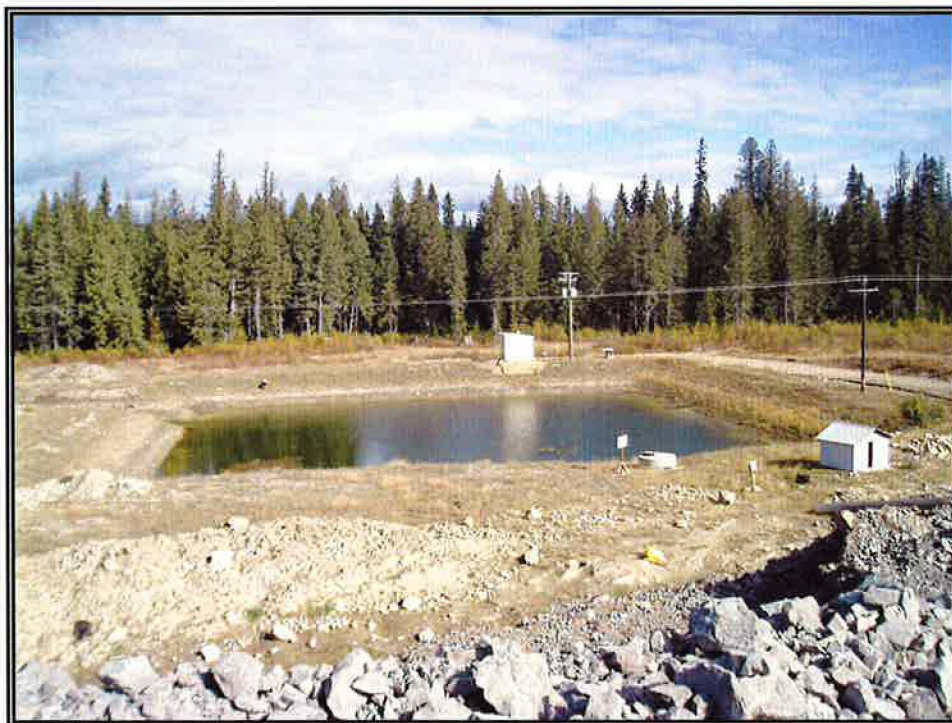
Photo 4: Main Embankment Seepage Collection

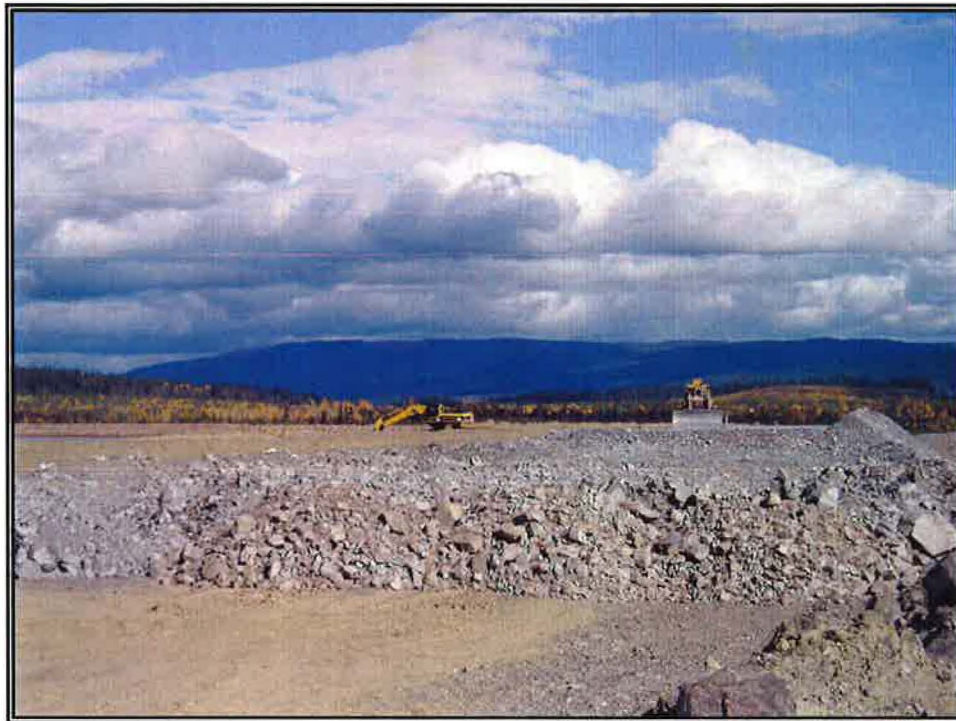
Photo 5: Construction on Main Embankment

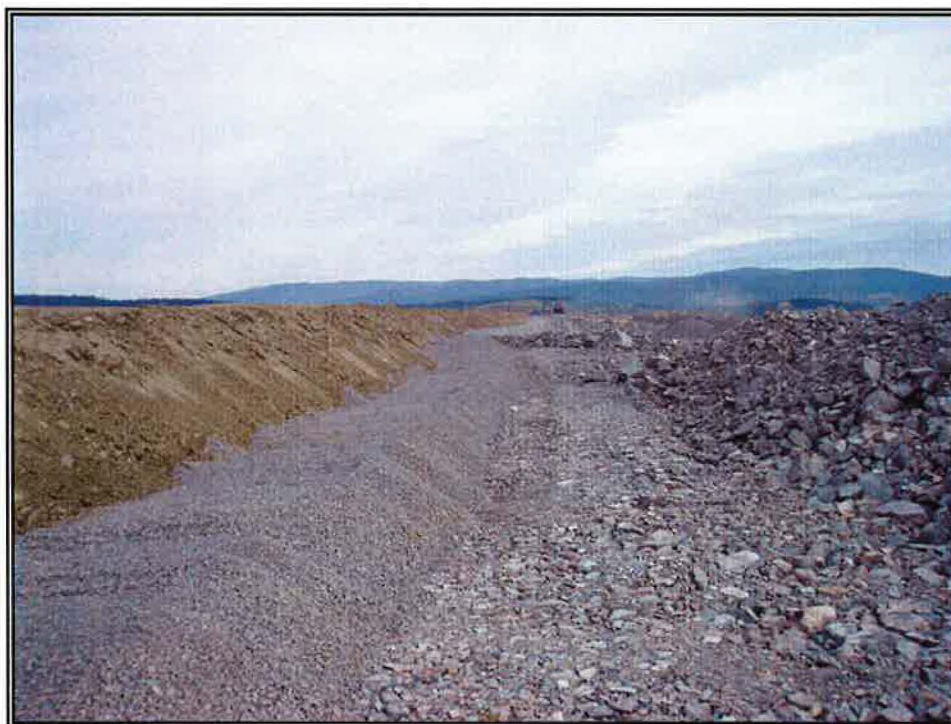
Photo 6: Zones of Main Embankment Dam

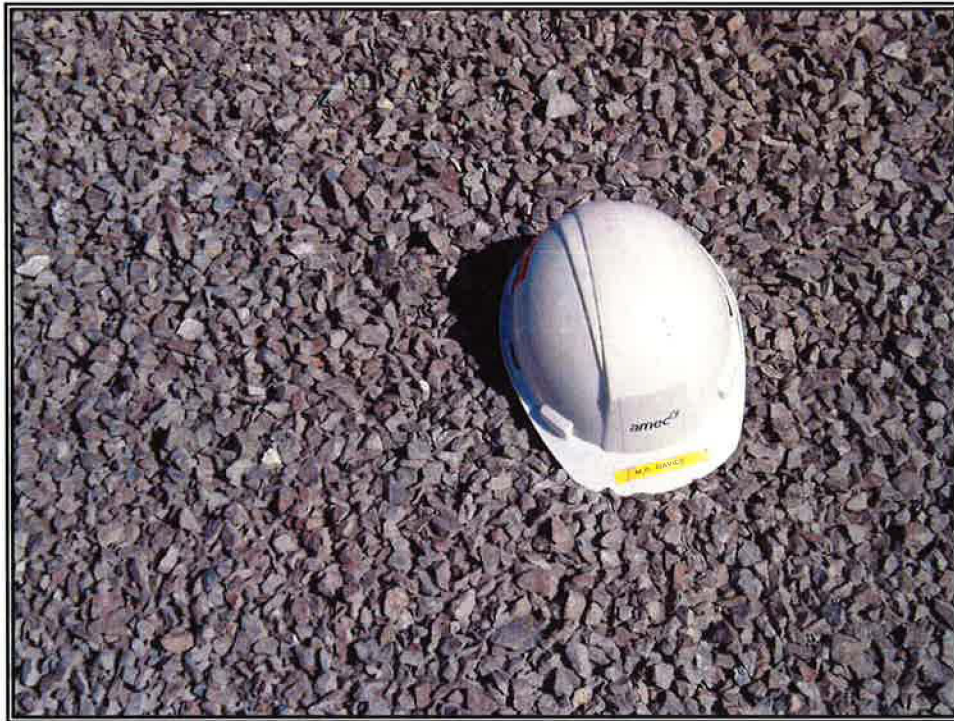
Photo 7: Main Embankment Transition Material

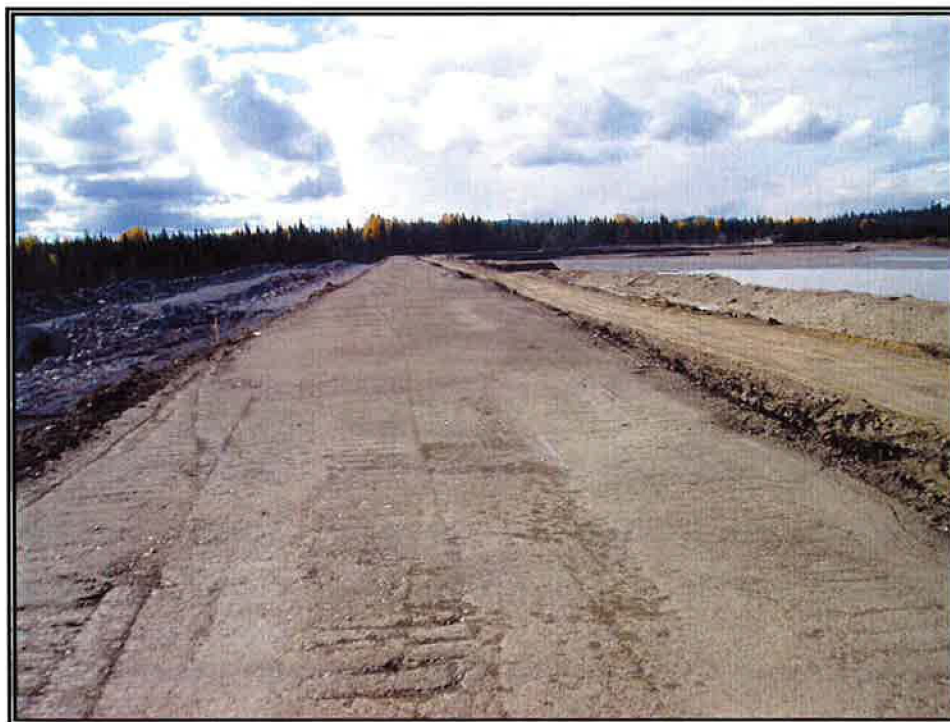
Photo 8: Main Embankment Compacted Core

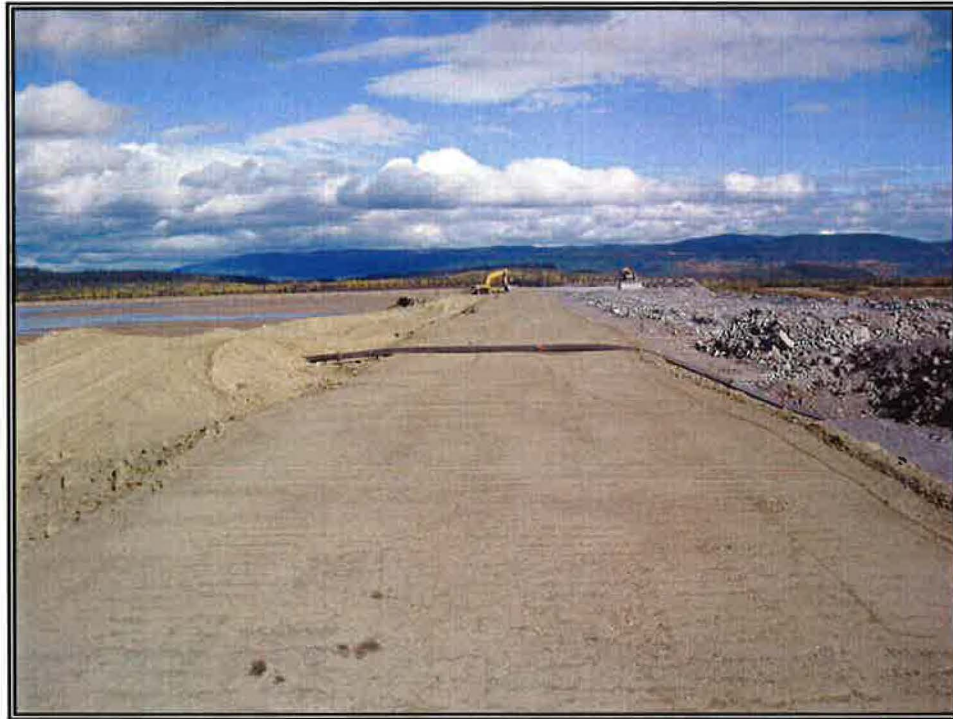
Photo 9: General Photograph of As-Built Robust Core

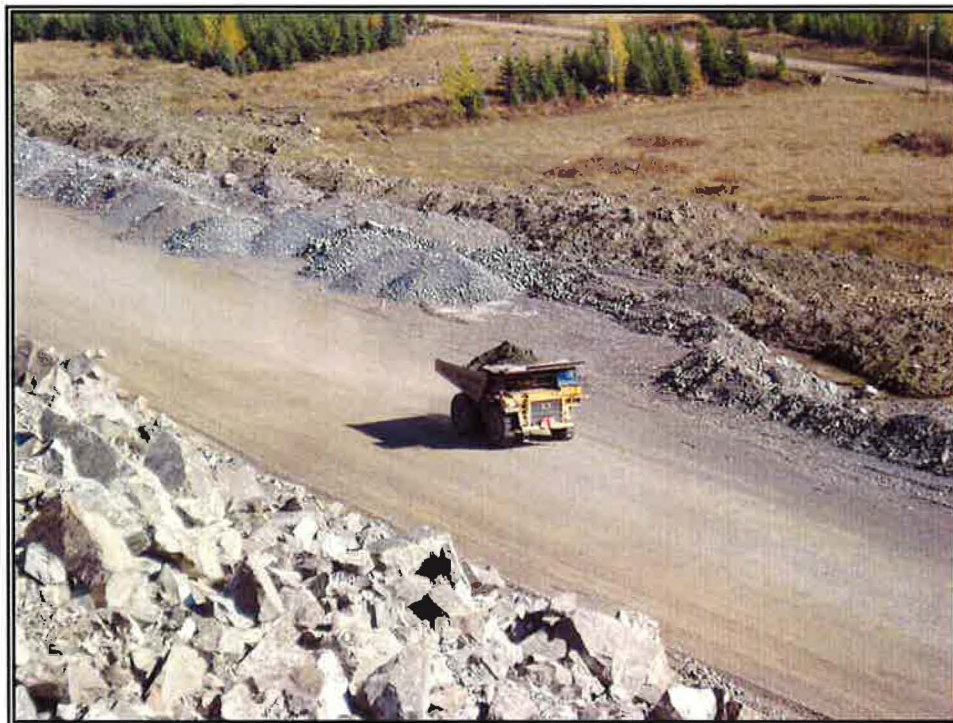
Photo 10: Haulage of Till from Borrow

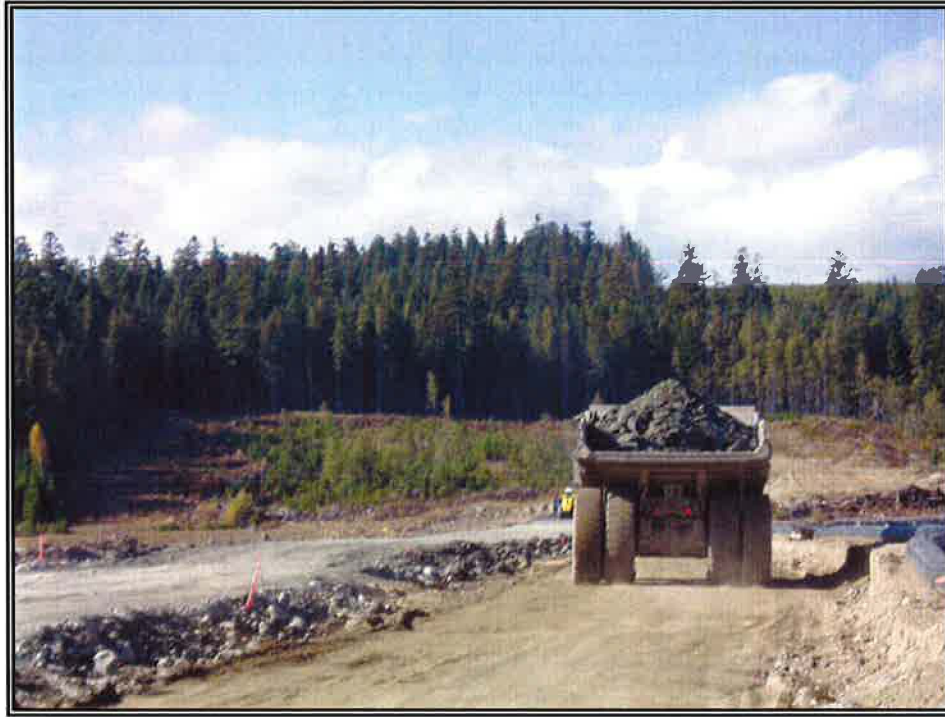
Photo 11: Till Haulage on South Embankment

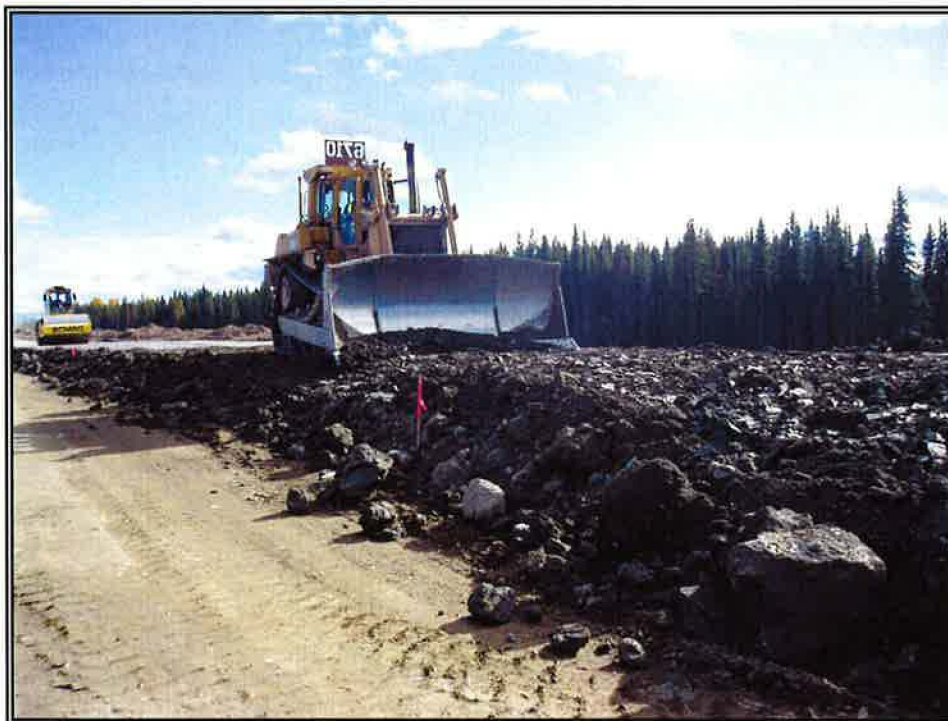
Photo 12: Placement of Till Core – South Embankment

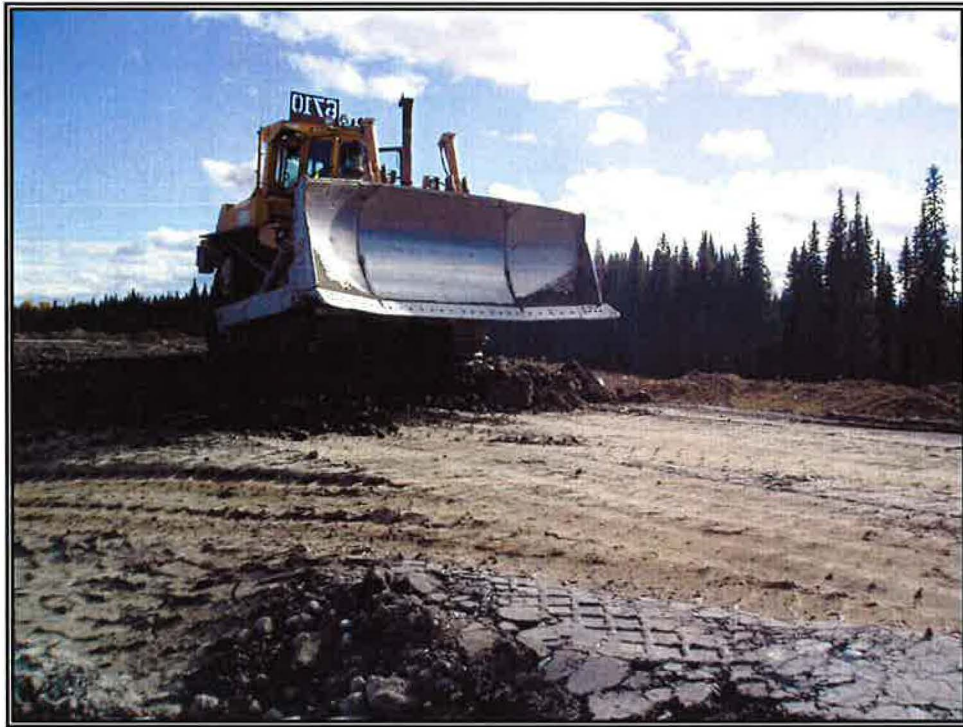
Photo 13:      Compacted Till – South Embankment

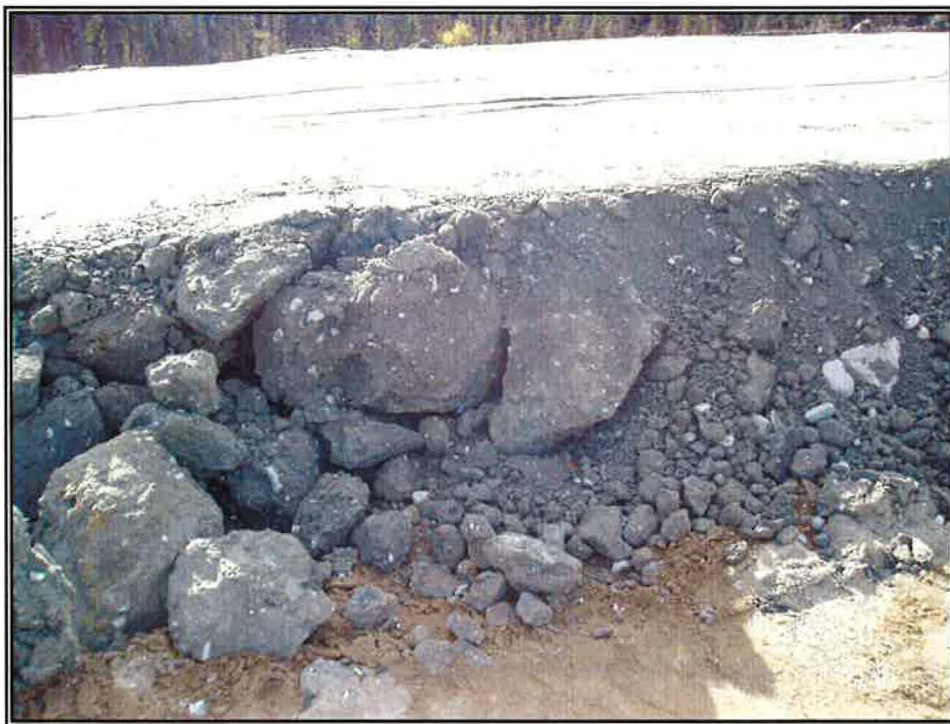
Photo 14:      Compacted Till – South Embankment

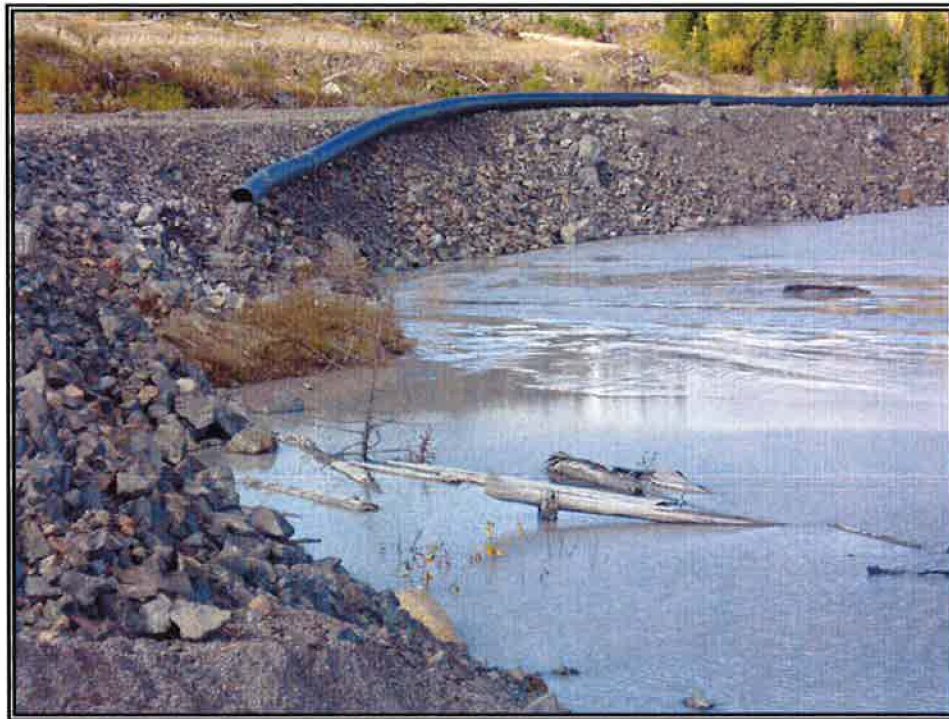
Photo 15: Tailings Overboarding at "Top" of Panel

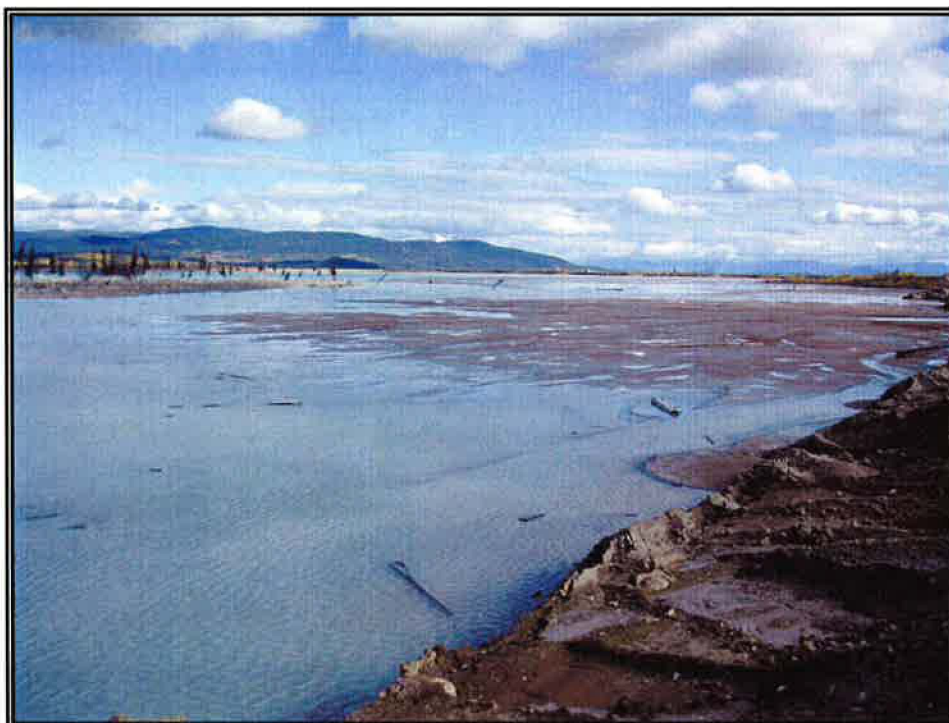
Photo 16: "Beach" Pondward of Deposition Location

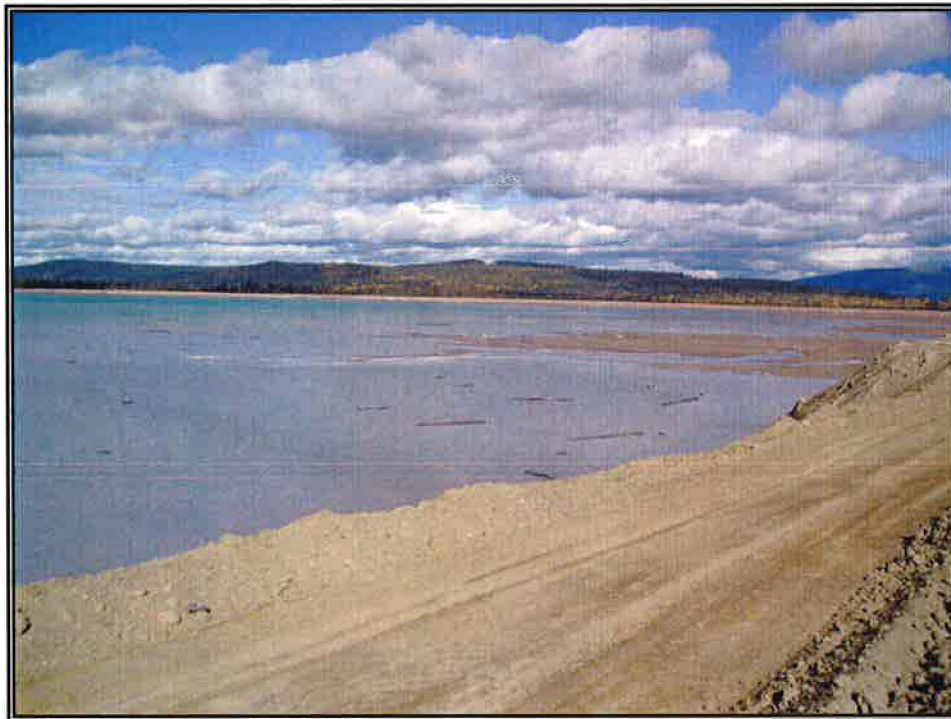
- **Dam Structures** – The three embankment dams all appeared in a good state of repair at the time of the DSR. There was no visual evidence of significant past issues (nor any documented). The lack of a tailings beach and inconsistency with beach profile and the closure concept for the TSF are notable but do not present immediate dam safety concerns. The lack of a beach profile consistent with closure objectives would address the lack of beach against the embankments and, for a number of reasons, should be addressed as soon as possible by the mine to avoid increased costs in this regard in the future. Again, however, dam safety is not a driving reason to address this lack of beach/positive beach profile.

Photo 17: Lack of Established Beach – Perimeter Embankment in Background

There is currently no surface discharge facility (spillway) and one will be required for closure (and is the prime reason why the current beaching practices should be modified to allow effective placement of a spillway). At other similar facilities in British Columbia, where there is no operating spillway, a longer duration PMF event than the 24 hour event has been used with the 24 hour duration being adopted for closure when there will be an appropriate spillway. This approach is recommended for the Mount Polley TSF.

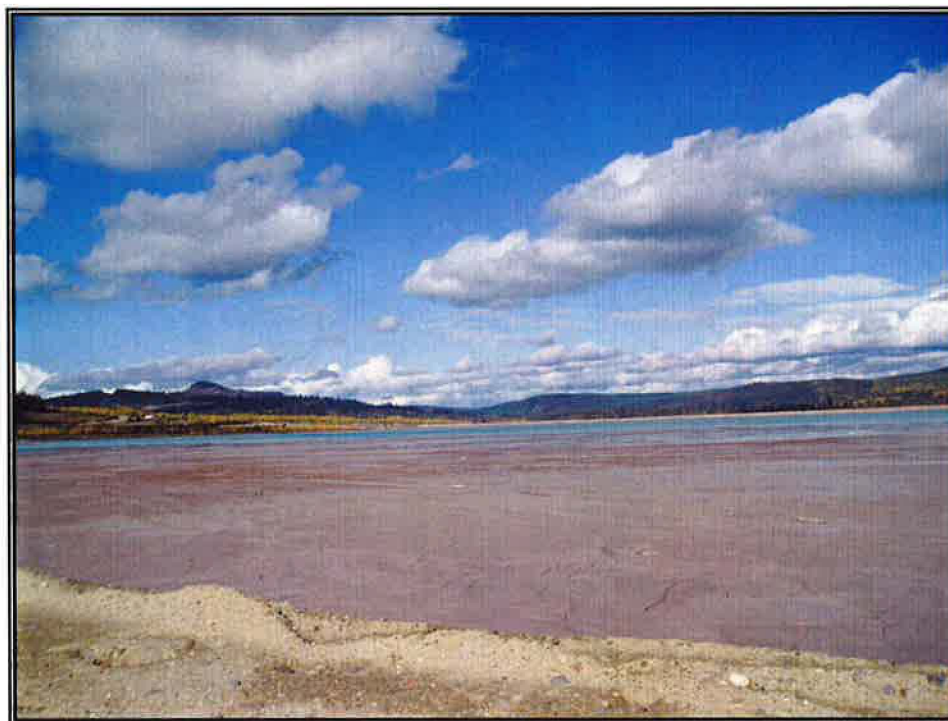
Photo 18: Minor Beach Development along Portion of Main Embankment

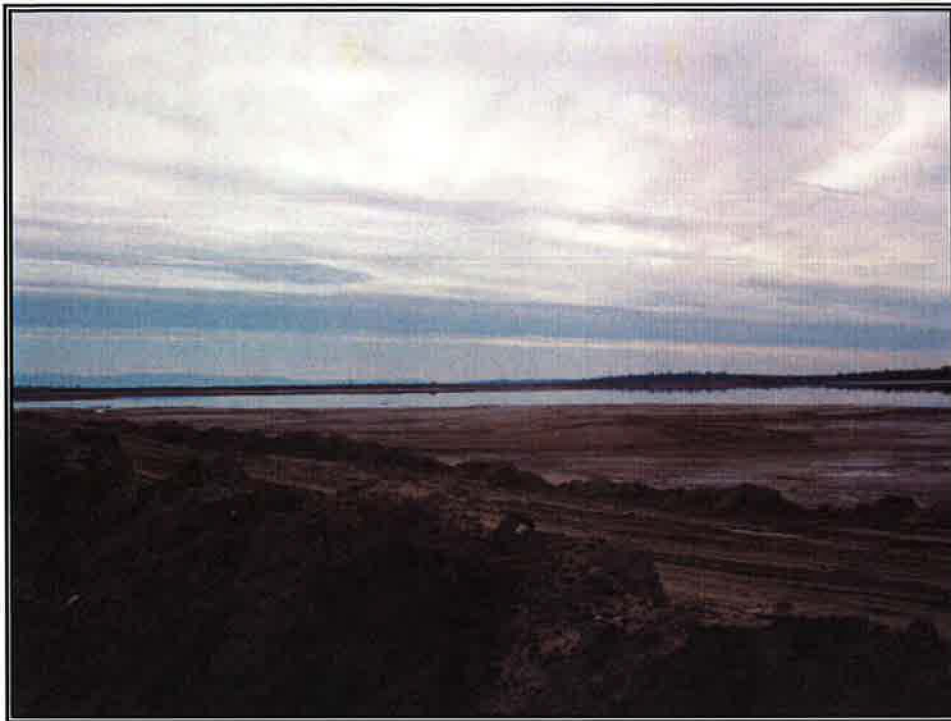
Photo 19: Tailings Pond from Northwest end of Perimeter Embankment

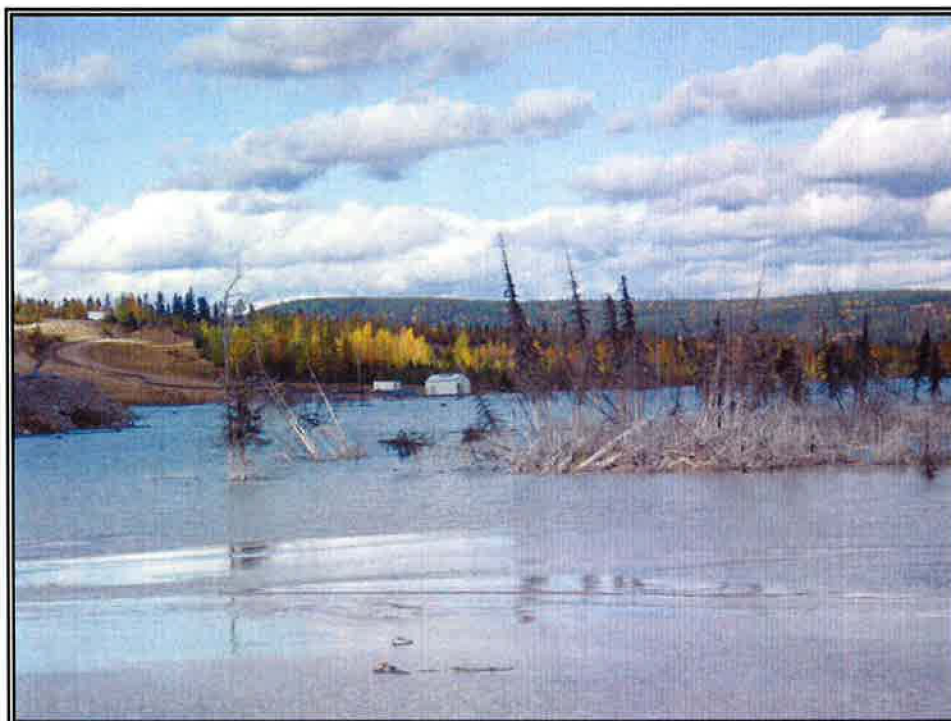
Photo 20: Tailings Water Reclaim Barge Location
