C.O. BRAWNER ENGINEERING LTD.
Consulting Geotechnical Engineers

October 23, 1995

Re: **Mt. Polly Tailings Dam**

The Mt. Polly Tailings Dam site was inspected with George Headley on Thursday, October 19, 1995. Photographs of the site are appended.

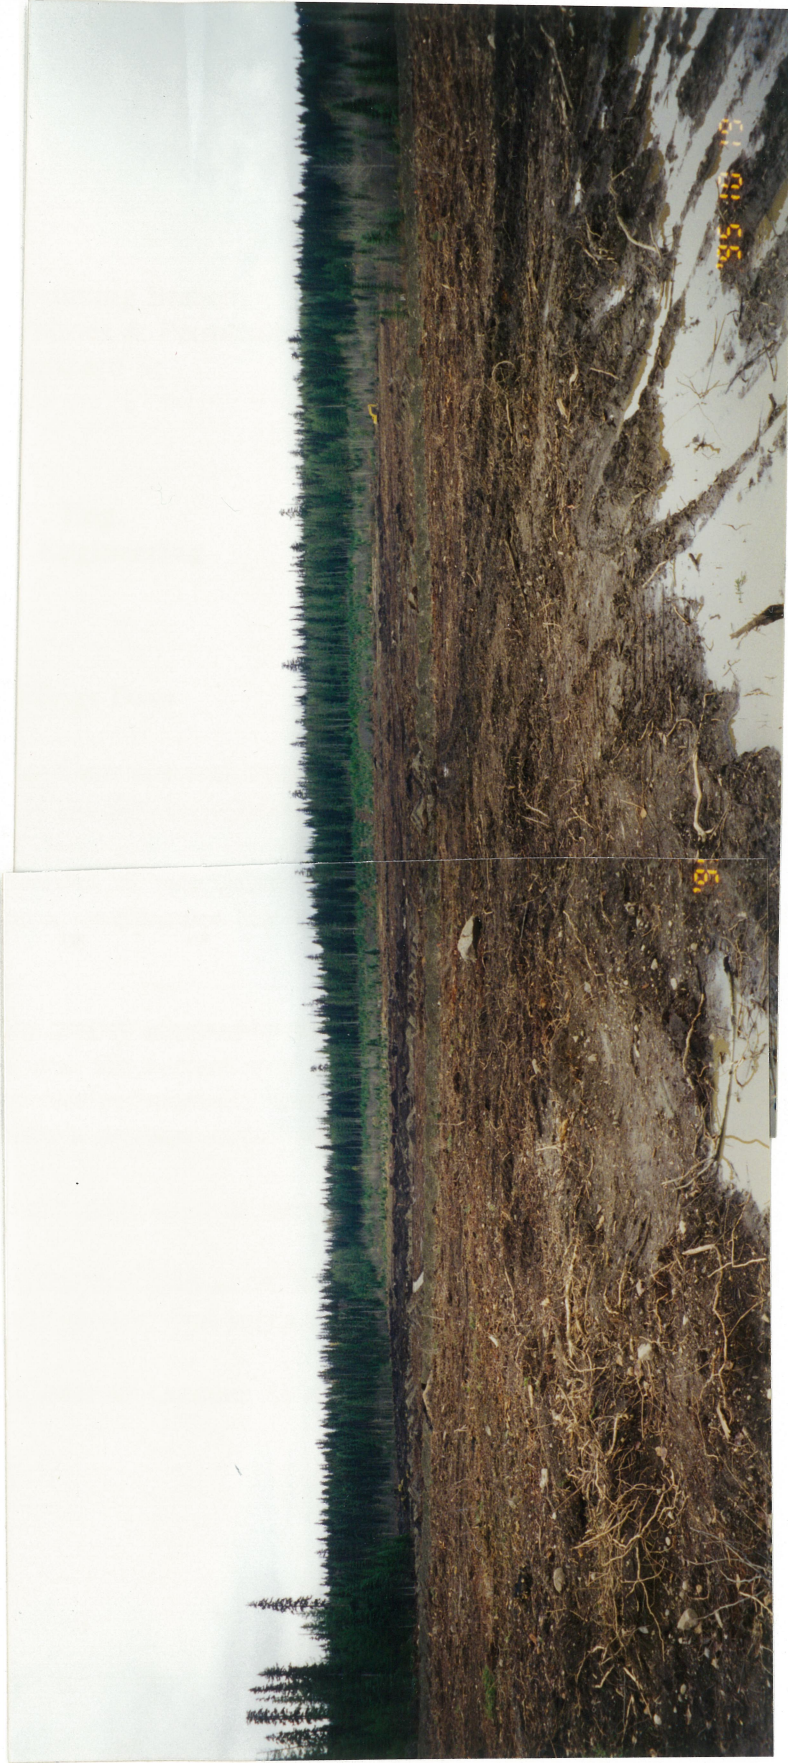
The site has been cleared of vegetation and numerous surface drainage trenches have been developed. The organic overburden has not been removed. All test pits have been filled back in.

Photo 1 - Looking west across the site of the main dam. The site has been cleared and drainage ditches have been installed. The surface organics have not been removed. Test pits have been backfilled.

All of the organic overburden must be removed.

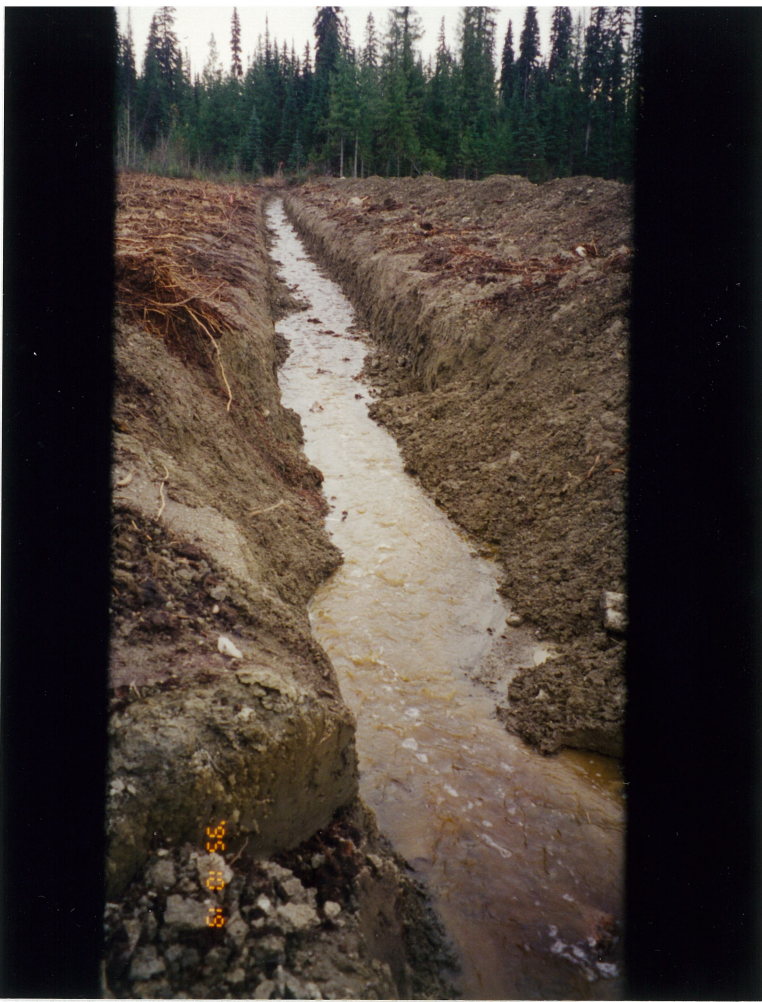
Photo 2 - Ditch excavated to contain a small creek across the site. The southern portion of the ditch is in medium dense to dense glacial till and the southern portion is in glacial lacustrine soils. Note the transition from stable side slopes to ravelling slopes. Easterly end of the dam.

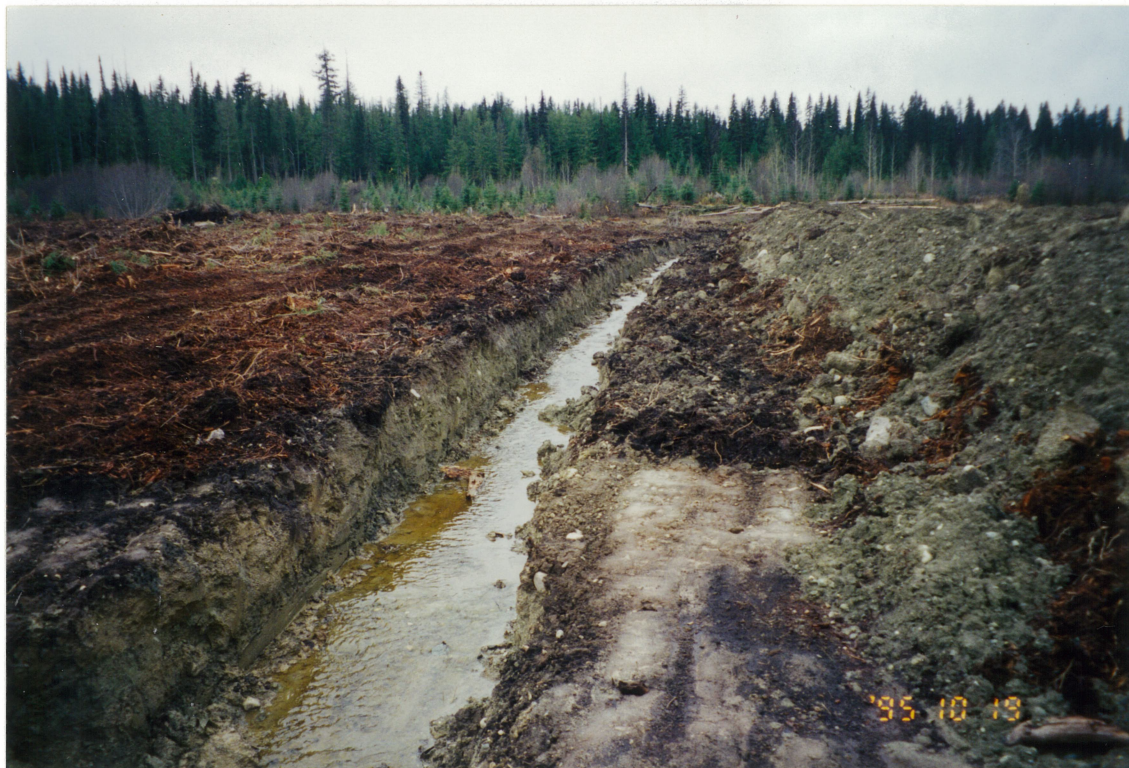
Photo 3 - Looking North along the westerly portion of the dam site. Drainage ditch in glacial till.

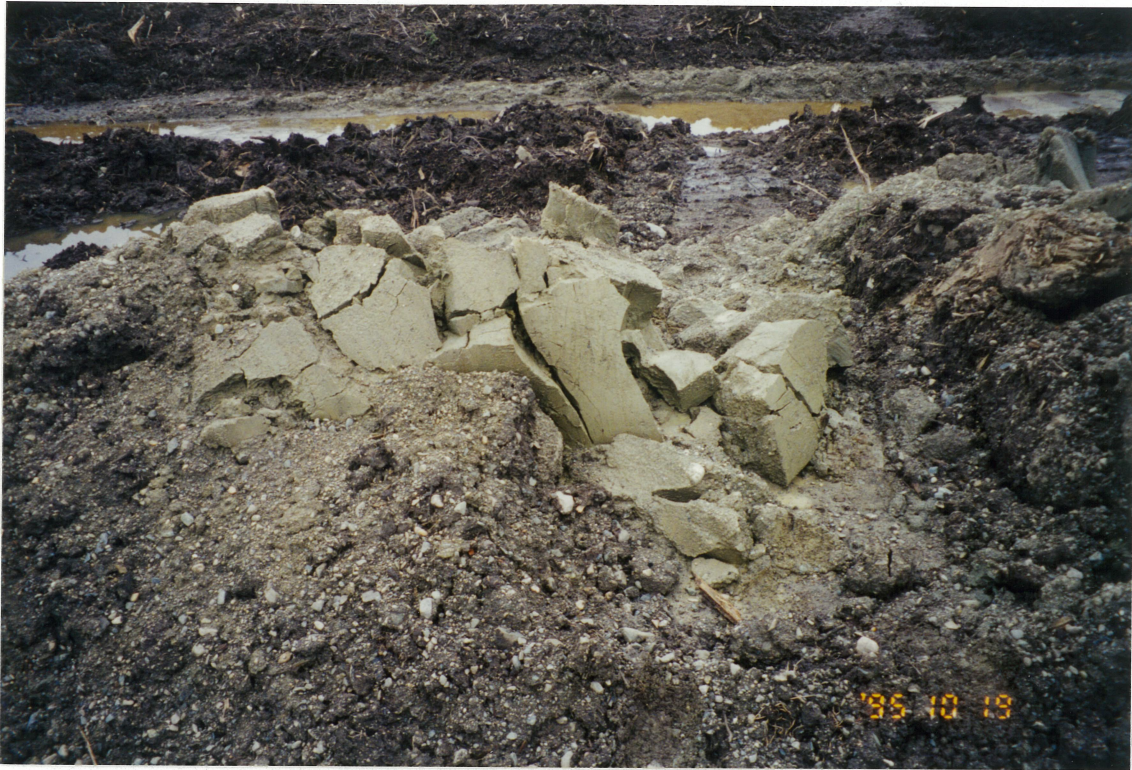
Photo 4 - Excavated medium dense glacial lacustrine clayey sandy silt. This material has medium strength, low permeability and medium-low compressibility.

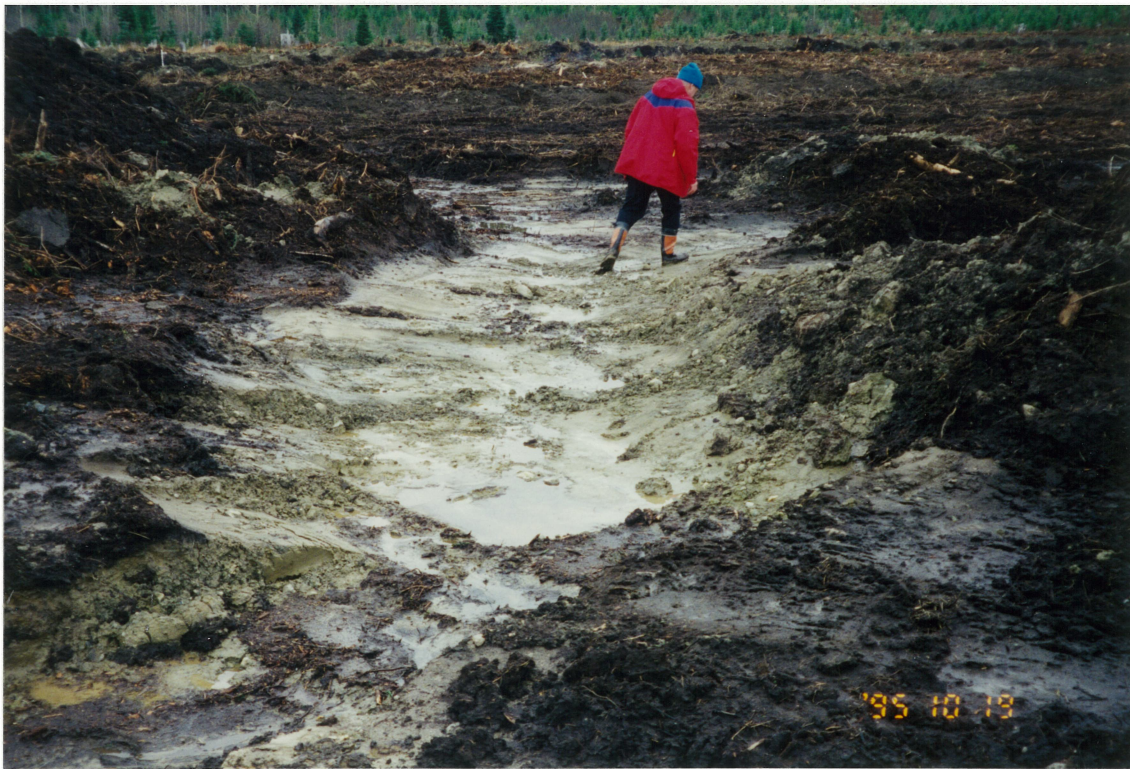
Photo 5 - Glacial till surface exposed by removing organic overburden. The exposed surface is slippery. Prior to placing and fill the surface must be scarified.

The excavation of the surface glacial till leaves a smooth surface. To tie the first layer of fill and disrupt the smooth surface, that surface must be scarified.

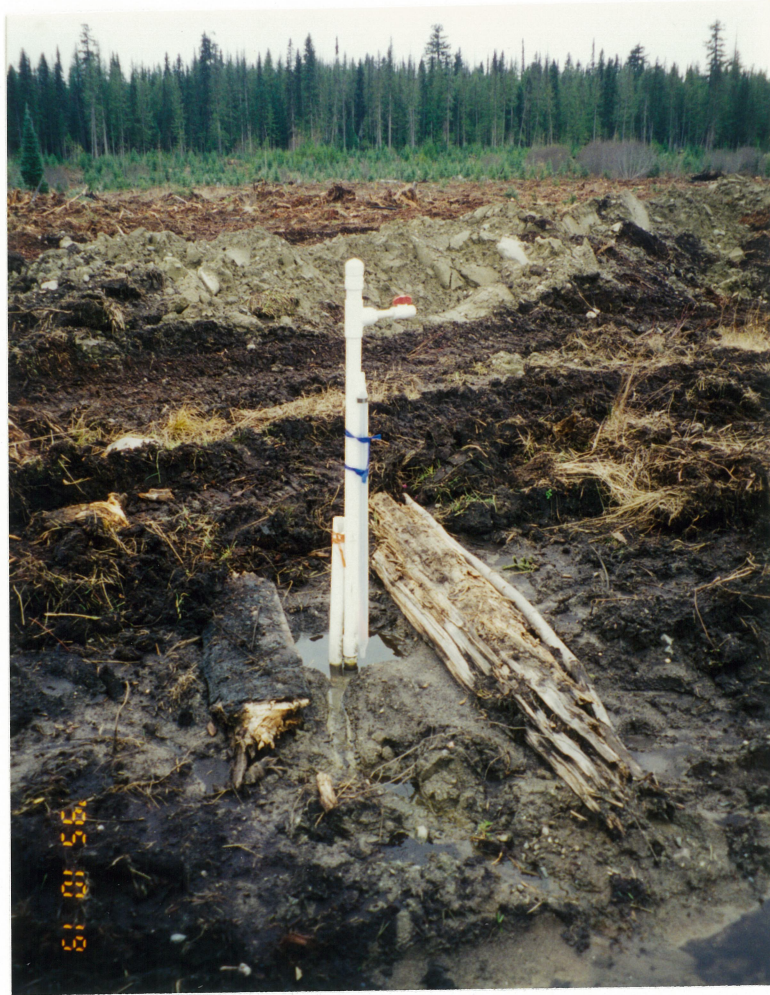
Photo 6 - Piezometer installed with water sampling capability. Toe area of the main dam.
