**MOUNT POLLEY MINING CORPORATION
MOUNT POLLEY MINE
TAILINGS STORAGE FACILITY**

**1998 ANNUAL INSPECTION REPORT
(REF. NO. 10162/9-5)**

JUNE 26, 1998

Knight Piésold
CONSULTING ENGINEERS

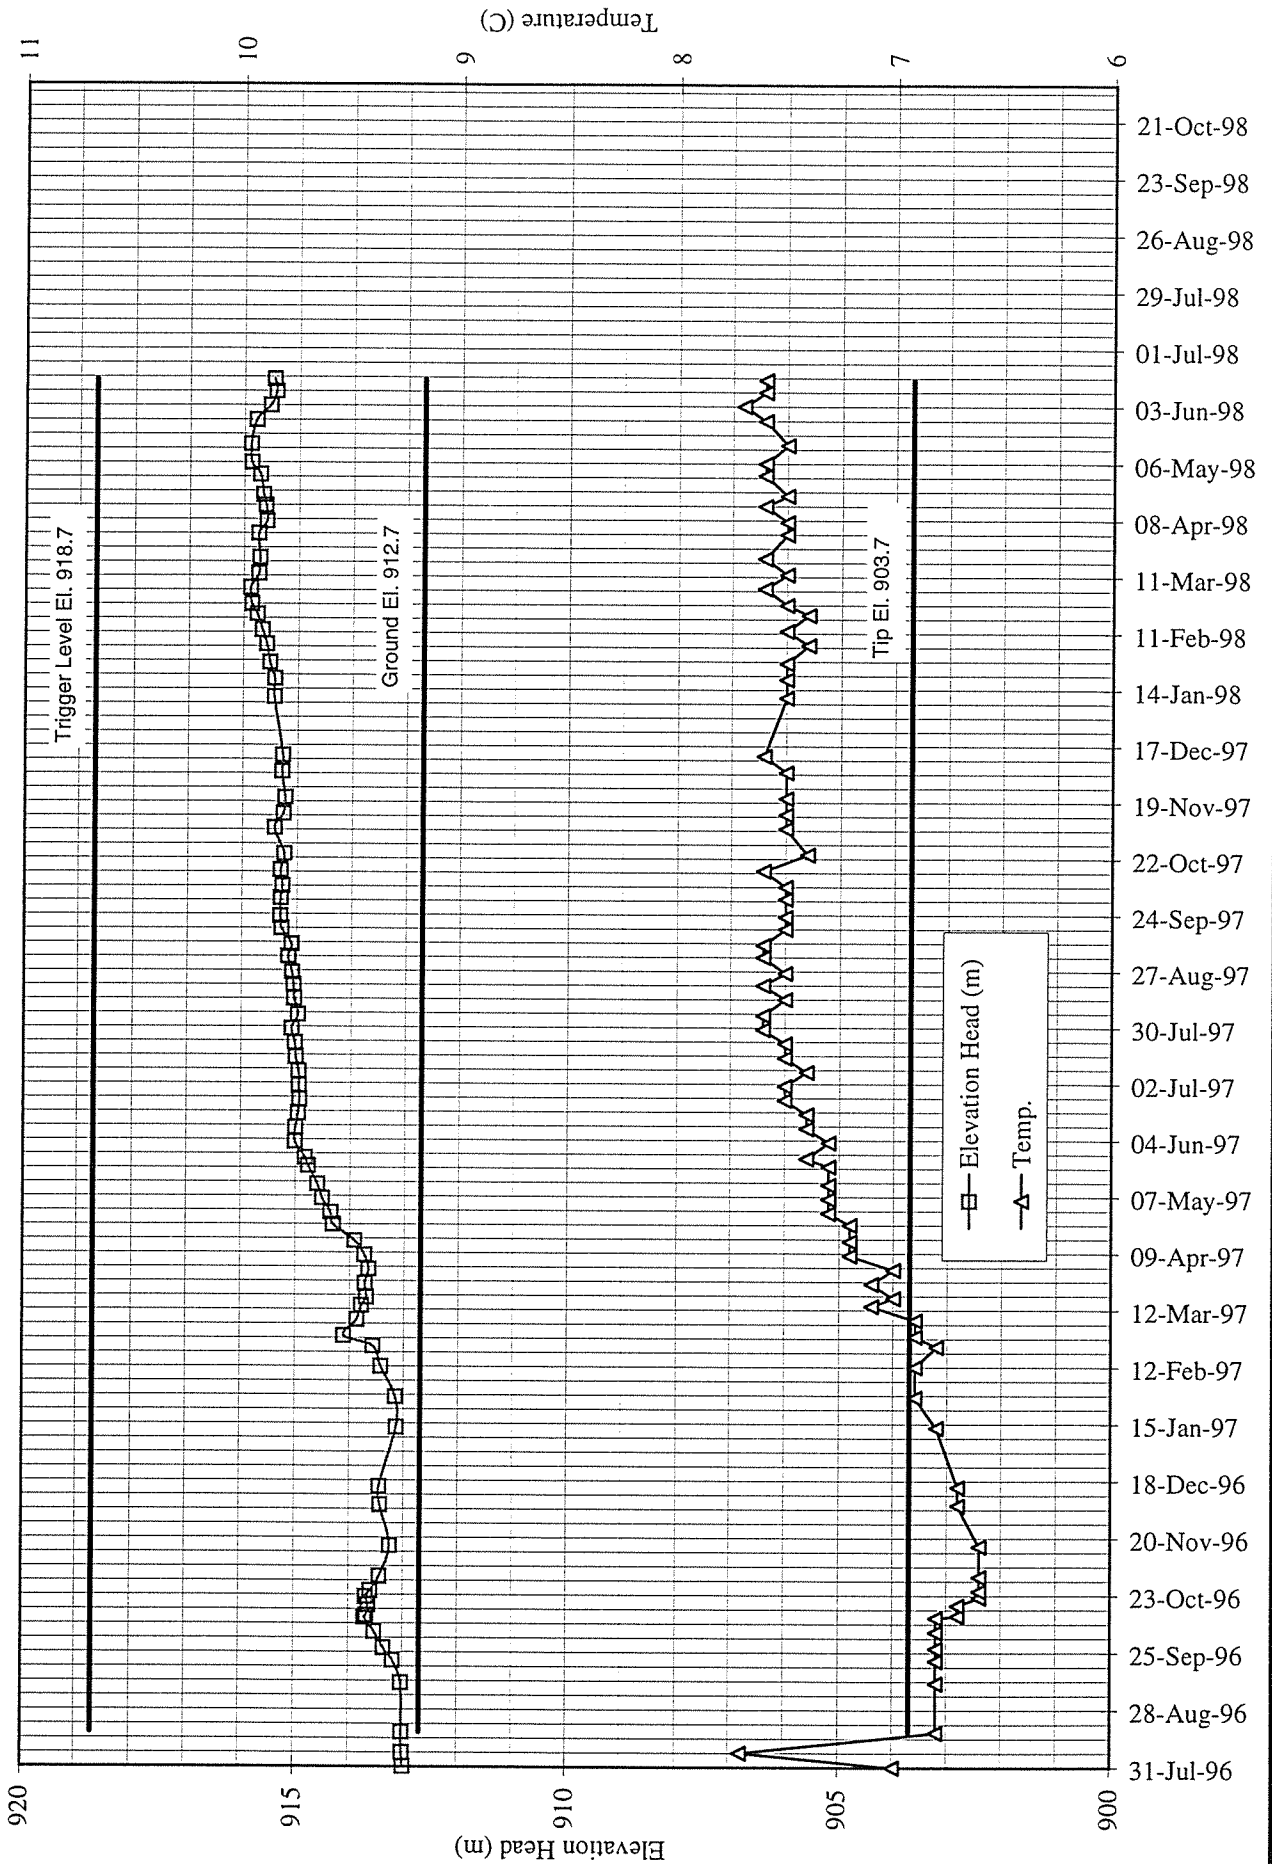
MOUNT POLLEY MINING CORPORATION.
MOUNT POLLEY PROJECT
TAILINGS STORAGE FACILITY
FOUNDATION PIEZOMETER - A2-PE2-01

- A2-PE2-01 is 9.0 m below ground (El. 903.68 m). The recorded pore pressure was 9.51 m after installation (El. 913.19 m), artesian by 0.51 m. The pore pressure has slowly and steadily increased by 2.2 m. The current pore pressure is 11.78 m (El. 915.46 m) and is therefore artesian (relative to original ground) by 2.79 m.
- A2-PE2-02 is 2.9 m below ground (El. 909.77 m). The recorded pore pressure was 1.95 m after installation (El. 911.72). The current pore pressure is 2.03 m (El. 911.80 m). Only minor fluctuations have been observed and no artesian pore pressures have developed.
- A2-PE2-06, 07, and 08 will soon be installed in drillholes.

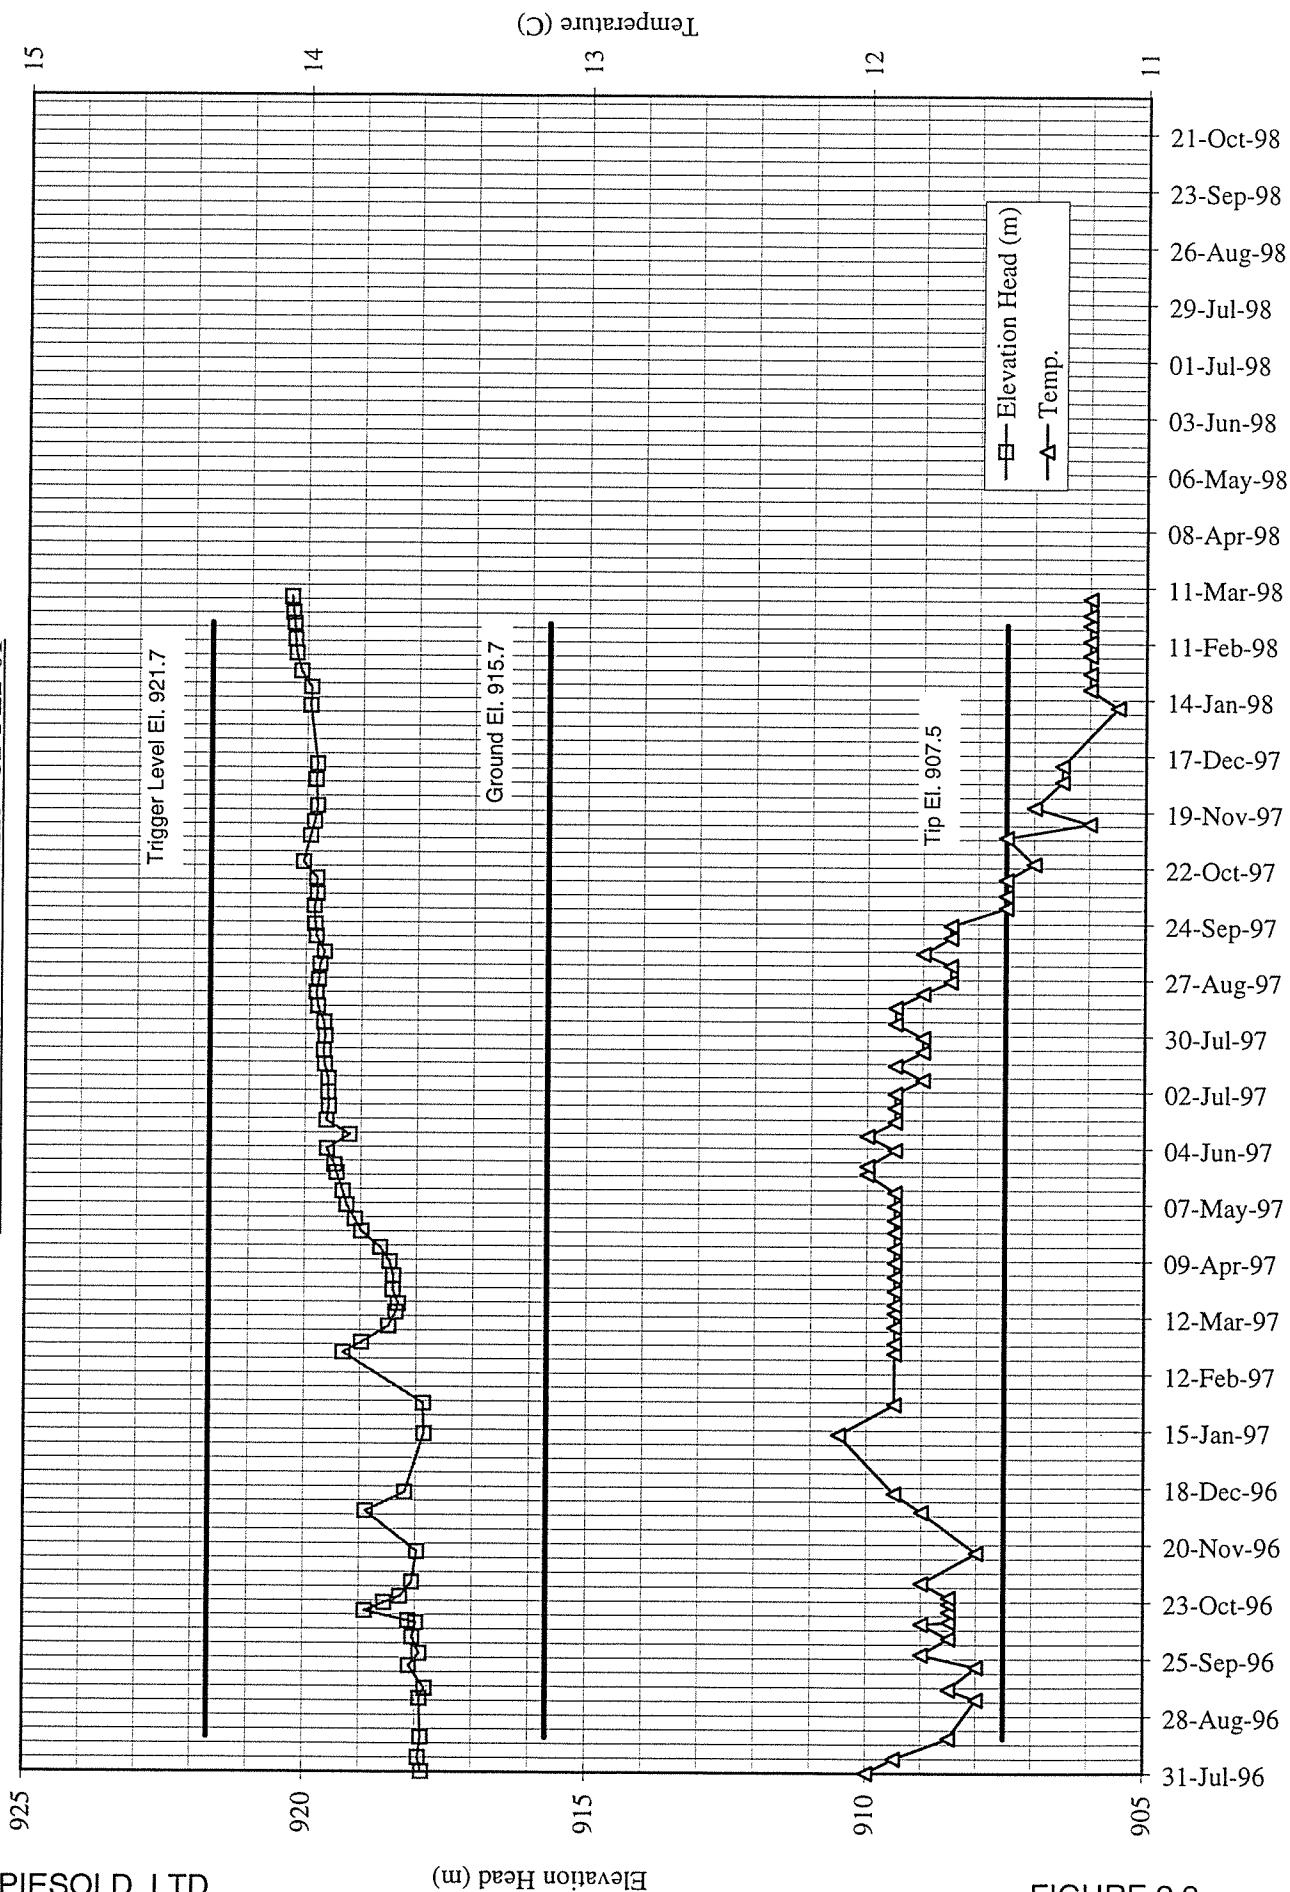
MOUNT POLLEY MINING CORPORATION.
MOUNT POLLEY PROJECT
TAILINGS STORAGE FACILITY
FOUNDATION PIEZOMETER - C2-PE2-01

- C2-PE2-01 is 8.2 m below ground (El. 907.48 m). The recorded pore pressure was 10.59 m after installation (El. 918.07 m), artesian by 2.36 m. The pore pressure slowly and steadily increased by about 2.23 m to an artesian condition of 4.60 m before the piezometer stopped working.
- C2-PE2-02 is 5.2 m below ground (El. 910.53 m). The recorded pore pressure was 5.56 m after installation (El. 916.09 m), artesian by 0.38 m. The pore pressure has increased by 0.63 m to 6.19 m (El. 916.72 m) and is now artesian (relative to original ground) by 1.00 m.
- C2-PE2-06, 07 and 08 will soon be installed in drillholes.

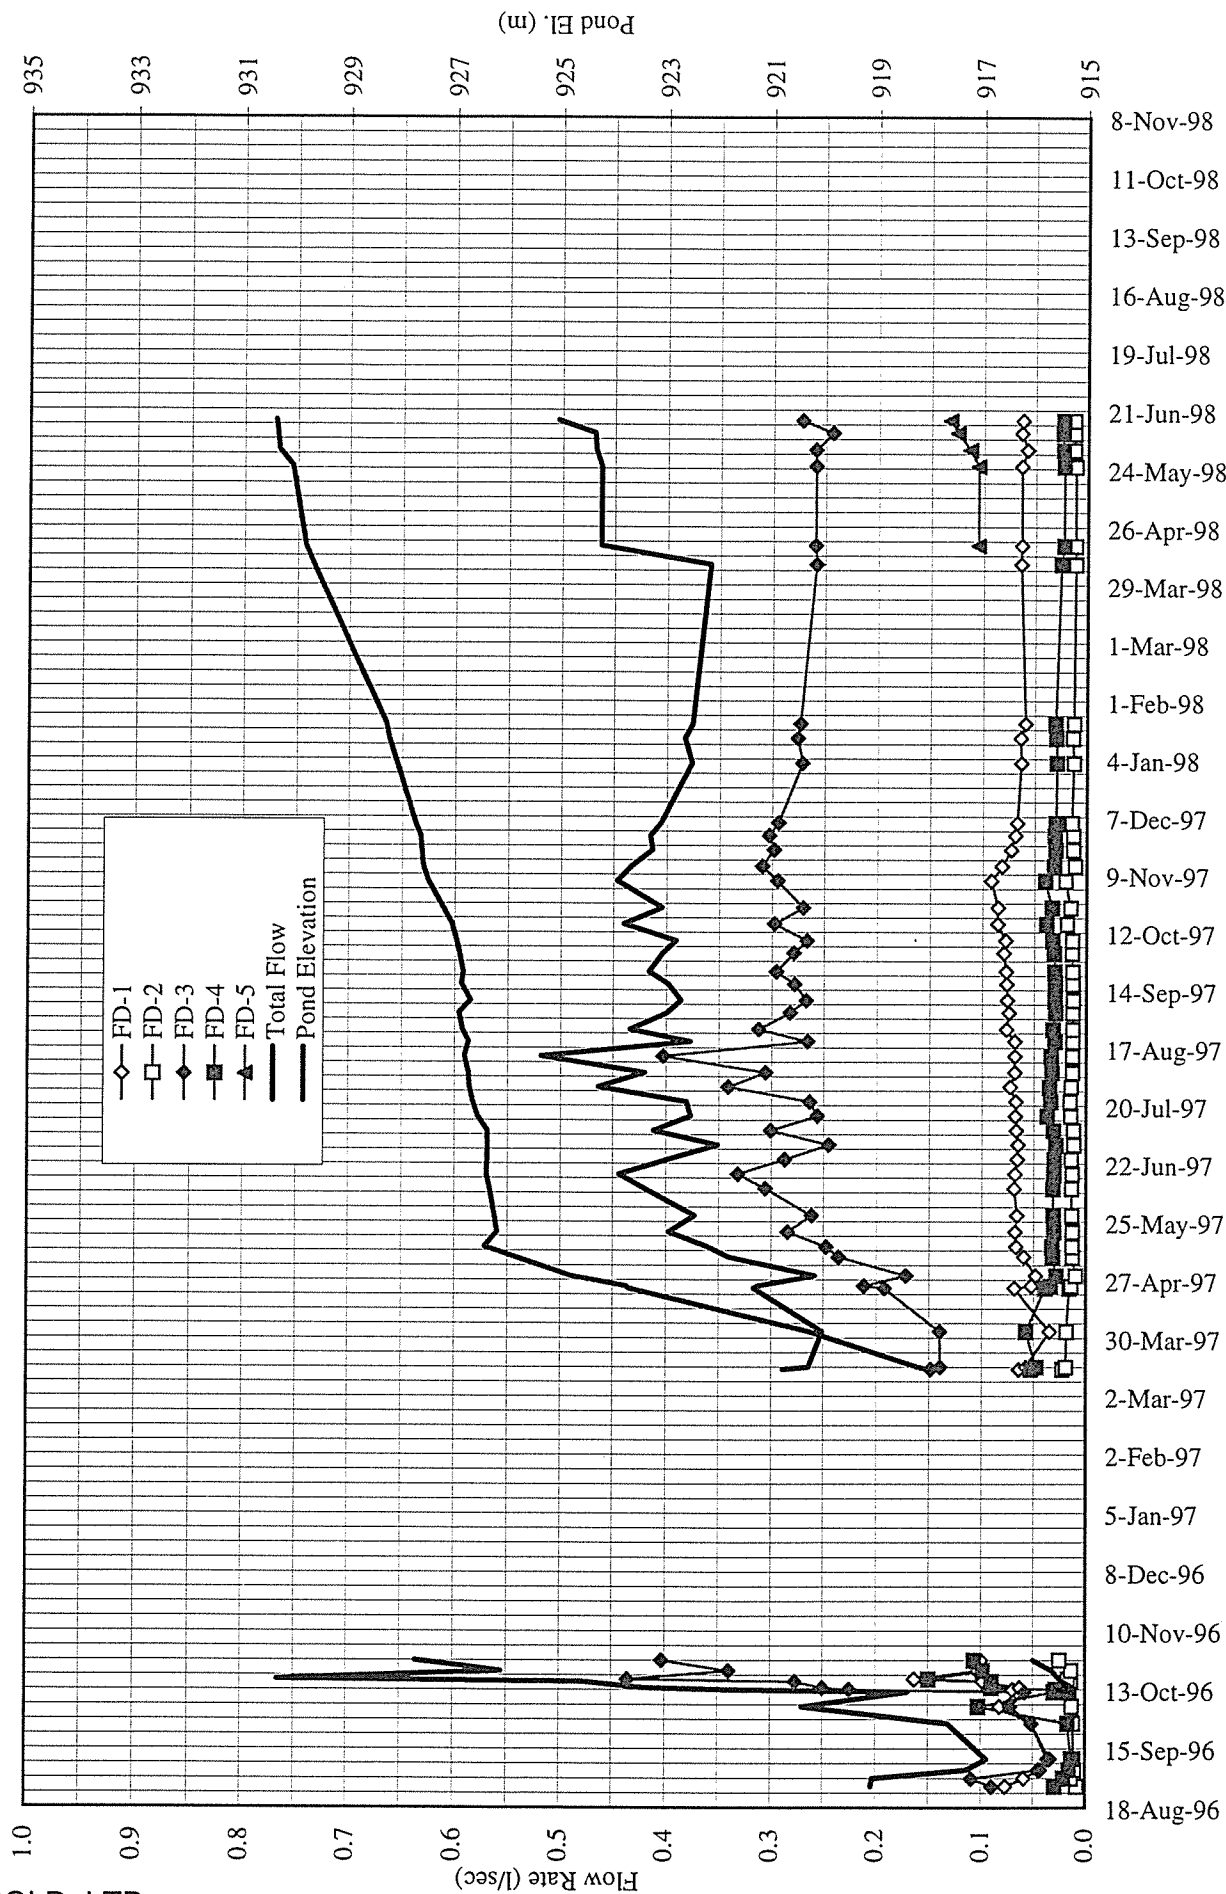
FIGURE 2.11

The foundation drain flow rates were last recorded June 16, 1998, after the installation of six Pressure Relief Wells in FD-5. A summary of the flow rates to date is presented on Table 2.4 and is shown graphically on Figure 2.11. The total flow rate is currently about 0.50 l/sec (30 l/min), an increase of about 0.14 l/sec (8.4 l/min) since FD-5 was installed. It should be noted that the flow rates were increasing from the time that the Stage 1B embankment was completed until August 1997, when tailings discharge from the Main Embankment was well established and the basin was being blanketed with tailings. It should also be noted that the flow rates from FD-5 increased by about 1.5 l/min when the 1998 Pressure Relief Wells were installed.

and are well below the predicted flow rate of 1.1 l/sec (not including baseline flows), as determined by seepage analyses for the Main Embankment foundation drains (see "Report on On-Going Construction Requirements, Ref. No. 10162/9-3).

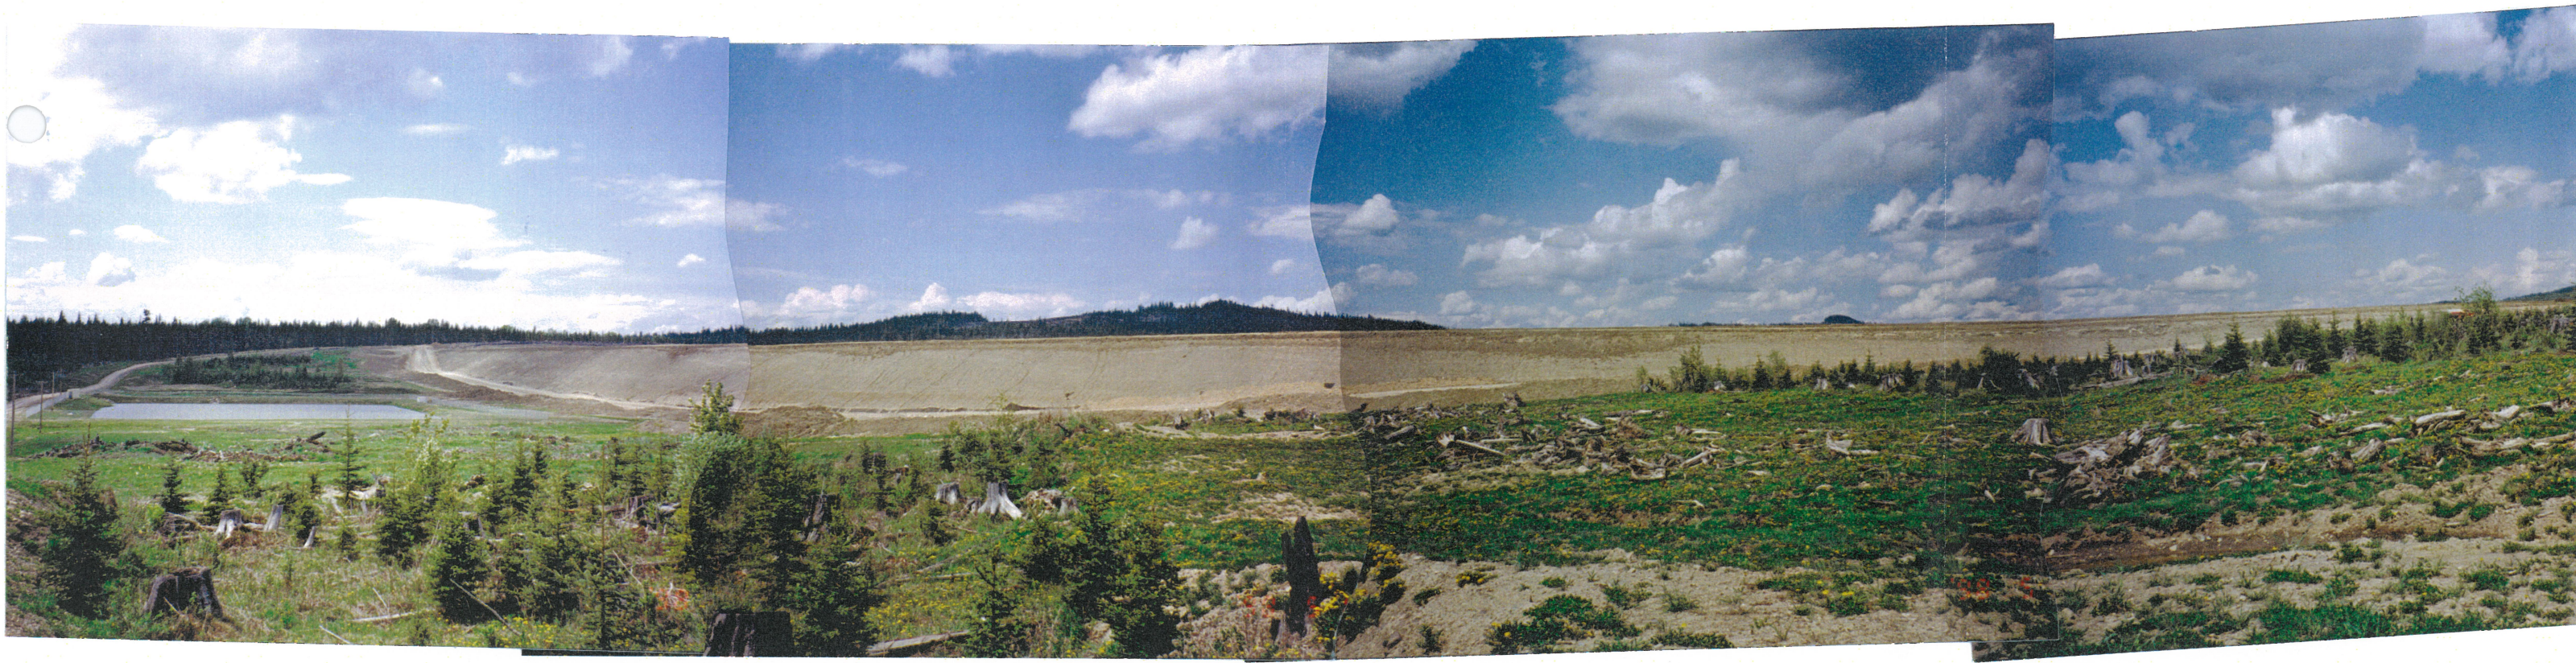
Main Embankment. View looking north, from Bootjack - Morehead Connector Road east of the Seepage Collection Pond. Photo taken near end of construction and only outstanding work is dressing of downstream slope. Note Seepage Collection Pond on left. Zone T material now provides good access to entire Tailings Storage Facility.

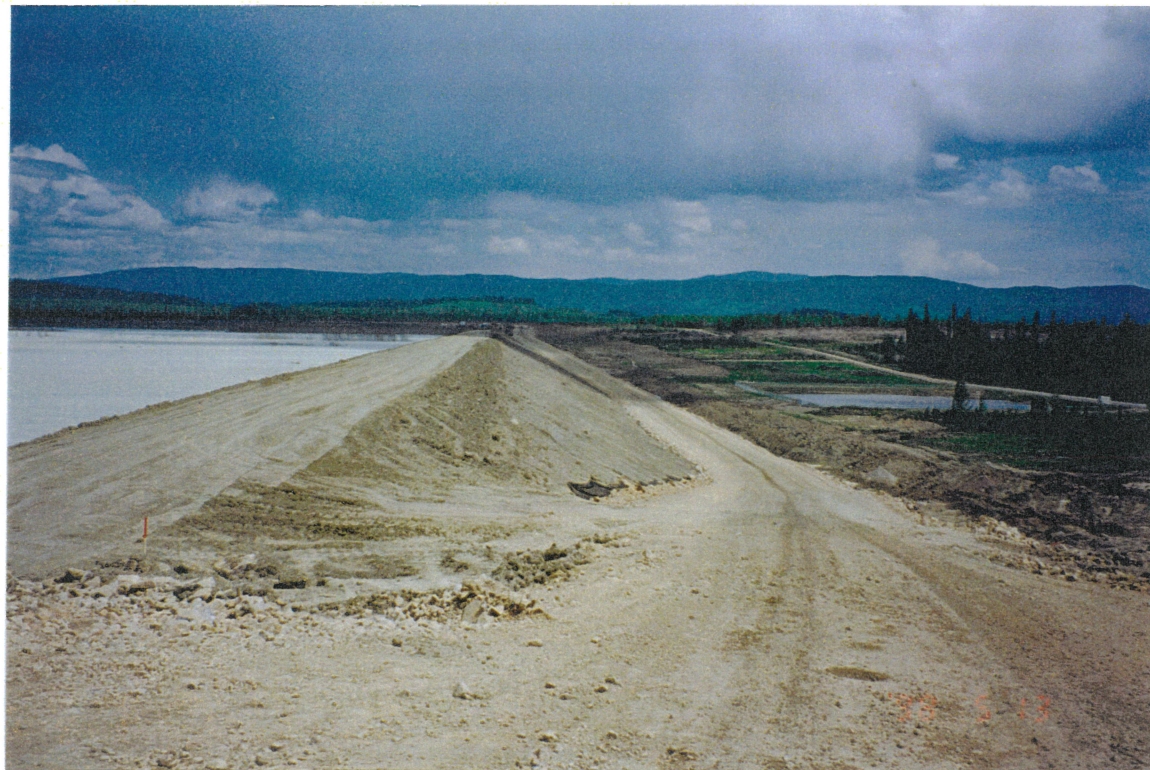
Main Embankment View looking east, from right abutment. Note Zone T material with filter fabric extending up to Stage 2A crest at right abutment.

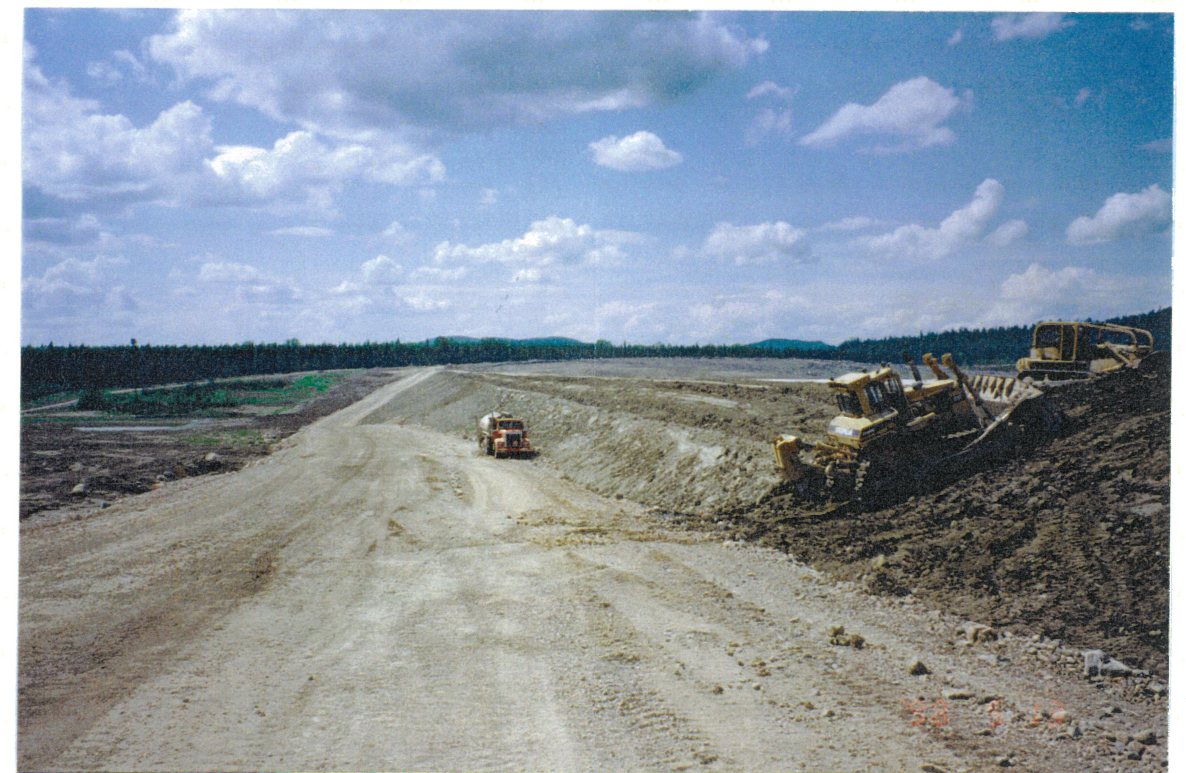
Main Embankment View looking west from left abutment. Final dressing of downstream slope.

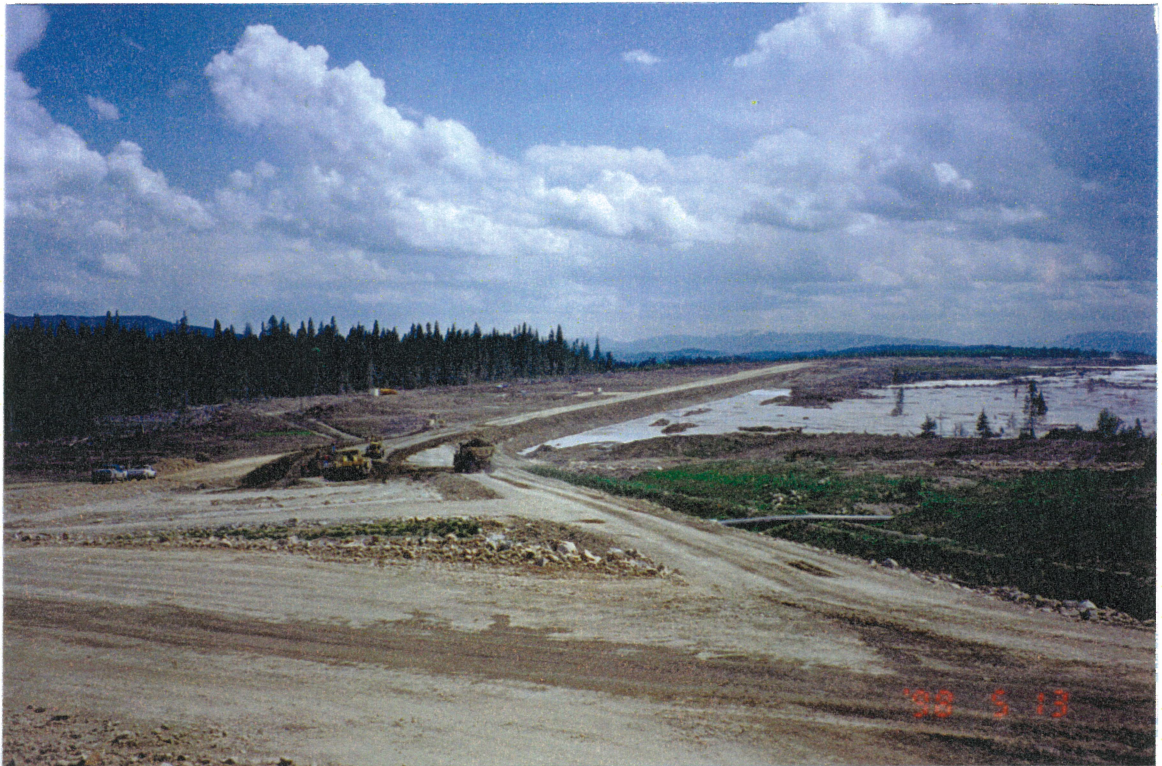
Perimeter Embankment from Left Abutment, end of Stage 2A Construction. Tailings discharge is through M1A dump valve. Note tailings beach development.

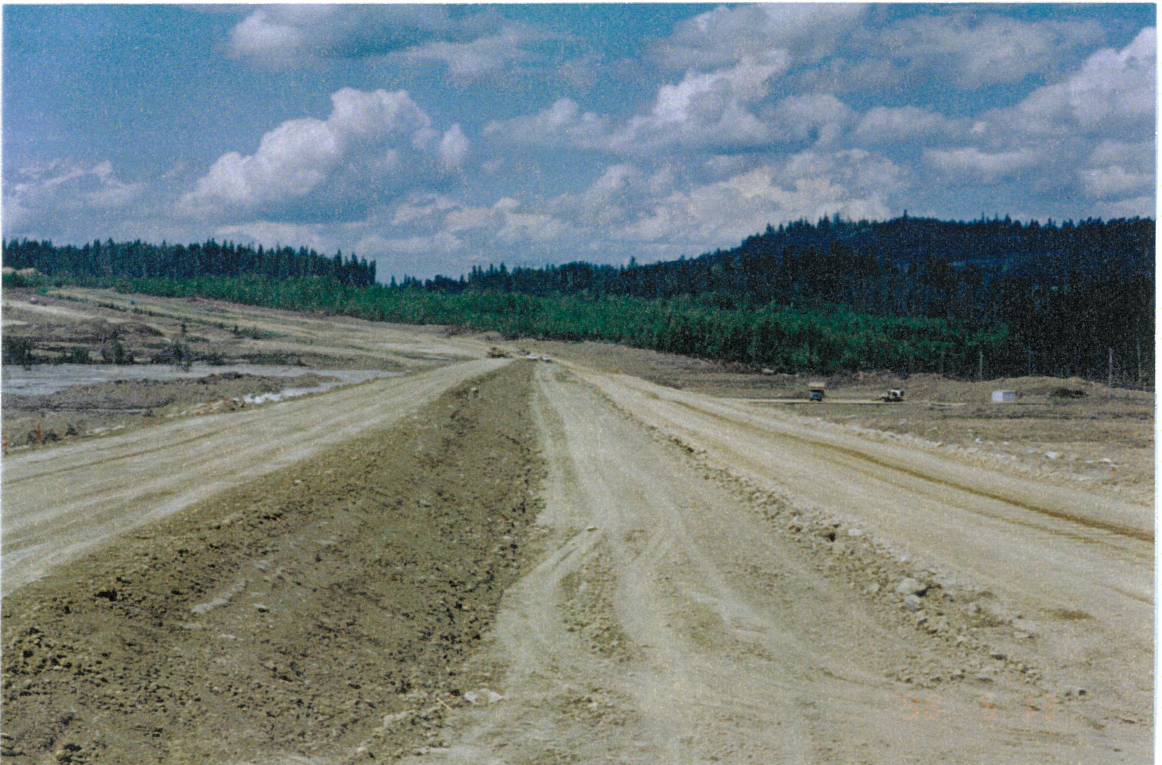
Perimeter Embankment from near right abutment. Note bench left on downstream side for construction of Longitudinal Drain in Stage 2B Construction.

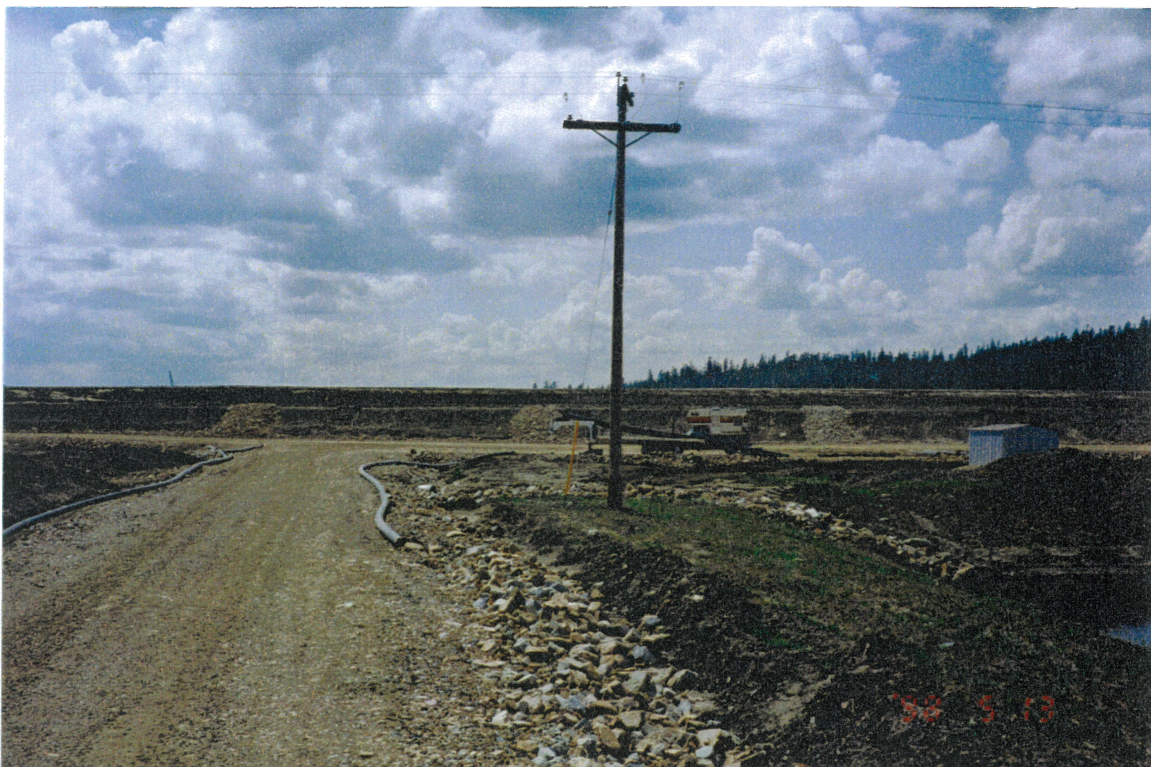
Perimeter Embankment. Looking upstream from access road on east side on Seepage Collection Pond. Note Outlet Drains going up face of embankment.

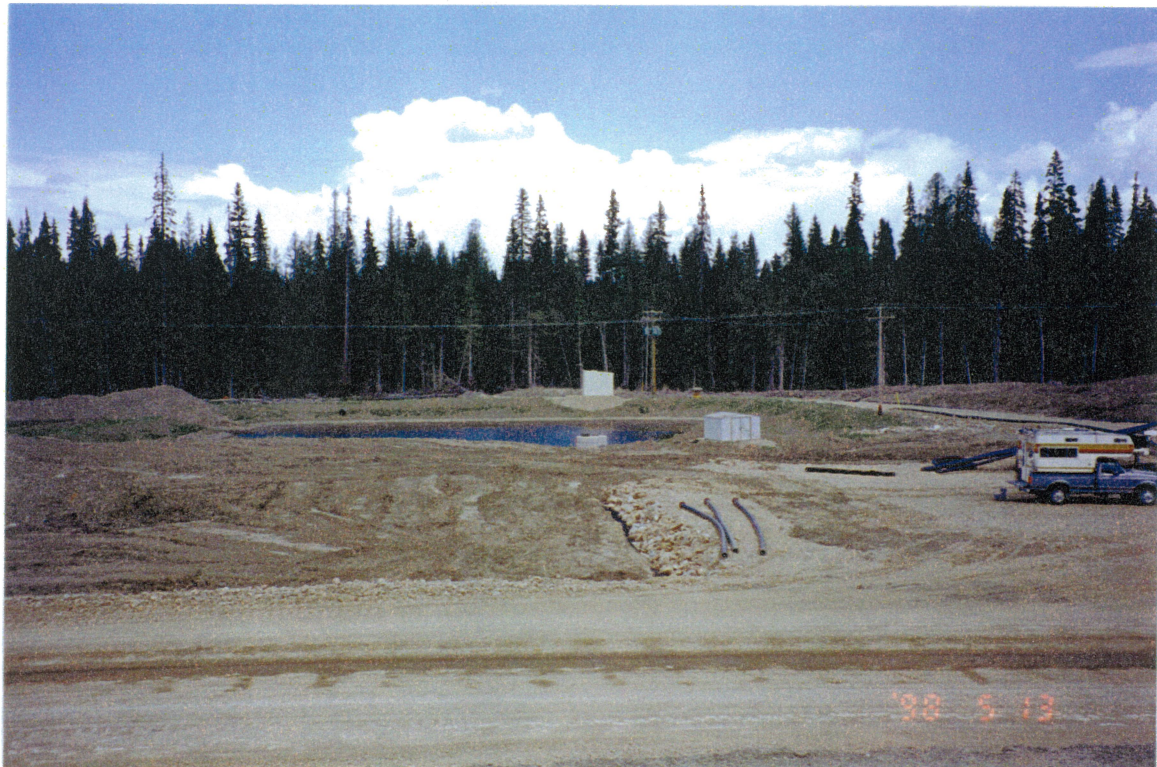
Perimeter Embankment. Looking downstream to Seepage Collection Pond. Note grading of area. Zone T platform was extended to final downstream toe.

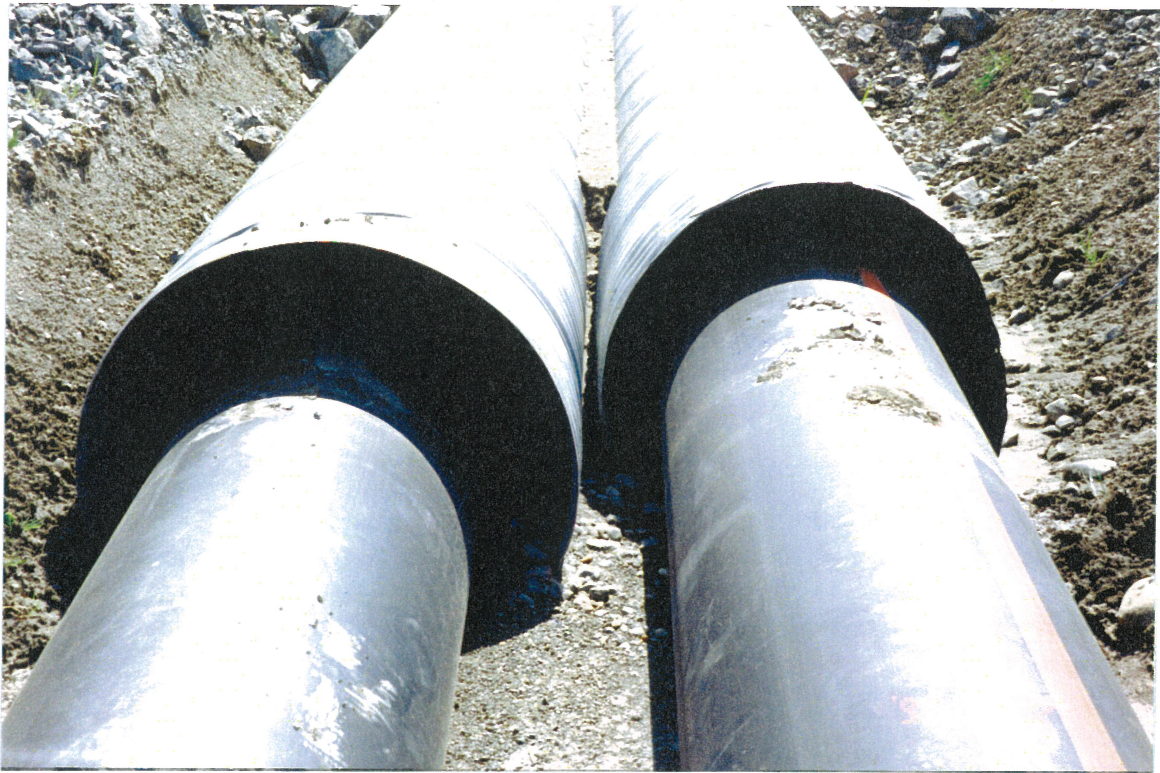
Pipeline Containment Channel. Upstream end of pipeline sleeves at Bootjack Creek Crossing. Note tailings at bottom of sleeves.

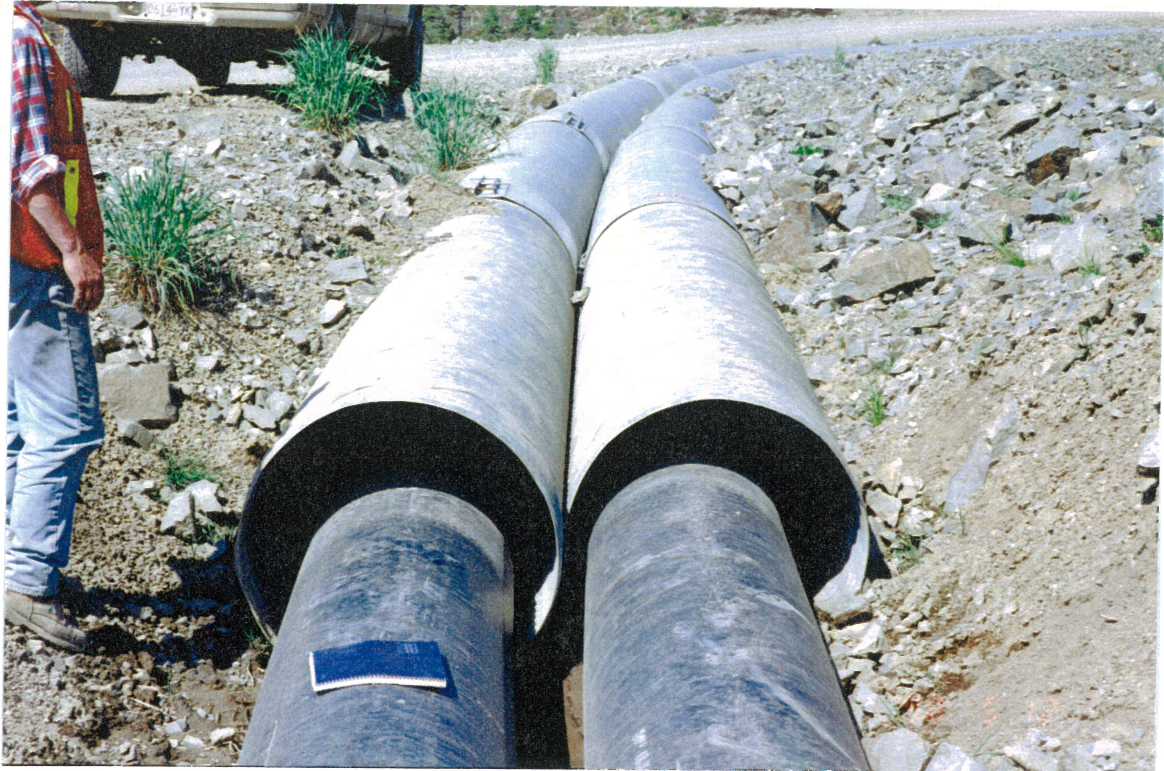
Pipeline Containment Channel. Downstream end of pipeline sleeves at Bootjack Creek Crossing. Note minor amount of tailings at bottom of sleeves.

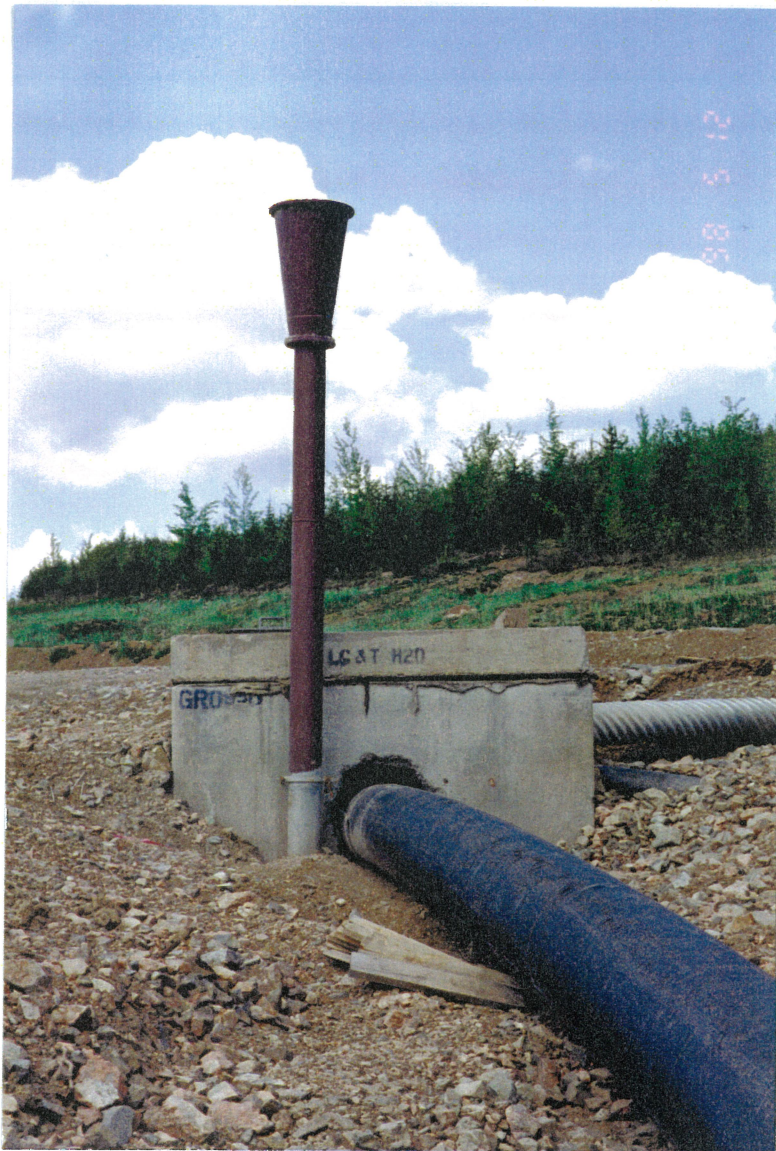
Tailings Pipeline System.
Revised T2 Dropbox. Tailings Pipeline now extends all the way from the Mill to the Tailings Storage Facility. T2 Dropbox provides surge protection and is connected to the pipeline by a bifurcation.

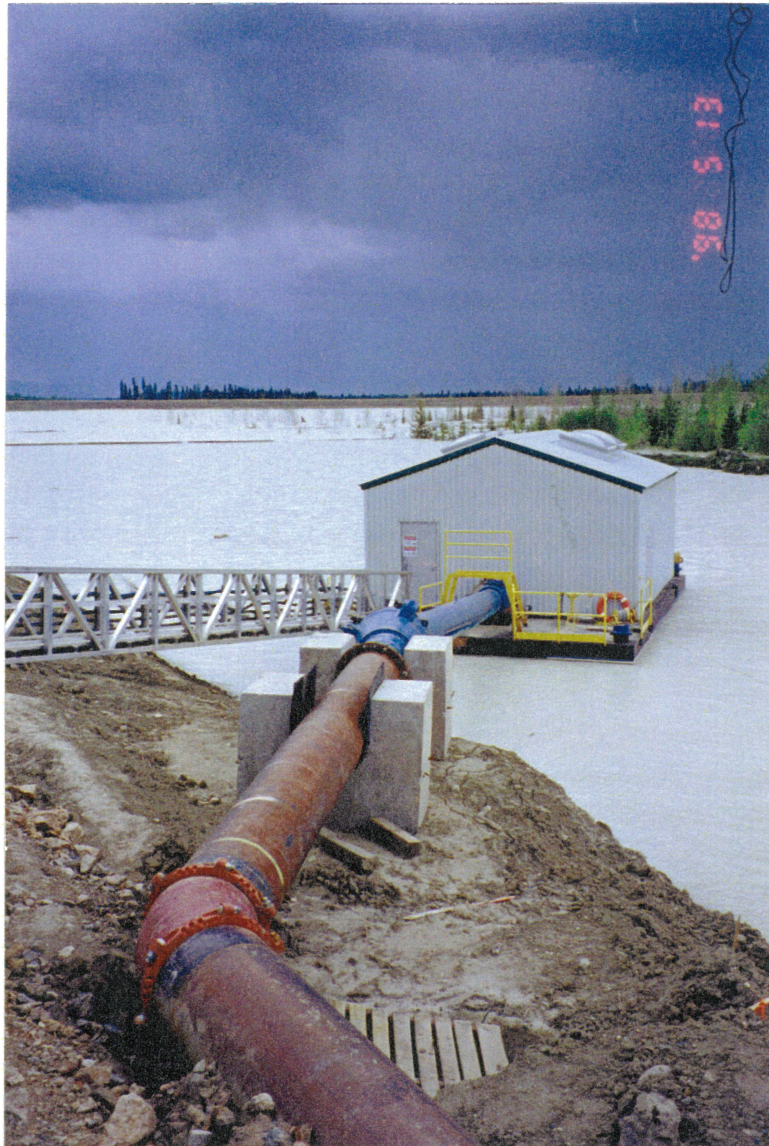
Reclaim Pipeline System. Reclaim Barge and Channel. Note 35 degree elbow added and barge alignment changed.

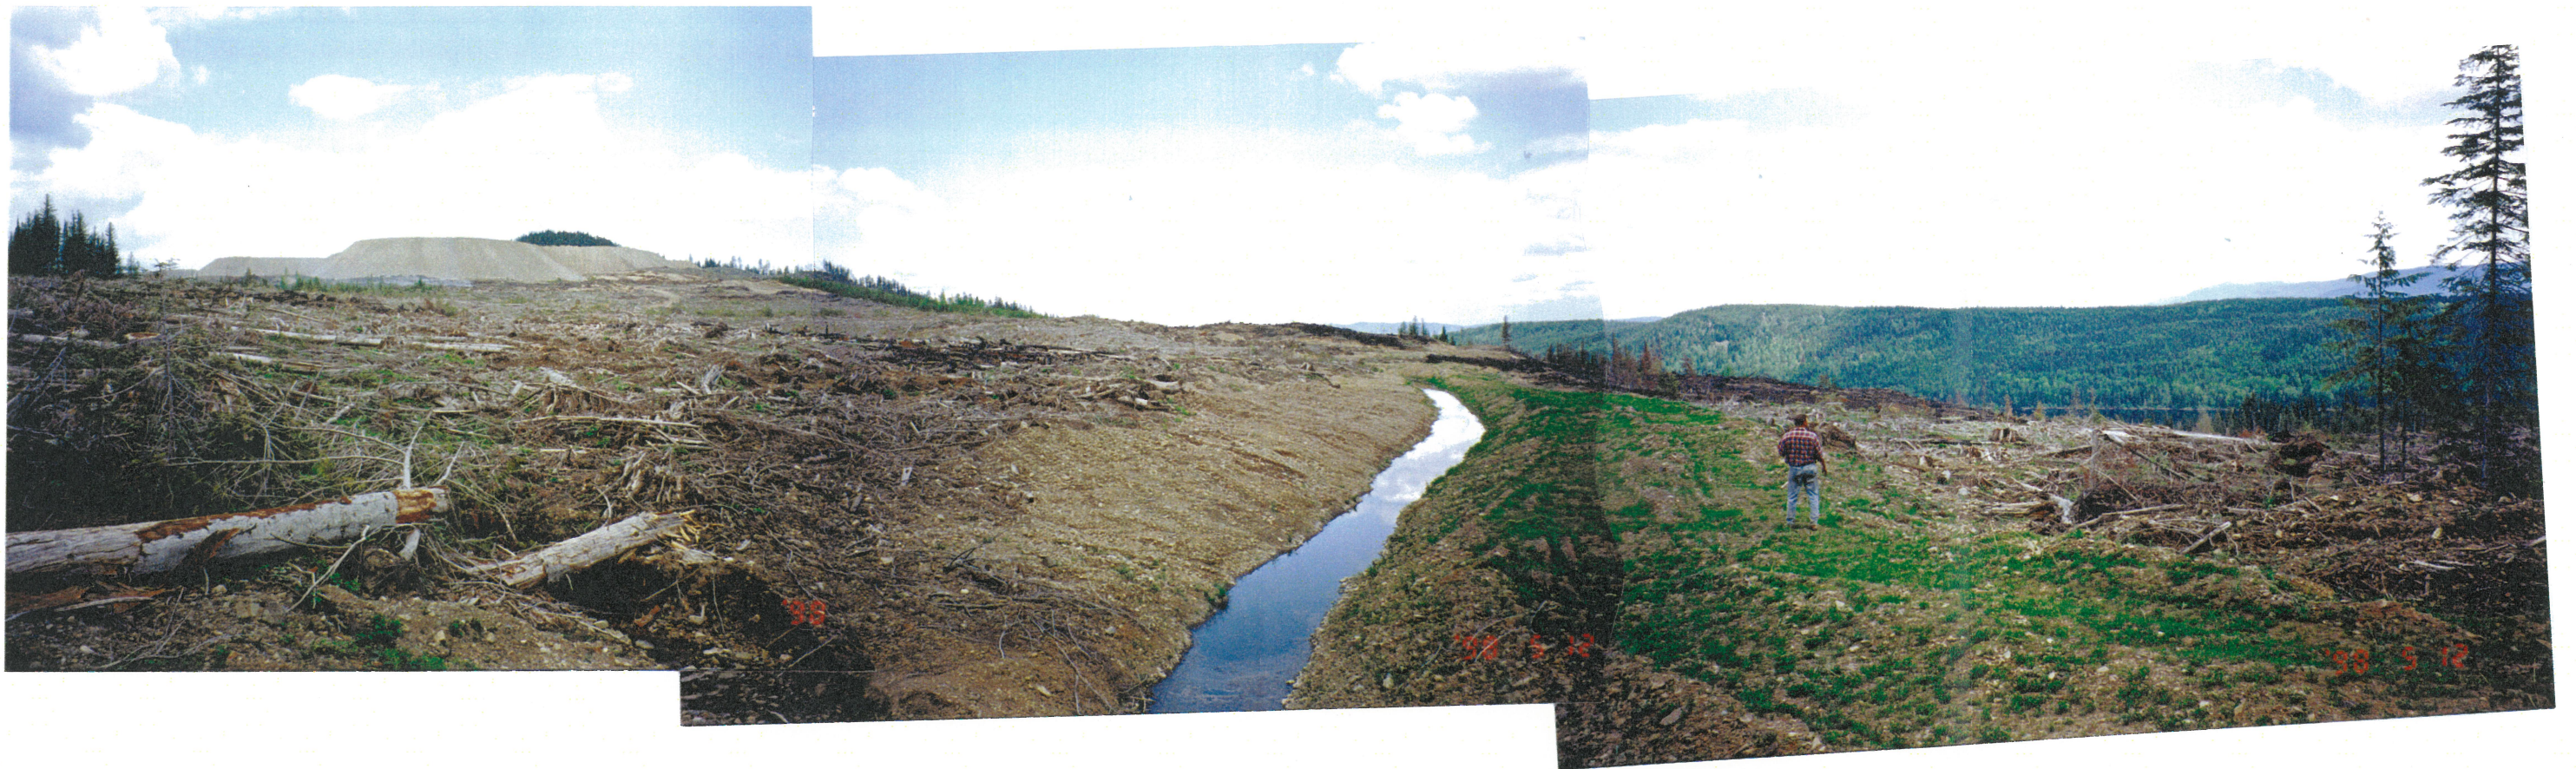
Southeast Sediment Pond - Runoff collection ditch, looking north. Note Mine waste dump to left and Polley Lake to right. Ditch is clear of obstructions.

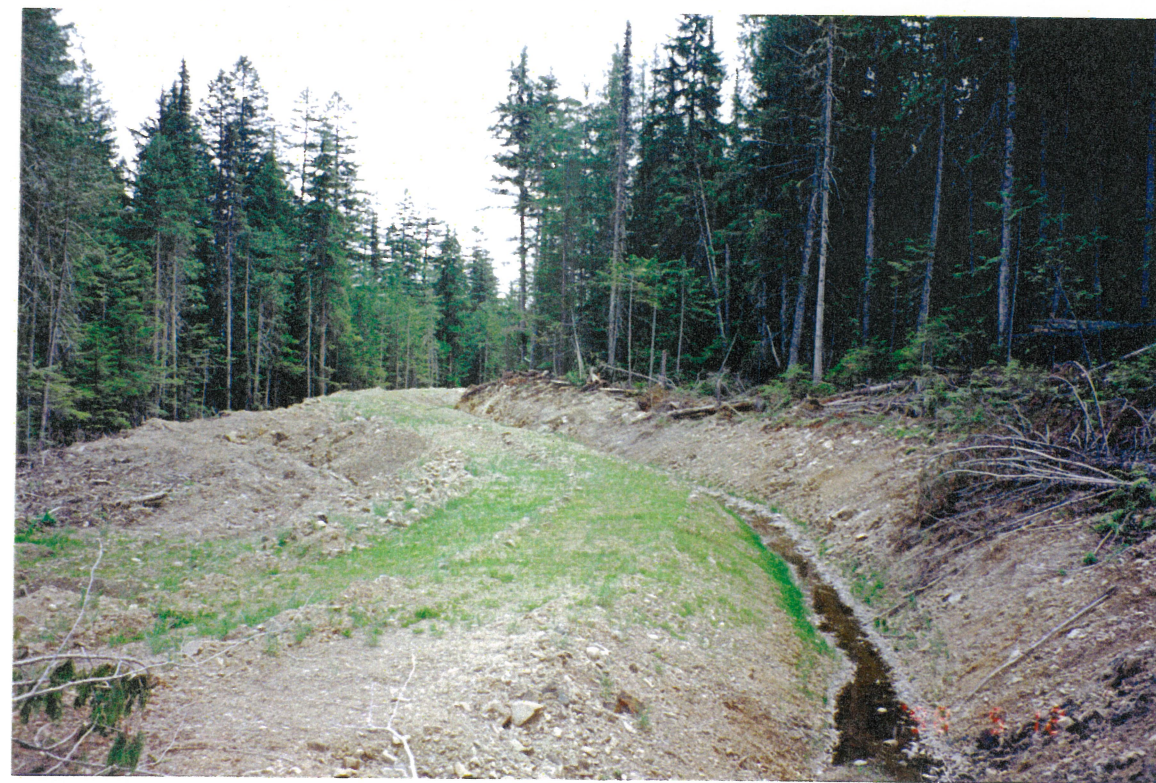
Southeast Sediment Pond - Runoff collection ditch, looking south. Ditch is clear of obstructions.

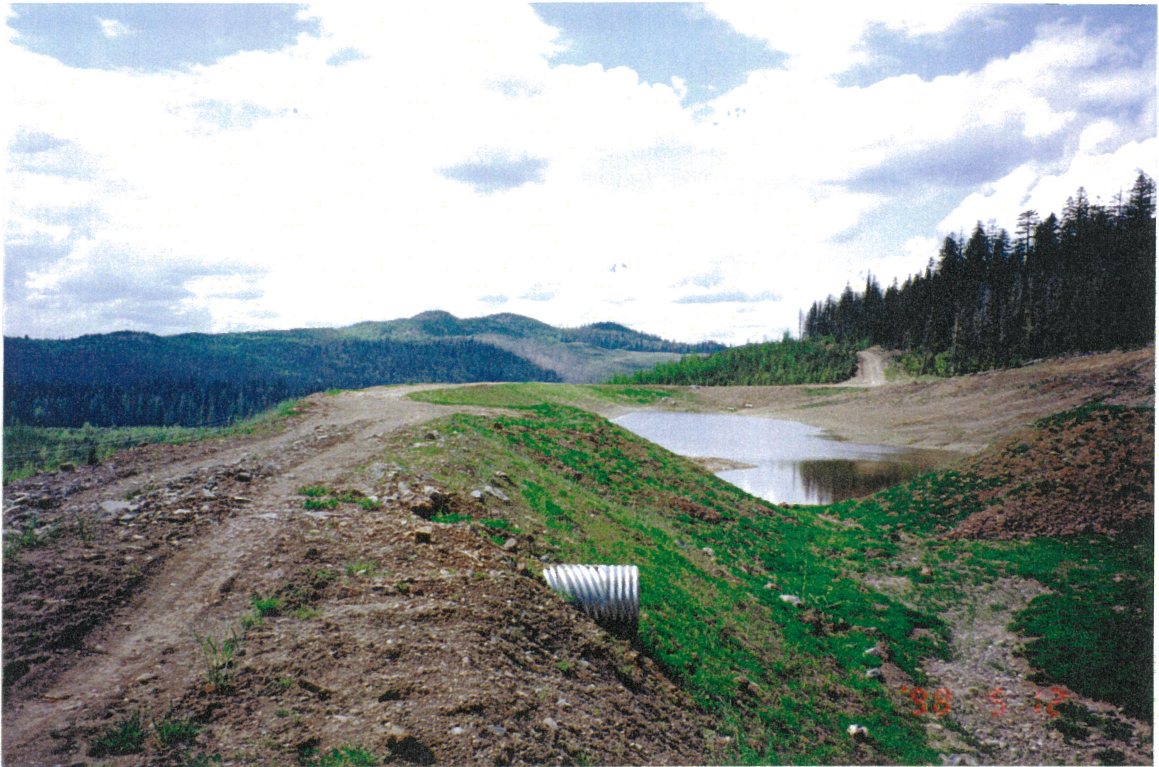
Southeast Sediment Pond. Looking west, from end of runoff collection ditch to the manhole sump. Note low water level and overflow culvert in foreground.
