**MOUNT POLLEY MINING CORPORATION
MOUNT POLLEY MINE
TAILINGS STORAGE FACILITY**

**1998 ANNUAL INSPECTION REPORT
(REF. NO. 10162/9-5)**

JUNE 26, 1998

Knight Piésold
CONSULTING ENGINEERS

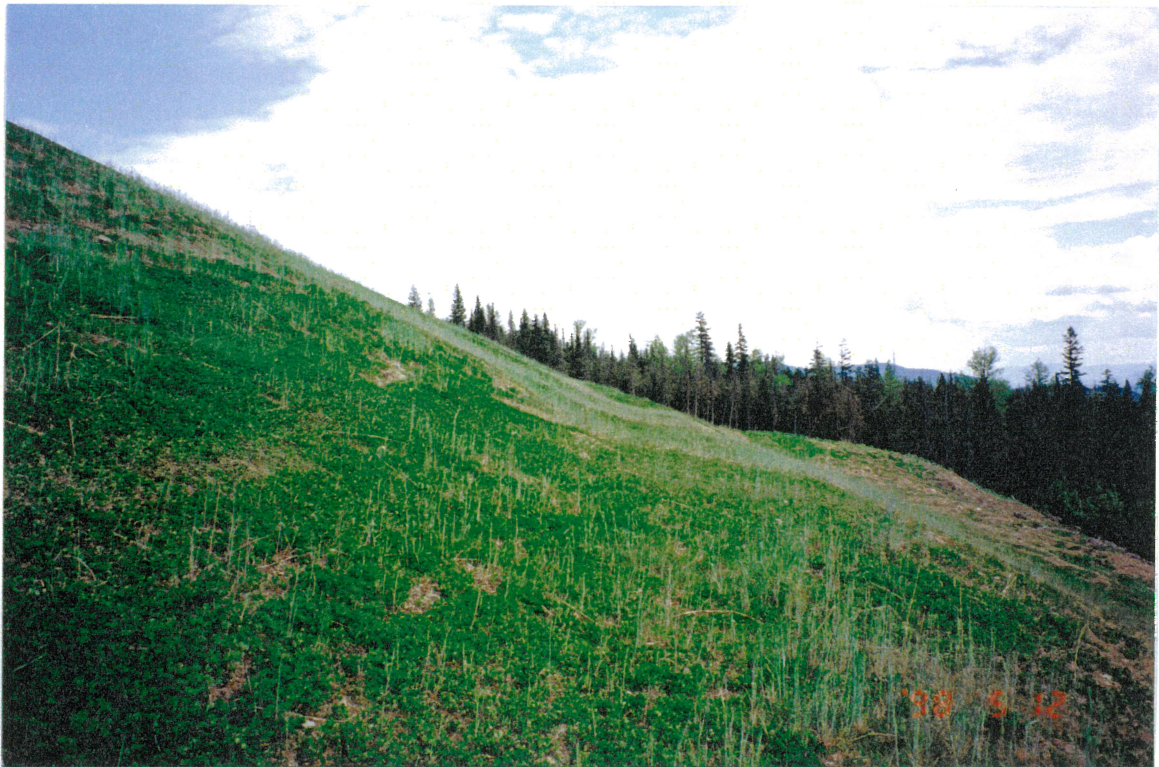
Southeast Sediment Pond. Downstream fill slope looking east. Note dry stable slope and well established re-vegetation.

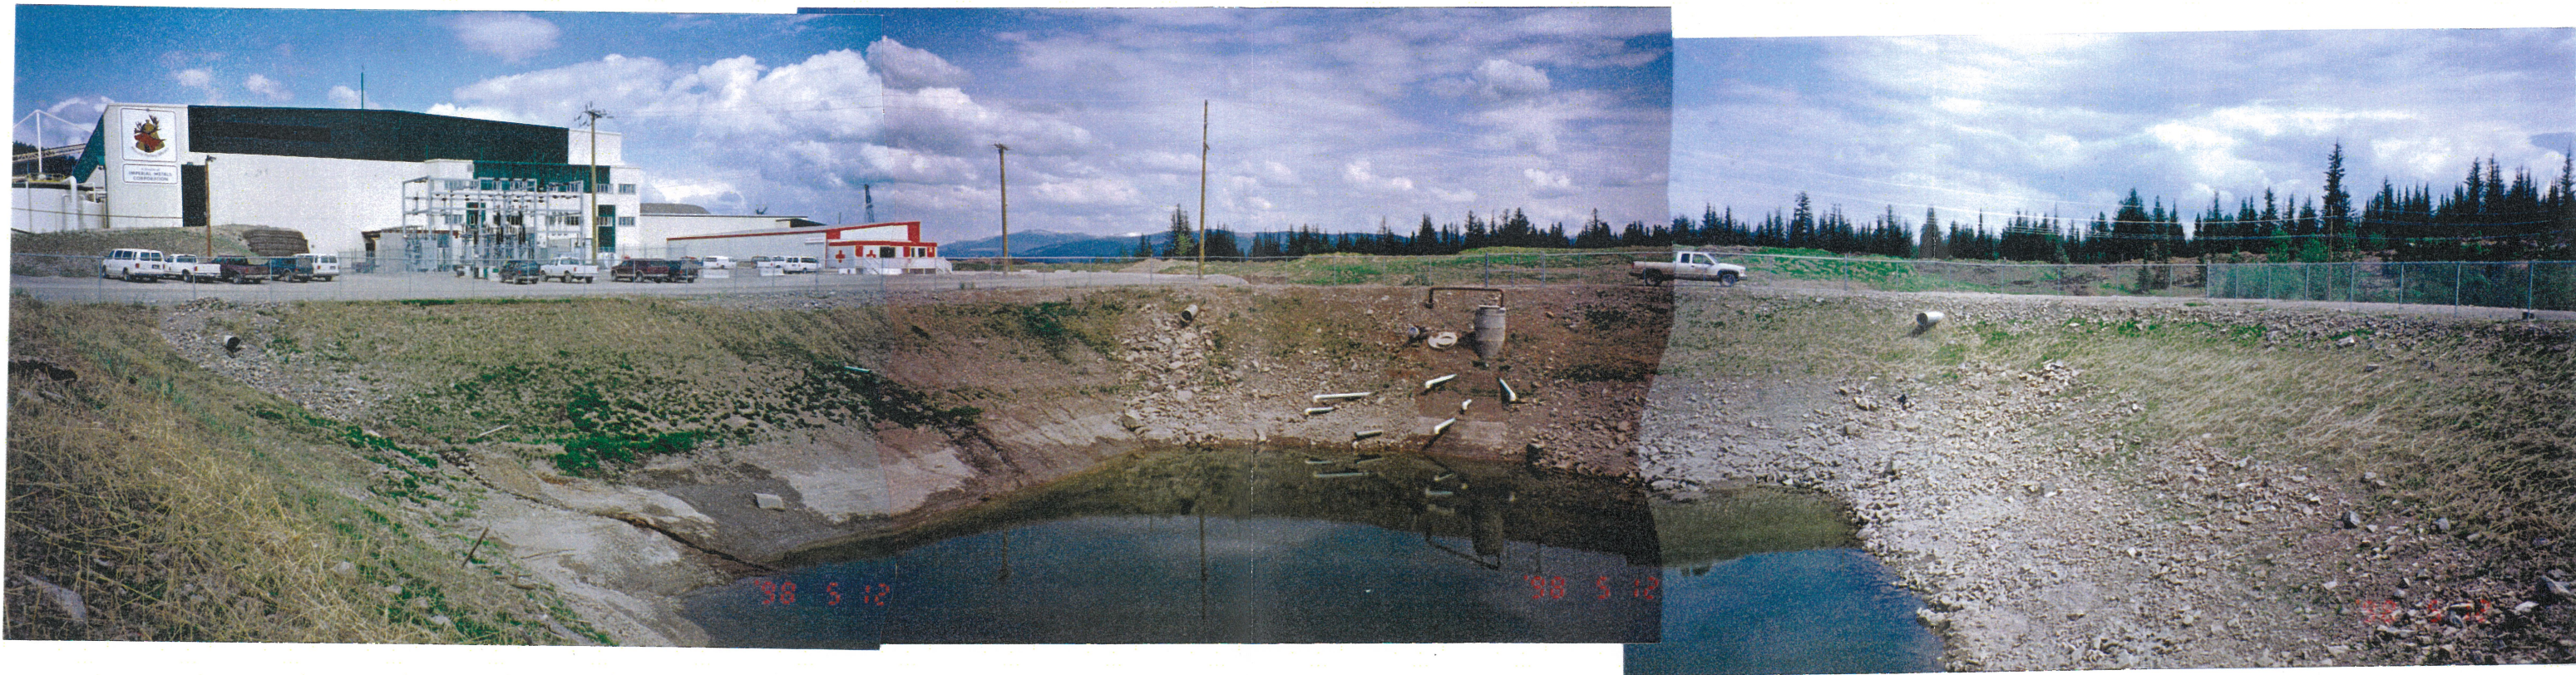
Millsite Sump. Note low water level and stable inner slopes.

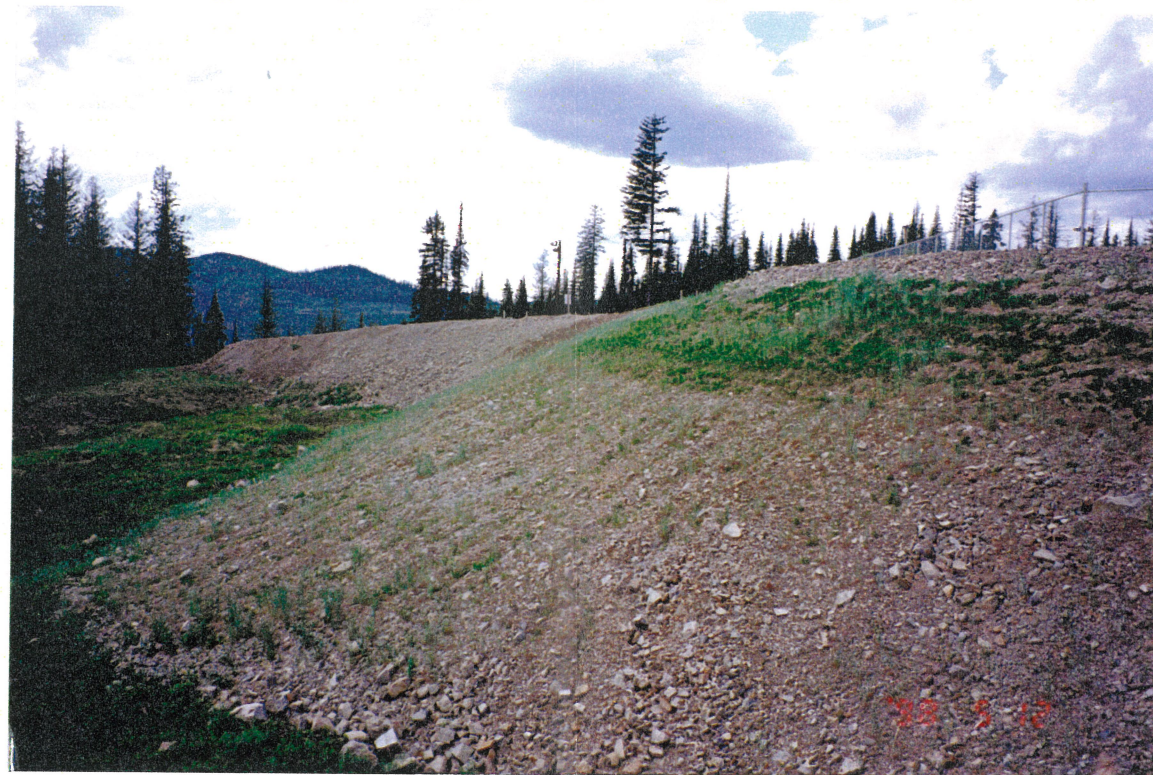
Millsite Sump. View of south slope, looking west. Slope was repaired and is stable. No seepage observed.

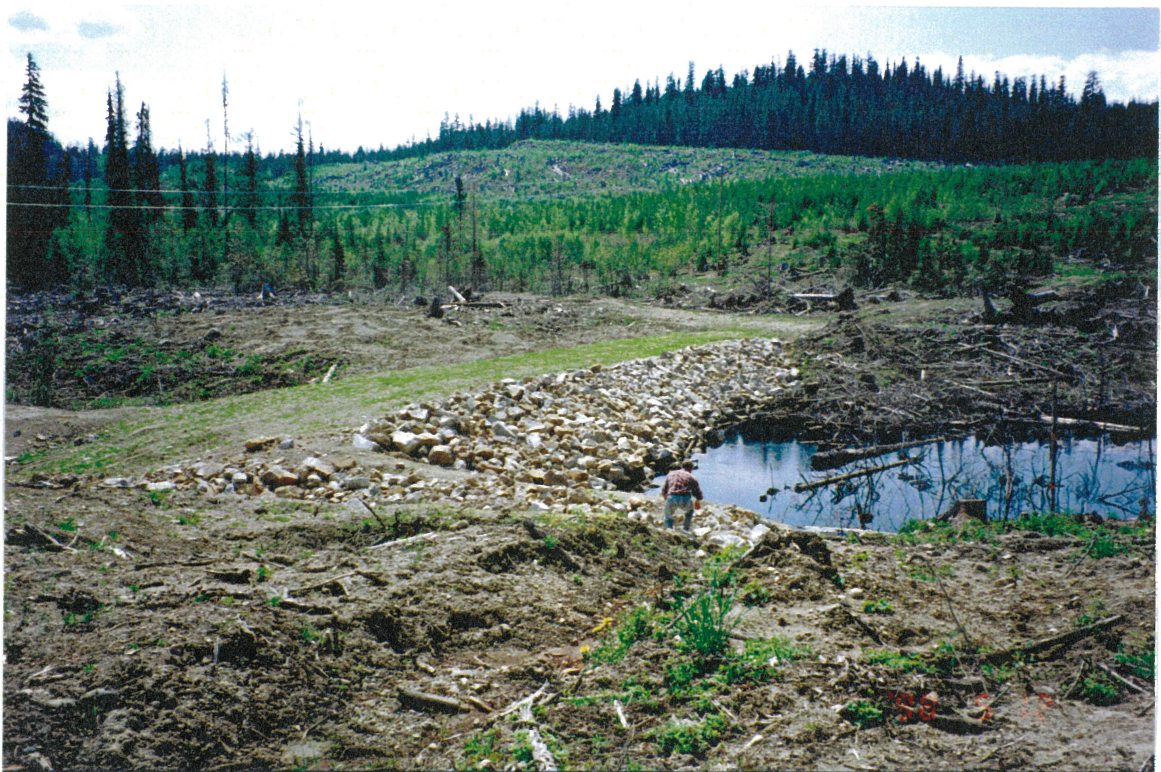
Southeast Bootjack Dam. View of upstream face of embankment, looking southwest. Ponded water is now seeping through old dam back into Bootjack Lake.

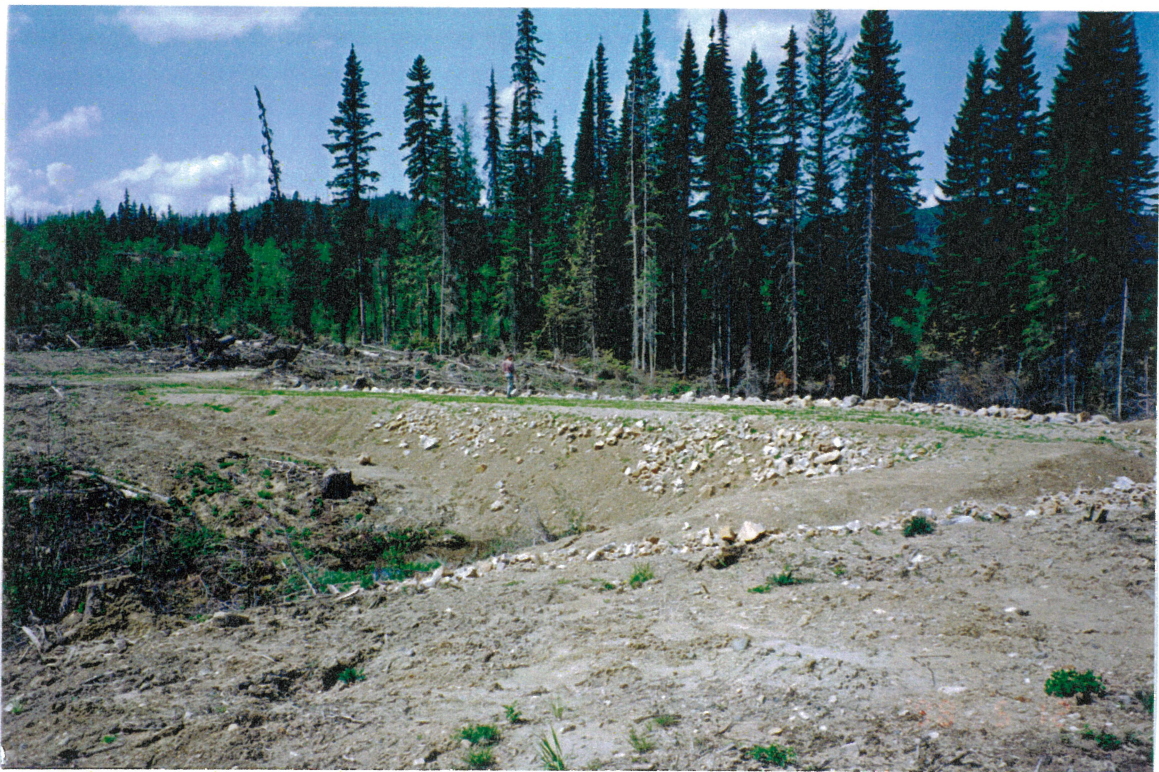
South Bootjack Dam. View of downstream face of embankment, looking northeast. Spillway in foreground is clear of obstructions.
