**MT. POLLEY MINE**

**N. ROSE GEOTECHNICAL INSPECTION OF OPEN PIT,**

**WASTE DUMPS AND TAILINGS DAMS**

**AUGUST 30, 2006**

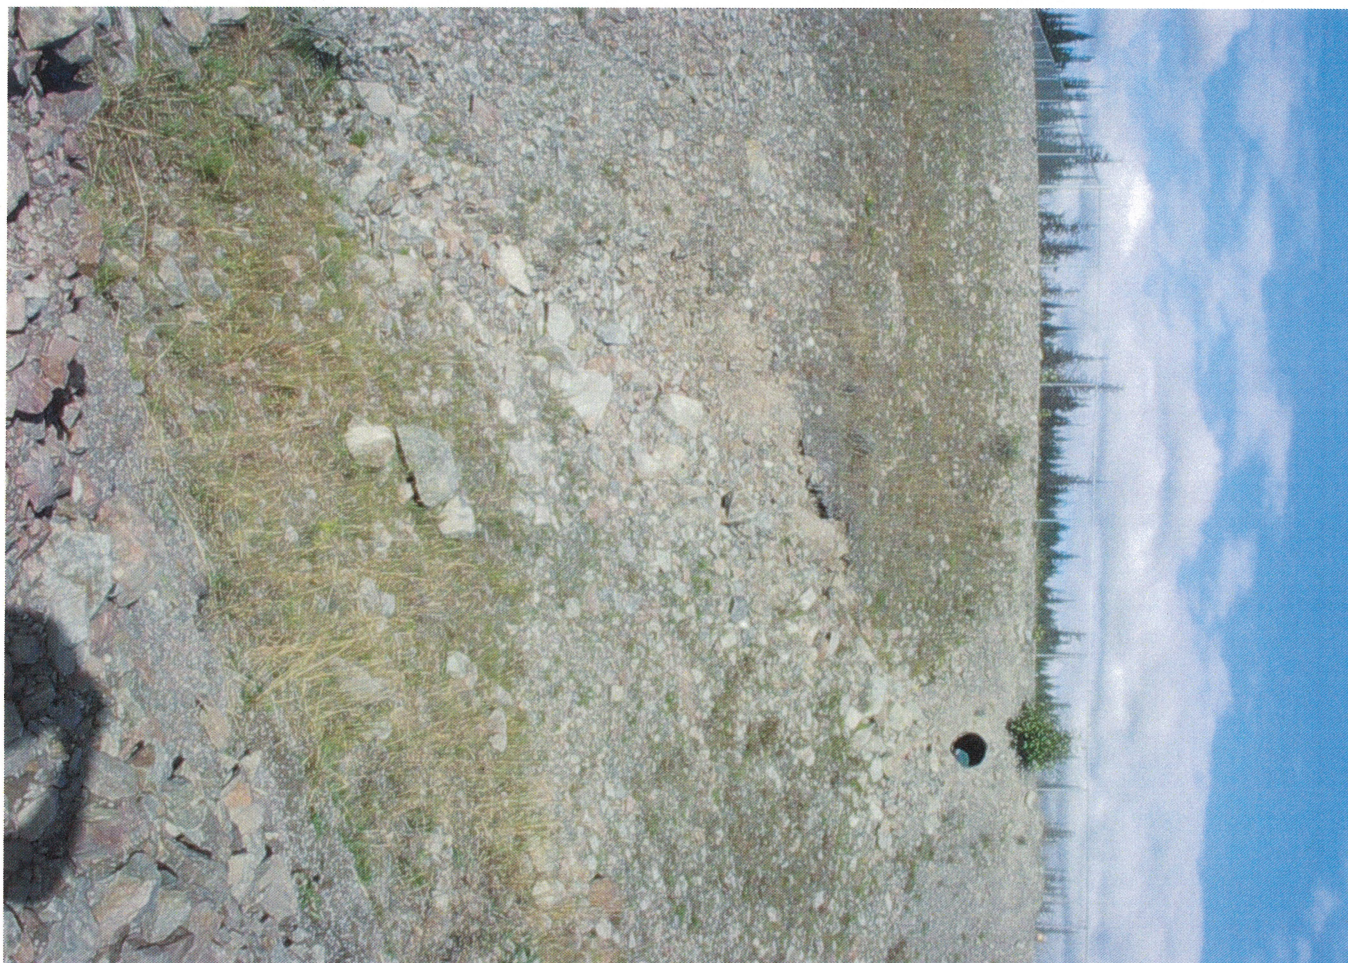
△ photo 3904

*Station 1:* Mill Site sump – erosion on outlet spillway. Requires remediation (e.g., rip rap).

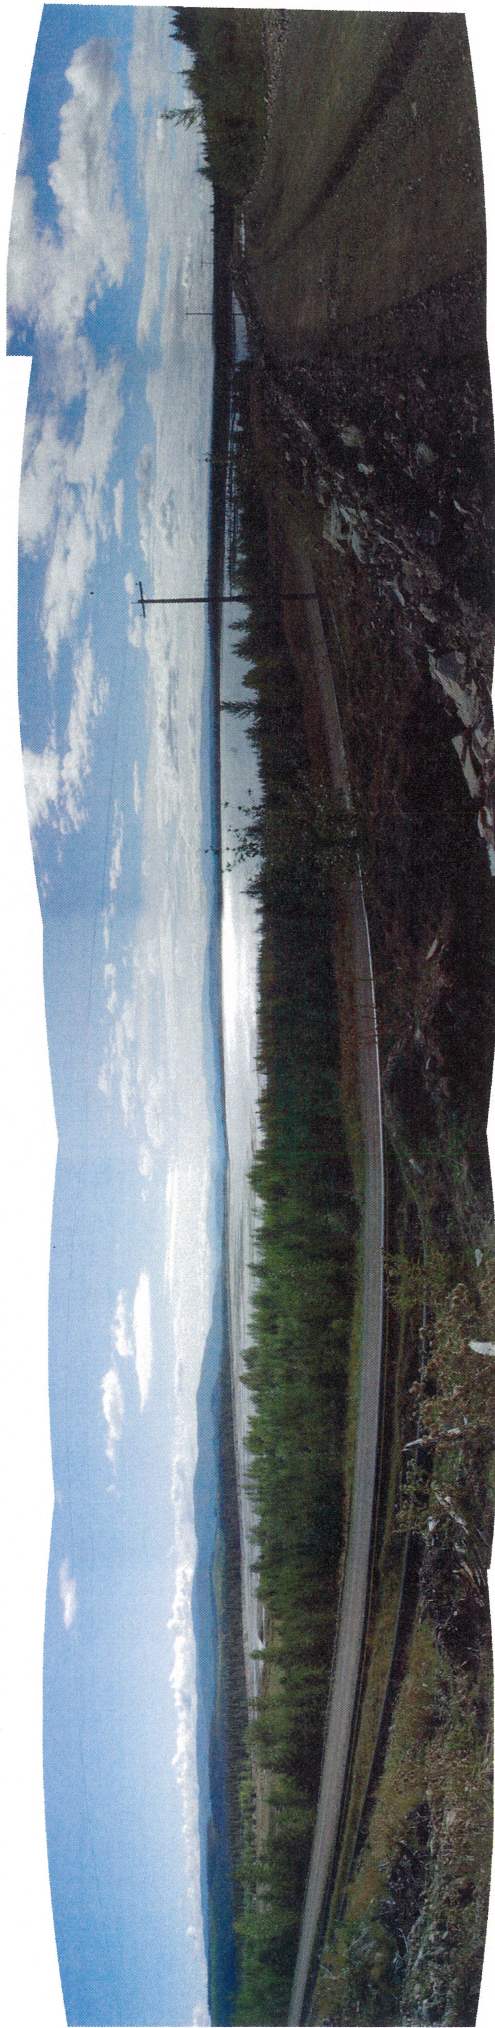
Δ2 Photos 3905-09

*Station 2:* Photo of TSF from road leading to barge. Notice beaches developed since last visit.

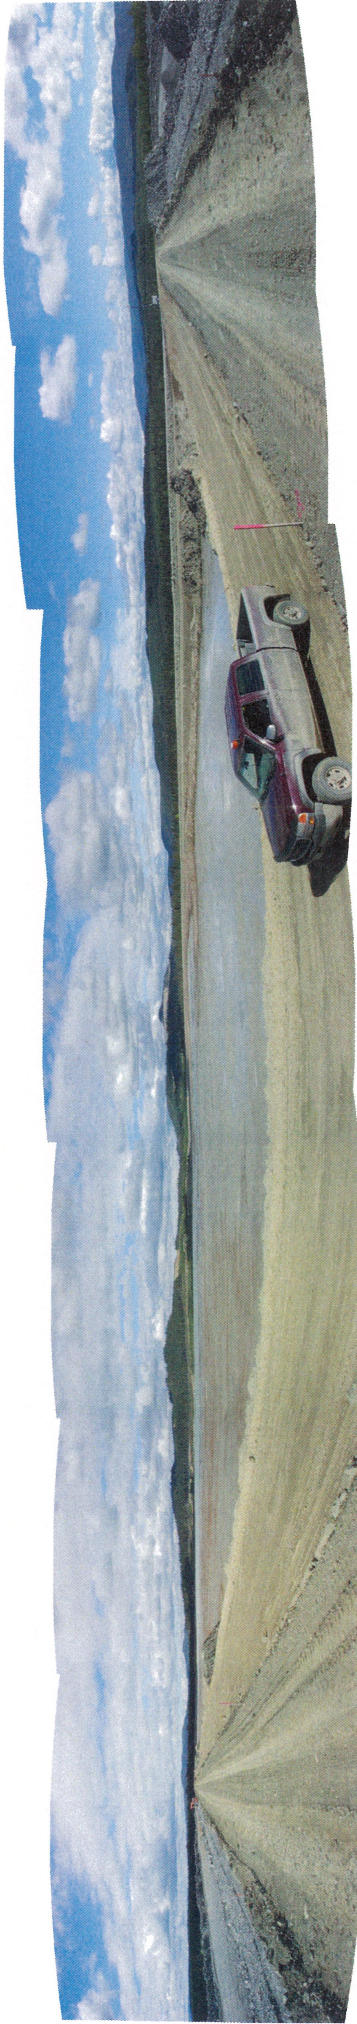
Δ3 Photos 3910-16

*Station 3:* Photo from corner of Perimeter and Main embankments; notice good beach development. Filter at 947m and till core at 948.2m el. Bruce Milligan informed Ron Martel that signage is required for single lane haulage.

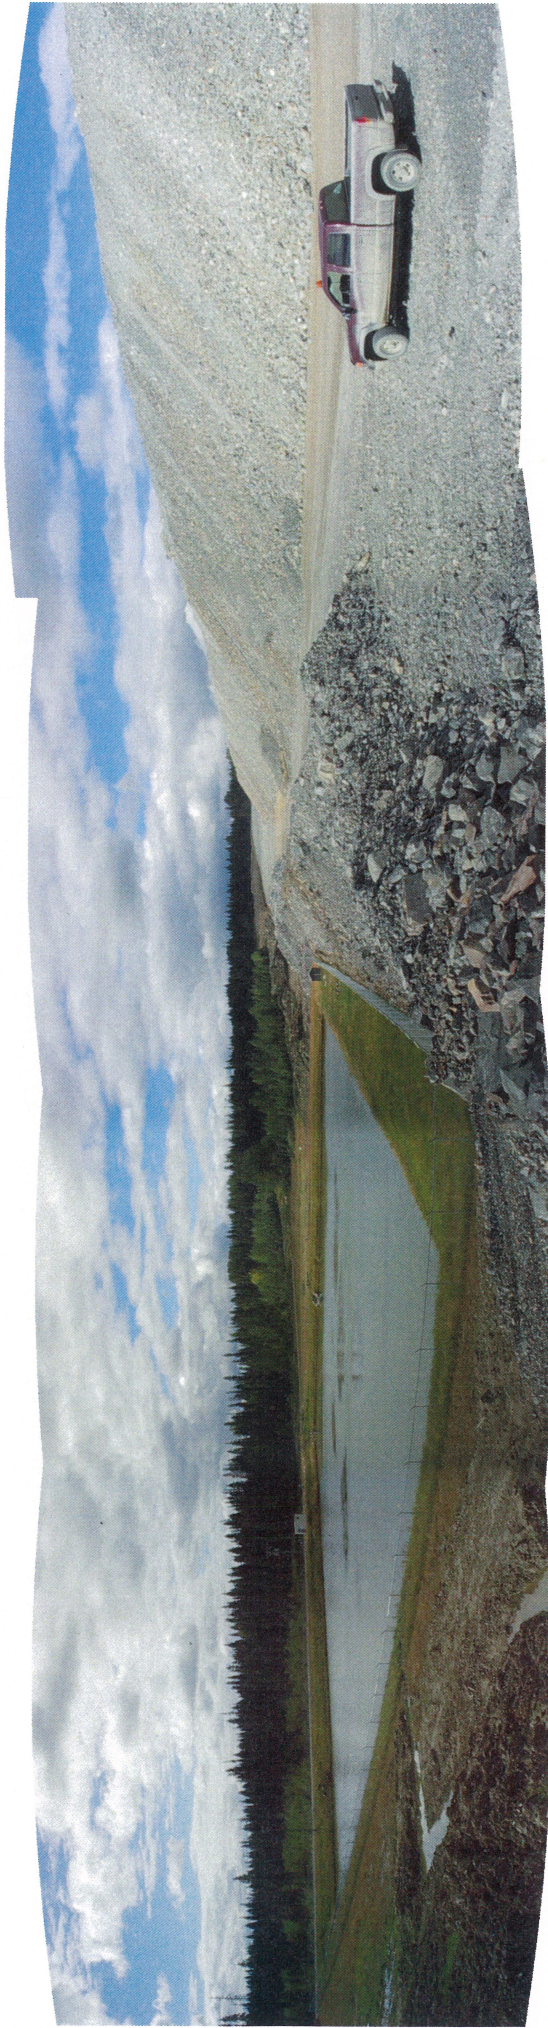
Δ4 Photos 3918-21

*Station 4:* Inclinator #3 near toe of Main Embankment; newly installed to 41m depth; pinned to bedrock. Photo of main seepage pond and downstream toe of Main Embankment.

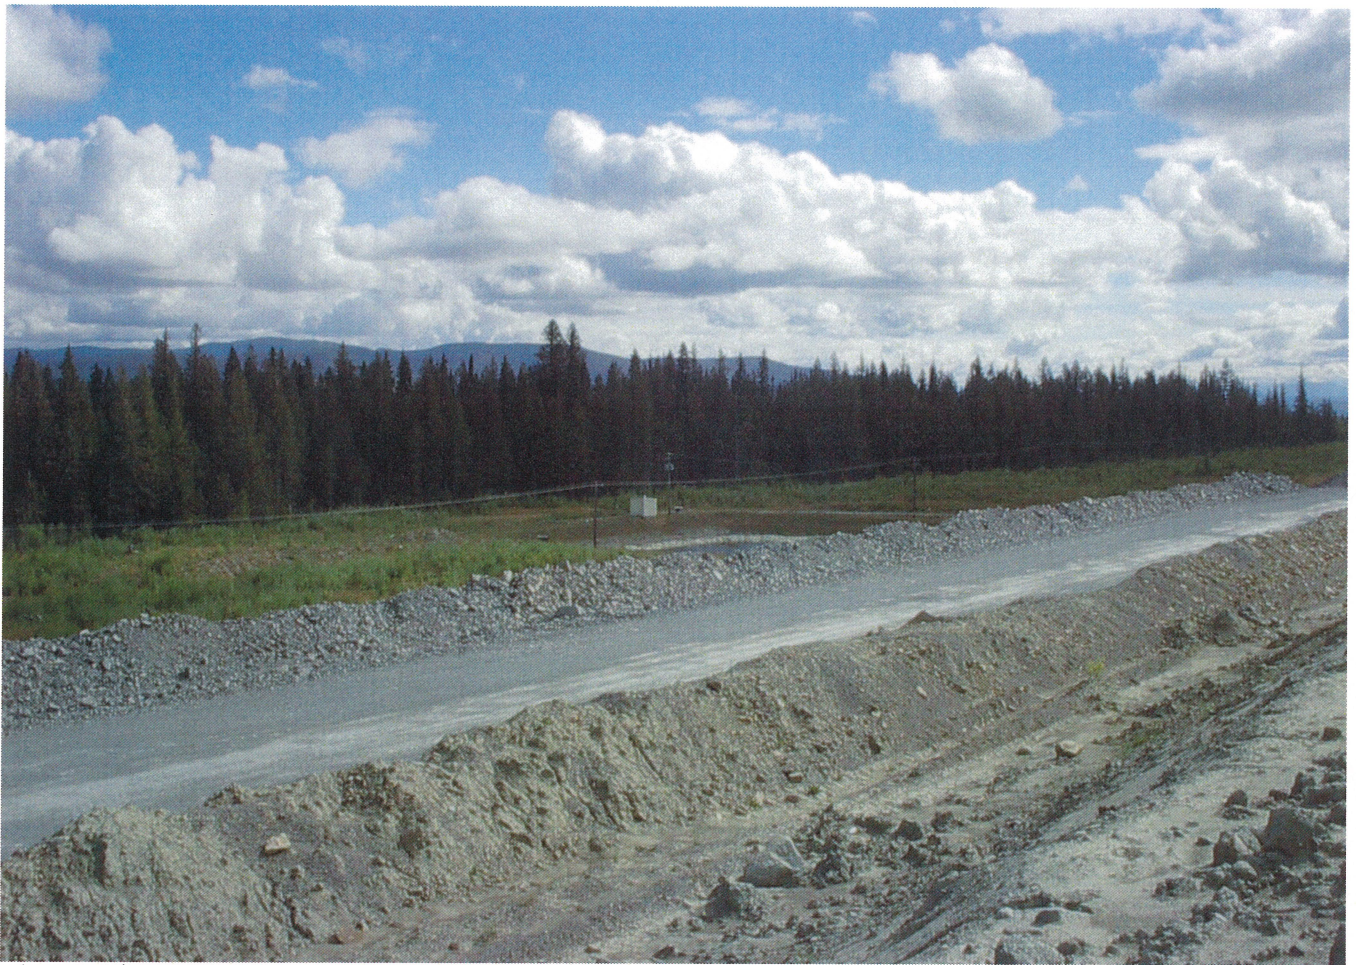
△5 Photo 3922

*Station 5:* Photo from Perimeter Embankment. Berm was placed along low point leading to South Embankment to raise the tailings pipeline such that a low point was prevented from forming in the tailings line. This has resulted in the ability to spigot across the full length of the impoundment. Spigotting was active along the South embankment to increase the beach widths in this area.

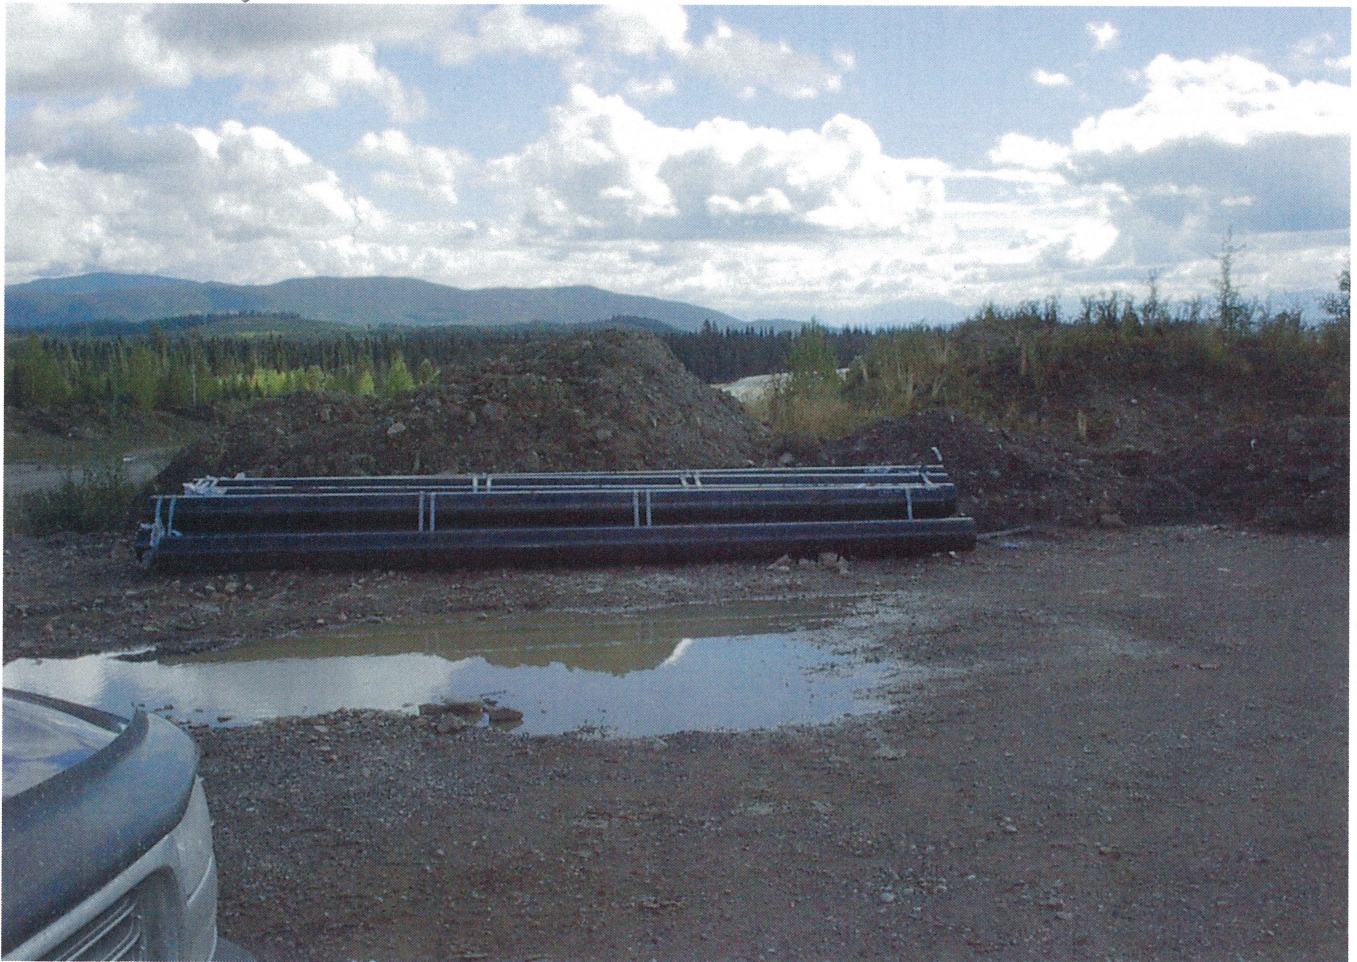
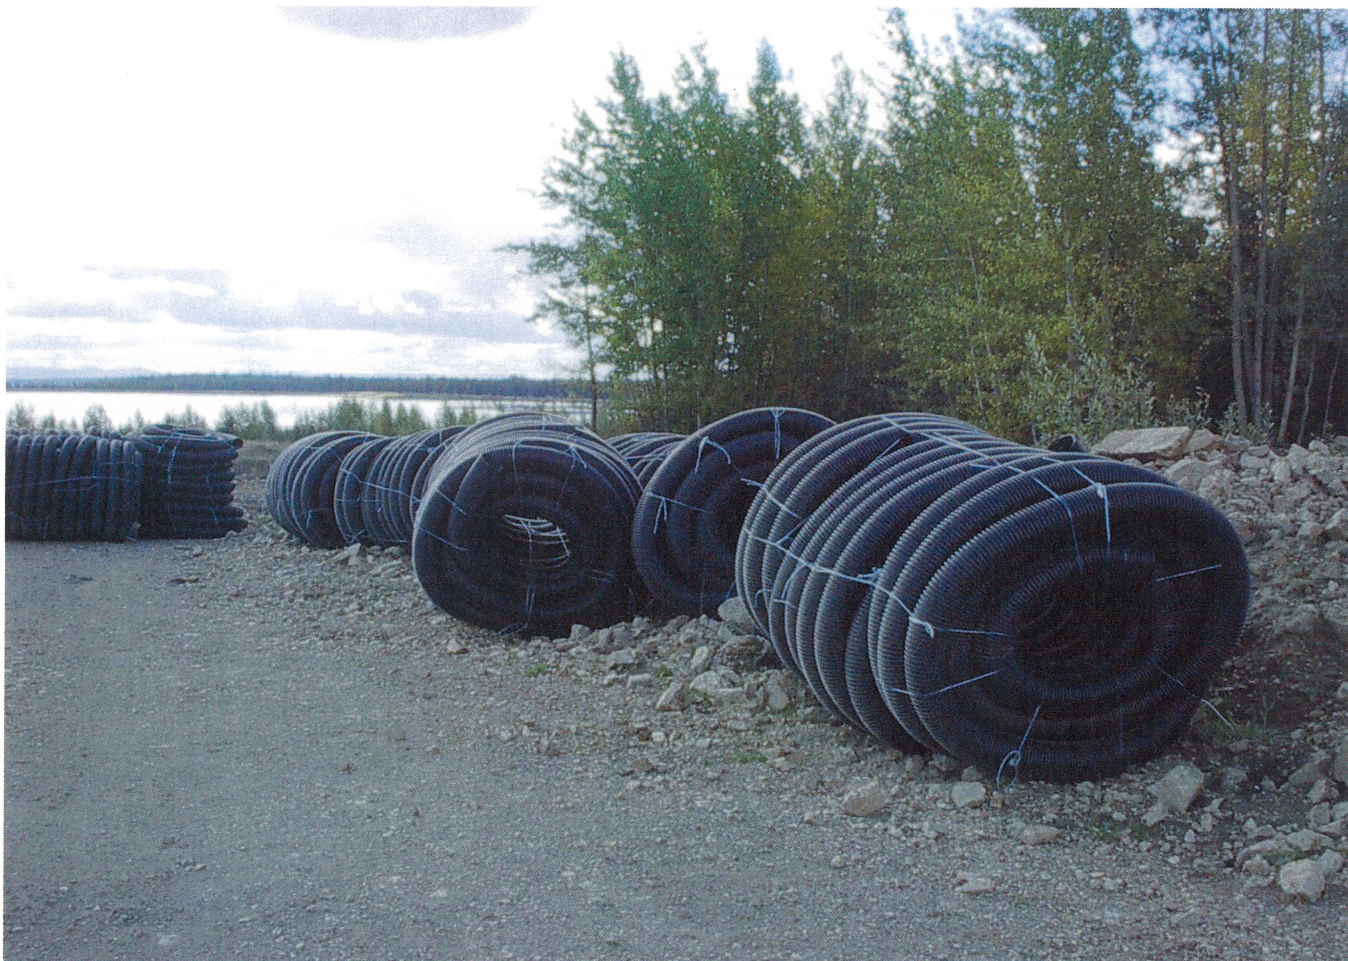
*Station 6:* Steel pipe and perforated pipe stockpiled. Steel pipe will be encased in concrete in the Perimeter Embankment to collect seepage flows from the upstream toe drains.

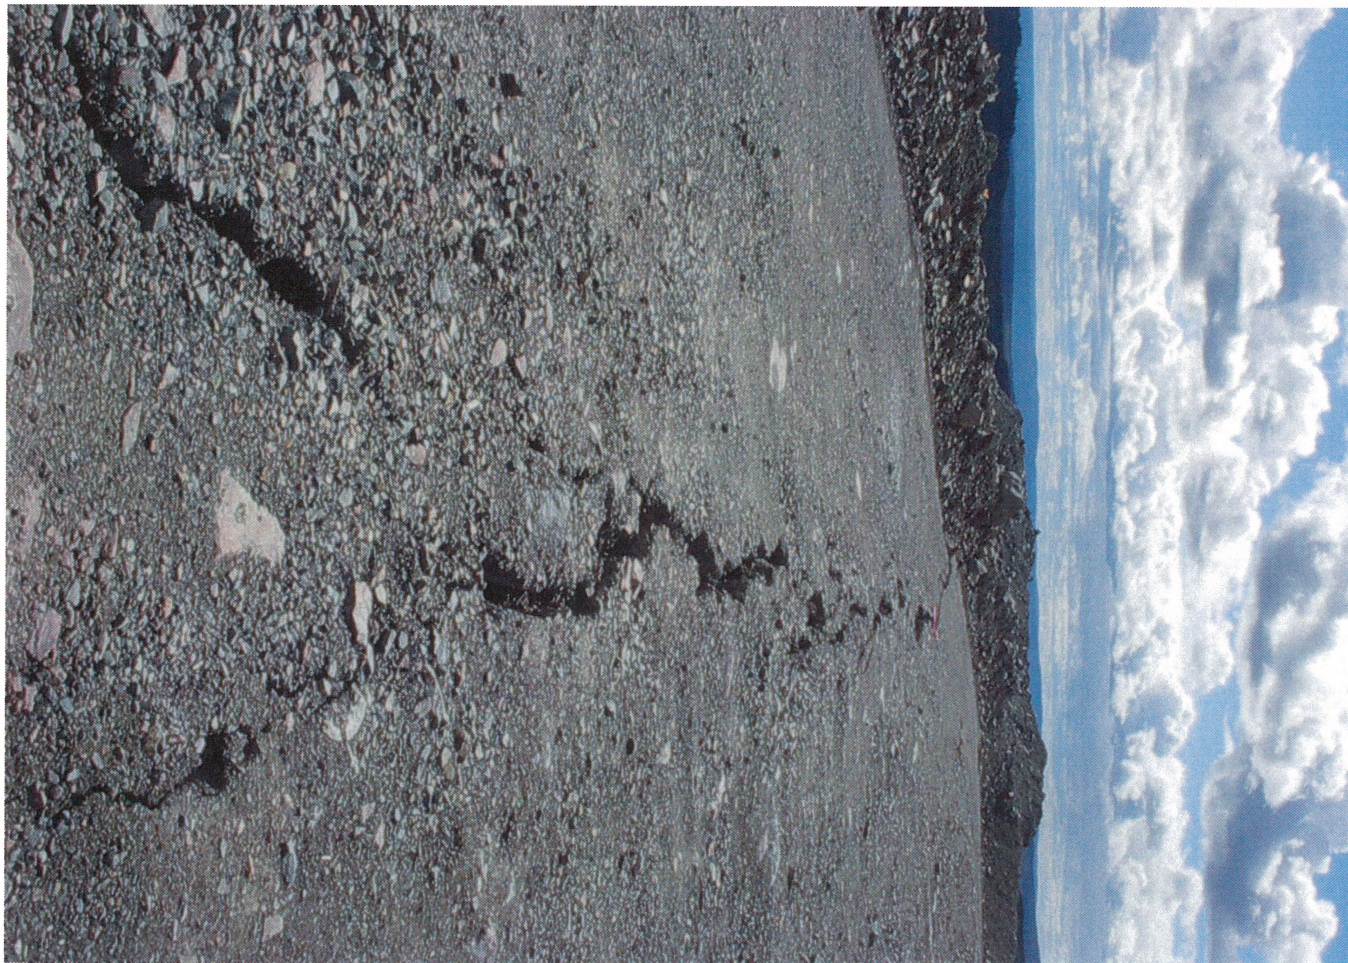
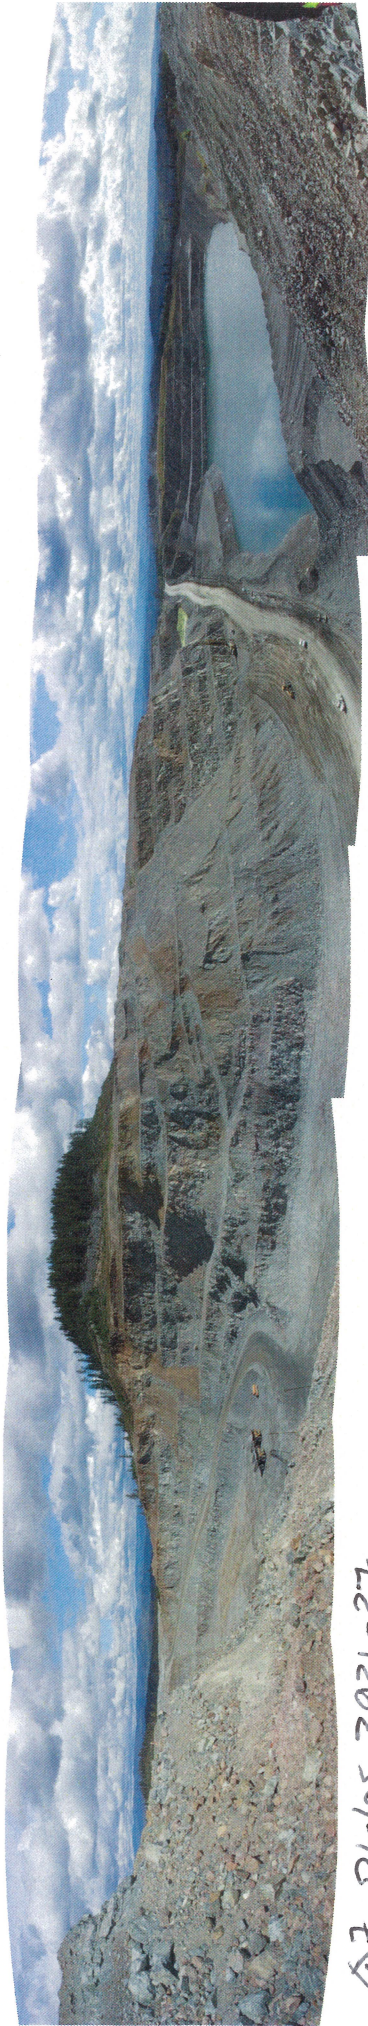
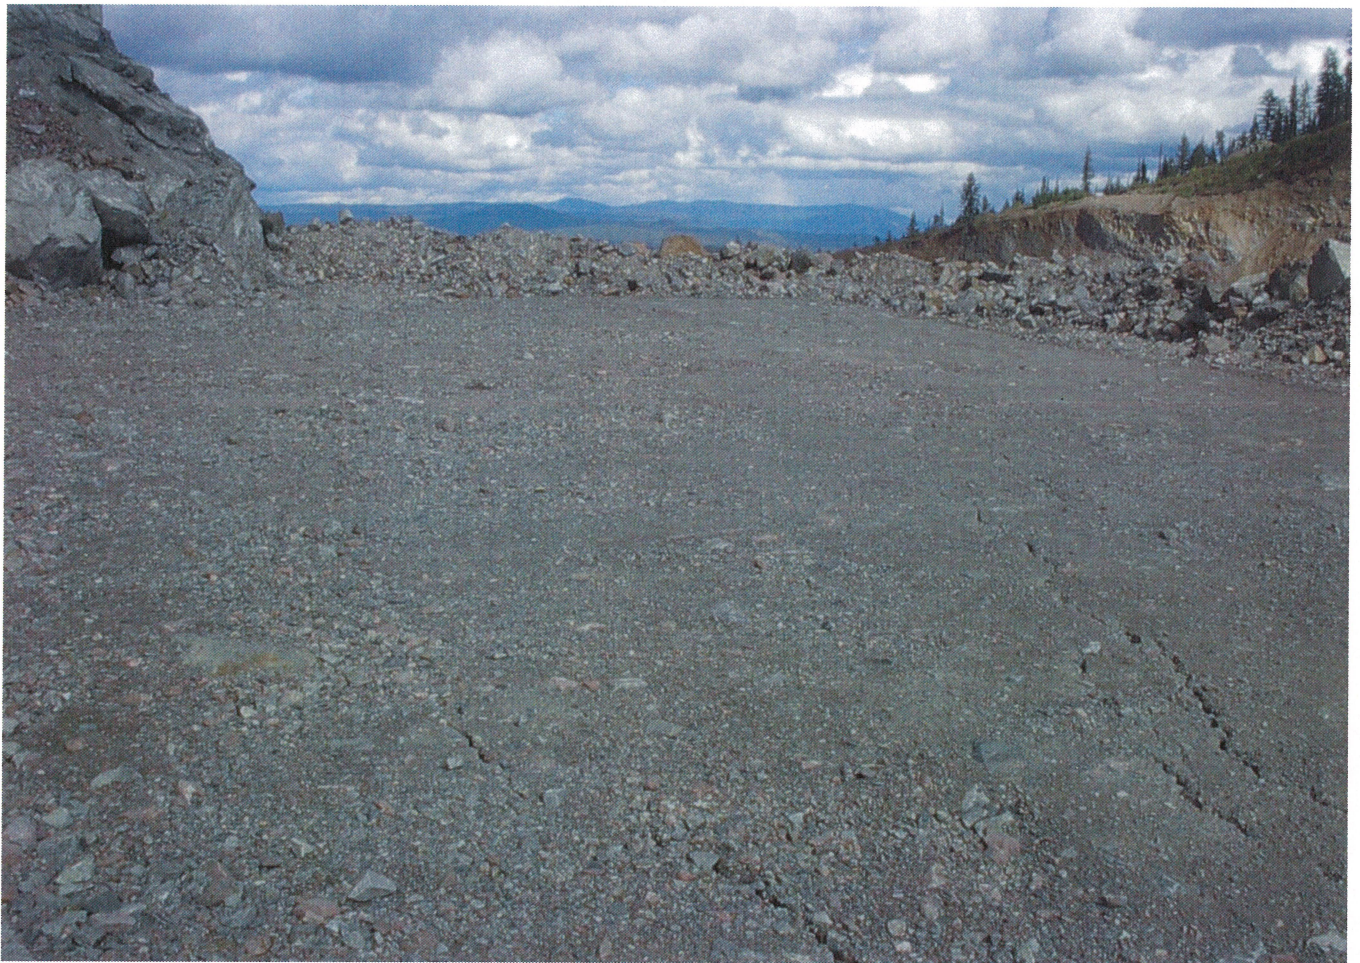
- Station 7:* Tension crack on west wall of Bell Pit. Maximum aperture 15cm, but generally 3 to 4 cm wide (see Fig. 2 plan map for estimated location). Continue to monitor prisms and visually inspect and mark crack locations on regular basis. Operations currently keeping equipment away from toe and inspecting while active in pit.  
View of east side of pit.

- $\Delta 7$  West wall crack - opened up 15cm - place pins for visual monitoring  
 - map cracks & place on plan.  
 View of east wall movement area on east wall

- Daily prism monitoring and assessment of monitoring data on west and east wall instability areas in the Bell Pit.
- Manual wireline extensometer and manual crack monitoring devices (e.g., rebar pins) could be used for manual monitoring in addition to prism surveys.
- A suitably sized rockfall impact barrier shall be placed on the north haulroad below the area of active instability if raveling or rockfall hazards develop on the haulroad
- Threshold monitoring movement rate and operational response criteria shall be developed for the west and east walls of the Bell Pit and submitted to the Ministry within 15 days of the receipt of this report.
- The recommendations made by the design consultant for remedial design changes shall be followed.

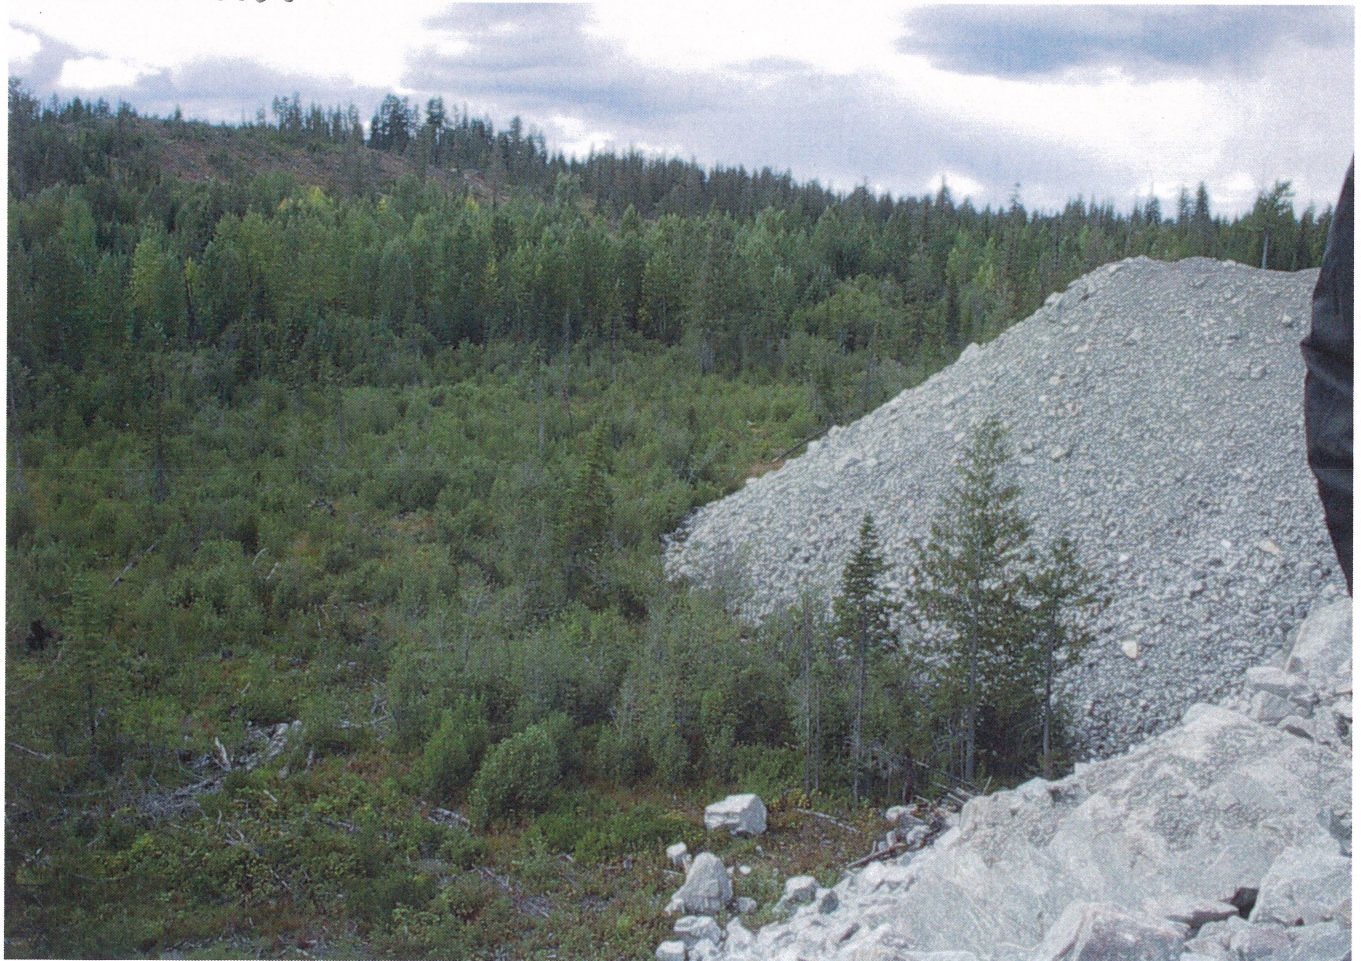
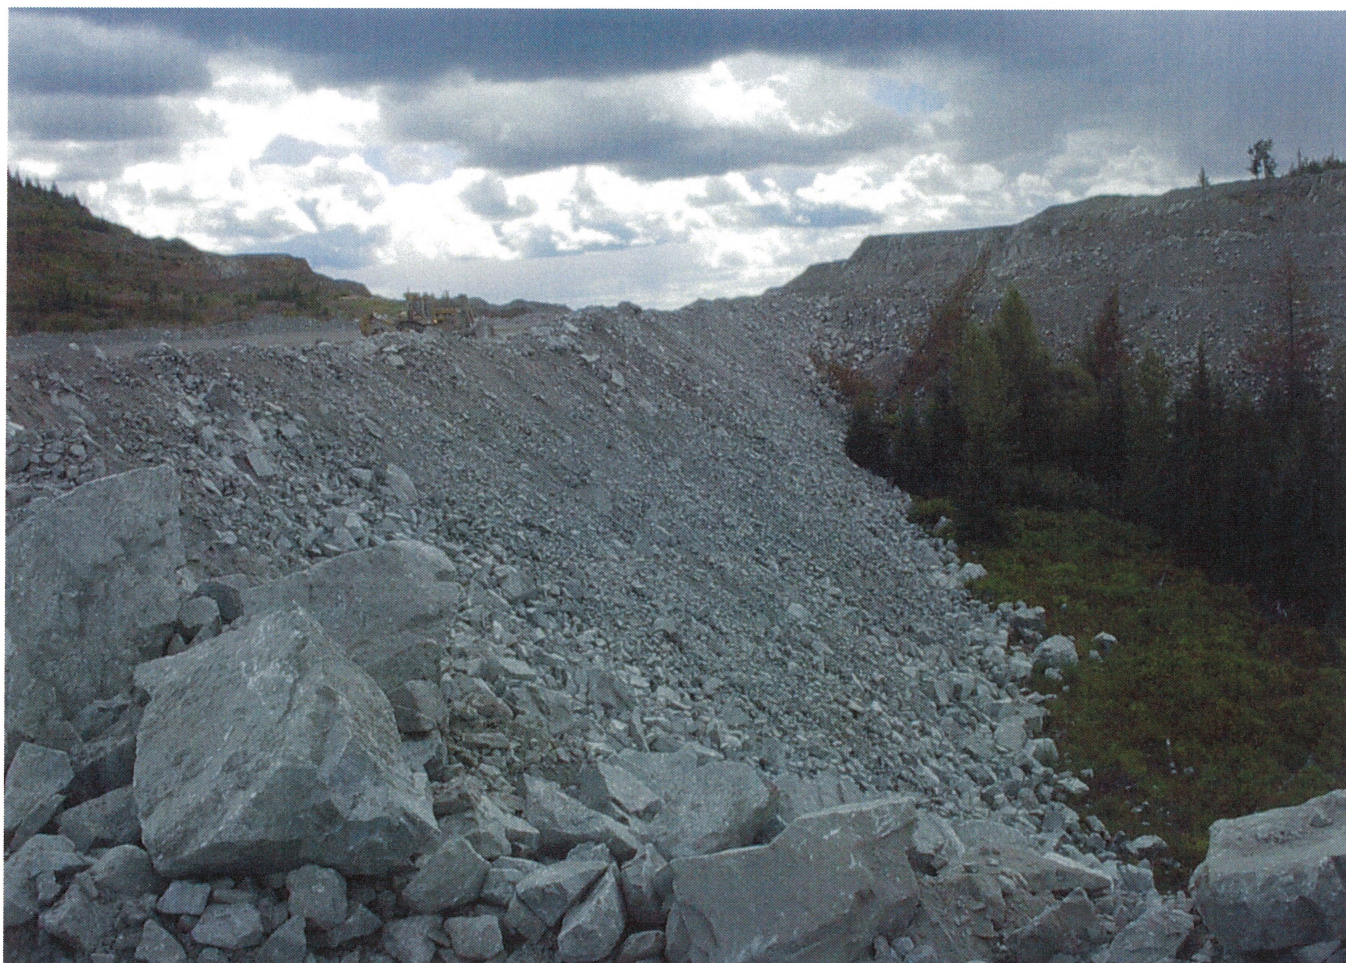
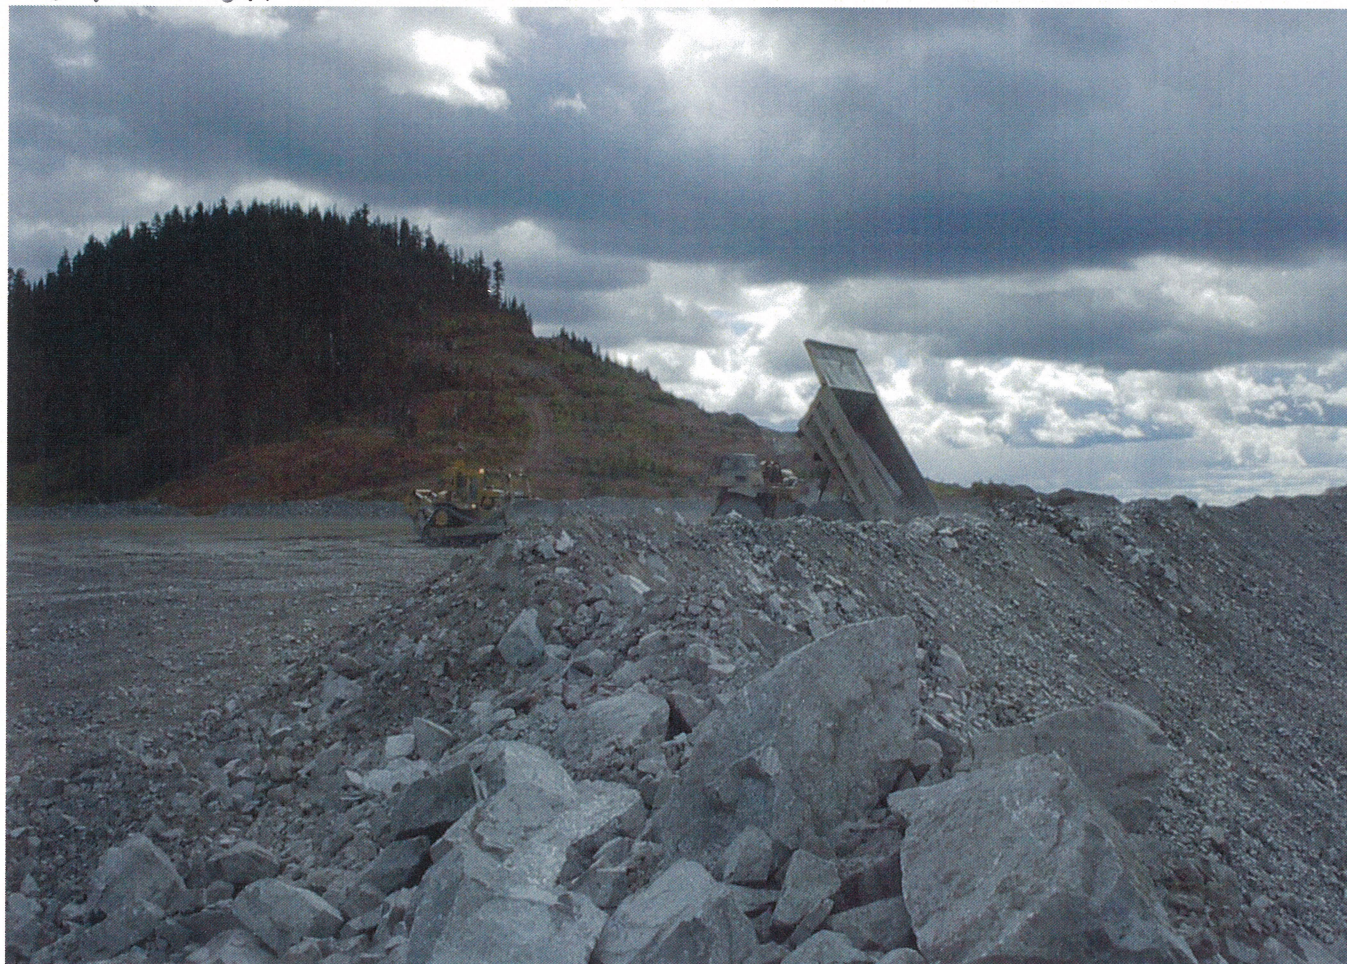
- Station 8:* Bell dump – swampy area contained by dump. Notice back tilting trees indicating local toe shearing in foundation. Dump on essentially flat ground. Important to dump and doze and limit crest advance rate to allow dissipation of pore pressures.

- $\Delta 8$  Bell Dump - contain swampy area - where trees tilting back near toe -  
 - essentially flat ground  
 - overbank dumping with dense vegetation.

- Active dumping on the Bell North Dump is occurring on relatively flat ground, but in marsh materials.
- Tilting trees at the toe of the dump indicates that some shearing may be occurring in the foundation, at the toe of the dump. Crest advance rates shall be controlled to allow pore pressures to dissipate.
- Mount Polley's Standard Dump Procedure, dated February 16, 2006 shall be followed. If unusual cracking, settlements overhangs or toe movement has occurred, the pit supervisor shall decide to dump extra short and push, or block off the area and re-assign the trucks to other dump or stockpile areas. The supervisor shall follow the Mine Operations Dump Monitor procedures, dated February 16, 2006, if potential dump instability is observed.
- The inactive northern portion of the Bell North Dump shall be blocked off and limited to light vehicle access only while not in use.

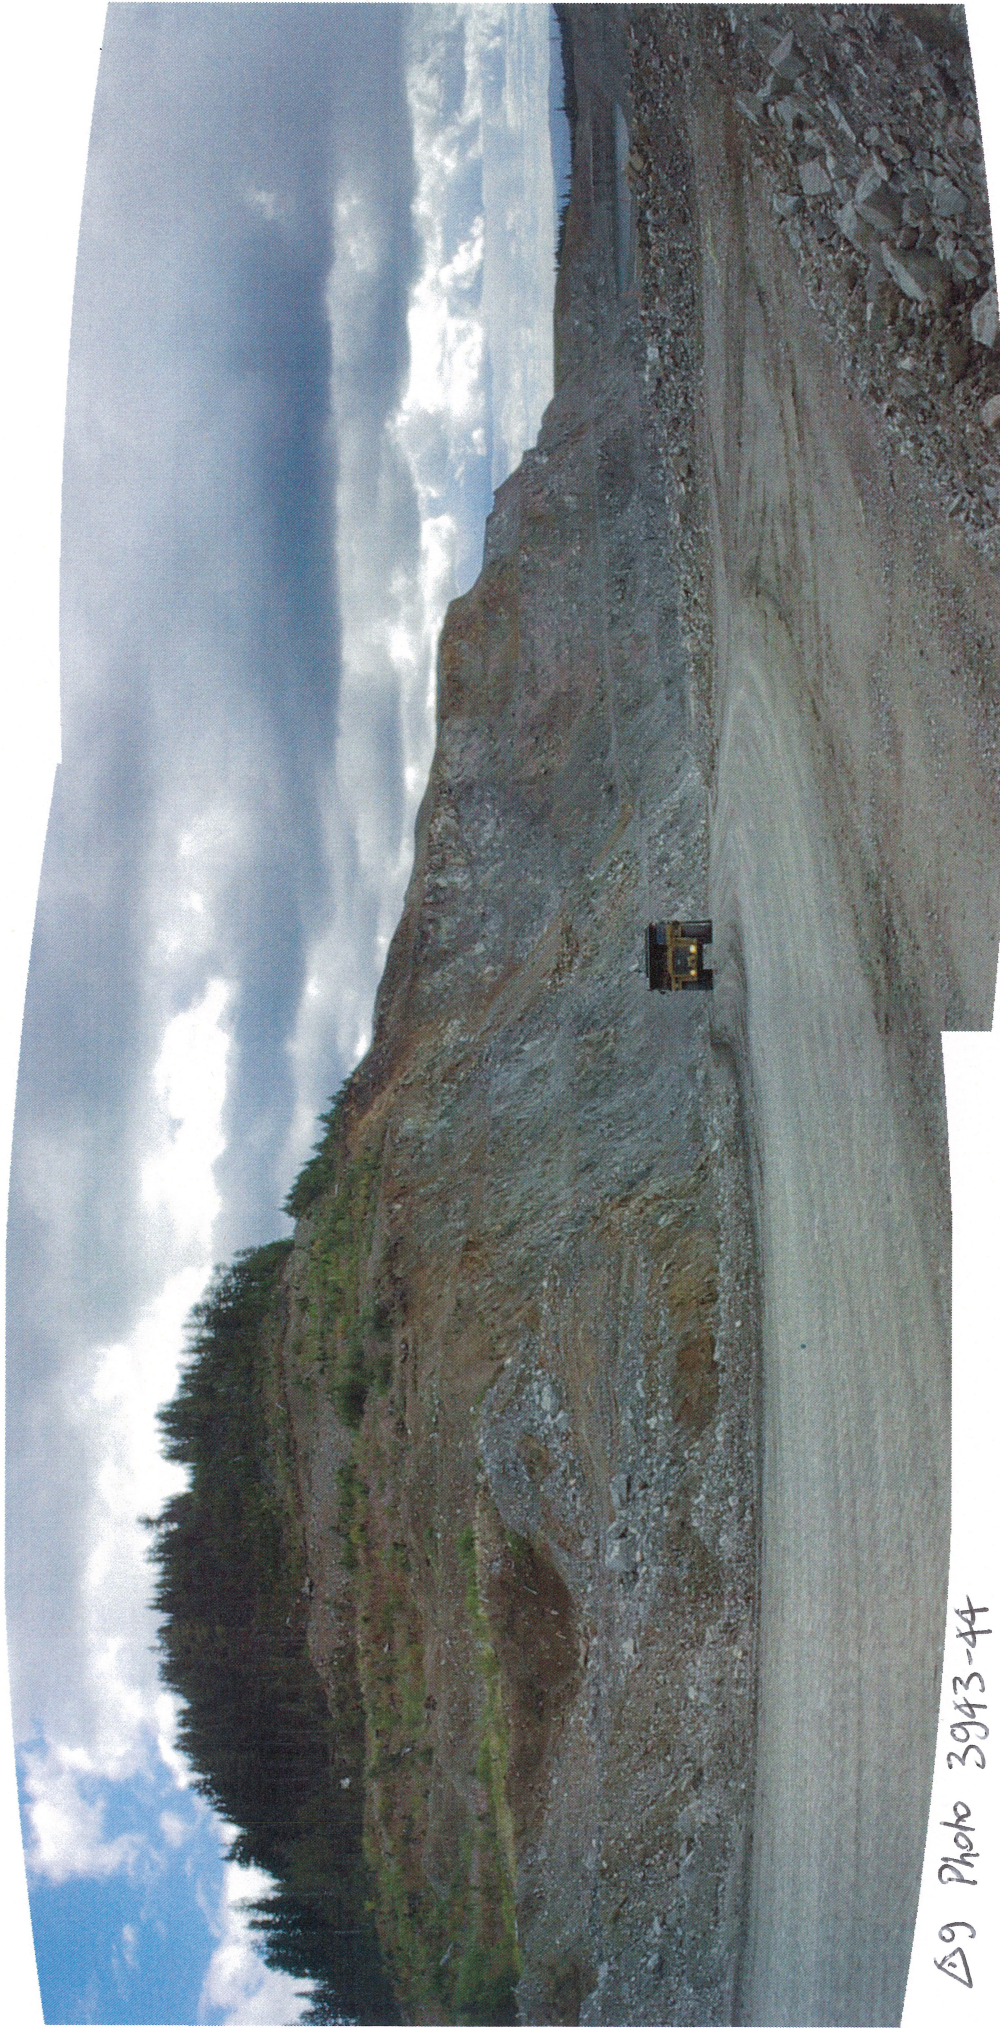
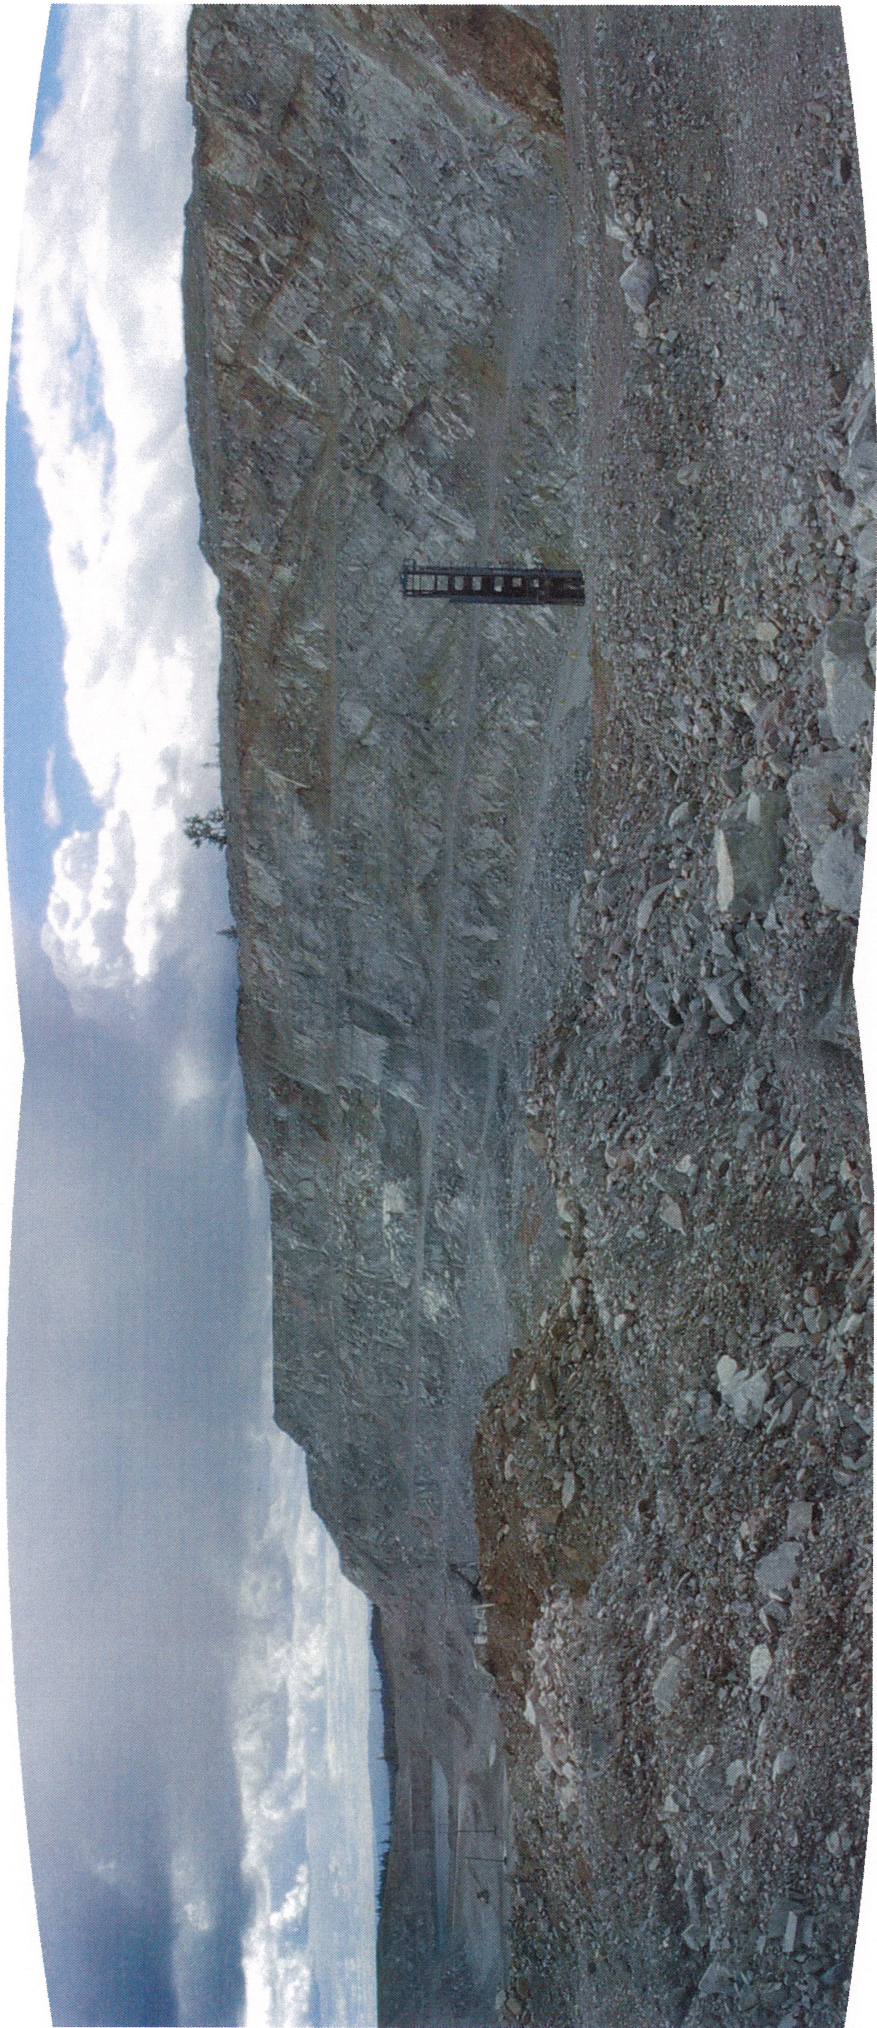
- Station 9:* Photo of east wall from north haulroad and photo of west wall.
- Station 10:* Photo of fault on southwest wall dipping at approximately 45°. Need to maintain keepout at toe when mining not active.  
Photo of northeast wall. Notice talus material above haulroad.

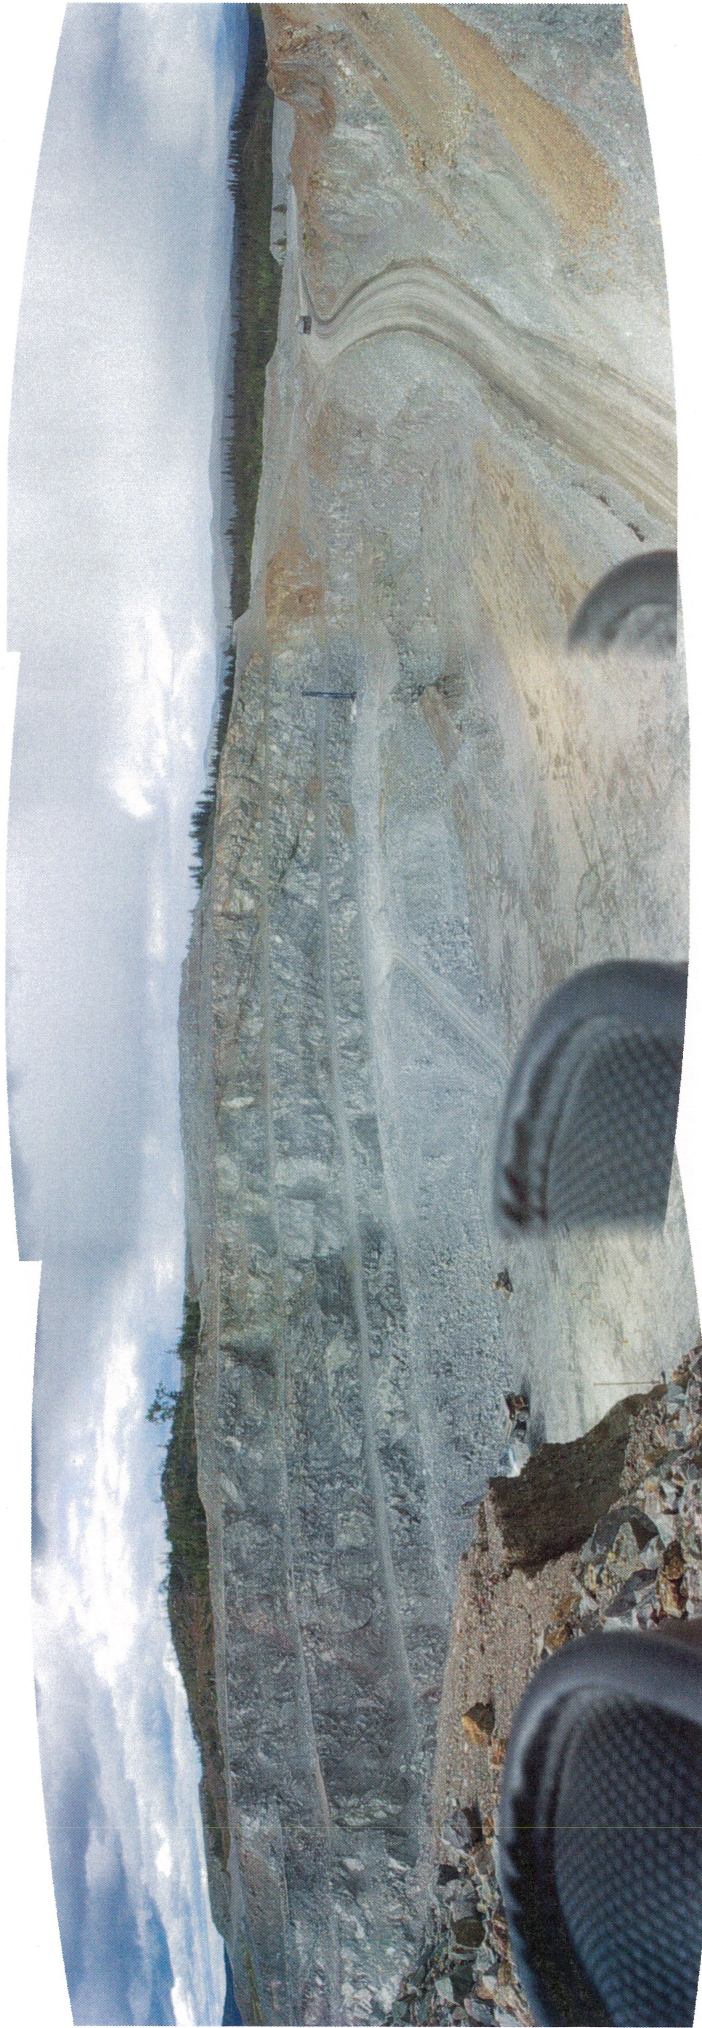
11 Photos 3951-53

- Station 11:* Photo of east wall of Bell Pit. Notice raveled material above haulroad. Indicated that toppling is mechanism of instability. Golder has issued remedial design.  
Photo of west wall.

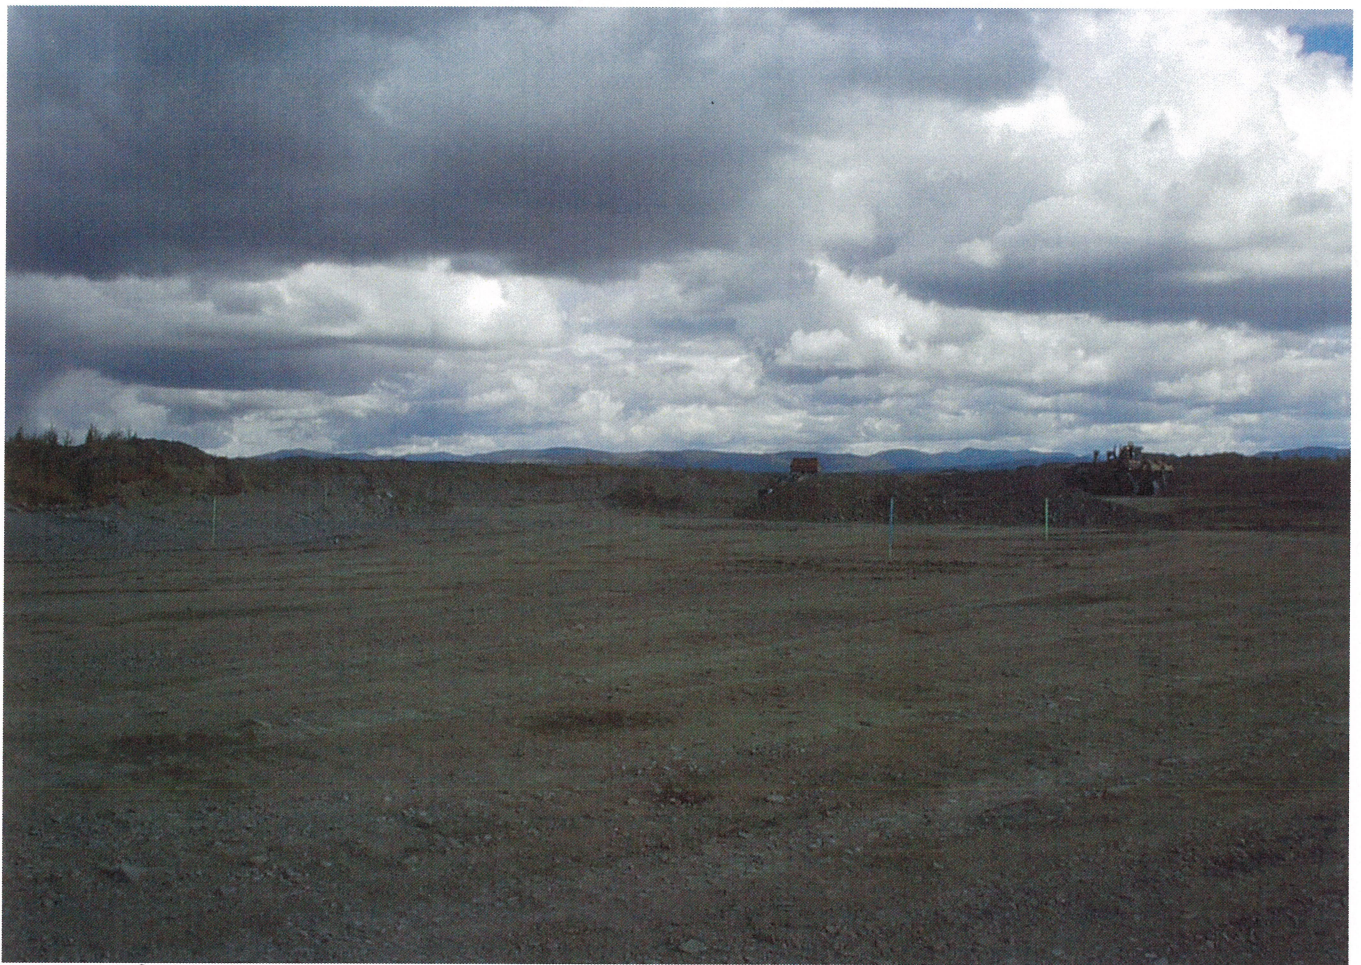
Δ12 Photo 3954

- Station 12:* Construction of foundation for heap leach site. Art Frye reported that verbal approval was provided by Chris Carr. Only seven metres deep and small trial. Permit application to follow.
