**MT. POLLEY MINE**

**N. ROSE GEOTECHNICAL INSPECTION OF OPEN PIT,**

**WASTE DUMPS AND TAILINGS DAMS**

**AUGUST 30, 2006**

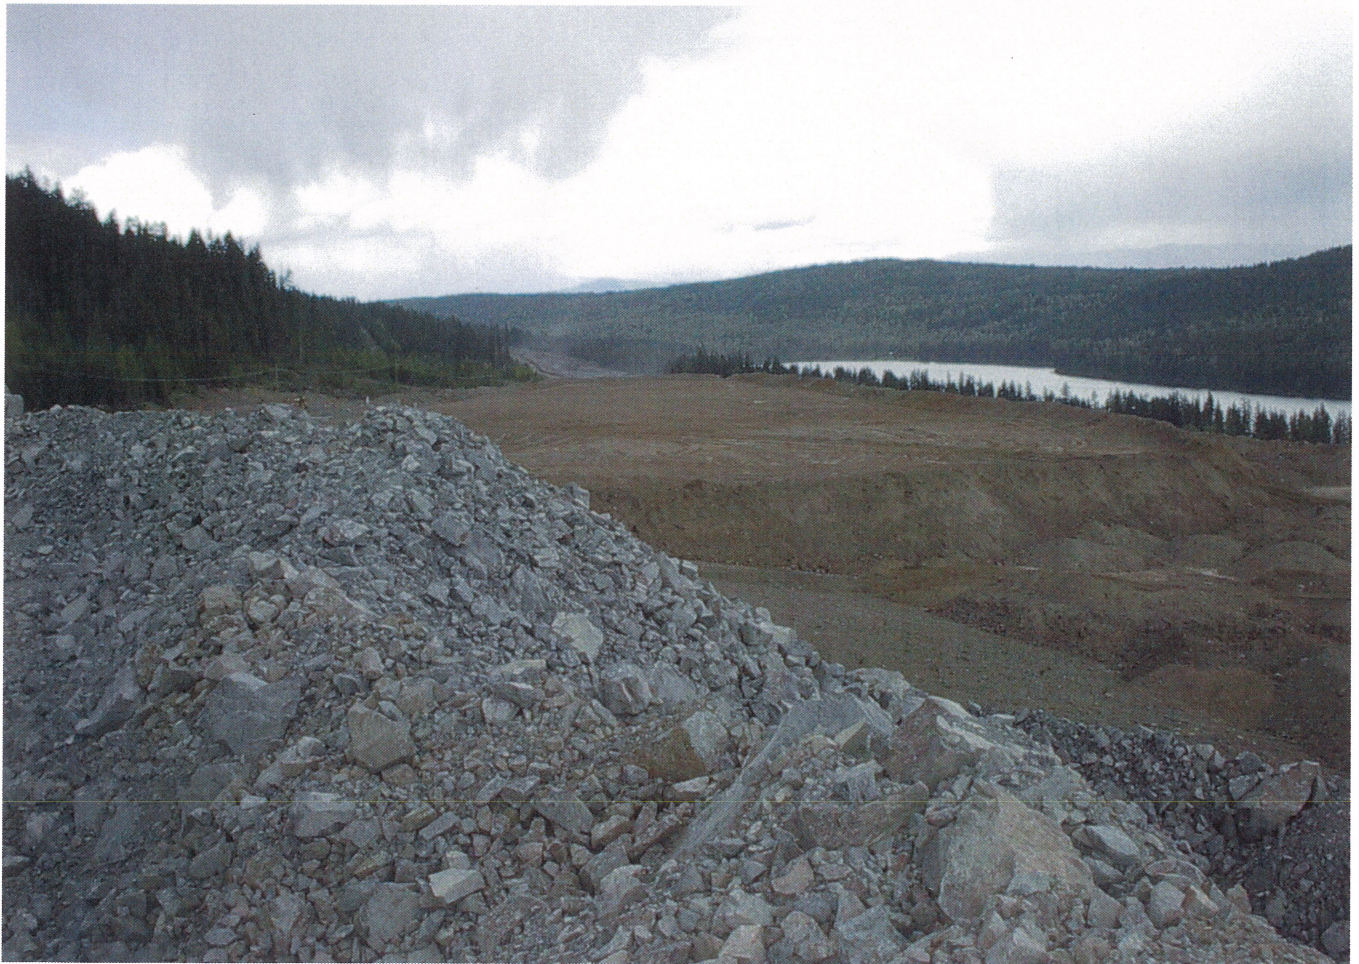
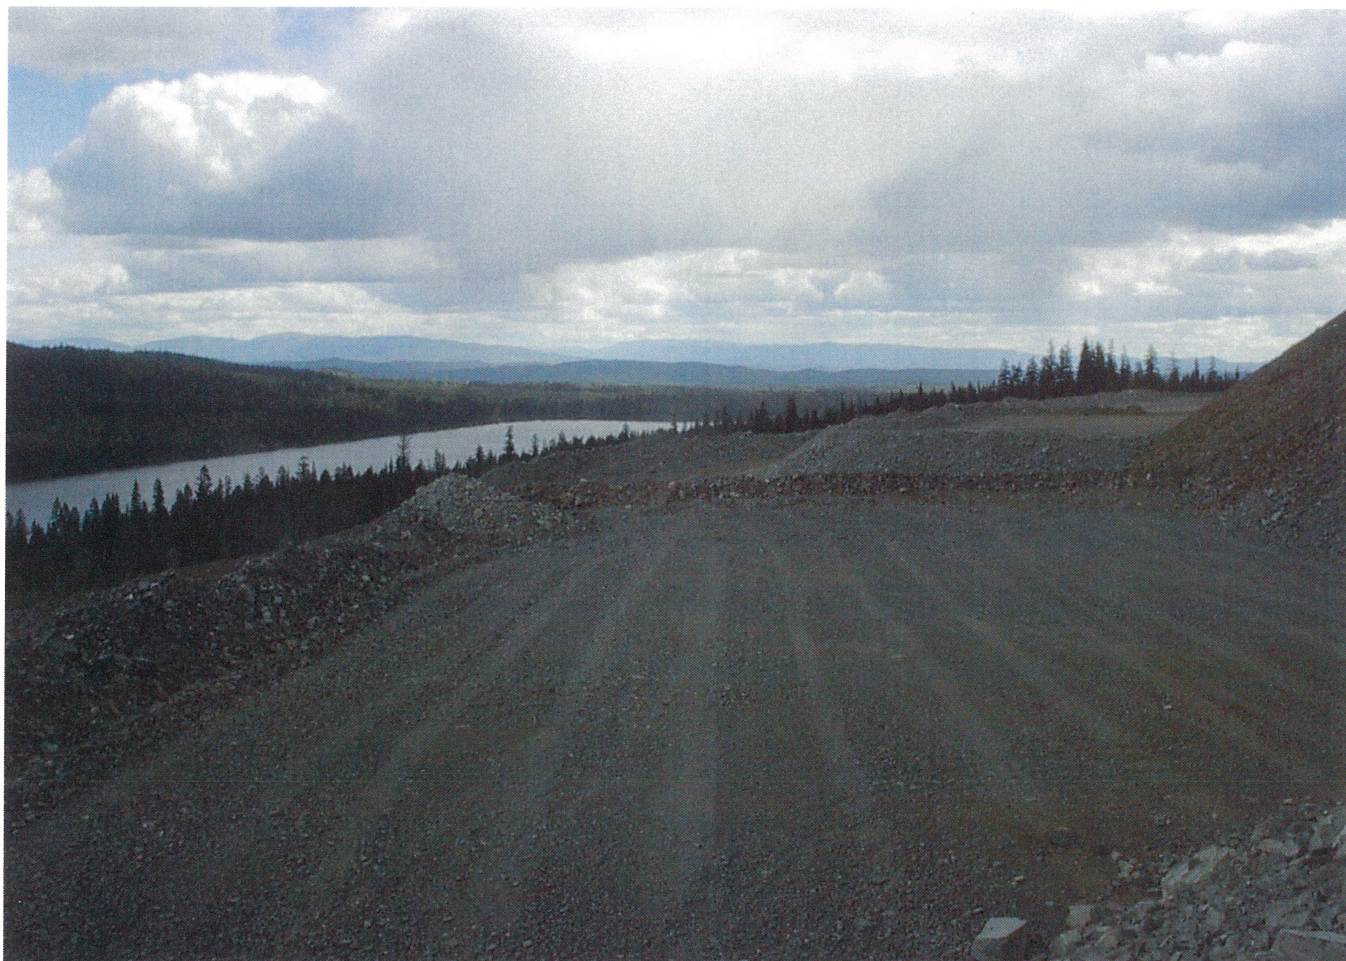
- Station 13:* Northeast Zone Dump. Golder till design slightly steeper than if waste rock (no boulders in till to roll), but MPMC using the 20° rule to limit the potential for boulder roll-out.

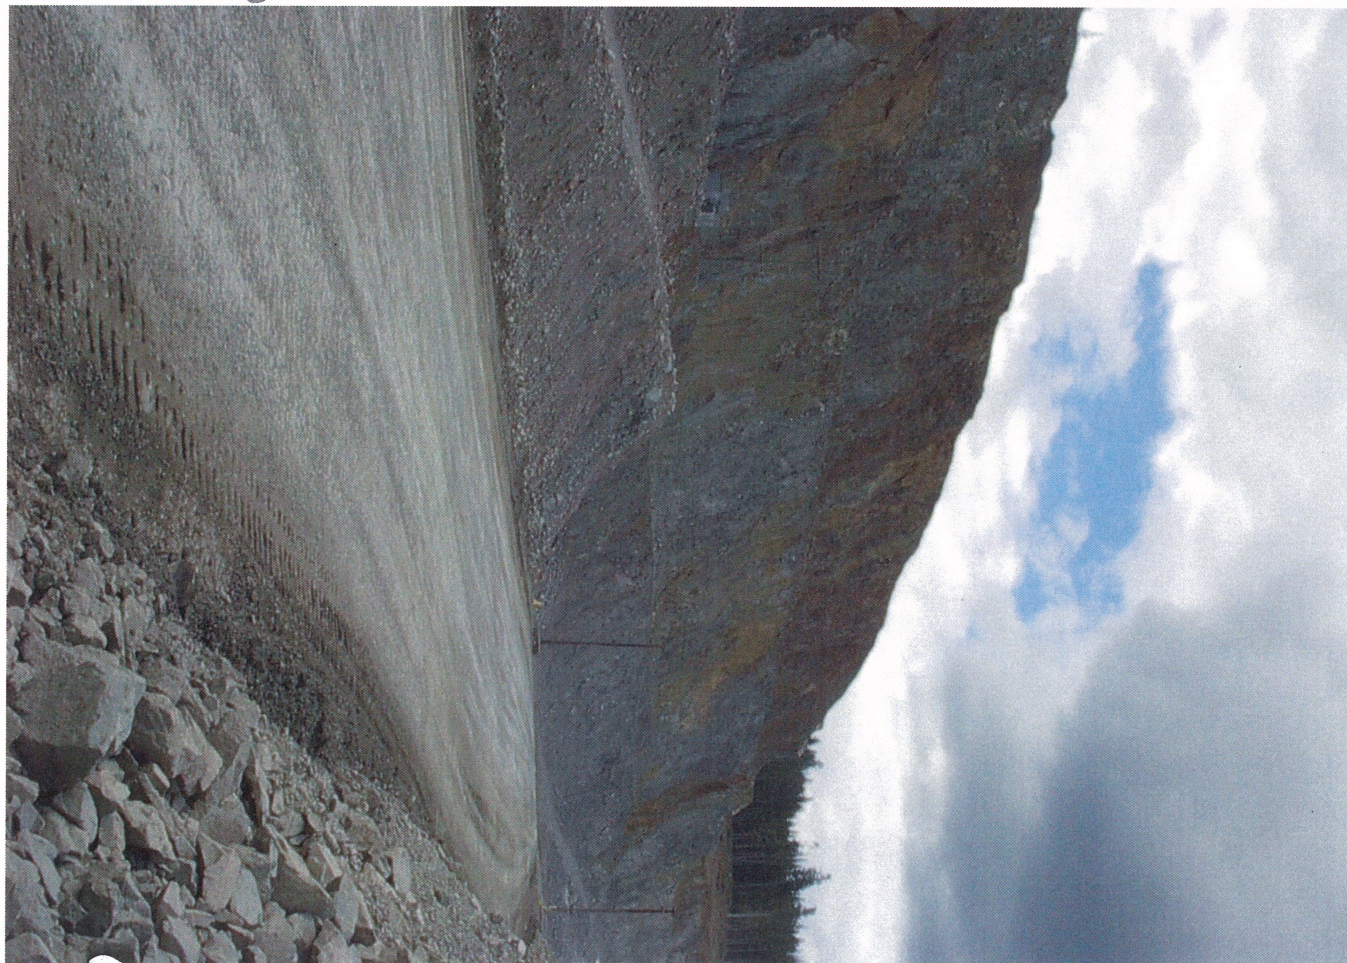
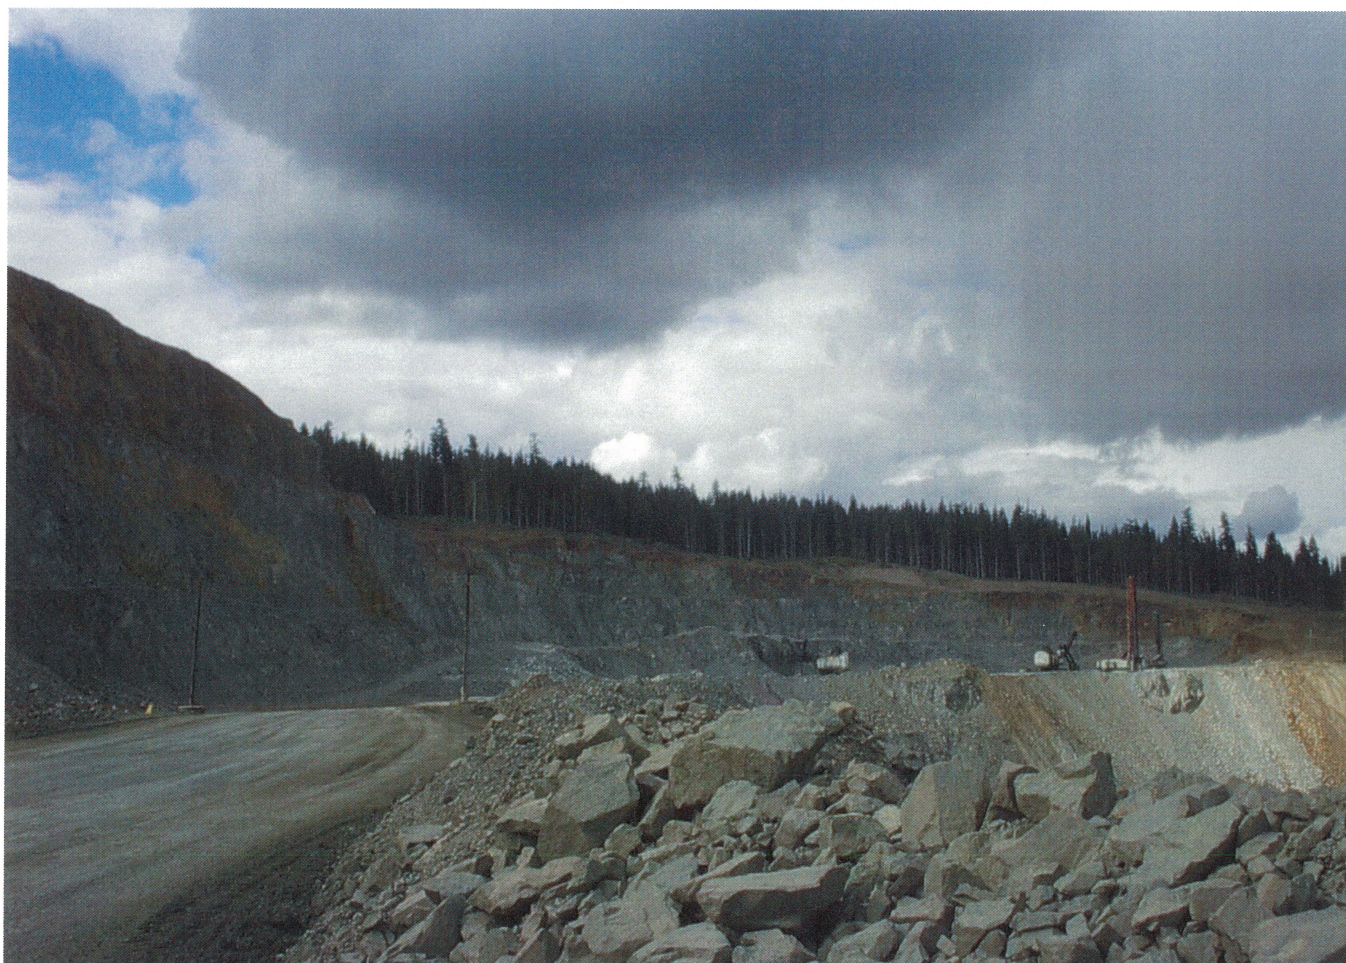
- Station 16:* Photo of west wall. Local narrow catchment, but wall adequately scaled and no signs of rockfall at working level.
- Station 17:* Entrance to TSF haulroad. Much improvement since last inspection.

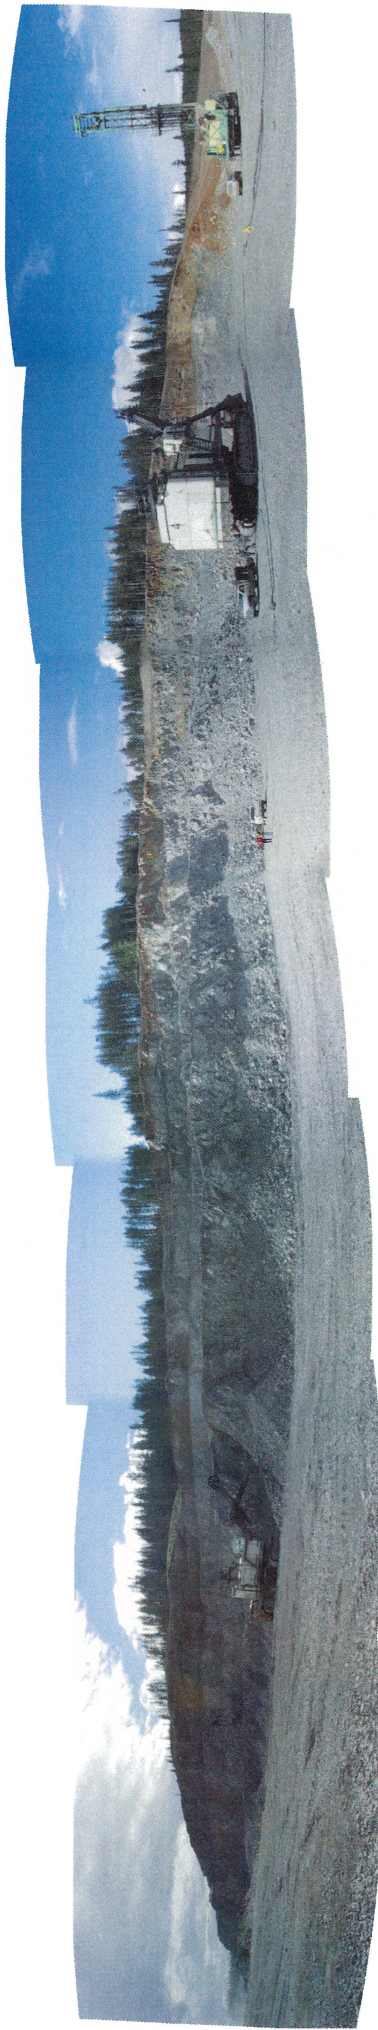
14 Photos 3957-63

- Station 14:* Photo of west wall of Wight Pit.
- Benches appear to be scaled adequately with shovel bucket.
  - Crest stakes in place on bench above shovel operating at 960m Level.

- Local breakback and loss of bench crests.
  - Change to i-kon electronic detonators is indicated to have improved wall conditions.
  - Inspect crest on regular basis; visual monitoring; install prisms for baseline.

- Structural breakback of bench crests noticed in upper benches, but recent change to i-kon electronic detonators is understood to be improving wall conditions.
- Walls look generally well scaled with shovel bucket during excavation.
- Prism monitoring shall be implemented starting with baseline prisms at the pit crest.
- Visual inspection of the pit crest shall be conducted on a regular basis.

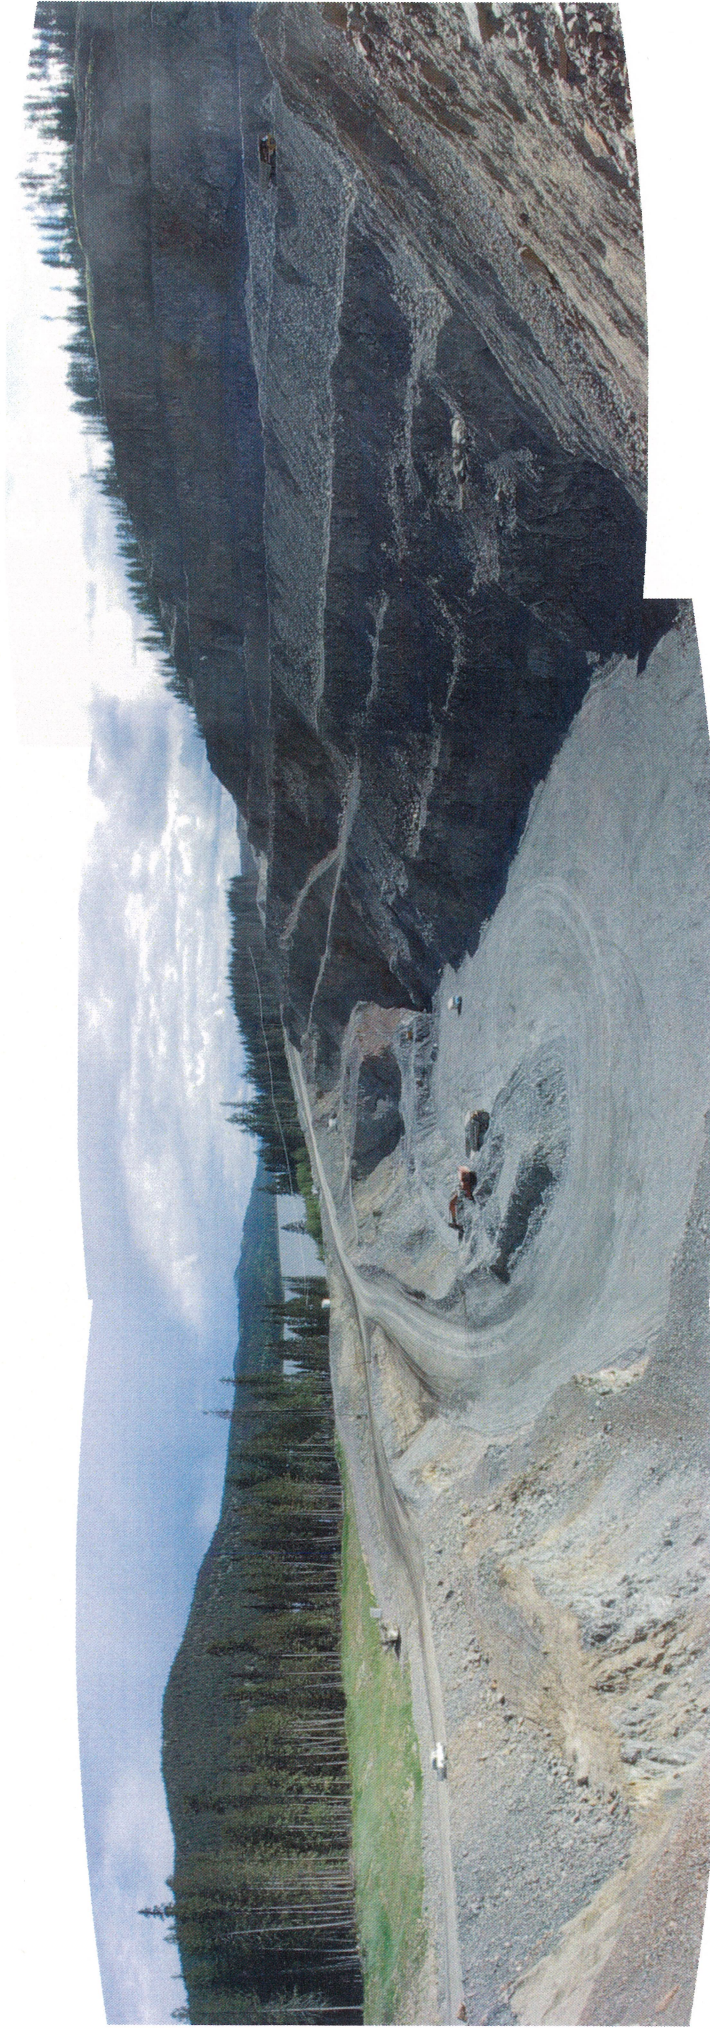
Δ15 Photos 3964-66

- Golder doing quarterly inspections.
  - Blasting – no longer stemming back row of trim and buffer. Orica to recommend blast designs.
- Station 15:* Photo of pit bottom. Notice till slope in area of lower ramp. One more bench to go at pit bottom, then final cut will continue down.

- bolder doing quarterly inspections - monitoring recommended when needed  
 - no longer stemming back row - ORLA to recommend blast designs.
- $\Delta 15$  Till on SE of pit bottom - temporary wall - over mined at top - undermined @ bottom

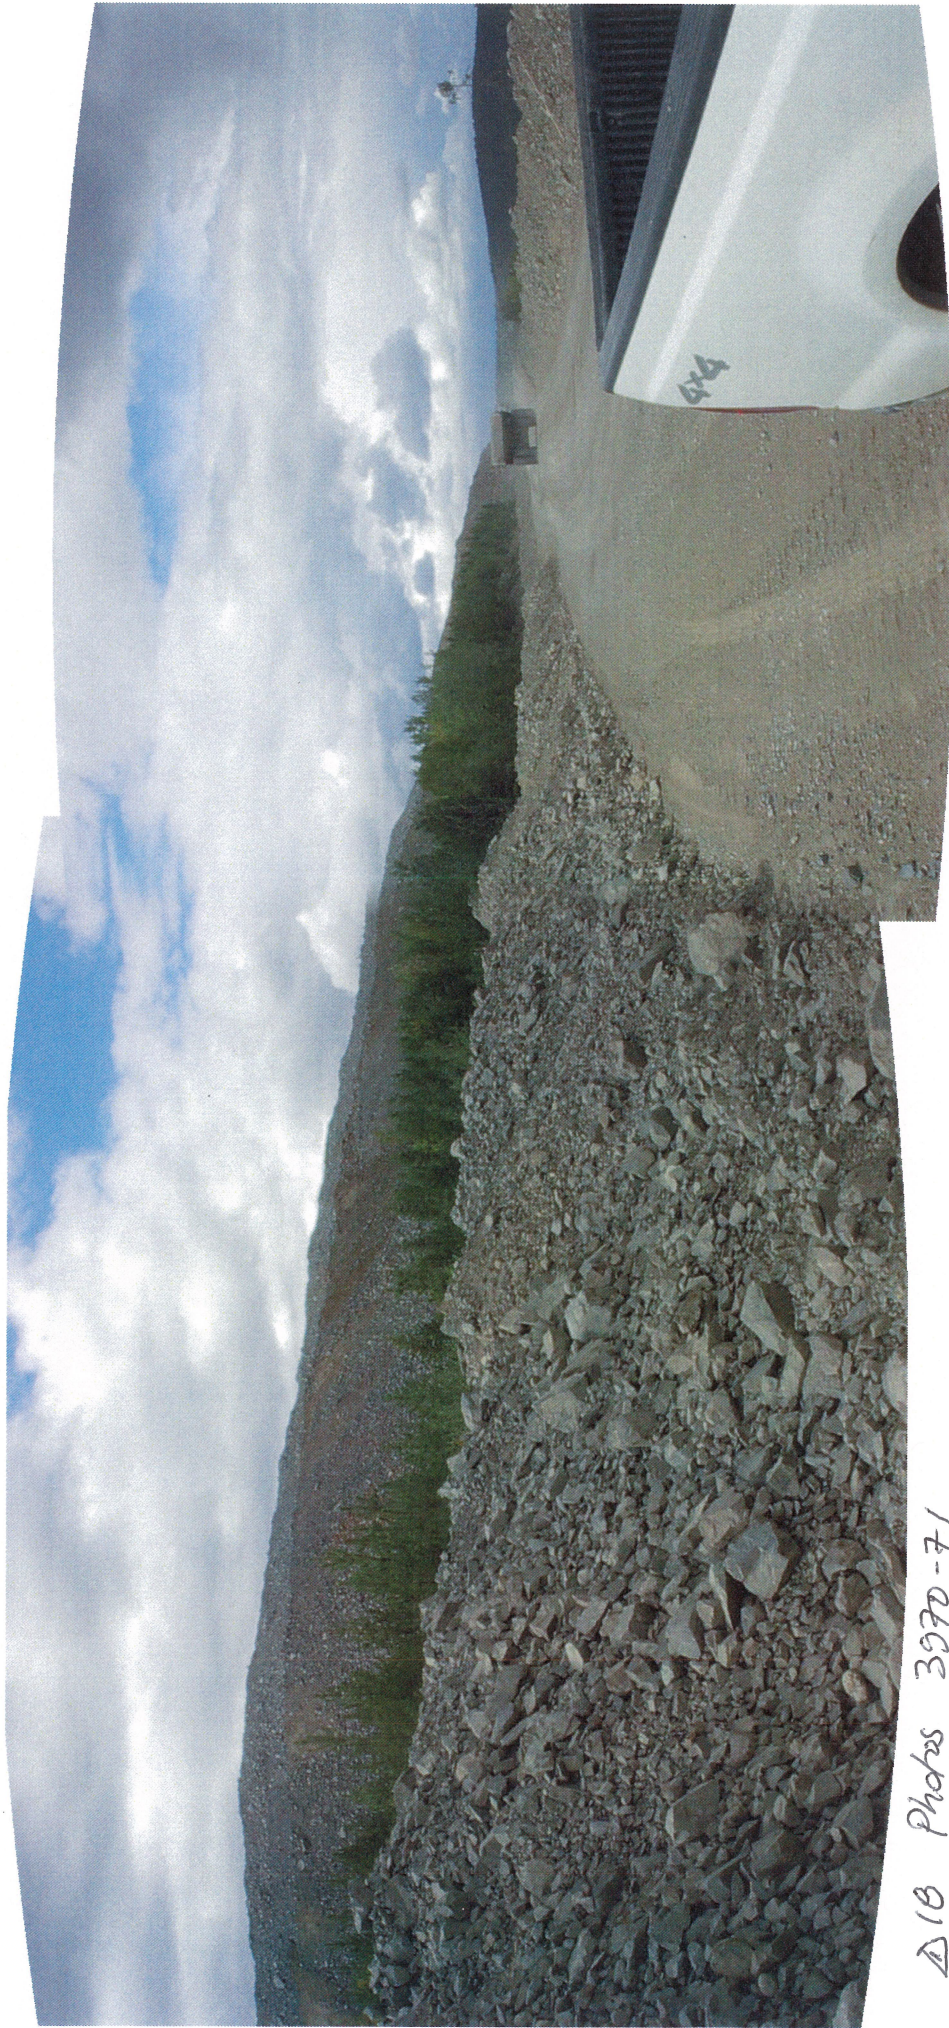
D18 Photos 3970-71

- Station 18:* Photo of NE dump looking north. Toe stakes are used to maintain overall slopes less than 20°. Notice portion overbuilt above road – no stability concerns noted.
