MT. POLLEY MINE

N. ROSE GEOTECHNICAL INSPECTION OF OPEN PIT,

WASTE DUMPS AND TAILINGS DAM

JULY 31, 2007

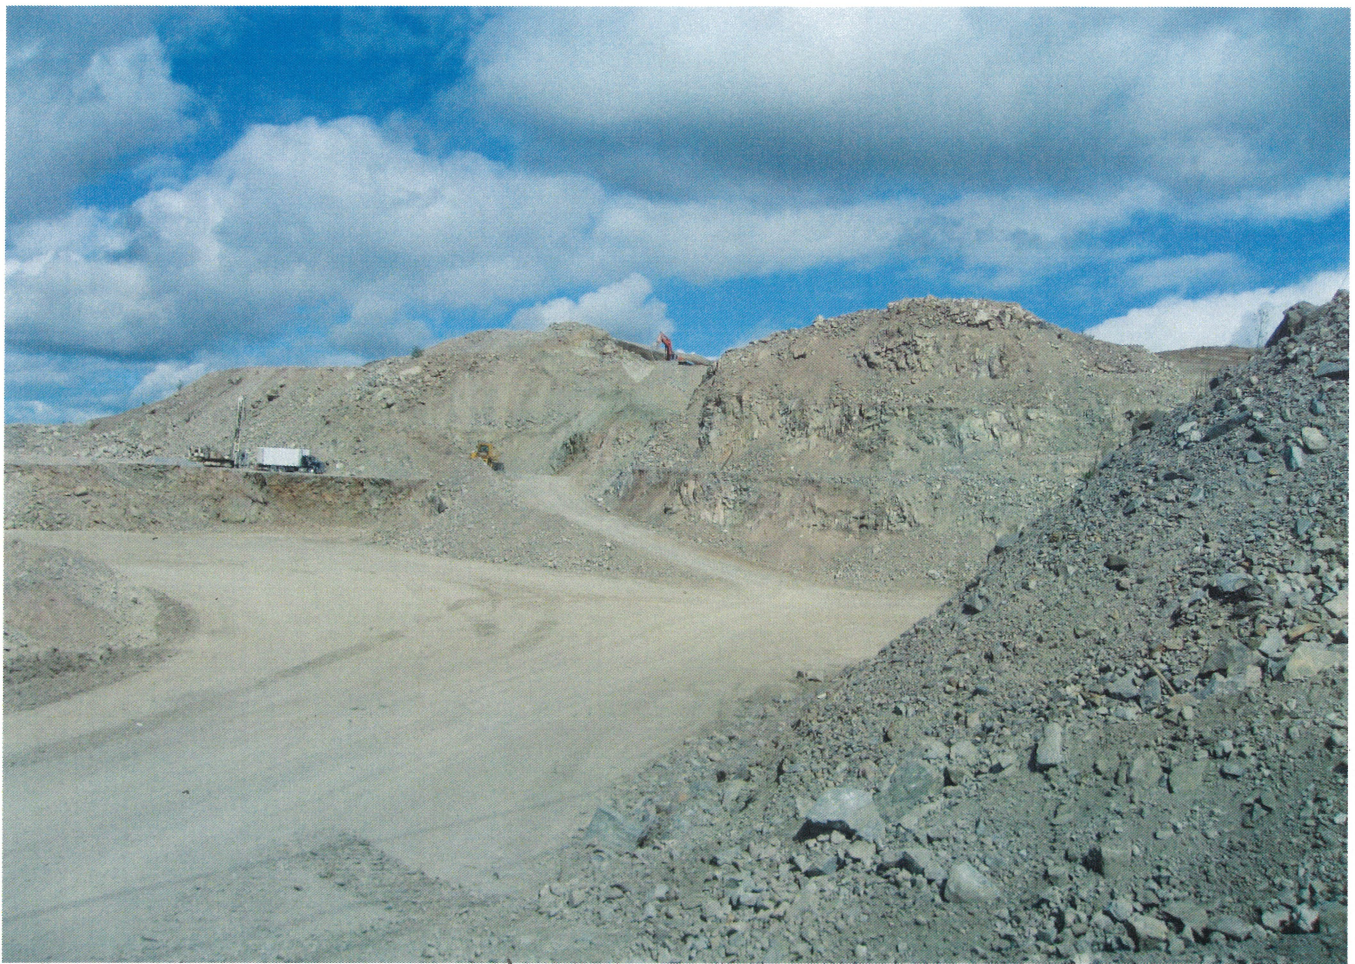
Station 1 (photo 1239)

Station 1: Photo of pioneering of upper benches in Springer Pit.

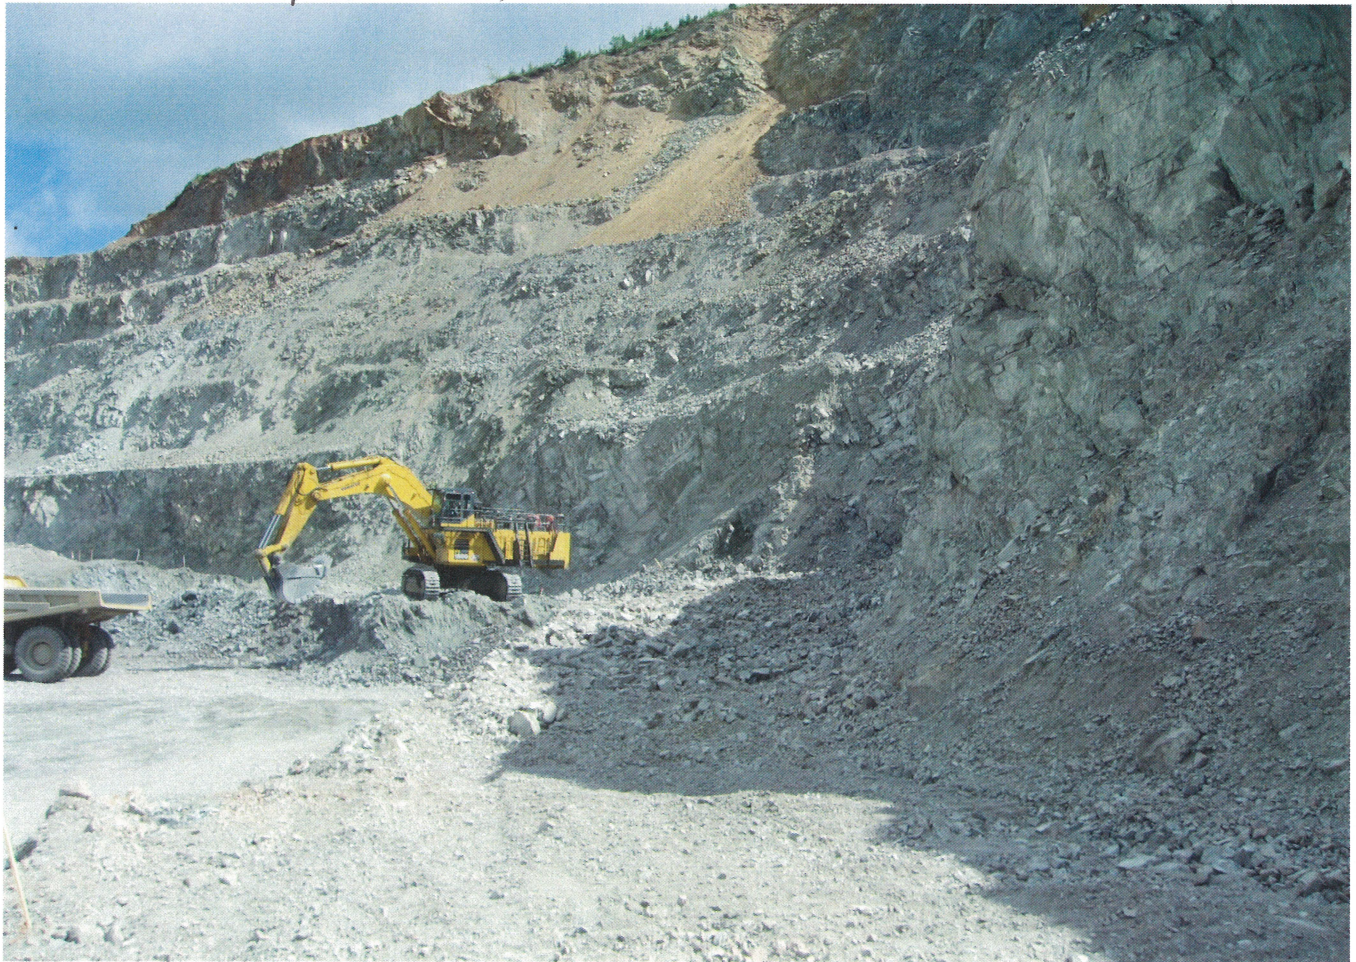
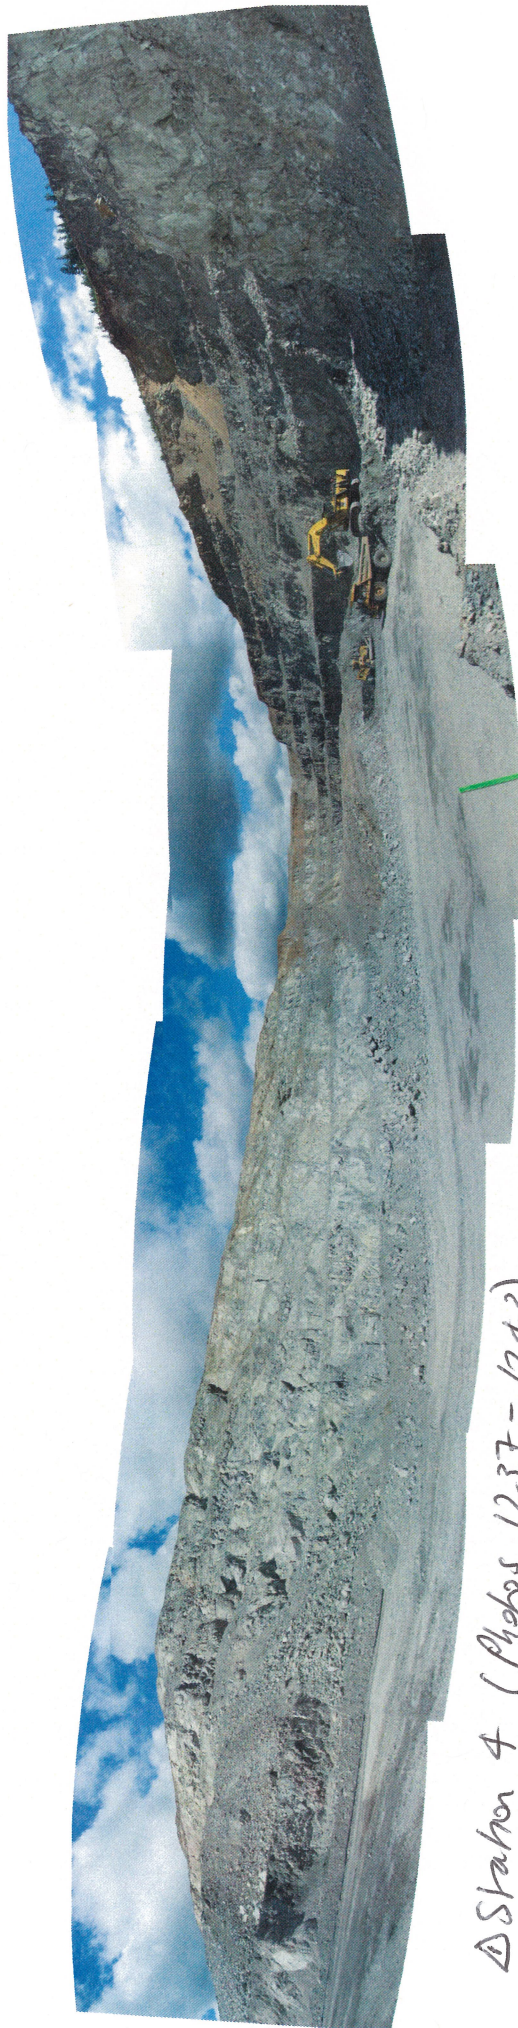
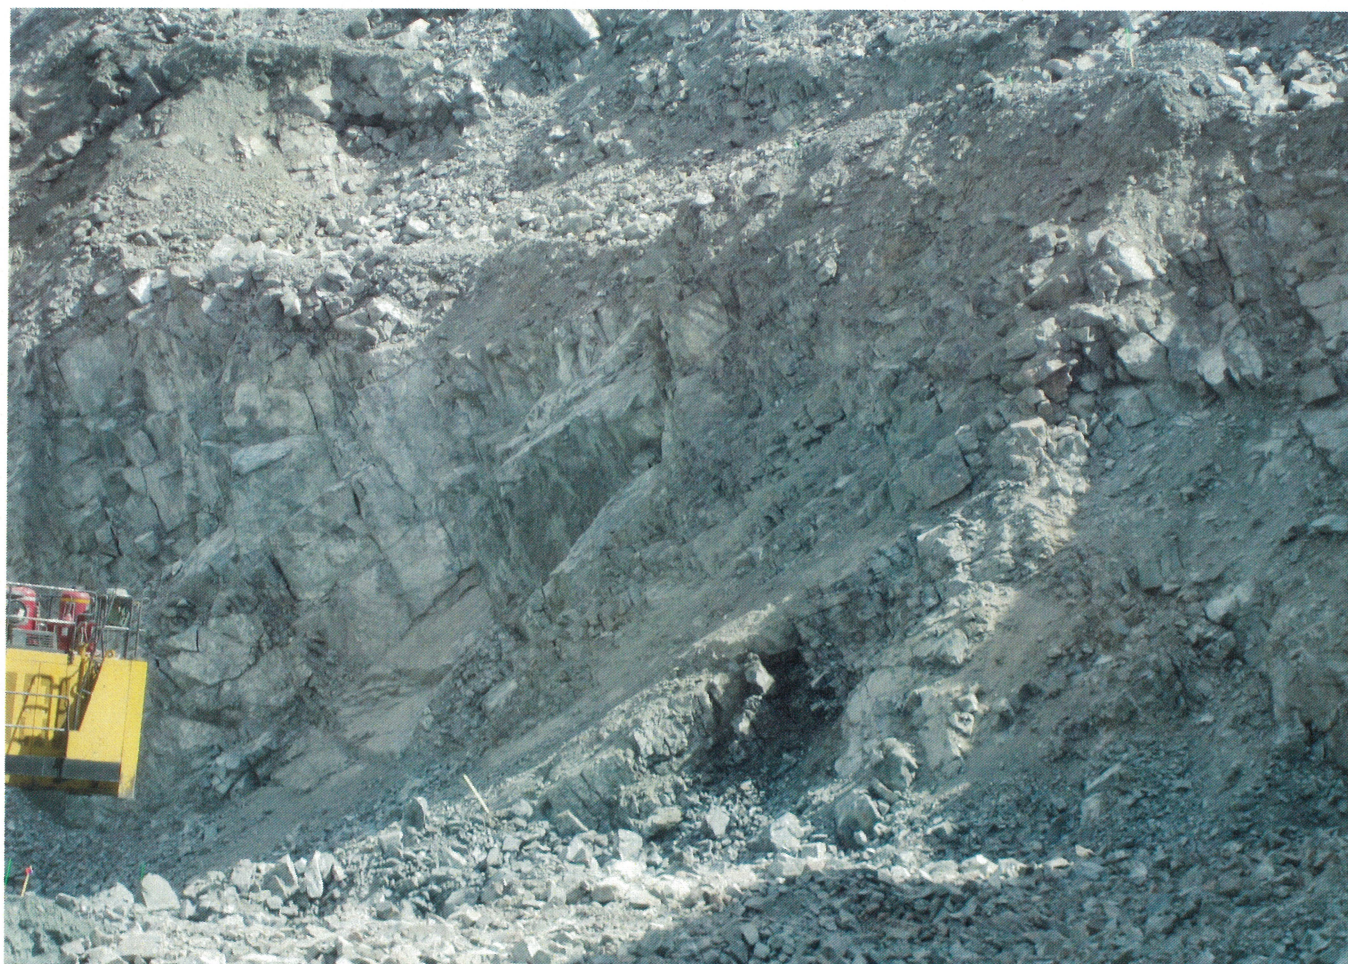
Station 4 (Photos 1237-1243)

Station 4: Panorama of Bell Pit. Notice northwest dipping structure in west wall and location of southwest offload cut. Previous instability on upper east wall is resulting in filled catch berms. Sloughing on bench above shovel related to steeply dipping north trending fault. **Intermediate west dipping joint set on east wall shall be mapped to determine possible impacts on bench designs. Bench crests shall be scaled with the shovel bucket and toes cleared during excavation to improve catchment for potential rockfalls. Extra precaution shall be taken while operating near the highwall in this area.**

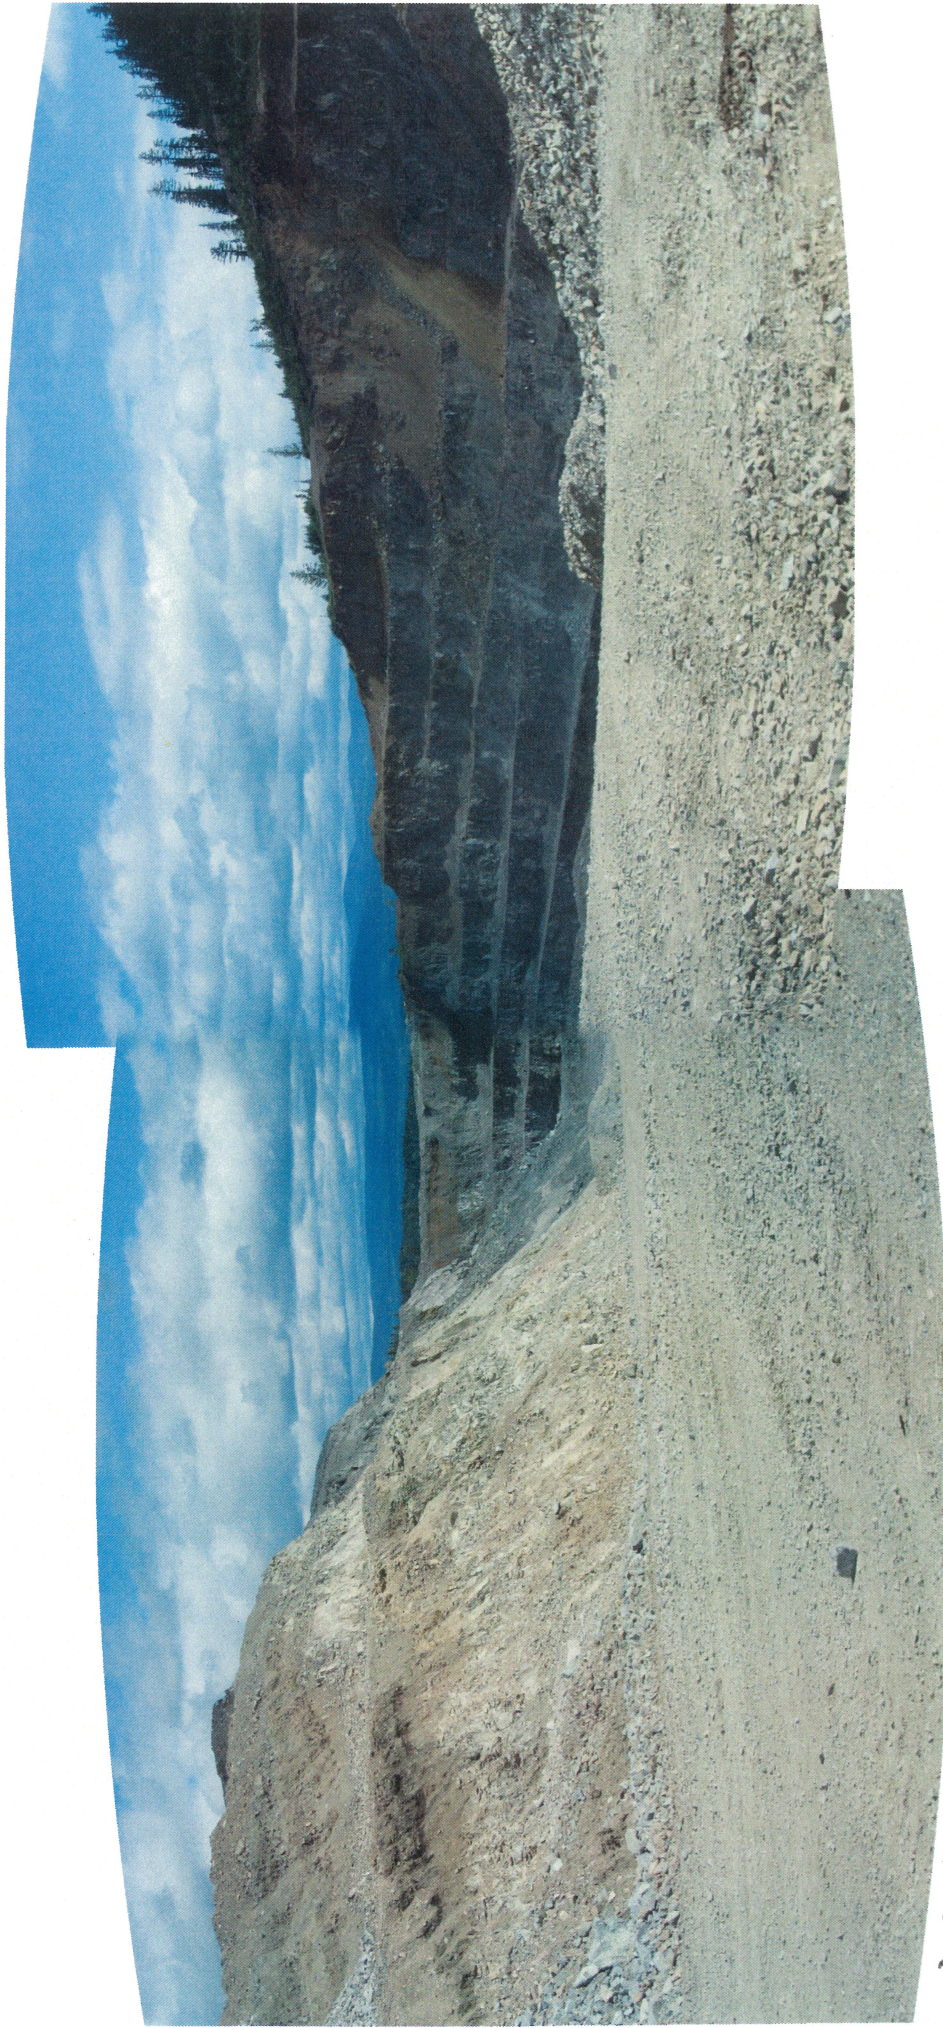
Δ Station 2 (Photos 1235-1236)

Station 2: Photo of offload cut that was implemented to stabilize slope displacements on west wall (behind east dipping structure observed during last inspection).

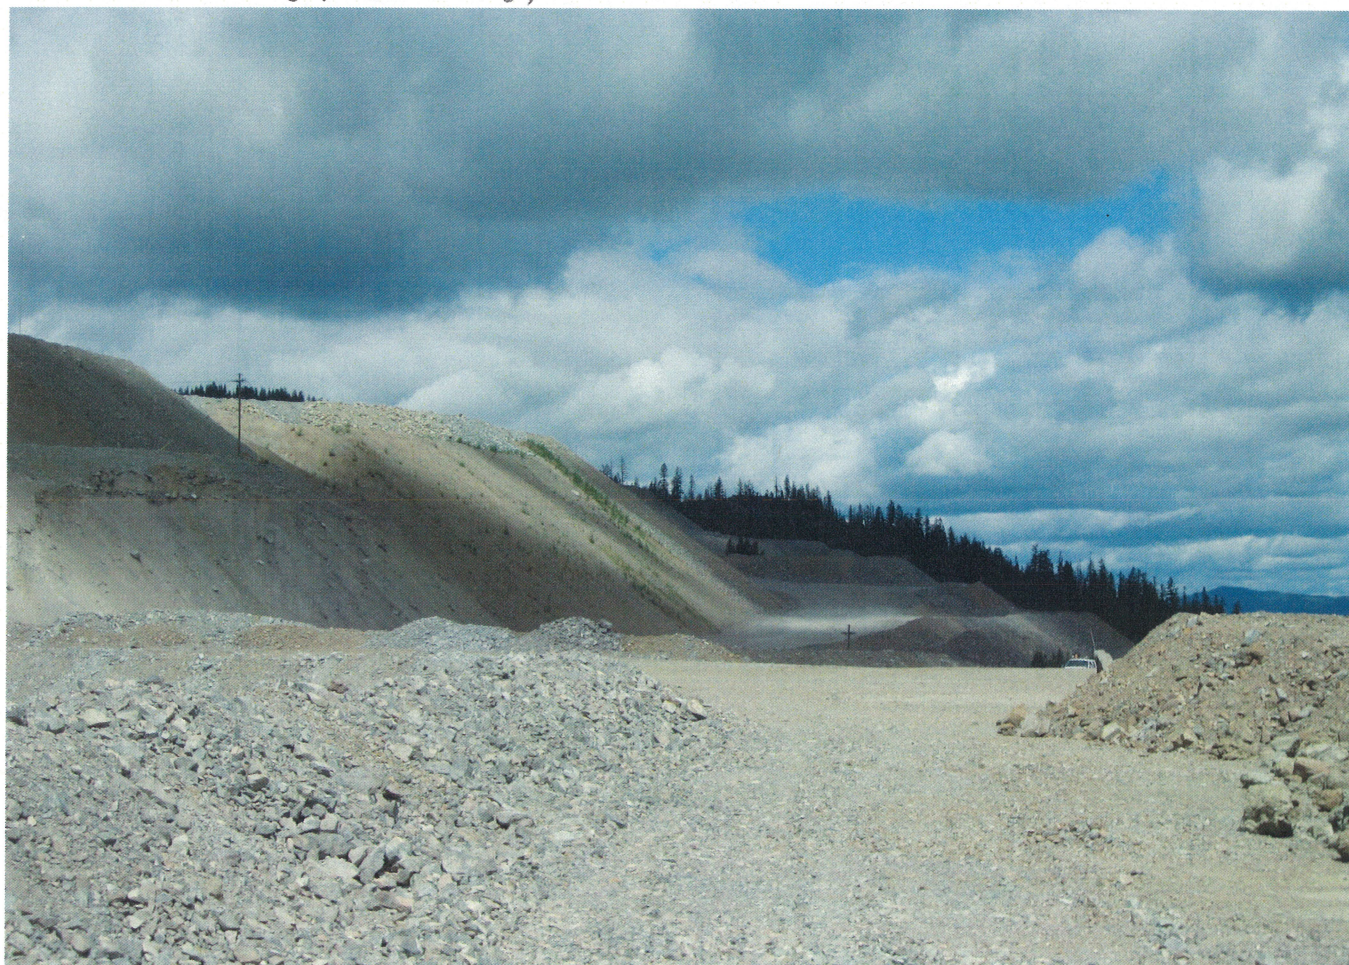
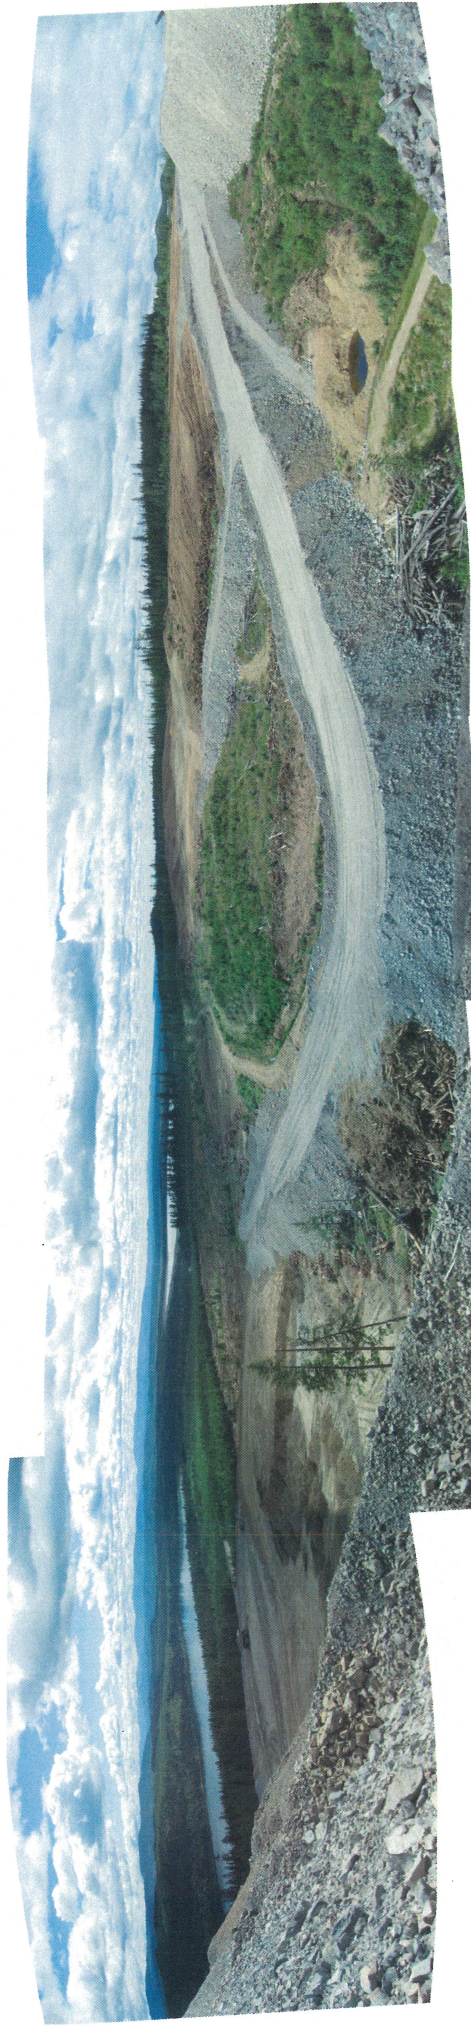
Station 6 (Photos 1246 to 1252)

Station 6: Photo of East dump toe lifts to flatten overall slope for heap leach construction and to achieve flatter reclamation angle. Panorama of Southeast Zone Pit area from Northeast Dump. Notice new Northeast Zone Dump Extension – stockpiling overburden for reclamation.

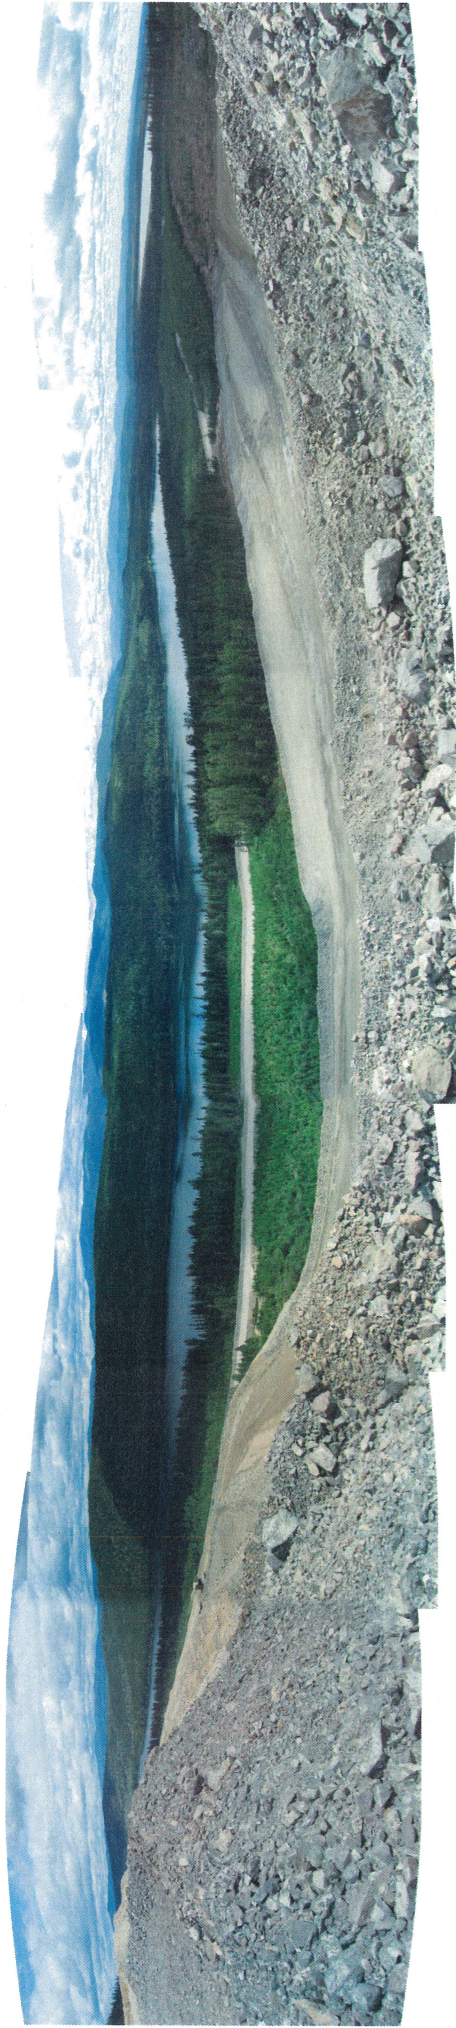
Station 7 (Photos 1254 to 1260)

Station 7: Photo of TSF haulroad access and access to dump extension. Measured 12° to TSF Haulroad with clinometer.

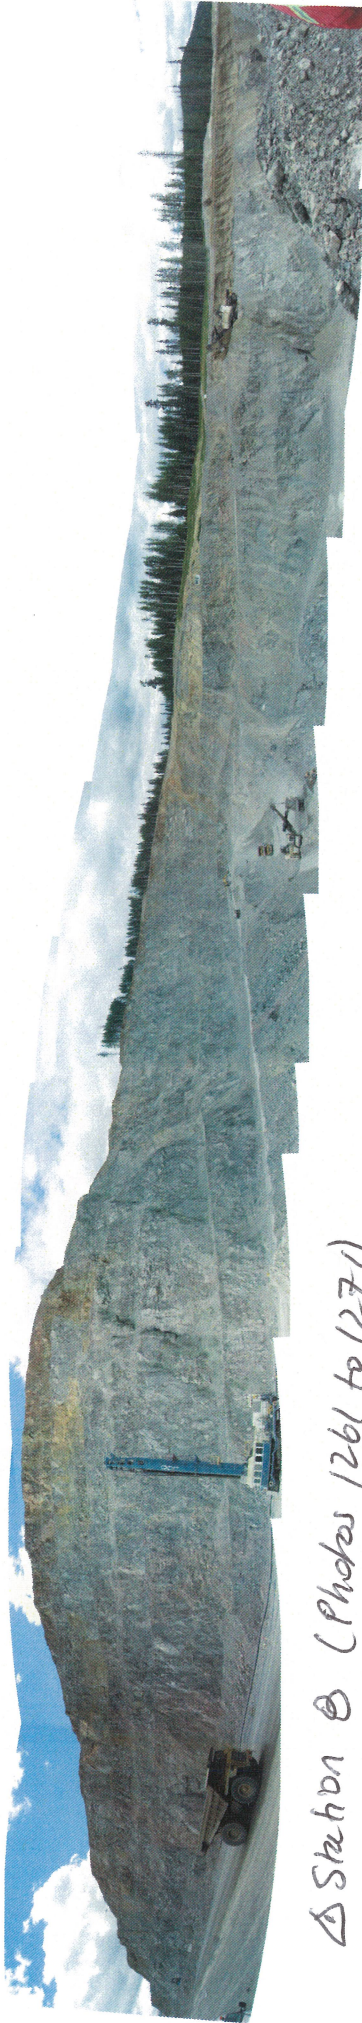
Station 8 (Photos 1261 to 1271)

Station 8: Wight Pit: Panorama from 912.5m Level.

- **Need Golder design for final southeast overburden slope.**
- Prisms currently located on 900 and 972m Levels.
- **If safe access available, prism monitoring shall be established on the 924m Bench, north of east-west trending dyke.**
- **Dykes/faults to be located on a map and correlated with area of current instability to determine if additional prism monitoring is required.**
- Seepage noted on southeast wall below current overburden contact.
- southeast pumps on timer, 15 hp and 5 hp pumps. Probes close together to cycle on-off.

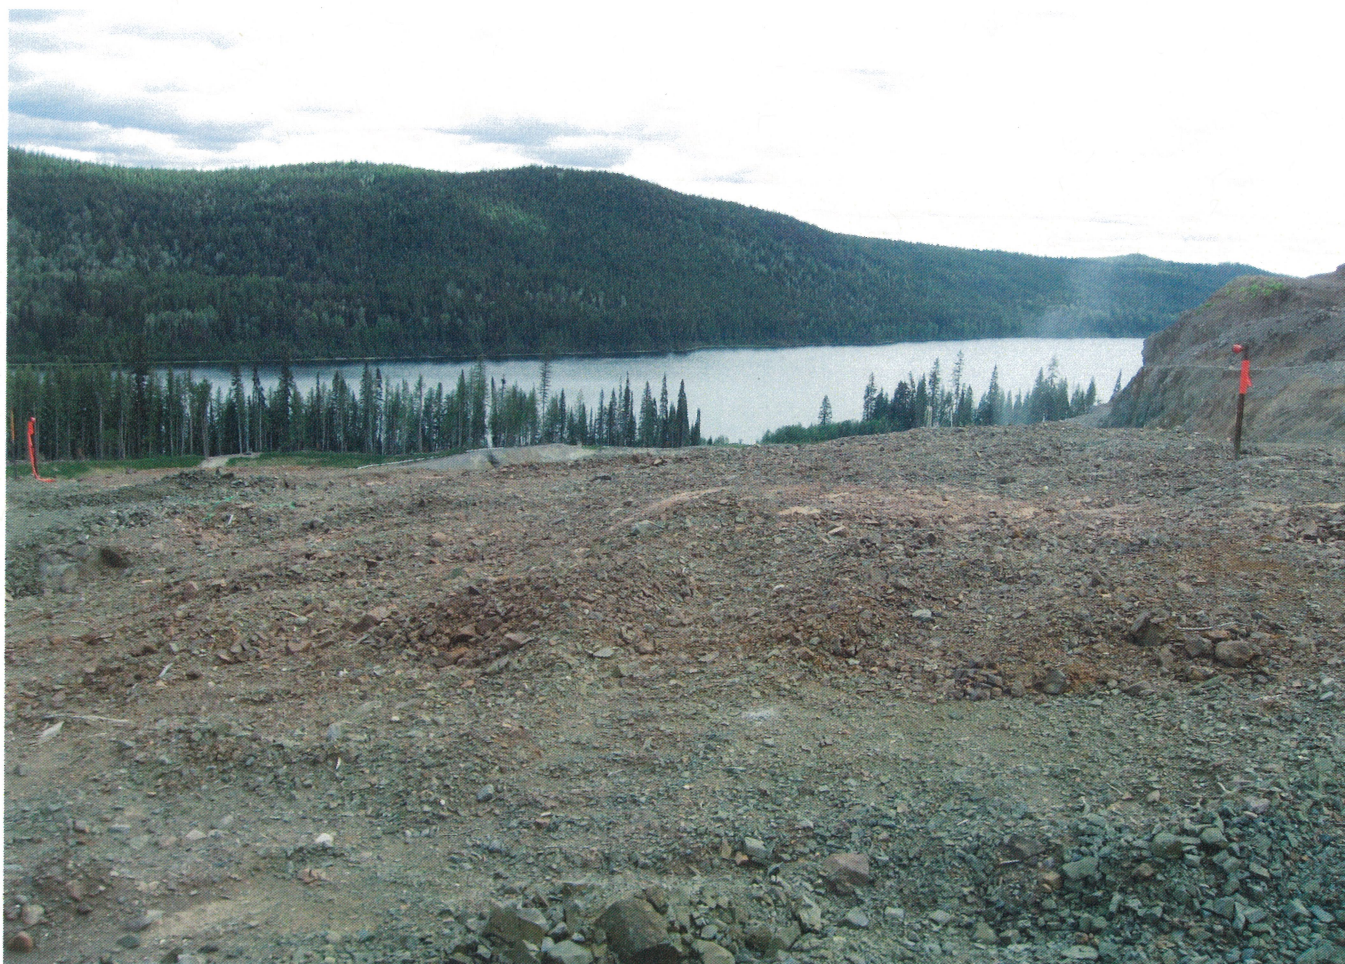
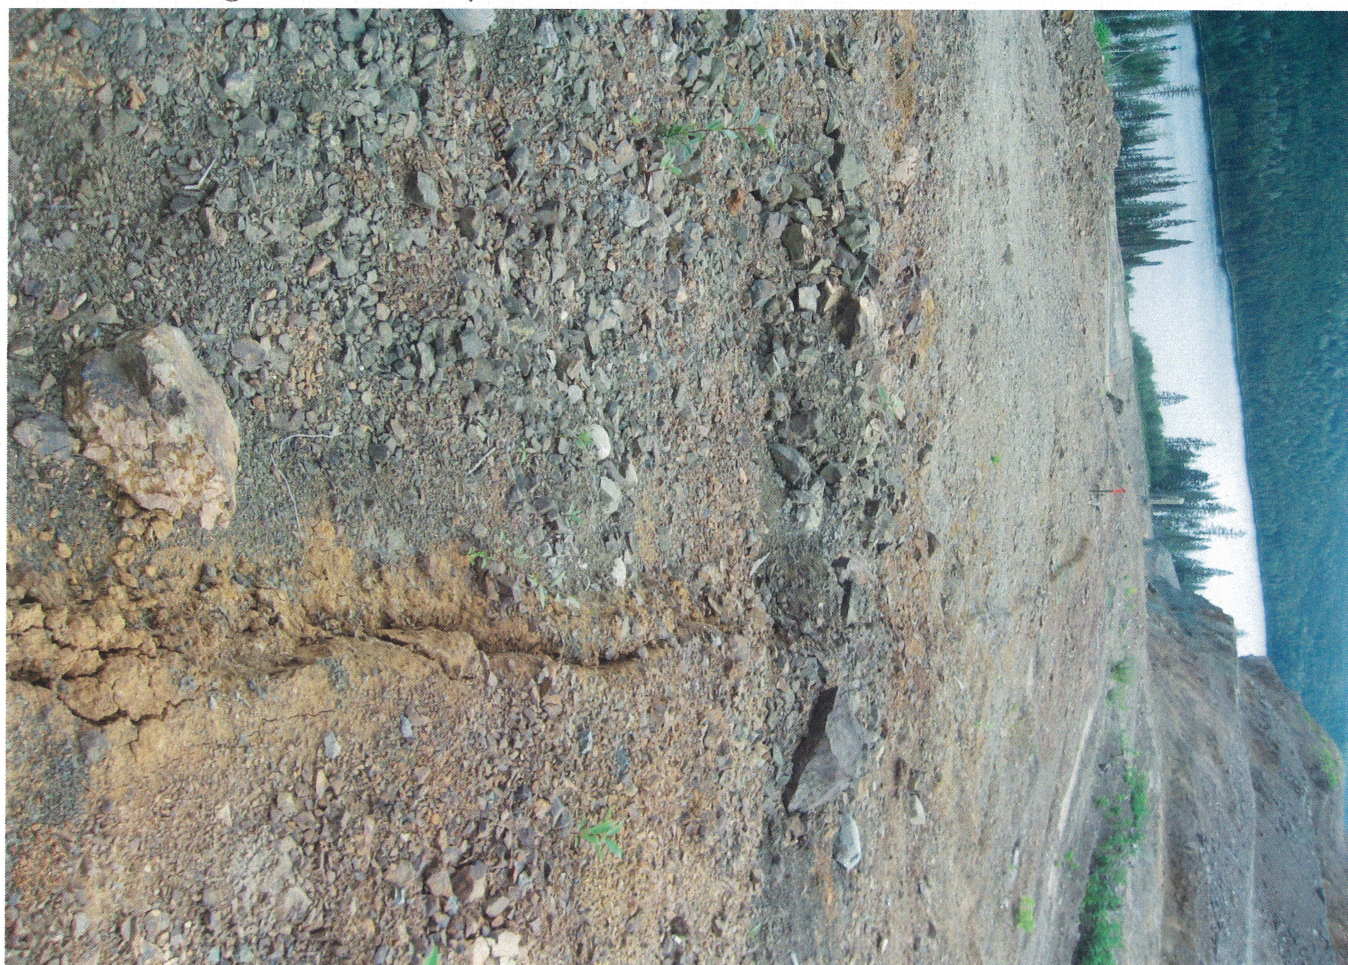
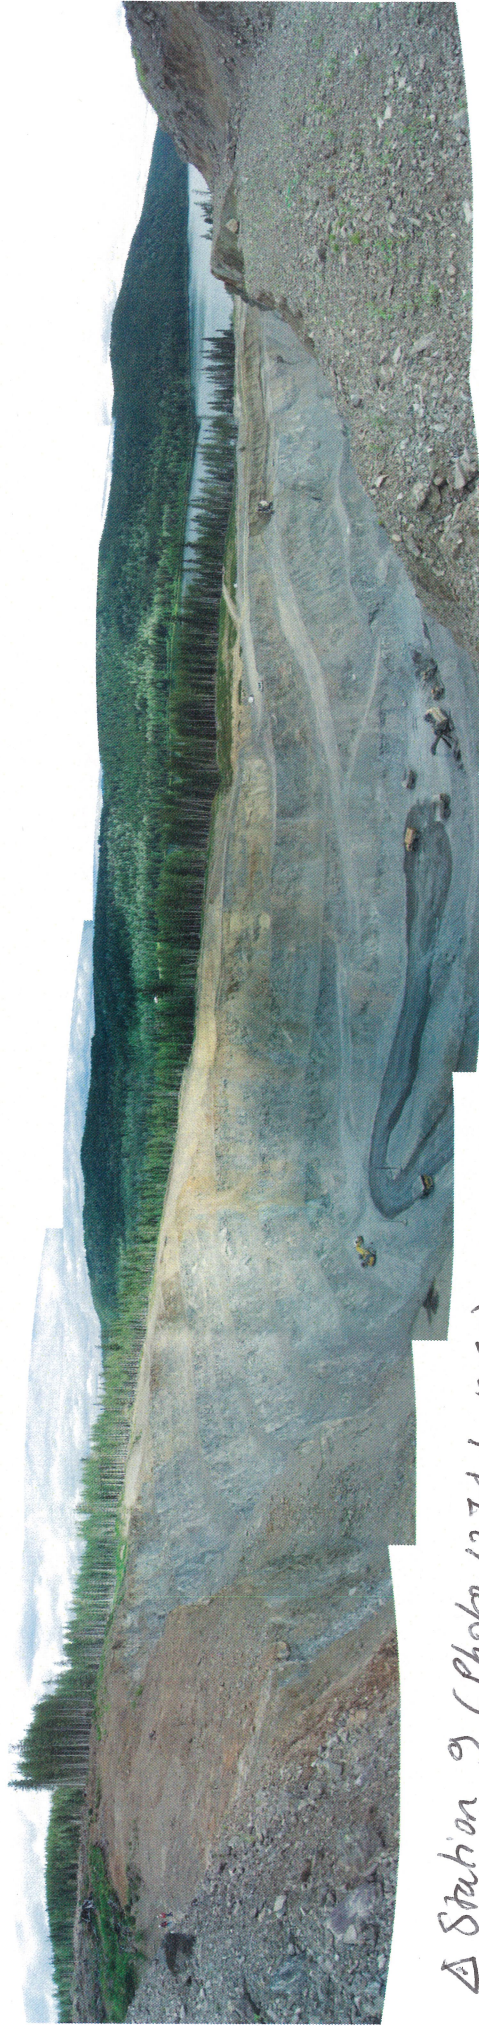
Δ Station 9 (Photo 1274 to 1279)

Station 9: Wight Pit inspection of west wall pit crest area.

- Major cracks behind pit crest following trend of dykes/faults.
- Need monitoring to delineate bounds of current movement (i.e., prisms located on outside of major structures as well as within).
- The pit crest area shall be inspected regularly for changes in slope conditions.
- Slope monitoring is being conducted daily during mining and is being reviewed weekly by the design consultant.
- Extensometers/crack monitors to be implemented as supplementary means of manual monitoring.
- **Movement rate thresholds and operational response procedures shall be developed for the west wall instability and submitted to the Ministry within 15 days of receipt of this report.**

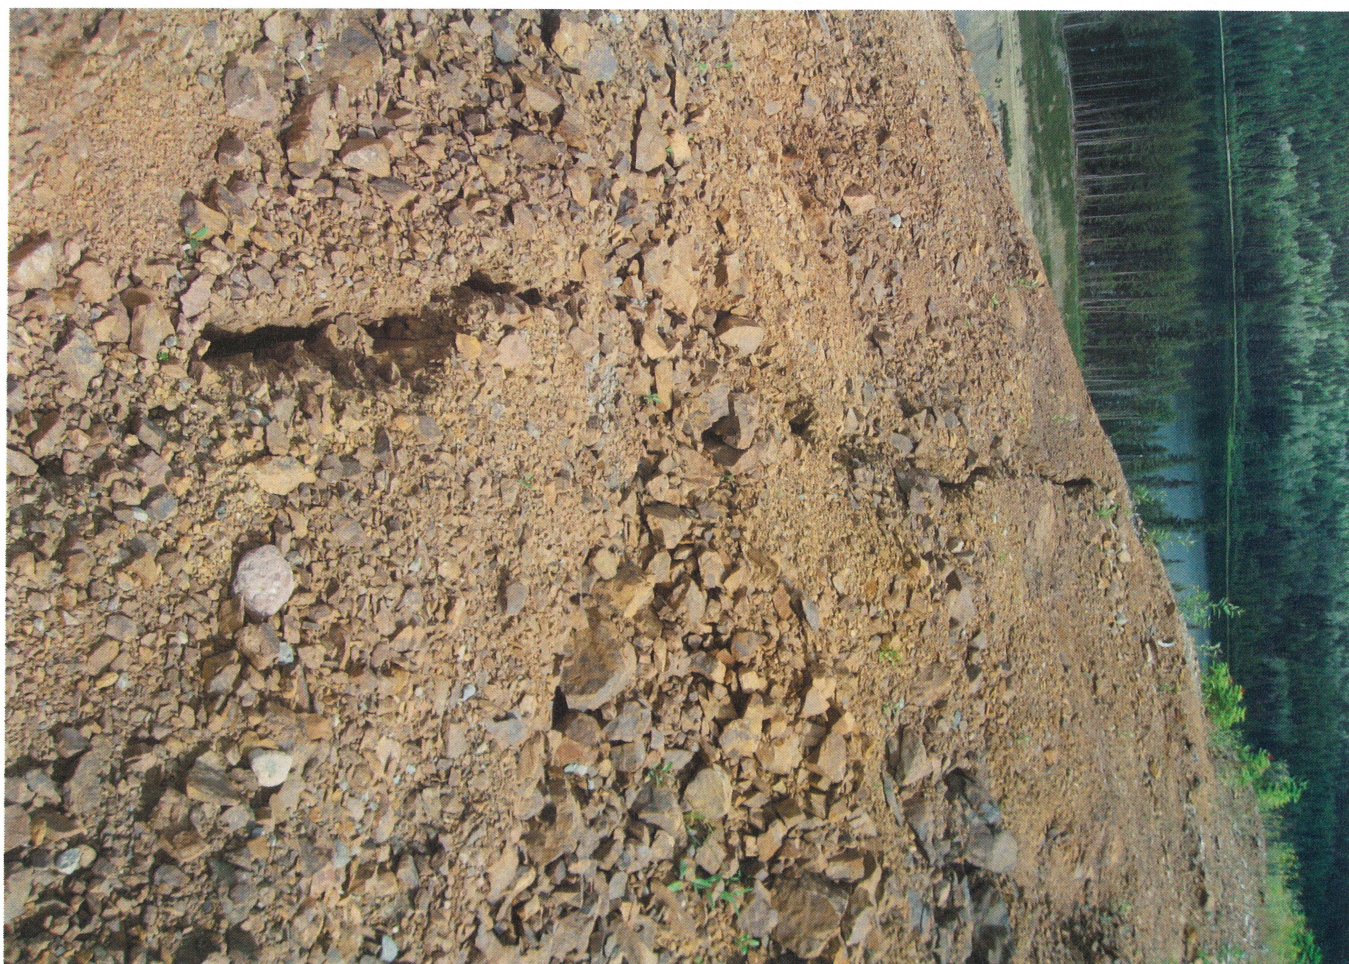
△ Station 10 (Photo 1280)

Station 10: Additional tension cracks observed beyond the limits observed by mine personnel and design consultant. **Crack locations to be surveyed and plotted on a plan map and correlated with faults/dykes. Additional prisms to be located within and outside tension cracks.**

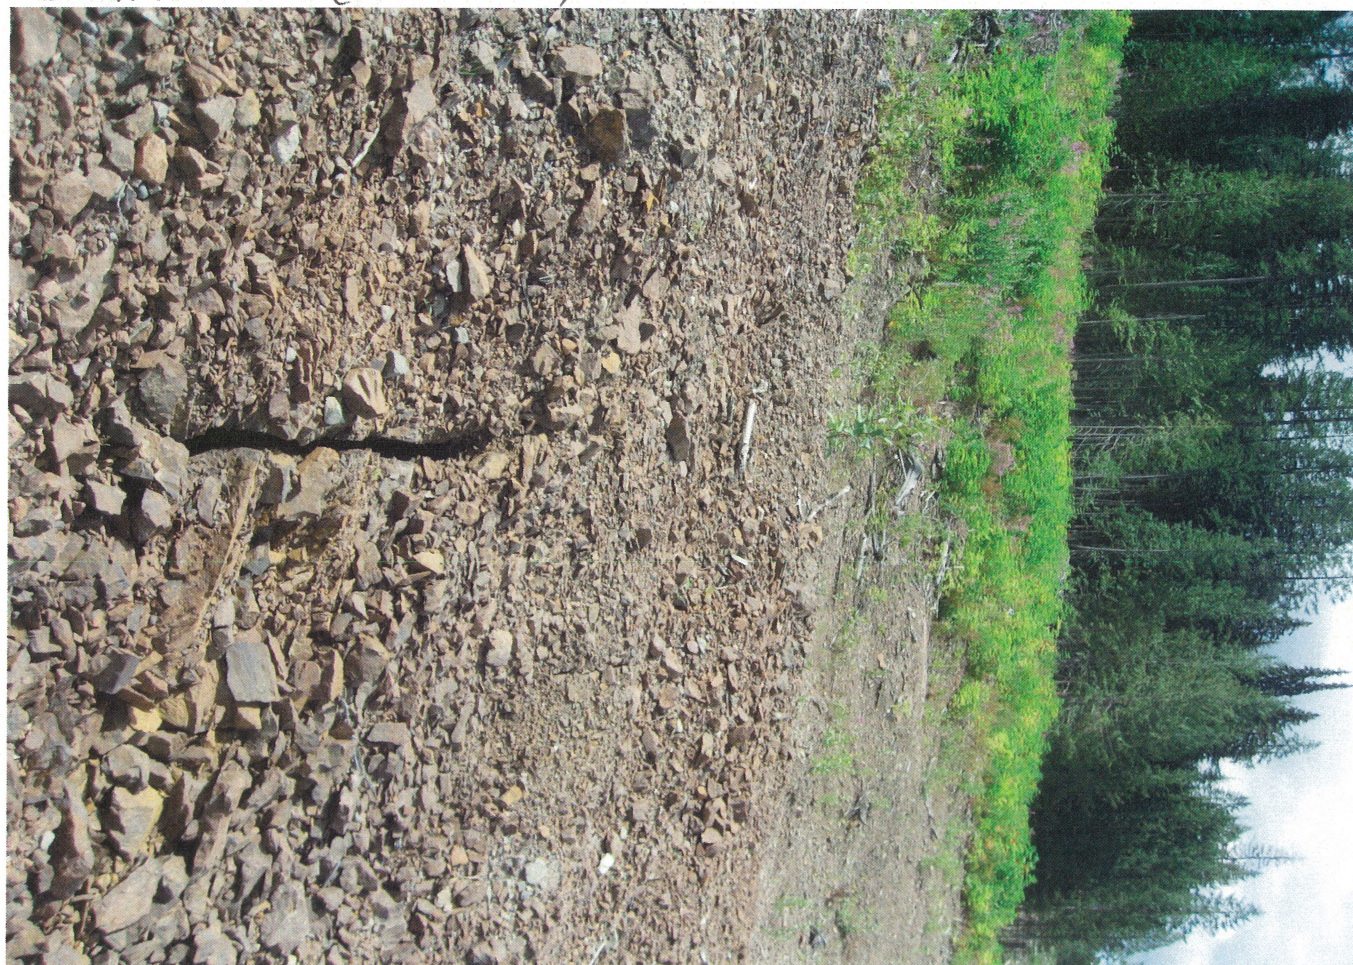
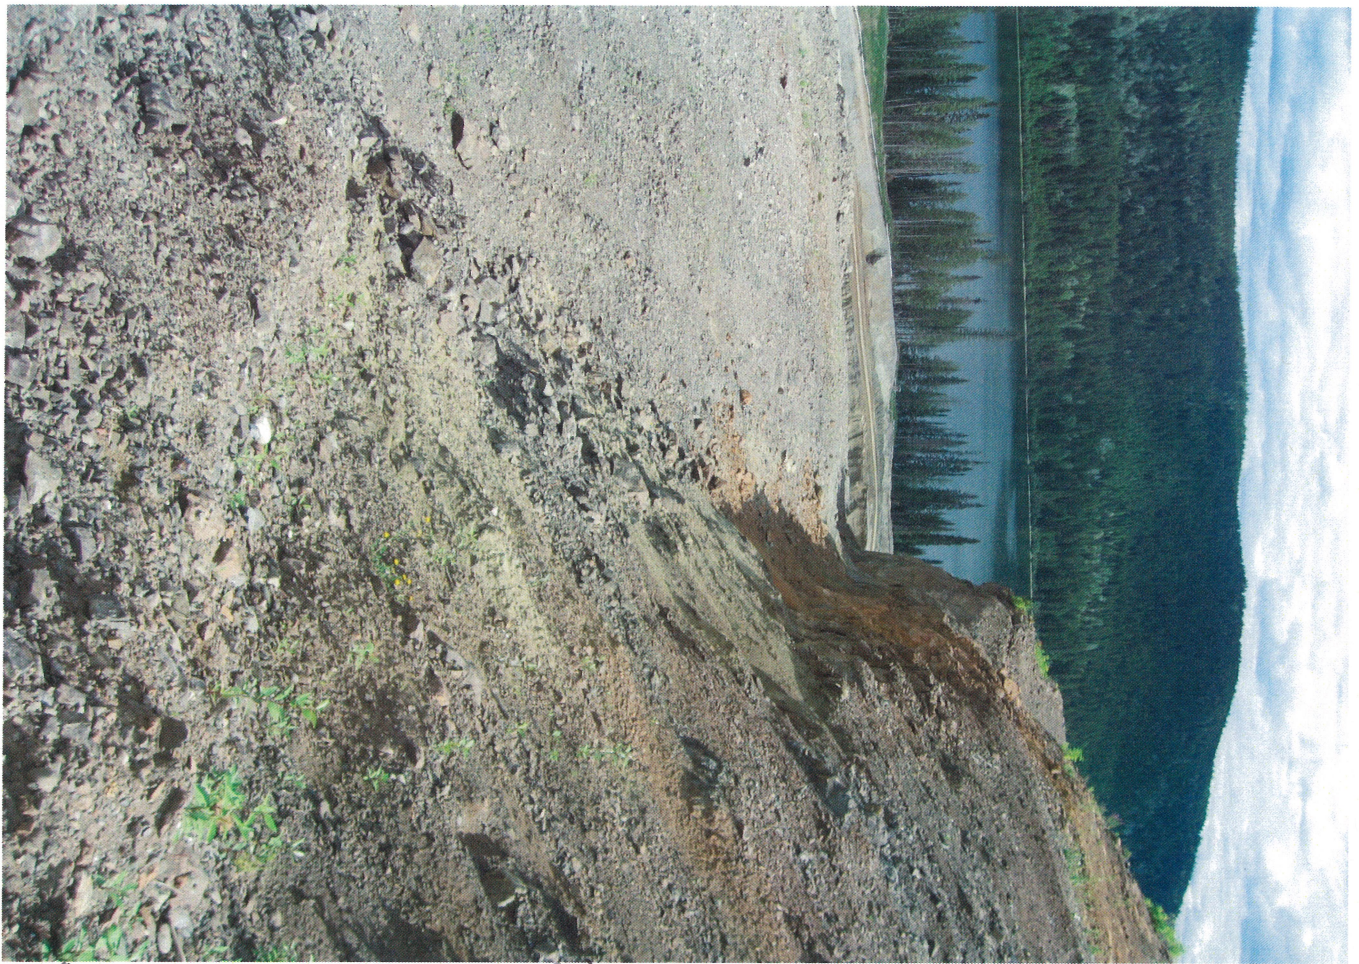
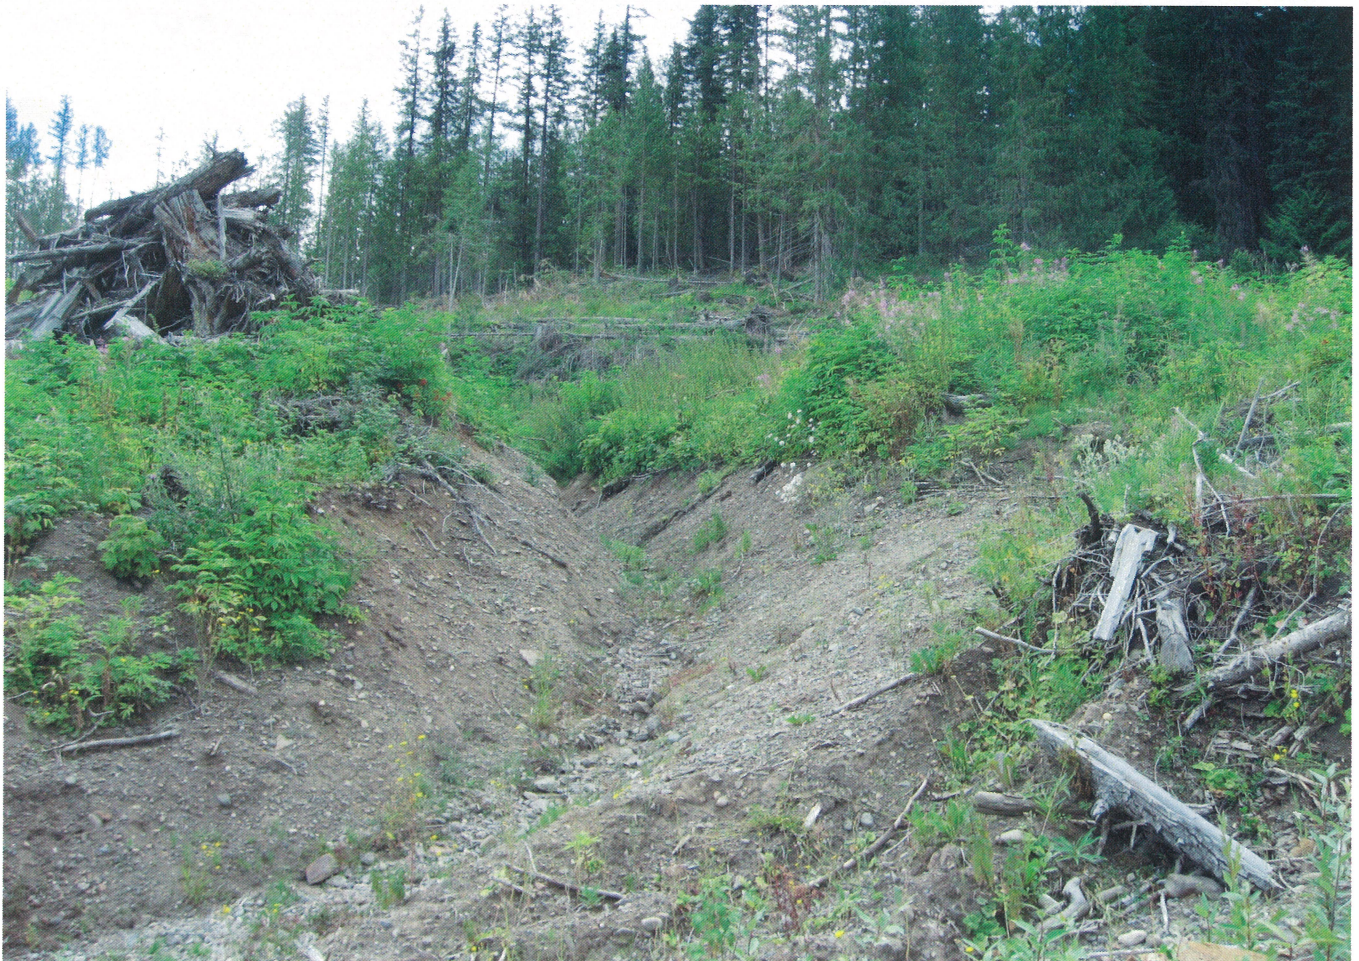
△ Station 11 (Photo 1281)

Station 11: Water ditching may be concentrating surface runoff in headscarp area. **Alternate diversion of surface water should be considered.**

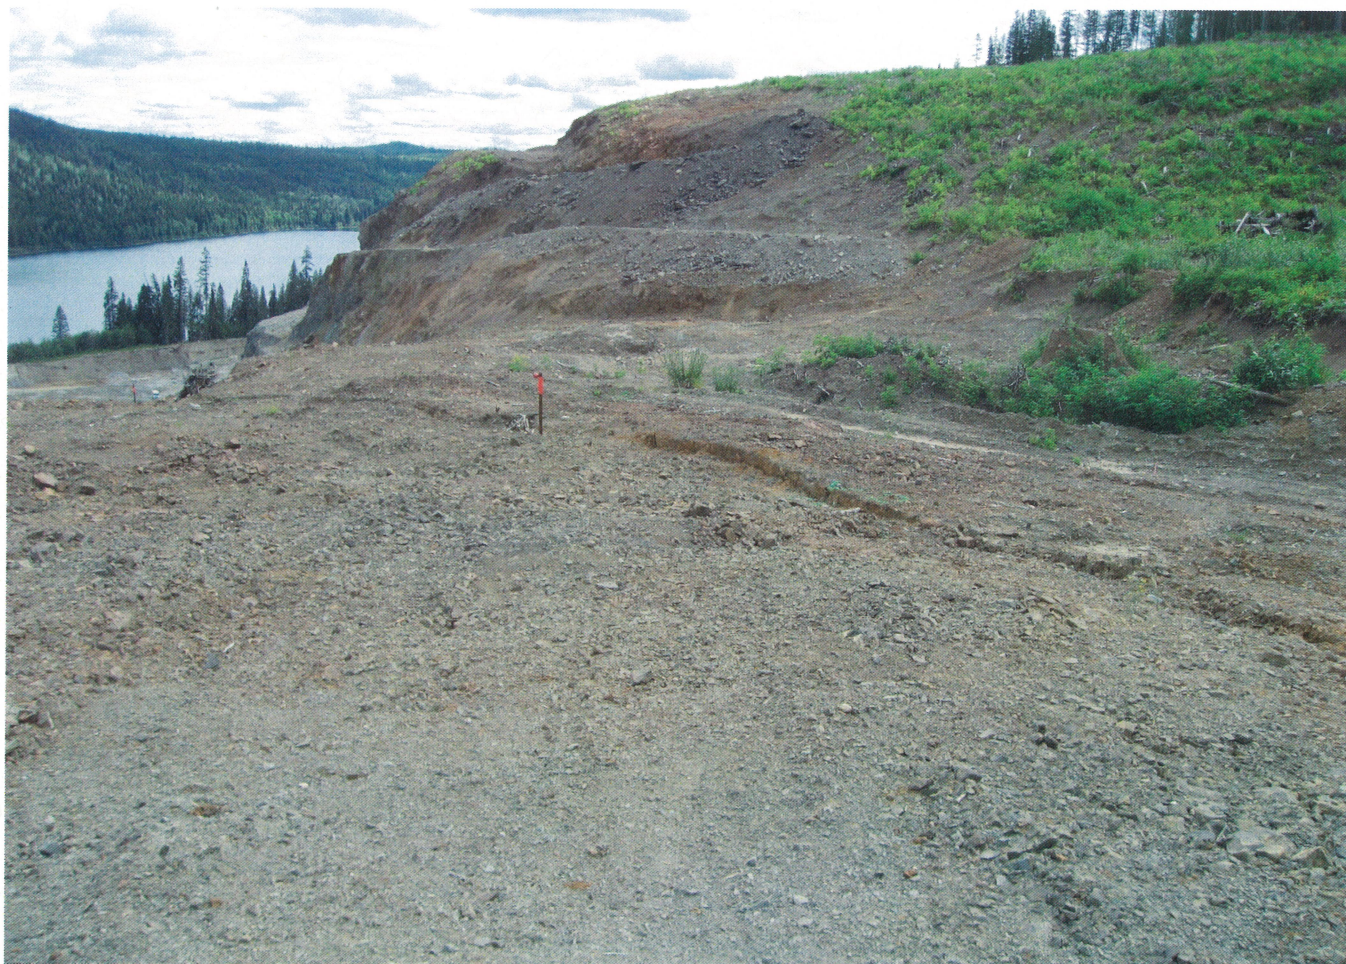
Δ Station 12 (Photo 1284)

Station 12: Approximately 10 to 15cm of downward displacement noticed on east-west trending fault on southern portion of instability.
