MT. POLLEY MINE

N. ROSE GEOTECHNICAL INSPECTION OF OPEN PIT,

WASTE DUMPS AND TAILINGS DAM

JULY 31, 2007

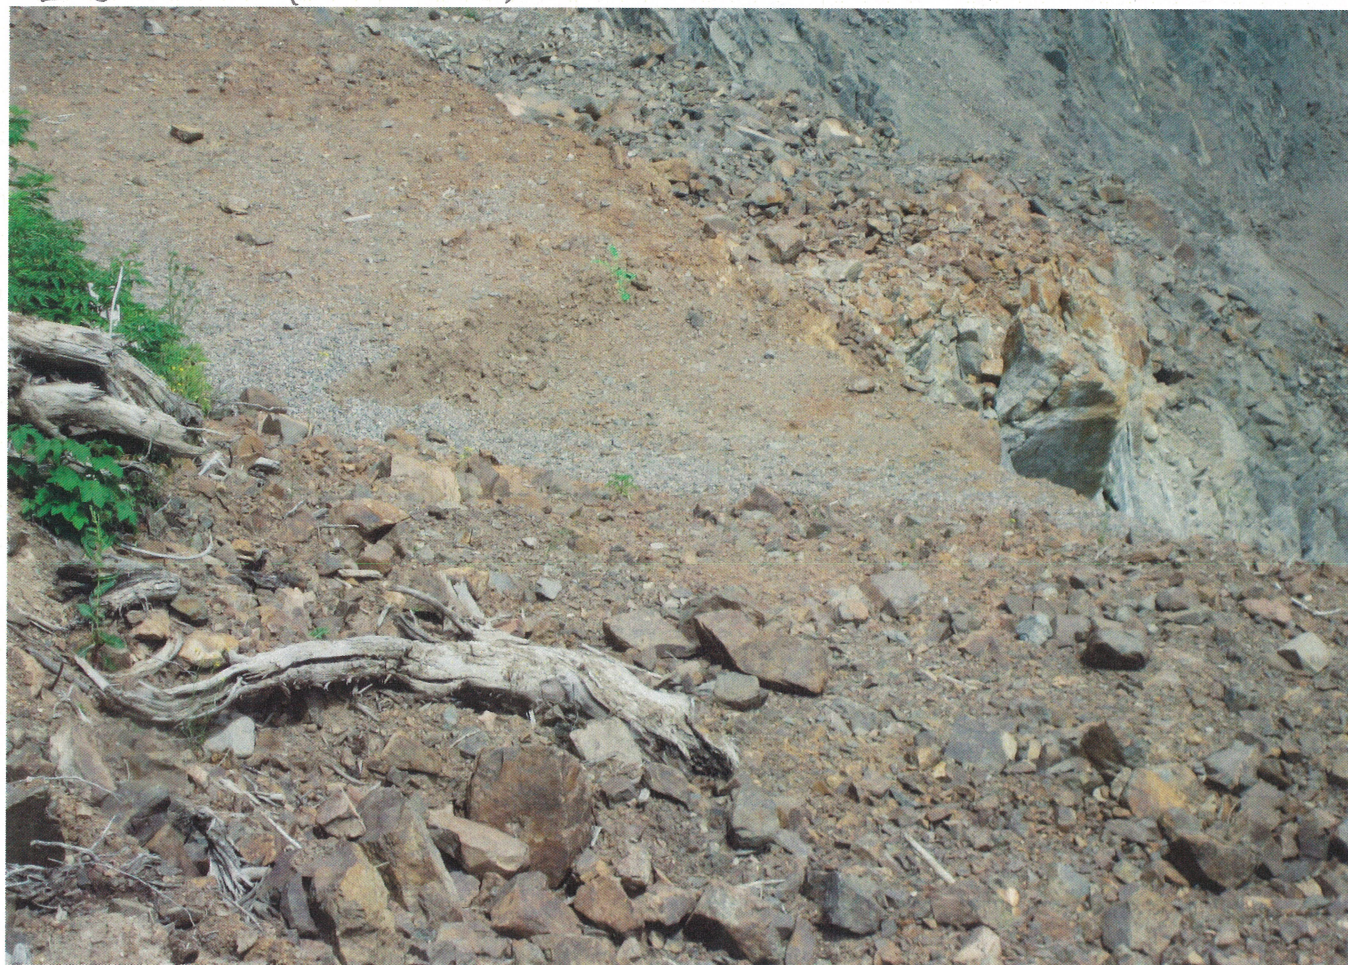
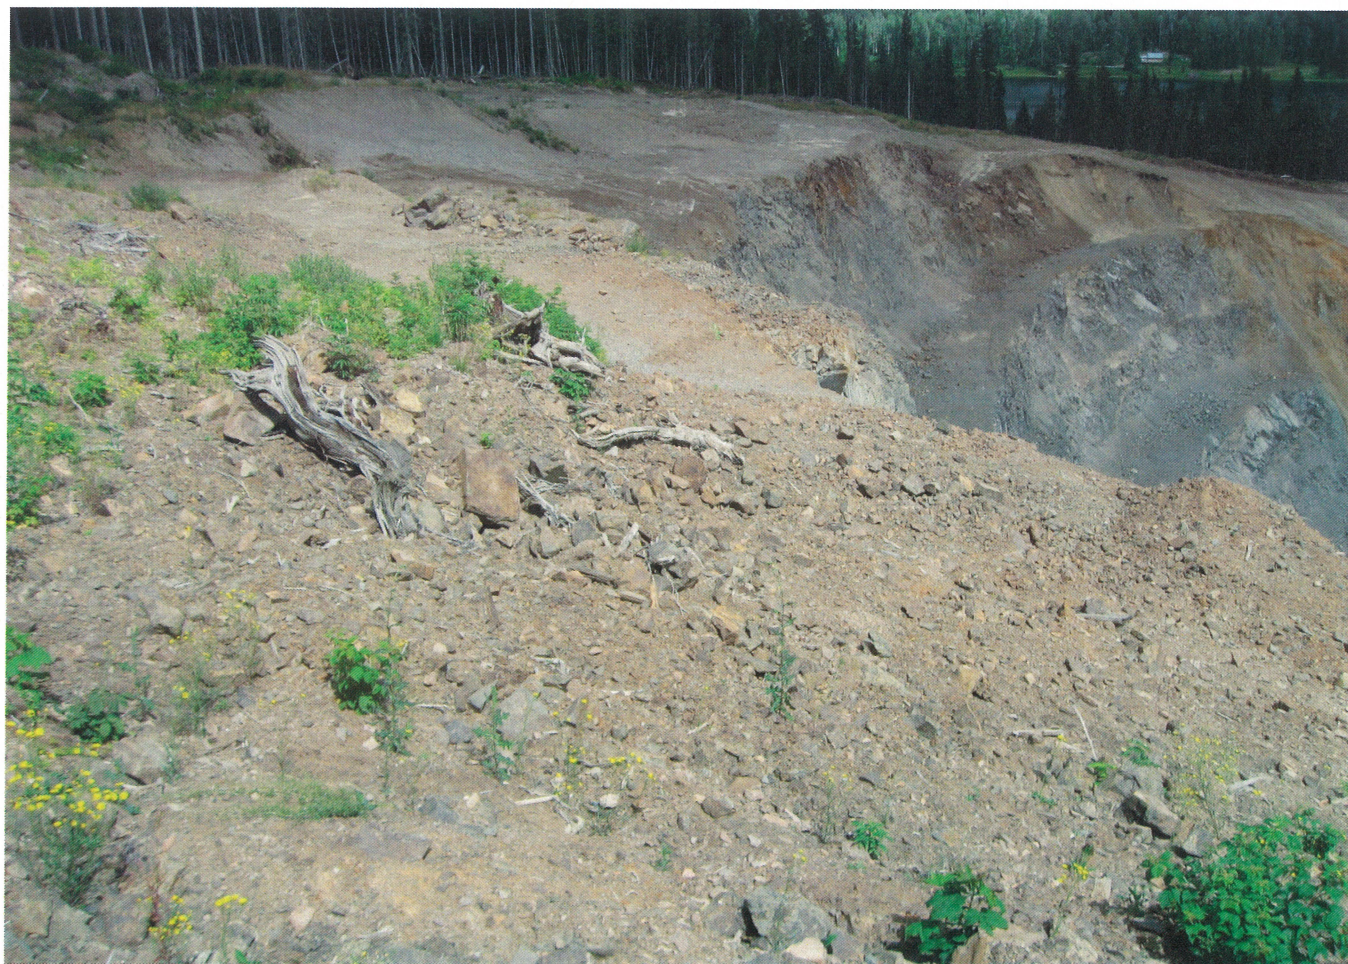
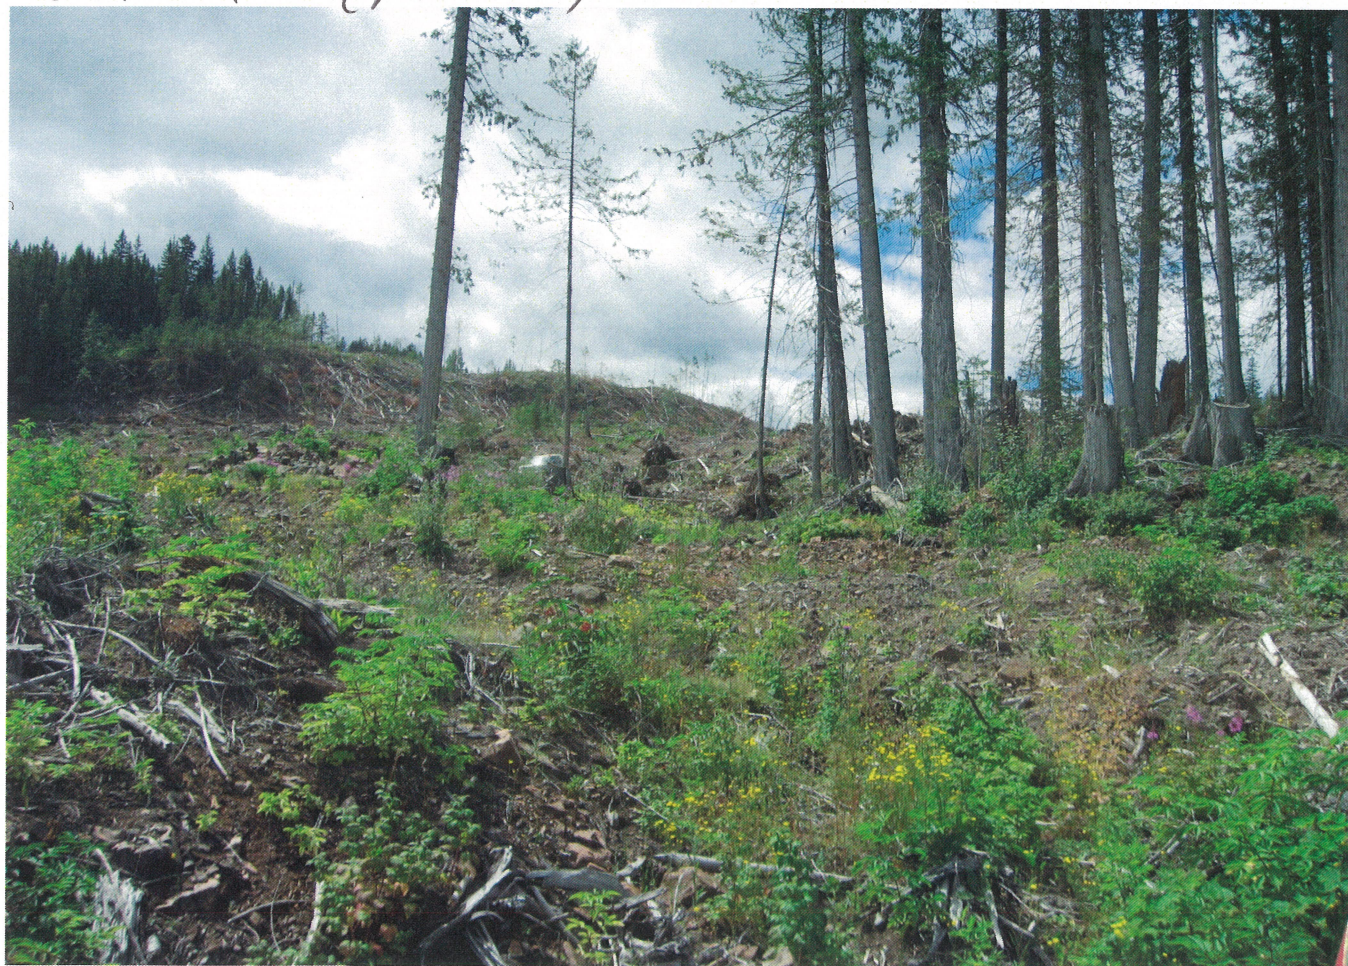
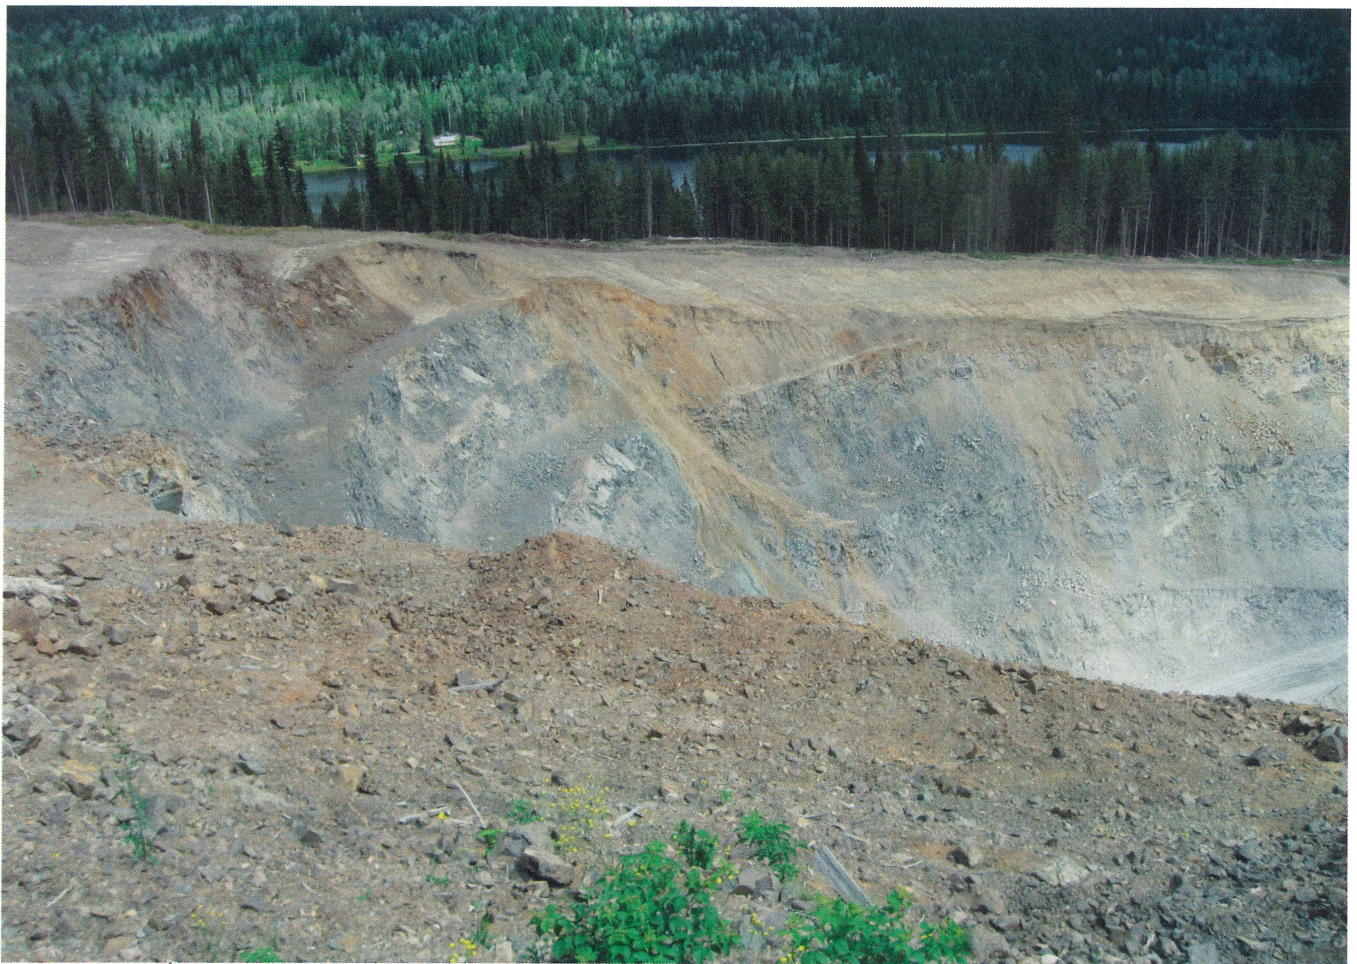
Δ Station 13 (Photo 1285)

Station 13: North bounding fault on northwest wall forms dyke on northeast wall – east-west trend.

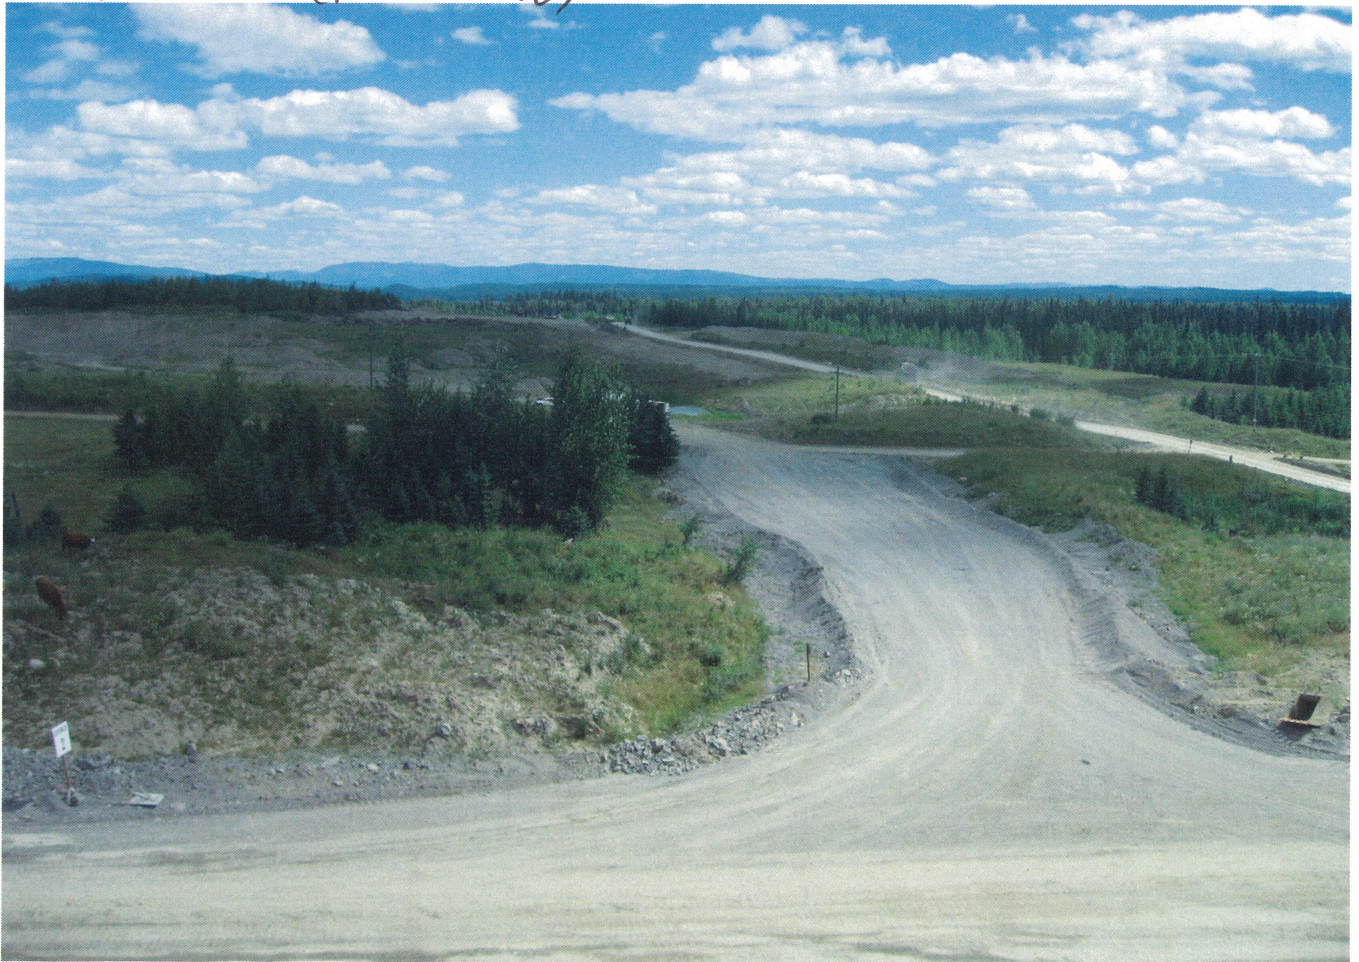
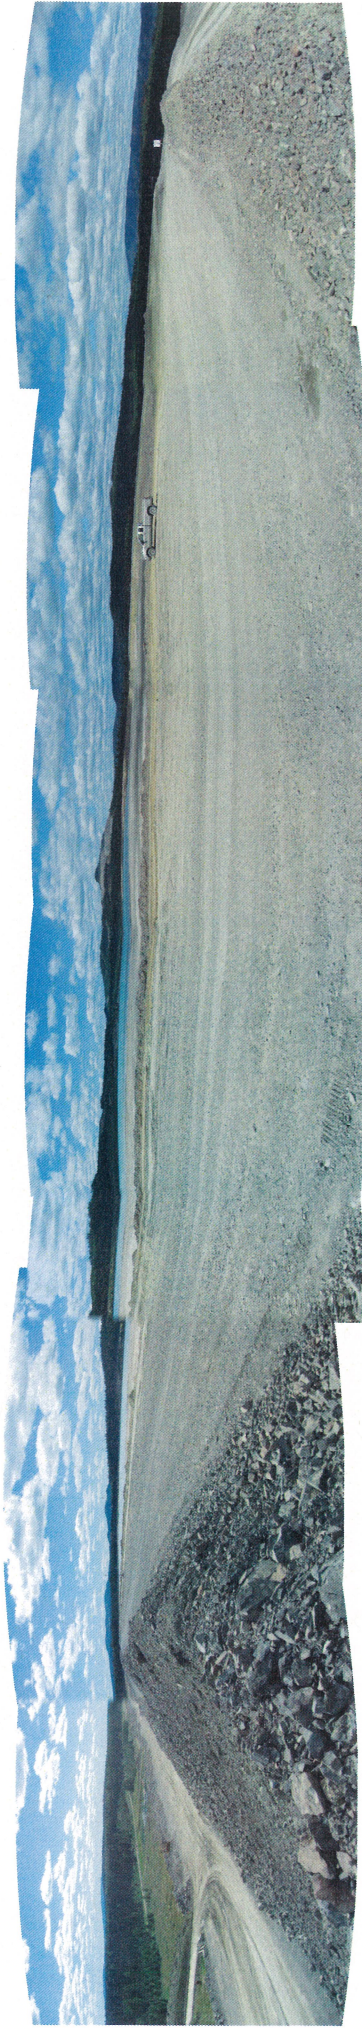
Station 14 (Photos 1290-1296)

Station 14: Photo of borrow pit area south of TSF. Panorama of Main Dam and impoundment. Upstream (U) Zone, 8m till core zone. Till zone is able to be narrowed to 5m if building all zones simultaneously at same height. This is included in Stage 6 permit application. Main Dam at 950m – to 951m in 6 weeks. Should be able to manage pond levels until next spring at 951m crest.

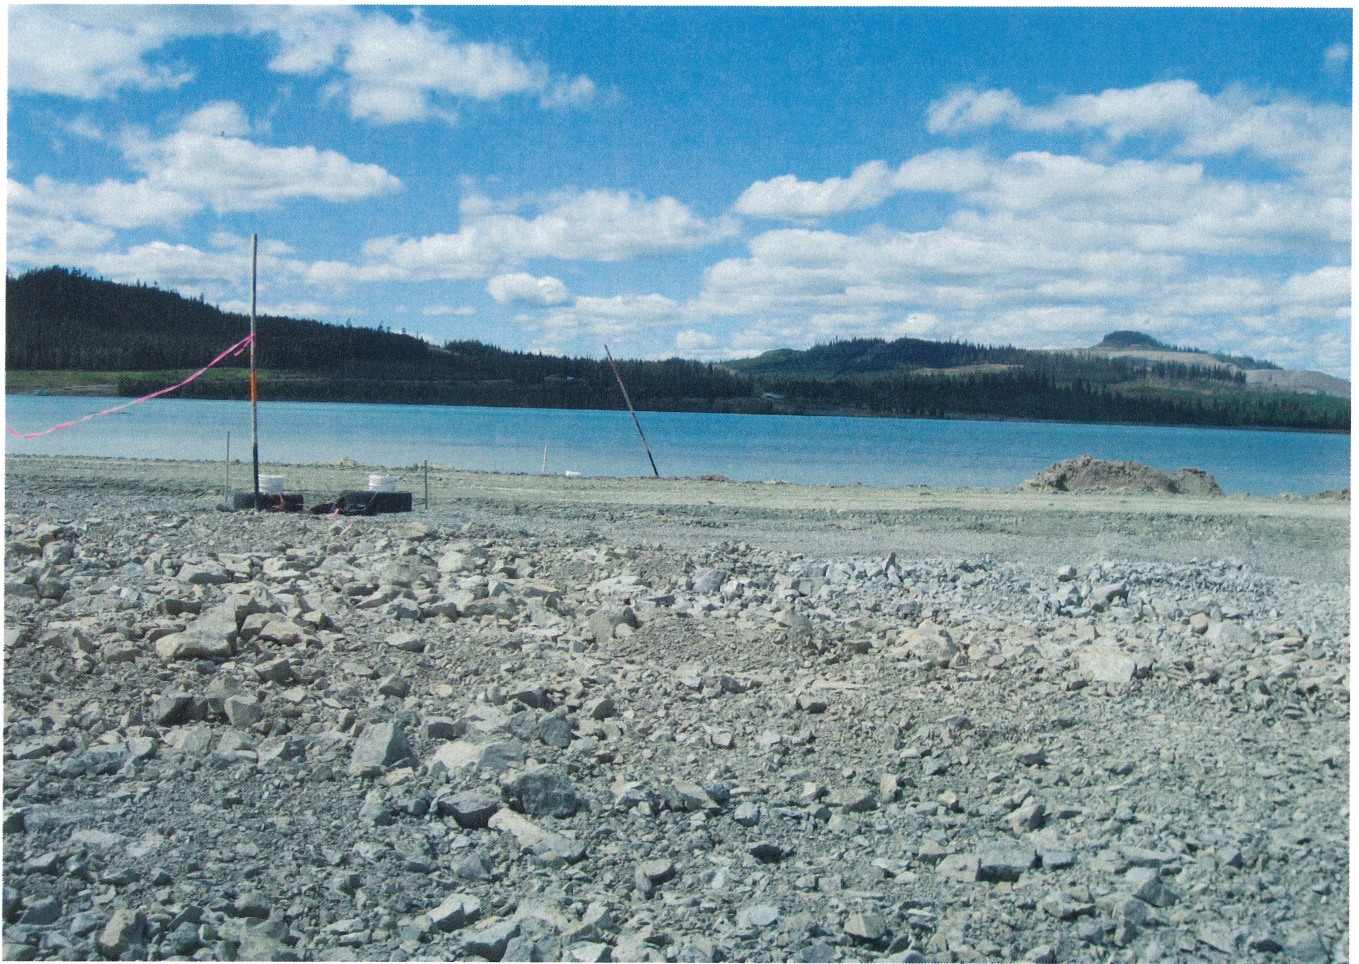
⑤ Station 15 (Photo 1297)

Station 15: Photo of piezometers on Main embankment.

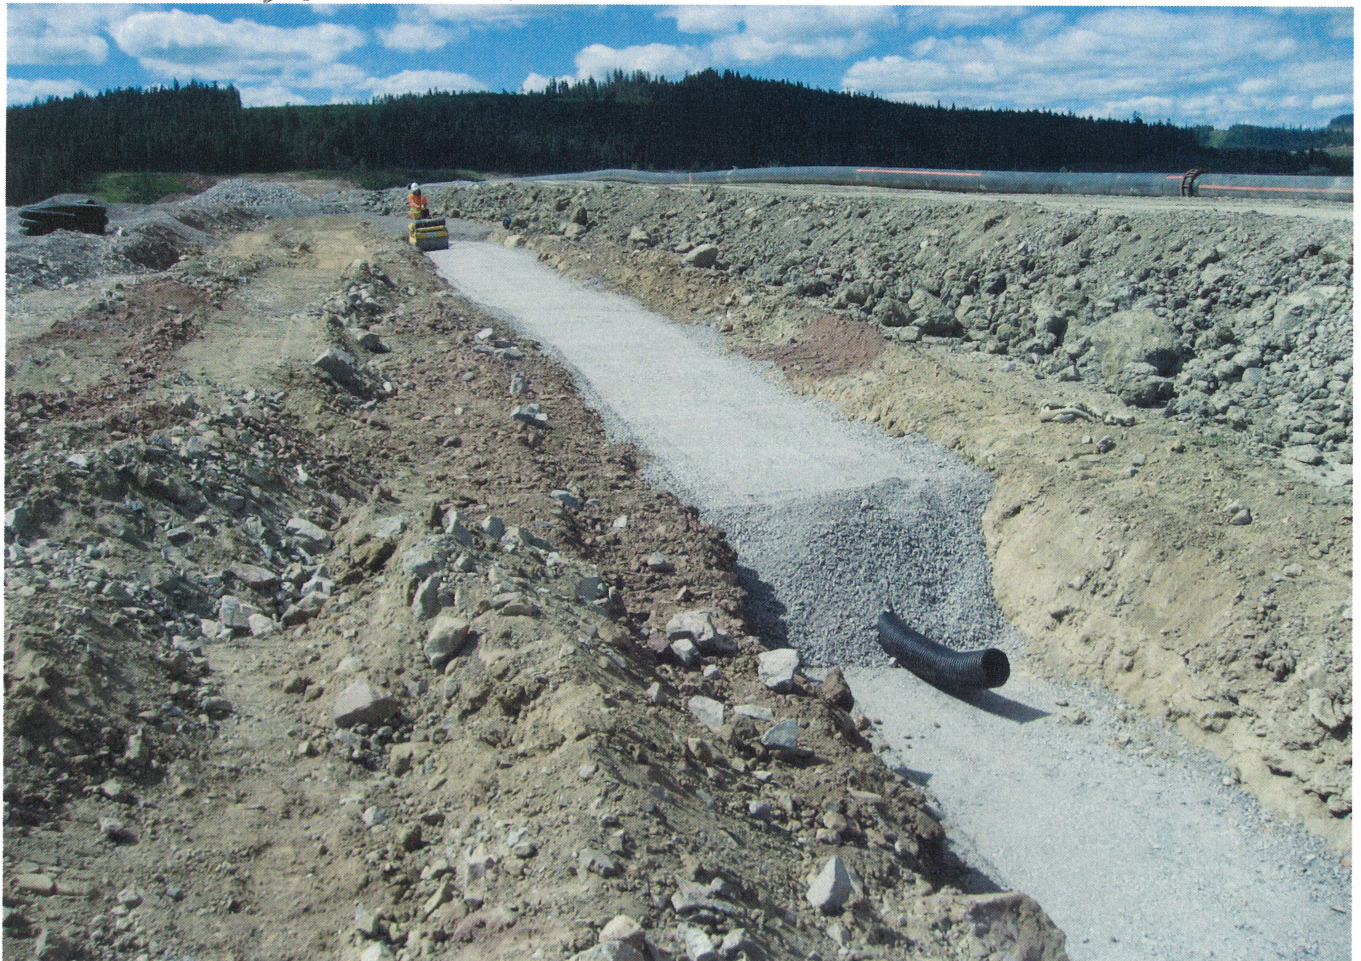
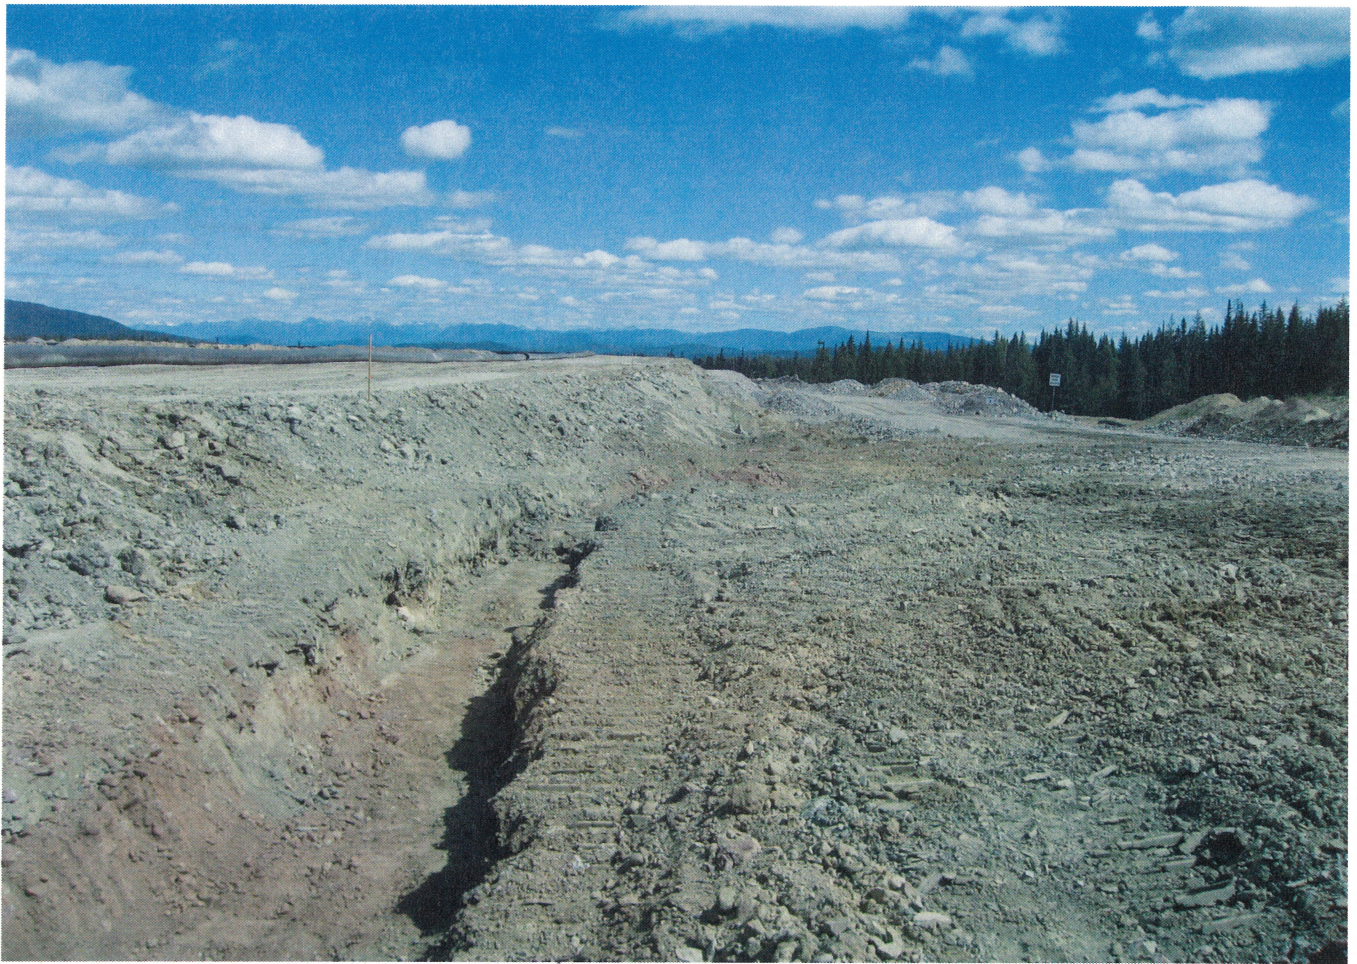
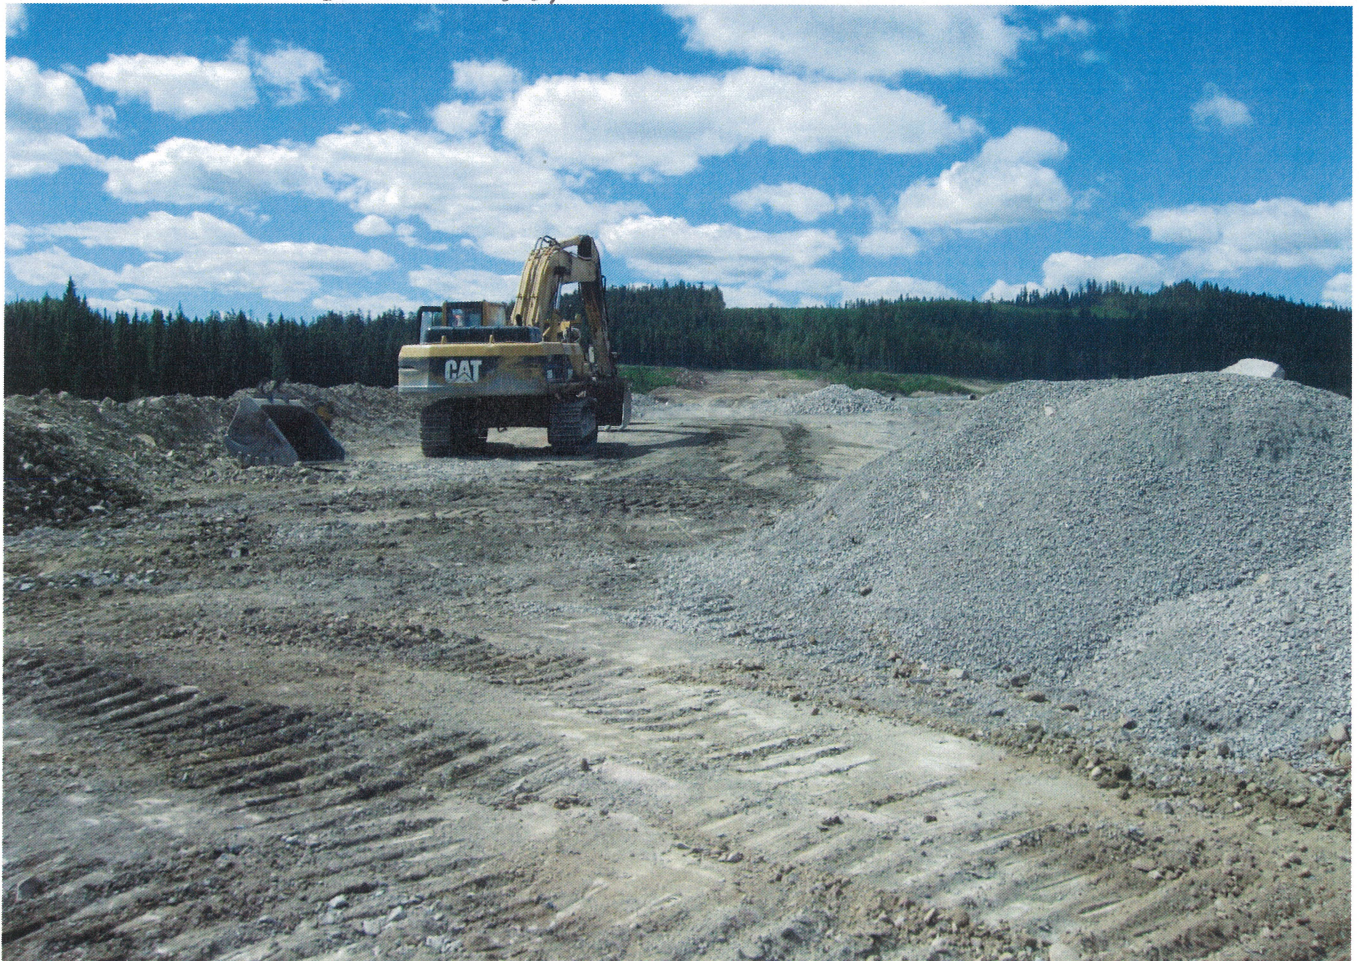
⑥ Station 16 (Photo 1298)

Station 16: Photo of South embankment – filter and transition zones, compaction.

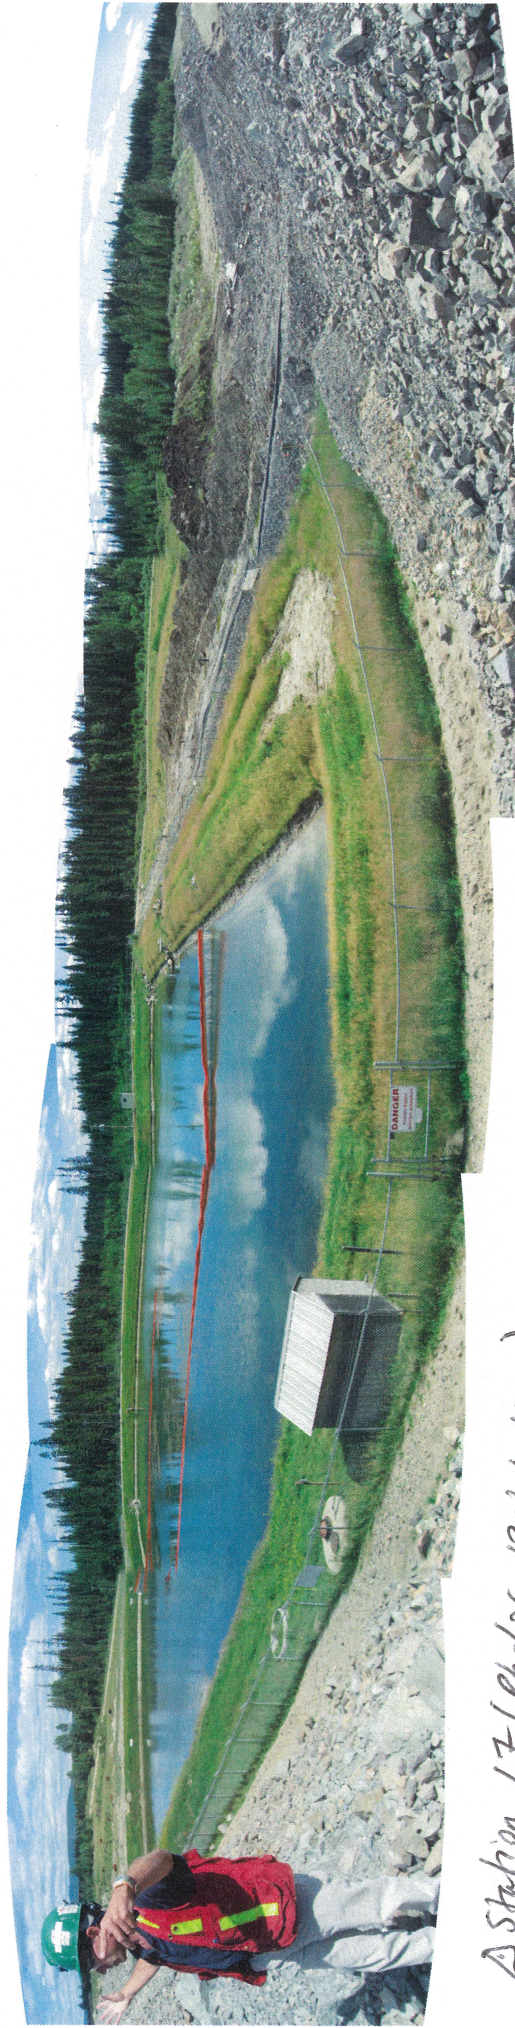
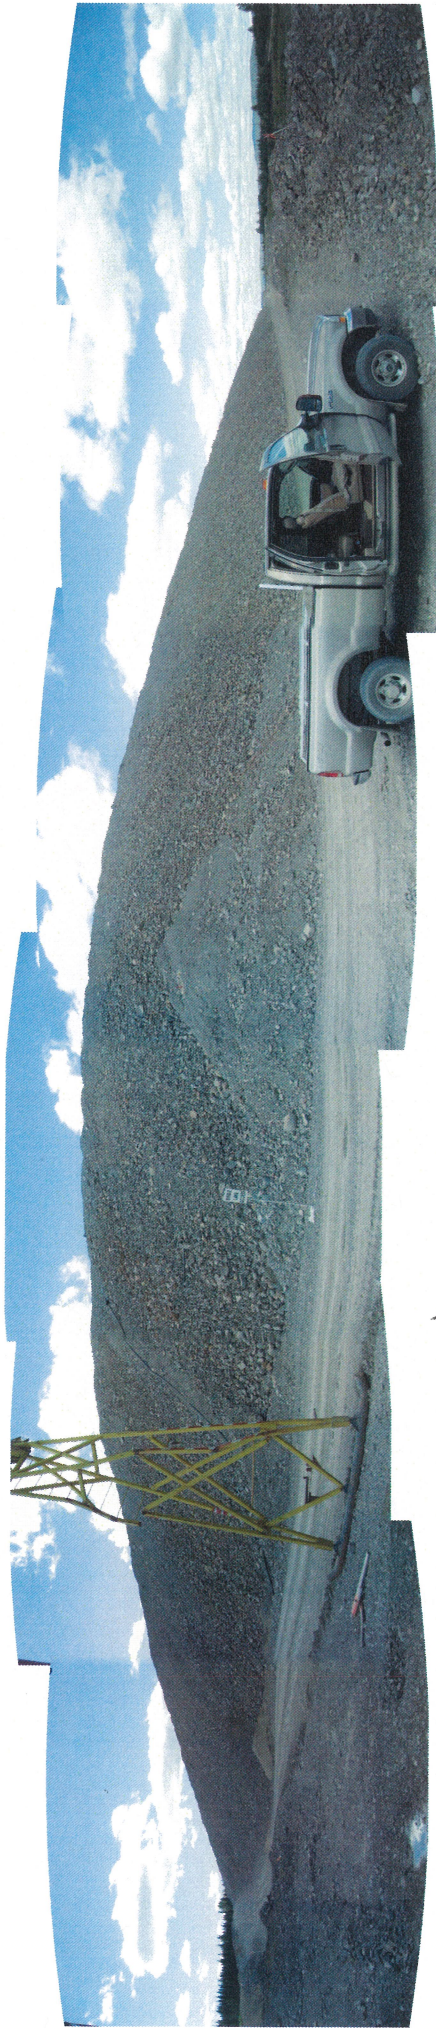
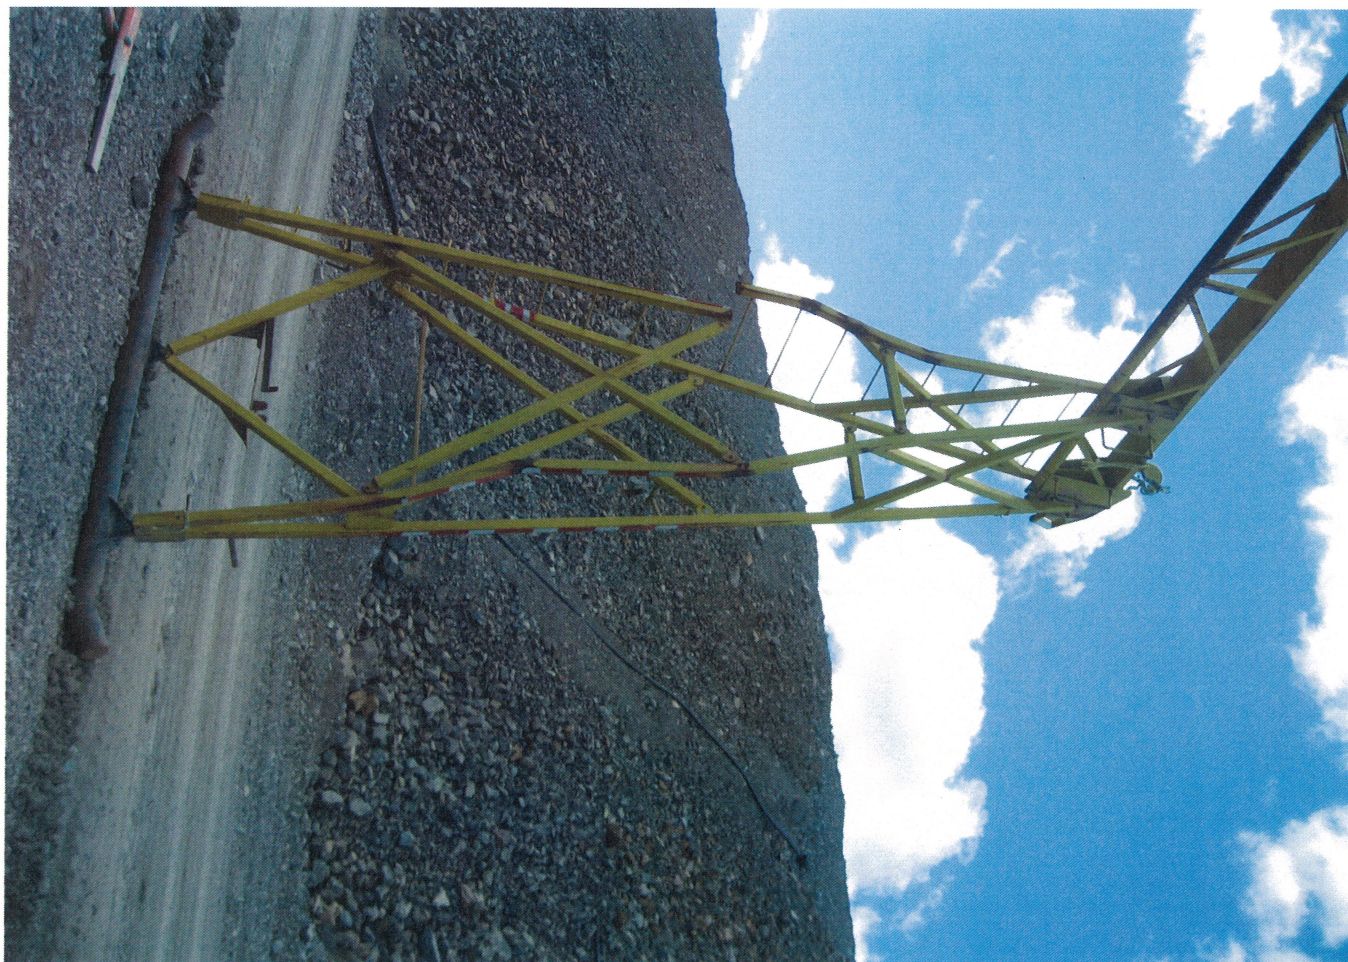
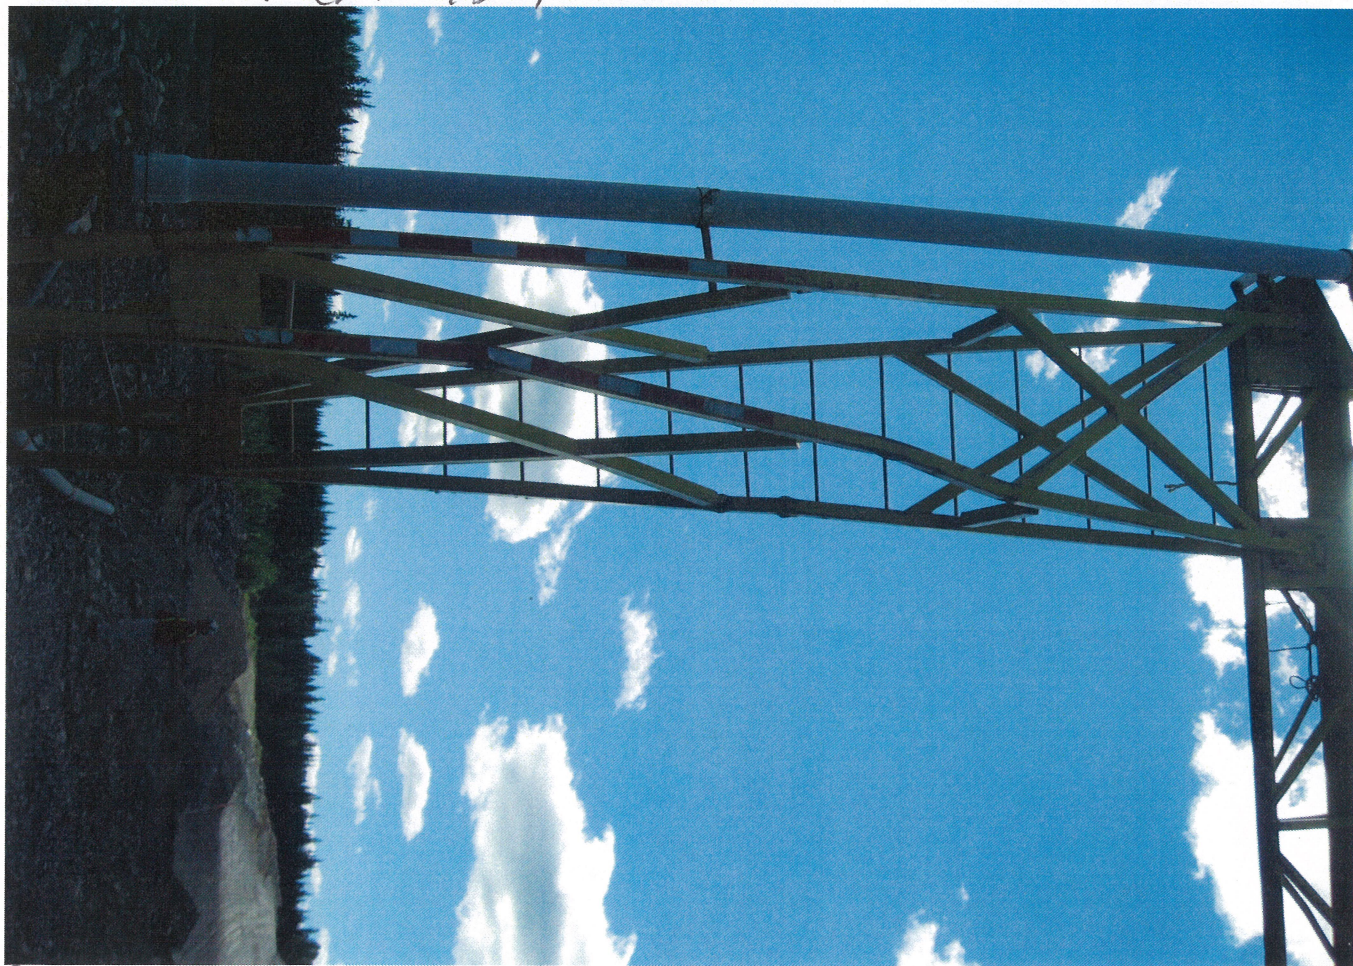
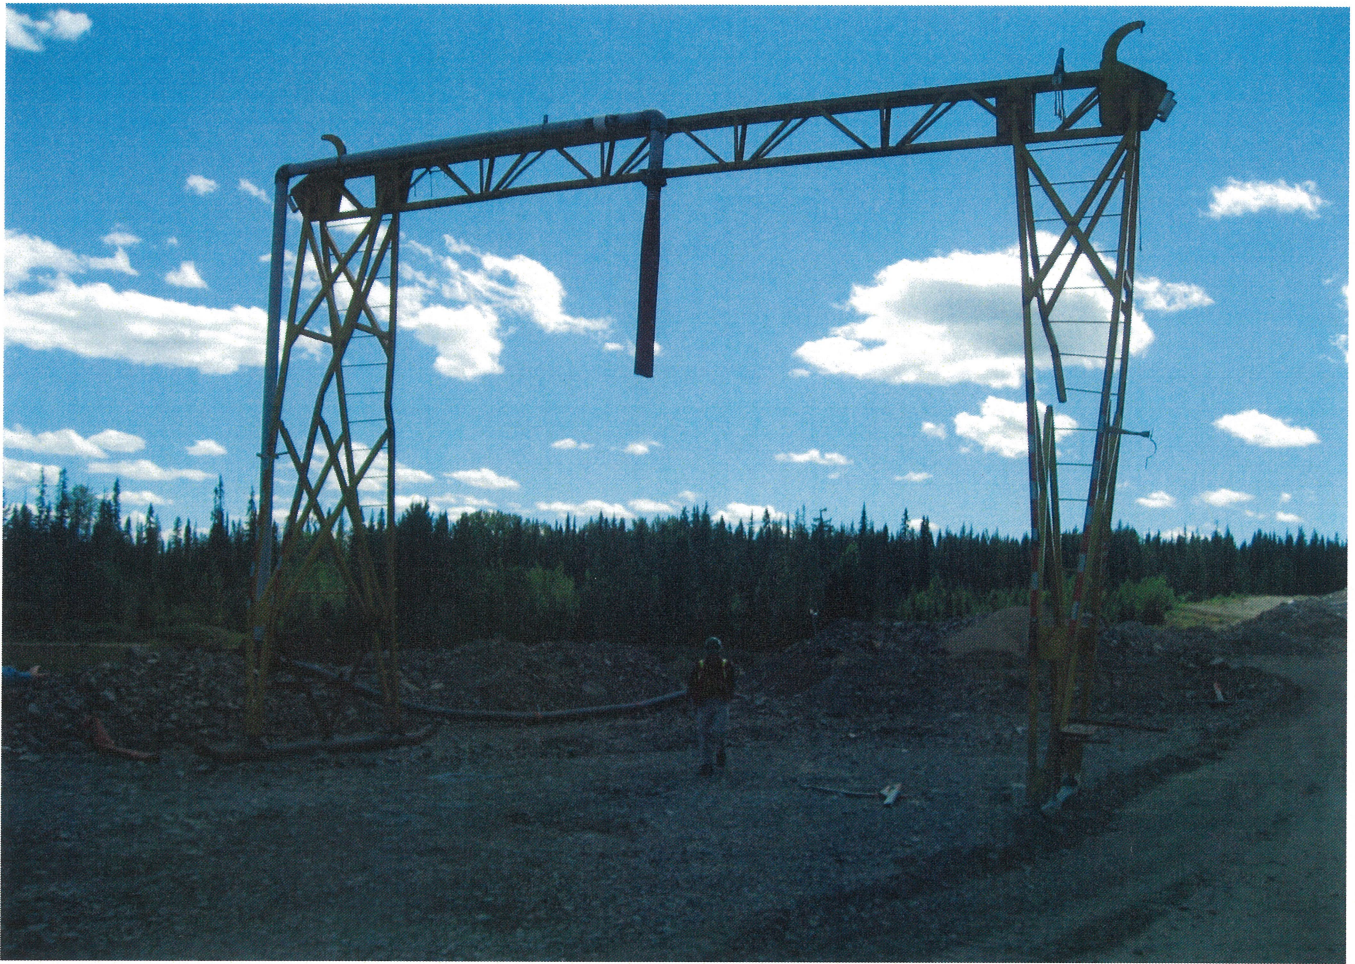
△ Station 17 (Photos 1301 to 1305)

Station 17: Seepage collection pond at toe of Main Dam. Discharge permit in place, but not discharging to environment.

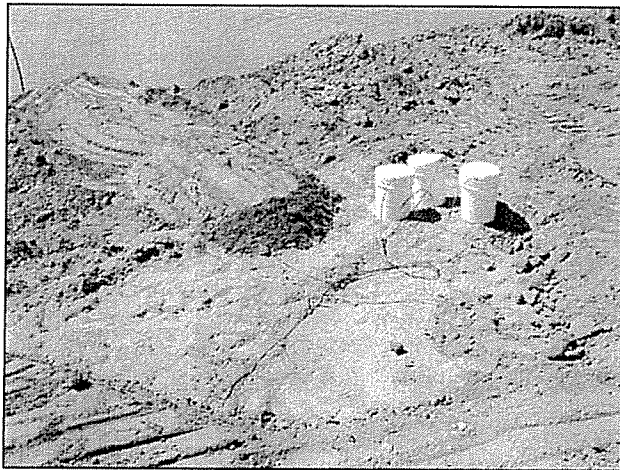
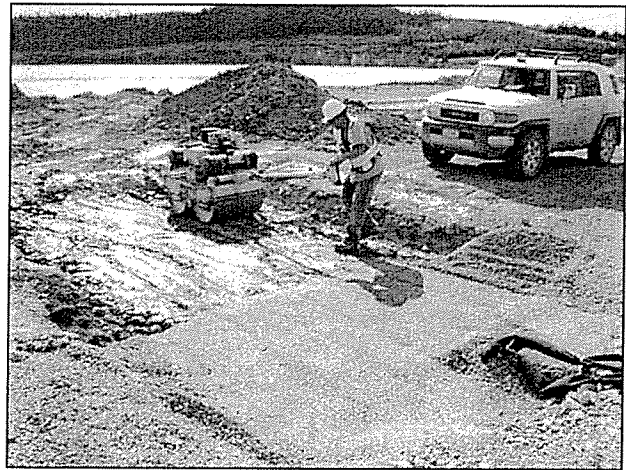
- Piezometer cables do not run completely through the Zone S material.
- Filter cloth was not placed around the wires in the Zone S material.

Photo 11 & 12: Piezometer installation on the Perimeter Embankment
