MOUNT POLLEY MINING CORPORATION
MOUNT POLLEY MINE

TAILINGS STORAGE FACILITY
REPORT ON 2008 ANNUAL INSPECTION

**TAILINGS STORAGE FACILITY
REPORT ON 2008 ANNUAL INSPECTION
(REF. NO. VA101-1/24-1)**

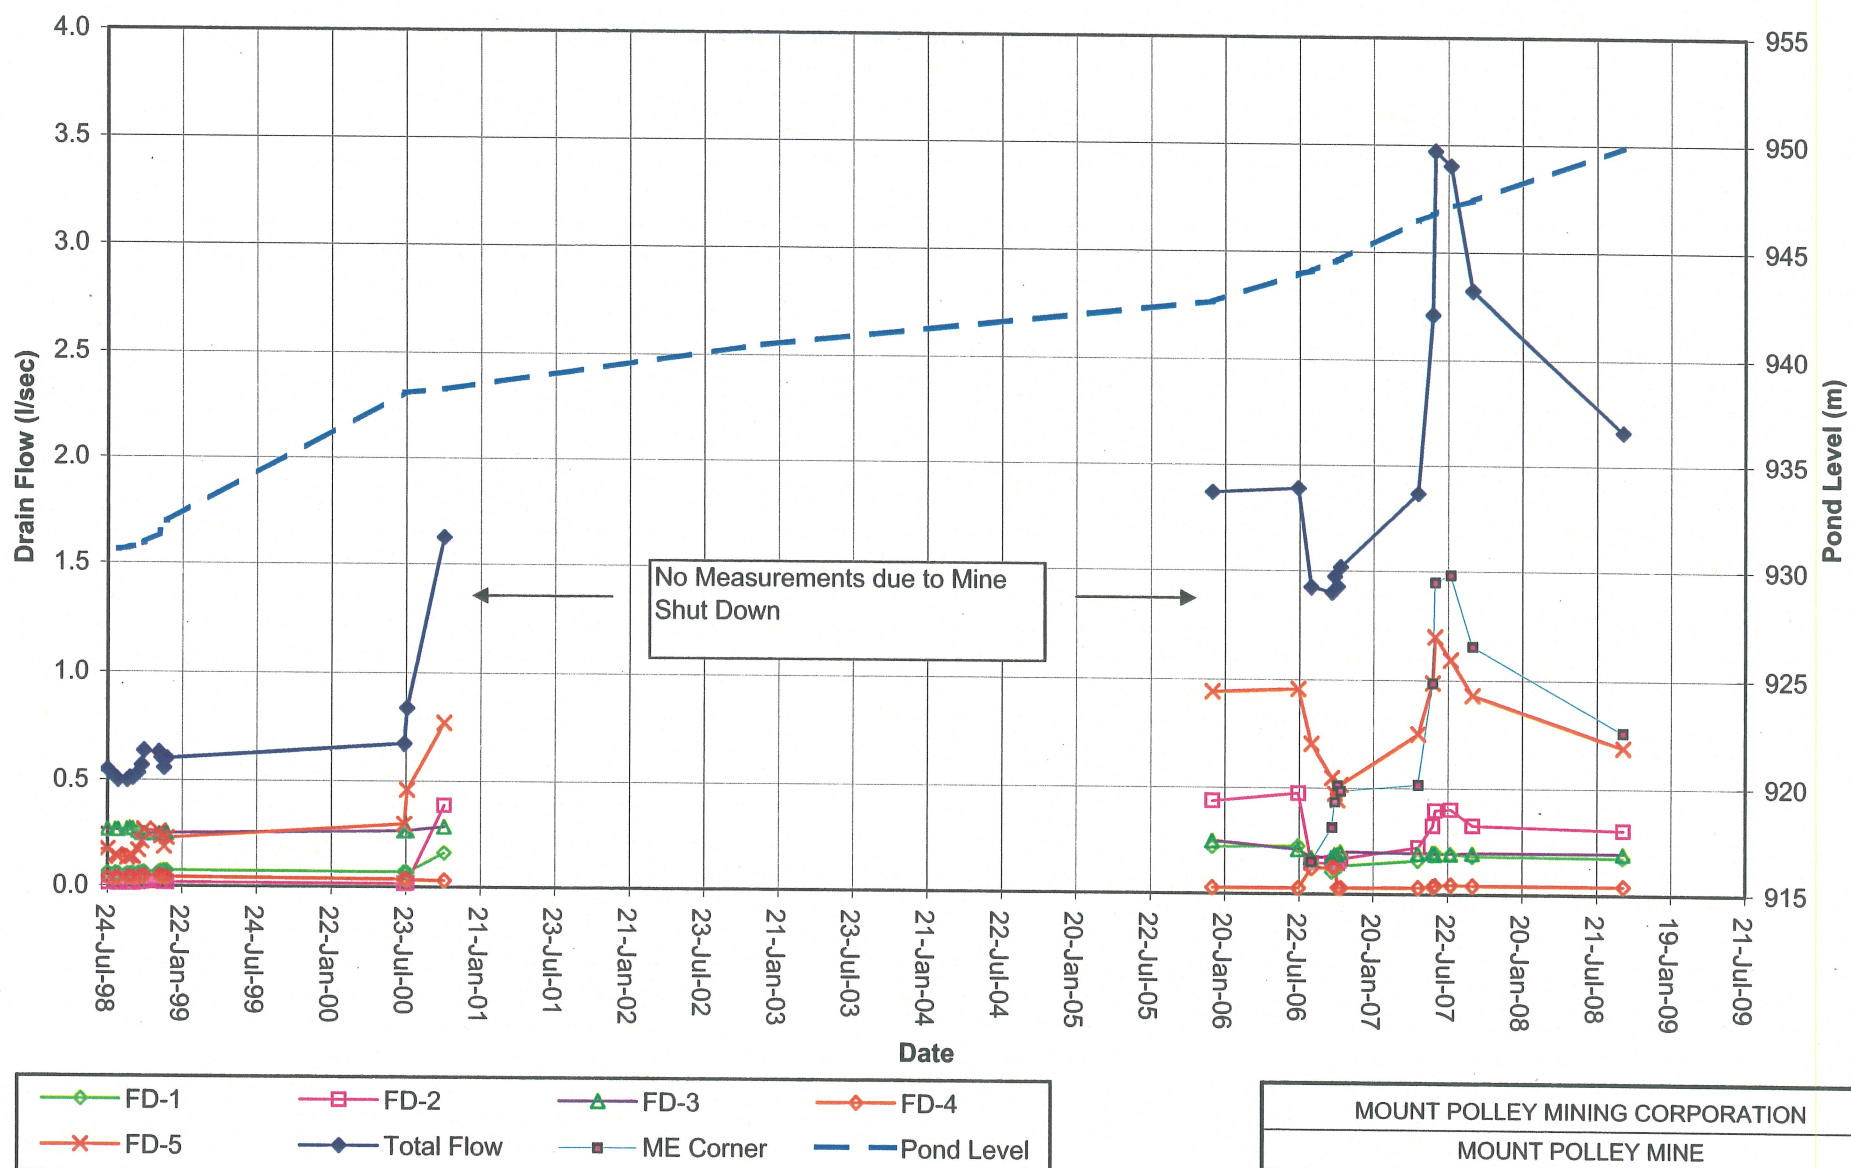
FIGURE 3.1.

The water from the foundation drains and upstream toe drains is pumped back into the TSF. The flow rates for the foundation drains are shown on Figure 3.1. The flow rates for the upstream toe drains are shown on Figure 3.2. The flows from foundation drains FD-1 to FD-5 have remained fairly constant during the past year at less than 0.4 l/s. The flows at the ME Corner foundation drain have decreased in the last year due to the development of a tailings beach in this area. The flows from the upstream toe drains fluctuate throughout the year in response to the tailings deposition location and the tailings pond location. The flow from the Main Embankment upstream toe drain averaged approximately 11 l/s during 2008 with the flow from the Perimeter upstream toe drain averaging approximately 3 l/s during 2008. The flows from the upstream toe drains have remained relatively constant, with the total flow increasing due to the commissioning of the Perimeter Embankment upstream toe drain. The water flowing from the upstream toe drains was clear.

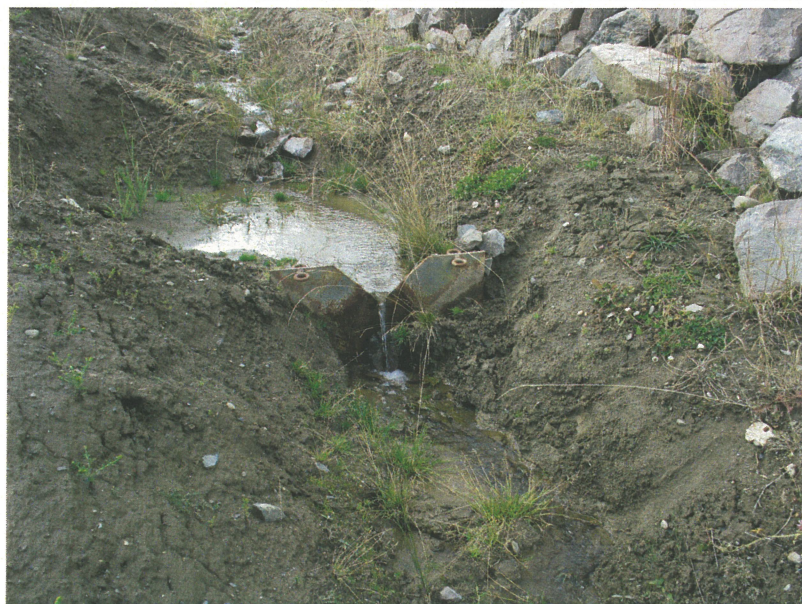
**PHOTO 3** – Main Embankment Foundation Drain flows from the ME/SE Corner.

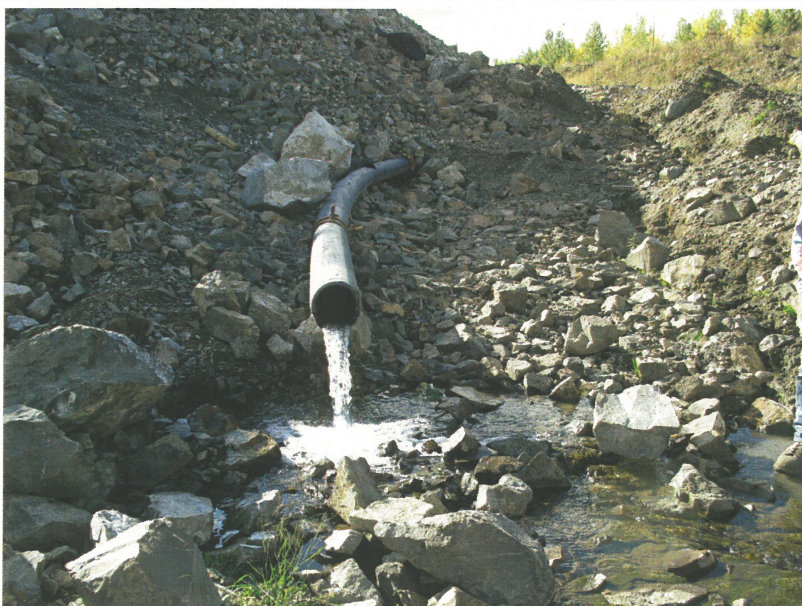
**PHOTO 4** – Perimeter Embankment Toe Drain flow running clear

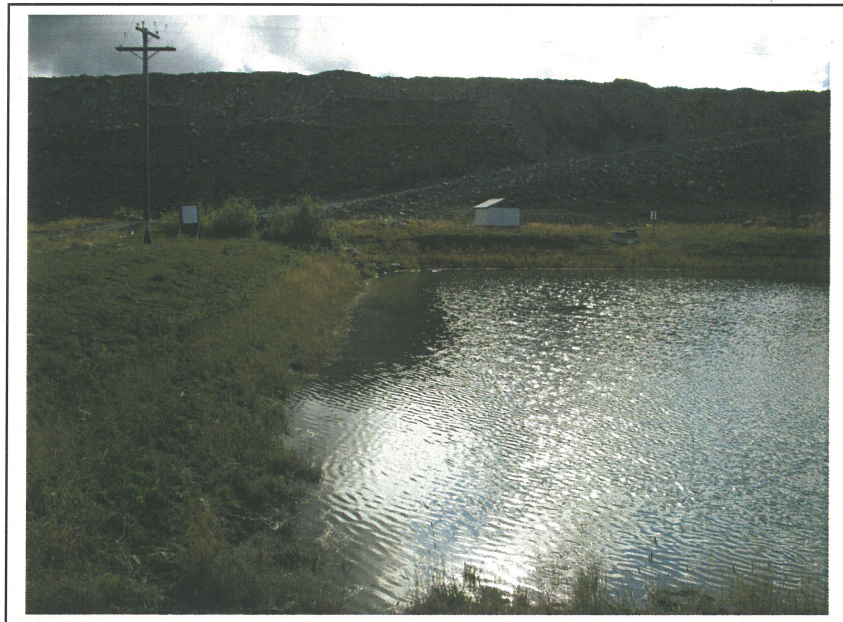
- The embankment fill slopes (inside and outside) were in good shape, with no signs of instability. No cracks were observed on the crest. No seepage or slumping of the slopes was observed.
- Grassy re-vegetation has become well established on the downstream embankment slopes.

**PHOTO 8** – Perimeter Embankment looking south, showing access ramp to PE seepage pond

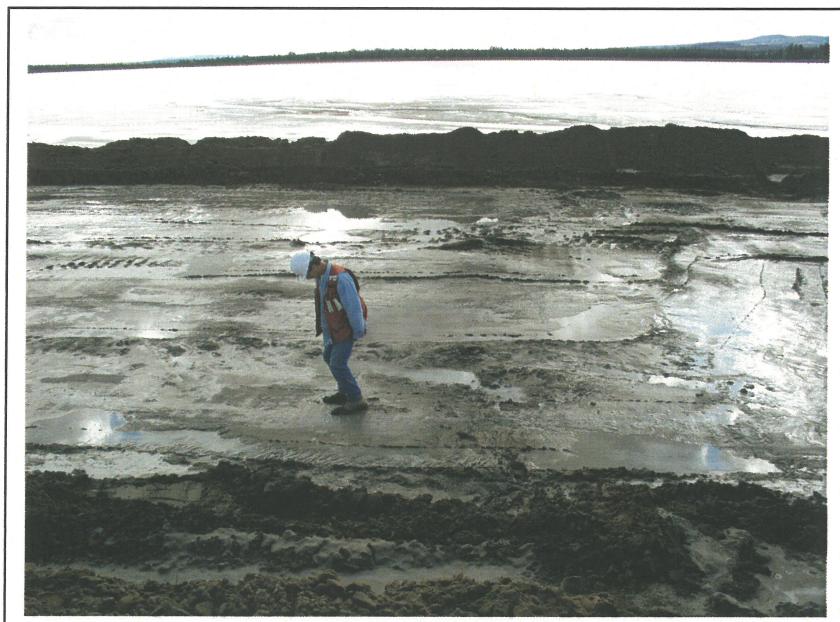
**PHOTO 11** – Recently completed Sand Cell

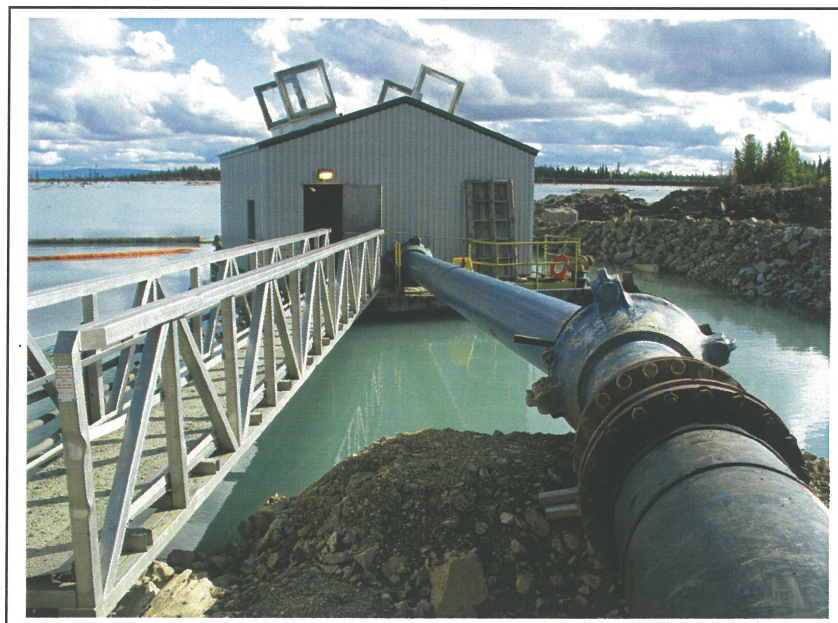
The reclaim pipeline was recycling supernatant water back to the mill for use in the process at the time of the inspection. There have been no reported problems with the reclaim pipeline and the pipeline was observed to be in sound condition.

**PHOTO 12** – Pump barge and reclaim pipeline

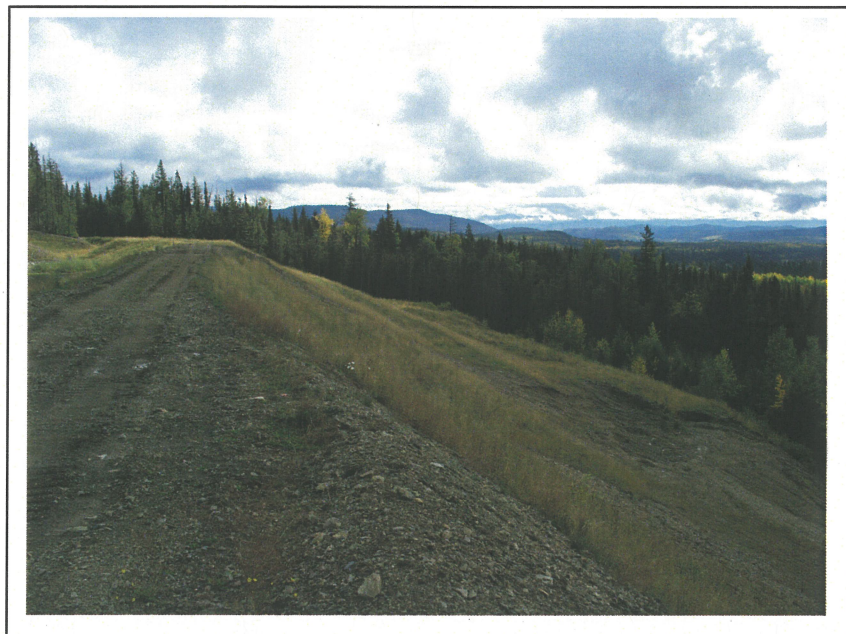
The Southeast Sediment Pond, Millsite Sump, and South Bootjack Dam were observed to be in good condition with no geotechnical issues outstanding. The Southeast Sediment Pond is no longer in service and runoff that previously reported to the Southeast Sediment Pond is now being routed to the Perimeter Embankment Seepage Collection Pond.

**PHOTO 16 – Southeast Sediment Pond Downstream Slope**

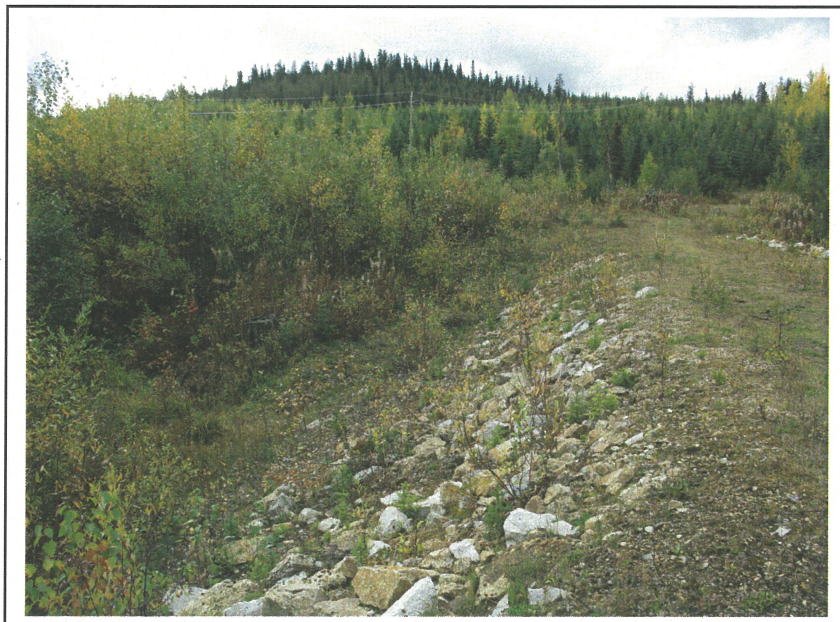
- The water level was low.
- Both upstream and downstream fill slopes were in good condition, with no evidence of seepage or slumping.
- No cracks were observed on the dam crest.
- The spillway contained some minor vegetation, but was generally unobstructed.

**PHOTO 18 – South Bootjack Dam**
