**MOUNT POLLEY MINING CORPORATION
MOUNT POLLEY MINE**

**REPORT ON
2000 AND 2001 ANNUAL INSPECTION
(REF. NO. 11162/14-2)**

Knight Piésold
CONSULTING

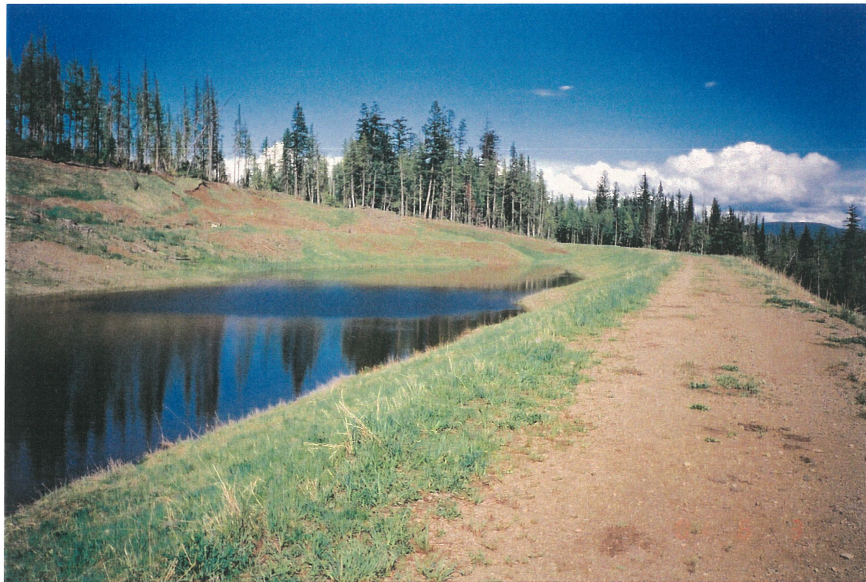
PHOTO 1: Southeast Sediment Pond – Looking East

Seeps were observed in the northwest fill slope of the Southeast Sediment Pond embankment. Seeps have been observed in this area since 1997. Additional seeps were observed further east and in an area where waste material and a topsoil pile is located. All seepage was observed to be clear, indicating that no erosion of fill materials was occurring. The seeps are likely attributed to an elevated groundwater table, which is temporarily higher during the freshet season. Tension cracks at the waste and topsoil pile have been reported in the past; however, no further signs of instability were observed during the inspection. The vegetation on the slopes of the waste dump and topsoil pile were observed to be well established.

- The pond level was at the normal operating level at the time of the inspection.
- The seeps observed in the northwest fill slope during previous inspections were once again present. All seepage was clear, indicating that no erosion of the fill was occurring.
- The embankment fill slopes are in good condition, with no new signs of instability.

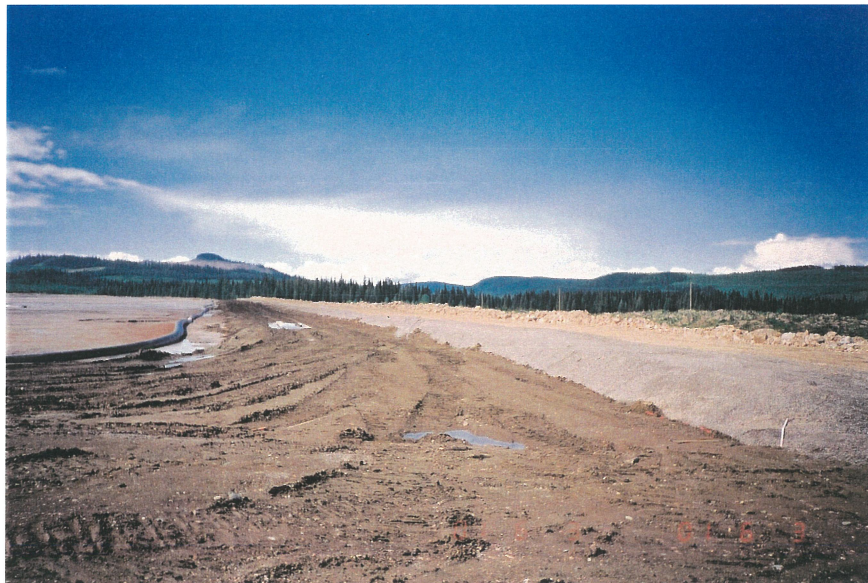
PHOTO 2 – Perimeter Embankment from Main Embankment –
Looking North

- No cracks were observed on the crest. The fill slopes for the Main and Perimeter Embankments exhibited no signs of instability, although the

- The Tailings Storage Facility embankments were observed to be in good condition. No seepage or slumping was observed. Saturated loose material on downstream slopes at the Perimeter Embankment must be removed prior to the next phase of construction. The embankment stability has been confirmed using updated geometry and material parameters.

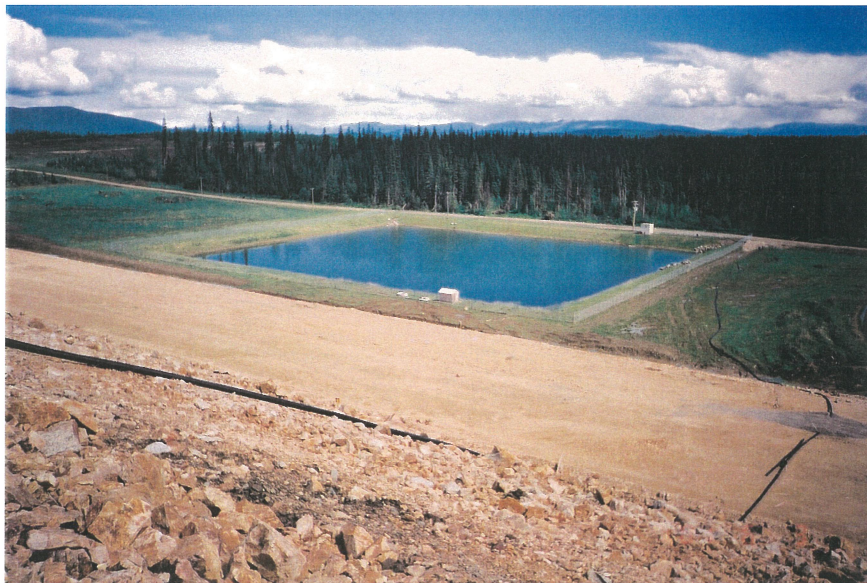
PHOTO 4: Main Embankment Seepage Collection Pond from Main Embankment Crest- Looking South

- The Seepage Collection Pond recycle pipelines at both the Main and Perimeter Embankments were discharging well upstream of the embankments and no erosion at the upstream toes of the embankments were observed. The Seepage Collection Ponds (SCPs) for the Main and Perimeter Embankments were observed to be in good condition. Minor erosion was observed on the north slope of the Main Embankment SCP, but no other evidence of wear was observed. The maximum pond levels were well below the overflow culverts and MPMC reported no uncontrolled discharges from the SCPs.

- The Seepage Collection Ponds were operating normally. Flow monitoring of the Foundation Drains and Upstream Toe Drain was carried out throughout the past winter and were found to be within seasonal flow ranges.

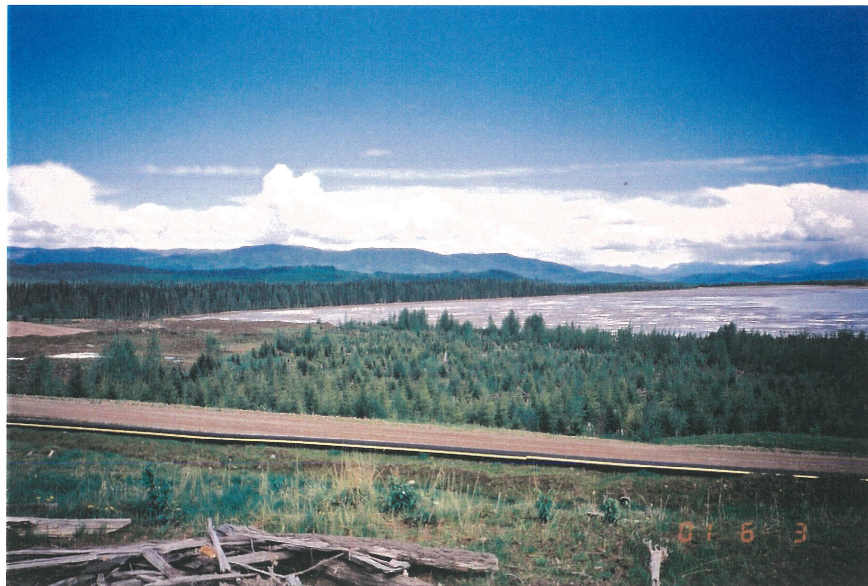
PHOTO 8: Perimeter Embankment Left Abutment and Reclaim Line – Looking East

- No unexpected or uncontrolled seepage was observed from the embankments, including the fill slopes and foundations, with the exception of trapped local runoff filtering through the Zone T haul road at the left abutment of the Perimeter Embankment. This seepage is discussed in Section 3.5.

Some seepage was observed at the left abutment of the Perimeter Embankment, but the source of this seepage is water from a ditch adjacent to the Polley Lake pipeline access road. It is believed that this water originates from rainfall and local runoff from the surrounding area. The culvert that transfers water under the road and into the ditch to the Perimeter Embankment Seepage Collection Pond is slightly elevated and water pools at the inlet. This causes the seepage which exits at the base of the embankment but seeps back into the Zone T road and the ditch at Setting Out Point S7. The observed flow rate is very low and the water is clear. The area below the embankment at this location is scheduled to be covered with material during Stage 3B Construction.

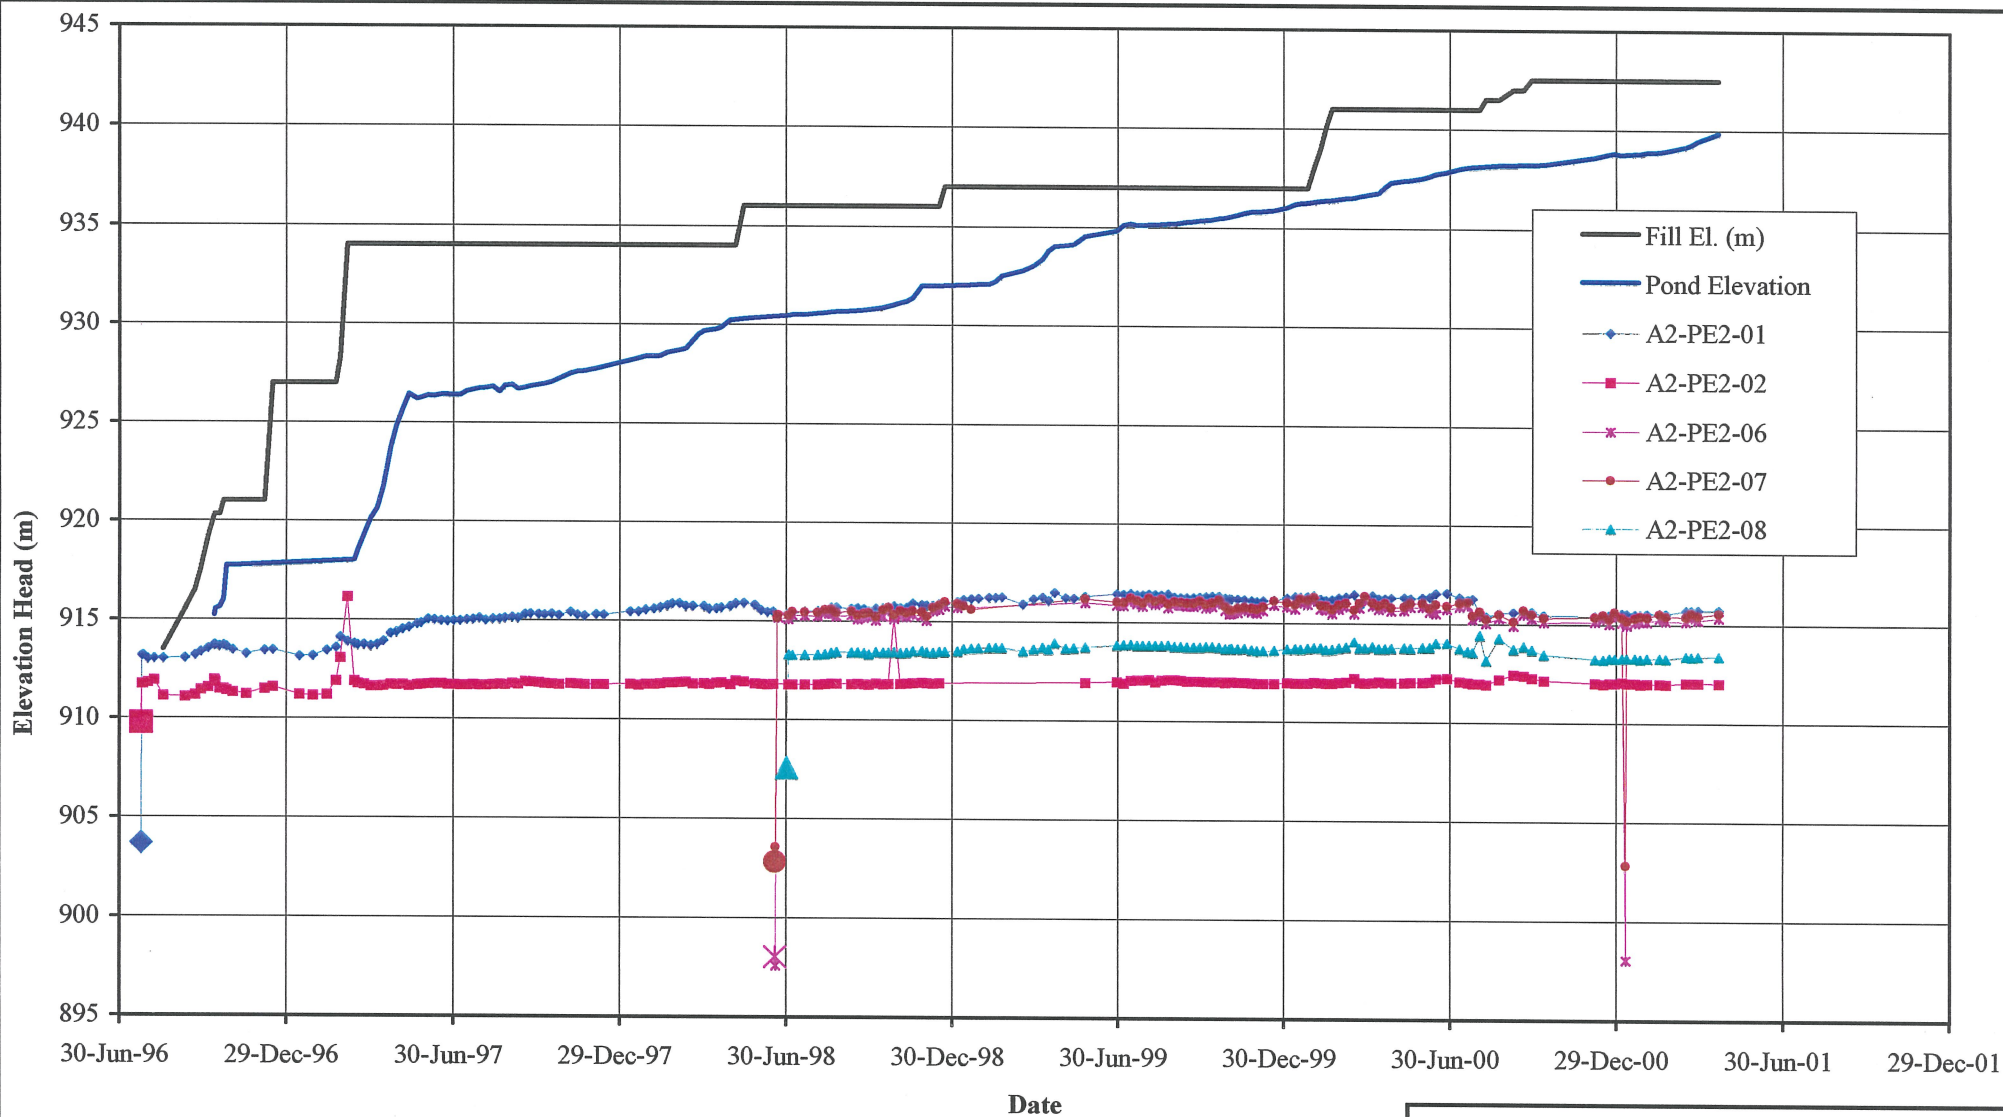
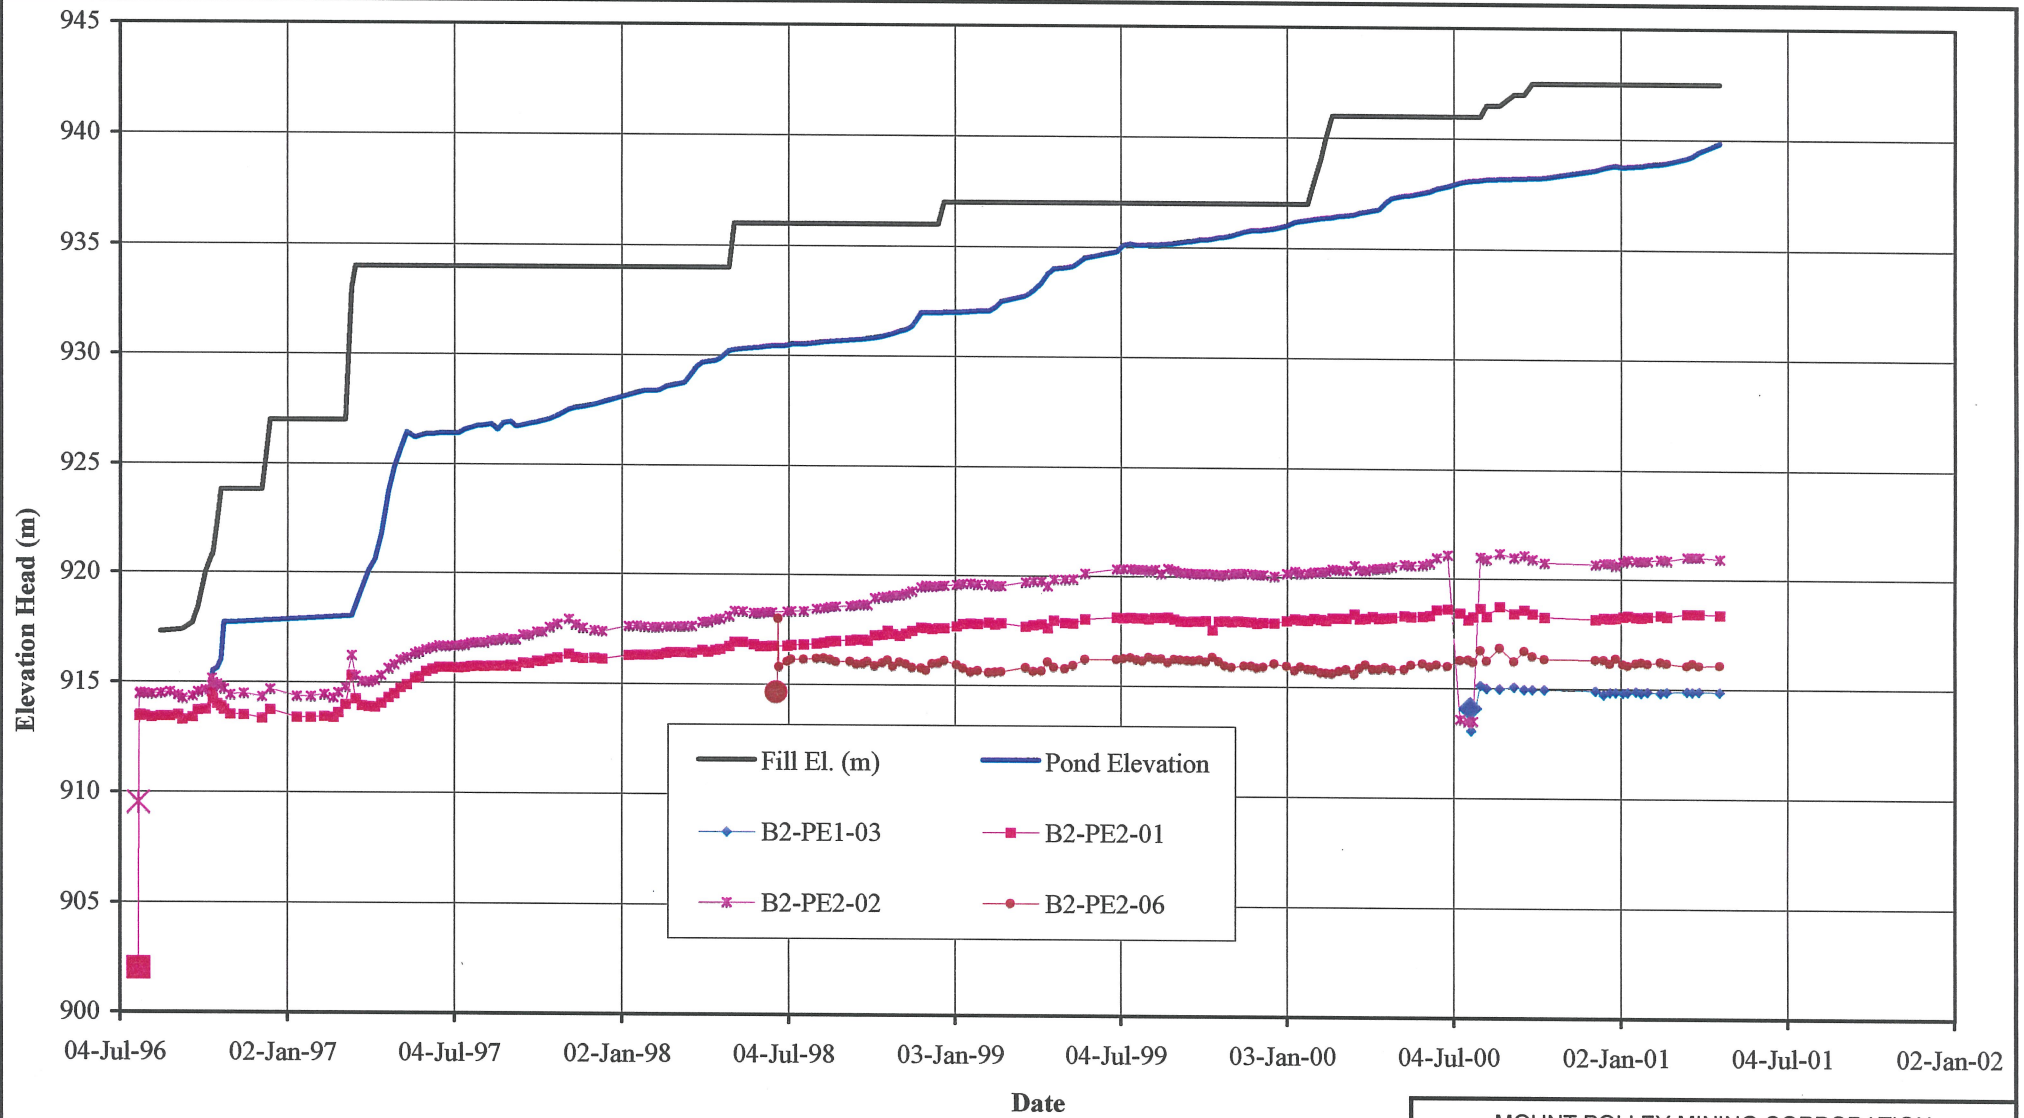
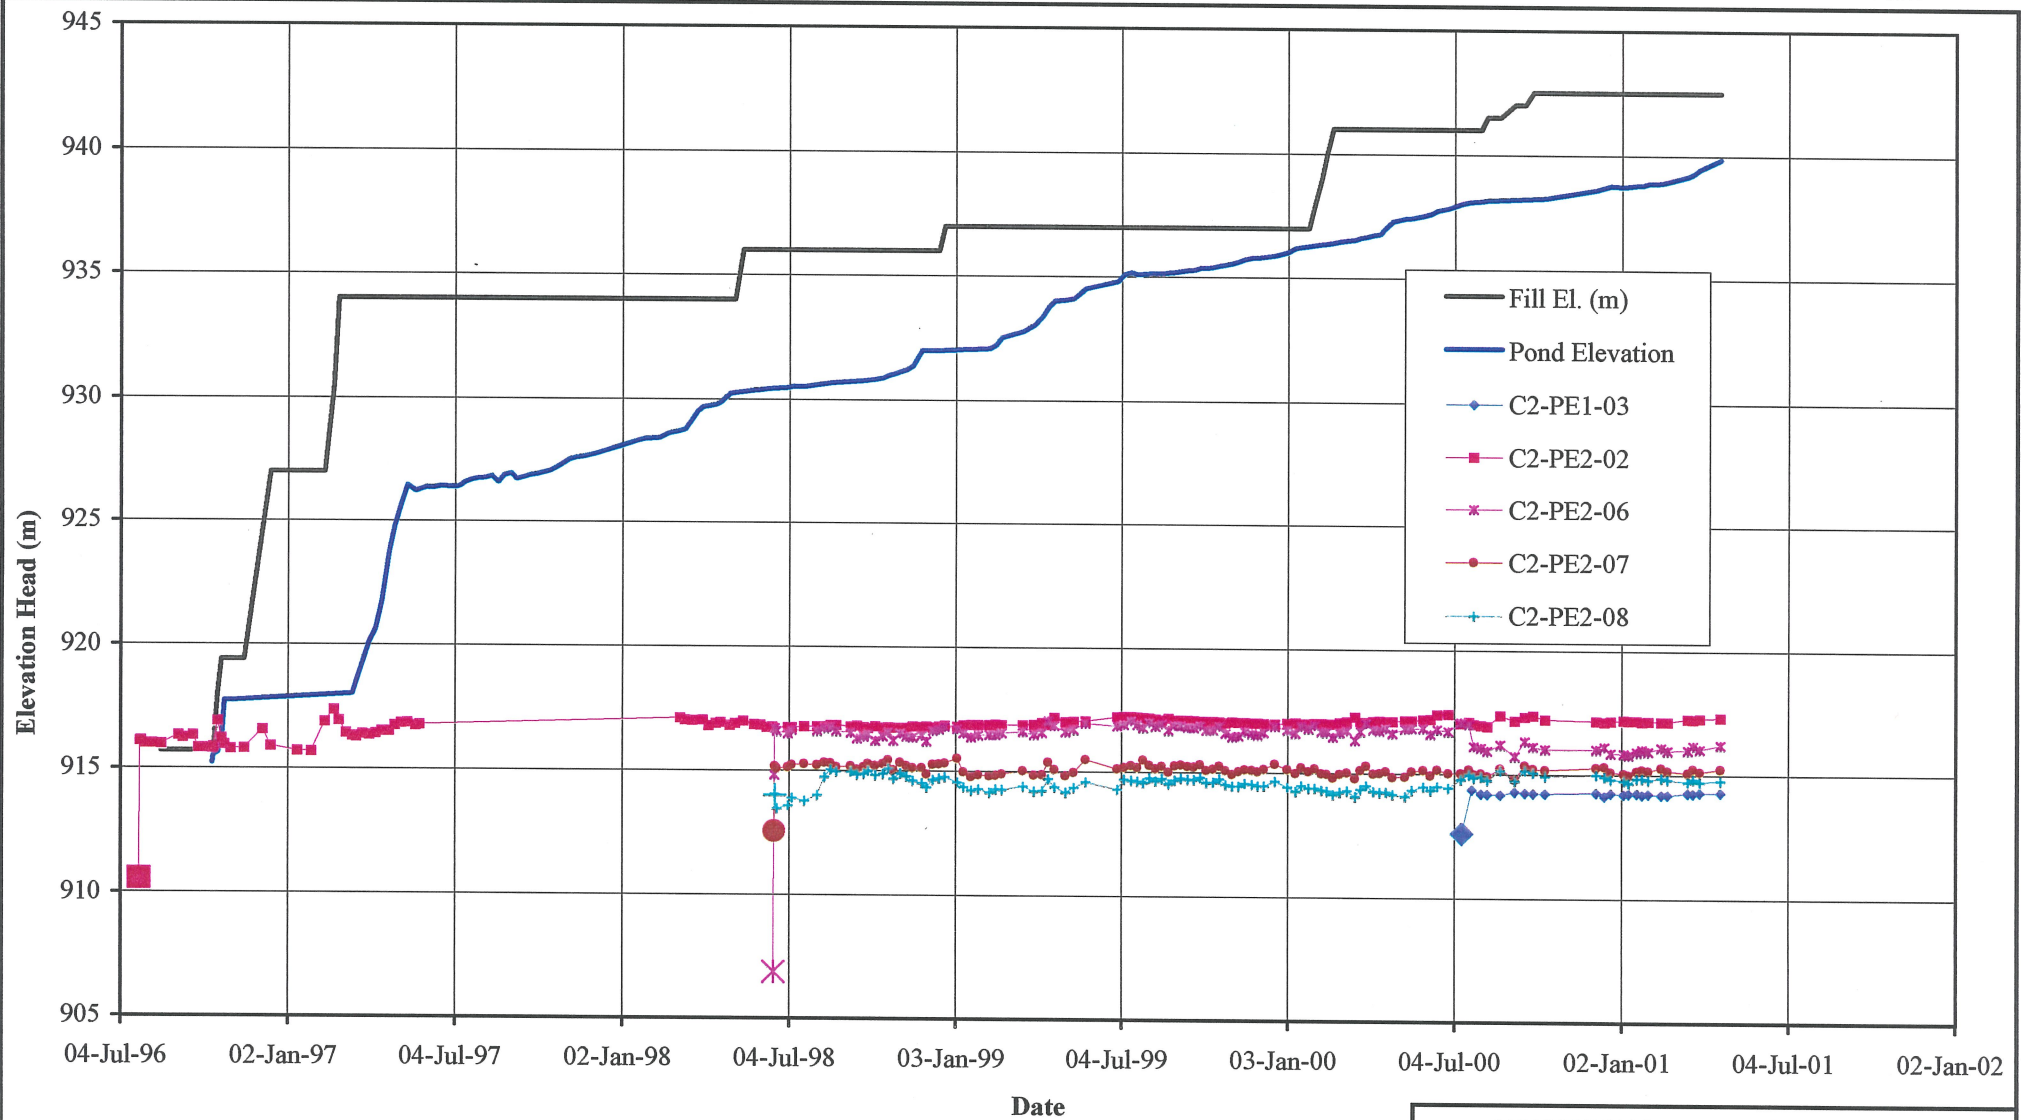
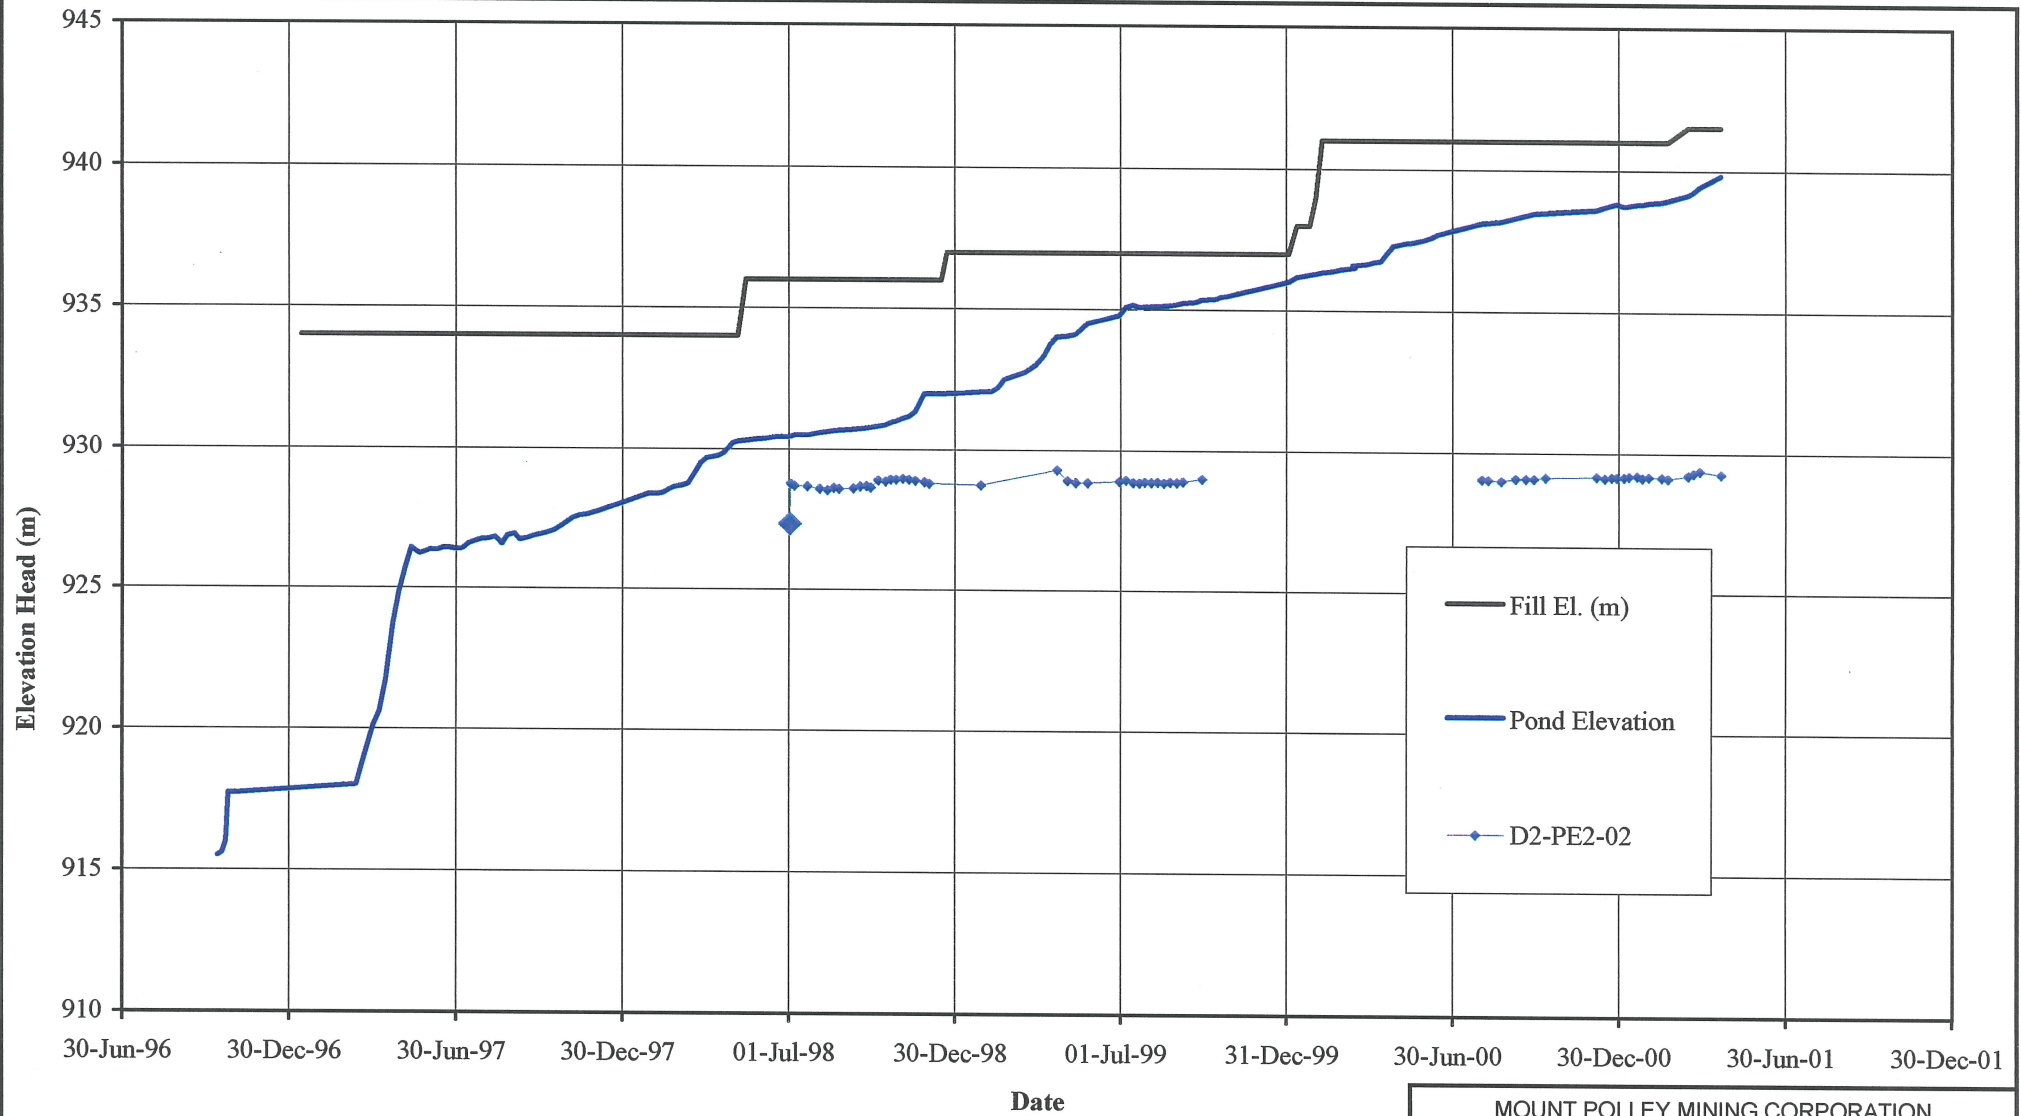
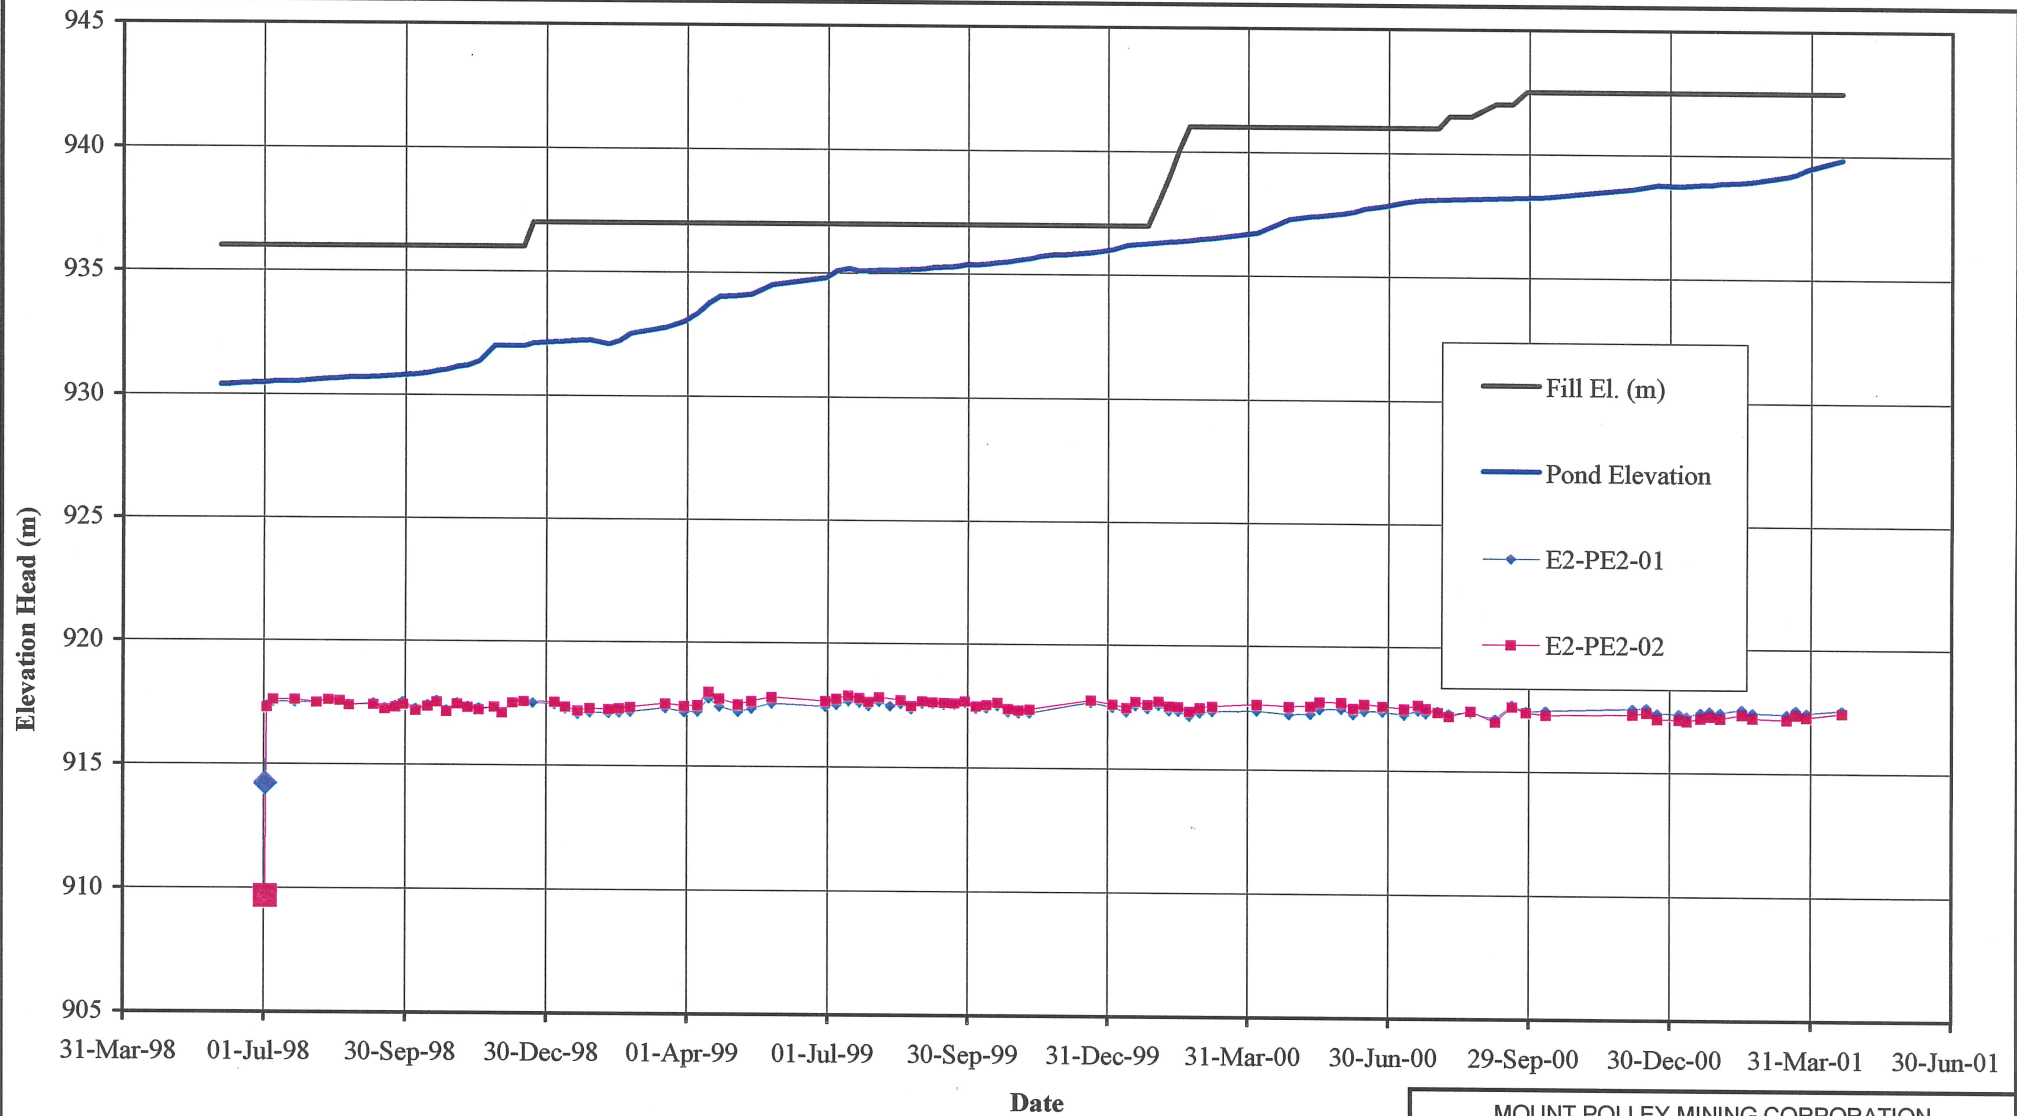
EMBANKMENT FOUNDATION PIEZOMETER RECORDS

Artesian conditions are present in the foundation under the Main Embankment. The piezometers in this area are used to monitor the pore pressures and to confirm that they remain below the threshold level of 6 metres above ground level. No unexpected high pore pressure increases were noted during the reporting period. The table below summarizes the artesian head values (above ground surface level) reached during the reporting period.

Although the highest level recorded is 4.1 m, none have reached the foundation piezometer trigger level of 6.0 m artesian pressure relative to original ground. All stability analyses completed at the Main Embankment use an artesian

It has been noted that artesian pressures have typically developed in the deeper piezometers, at elevations below El. 910 m. This corresponds roughly to the top of the glaciolacustrine/glaciofluvial material and these artesian pressures are therefore not unexpected (Planes A, B and C). It should also be noted that no artesian conditions have been encountered at Plane E, where coarser glaciofluvial material is present.

Another trend that has developed is that many of the pore pressures of the foundation piezometers have increased slightly over time. This is likely due to tailings deposition and rising pond level over the life of the mine.
