MOUNT POLLEY MINING CORPORATION
MOUNT POLLEY MINE

TAILINGS STORAGE FACILITY
REPORT ON 2002 ANNUAL INSPECTION
(REF. NO. VA101-00001/3-1)

Knight Piésold Ltd.

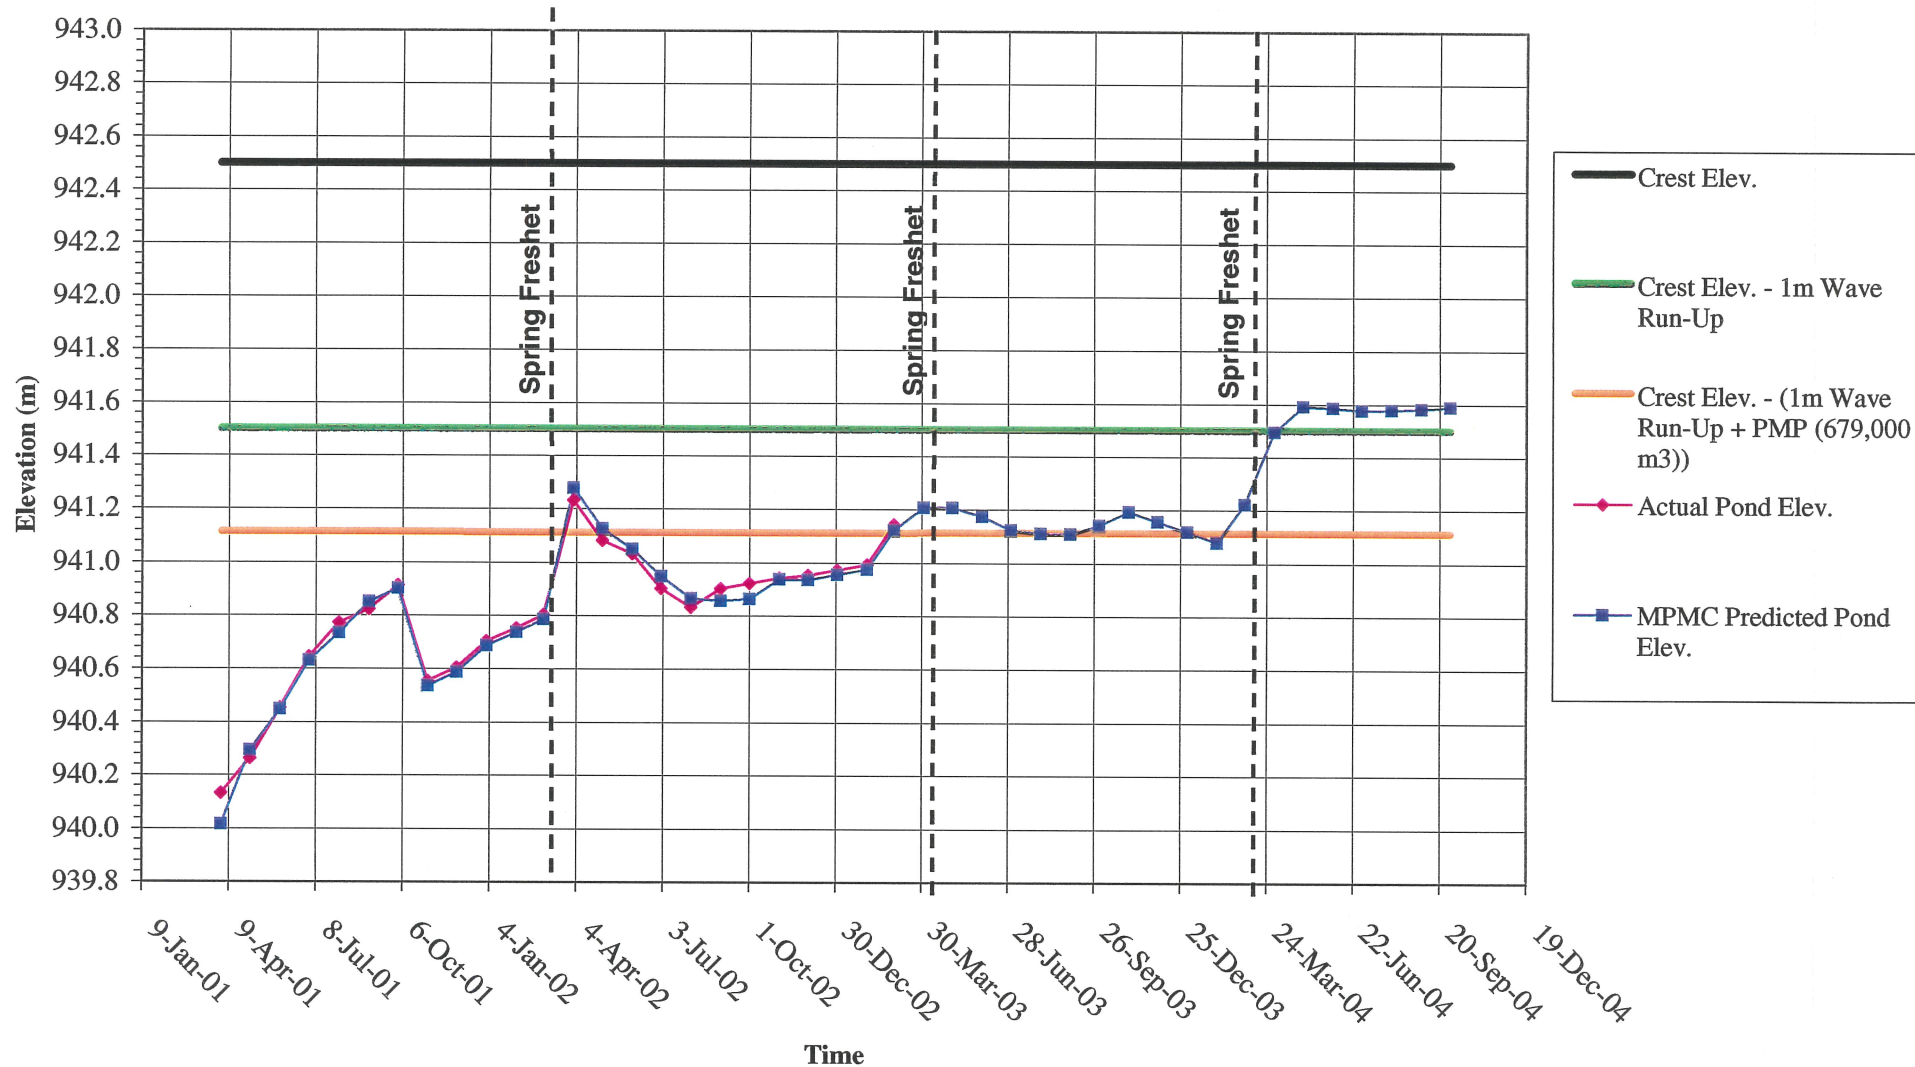
- 1) Pumping took place during Oct 2001 (483,000 cubic metres) & May 2002 (513,000 cubic metres).

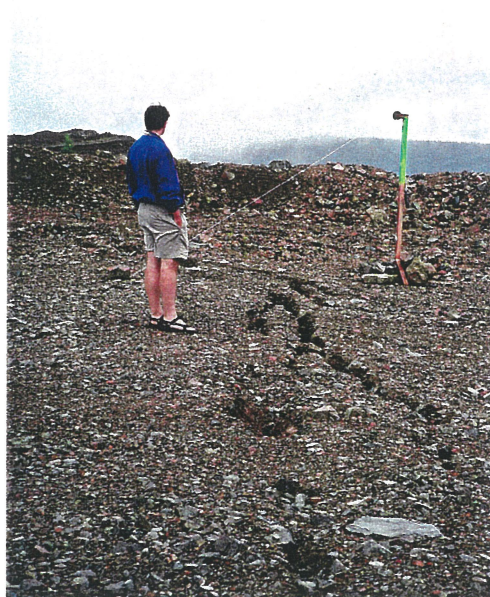
PHOTO 10: Tension cracks along east side of Waste Dump

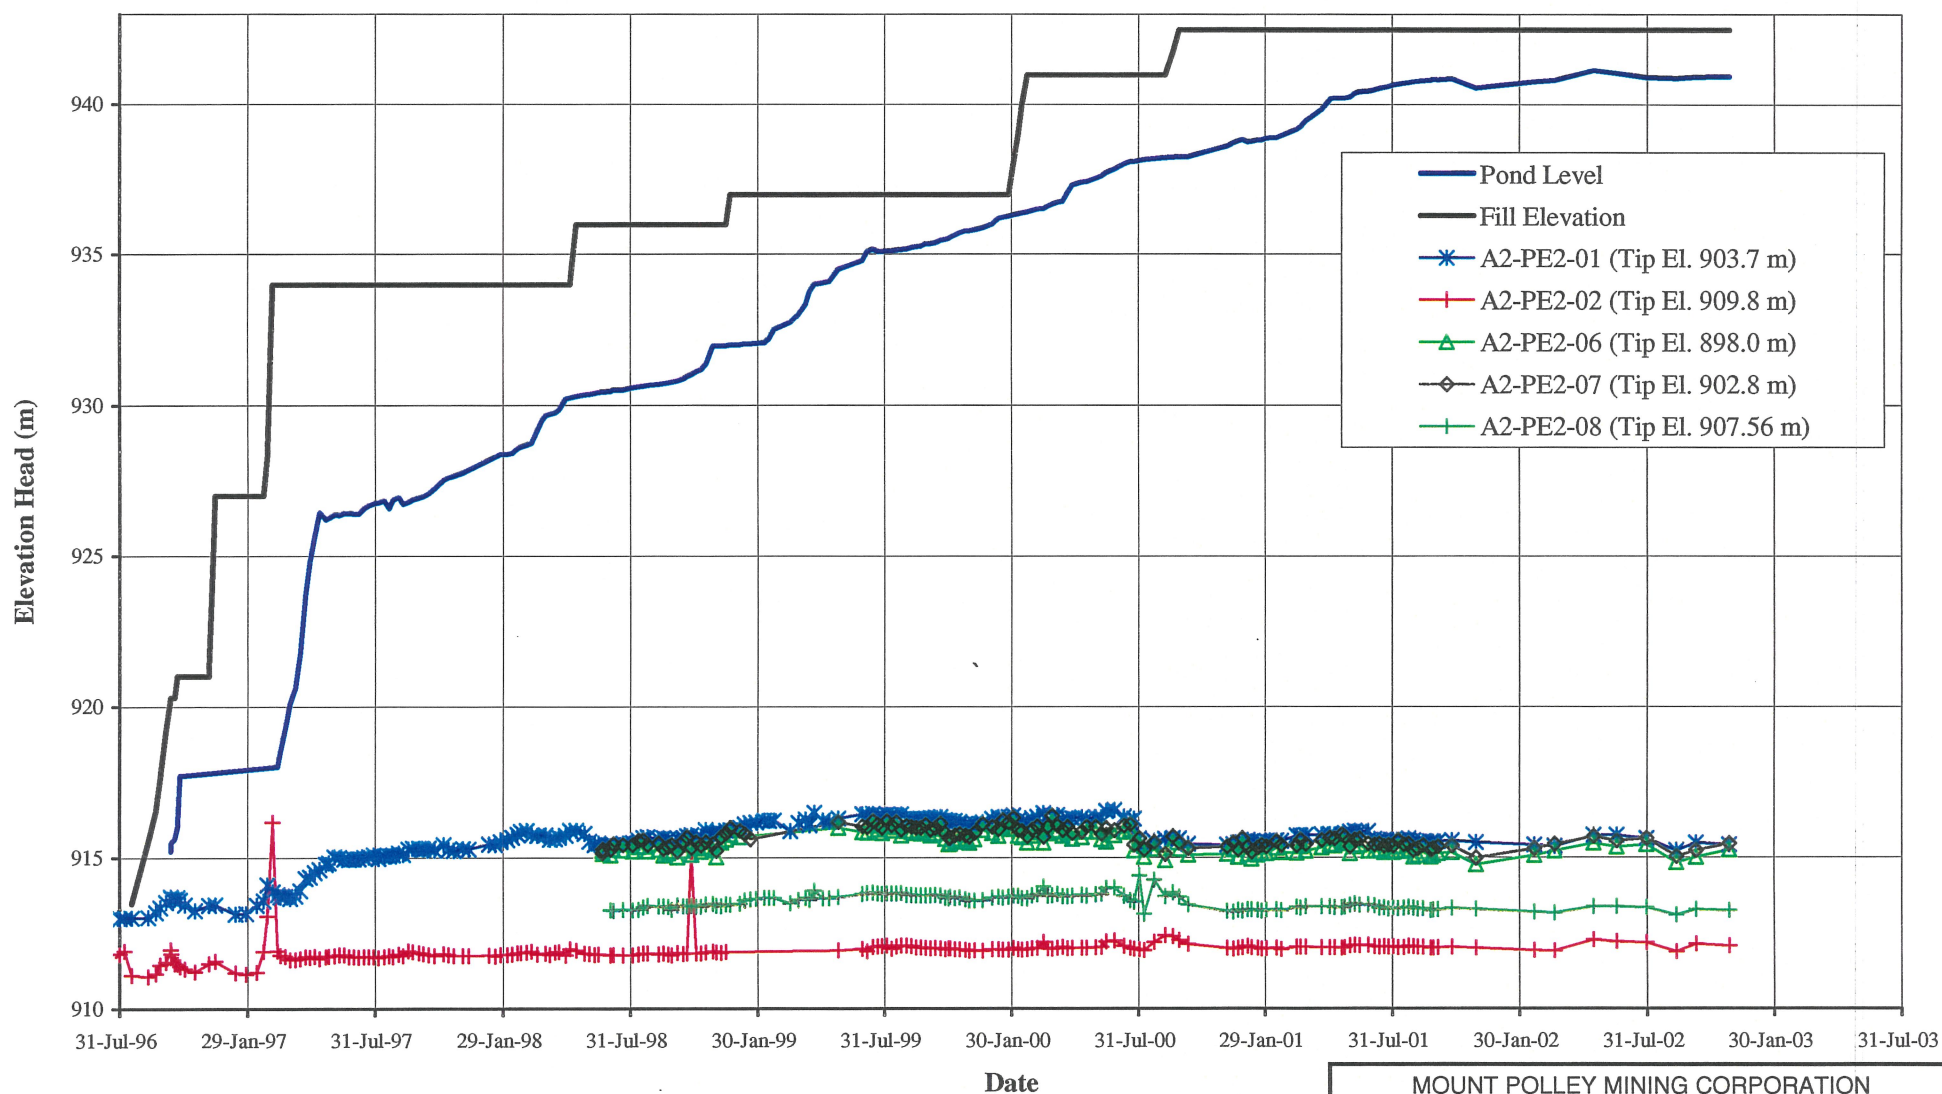
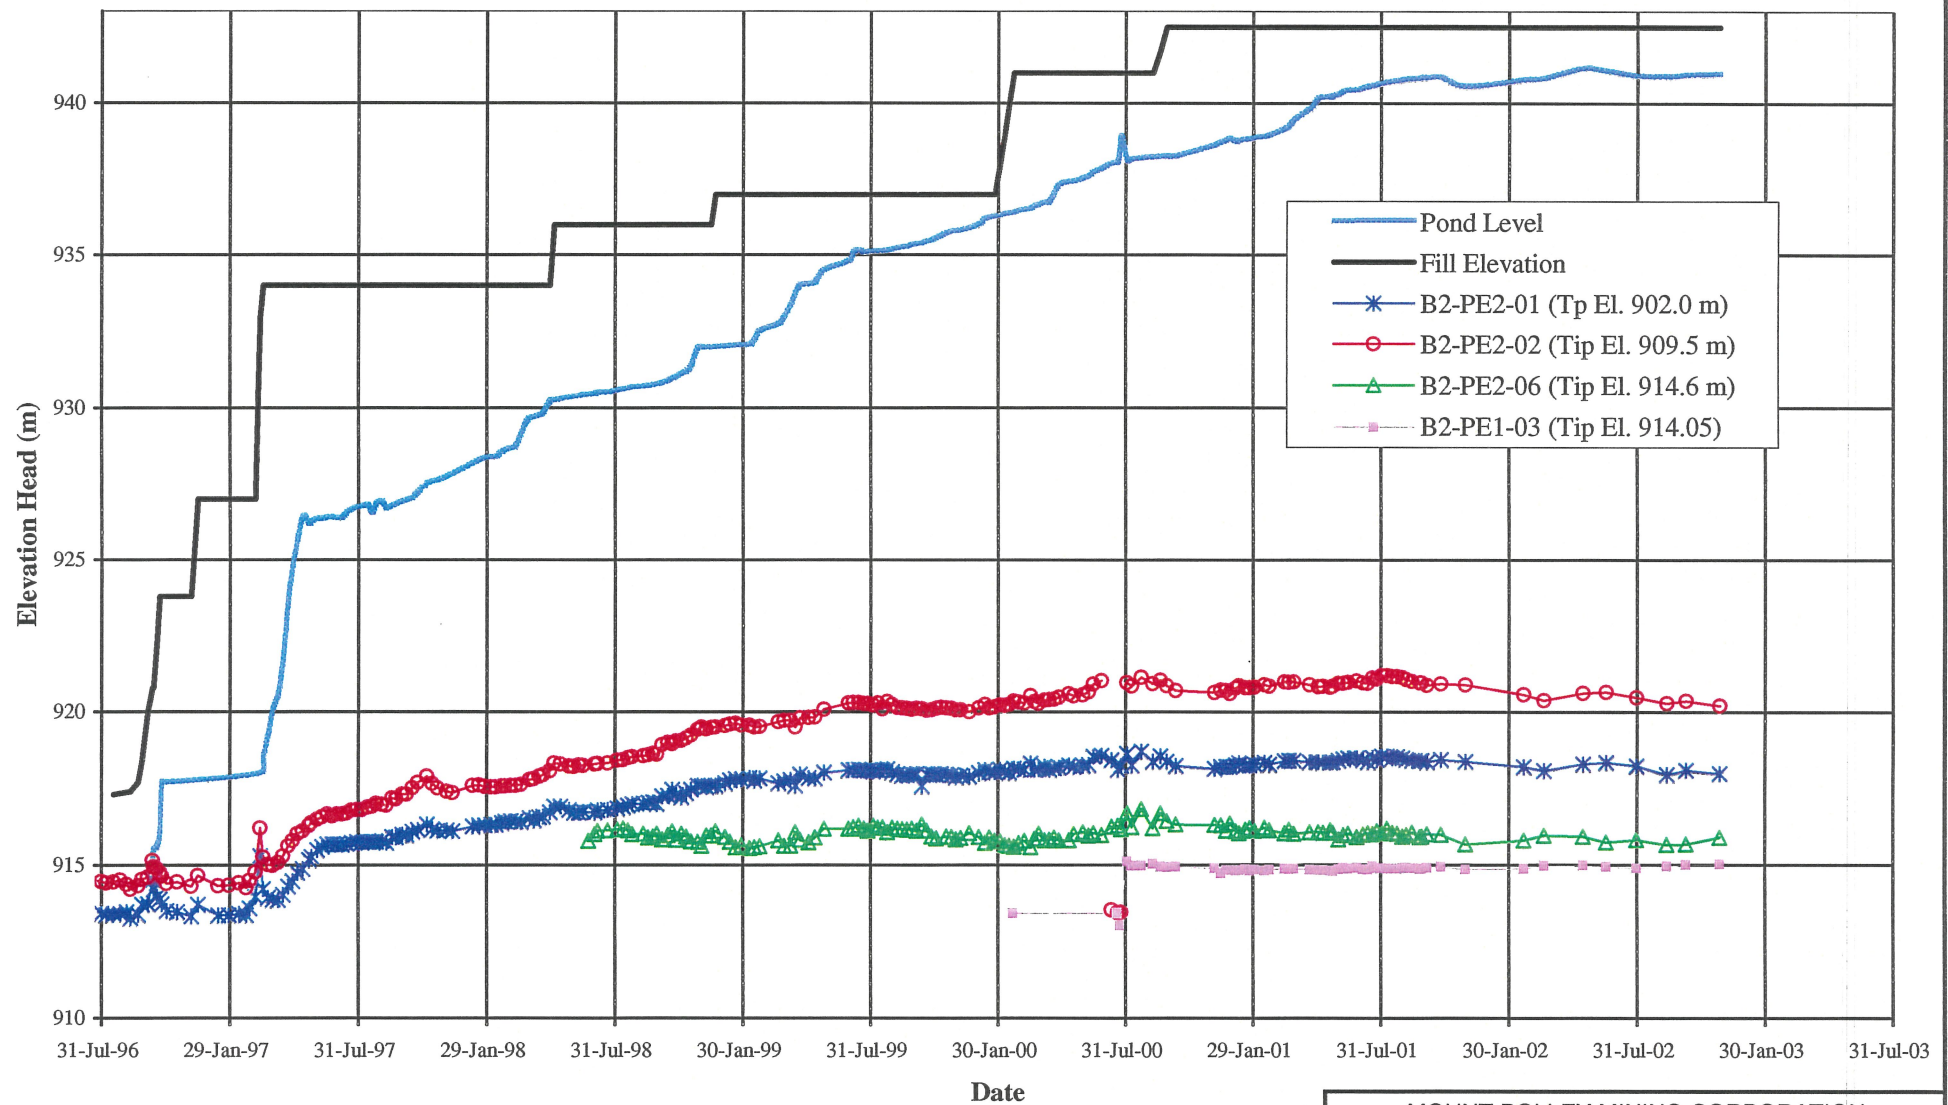
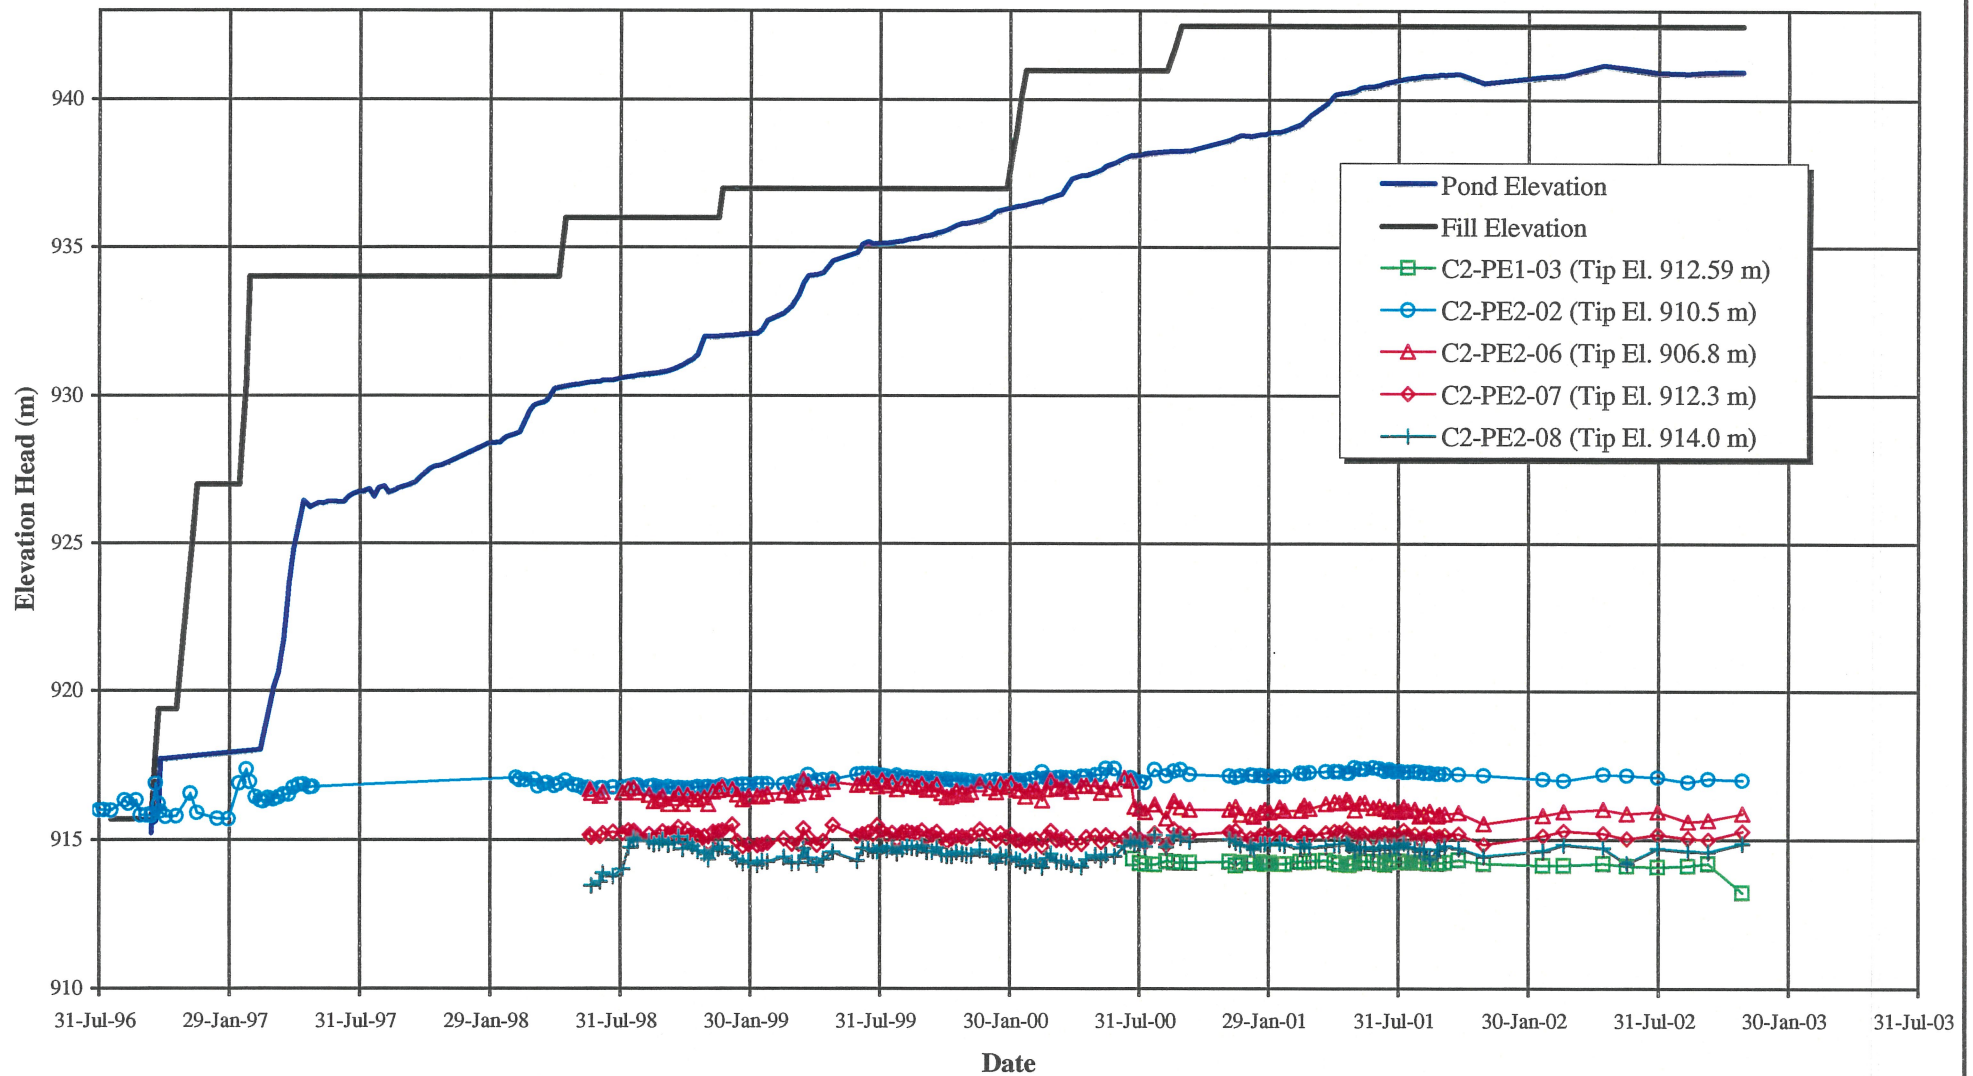
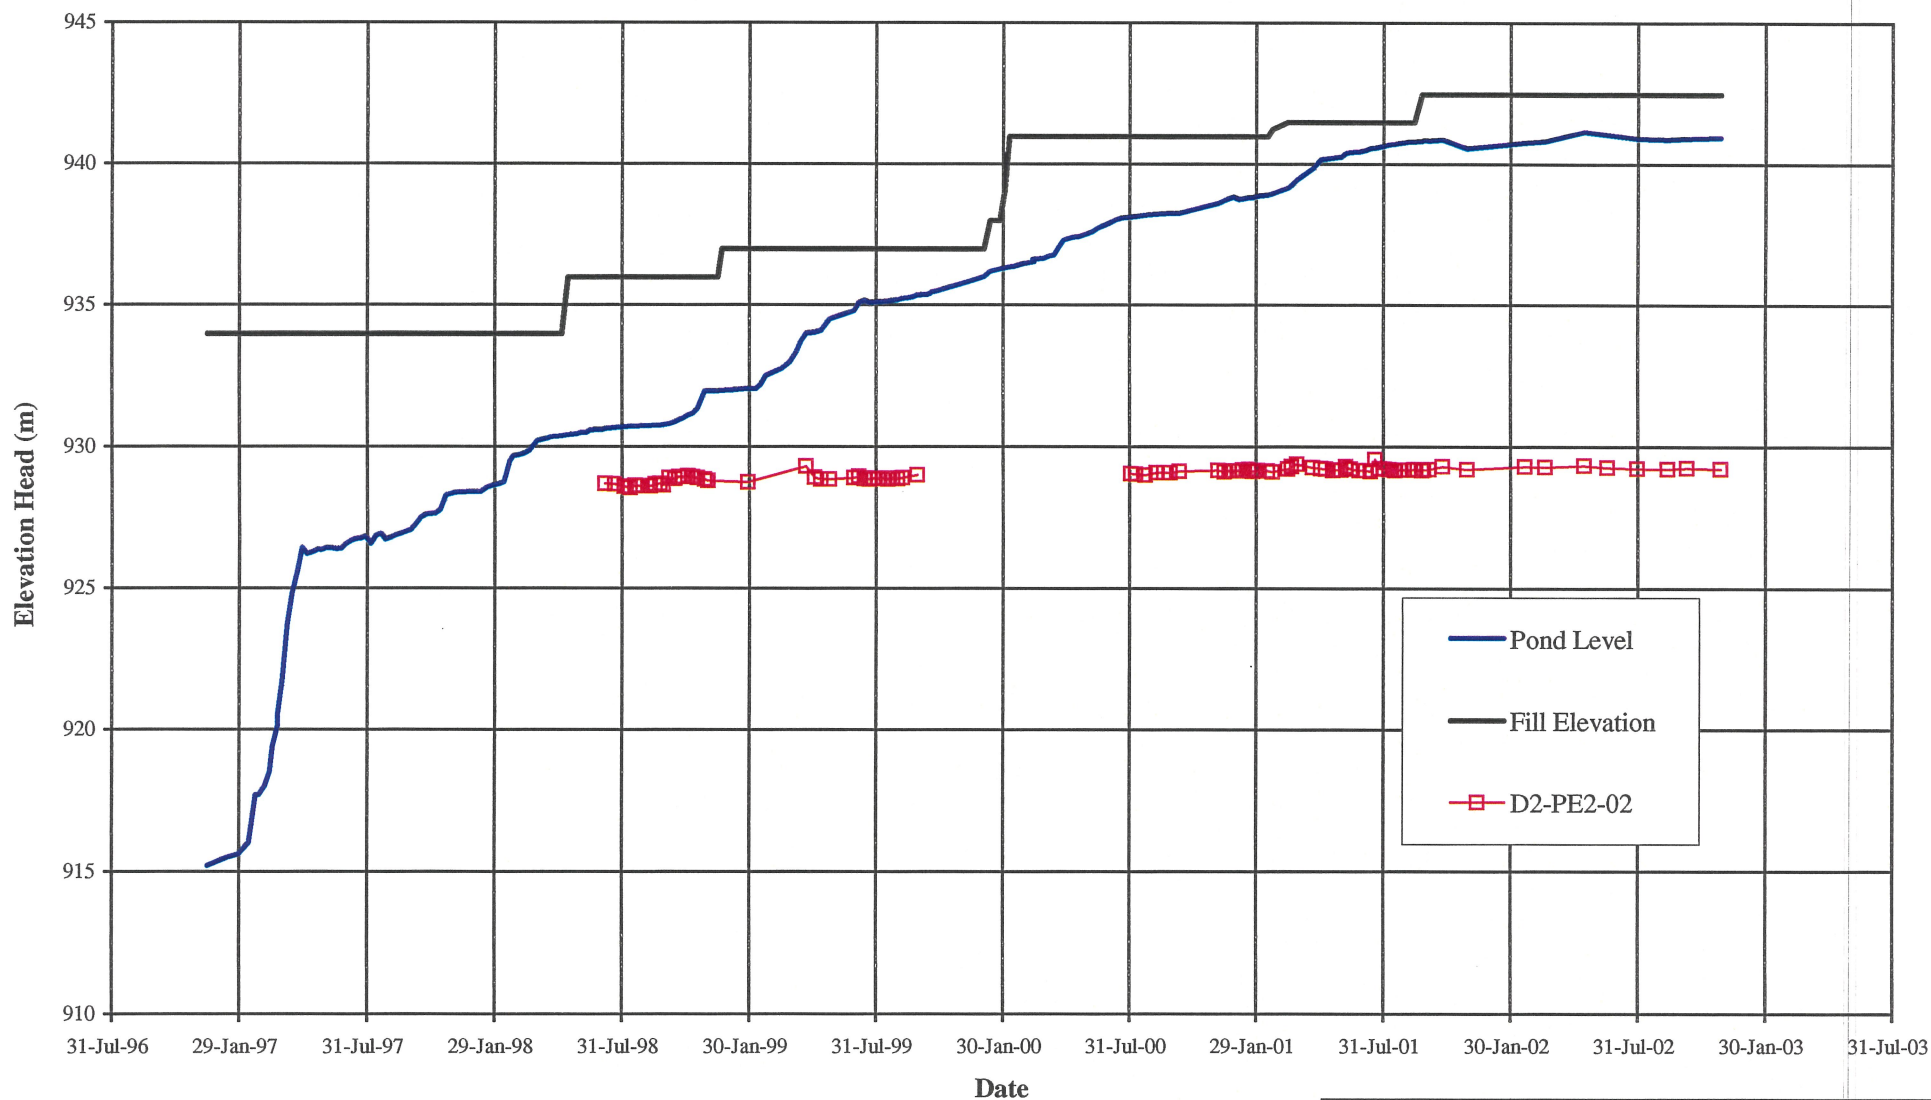
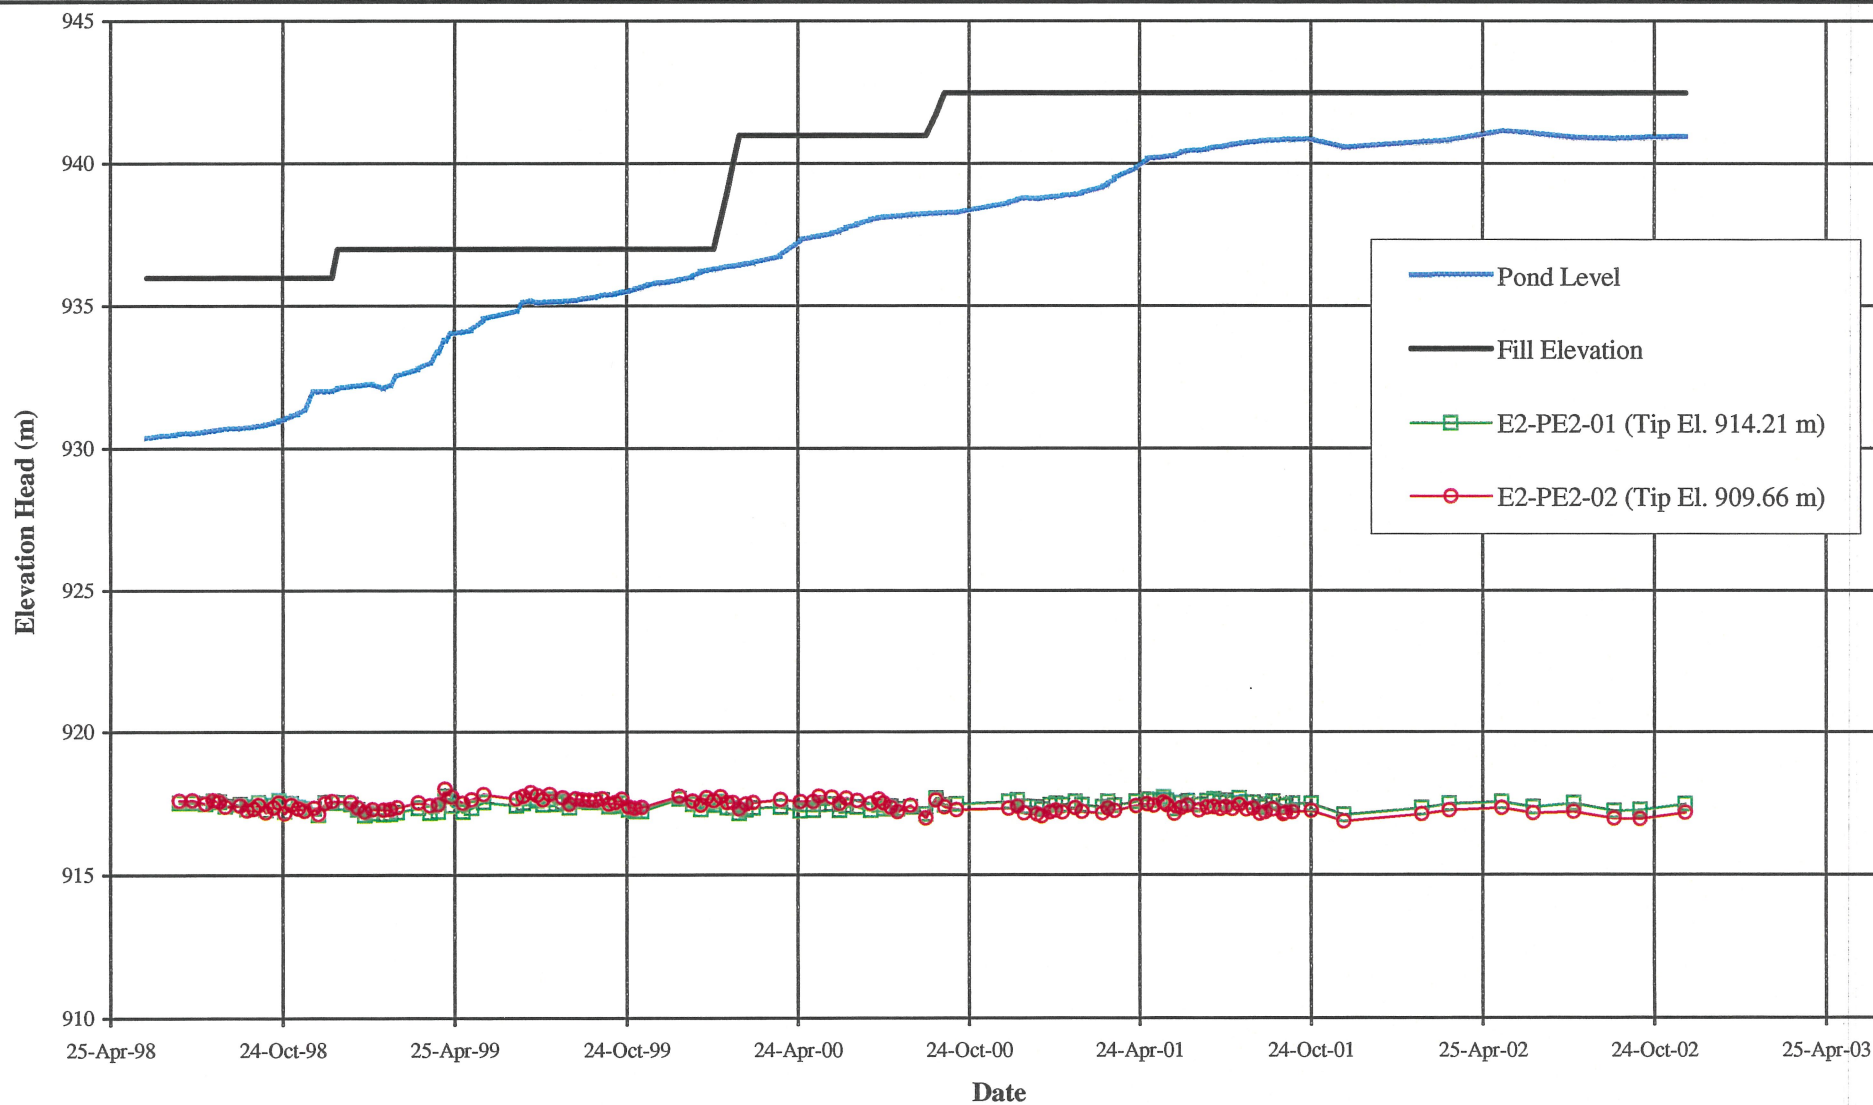
Artesian conditions are present in the foundation under the Main Embankment. The piezometers in this area are used to monitor the pore pressures and to confirm that they remain below the threshold level of 6 metres above ground level (KP Ref. No. 1162/7-2). No unexpected high pore pressure increases were noted during the reporting period. The table below summarizes the maximum artesian head values (above ground surface level) reached during the reporting period.

Although the highest level recorded is 4.22 m, none have reached the foundation piezometer trigger level of 6.0 m artesian pressure relative to original ground. All stability analyses completed at the Main Embankment (KP Ref. No. 1162/7-2) use an artesian pressure of 6.0 m for the

It has been noted that artesian pressures have typically developed in the deeper piezometers, at elevations below El. 910 m. This corresponds roughly to the top of the glaciolacustrine/glaciofluvial material and these artesian pressures are therefore not unexpected (Planes A, B and C). It should also be noted that no artesian conditions have been encountered at Plane E, where coarser glaciofluvial material is present.

During operation of the mine, a trend that developed was that many of the pore pressures of the foundation piezometers increased slightly over time. This was likely due to tailings deposition and a rising pond level. While in the period of Care and Maintenance, this trend has levelled off, and the foundation piezometer levels have become steady. ✓
