**MOUNT POLLEY MINING CORPORATION
MOUNT POLLEY MINE**

**TAILINGS STORAGE FACILITY
REPORT ON 2004 ANNUAL INSPECTION
(REF. NO. VA101-01/7-1)**

Knight Piésold Ltd.

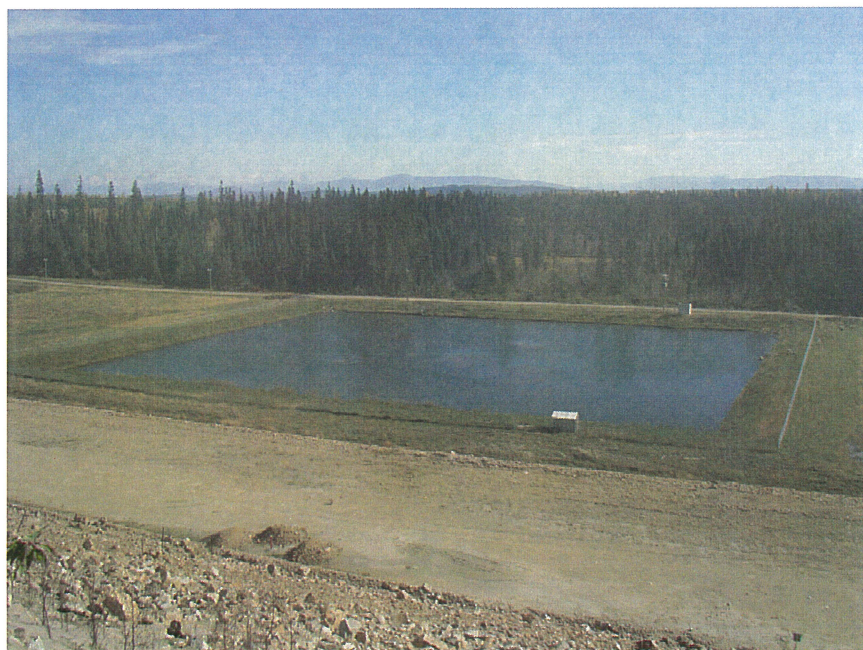
PHOTO 1 – Main Embankment Seepage Collection Pond.

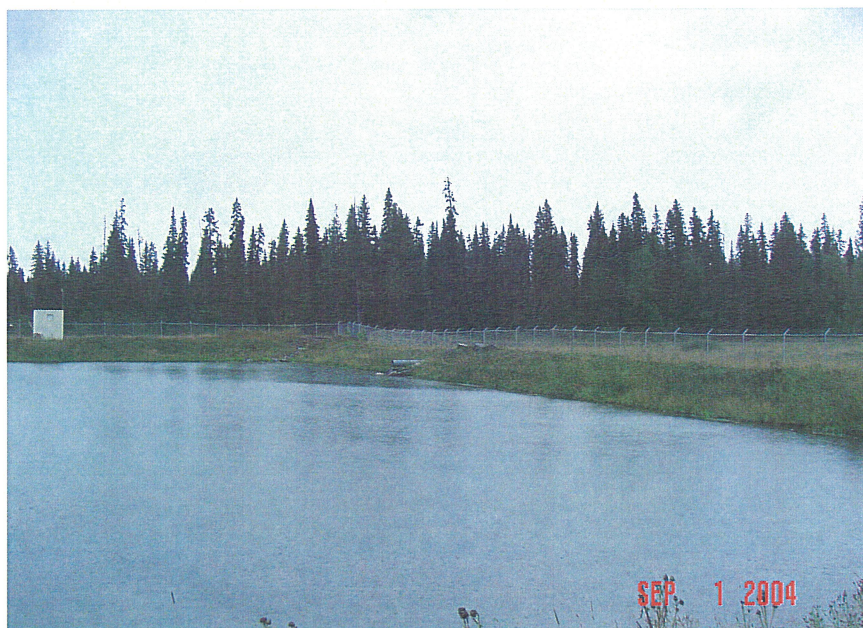
- No signs of instability were observed in the embankment fill slopes.
- The seepage collection ponds were observed to be in good condition with no observed erosion activity.
- No unexpected or uncontrolled seepage was observed from the embankments including fill slope and foundations.
- All perimeter surface water diversion ditches were unobstructed and those that were flowing had clear water.
- There is evidence of dust accumulation on the Main Embankment crest.

PHOTO 2 – Main Embankment and Seepage Collection Pond.

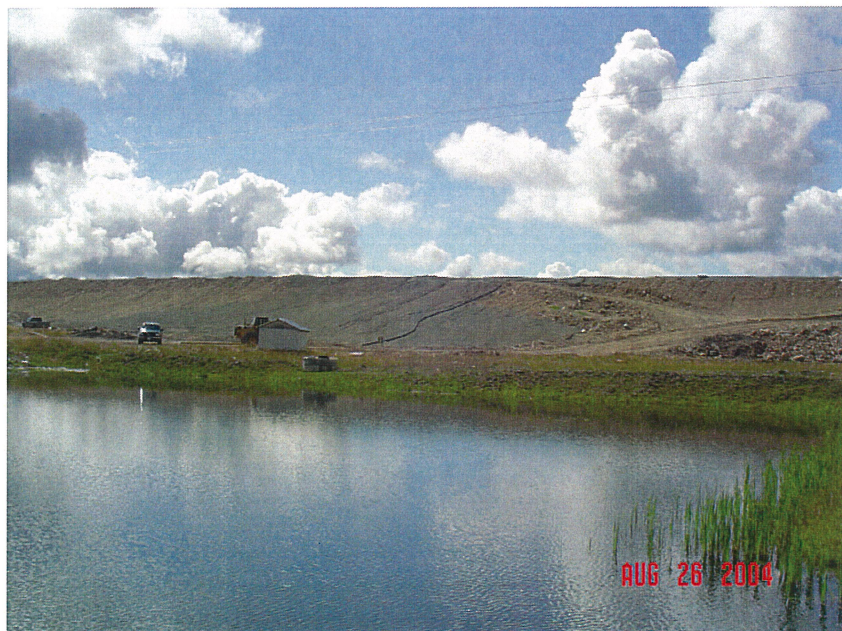
- No seepage was observed for the embankments.
- Water flowing in the ditch was clear.
- The overflow culvert for the pond was clear of obstructions.
- The embankment fill slopes (inside and outside) looked to be in very good shape, with no signs of instability. No cracks were observed on the crest. No seepage or slumping of the slopes was observed.
- Grassy re-vegetation has become well established on the downstream embankment slopes.

PHOTO 3 – Perimeter Embankment Seepage Collection Pond.

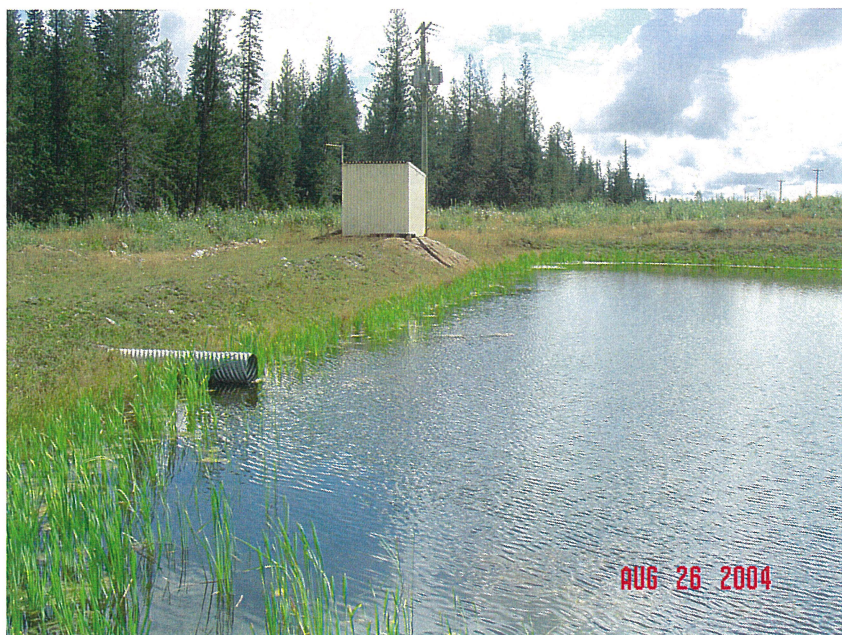
PHOTO 4 – Perimeter Embankment and Seepage Collection Pond.

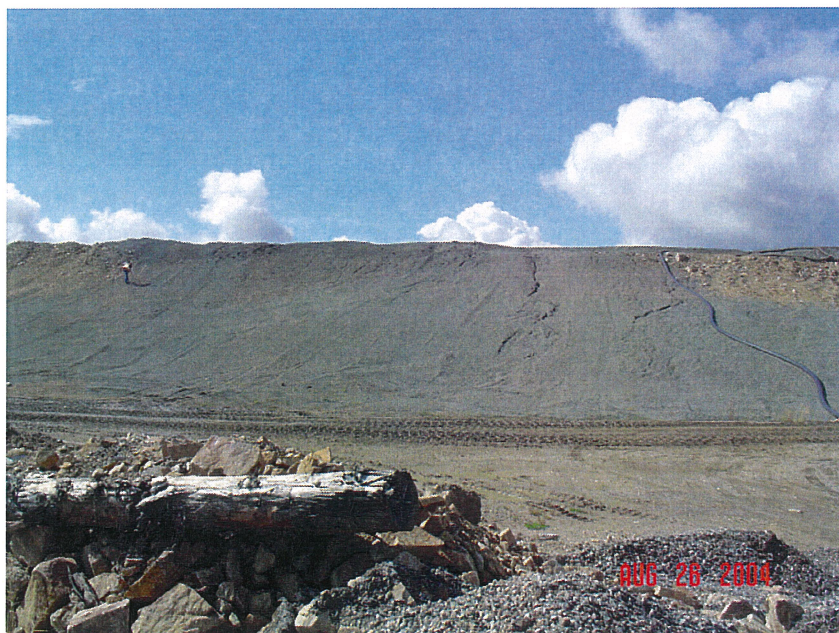
PHOTO 5 – Perimeter Embankment cyclone sand test section before new construction and upgrades.

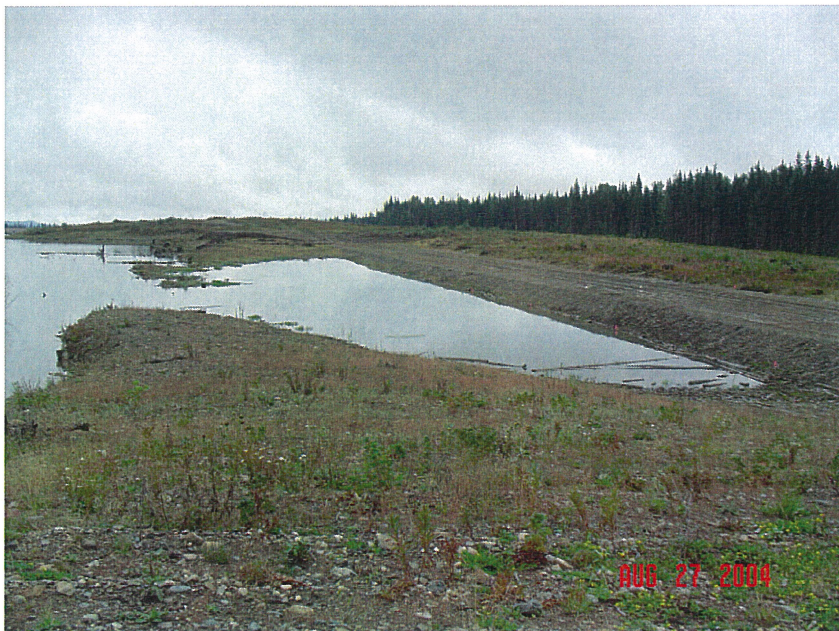
PHOTO 6 – South Embankment.

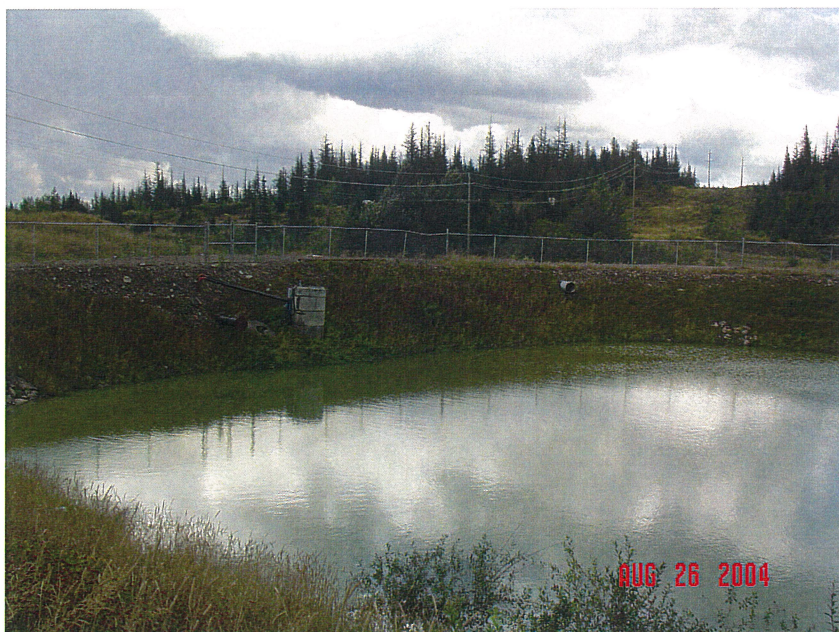
Surface water from the Open Pit and Mill Site Areas is routed into the mill-site sump where it is transferred to the TSF via the tailings pipeline. The embankments at the Millsite Sump were observed to be in good shape, and no cracks, seepage or slumping was noted. The emergency overflow culvert was clear of obstructions, however the spillway was showing signs of erosion and should be repaired. The erosion occurred during an extensive clean-up program at the mill site in preparation for start-up and is unlikely to happen again.

PHOTO 7 – Millsite Sump

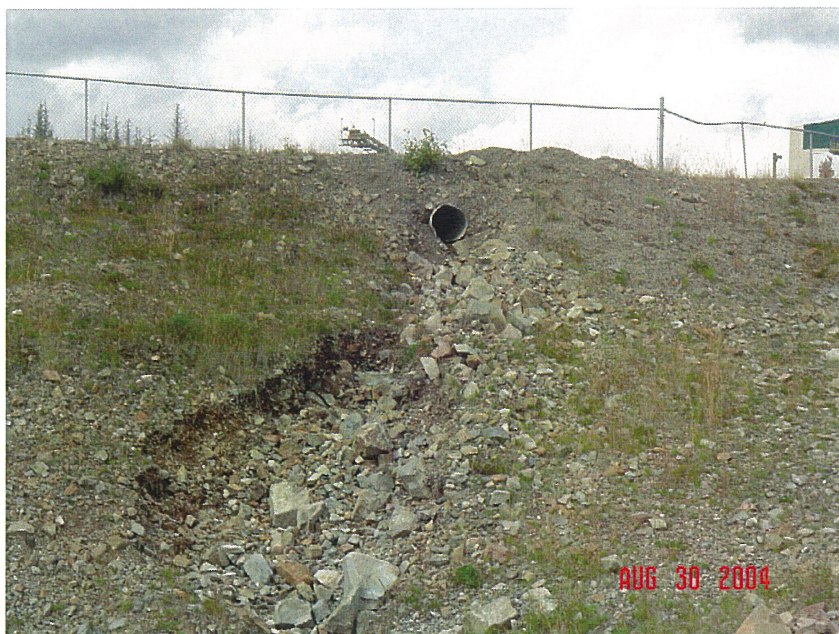
The Southeast Sediment Pond, Millsite Sump, and South Bootjack Dam were observed to be in a good condition with no geotechnical issues outstanding. However the Millsite Sump spillway was showing signs of erosion and should be repaired.

PHOTO 8 – Millsite Sump Spillway showing signs of erosion.

- Repair the spillway at the Millsite Sump.
- Lower the water level in the Main Embankment Drain Monitoring Sump so that the flows from the Foundation and Upstream Toe Drains can be monitored at the required frequency.

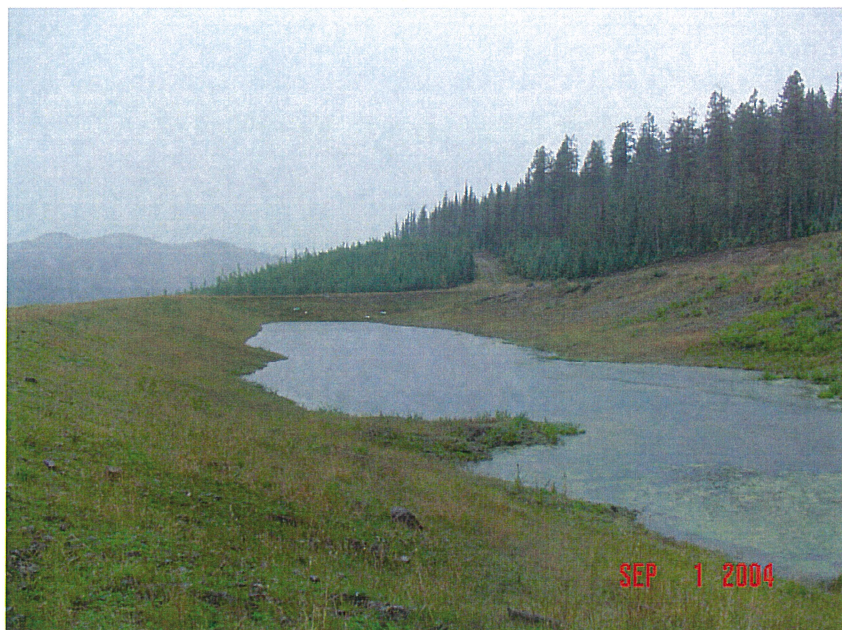
PHOTO 9 – Southeast Sediment Collection Pond.

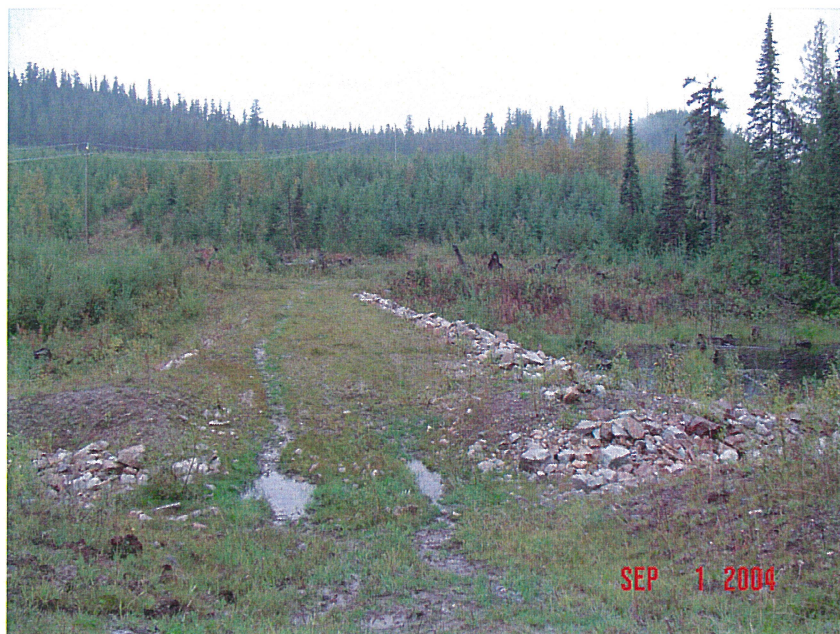
- The water level was low.
- Both upstream and downstream fill slopes were in good condition, with no evidence of seepage or slumping.
- No cracks were observed on the dam crest.
- The spillway contained some minor vegetation, but was generally unobstructed.

PHOTO 10 – South Bootjack Dam.

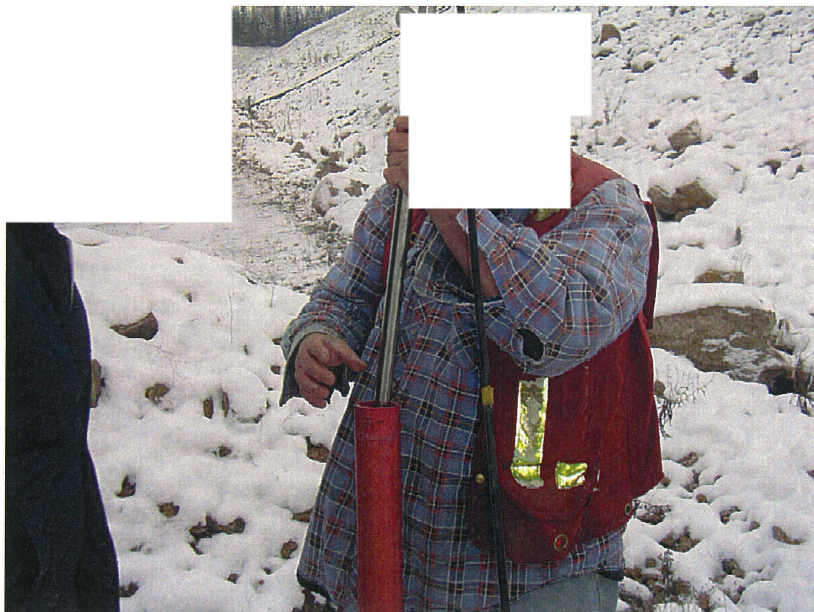
PHOTO 11 – Slope indicator tests.
