**MOUNT POLLEY MINING CORPORATION
MOUNT POLLEY MINE**

**TAILINGS STORAGE FACILITY
REPORT ON 2005 ANNUAL INSPECTION
(REF. NO. VA101-01/11-1)**

Rev. No.	Revision	Date	Approved
Rev 0	Issued in Final	May 3, 2006	KJB

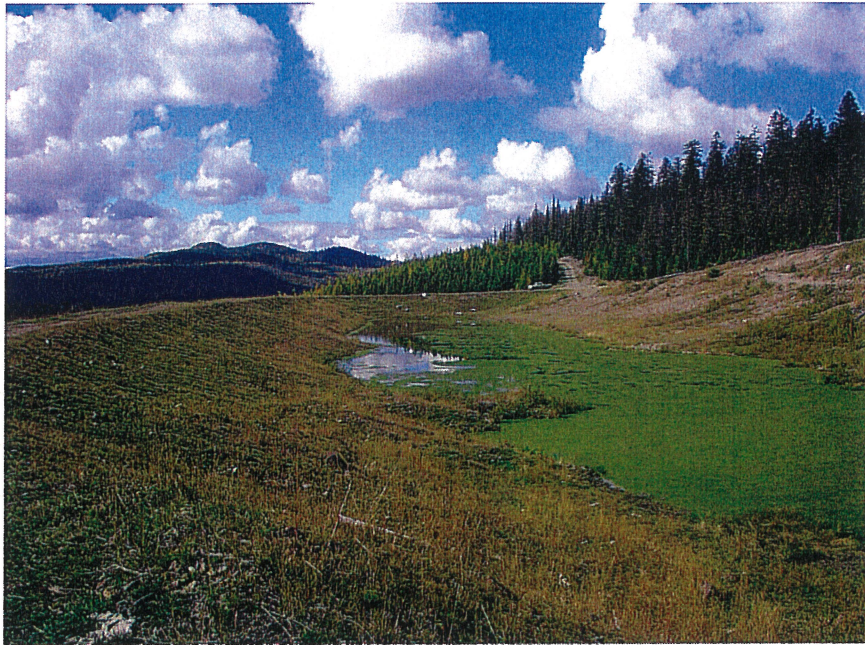
PHOTO 1: Southeast Sediment Control Pond

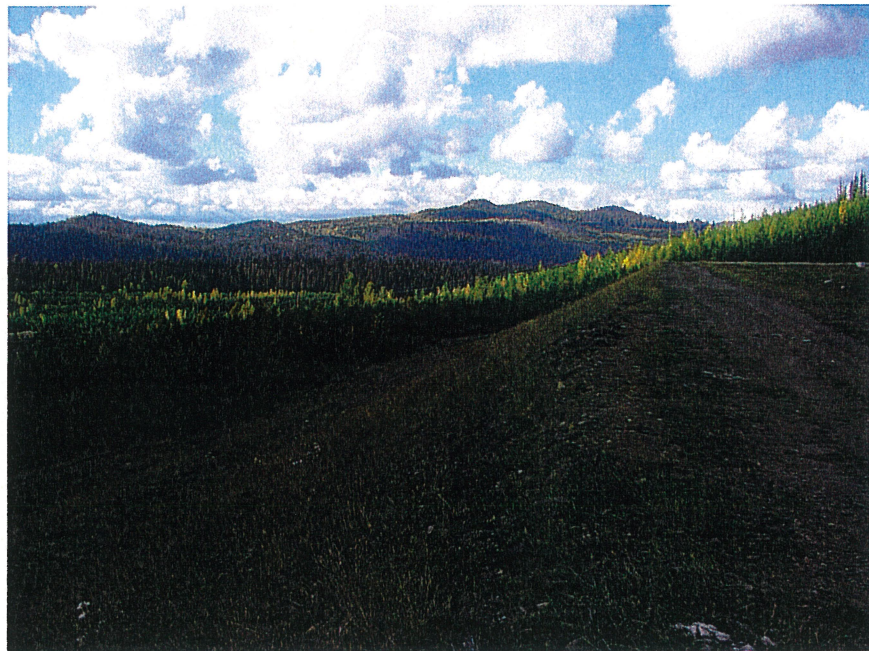
- No seepage was observed for the embankments.
- Water flowing in the ditch was clear.
- The overflow culvert for the pond was clear of obstructions.
- The embankment fill slopes (inside and outside) were in very good shape, with no signs of instability. No cracks were observed on the crest. No seepage or slumping of the slopes was observed.
- Grassy re-vegetation has become well established on the downstream embankment slopes.

PHOTO 2: Southeast Sediment Control Pond crest and downstream slope.

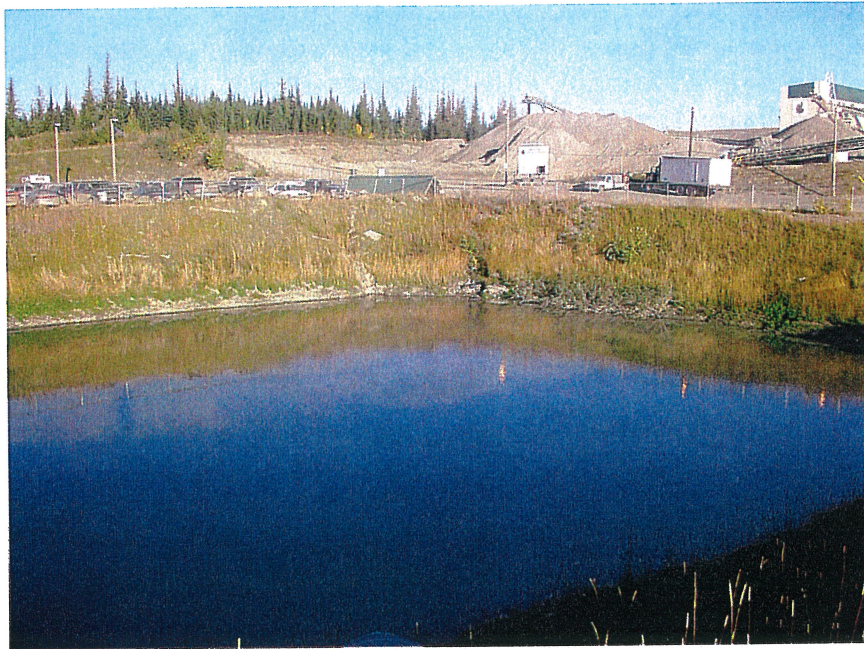
Surface water from the Bell and Cariboo Pits and Mill Site Area is routed into the mill-site sump where it is transferred to the TSF via the tailings pipeline. The embankments at the Millsite Sump were observed to be in good shape, and no cracks, seepage or slumping was noted. The emergency overflow culvert was clear of obstructions, however the spillway showed signs of erosion and should be repaired. The erosion occurred during an extensive clean-up program at the mill site in 2004 prior to start-up and is unlikely to happen again. The repair of the millsite spillway is an outstanding recommendation from the 2004 Annual Inspection Report.

PHOTO 3: Millsite Sump.

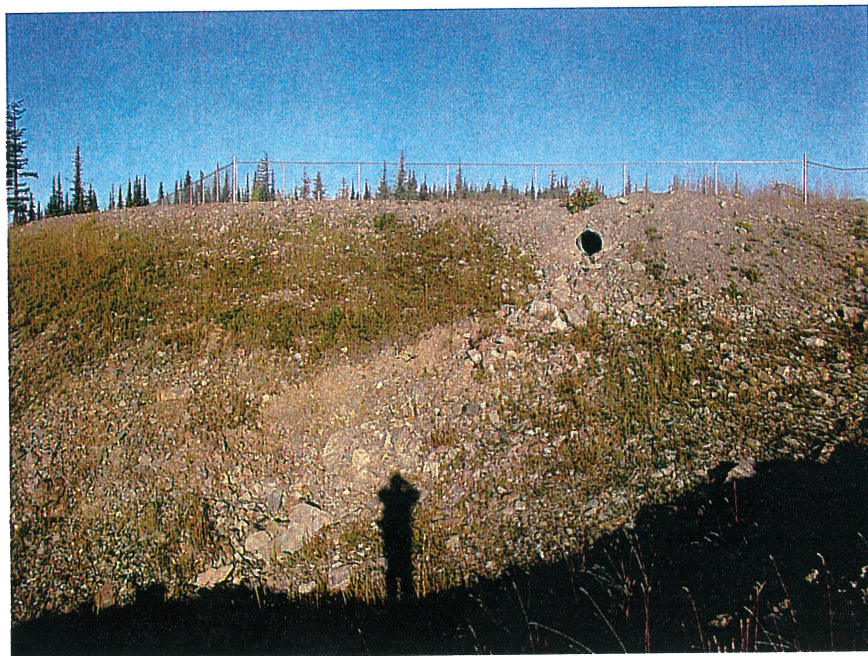
observed to be in a good condition with no geotechnical issues outstanding. However the Millsite Sump spillway was showing signs of erosion and should be repaired.

PHOTO 4: Millsite Sump Spillway showing signs of erosion

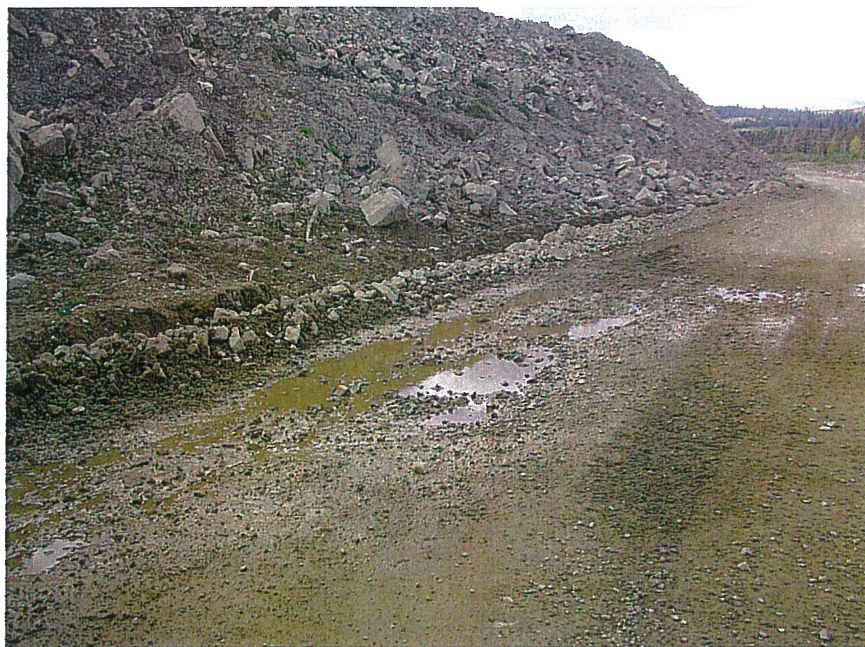
No major unexpected or uncontrolled seepage was observed from the embankments. The small amount of seepage observed at the base of the Perimeter Embankment between chainages 29+00 to 32+00 is being routed to the Perimeter Embankment Seepage Collection Pond.

PHOTO 5: Minor seep at the Perimeter Embankment. Seepage routed to the Perimeter Embankment Seepage Collection Pond.

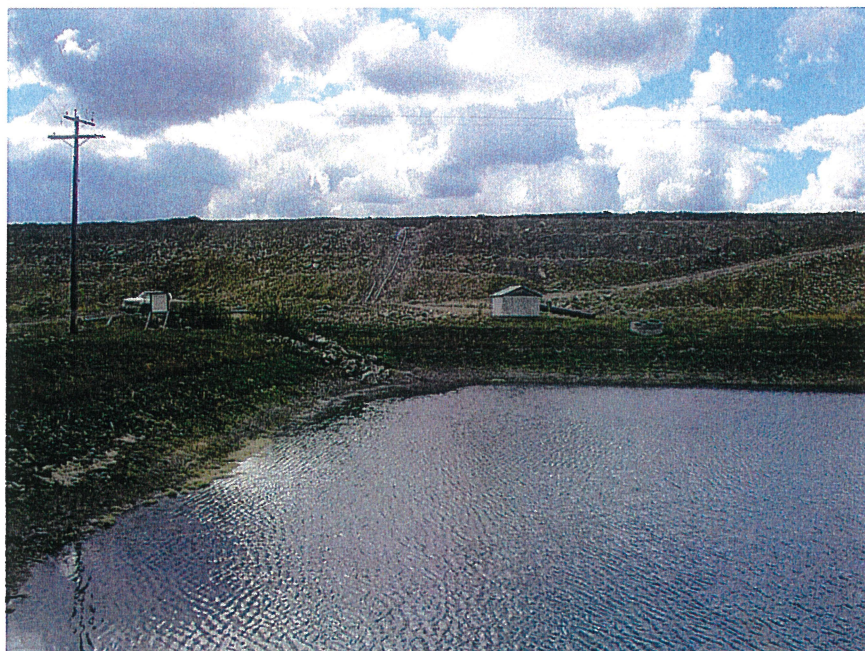
PHOTO 6: Perimeter Embankment with the Perimeter Embankment Seepage Collection Pond in the foreground.

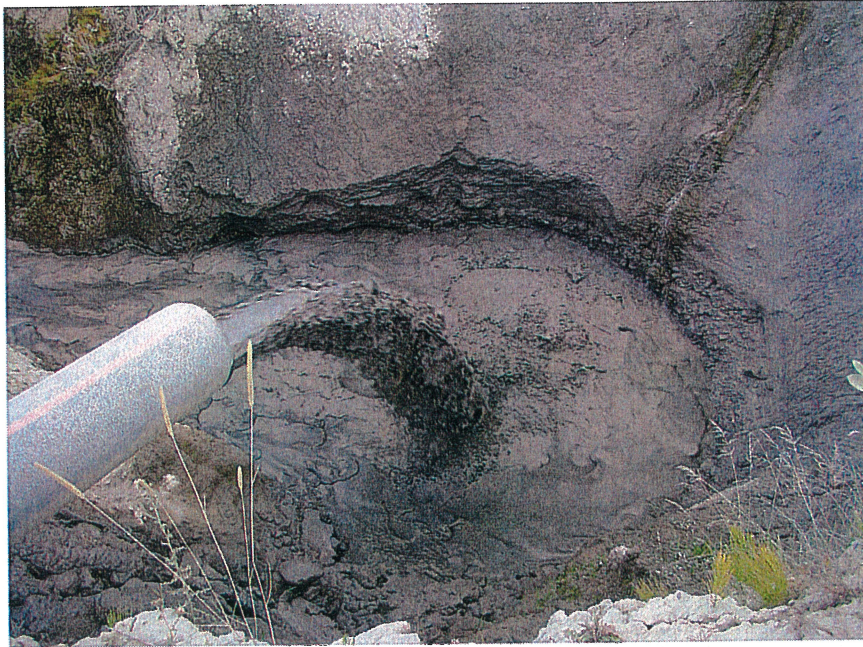
PHOTO 7: Single point discharge into the TSF at the knife gate valve located at the west end of the Perimeter Embankment.

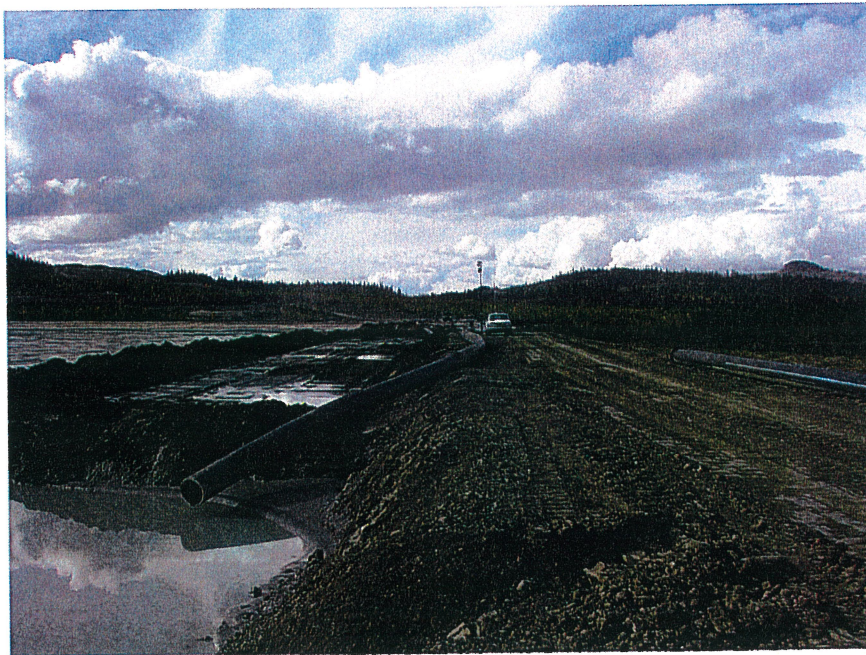
PHOTO 8: Perimeter Embankment. Construction of Zone U using the coarse tailings sand.

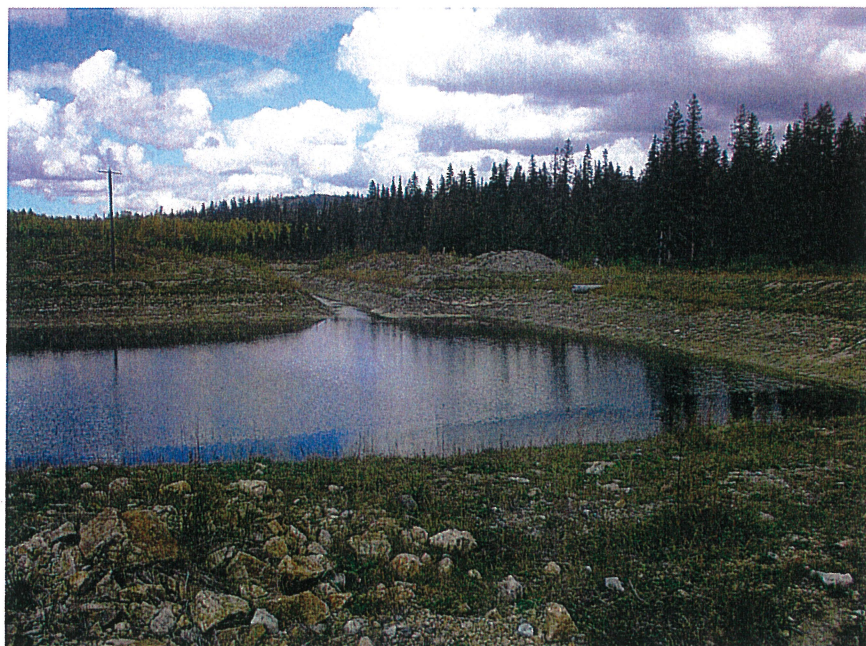
PHOTO 9: Perimeter Embankment seepage collection pond.

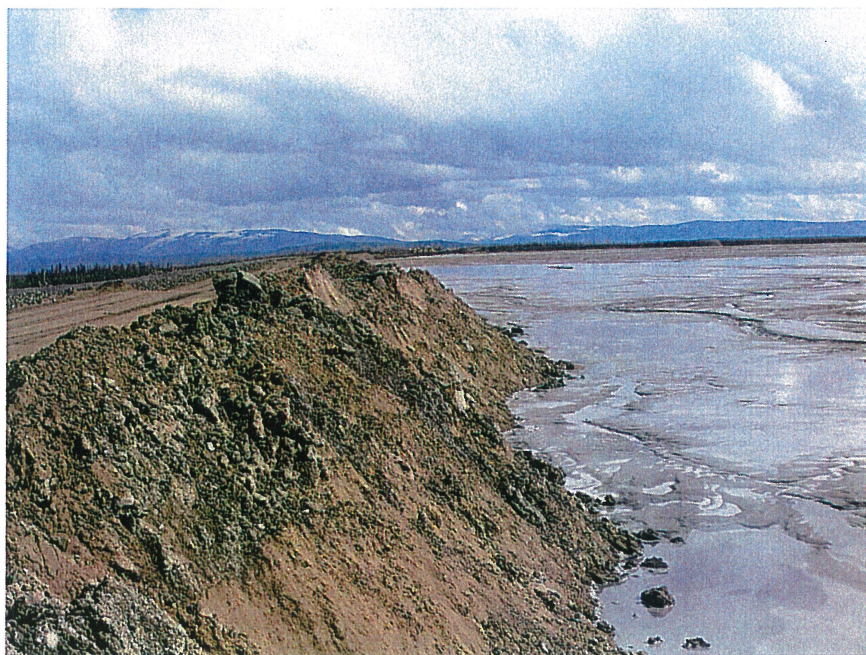
PHOTO 10: Perimeter Embankment. Confining berm used for the construction of the Zone U section using coarse tailings sand.

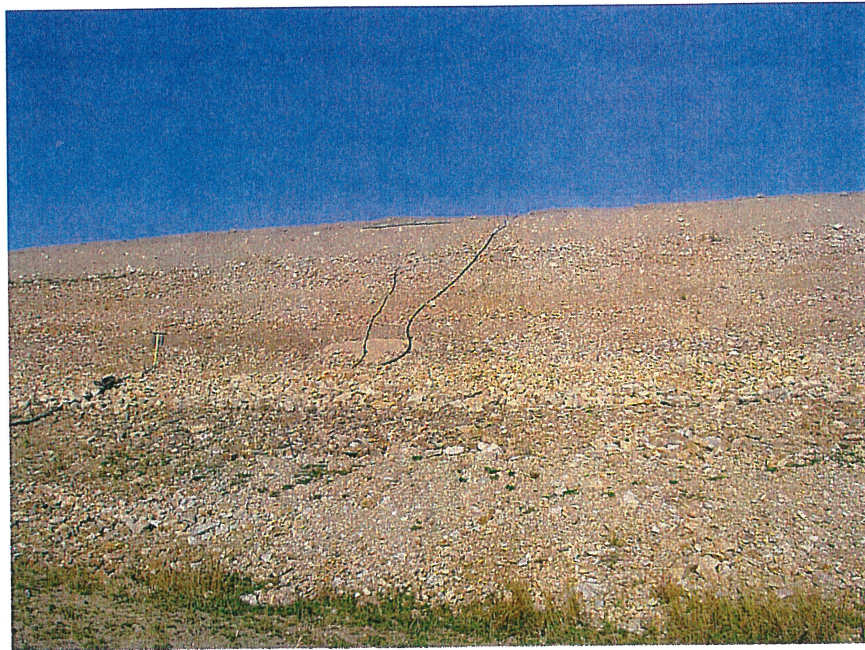
PHOTO 11: Main Embankment downstream slope.

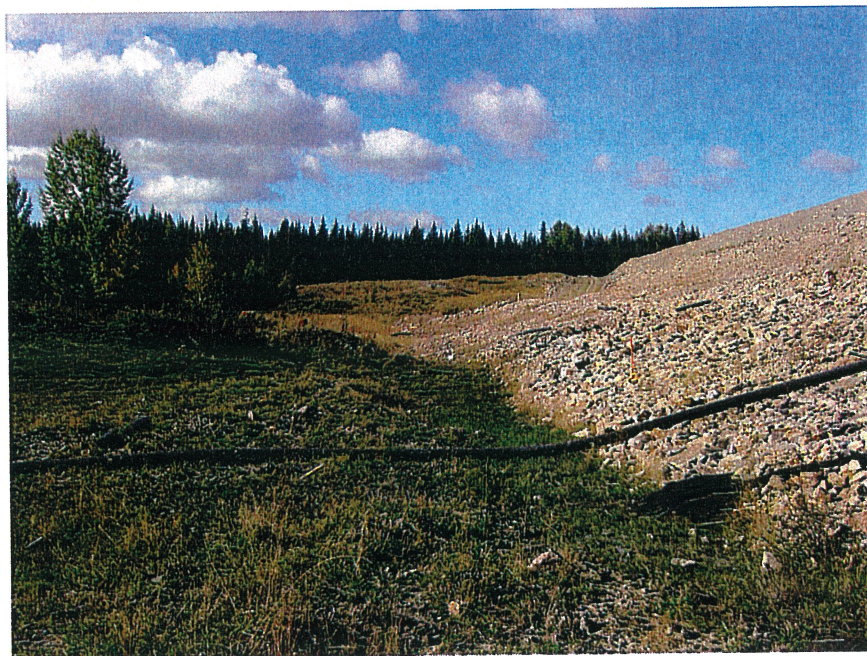
PHOTO 12: Main Embankment downstream toe.

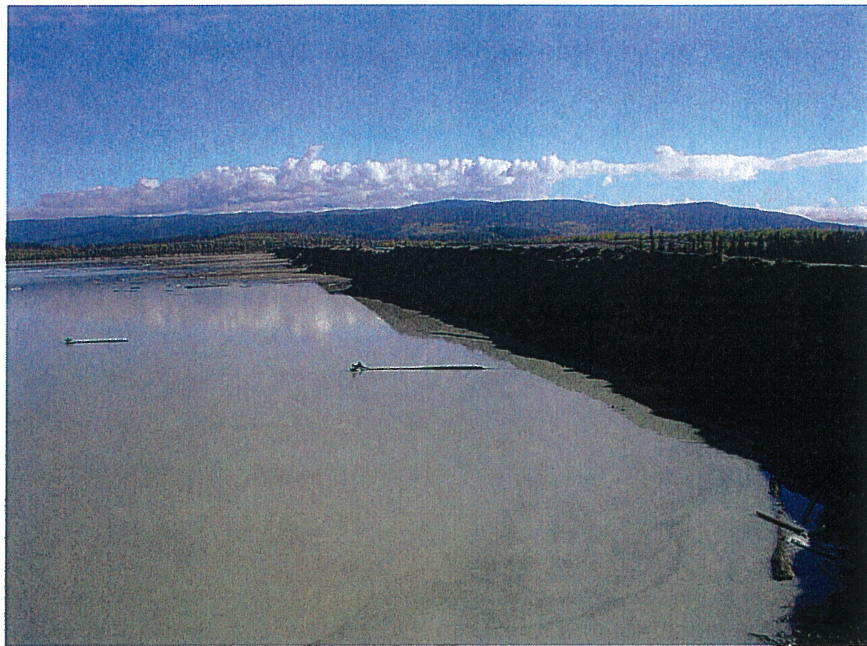
- No signs of instability were observed in the embankment fill slopes.
- The Tailings Pond was against the west end of the Main Embankment (app. chainage 16+00 to 19+00). This was the result of prolonged discharge of tailings from the Perimeter Embankment and from the knife gate valve. The most efficient use of the TSF is made when tailings can be evenly distributed from around the perimeter of the facility. Evenly discharging the tailings from around the facility optimizes the development of

tailings beaches and keeps the supernatant pond clear of the embankments, thereby increasing seepage paths and limiting seepage loss from the facility. Beached tailings, when left to drain and consolidate, form the competent foundation needed for the modified centreline construction of embankment raises.

PHOTO 13: Main Embankment with the tailings pond up against the Zone U material.

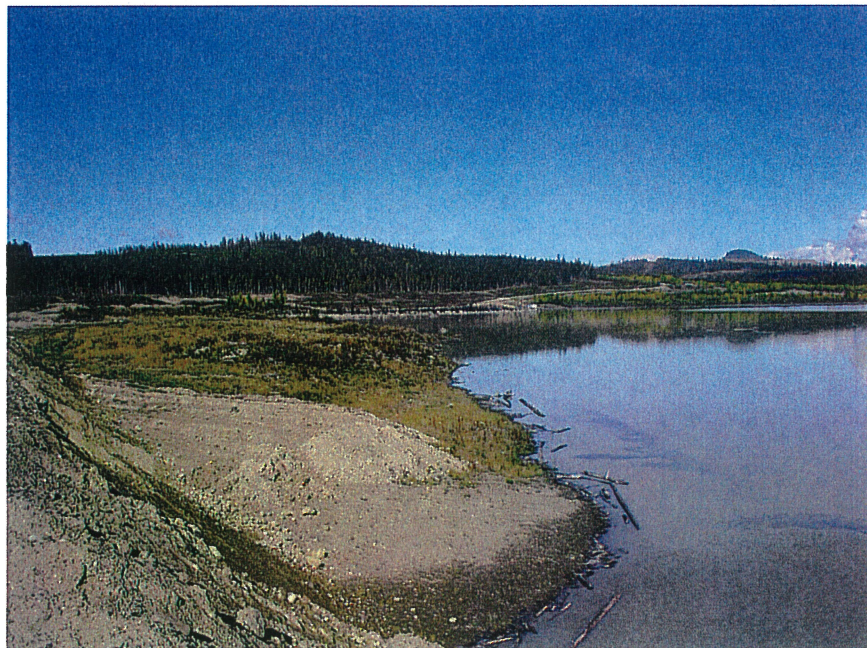
PHOTO 14: Knoll between the Main and South Embankments where the basin liner investigation was required.

- The knoll between the Main and South Embankment should be investigated to ensure that the thickness of the low permeability basin liner is sufficient in this area prior to it being inundated with tailings.
- No major unexpected or uncontrolled seepage was observed from the embankments, including fill slope and foundations. However, a small amount of seepage was observed at the base of the Perimeter Embankment between chainages 29+00 to 32+00. The seepage is likely coming from the internal embankment drain as it exits the TSF within this area. The seepage should be directed to a drainage ditch outside of the ultimate toe of the embankments and routed to the Perimeter Embankment Seepage Collection Pond. This was completed in February 2006.

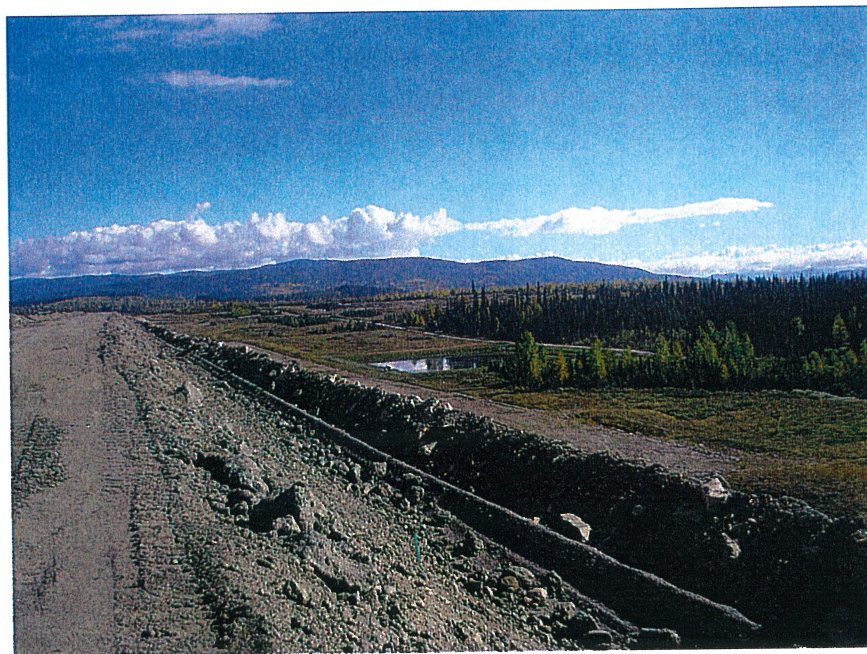
PHOTO 15: Main Embankment crest and the seepage collection pond.

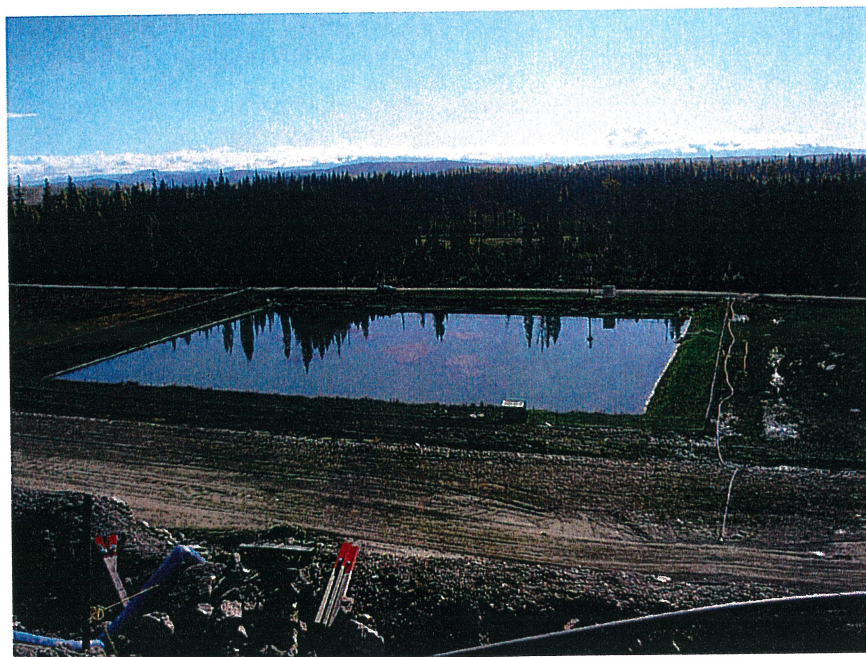
PHOTO 16: Main Embankment seepage collection pond.

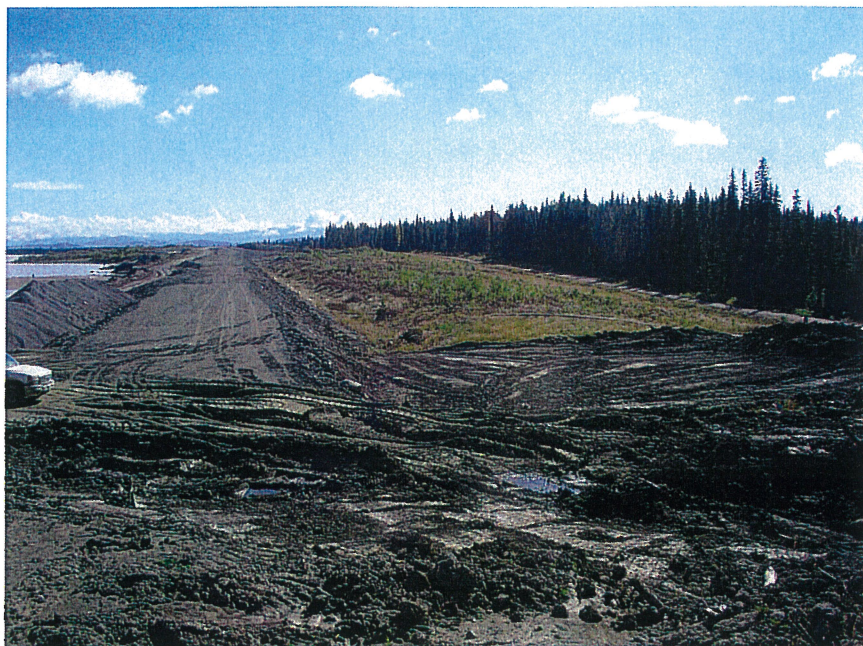
PHOTO 17: South Embankment crest and downstream area.

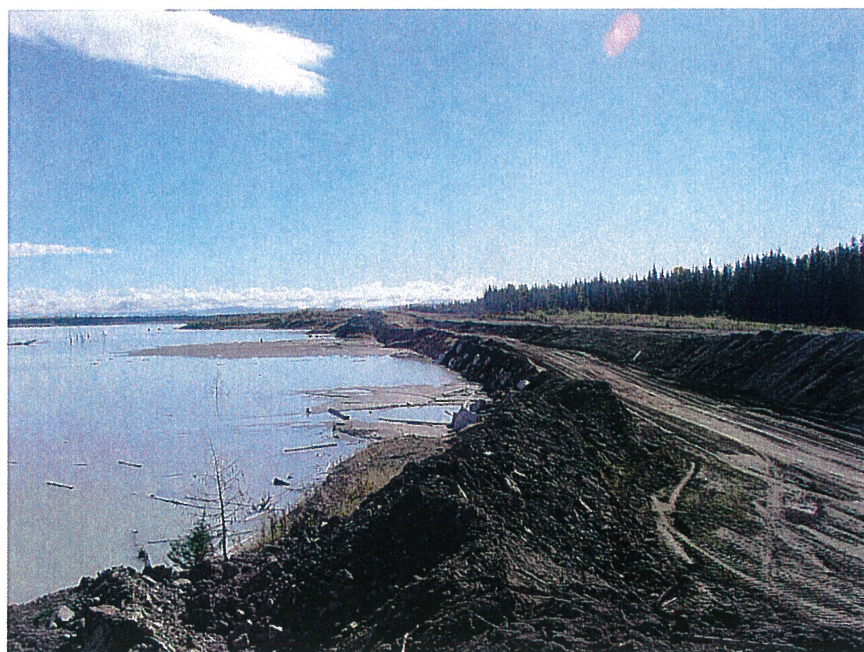
PHOTO 18: South Embankment showing pond up against the Zone U material.

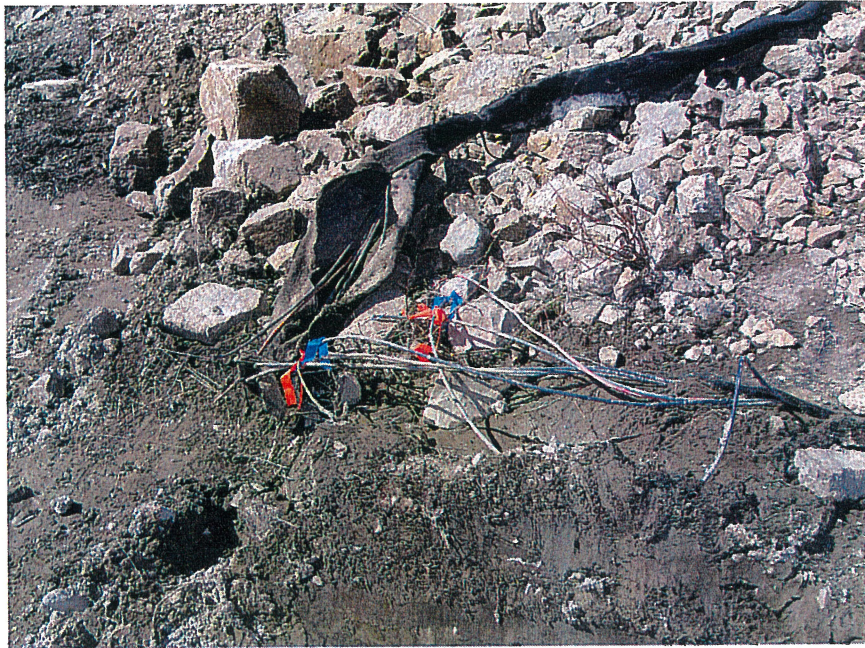
No piezometer data had been collected from Sept 22, 2005 to April 30 2006 due to a malfunctioning readout box connector cable and the accidental destruction or burying of piezometer cables during the Stage 4 construction program. MPMC will update the piezometer records as the damaged cables are repaired and the piezometer data will be further reviewed as part of the Stage 4 Construction Report. There were no concerns with the piezometer collected prior to September 22, 2005.

PHOTO 19: Damaged Piezometer cables at the Main Embankment.

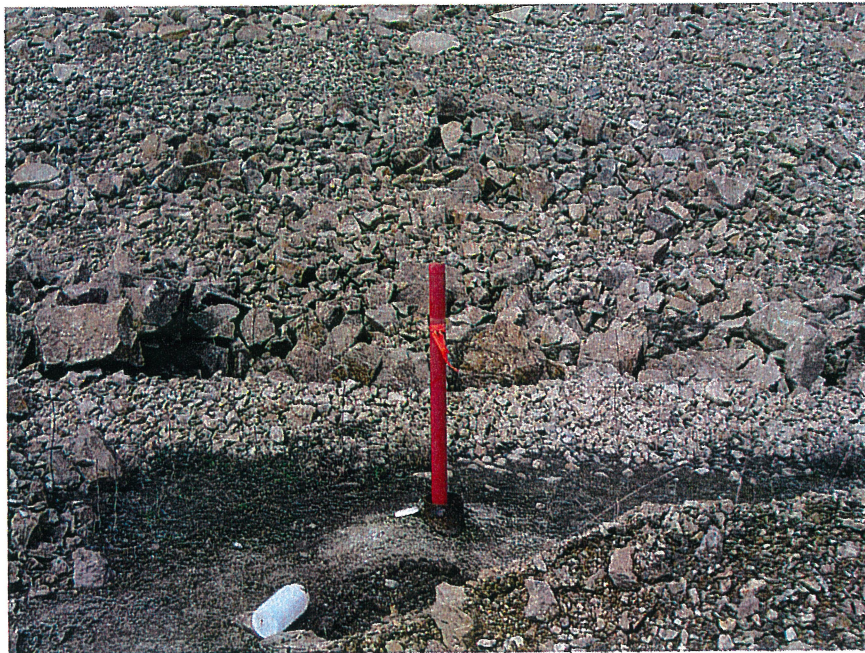
The two slope inclinometers installed at the toe of the Main Embankment in July 2001 were read in March 2006. The results show that there have been no significant deviations in the inclinometers as compared to the installation readings of 2001 and the readings from October 2004.

PHOTO 20: Existing inclinometers at the Main Embankment. These are to be extended during the Stage 5 Construction program.

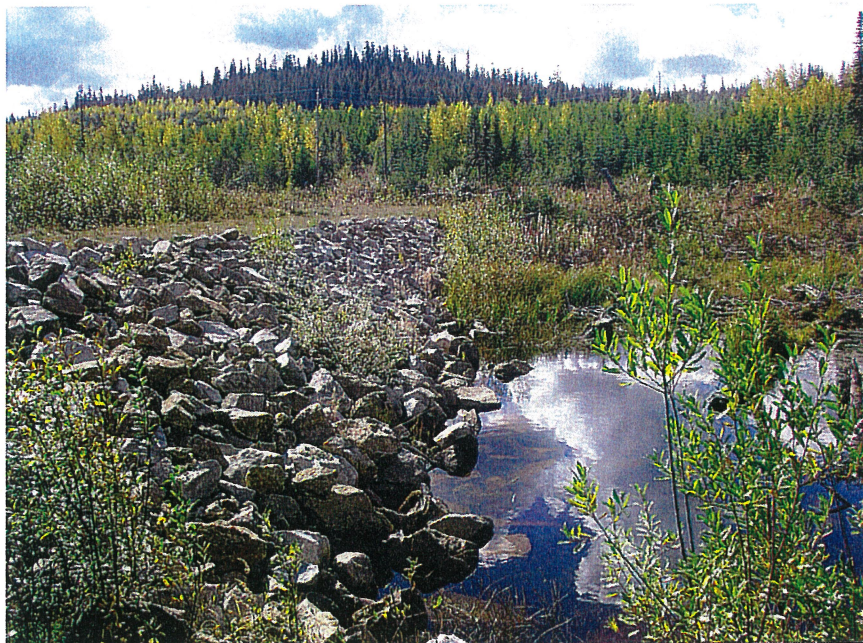
- The water level was low.
- Both upstream and downstream fill slopes were in good condition, with no evidence of seepage or slumping.
- No cracks were observed on the dam crest.
- The spillway contained some minor vegetation, but was generally unobstructed.

PHOTO 21: South Bootjack Dam – Upstream slope.

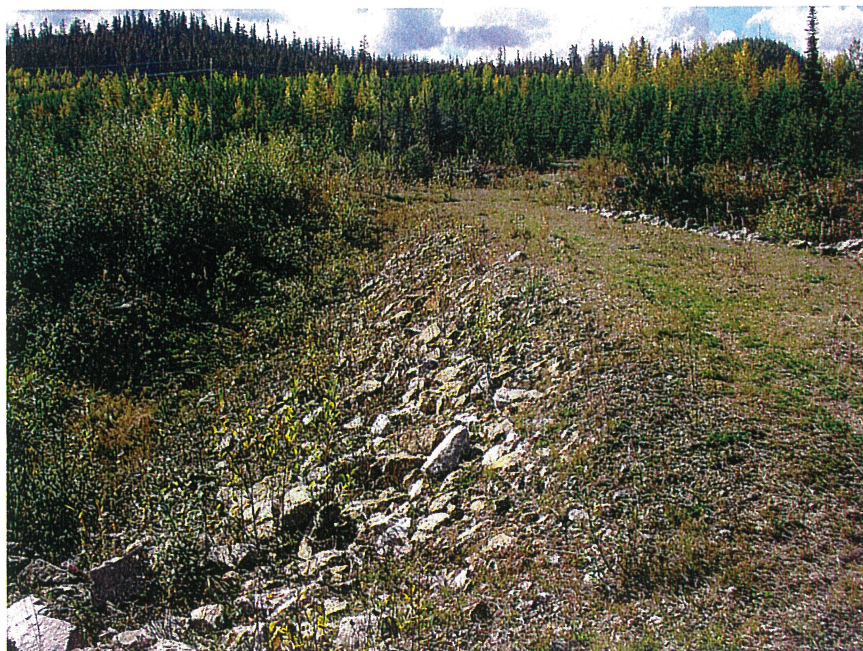
PHOTO 22: South Bootjack Dam – Downstream slope.
