MOUNT POLLEY MINING CORPORATION
MOUNT POLLEY MINE

TAILINGS STORAGE FACILITY
REPORT ON 2007 ANNUAL INSPECTION
(REF. NO. VA101-01/20-1)

Rev. No.	Revision	Date	Approved
Rev 0	Issued in Final	December 19, 2007	<i>AKB</i>

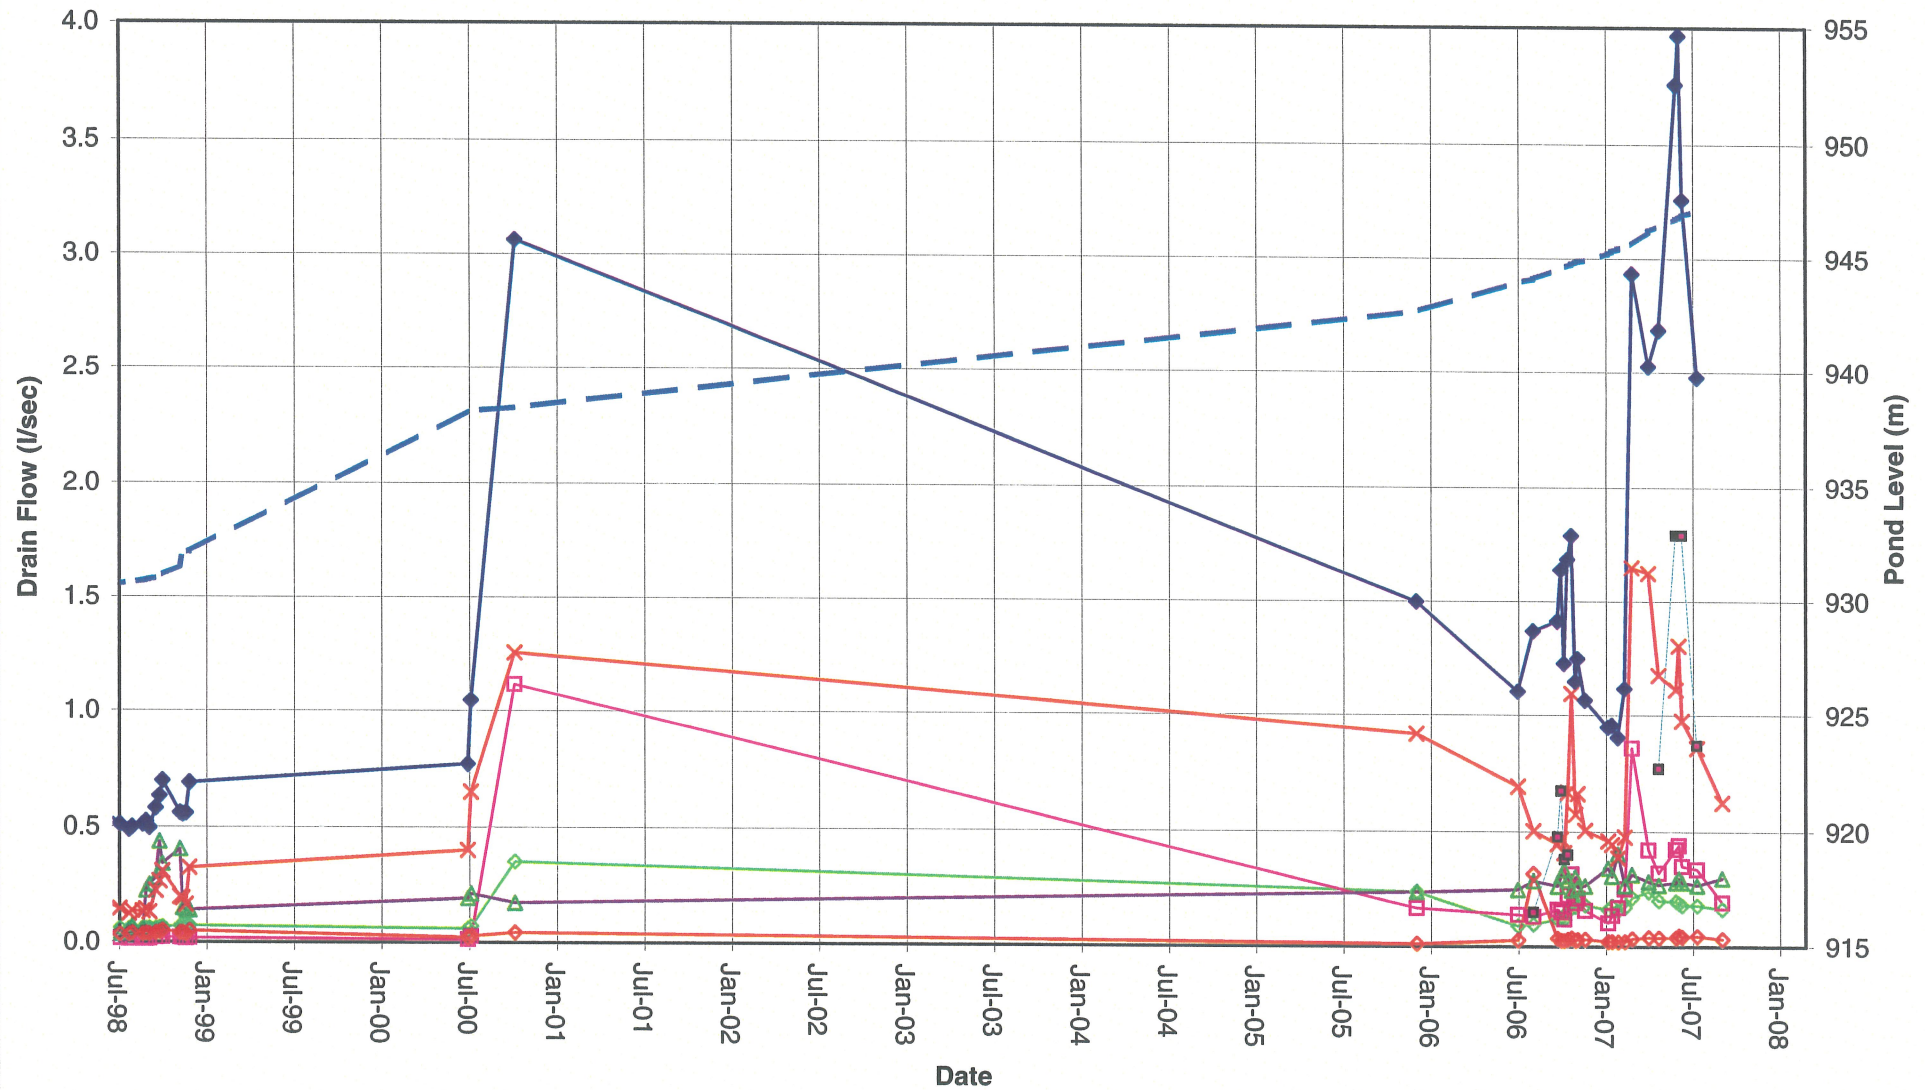
PROJECT / ASSIGNMENT NO.
VA 101-1/20REF NO.
1**FIGURE 3.2**REV.
0

The total flows from the foundation drains have increased slightly in the last year, especially in foundation drain FD-5 and the ME Corner foundation drain, which are both located at the corner of the Main and South Embankments. The increased flows were most likely due to the lack of tailings beach development in this area, as the tailings embankment has only recently expanded to cover the gap between the Main and South Embankments and there was limited beach development in this area. The flow rates in these foundation drains appear to be declining as the tailings beach is developed in this area and the pond relocates away from the embankment. The flows from the foundation drains were clear.

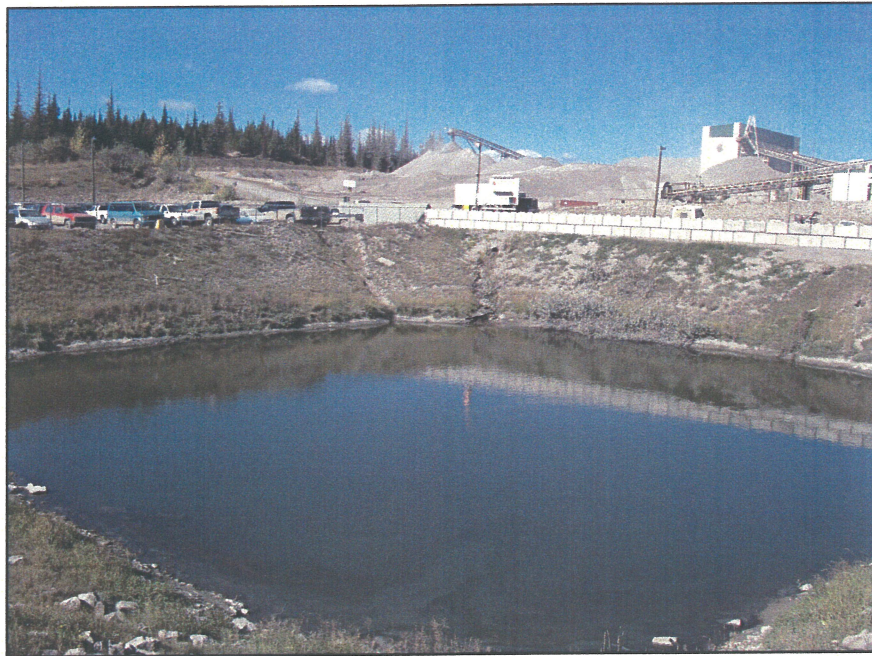
Surface water from the Bell and Cariboo Pits and Mill Site Area is routed into the Mill Site Sump where it is transferred to the TSF via the tailings pipeline. The embankments at the Mill Site Sump were observed to be in good condition, and no cracks, seepage or slumping was noted. The emergency overflow culvert was clear of obstructions.

PHOTO 3 – Millsite Sump

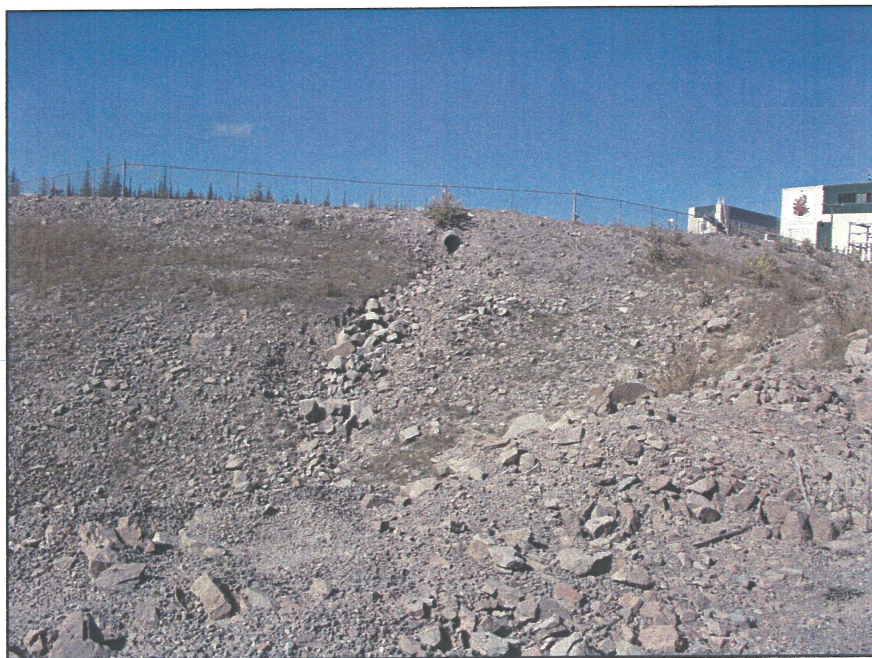
PHOTO 4 – Millsite Sump Spillway

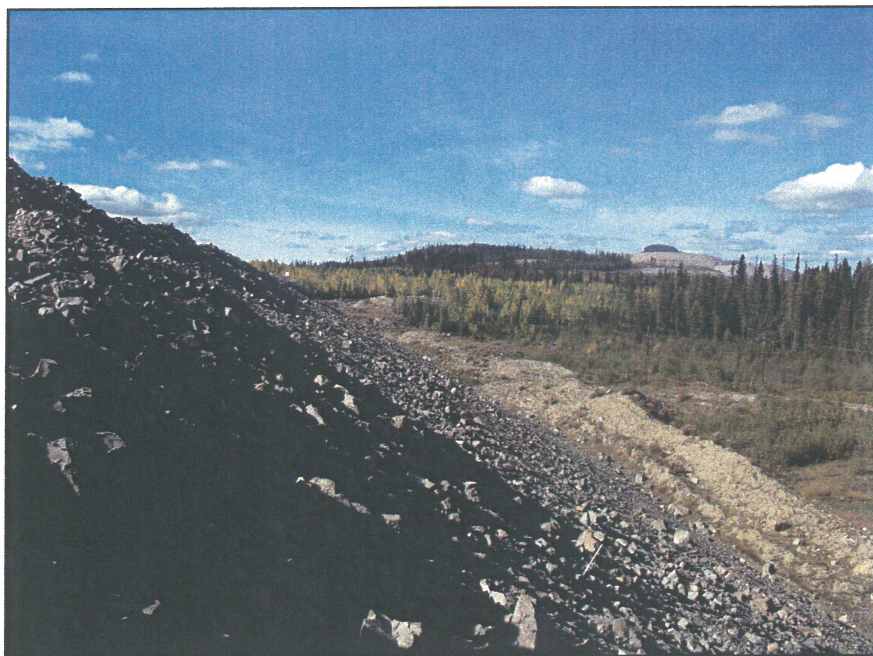
PHOTO 5 – Perimeter Embankment downstream slope looking North.

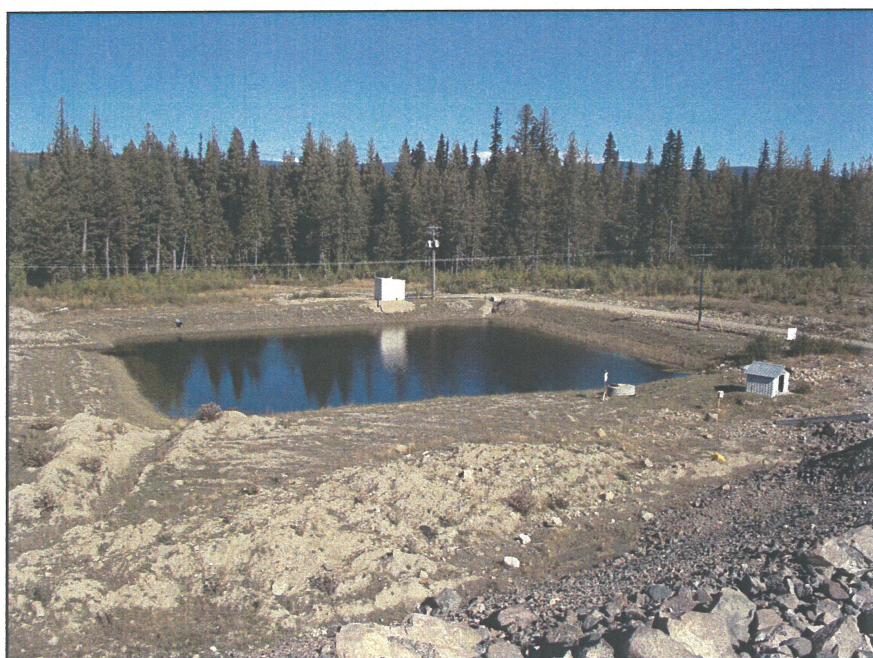
The Main and Perimeter Embankment seepage collection ponds are located immediately downstream of their respective embankments. These ponds were excavated in low permeability glacial till materials in 1997 and collect water from the embankment drain systems and from local runoff. The seepage collection ponds were observed to be in good condition with no observed erosion activity.

PHOTO 6 – Perimeter Embankment Seepage Collection Pond

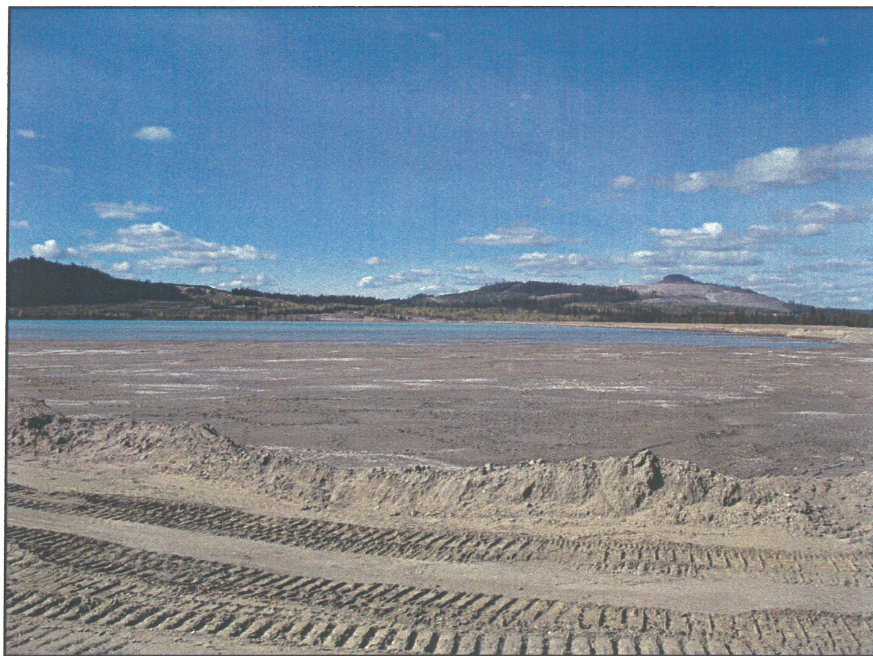
The recommended minimum tailings beach widths are generally being achieved by MPMC. However, it was noted during the inspection that the minimum beach requirements needed to be reinstated along a section of the Main Embankment, approximately 200 m in length.

PHOTO 11 – Tailings beach on the Main/Perimeter Embankment Corner

- A beach width of at least 20 m is to be maintained along the abutments of the embankments (where the embankment contacts natural ground) and at least a 10 m width elsewhere to keep the pond away from the embankments.
- MPMC should develop a plan and schedule to enable the minimum target beach widths to be re-established within a 2 week period should they be infringed upon.
- MPMC shall increase the frequency of measurements for embankment instrumentation systems (piezometers and foundation drains - flow rate and turbidity) to at least once per week during any periods that ponded water encroaches within the minimum target beach widths.

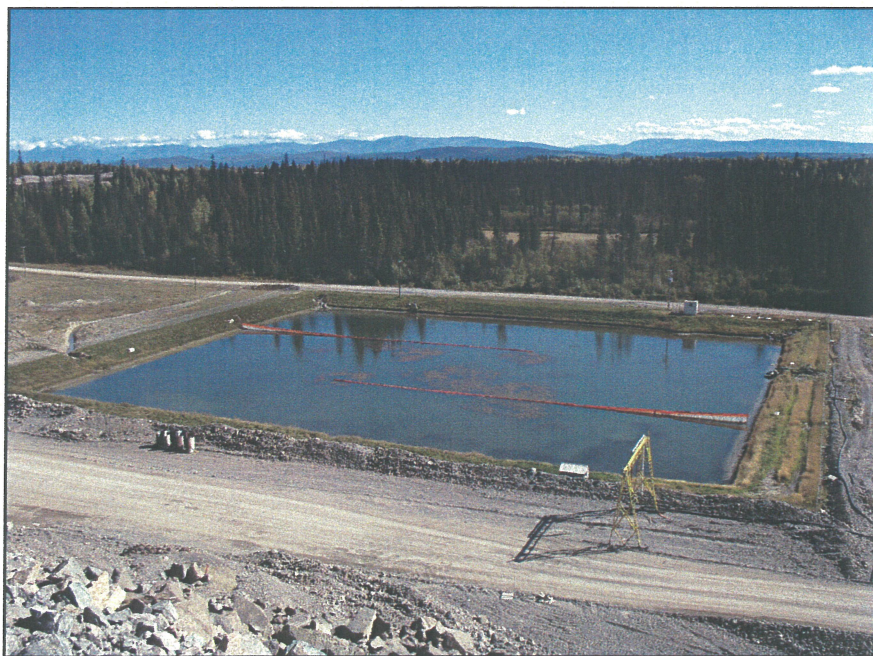
PHOTO 13 – Main Embankment seepage collection pond.

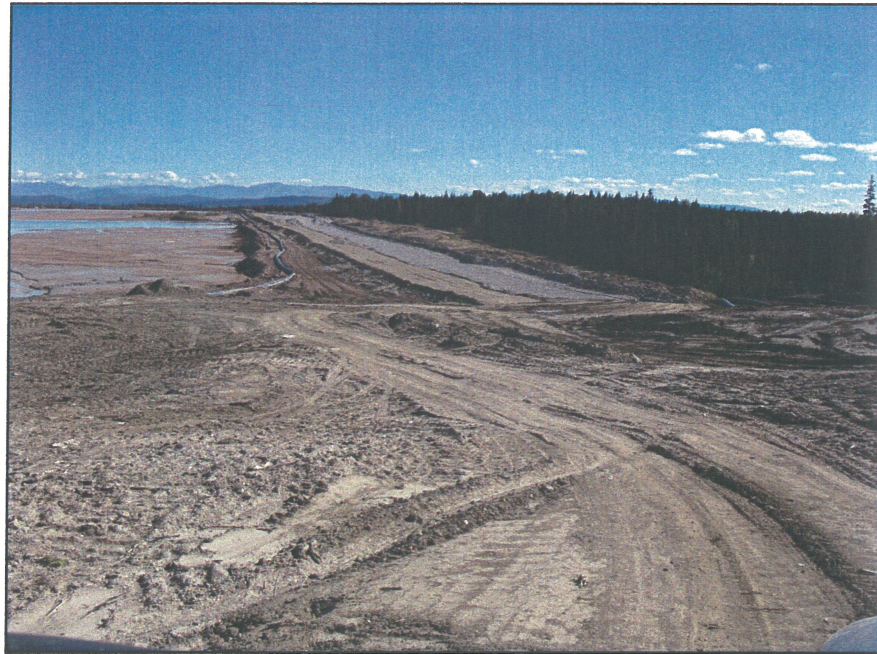
The tailings were being discharged from the Perimeter Embankment into sand cells at the time of the inspection. The prolonged discharge of tailings into the sand cells on one of the embankments can result in the migration of the tailings pond across the facility. MPMC has added an additional section to the tailings pipeline that enables them to move the tailings discharge point around the facility without having to relocate large sections of the tailings pipeline. This has been effective in establishing tailings beaches around the facility. However, the tailings pond was up against a part of the Main Embankment at the time of the inspection which has resulted in increased flows in the Main Embankment upstream toe drain and the foundation drains at the corner of the Main and South Embankments.

PHOTO 15 – South Embankment showing recent sand cell construction.

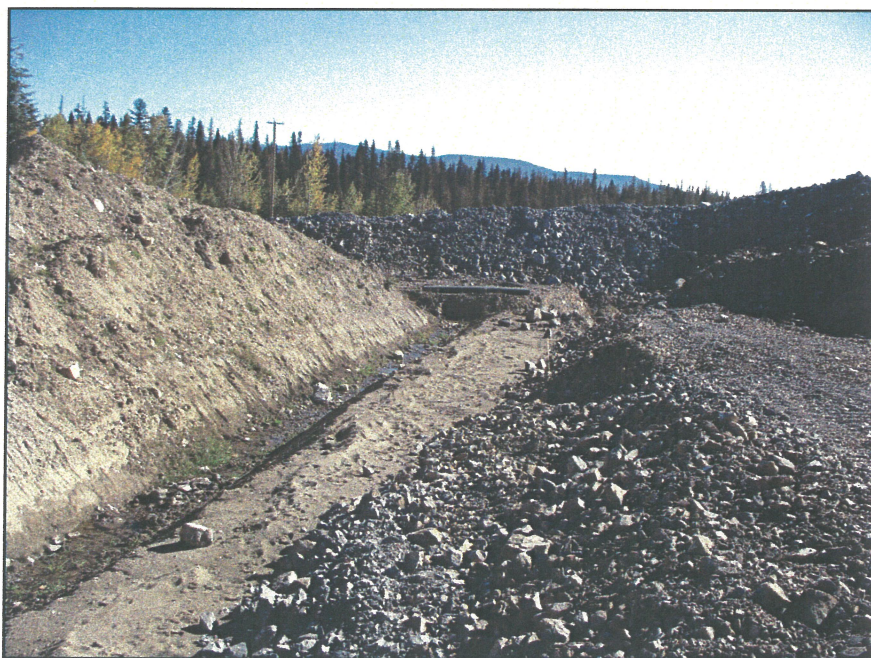
The upstream toe drain at the Perimeter Embankment drains into the Perimeter Embankment Seepage Collection Pond via a ditch. The flow rates are currently measured at the end of the pipe which exits the concrete encasement. The water from the upstream toe drains and foundation drains is currently pumped back into the TSF. The flow rates for the Main and Perimeter Embankment upstream toe drains are presented in Table 3.1 and shown on Figure 3.1. The flow rates for the foundation drains are presented in Table 3.2 and shown on Figure 3.2.

PHOTO 18 – Perimeter Embankment ditch routed to Perimeter Embankment Seepage Collection Pond for the upstream toe drain flow.

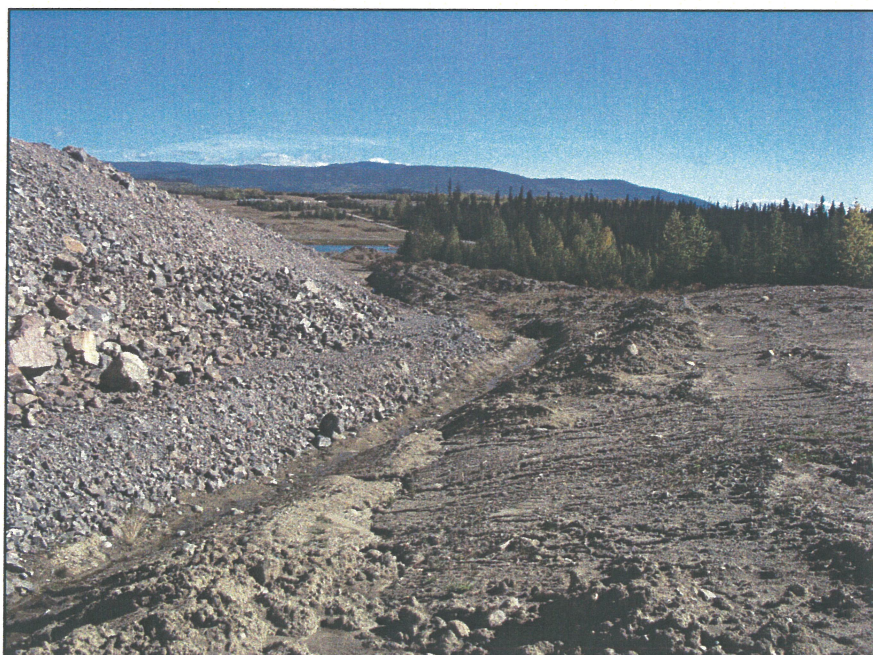
PHOTO 20 – Main Embankment ultimate downstream toe with a ditch routed to the Main Embankment Seepage Pond.

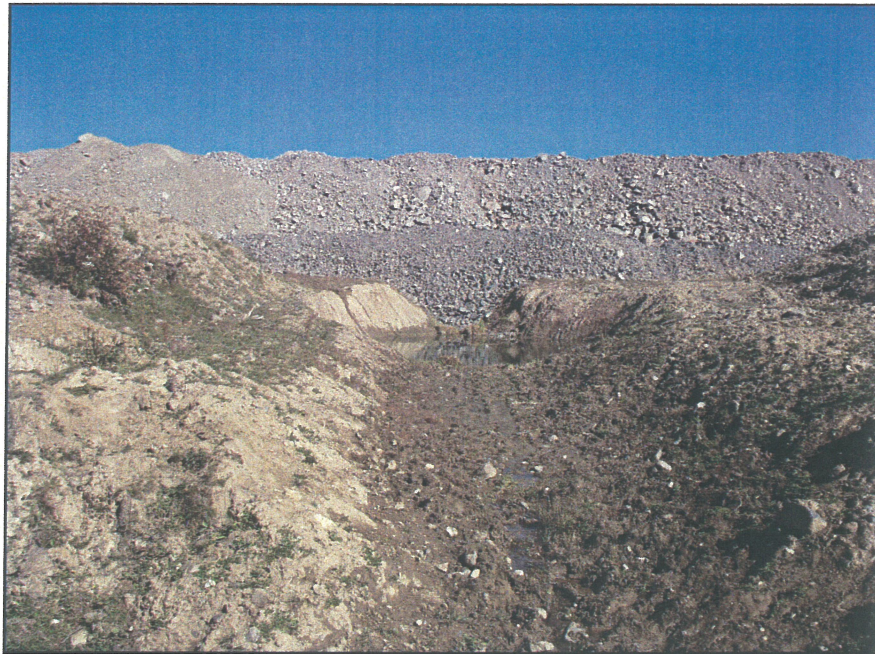
PHOTO 21 – South Embankment foundation drain excavated sump.

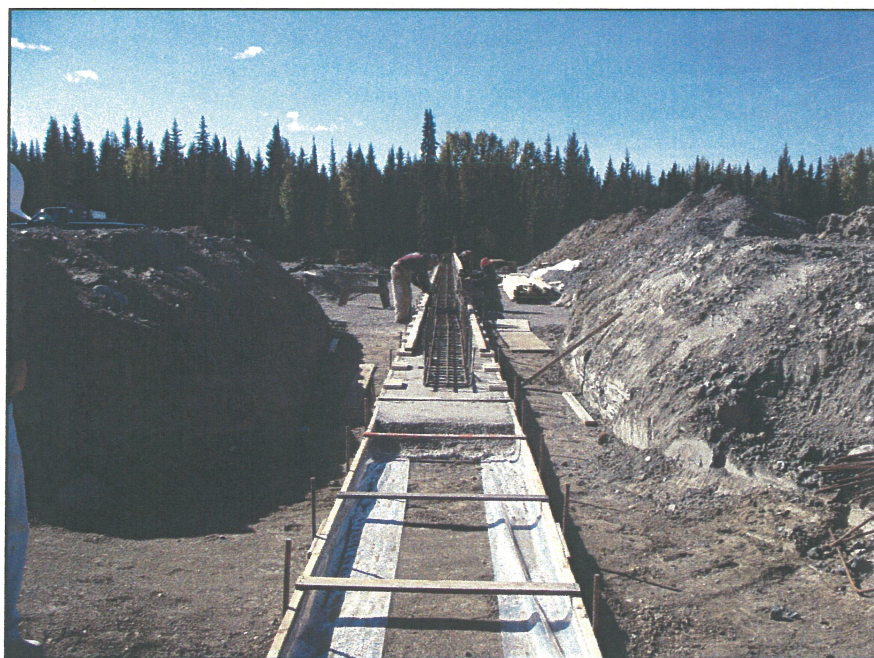
PHOTO 22 – South Embankment Concrete Encasement preparation.

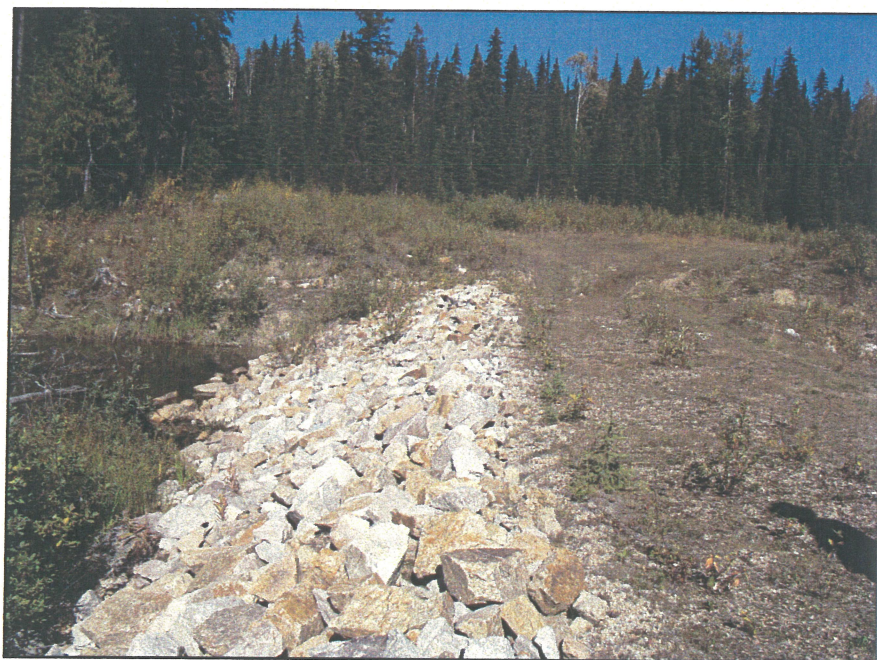
- The water level was low.
- Both upstream and downstream fill slopes were in good condition, with no evidence of seepage or slumping.
- No cracks were observed on the dam crest.
- The spillway contained some minor vegetation, but was generally unobstructed.

PHOTO 23 – South Bootjack Dam – Upstream Slope.

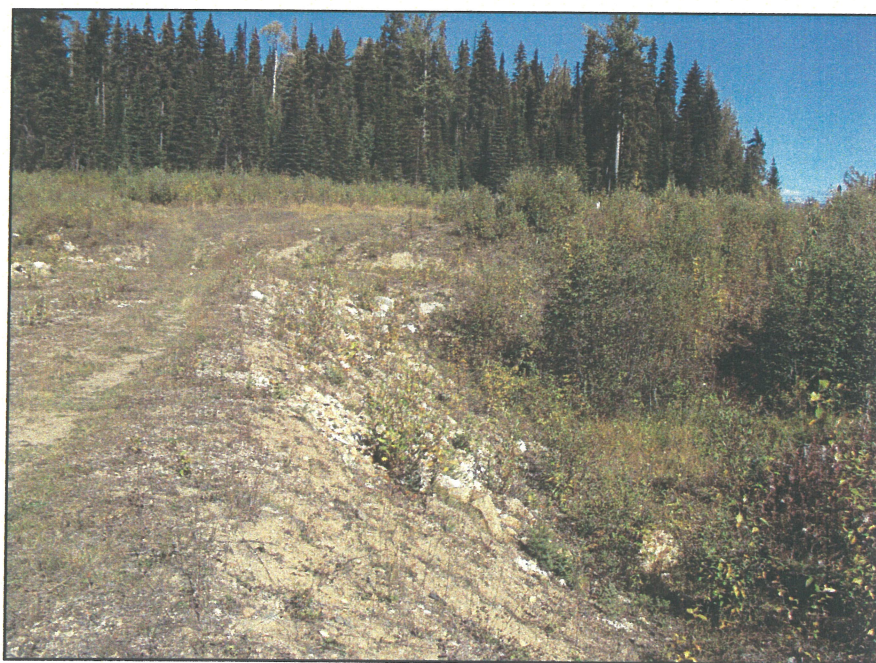
PHOTO 24 – South Bootjack Dam – Downstream Slope.
