FINAL REPORT

DAM SAFETY REVIEW

Mount Polley Mine
Likely, British Columbia

December 2006

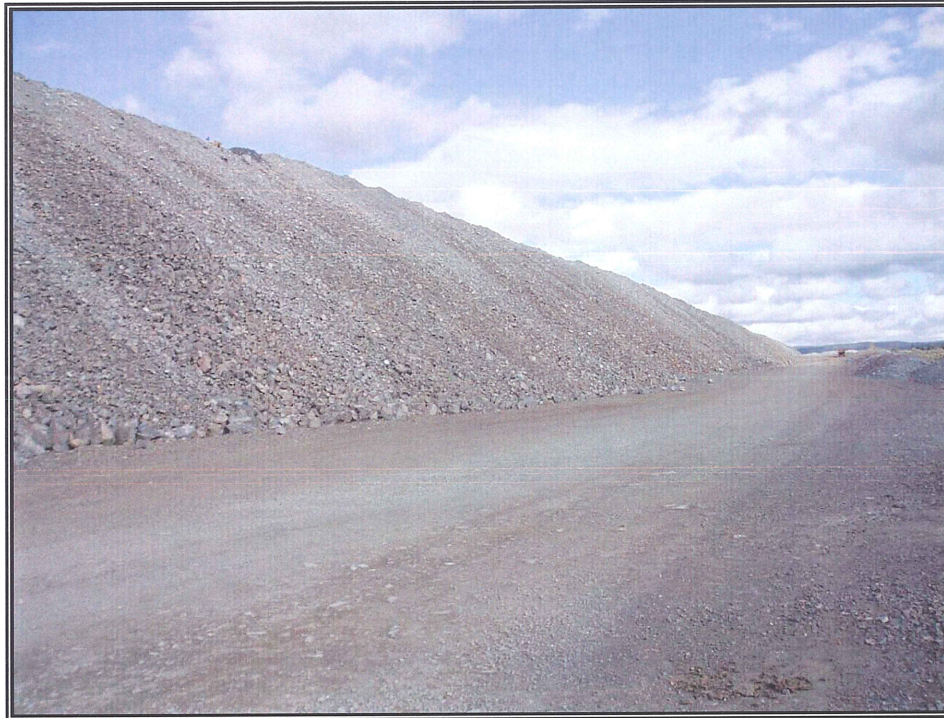
Photo 1: Main Embankment Shell – Looking Northeast

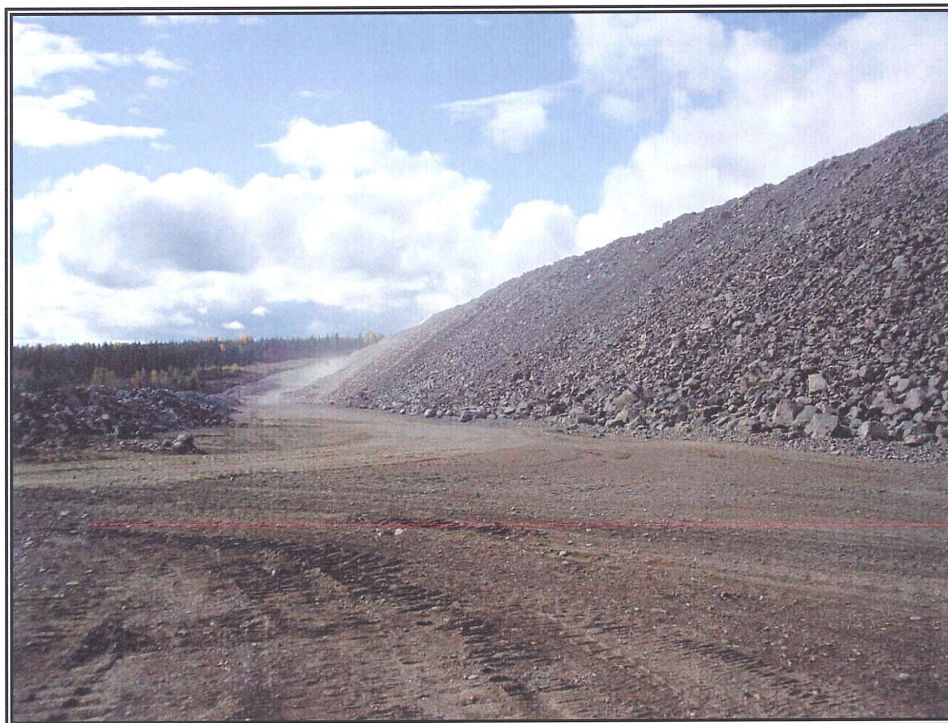
Photo 2: Main Embankment Shell – Looking Southwest

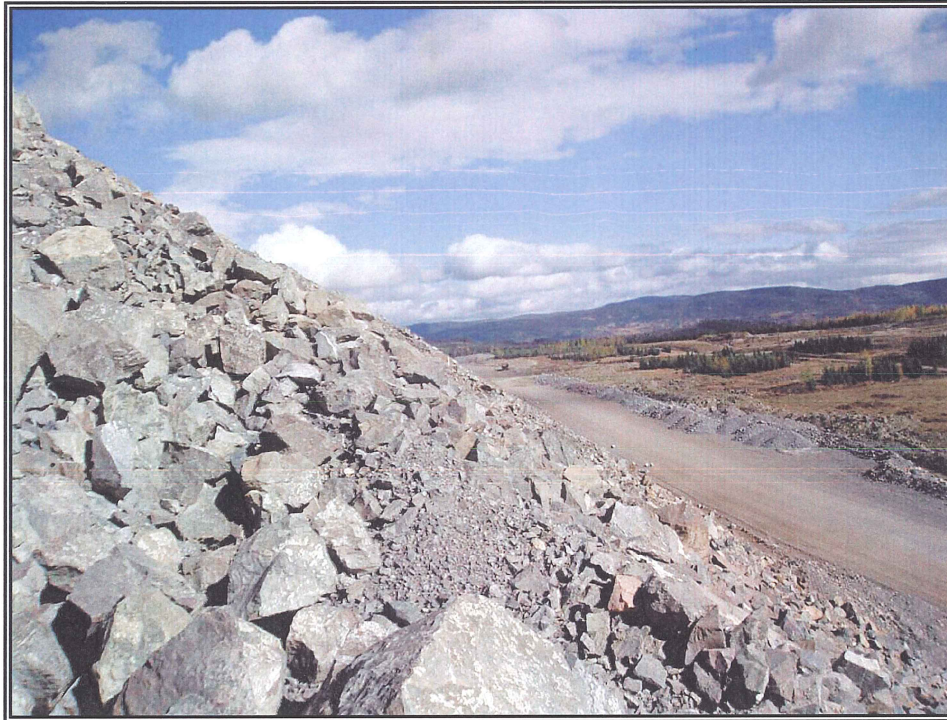
Photo 3: Nature of Main Embankment Rockfill

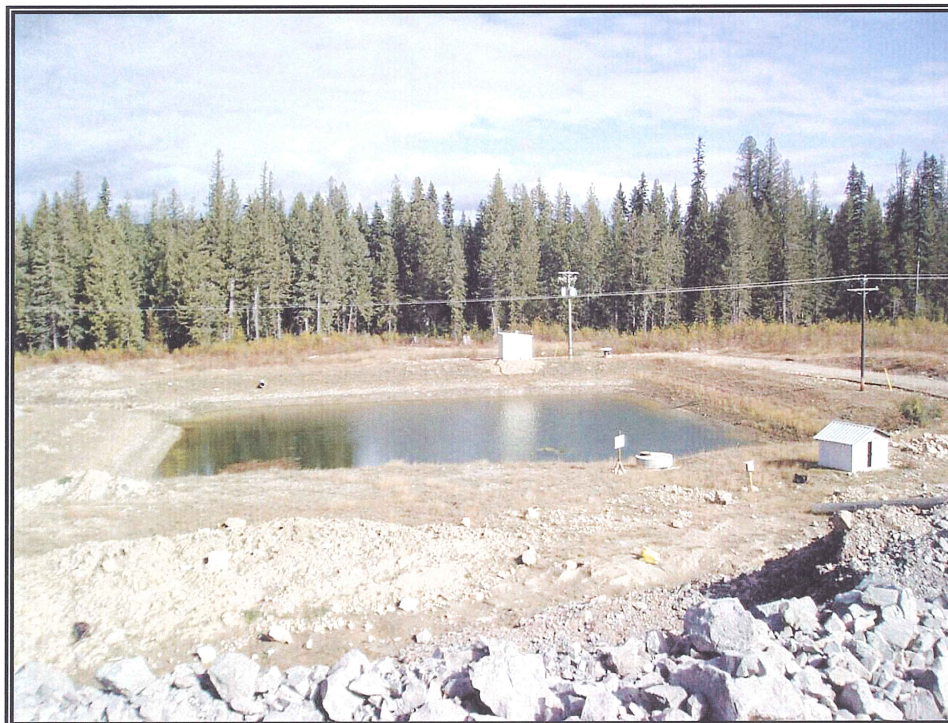
Photo 4: Main Embankment Seepage Collection

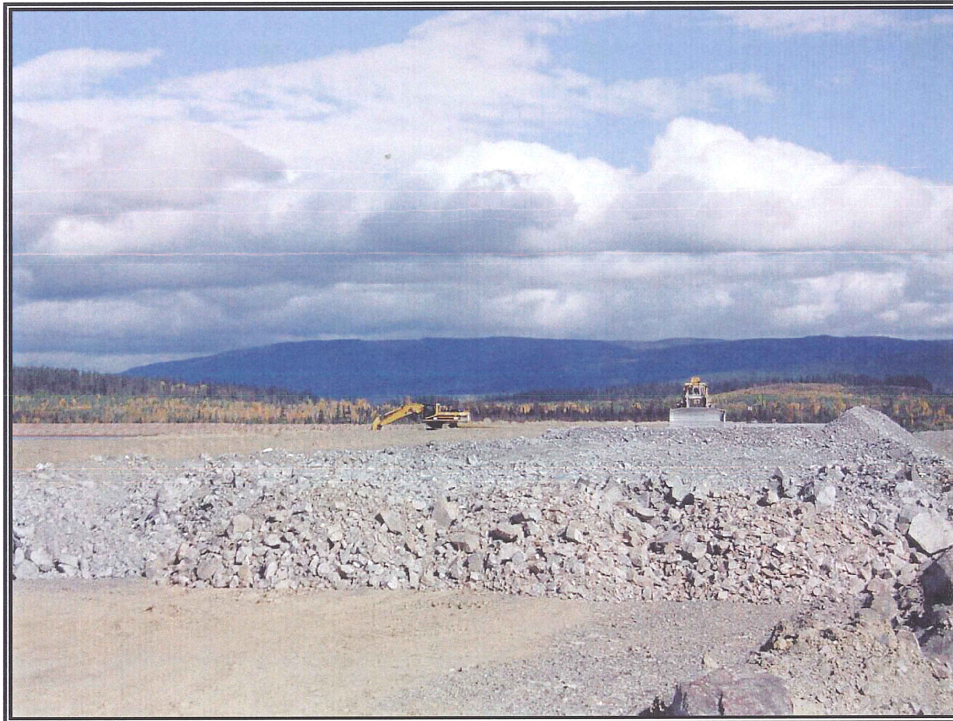
Photo 5: Construction on Main Embankment

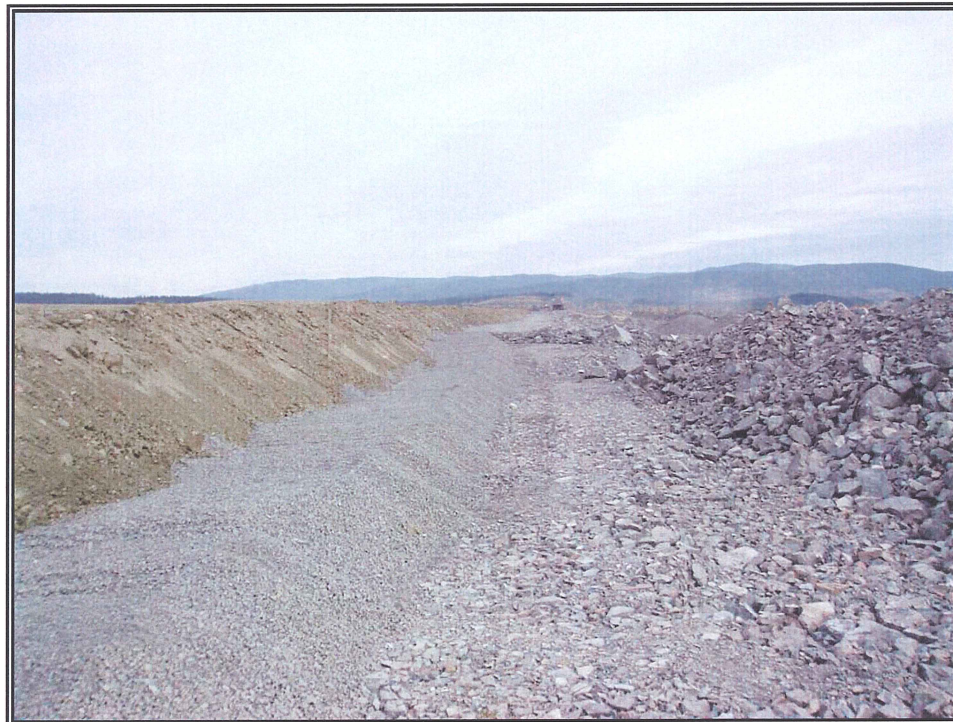
Photo 6: Zones of Main Embankment Dam

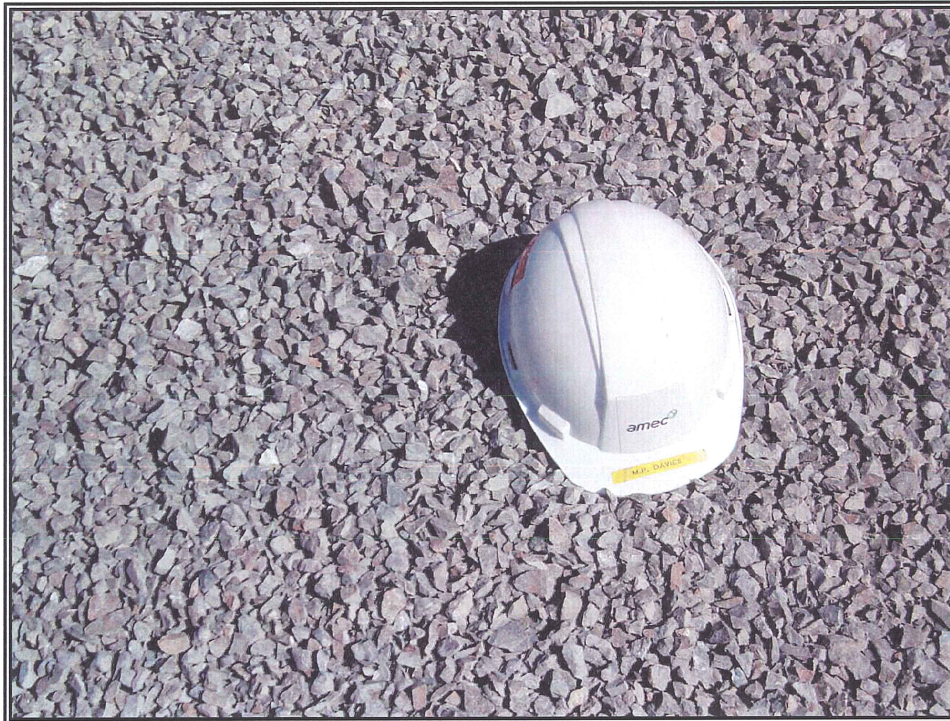
Photo 7: Main Embankment Transition Material

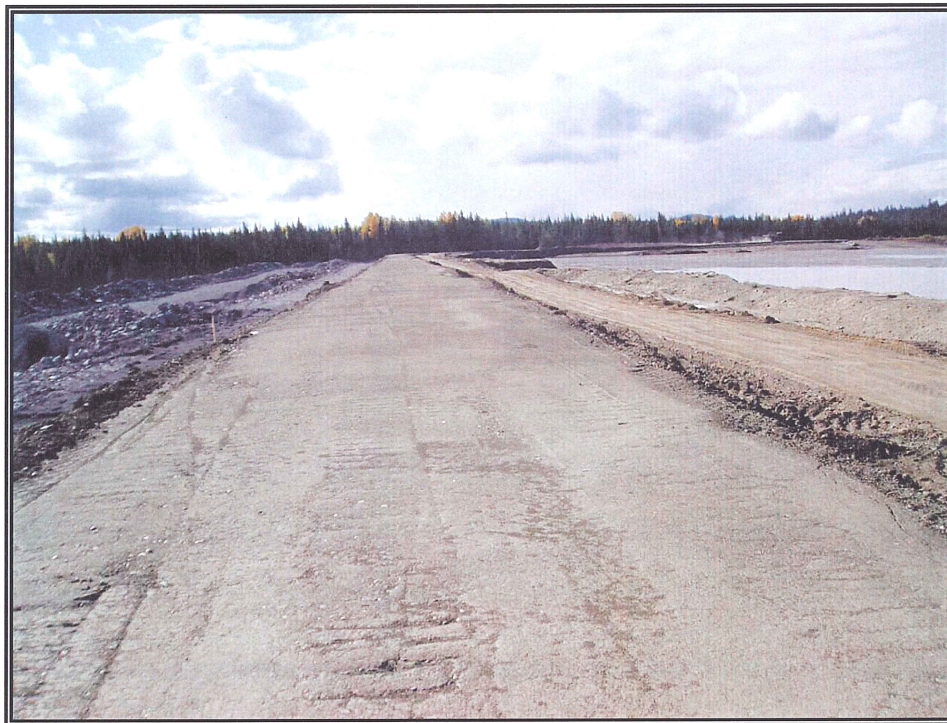
Photo 8: Main Embankment Compacted Core

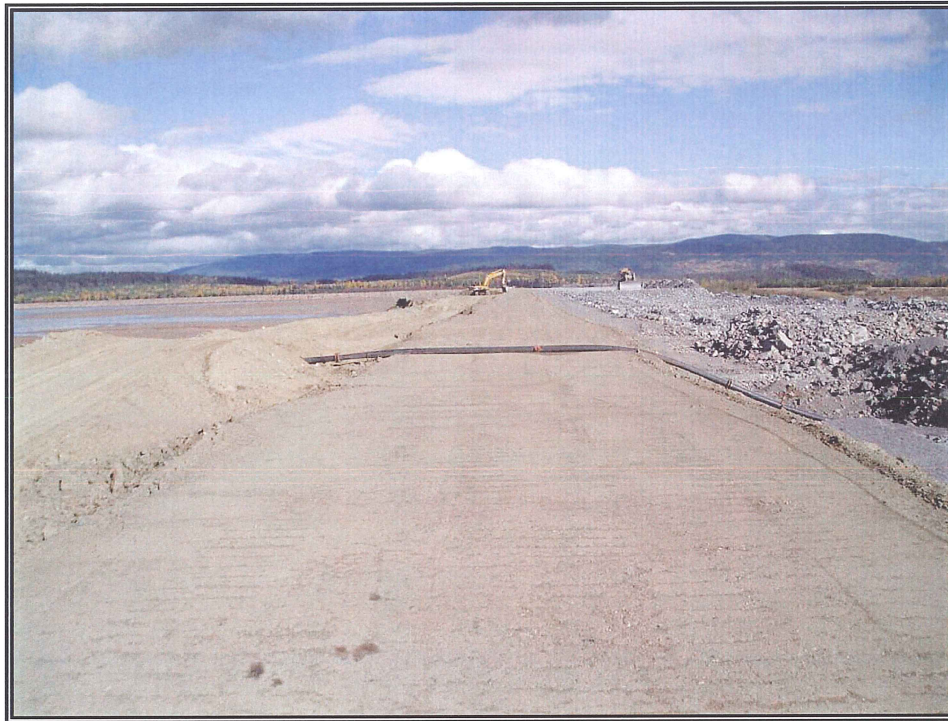
Photo 9: General Photograph of As-Built Robust Core

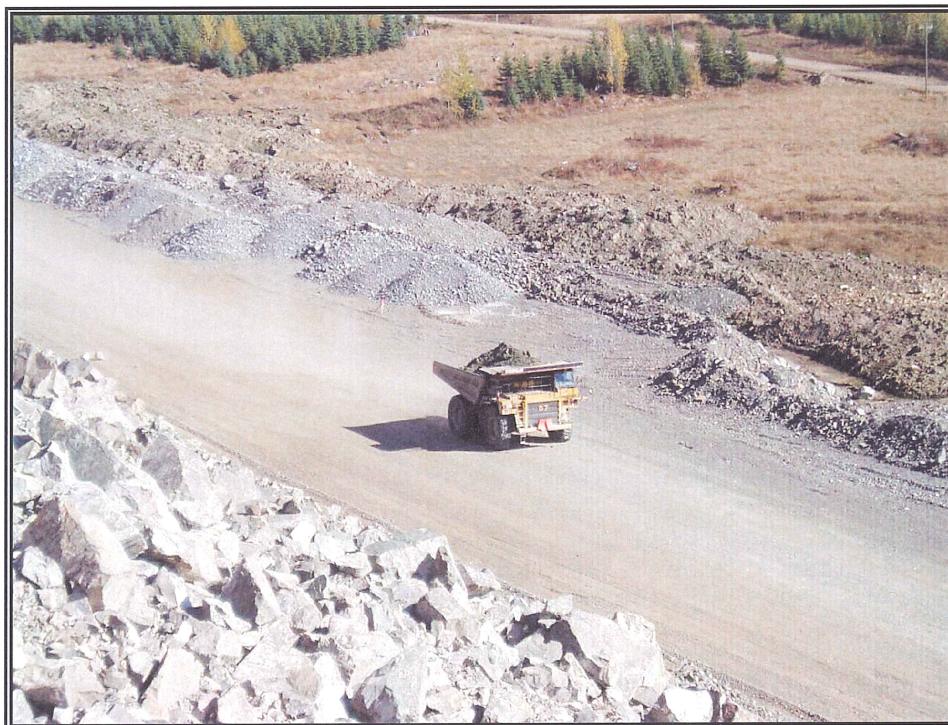
Photo 10: Haulage of Till from Borrow

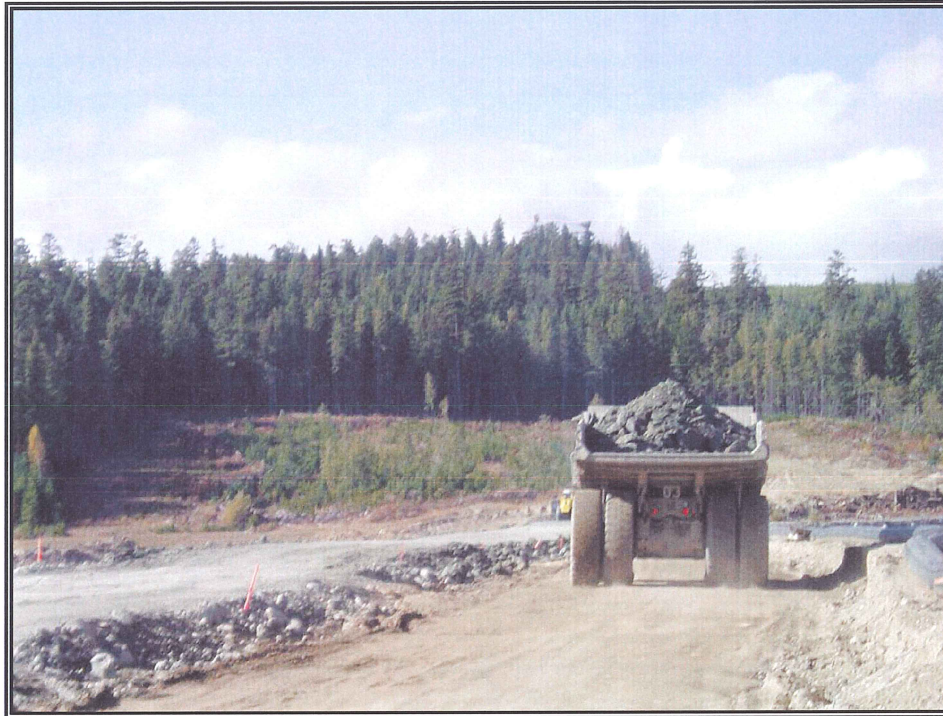
Photo 11: Till Haulage on South Embankment

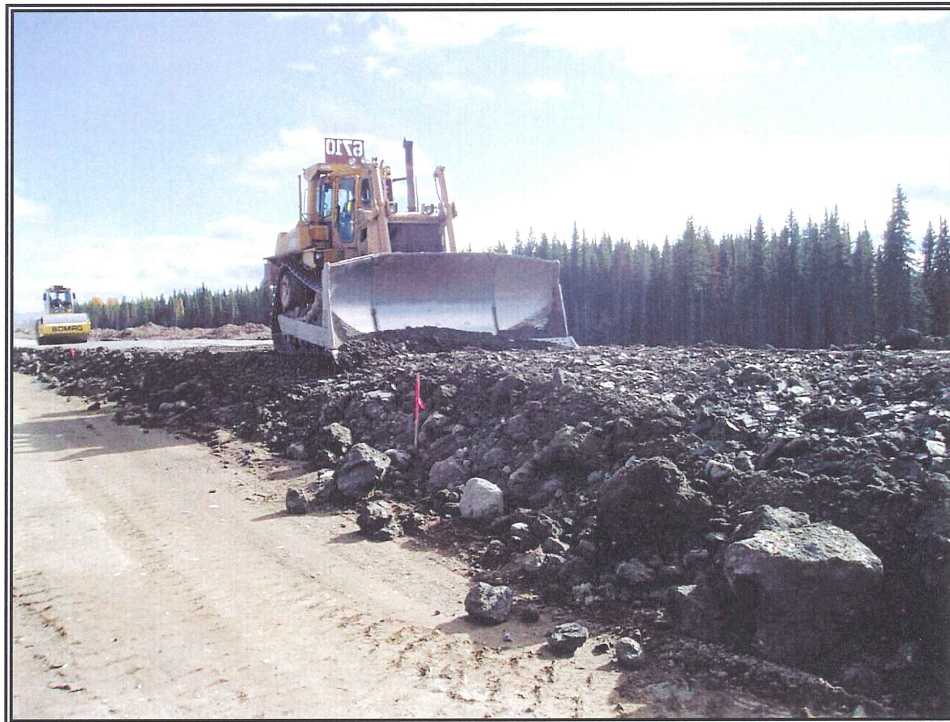
Photo 12: Placement of Till Core – South Embankment

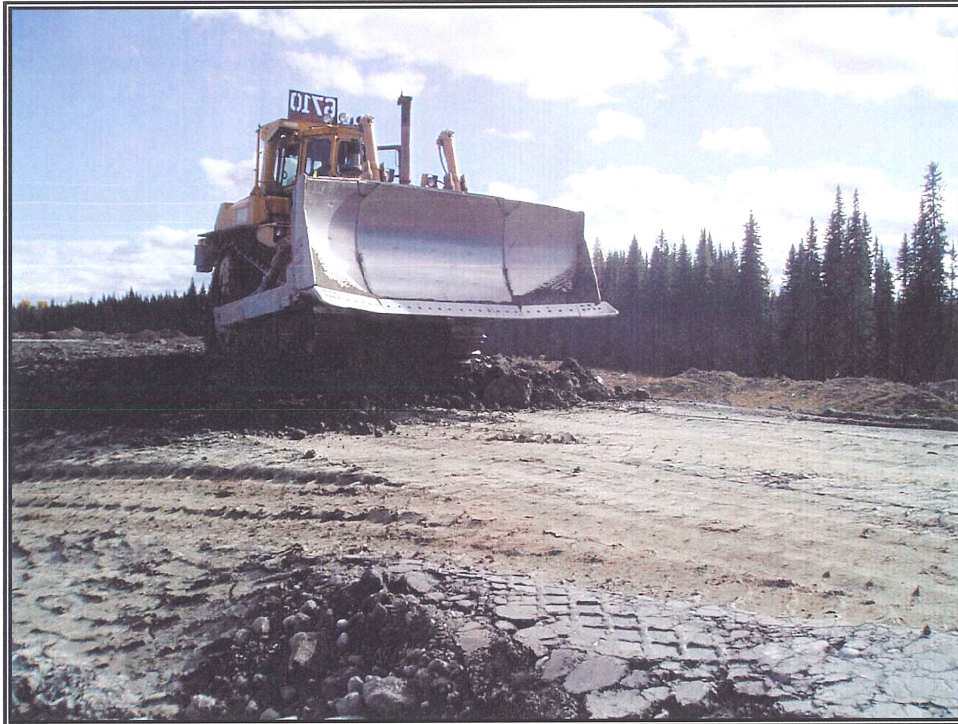
Photo 13: Compacted Till – South Embankment

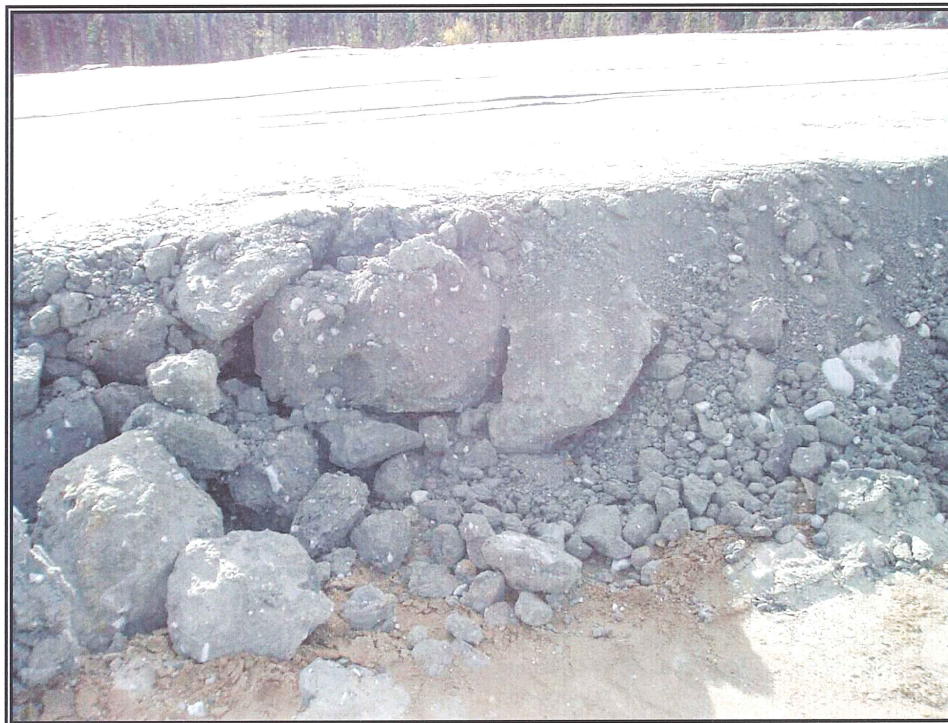
Photo 14: Compacted Till – South Embankment

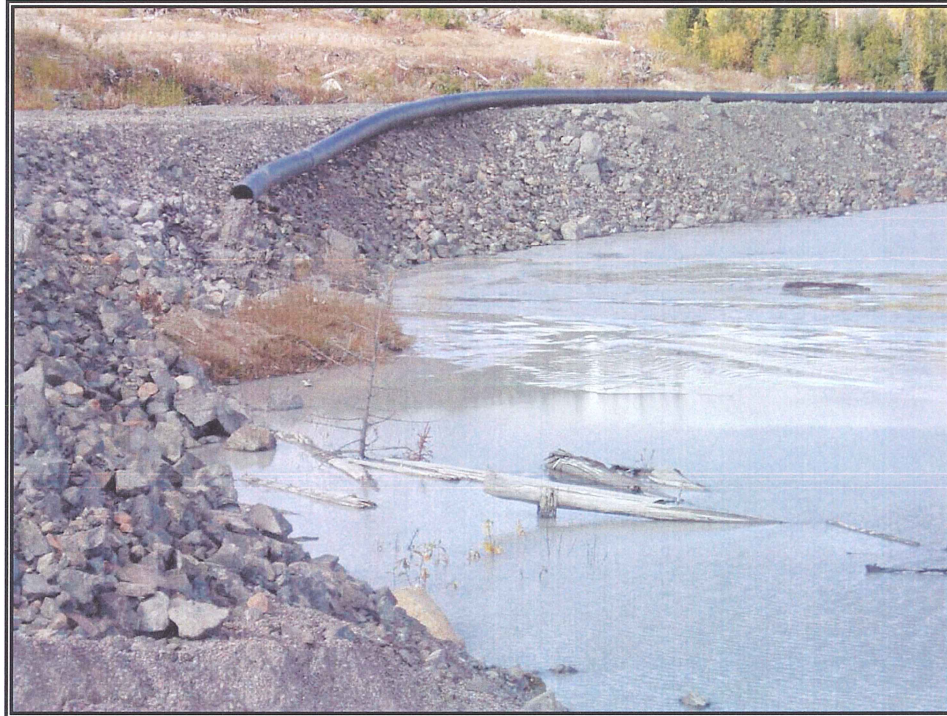
Photo 15: Tailings Overboarding at "Top" of Panel

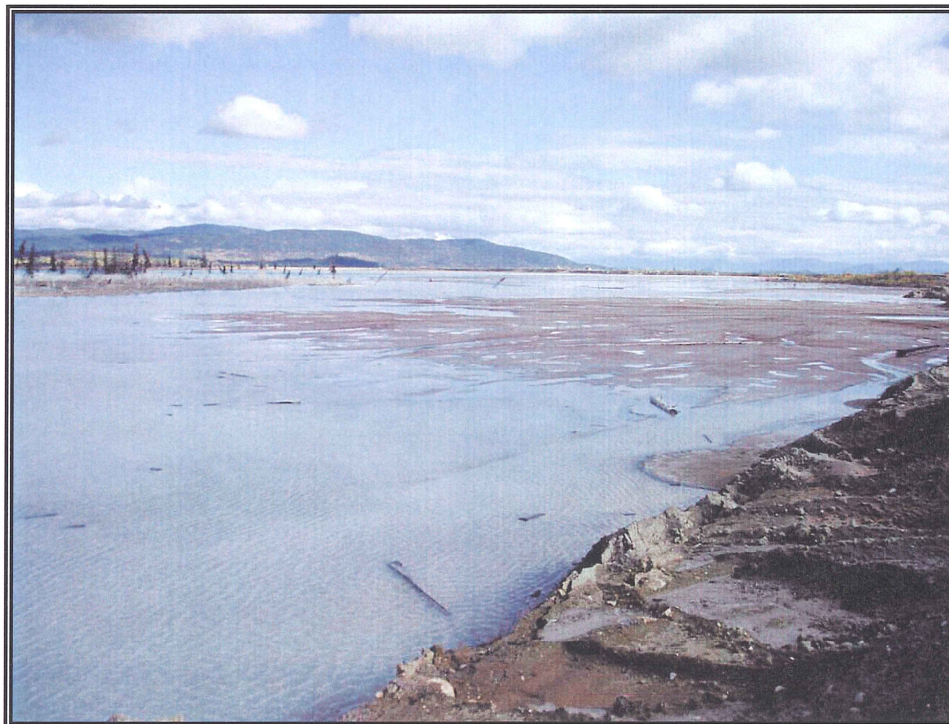
- **Dam Structures** – The three embankment dams all appeared in a good state of repair at the time of the DSR. There was no visual evidence of significant past issues (nor any documented). The lack of a tailings beach and inconsistency with beach profile and the closure concept for the TSF are notable but do not present immediate dam safety concerns. The lack of a beach profile consistent with closure objectives would address the lack of beach against the embankments and, for a number of reasons, should be addressed as soon as possible by the mine to avoid increased costs in this regard in the future. Again, however, dam safety is not a driving reason to address this lack of beach/positive beach profile.

Photo 16: "Beach" Pondward of Deposition Location

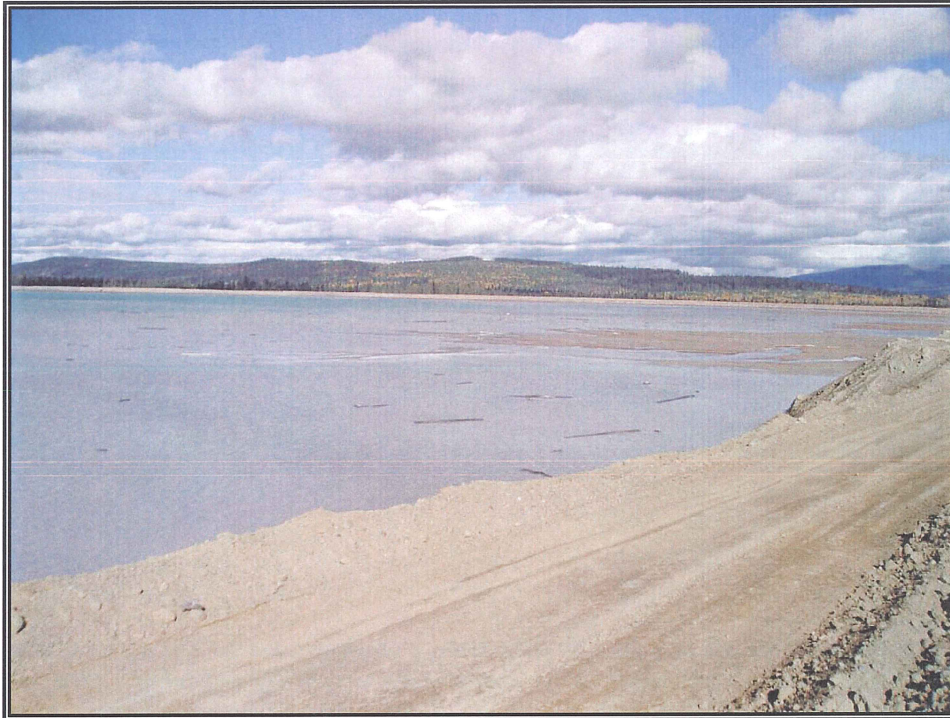
Photo 17: Lack of Established Beach – Perimeter Embankment in Background

There is currently no surface discharge facility (spillway) and one will be required for closure (and is the prime reason why the current beaching practices should be modified to allow effective placement of a spillway). At other similar facilities in British Columbia, where there is no operating spillway, a longer duration PMF event than the 24 hour event has been used with the 24 hour duration being adopted for closure when there will be an appropriate spillway. This approach is recommended for the Mount Polley TSF.

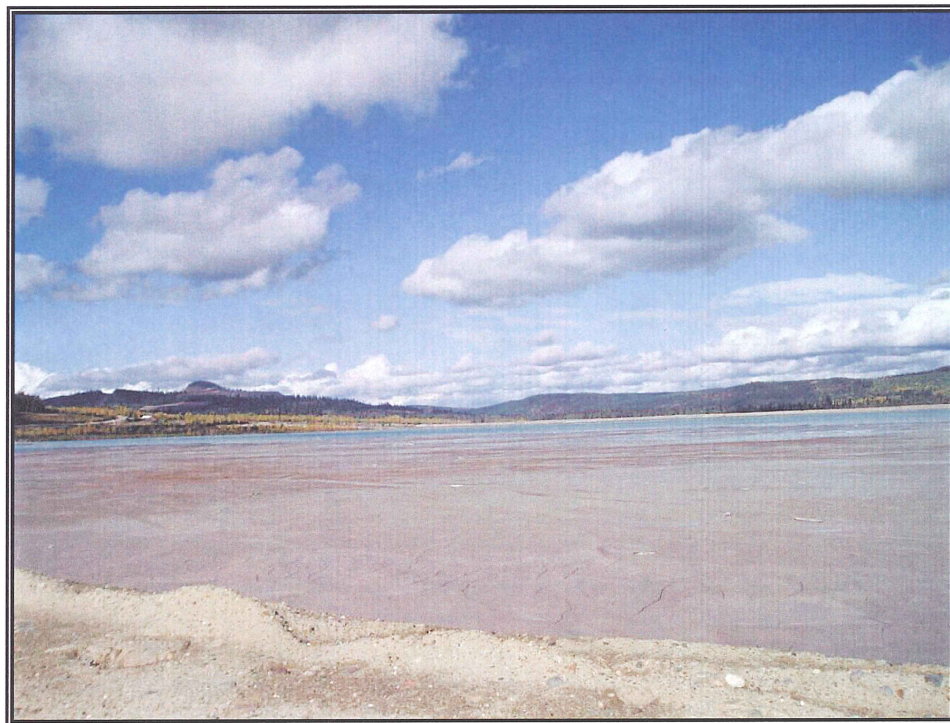
Photo 18: Minor Beach Development along Portion of Main Embankment

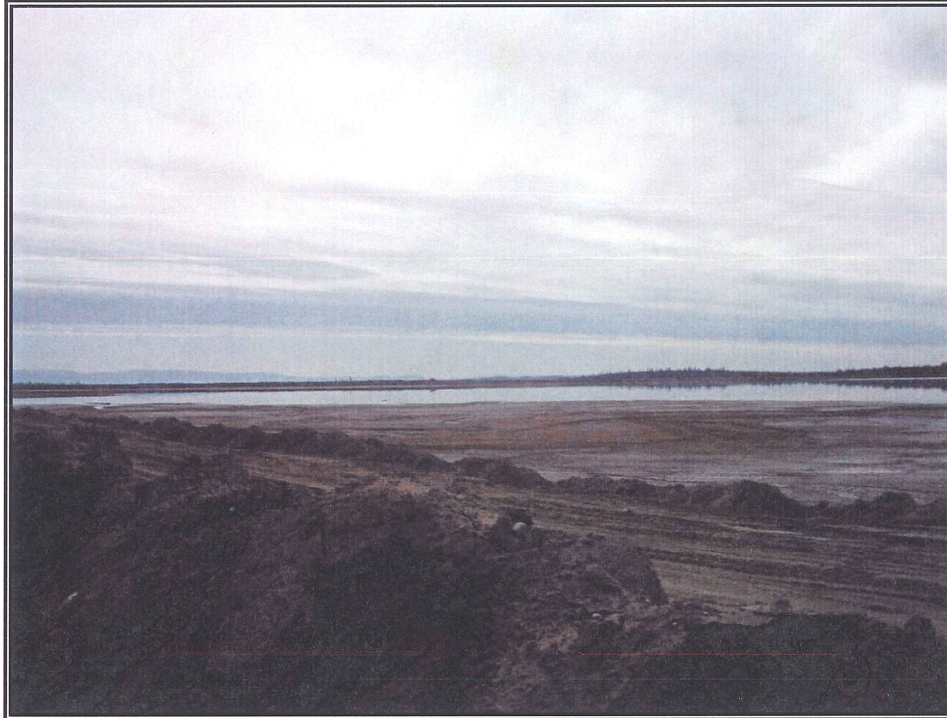
Photo 19: Tailings Pond from Northwest end of Perimeter Embankment

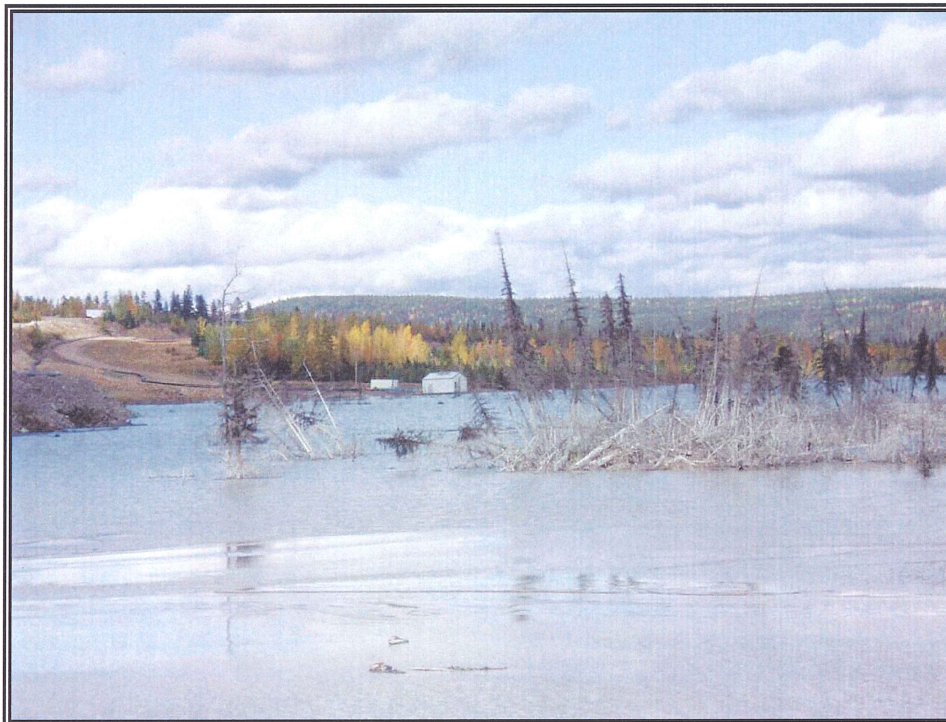
Photo 20: Tailings Water Reclaim Barge Location
