YOUR REFERENCE  
OUR REFERENCE  
NUMBER  
10162/9.01  
8/2028  
August 7, 1998

## **Re: Wood Debris Along Upstream Face of Tailings Embankment**

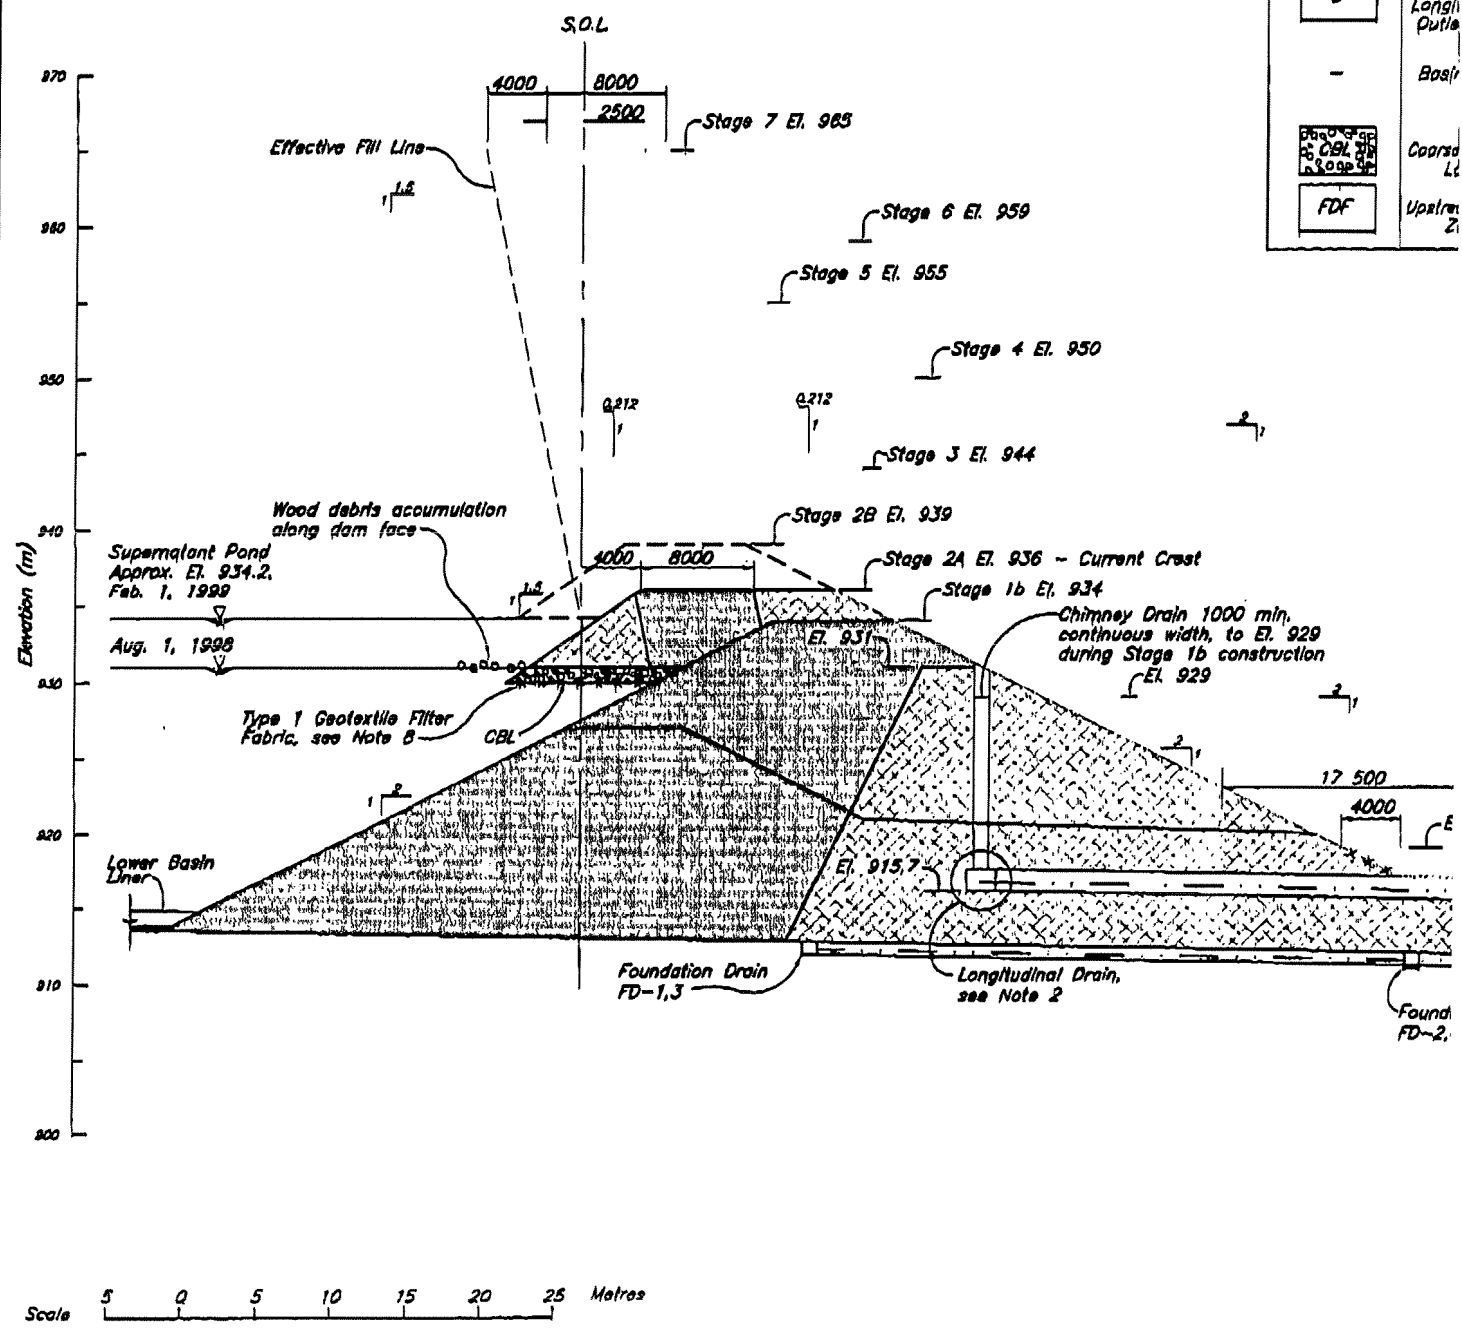
The attached Figure 1 illustrates the location and extent of the wood debris that has accumulated along the upstream face of the tailings dam.

In general, it is good practice to keep wood debris away from the dam face and avoid burial in the tailings beach where primary rotting wood debris could result in settlement at a future date, and/or create a higher permeability zone. However, we have evaluated the potential adverse implications in more detail and compared these

with the costs for removal of the wood debris. This evaluation suggests that it will be possible to bury the wood debris in the tailings beaches during tailings deposition without incurring additional risk of adverse impacts. The upstream toe drain system has not yet been installed, and therefore, the long term phreatic surface in the impoundment will be maintained above the level of the wood debris. The wood debris would not be susceptible to decay during operations. Also, decomposition of the wood debris (if were to occur) would not result in excessive differential settlement which could adversely affect the integrity of the dam structure.

We believe that MPMC should be concentrating efforts on spigotting and/or cycloning to form a continuous tailings beach along the upstream face of the dam rather than cause further delays with wood removal activities. However, appropriate precautions should be included to ensure that this problem does not re-occur. We recommend that a log boom be constructed using the larger logs that are currently situated along the dam face.
