REPORT OF GEOTECHNICAL INSPECTOR
(Issued pursuant to Section 15 of the Mines Act)

Name of Property: Mount Polley Mine **Permit No.:** M-200

Date of Inspection: September 24, 2012

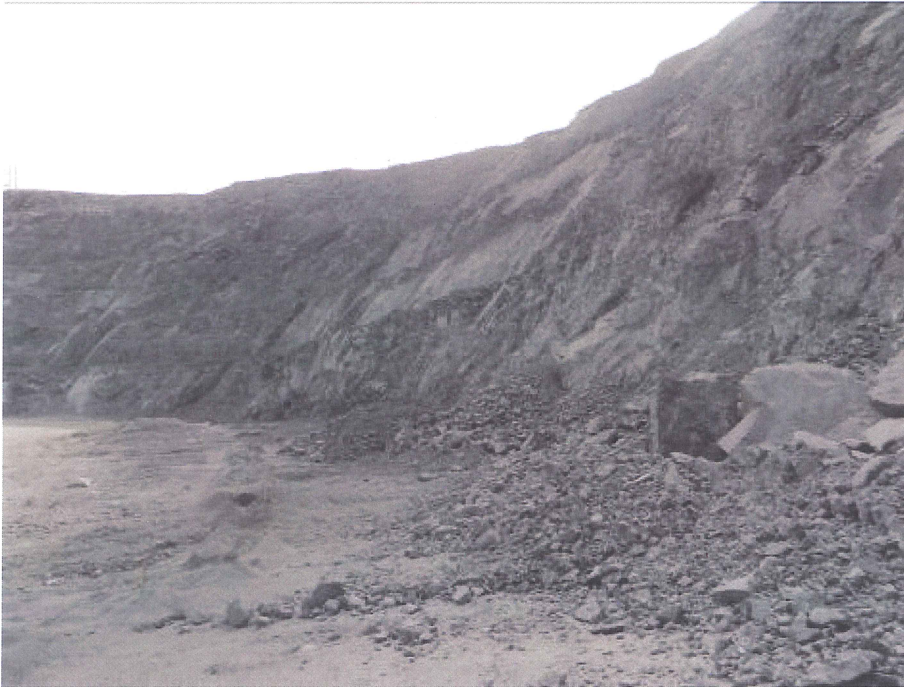
Photo 1: Springer Pit. Benches lost entirely above 1036 bench due to adverse geologic structure. Note that drilling was recently completed 12 m from the toe and that minor rockfall has run out as far as these holes.

Within 60 days the Mine shall submit a pit slope design report to the Chief Inspector for the Springer Pit pushback. The report shall address the following:

- 1. Provide recommendations that ensure that the final width of all catchment benches are 8m as per Section 6.23.2 of the code. Note that the 8m requirement does not apply to regular benches; however these must still be maintained to prevent accumulation of rockfall that creates a downslope hazard.*
- 2. If proposed, provide details of proposed multiple bench system of mining as per Section 6.23.2 of the code.*
- 3. Address safety concerns associated with pushback material filling the benches of the operating pit as per Section 6.23.2 of the code*

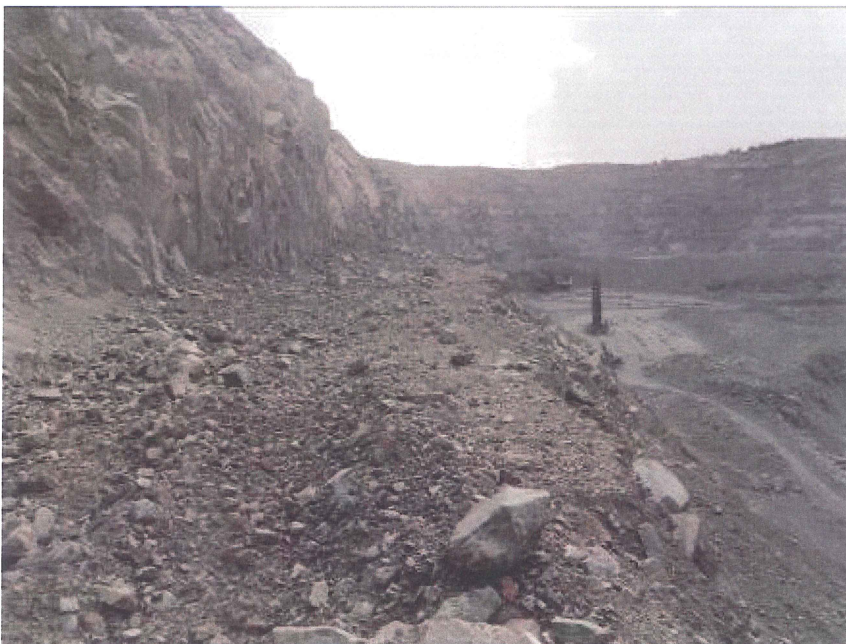
Photo 2: Northeast side of 1072 Bench. Crest break back has resulted in almost 50% of bench having a width less than 8m. Note that much rockfall is present but benches are not full.

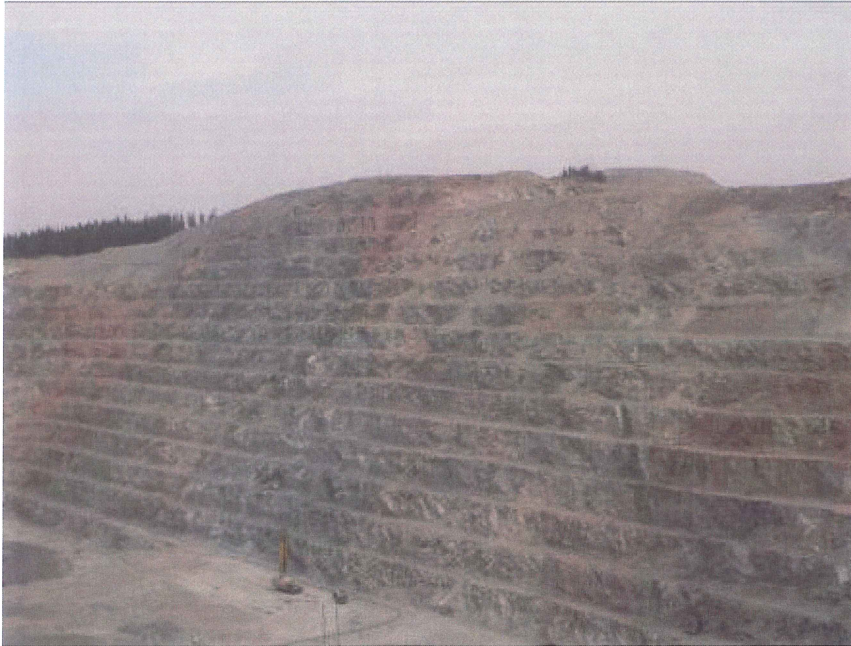
Photo 5: Material from push back is progressively filling upper benches resulting in loss of rock fall catchment and rock cascading down pit.

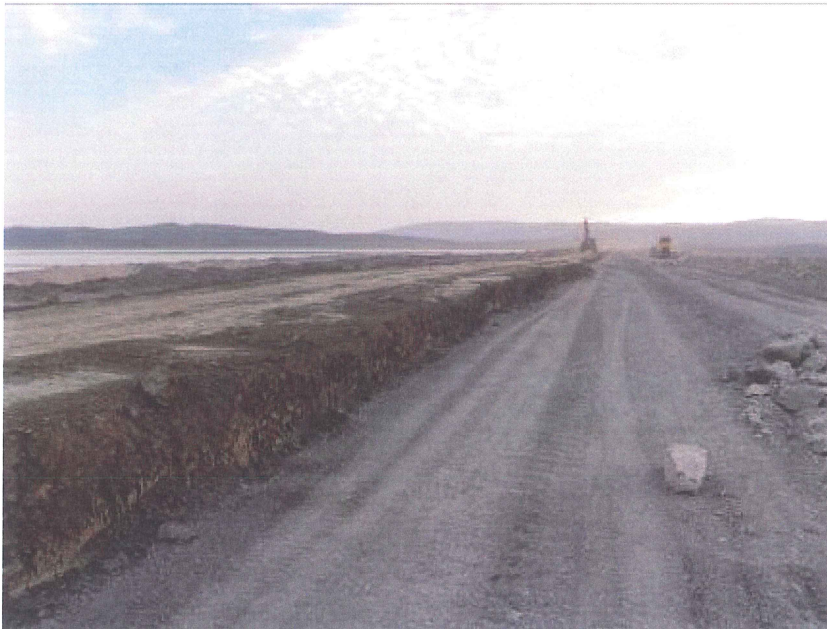
The Stage 8 dam raise to elevation 963.5m was underway at the time of this inspection. EMNG has previously reviewed and accepted the designs for this lift. We reviewed placement procedures for the till core and filters, see Photo 6. We also observed sand cell construction on the upstream side of the west dam and discussed the problems and potential impacts of limited sand placement on the central dam due to gravity placement limitation, it is understood that the Mine's consultants (AMEC) will be reviewing. We also inspected the keyway tie in on the South Dam. All construction appears to be well done. A quality control and quality assurance program is in place and it is understood that there have been no significant issues. The Mine reports that instrumentation has responded as expected during construction. It was noted that some of the instrumentation is not well protected from potential construction equipment damage and recommend that this be remedied.

Photo 6: TSF. Stage 8 till and filter construction. To facilitate compaction till is placed at 2:1 slope beyond line then trimmed back.
