Re: Mine Inspection June 7, 2008
Property: Mount Polley Mine

Report of Inspector of Mines

Geotechnical

Inspection No.: 15354
File: 18040-02-07
Mine No.: 1101163
Emp/Cont: 0 / 0
Orders H&S: 2 RECL 0
Stop Work: 0

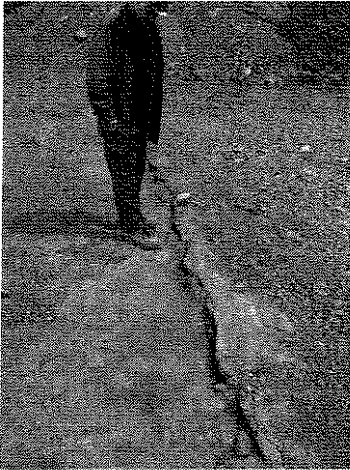
Fig. 1

Tension crack was noticed developing on the south west crest of the pit (Fig. 1). It appeared the crack was aligned with the main

fault structure striking North-West direction. The movement of the tension crack shall be monitored with both prism monitoring and by inserting steel pins on both side of the crack and monitoring the displacements.

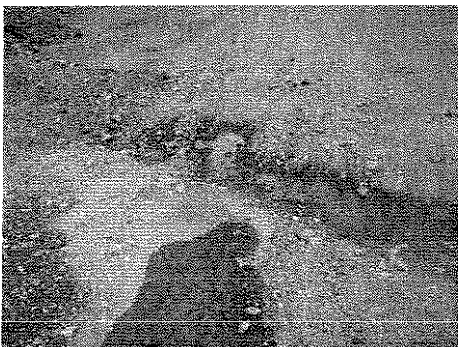
Fig. 2

It was observed that some water runoff was noticed to be feeding the main fault. The observed water runoff shall be diverted away or above the main fault.

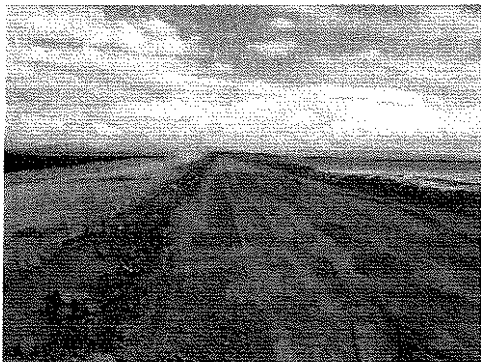
Fig. 3

SECTION :10.1.11 Departure From Approval

The specification for till used in the construction of the dam core (Zone S) requires that rock inclusions larger than 4 inches be removed prior to compaction. Rock boulders over 12 inch in size were noted in the till core and shall be removed by machine or by hand.
