**MINISTRY OF ENERGY AND MINES**  
Mines and Mineral Resources Division

**REPORT OF GEOTECHNICAL INSPECTOR**  
(Issued pursuant to Section 15 of the Mines Act)

**Name of Property:** Mount Polley Mine **Permit No.:** M-200

**Date of Inspection:** September 13, 2013

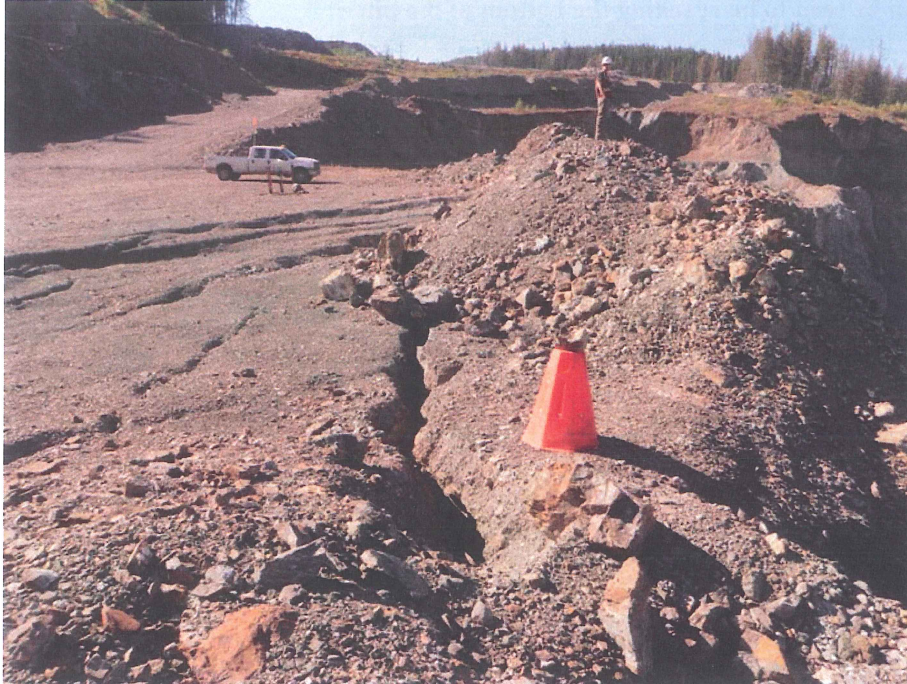
the exception of the installation of 6ft friction bolts in the back. The stability of the Wight Pit and potential impact on underground infrastructure at the base of the pit is a concern that needs to be properly assessed.

**Photo 1: Tension Cracks and slump on south west crest of Wight Pit above underground access**

*Prior to commencing production mining the Mine shall complete a detailed assessment of the Wight Pit slope stability and rockfall hazard to the infrastructure located within the pit. The analysis should consider the effects of blast vibrations from production blasts. Details of pit slope monitoring program and trigger levels shall be included in the report.*

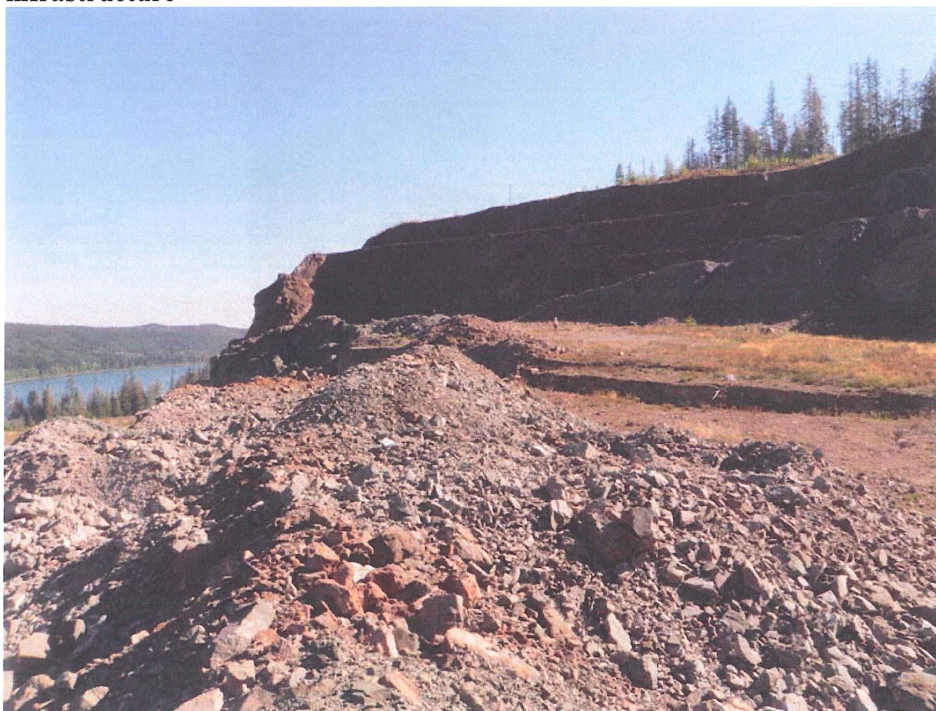
**Photo 2: Tension Cracks and slump on western crest of Wight Pit above underground infrastructure**
