**IMPERIAL METALS CORPORATION**

**GEOTECHNICAL REVIEW, DRAINAGE ASPECTS**

**MAIN EMBANKMENT DAM**

**MT. POLLEY PROJECT, BRITISH COLUMBIA**

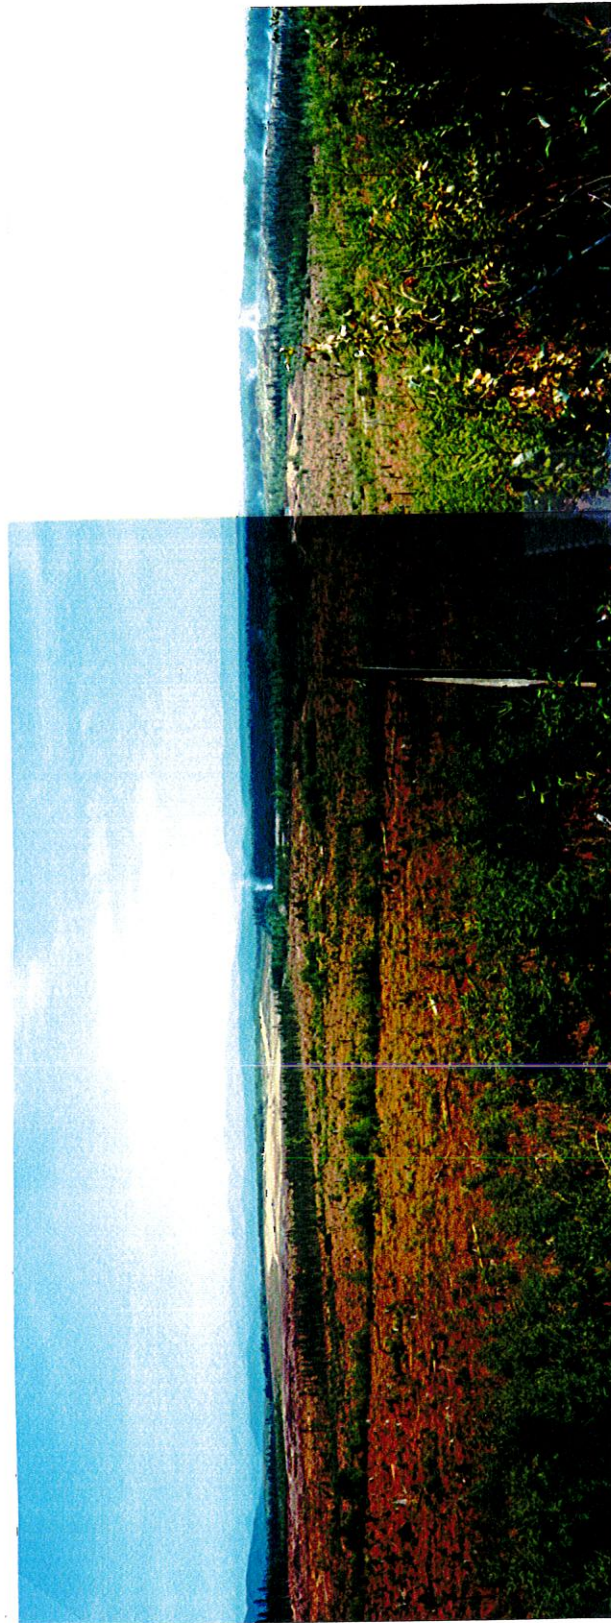
**Photo 1** Overall View of Tailings Storage Facility Site  
from West Side, Looking South-East towards  
Main Embankment Area.

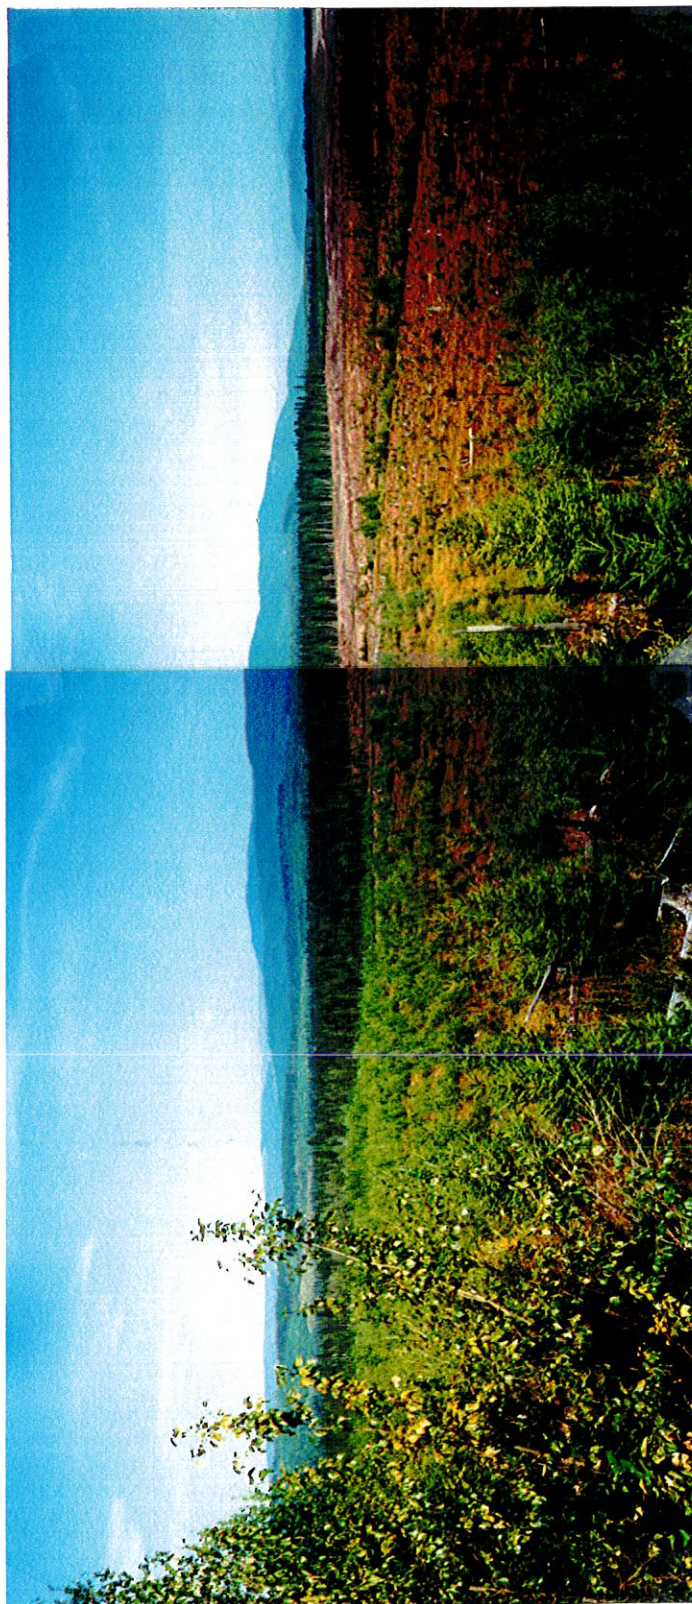
**Photo 2.** As for Photo 1 but Looking North towards  
Perimeter Embankment Area

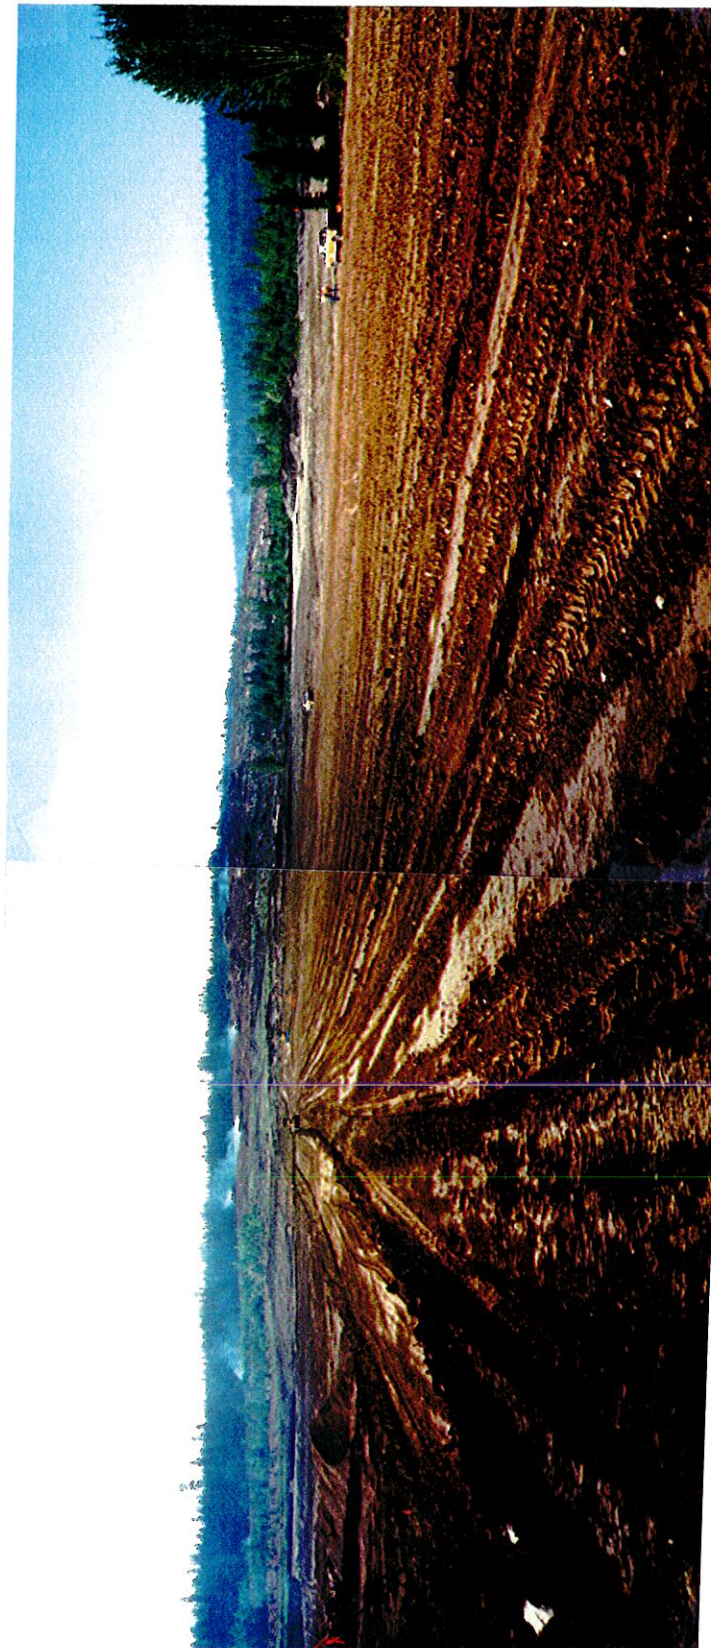
- (i) Photos 1 and 2 are taken from the high ground at about the Westerly limit of the Tailings Area at final elevation.
- (ii) The base of Stage Ib of the Main Embankment Dam is shown under construction in Photos 3 to 5, inclusive. The Basin liner already in place is visible in the right hand side of Photos 3 and 5.
- (iii) The base of Zone B of Stage Ib of the Main Embankment Dam is visible in Photos 6 and 7.
- (iv) Part of an embankment foundation drain can be seen in Photo 7.
- (v) Overall views of the Seepage Collection Pond are given in Photos 8 and 9. These show that excavation has been for the most part in the upper glacial till formation, with occasional exposures of a bluish-grey material which is

**Photo 3.** Base of Stage 1b of Main Embankment. Looking North-East

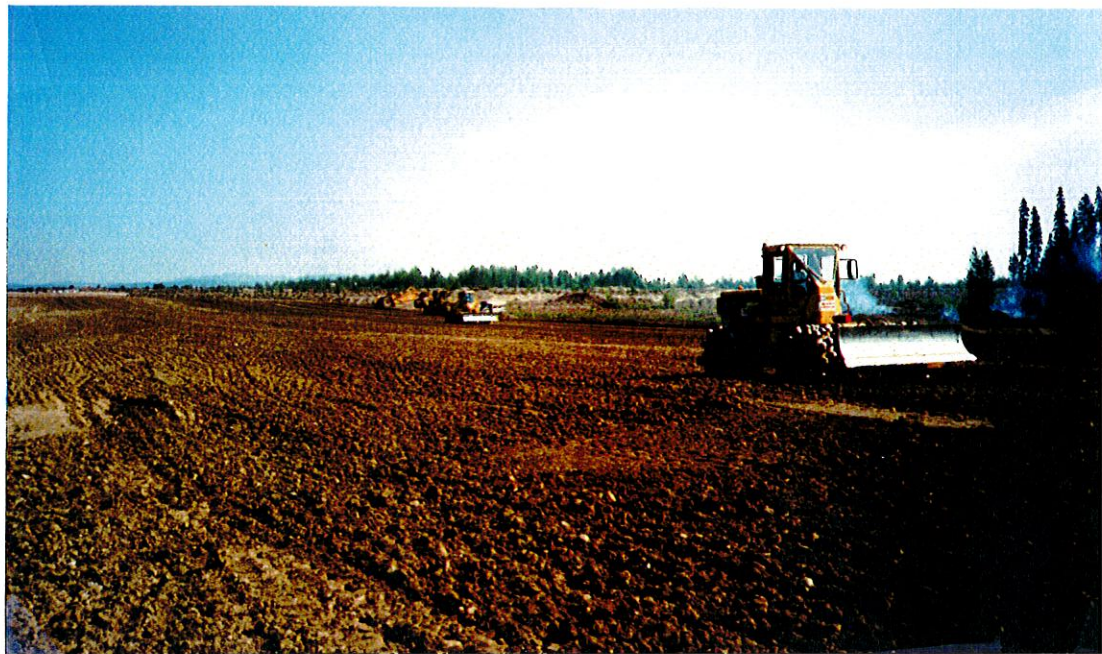
**Photo 4.** Base of Stage 1b of Main Embankment. Looking South-West.

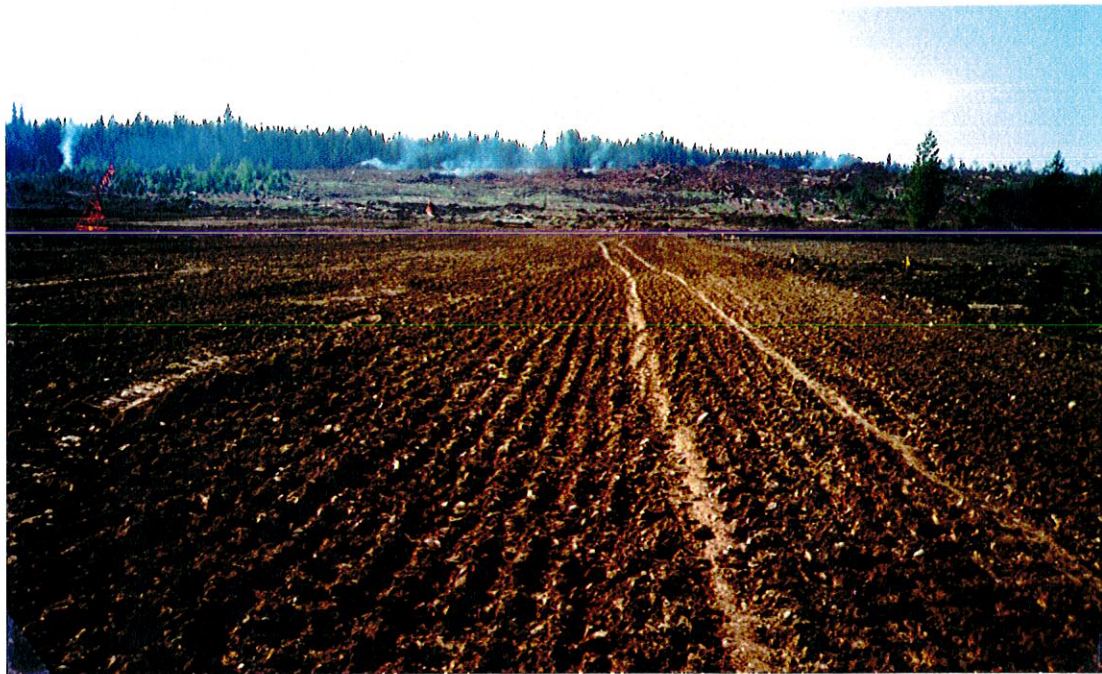
**Photo 5.** Base of Stage 1b of Main Embankment and Adjoining Basin Liner. Looking South-West.

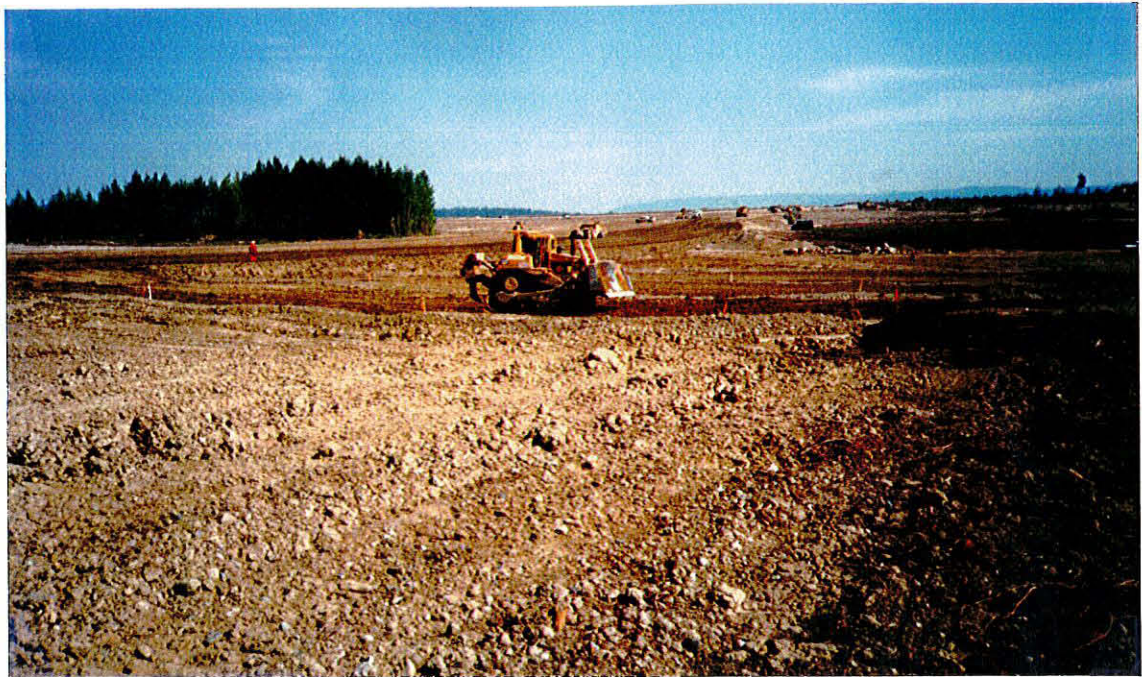
**Photo 6.** Base of Zone B of Stage 1b of Main Embankment near Seepage Collection Pond. Looking North-East.

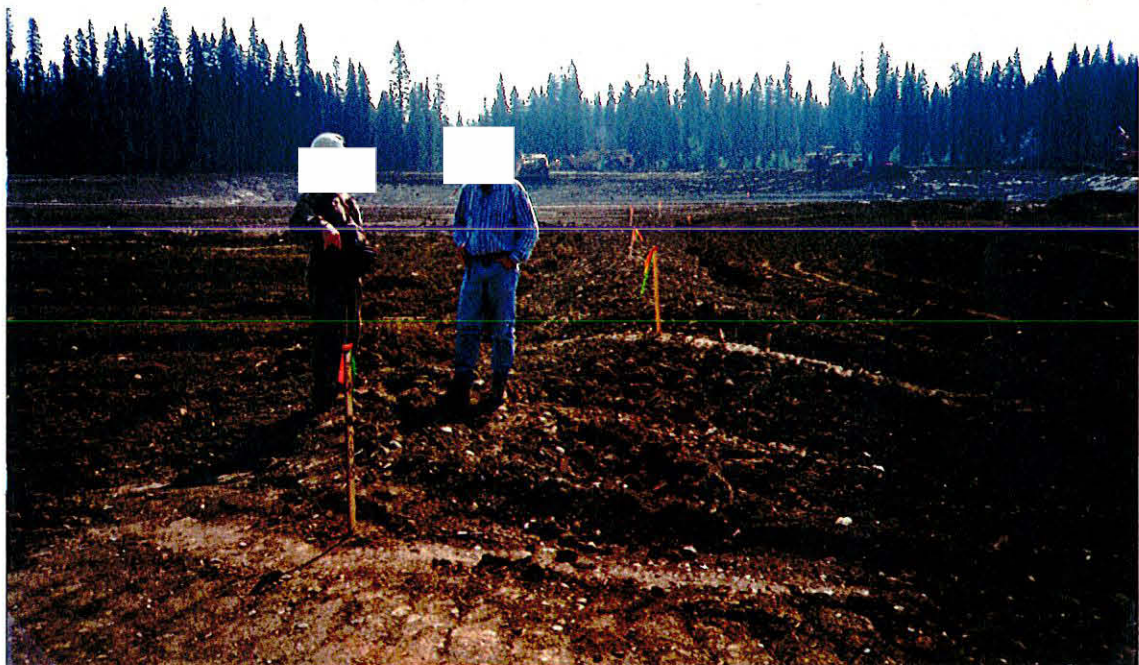
**Photo 7.** Base of Zone B of Stage 1b of Main Embankment. A Foundation Drain visible. Looking South-East.

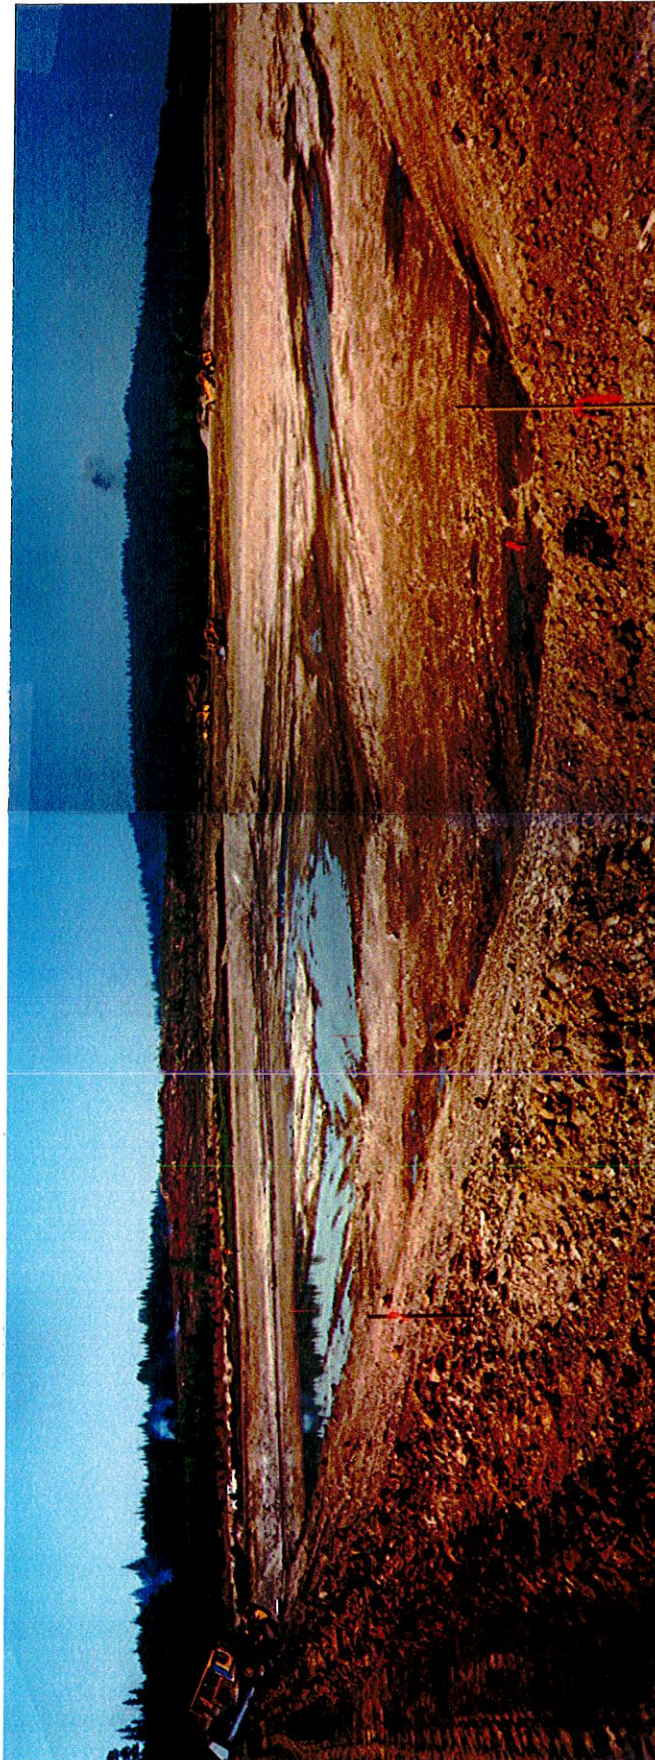
**Photo 8.** Panoramic View of Main Embankment Seepage  
Collection Point. Looking West.

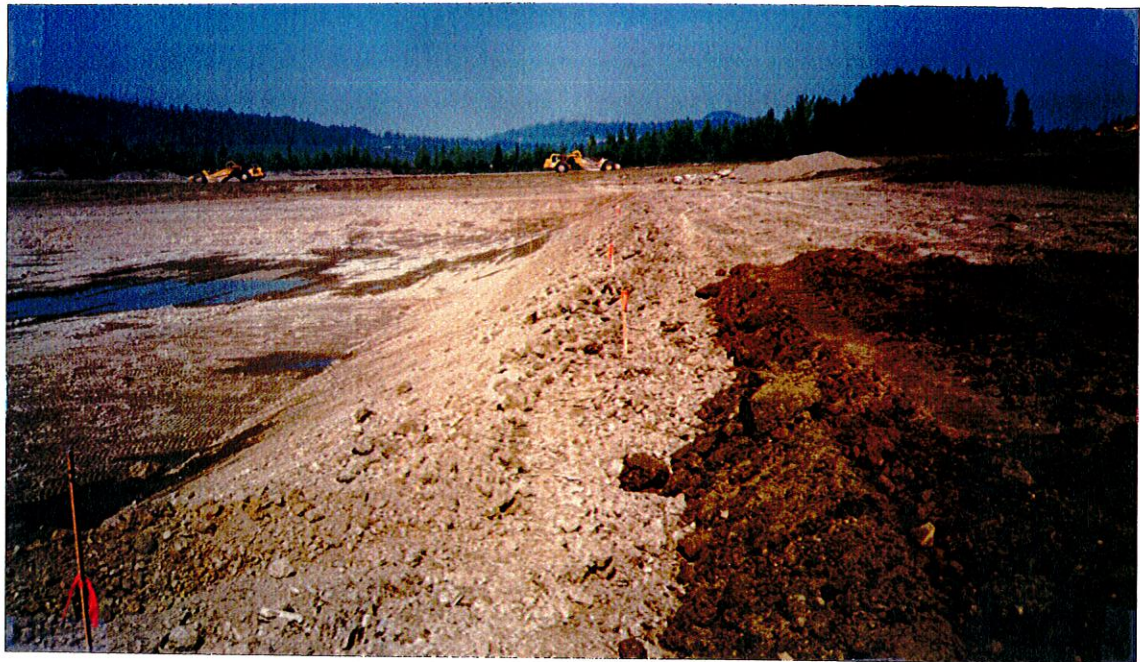
**Photo 9.** East Side of Main Embankment Seepage Collection Pond. Looking North.

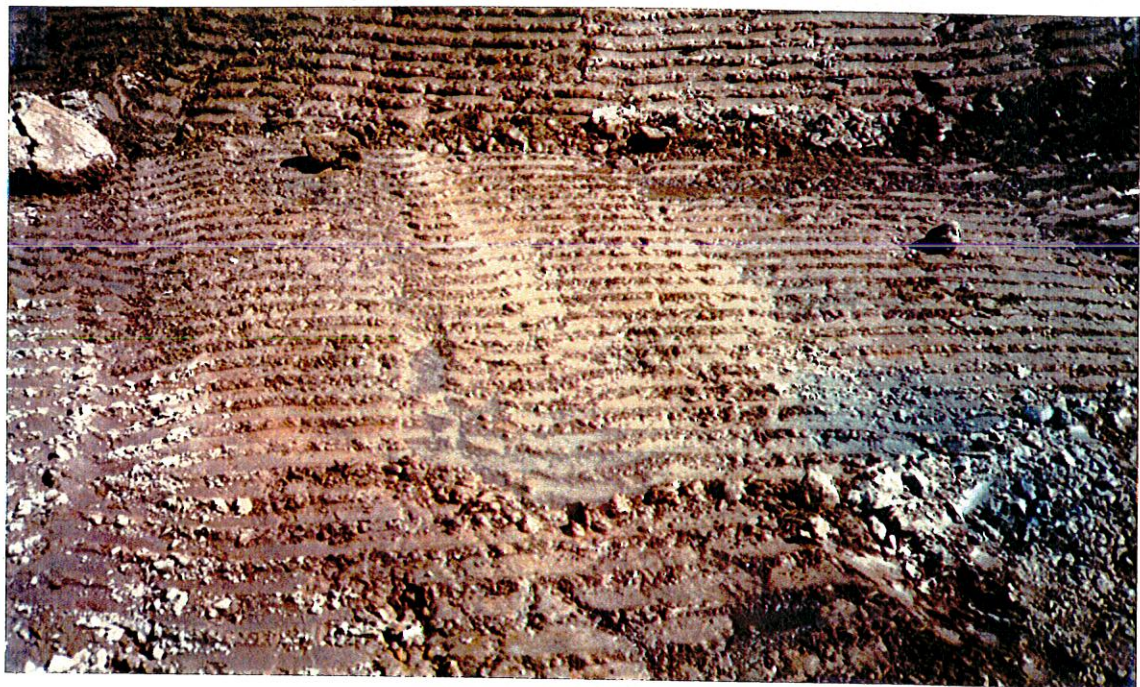
**Photo 10.** Base of Main Embankment Seepage Collection Pond near South-East Corner.

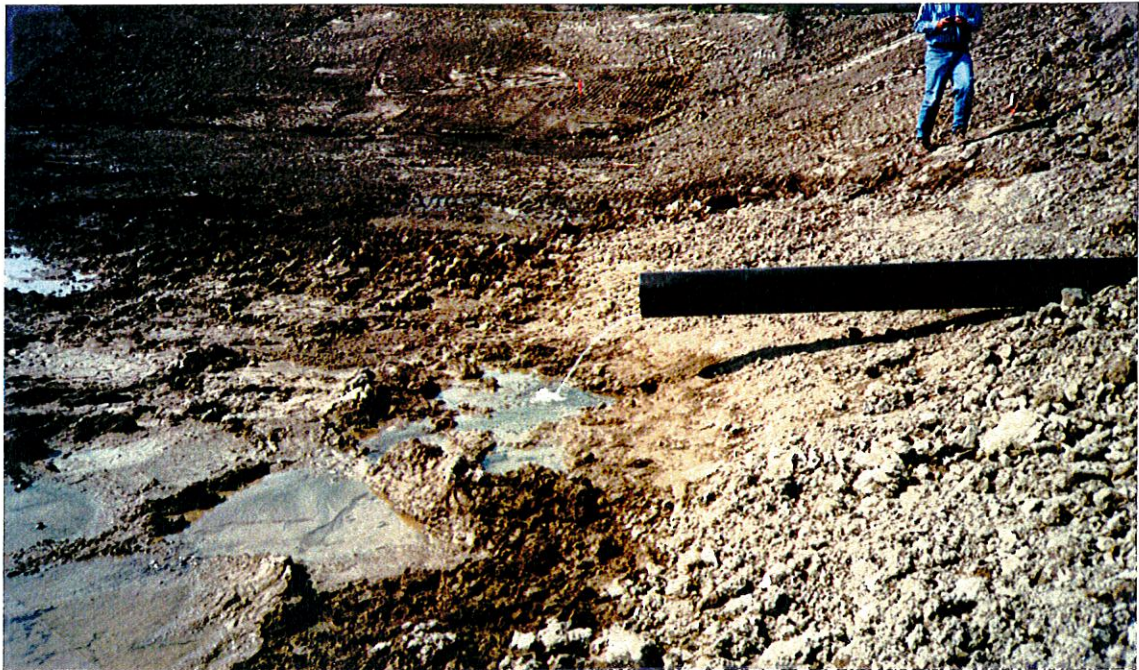
**Photo 11.** Outlet from Drain Monitoring Sump Discharging into Main Embankment Seepage Collection Pond.

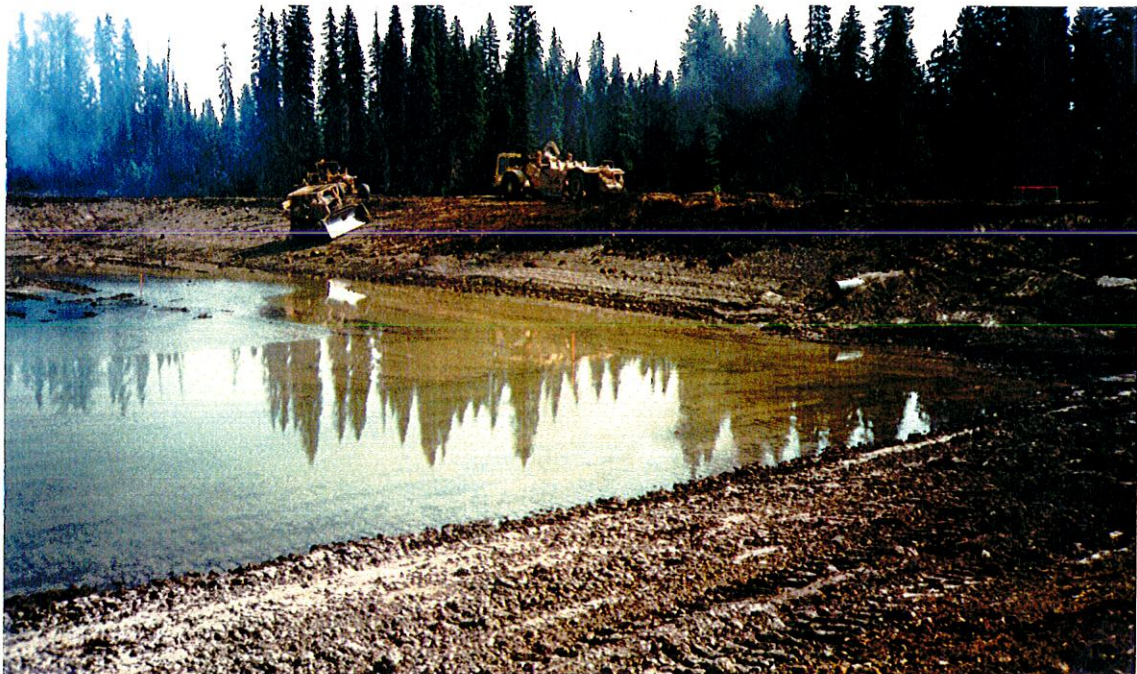
**Photo 12.** Decant from Main Embankment Seepage Collection Pond in South-West Corner.

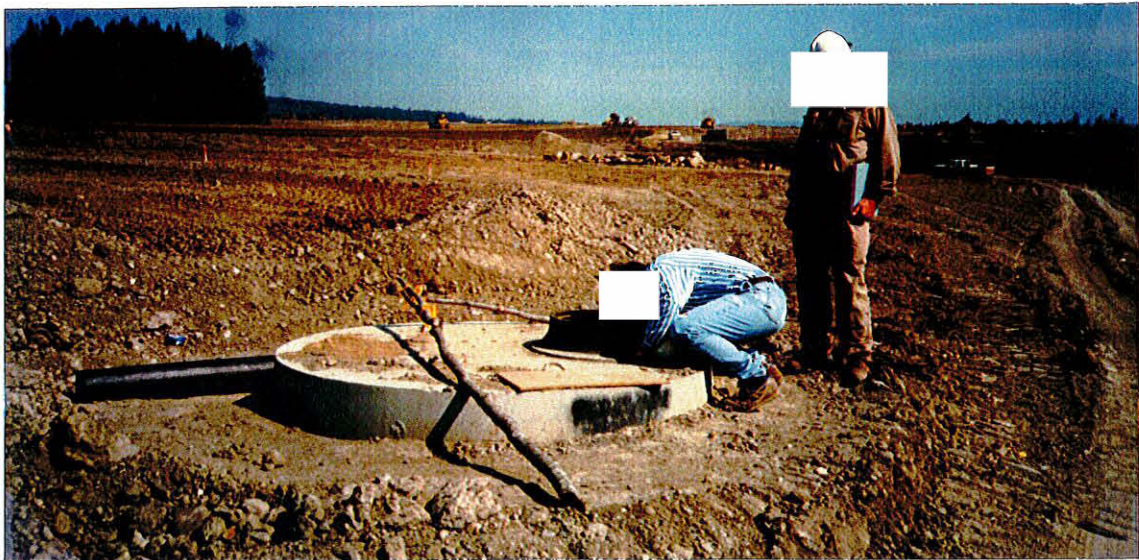
**Photo 13.** Top of Drain Monitoring Sump at Main Embankment.

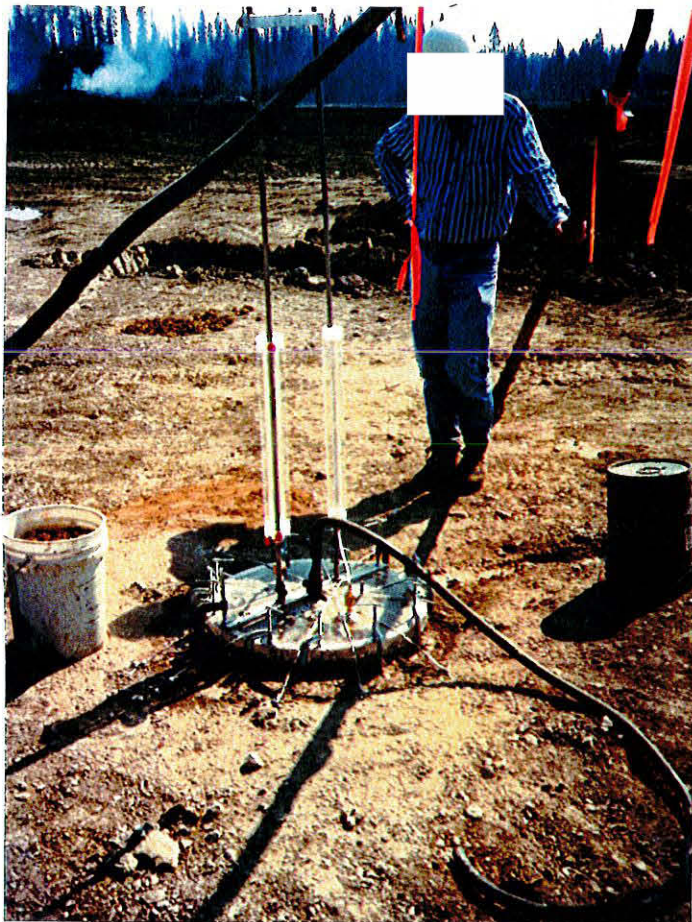
**Photo 14.** View of Field Air Entry Permeameter Testing of Basin Liner.

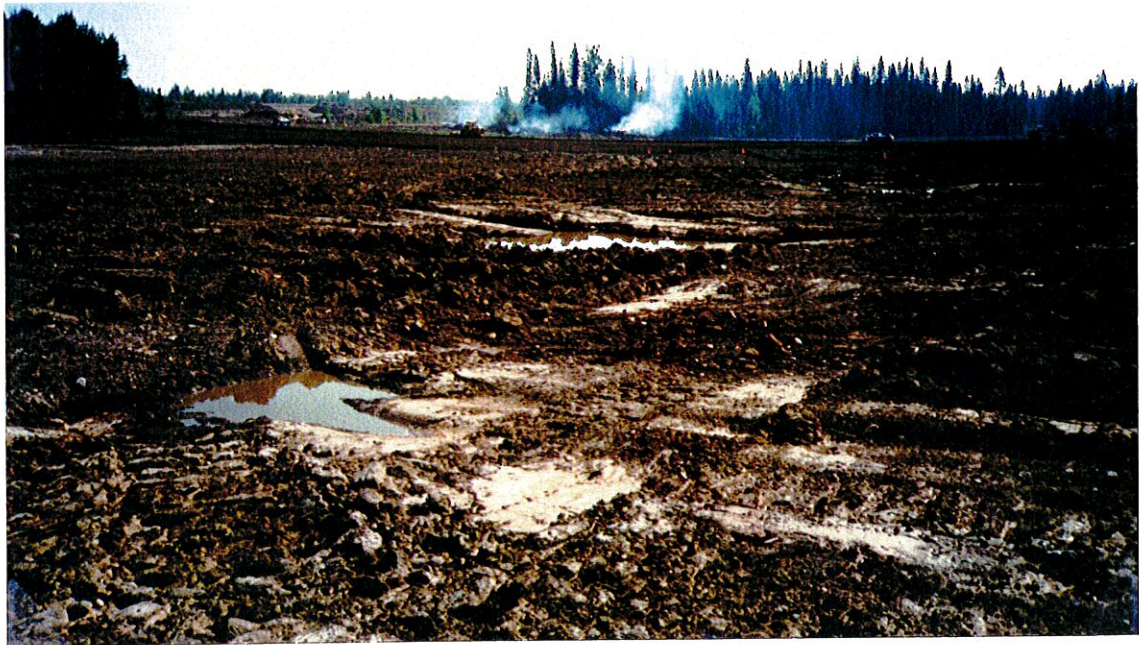
**Photo 15.** Surface of Basin Liner. Looking East.

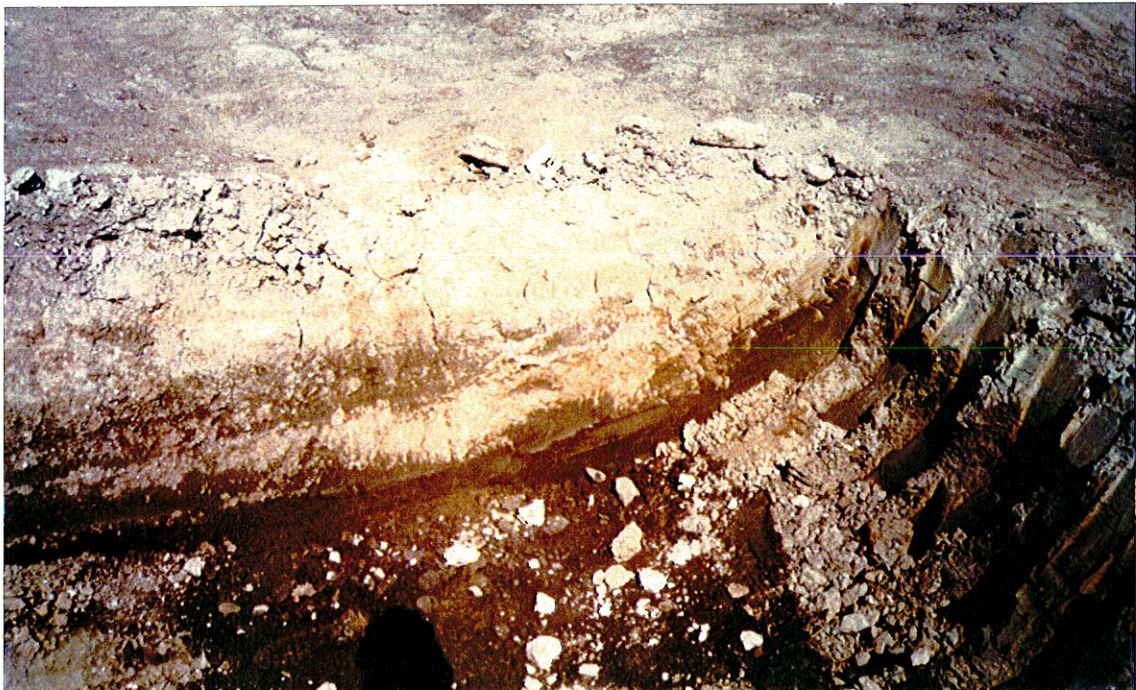
**Photo 16.** Exploration Trench Near South-West Edge of Basin Liner.

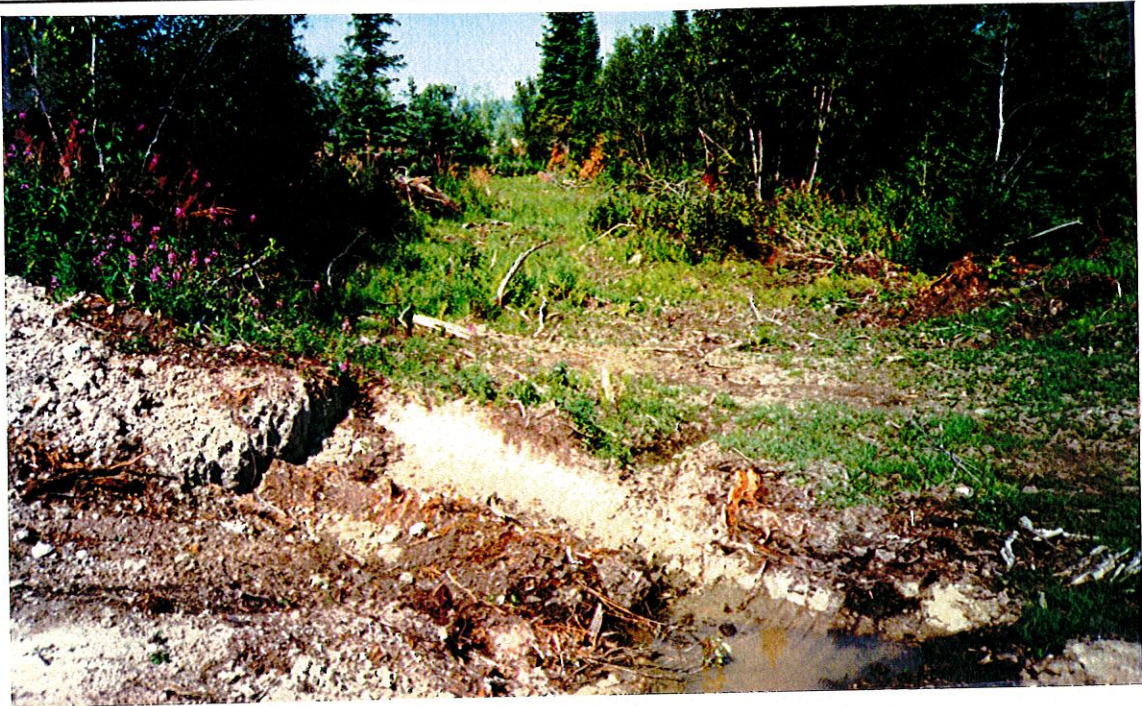
The till cap appears to have been completely removed locally in the base of the Reclaim Barge Channel (Ref. 9.8 and Photo 19, Appendix I). It was also recommended that these local areas be checked and sealed, as required. Similarly the local area, (probably a former stream bed) at the upstream edge of the Basin Liner. (Photo 17 in Appendix I).

**Photo 17.** Previous Stream and Trail of Juncture with West Edge of Basin Liner. Looking North-West.

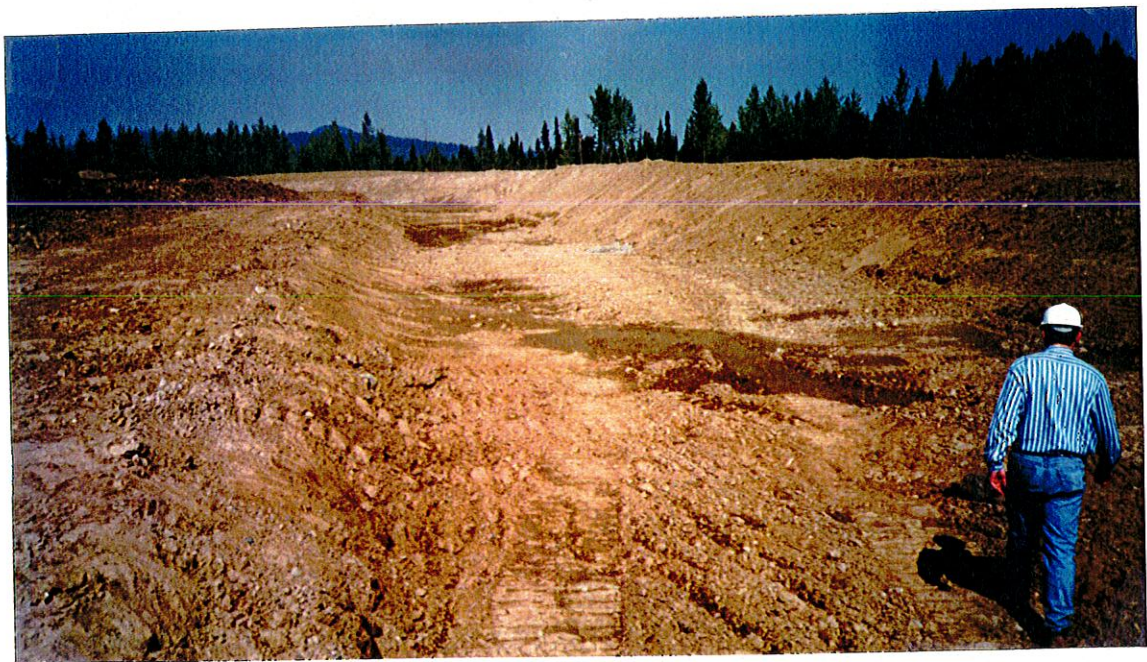
**Photo 18.** South end of Reclaim Barge Channel. Looking North-West.

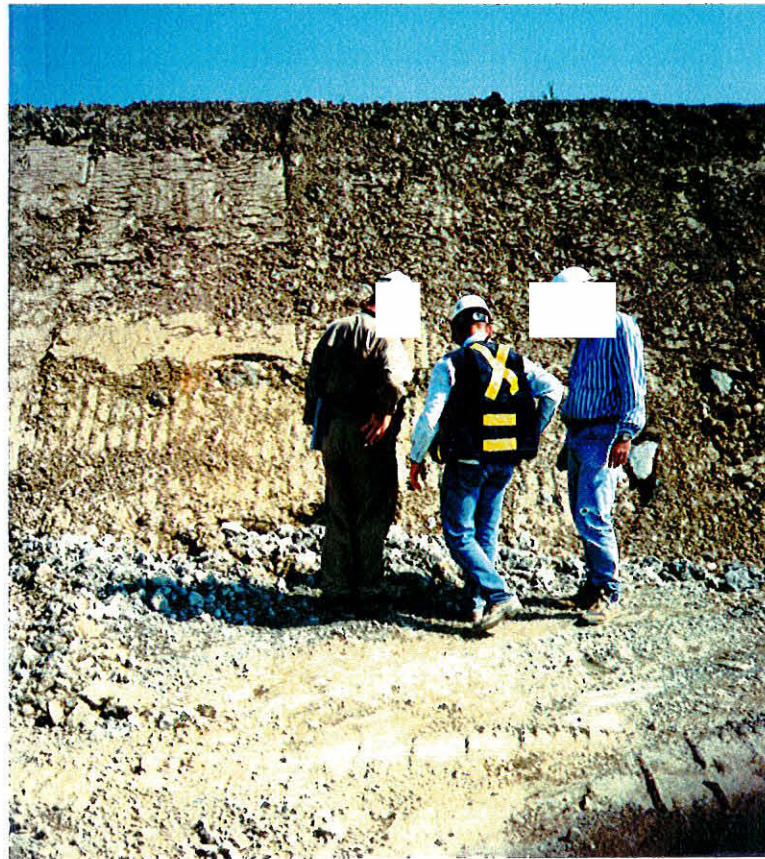
**Photo 19.** Exposure in base of Reclaim Barge Channel, East Side, Near South end.

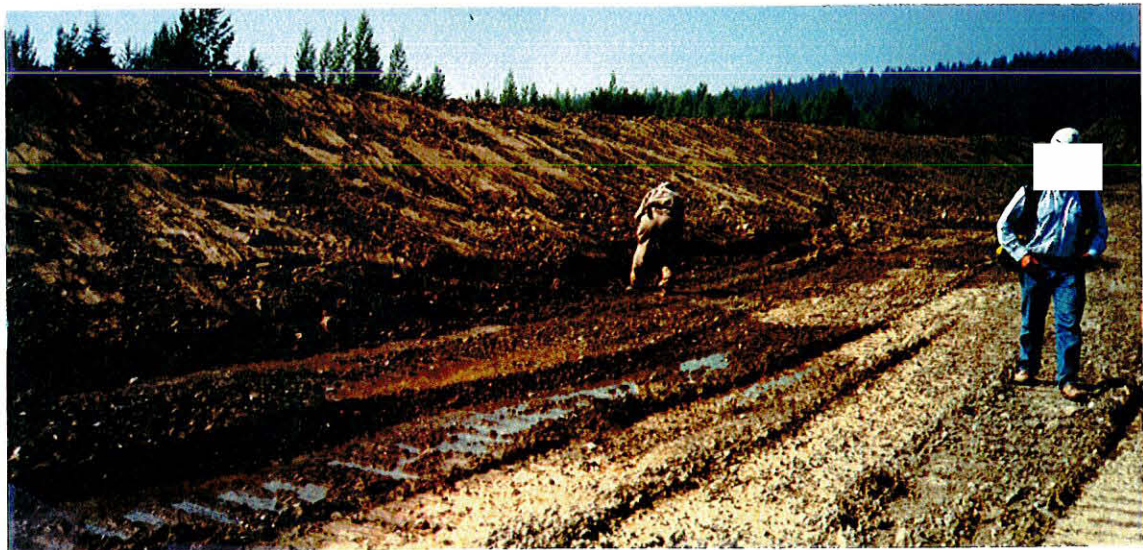
**Photo 20.** North Side of Reclaim Barge Channel at About Mid-Length.

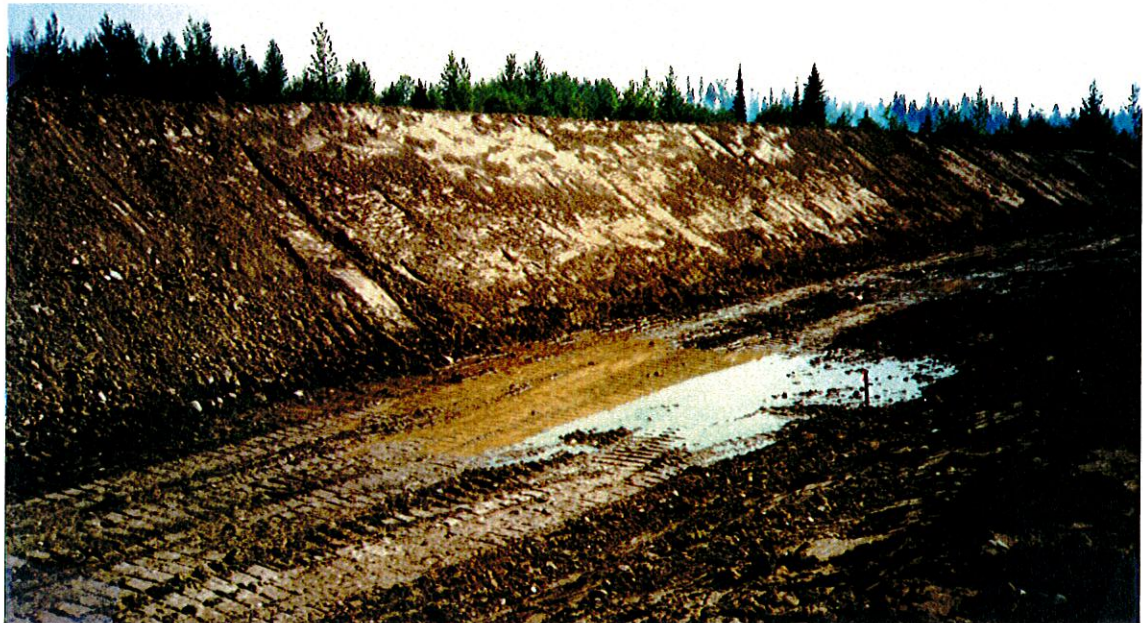
**Photo 21.** As for Photo 20 but at a Location Further West.

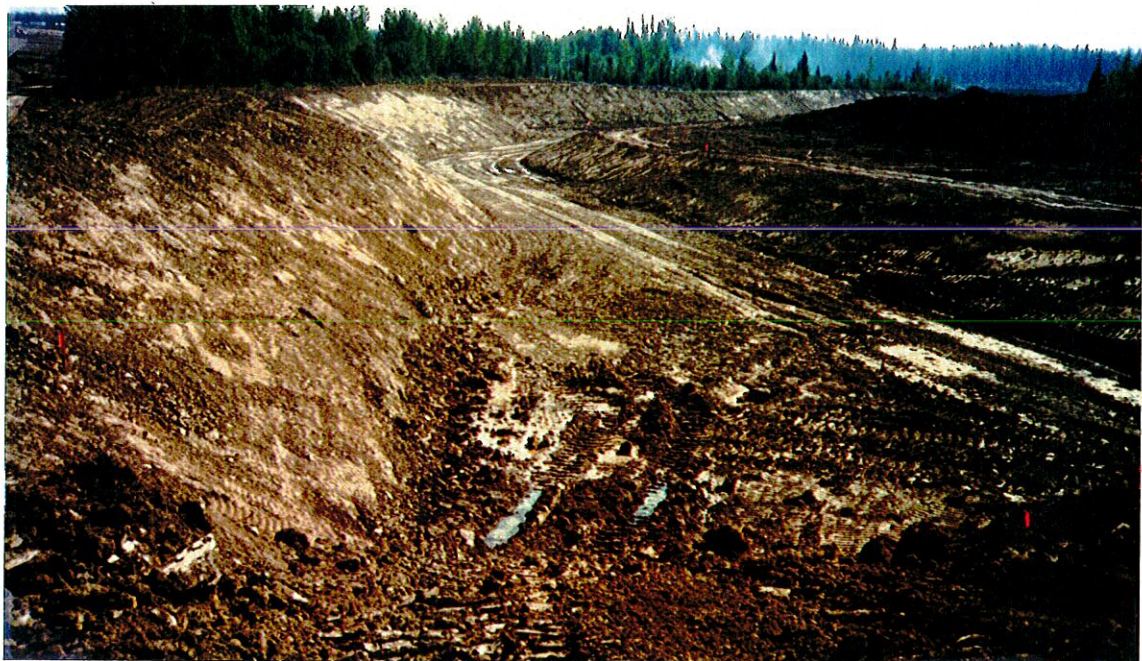
**Photo 22.** West End of Reclaim Barge Channel at the Time.  
Looking East Towards Main Embankment.

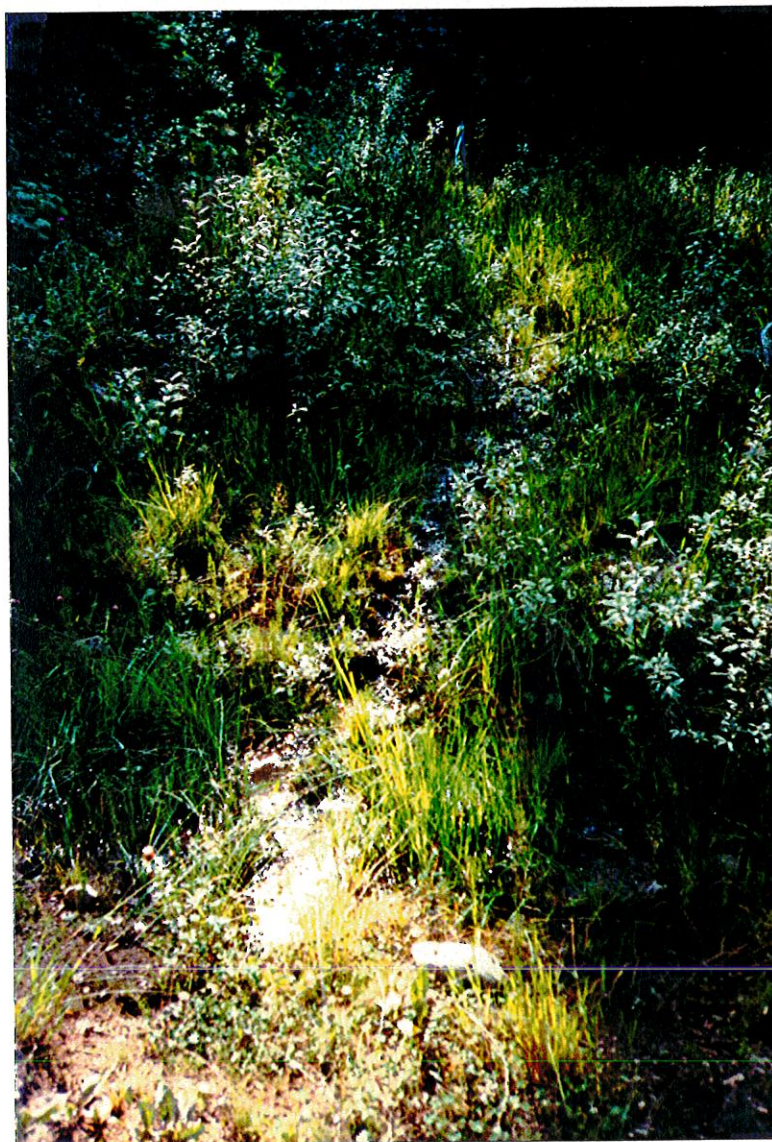
**Photo 23.** Flow from a Cased Borehole Near Junction of West Perimeter Road and Proposed South Embankment.
