**MOUNT POLLEY MINING CORPORATION
MOUNT POLLEY MINE**

**REPORT ON
1999 ANNUAL INSPECTION
(REF. NO. 11162/13-9)**

MOUNT POLLEY MINING CORPORATION

1999 ANNUAL INSPECTION

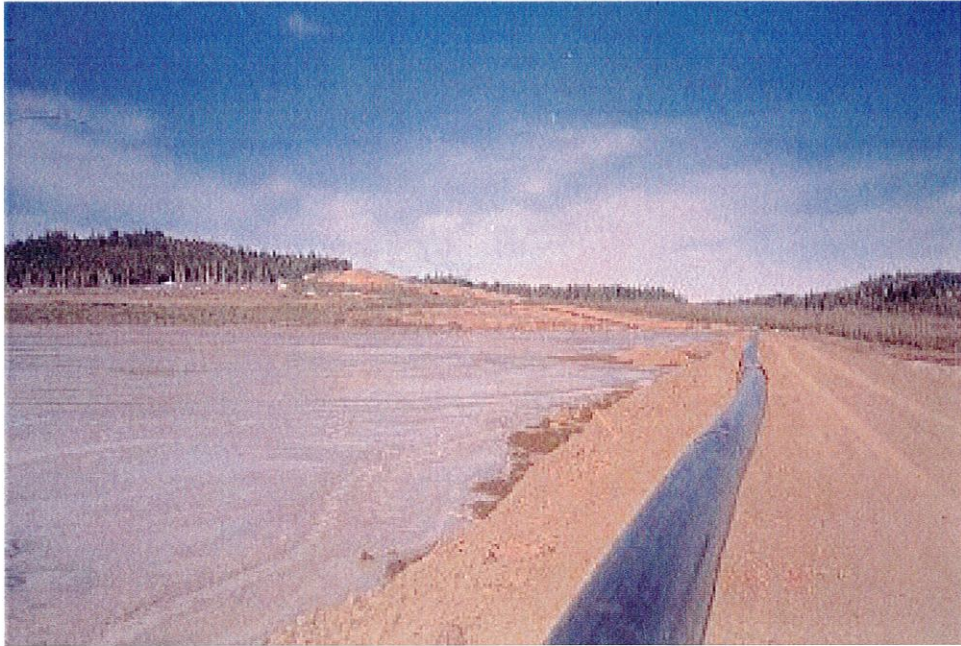
Photo No. 4: Perimeter Embankment, near CH 37+20 looking north. Note tailings beach development in northeast corner of the tailings impoundment.

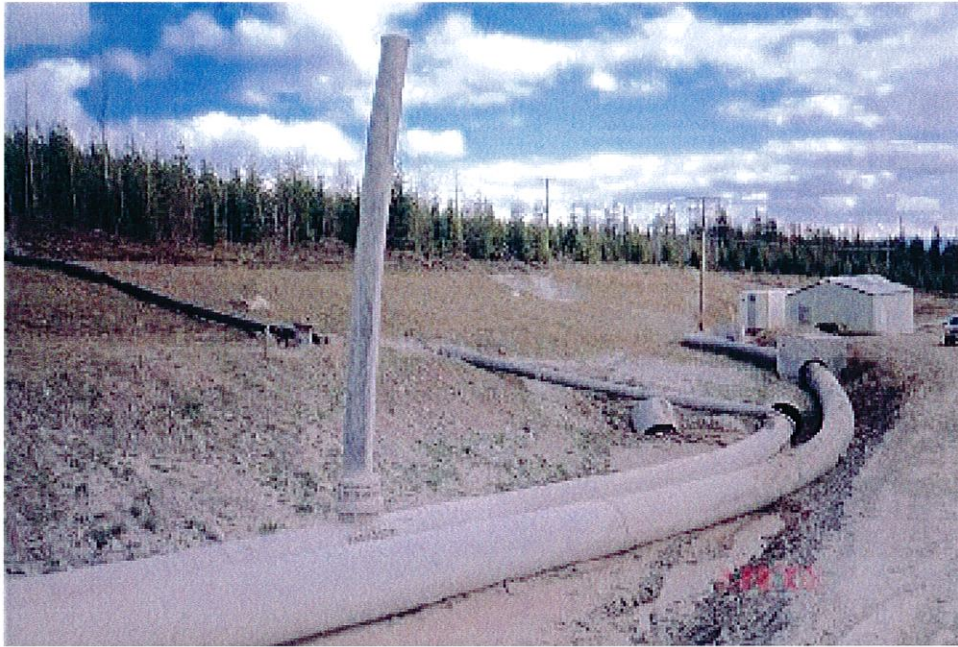
Photo No. 10: Tailings Pipeline with T2 Drop Box and Reclaim Booster Pump Station in background. Vertical pipe provides pressure relief, if required, during cycloning.

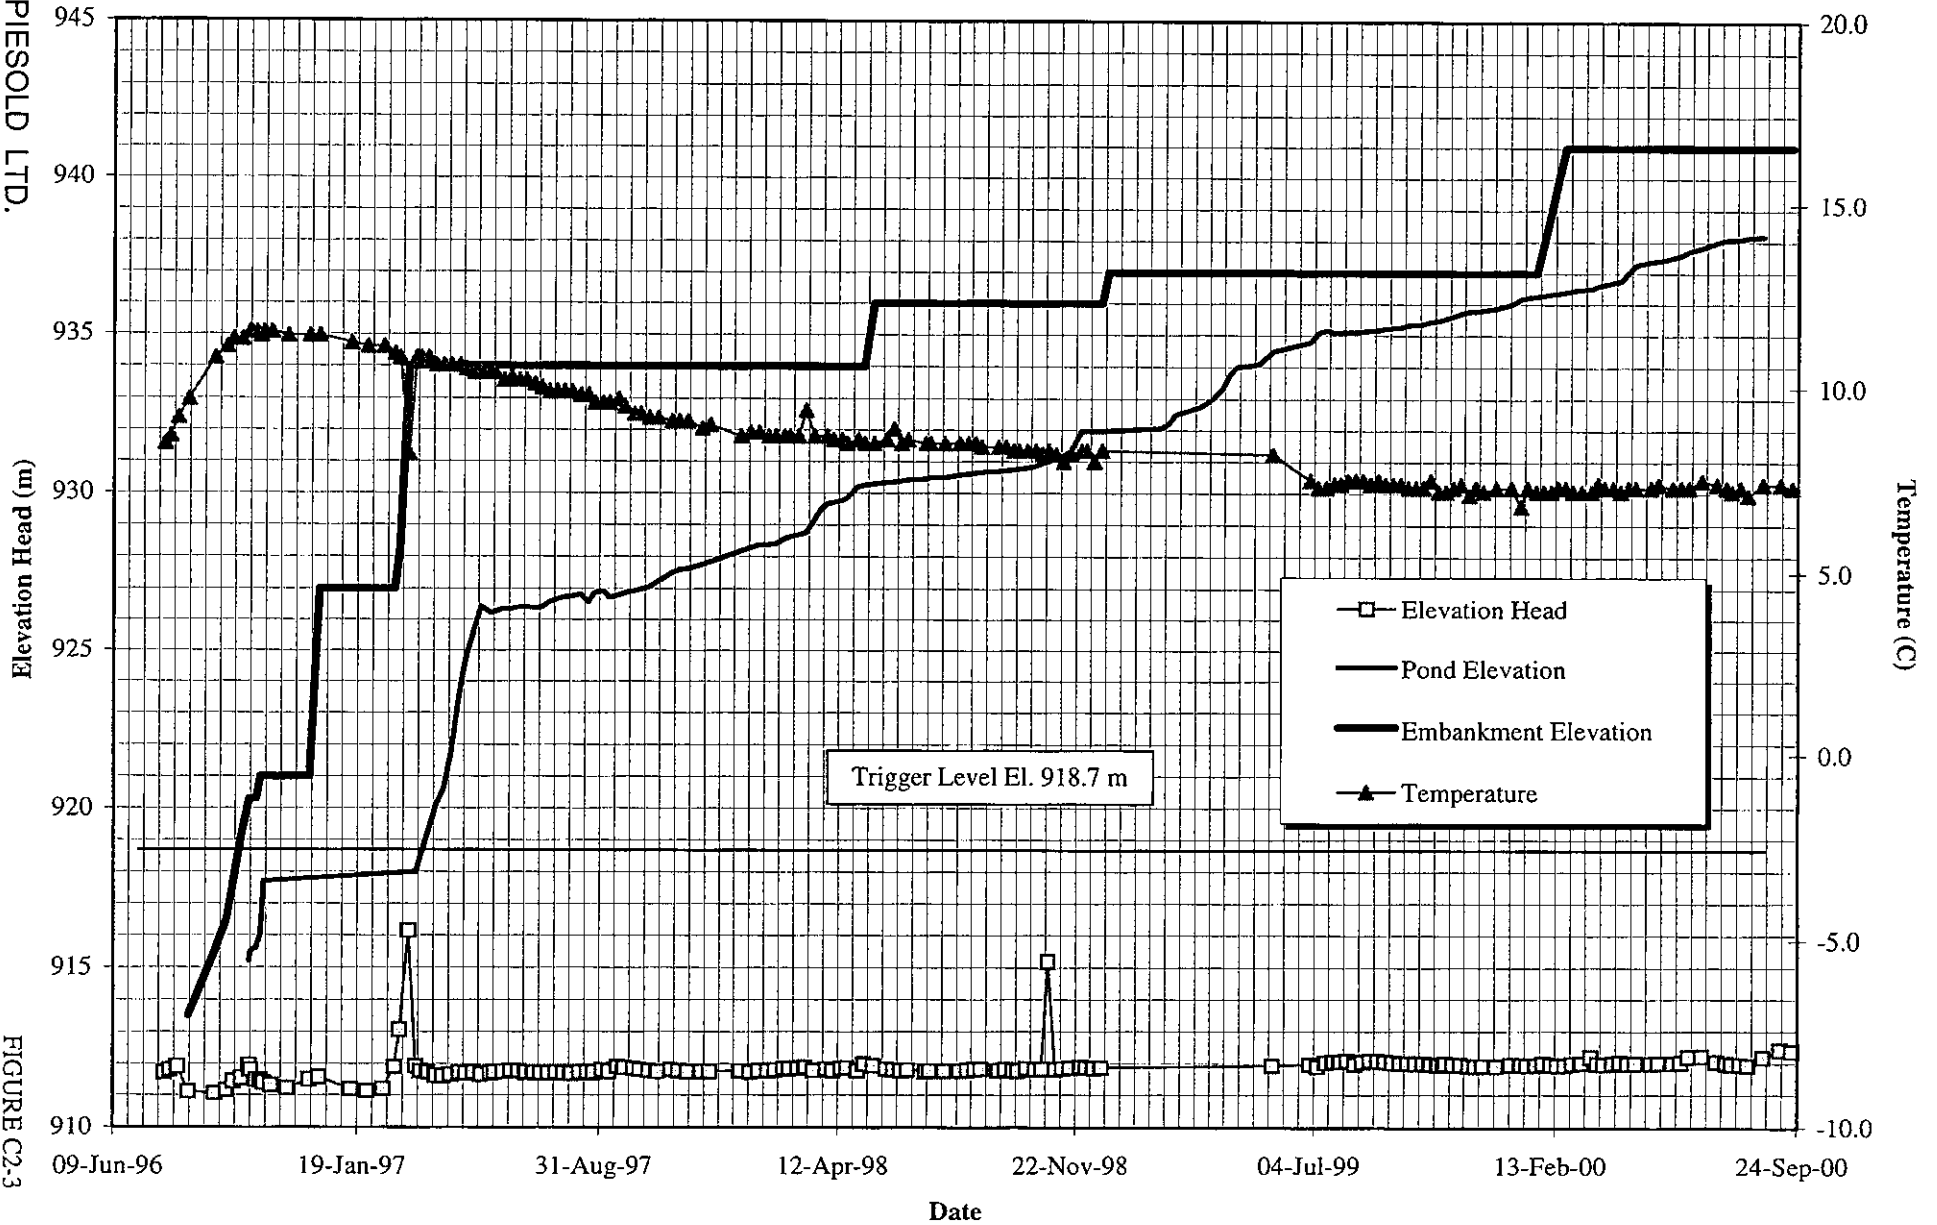
FIGURE C2.3

A total of 16 piezometers had been installed in the embankment foundations at the time of the inspection. Twelve remained in operation. No unexpected high pore pressure increases were observed during the monitoring period. The highest water level indicated by the foundation piezometers was an artesian level of 3.7 m, recorded in A2-PE2-01. Piezometers A2-PE2-02,

A2-PE2-06, A2-PE2-07 and B2-PE2-02 indicated artesian pressures of approximately 3.0 m. Although these levels were high, none had reached the foundation piezometer trigger levels of 6.0 m artesian pressure (relative to original ground). The trigger levels are based on embankment stability analyses. These values, if exceeded, will require investigations and contingency or remedial actions to be taken.

MOUNT POLLEY MINING CORPORATION
MOUNT POLLEY MINE
PIEZOMETER A2-PE2-02
(Foundation Piezometer El. 909.8 m)

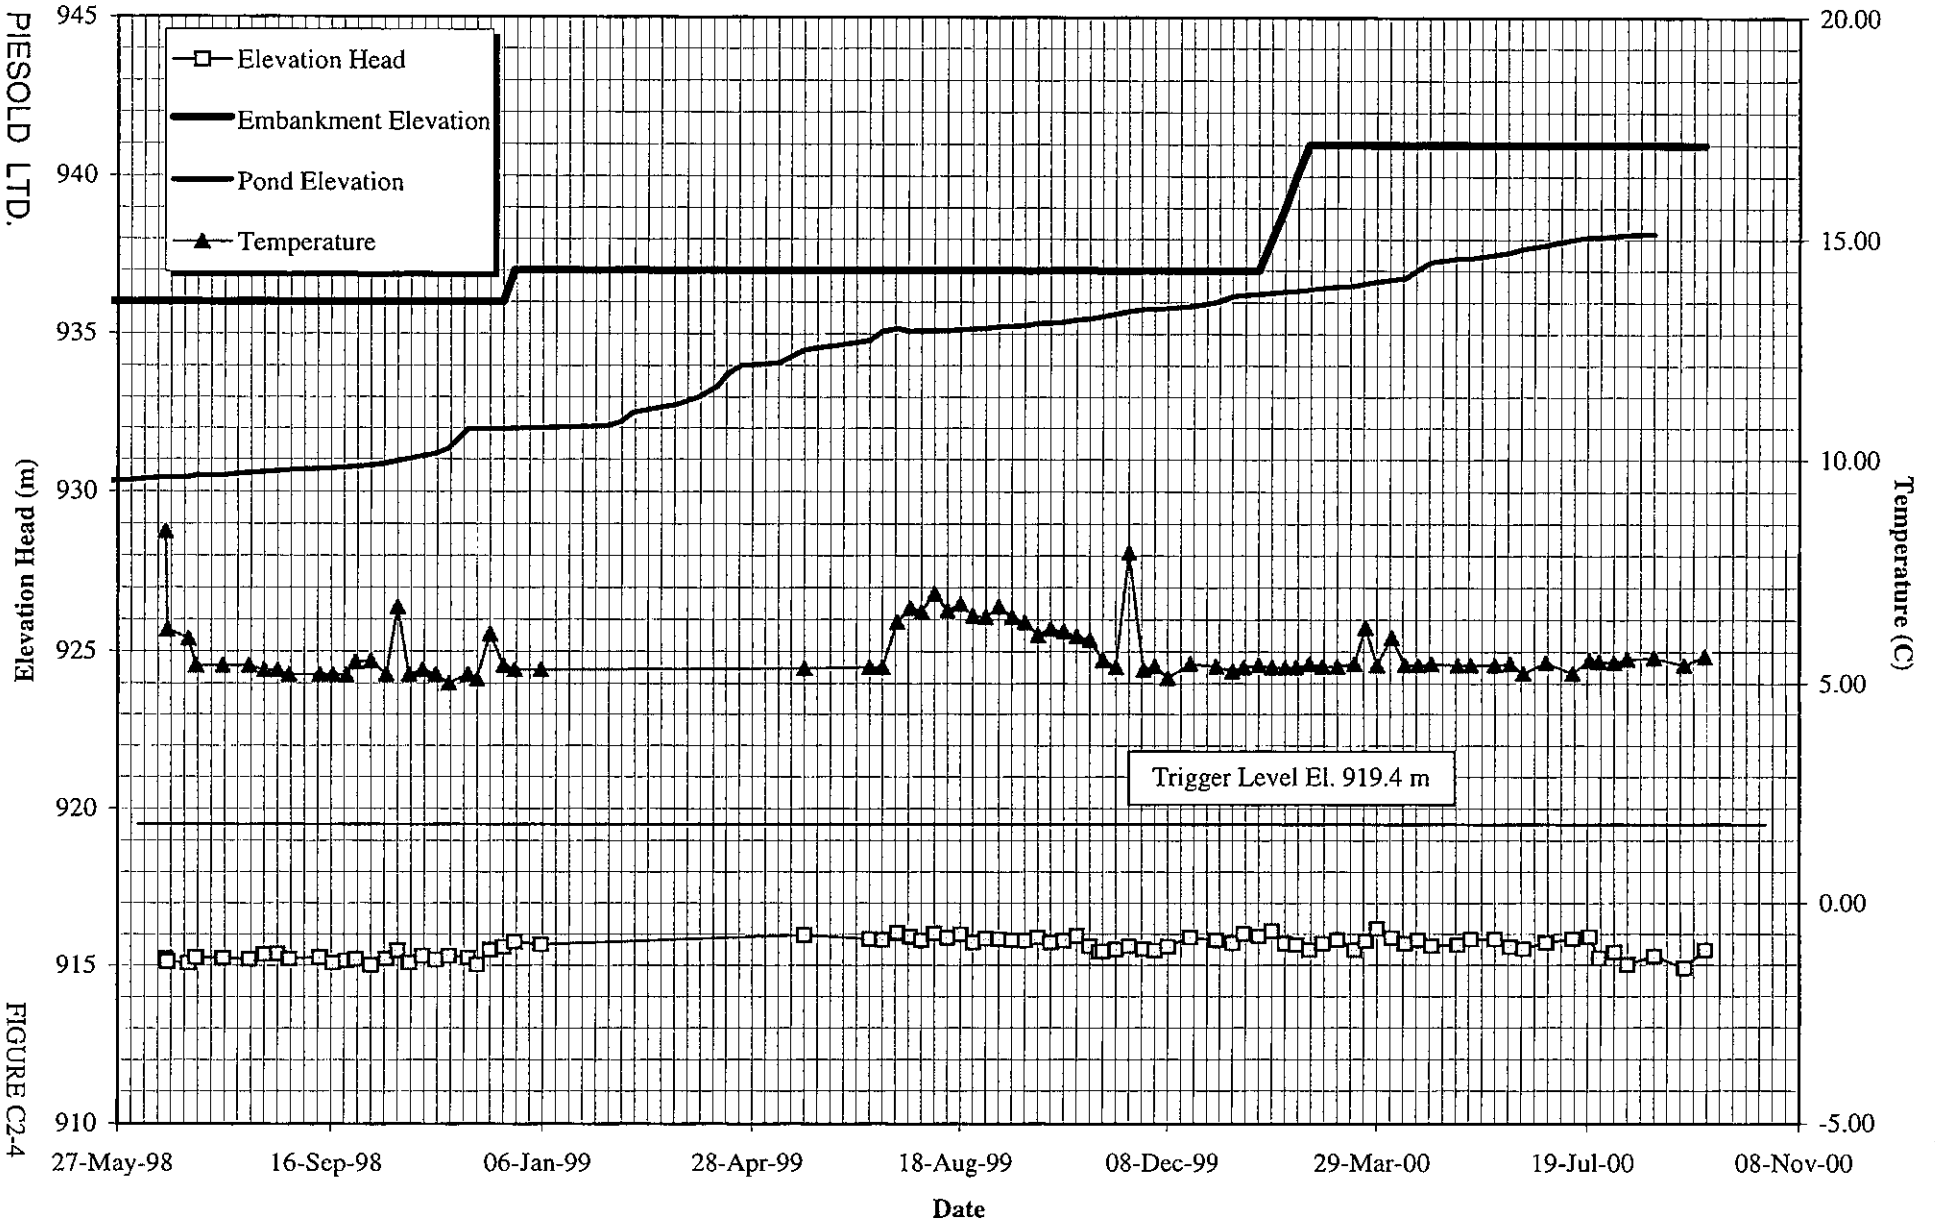
FIGURE C2.4

MOUNT POLLEY MINING CORPORATION
MOUNT POLLEY MINE
PIEZOMETER A2-PE2-06
(Foundation Piezometer El. 898.0 m)

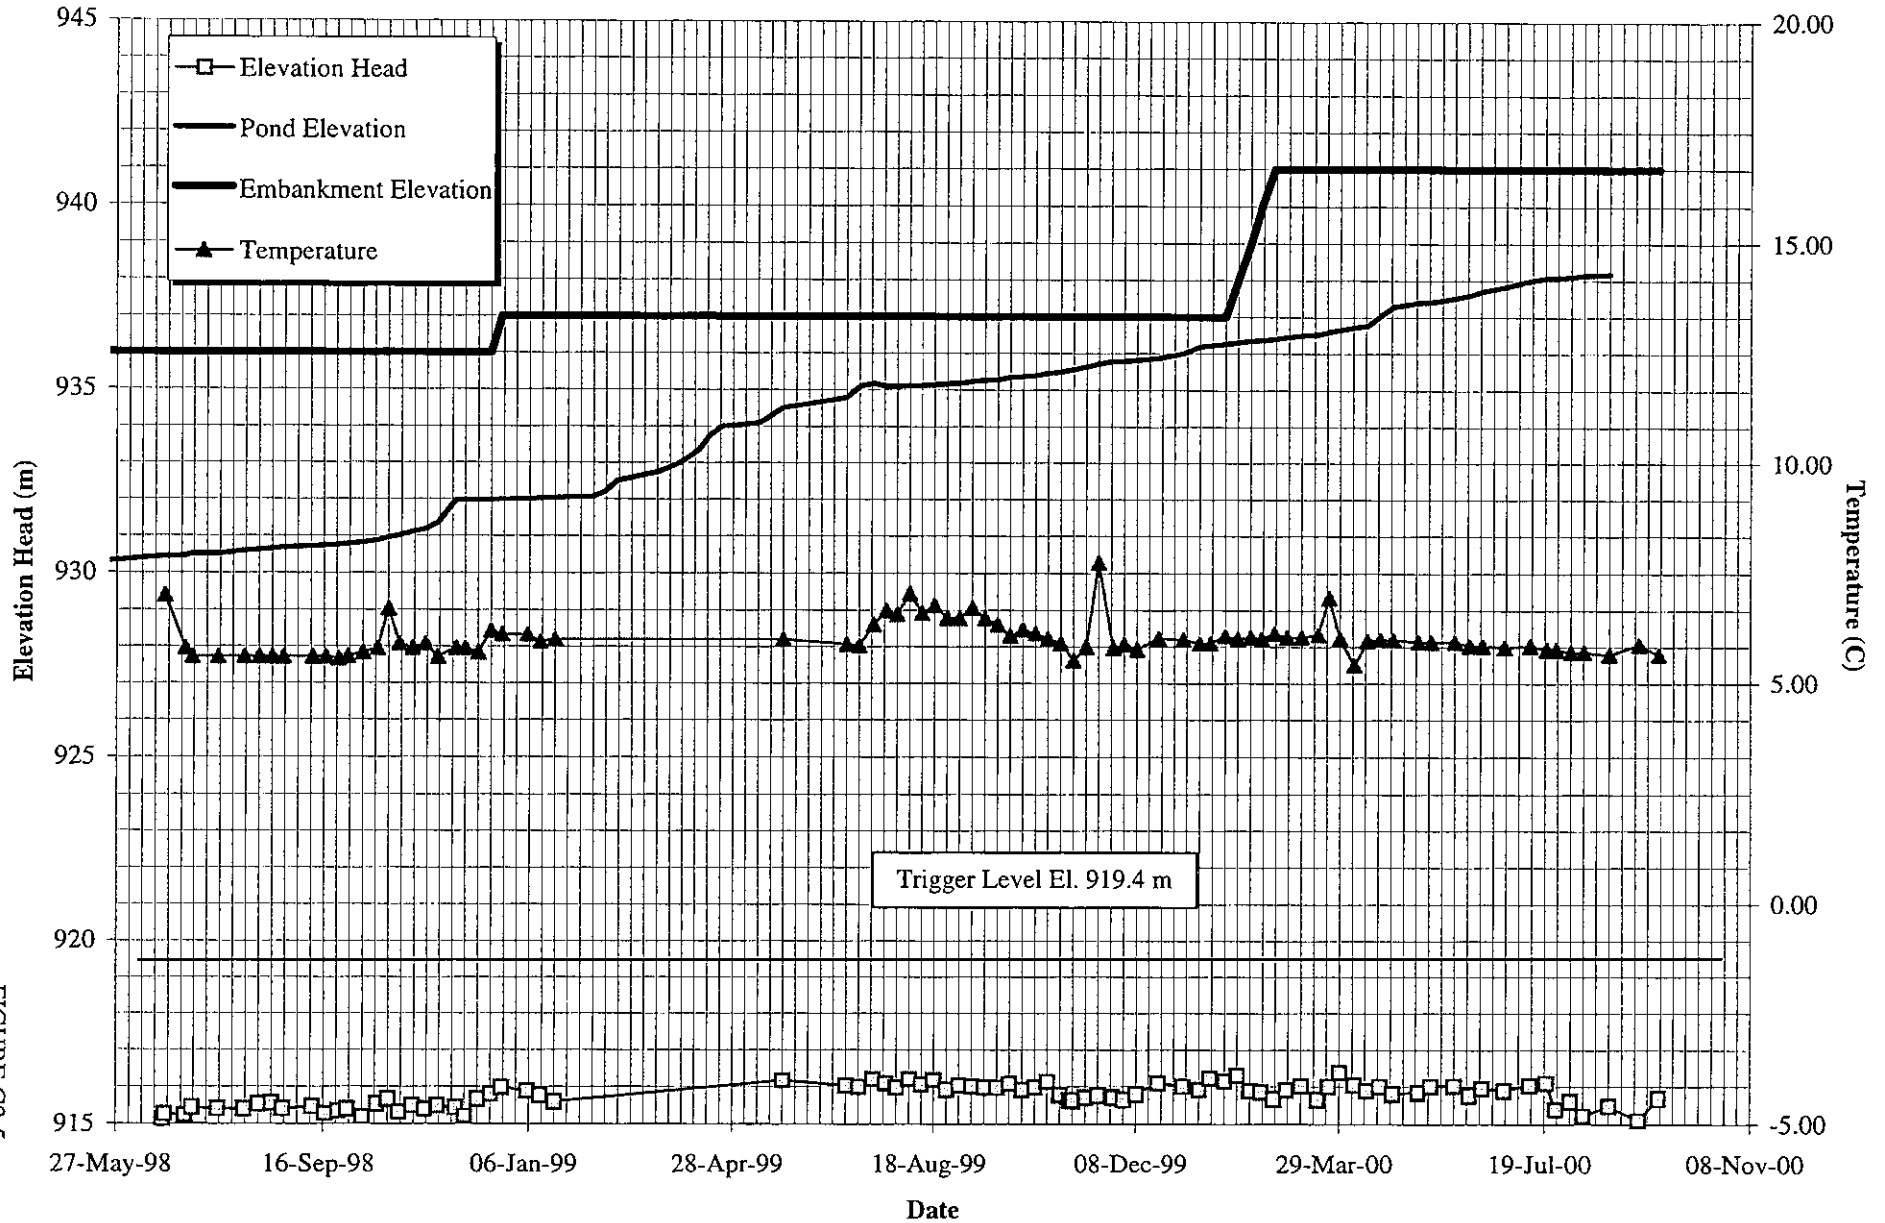
FIGURE C2-5

MOUNT POLLEY MINING CORPORATION
MOUNT POLLEY MINE
PIEZOMETER A2-PE2-07
(Foundation Piezometer El. 902.8 m)

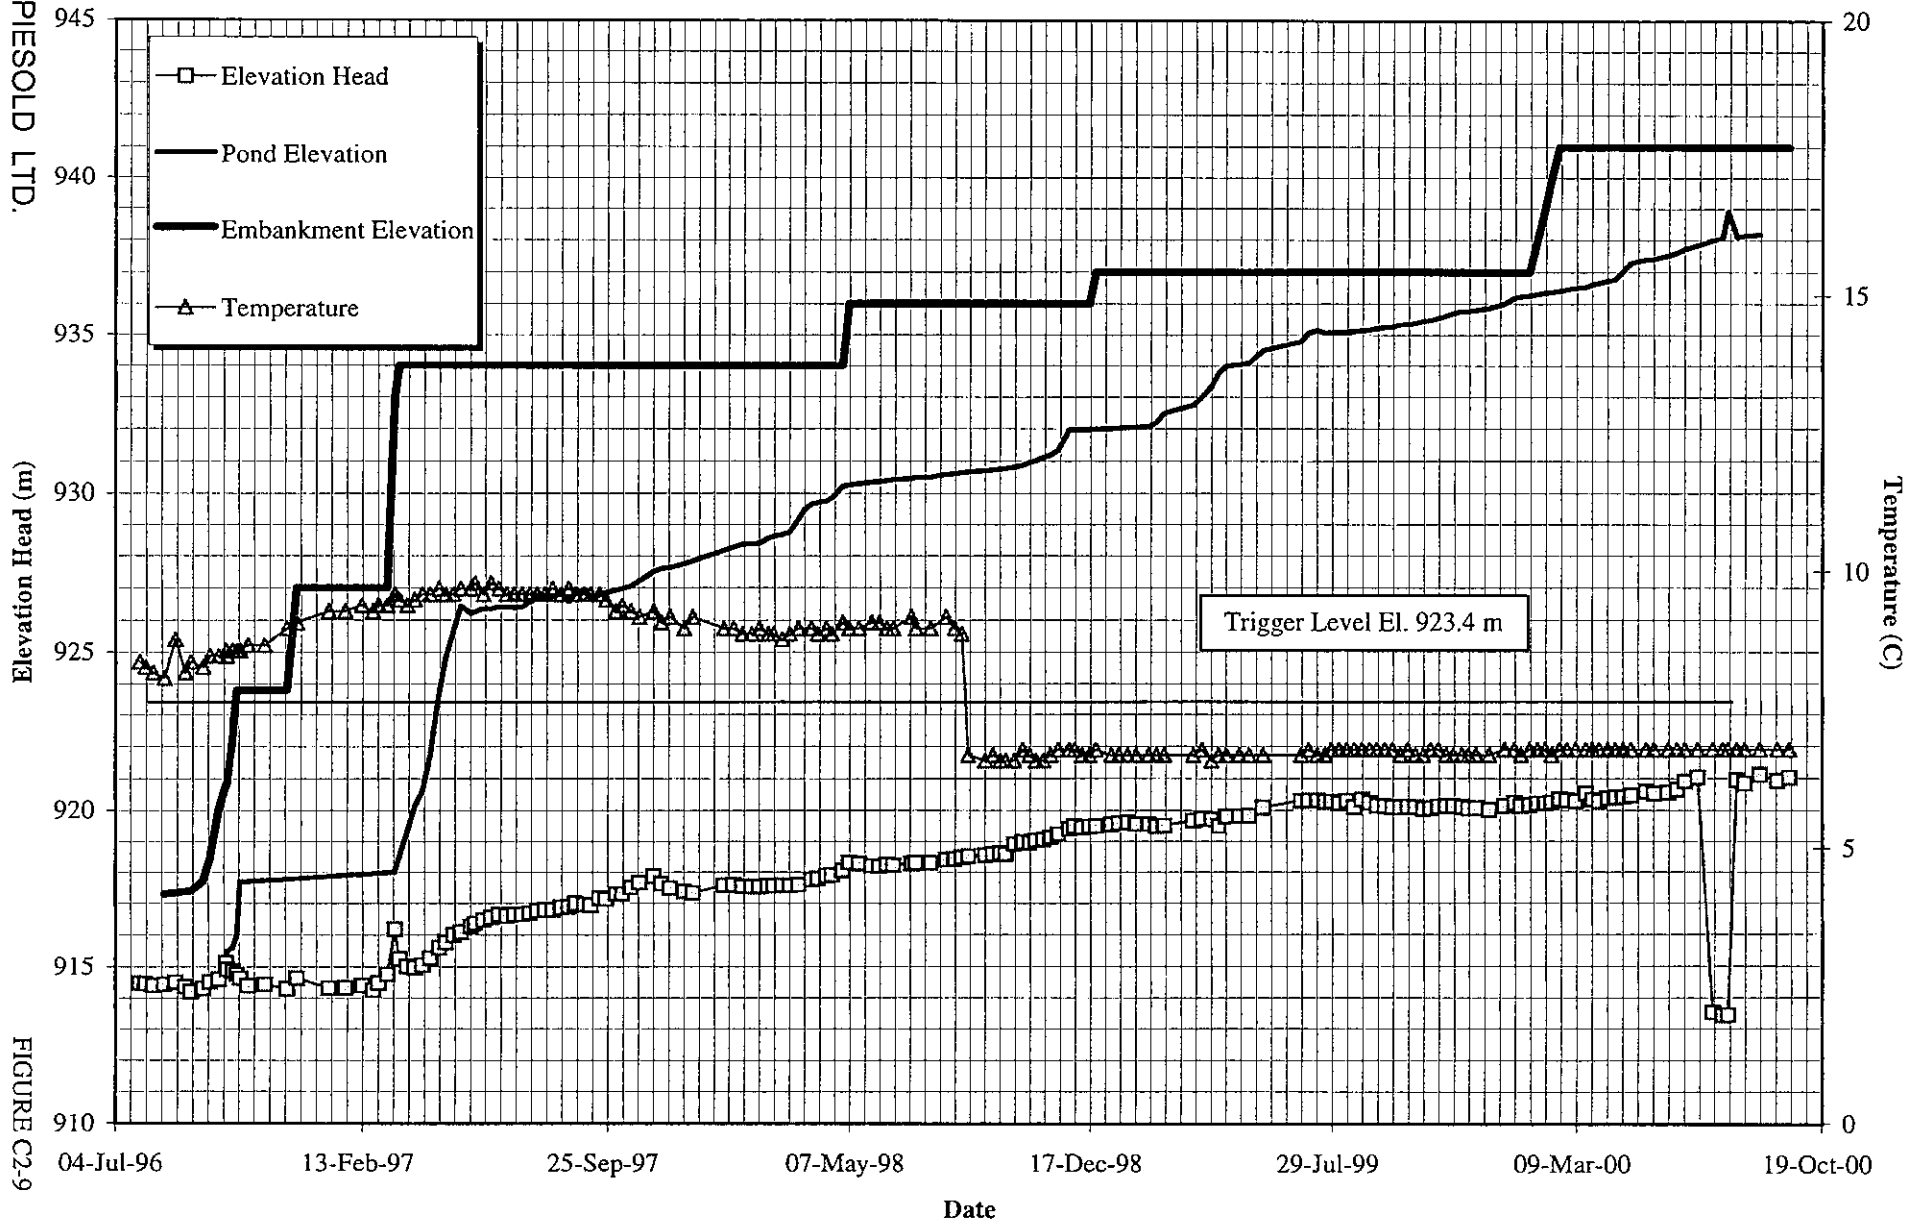
FIGURE C2.9

MOUNT POLLEY MINING CORPORATION
MOUNT POLLEY MINE
PIEZOMETER B2-PE2-02
(Foundation Piezometer El. 909.5 m)
