MOUNT POLLEY MINING CORPORATION
MOUNT POLLEY MINE

TAILINGS STORAGE FACILITY
REPORT ON 2009 ANNUAL INSPECTION

**TAILINGS STORAGE FACILITY
REPORT ON 2009 ANNUAL INSPECTION
(REF. NO. VA101-1/27-1)**

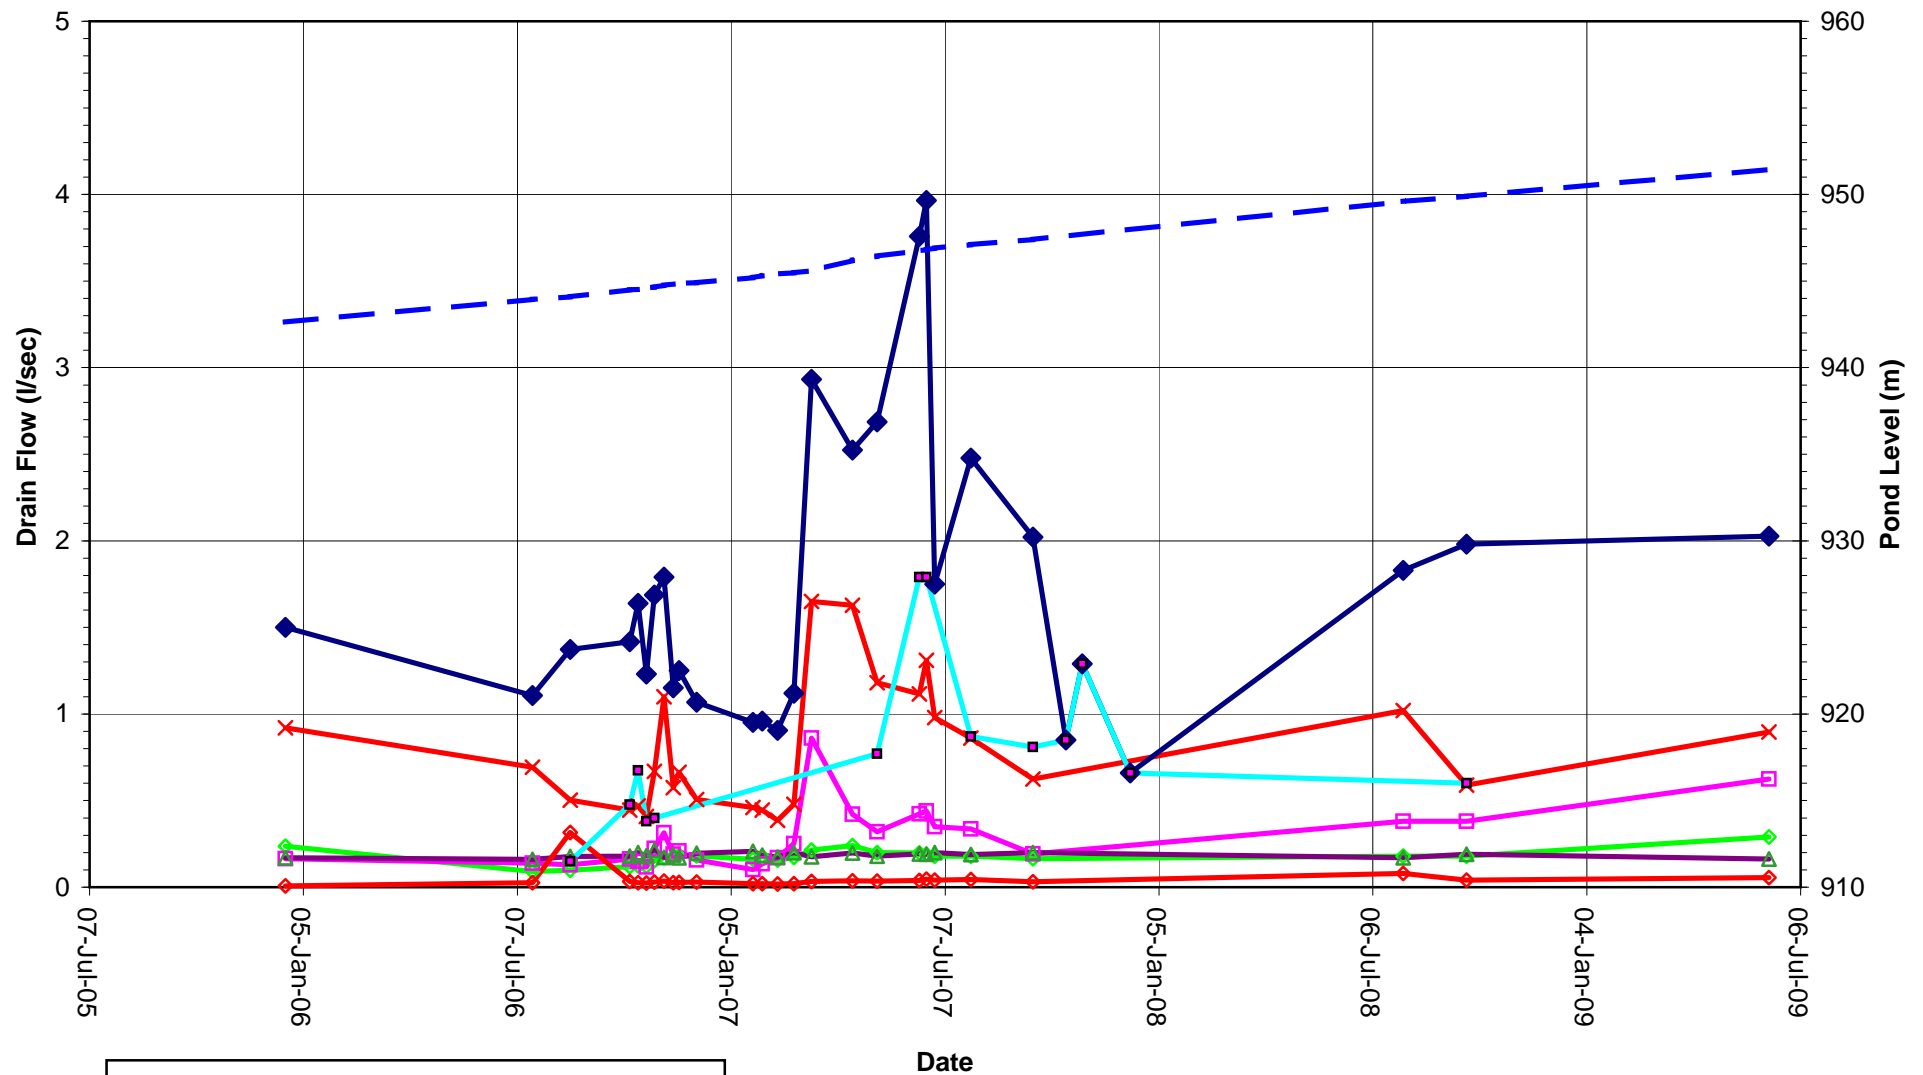
TAILINGS STORAGE FACILITY
MAIN EMBANKMENT
FOUNDATION DRAIN FLOWS

Water from the foundation drains and upstream toe drains flows into the seepage collection ponds where it is temporarily stored prior to being pumped back into the TSF. The flow rates for the foundation drains are shown on Figure 3.1. The flow rates for the upstream toe drains are shown on Figure 3.2. The total flows from foundation drains FD-1 to FD-5 have remained fairly constant during the past year at approximately 2.0 l/s. The flows from the upstream toe drains fluctuate throughout the year in response to the tailings deposition location and the tailings pond location. The flow from the Main Embankment upstream toe drain, as measured in June 2009, was approximately 11 l/s, which is slightly less than the same flows measured in 2008. The flow from the Perimeter Embankment upstream toe drain, as measured in June 2009, was approximately 8 l/s, which is consistent with the measured flows from 2008.

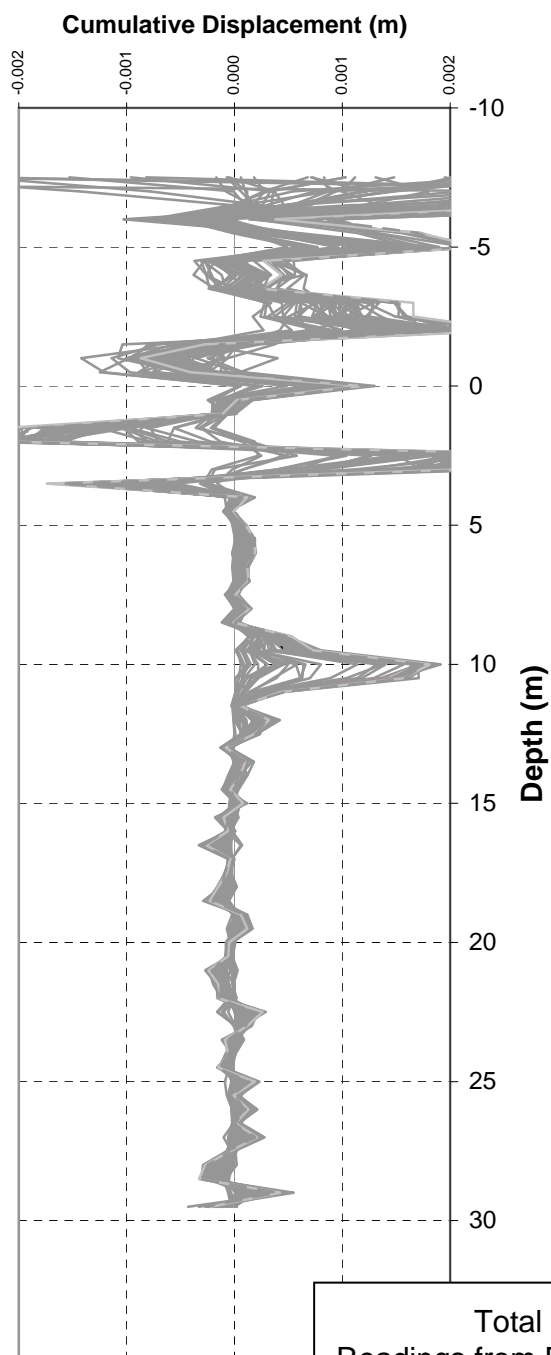
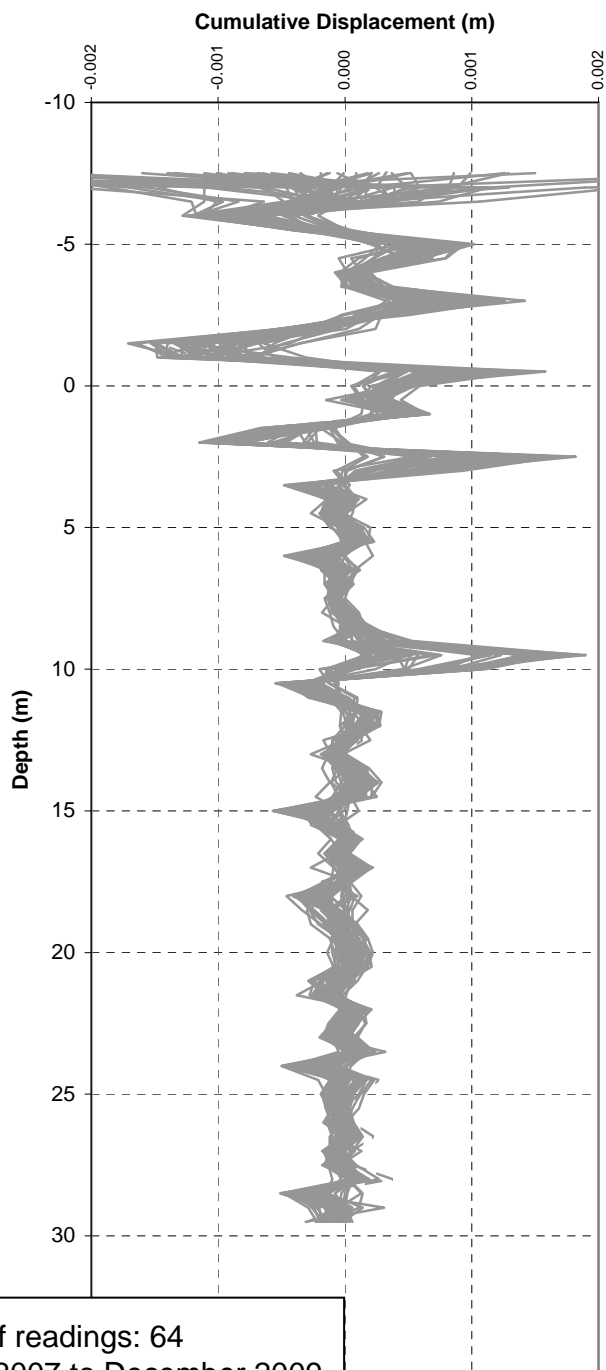
The TSF instrumentation currently consists of four slope inclinometers installed at the Main Embankment and 62 operating vibrating wire piezometers installed in the Main, Perimeter and South Embankments. The piezometers monitor the pore pressures in the foundation materials, embankment fill materials, the tailings mass and the embankment drains. There have been no significant deviations in the inclinometers and no unexpected or anomalous pore pressures reading in the vibrating wire piezometers. However, inclinometer SI01-02 is showing slight deviations at an approximate depth of 10 m below ground in the lacustrine silts. This is being closely monitored by MPMC who have increased the monitoring frequency of the inclinometers to weekly. MPMC has also expanded the buttress at the Main Embankment as a result of the measured displacements in SI01-02.

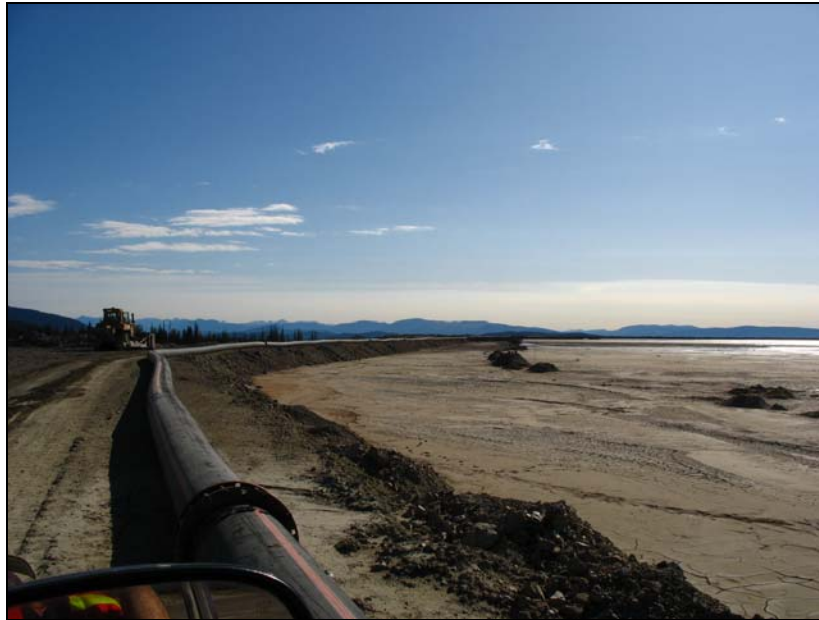
PHOTO 1 – Tailings beach development on the Perimeter Embankment

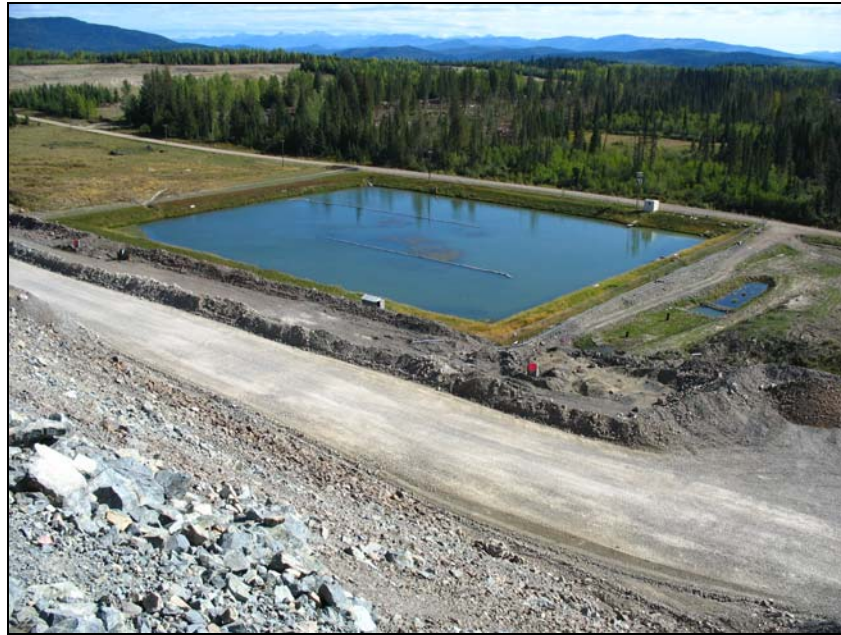
runoff. The seepage collection ponds were observed to be in good condition with no observed erosion activity.

PHOTO 3 – Main Embankment Seepage Collection Pond

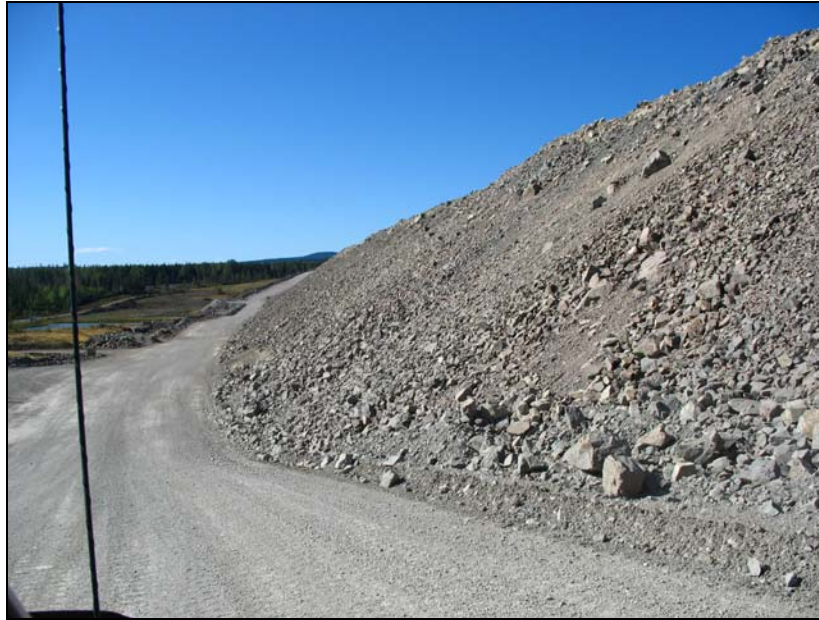
- No signs of distress were identified on the tailings embankments. The embankment slopes were approximately planar and there was no evidence of cracking, bulging or slumping in the embankment fill. The embankment crest appeared to be relatively level with no signs of differential settlement or distress. There was no evidence of animal burrowing.

PHOTO 5 – Main Embankment looking west
