**MOUNT POLLEY MINING CORPORATION
MOUNT POLLEY PROJECT
TAILINGS STORAGE FACILITY
AND ANCILLARY FEATURES**

**MAY 1, 1997 SITE INSPECTION
(REF. NO. 1627/4)**

SUBJECT: Site Inspection (May 1, 1997)

MOUNT POLLEY
SITE INSPECTION - MAY 1, 1997

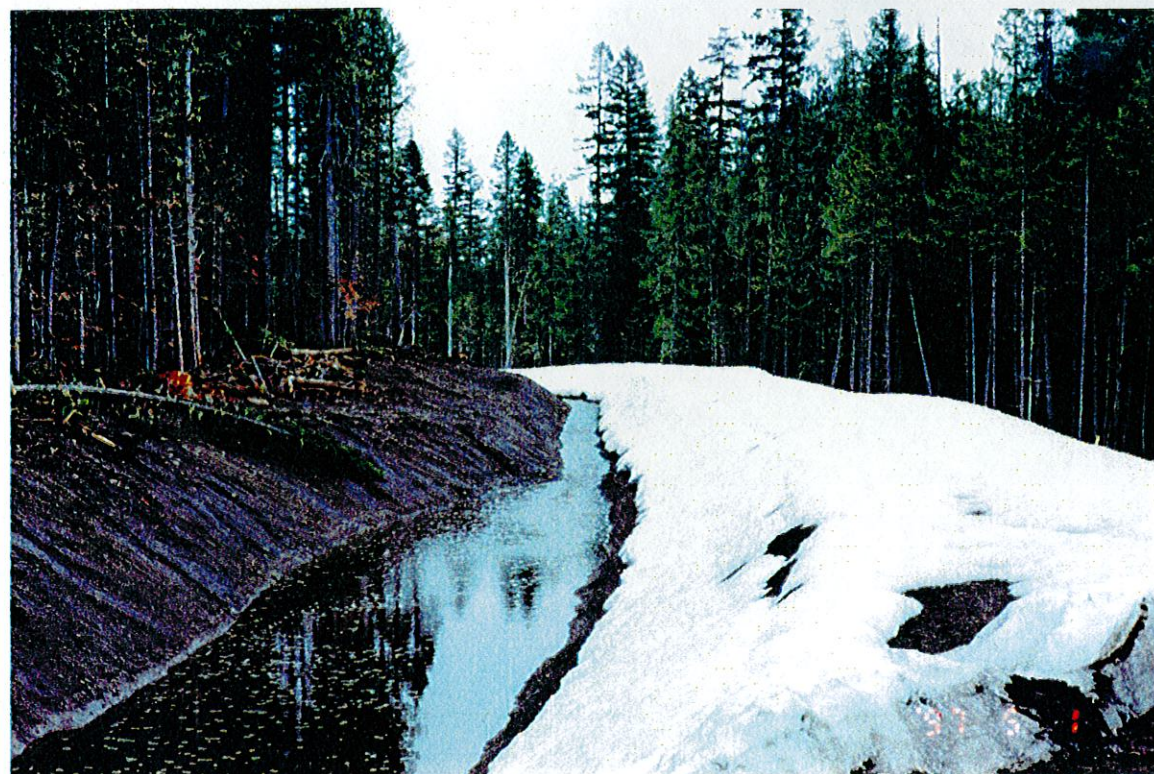
- (1, 2, 3) • Pond level is El. 1056.0 m, which is below the invert of the overflow culvert. Pond level is now decreasing.
- (7, 8) • Spring located on west side of pond, just before corner.

Photo No. 1 - Waste Dump Ditch just before entering Southeast Sediment Pond (SESP); looking upstream.

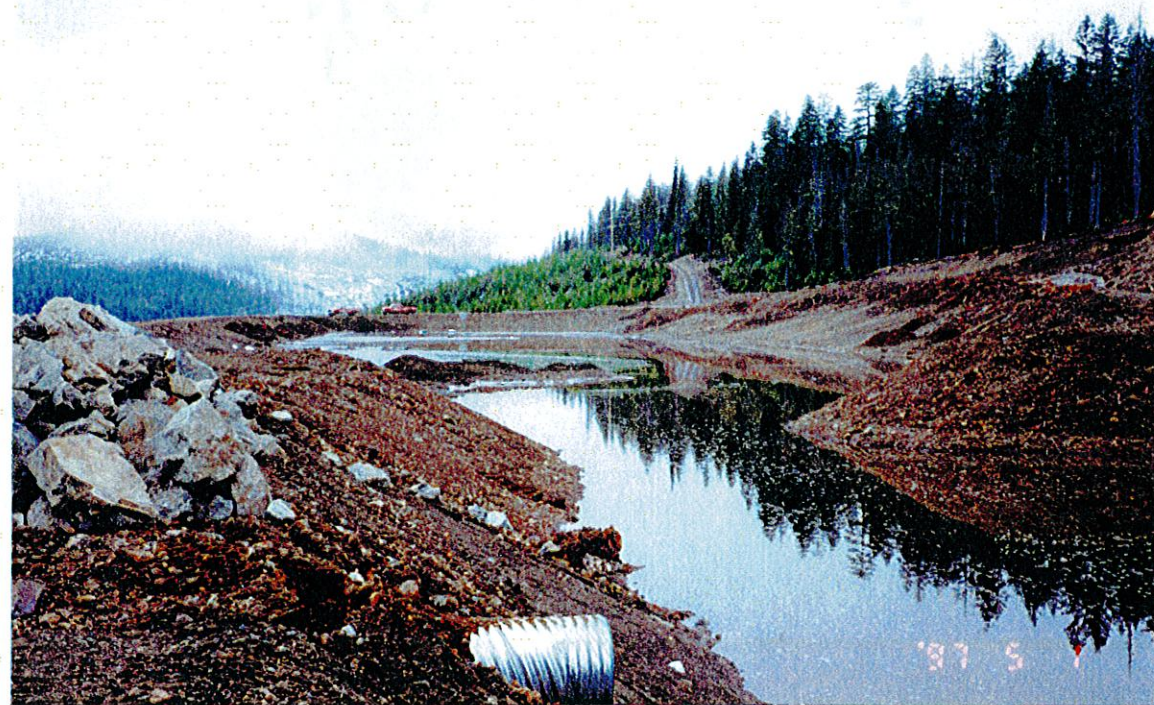
Photo No. 2 - Waste Dump Ditch entering SESP, with overflow culvert in foreground; looking downstream.

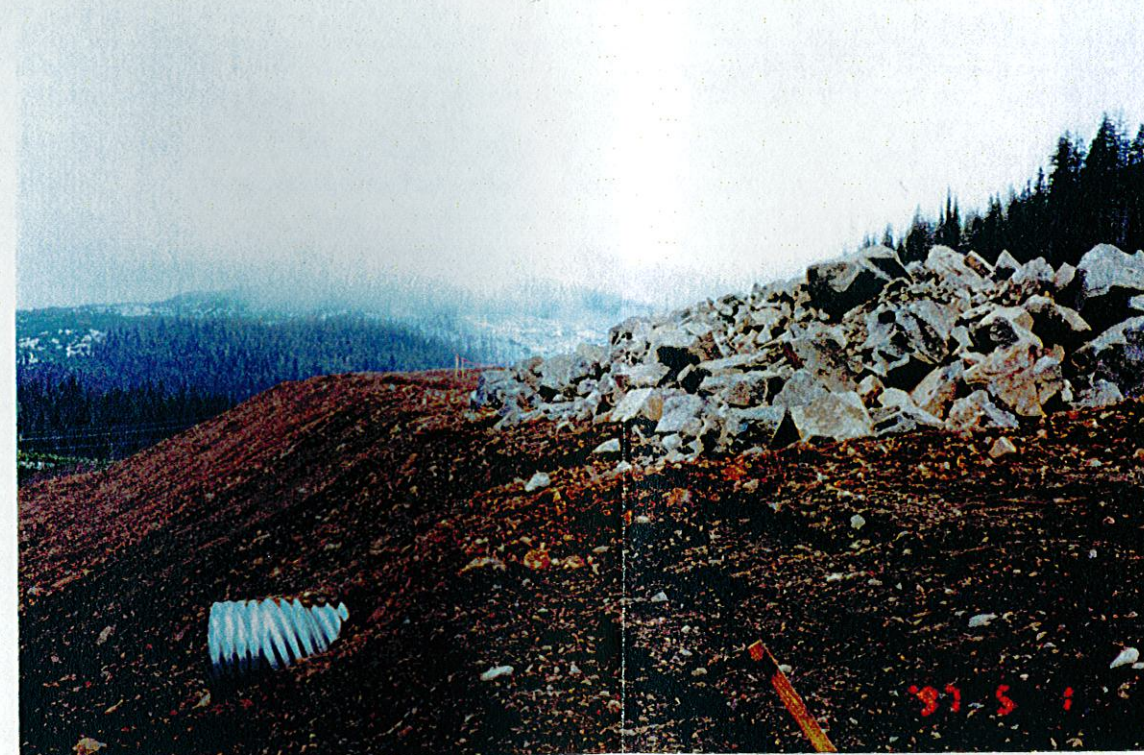
- (3) minor cracking.
- (4) • The manhole sump has water leaking in through one of the joints. This is a concern because it may mean that the fill is completely saturated. This should be inspected when the pond is lower.

Photo No. 3 - Overflow culvert for SESP. Riprap stockpiled for placement at culvert outlet. Roadway cracking and slumping.

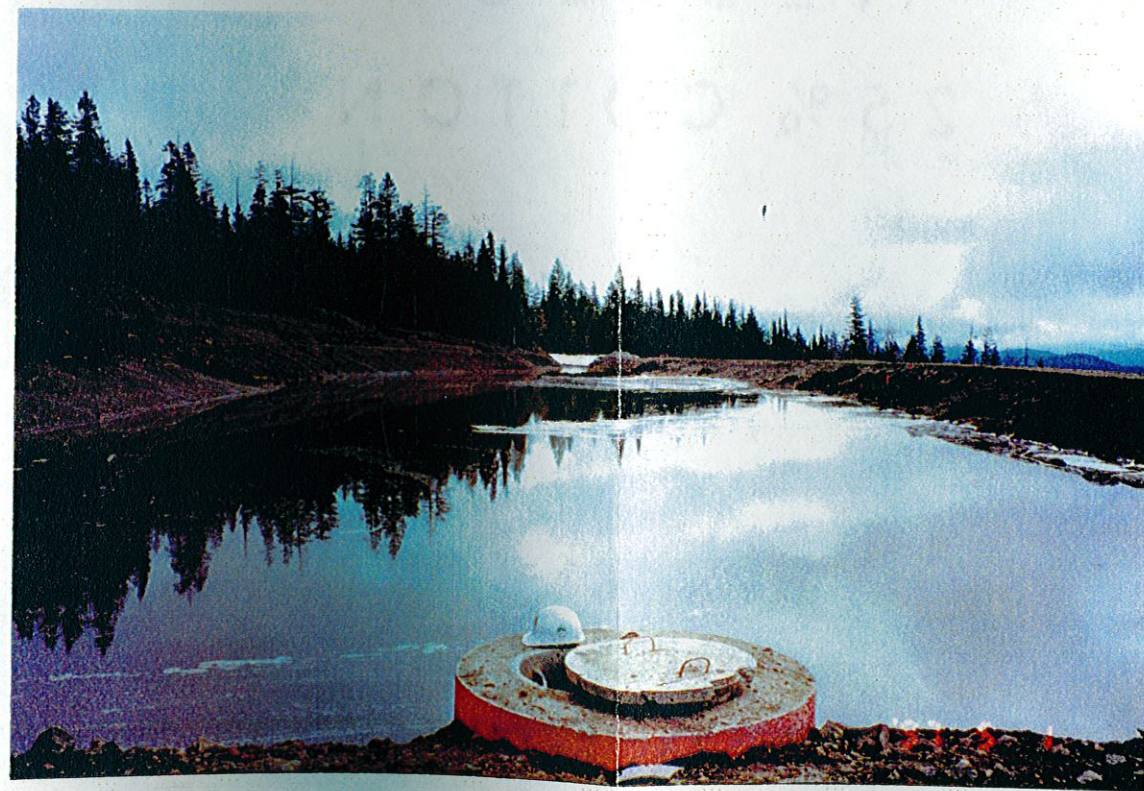
- (4) • The manhole sump currently has 3 of 4 pipes operating. Previously all 4 pipes were opened and the 10" outlet pipe to the T2 dropbox easily kept up. MPMC are planning to add another inlet pipe at the second lowest level. To do this, they propose to temporarily block the inlet ditch after the flow slows down, causing water to spill out the overflow culvert. The overflow culvert is not ready and needs riprap first. Also, the road/berm on the downhill side of the channel needs to be repaired at the overflow culvert because there is some

Photo No. 4 - SESP looking upstream from manhole decant. 3 of 4 pipes in operation. 1 joint between manhole sections is leaking.

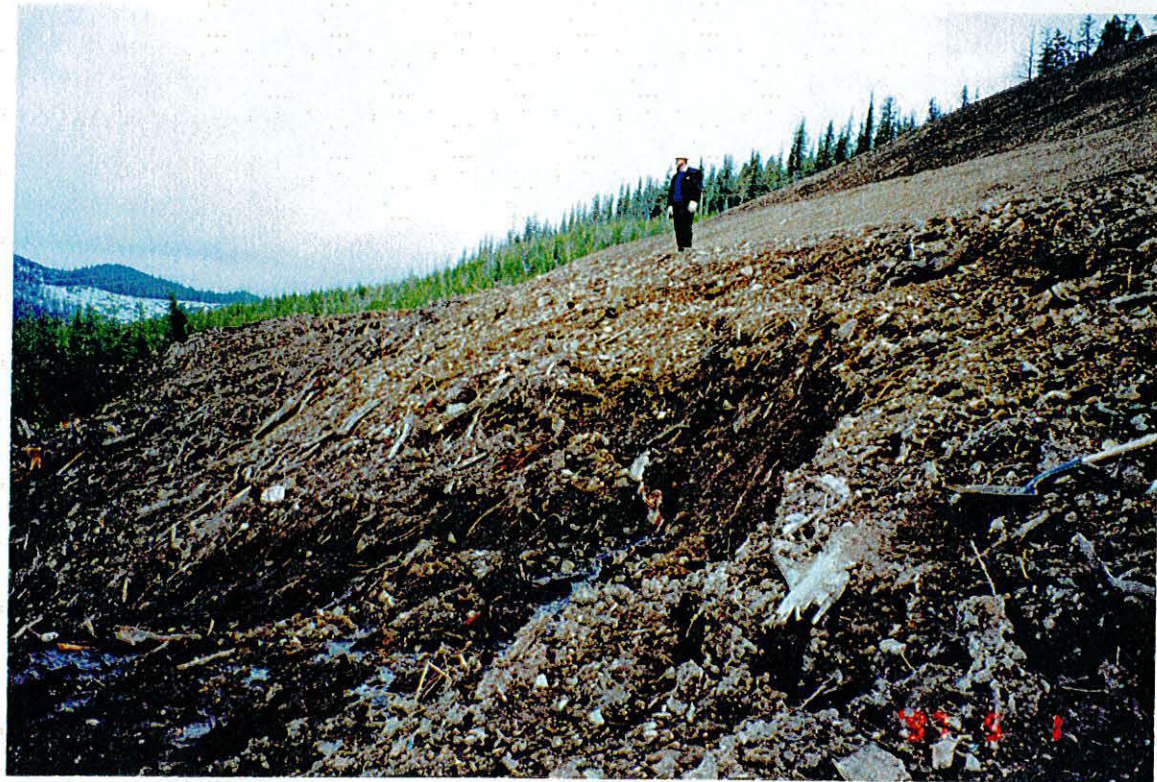
- (5, 6) • A walk along the toe revealed numerous springs exiting from the toe of the topsoil/stripping waste piles. The piles are saturated and unstable, with cracking and some slump failures. This is seen for the full length of the embankment, wherever stripping piles are present.

- (5, 6) • As above, the fill above the wet stripping piles is not greatly affected and most cracking is on the groomed areas below the 2H:1V final (overall) toe.

Photo No. 5 - Saturated topsoil/stripping waste past final DIS toe has slumped. Note spring at base.

- The springs and fill condition must be closely monitored. A graded filter should be installed (with filter fabric) if any signs of instability in the fill are observed.

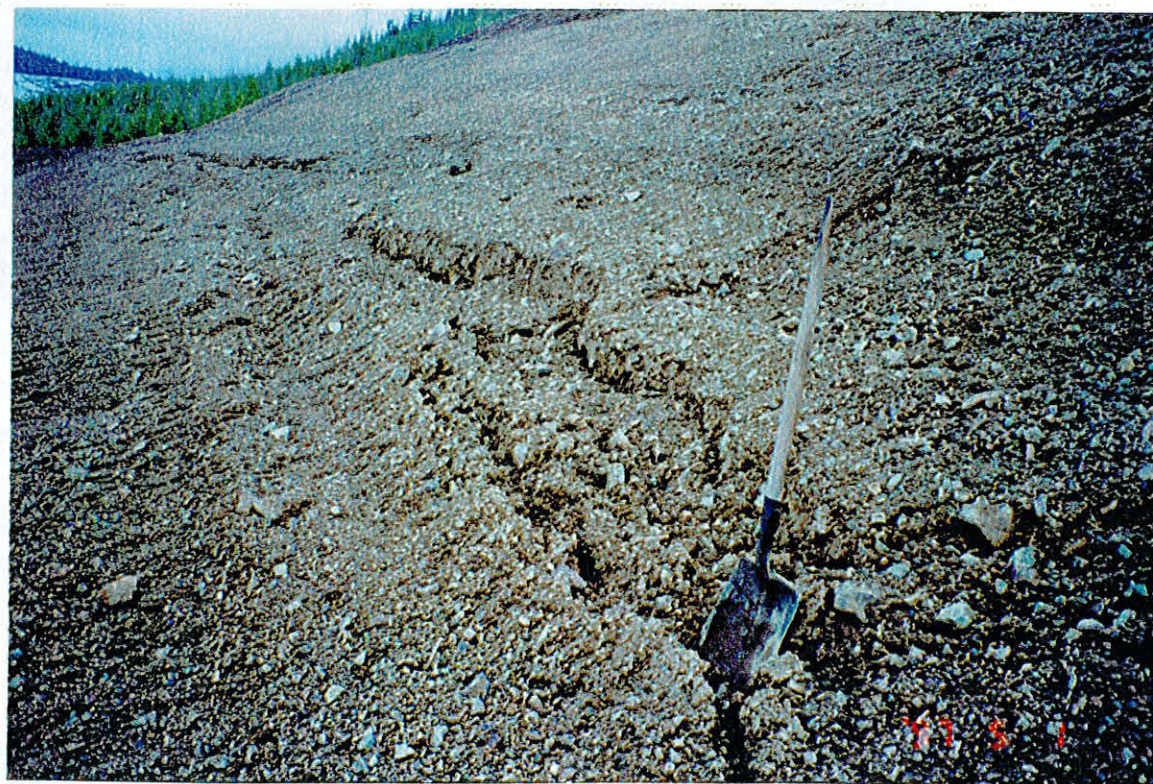
Photo No. 6 - Cracking on groomed areas below final DIS toe caused by saturated topsoil/stripping waste below.

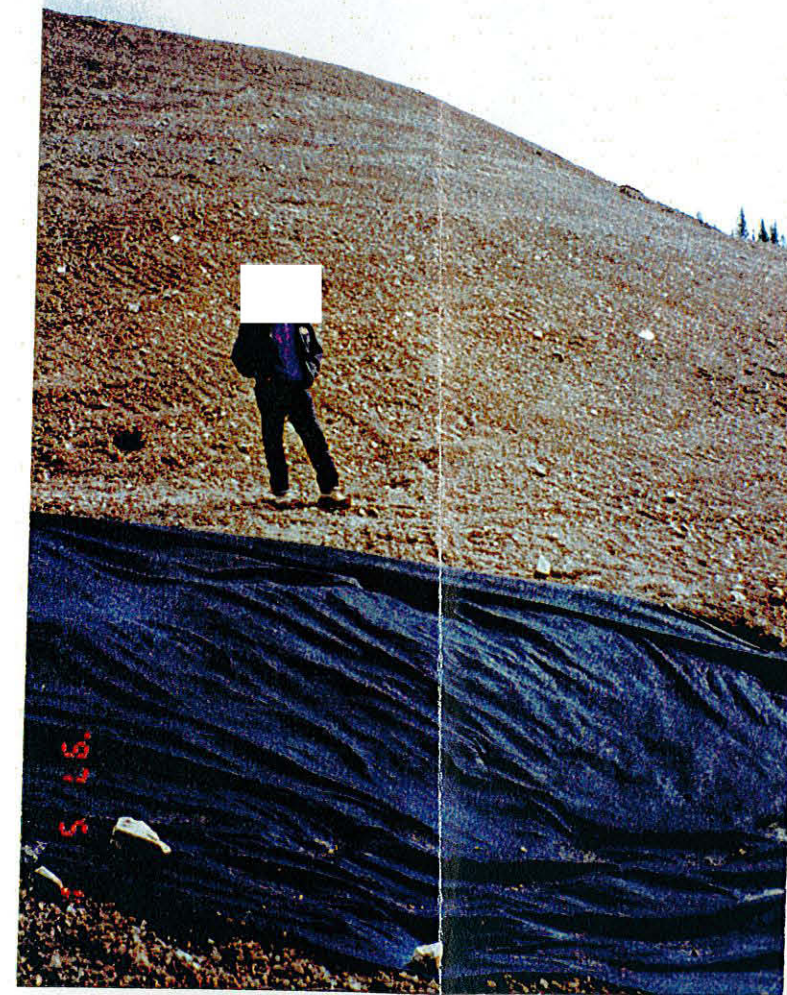
- (7, 8) • Water appears to be from below the embankment fill, probably in the top of the fractured bedrock at the till interface.
- (7, 8) • Water exiting seep is clear. The length of the area where occasional springs are present at the corner is approx. 25 m.

- (7, 8) • The fill above the spring does not appear to be adversely affected. The fill immediately above the spring is wetter, but not higher above (likely due to wetting from saturated material below).

Photo No. 7 - Fill above seep/spring at corner of SESP. Fill does not appear adversely affected. Note small investigation hole above filter fabric.

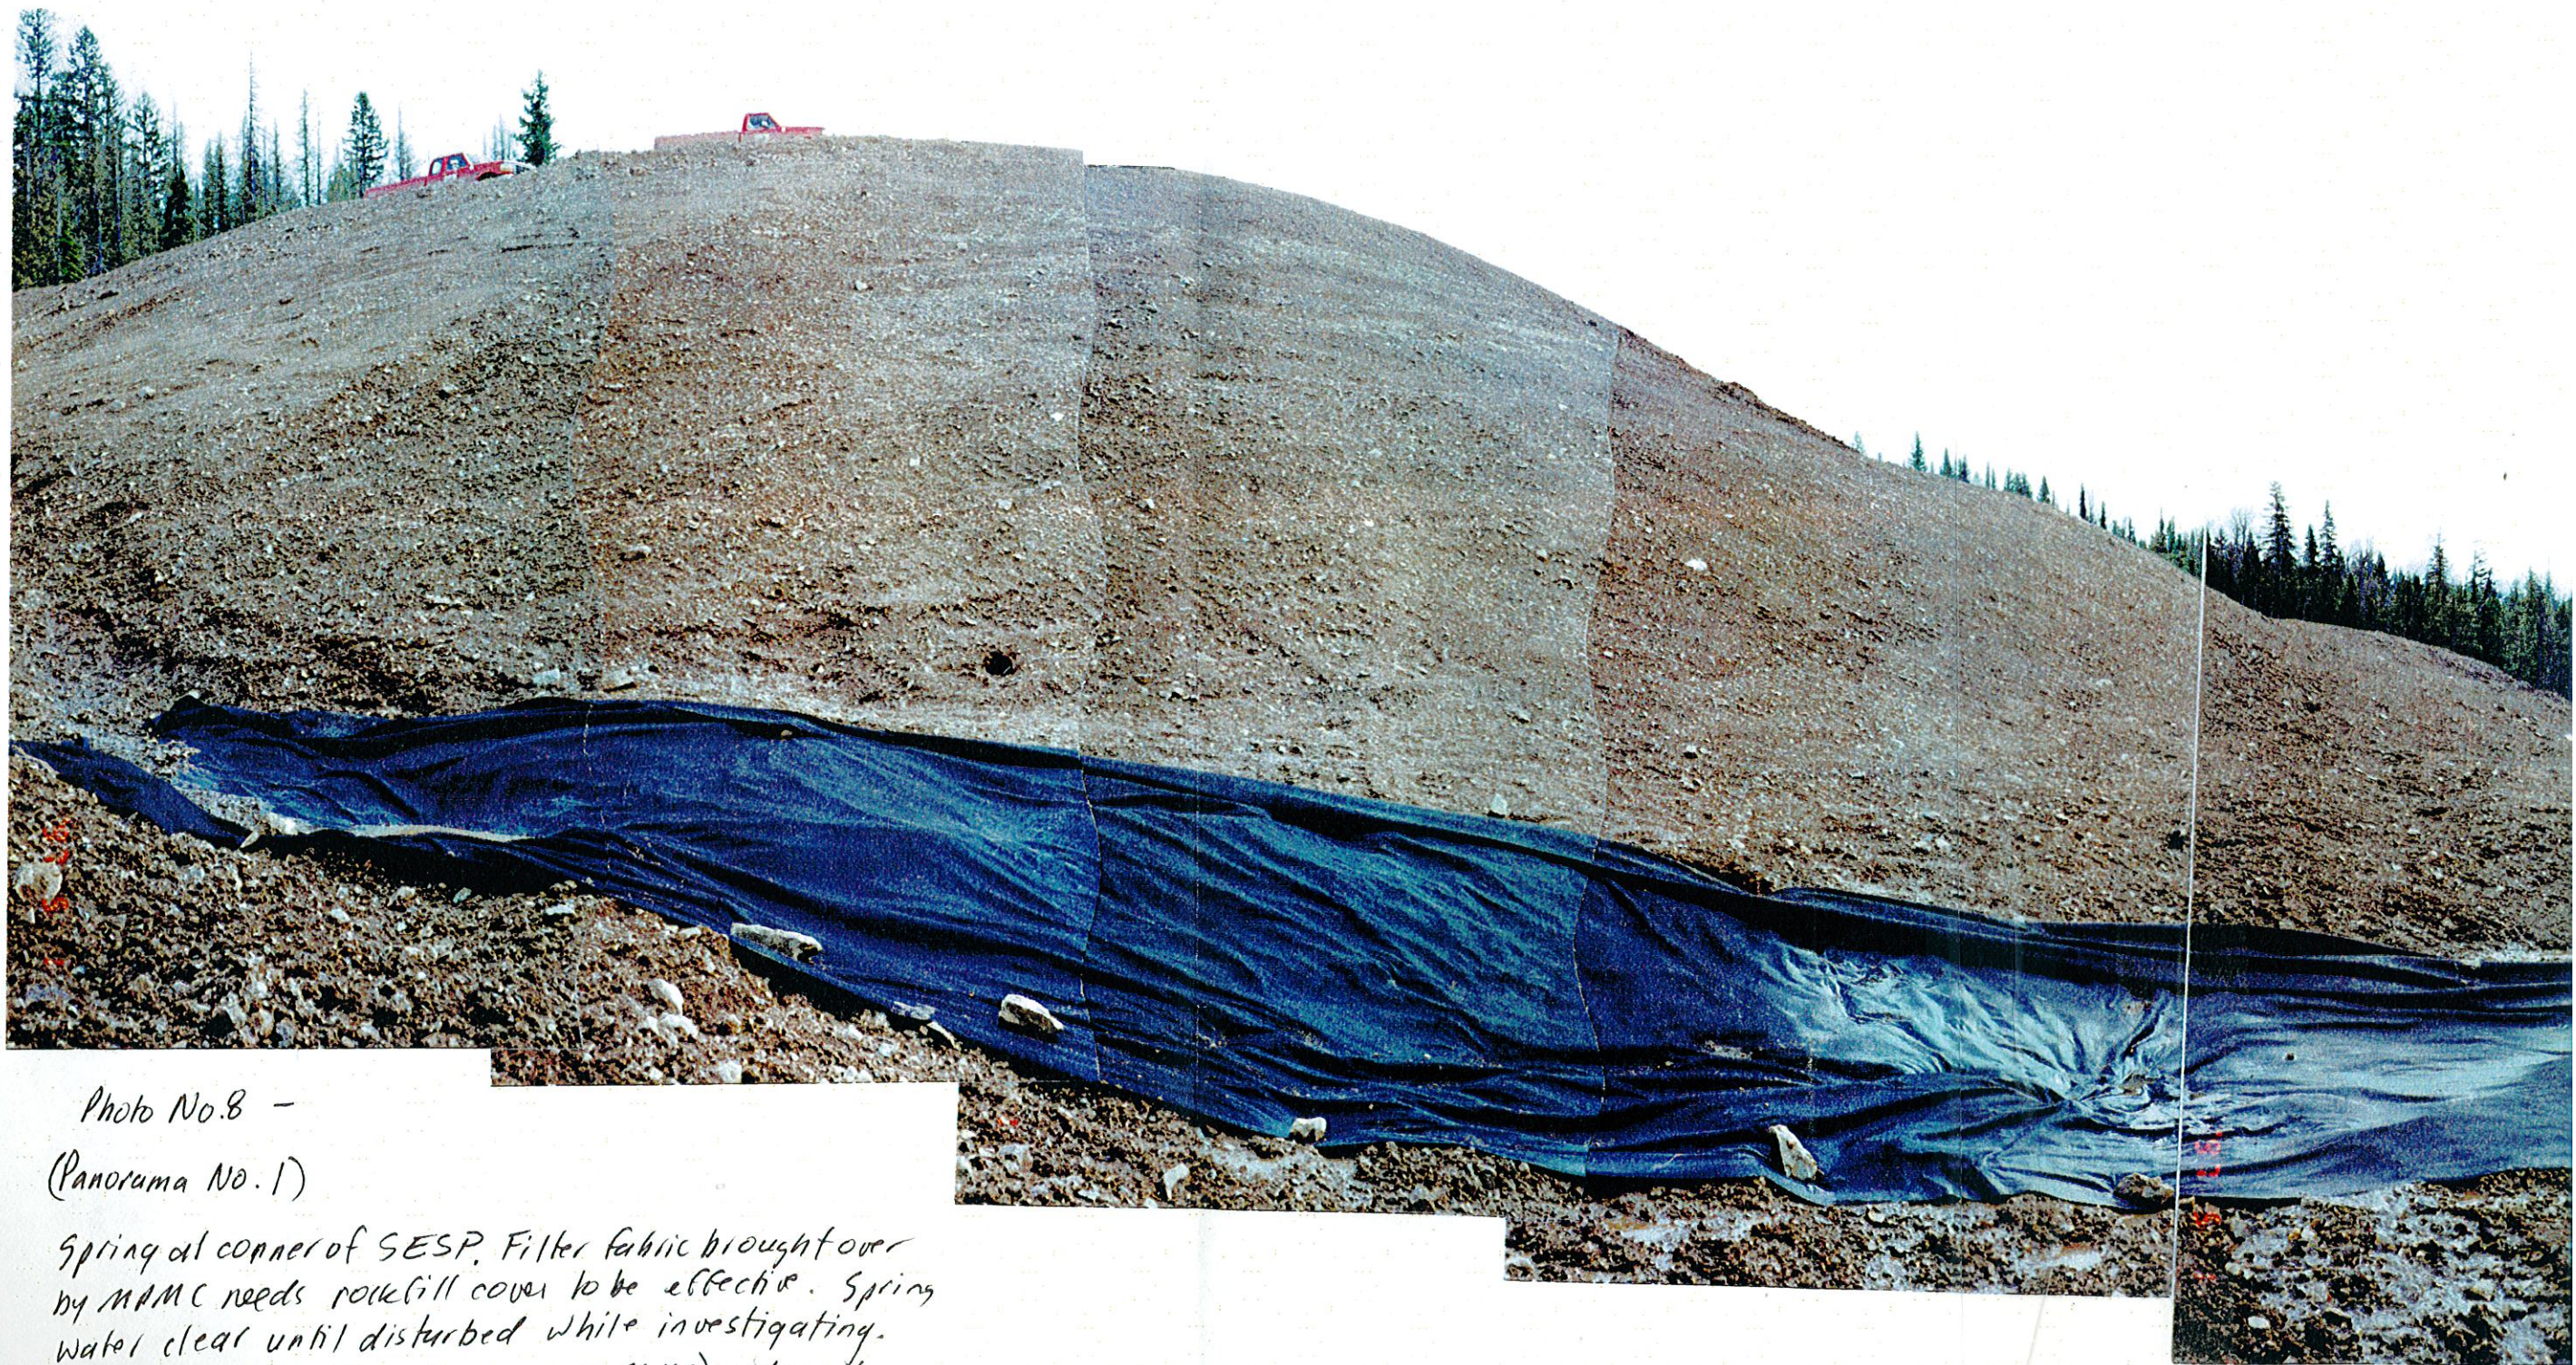
Photo No.8 -

- MPMC reports that the spring flows seem to be affected by the pond elevation (EWL). This is likely due to recharge from a higher pond onto the exposed fractured rock at the back of the pond. It was reported that the spring flows slowed down after the pond level dropped. The pond liner level needs to be confirmed.

Spring at corner of SESP. Filter fabric brought over
by MPMC needs rockfill cover to be effective. Spring
water clear until disturbed while investigating.
Note water flowing down west (LHS) side at
base of fill.

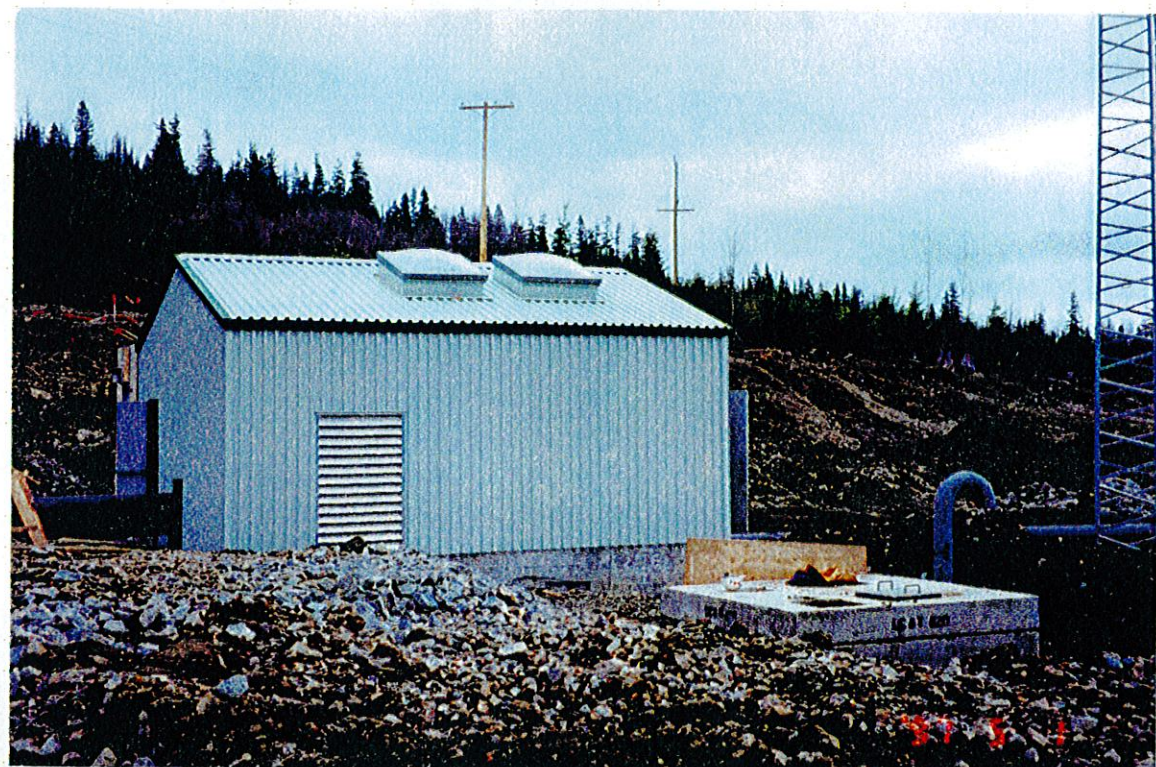
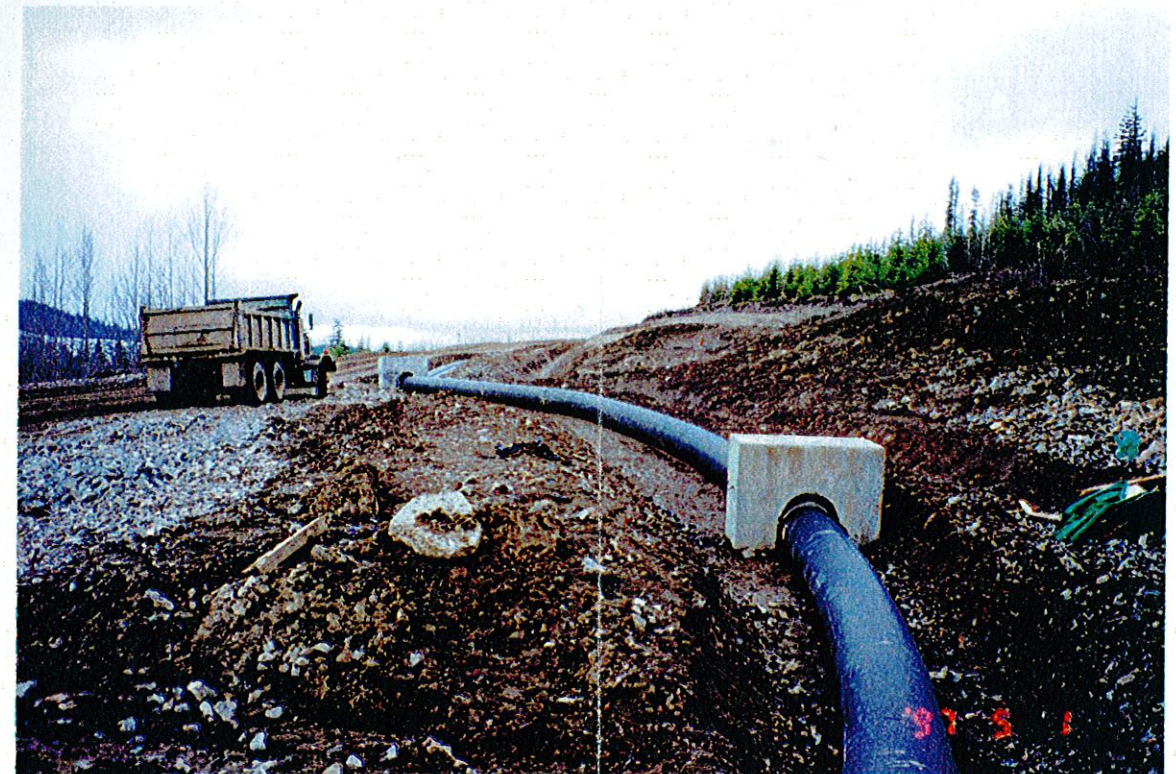
- (11) • Two anchor blocks have been placed on the bends on the reclaim line coming out of the pumphouse. Two more anchor blocks should be installed so that there are two at each section of the S-shaped curve.

- (11) • The tailings line appears to go up slightly where the pipes cross, uphill from the T2 dropbox. This should be fixed so that there are no high spots.

Photo No. 11 - Anchor blocks on reclaim line. Two more blocks are required as per design drawings. Note that tailings line goes up before pipeline crossing.

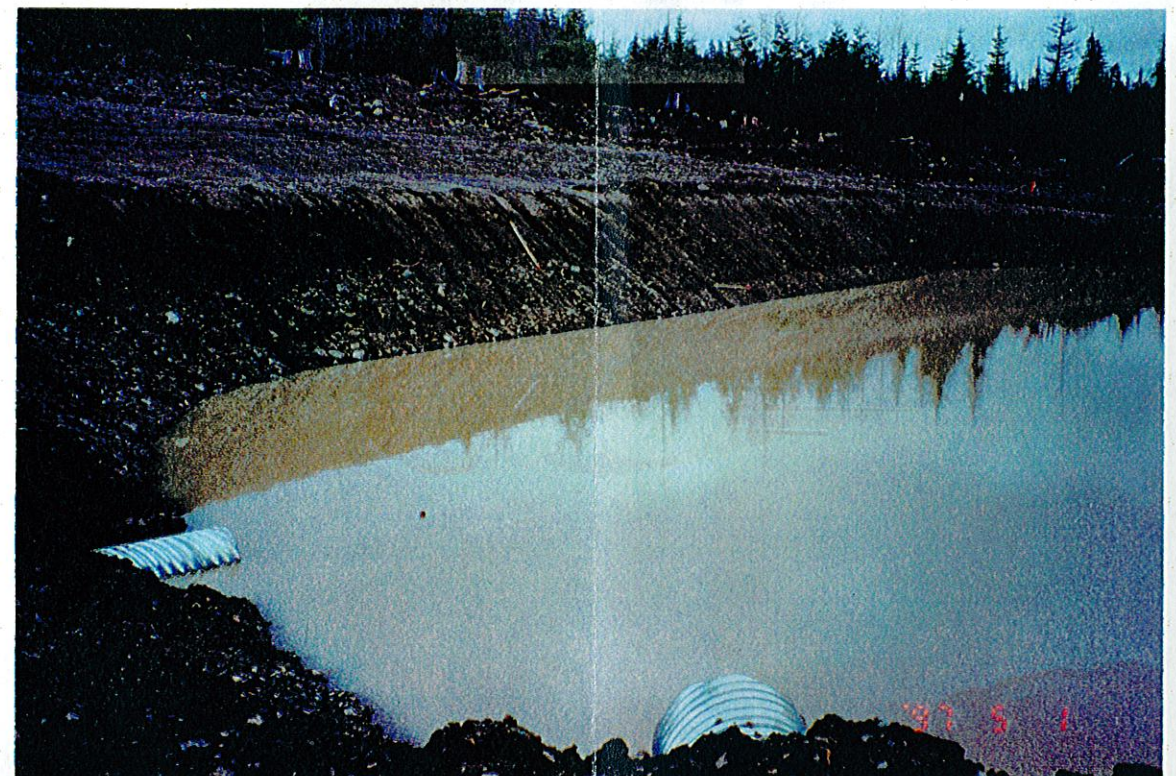
- (12) • The overflow culvert at the overflow pond is higher than the inlet pipe. Therefore, the inlet pipe will back up if the pond is filled. The overflow culvert extends through the fill, with a riprap lined channel extending to the pipe containment channel (not a culvert all the way to the channel).

Photo No. 12 - Overflow pond for T2 dropbox. Overflow culvert is higher than inlet pipe.

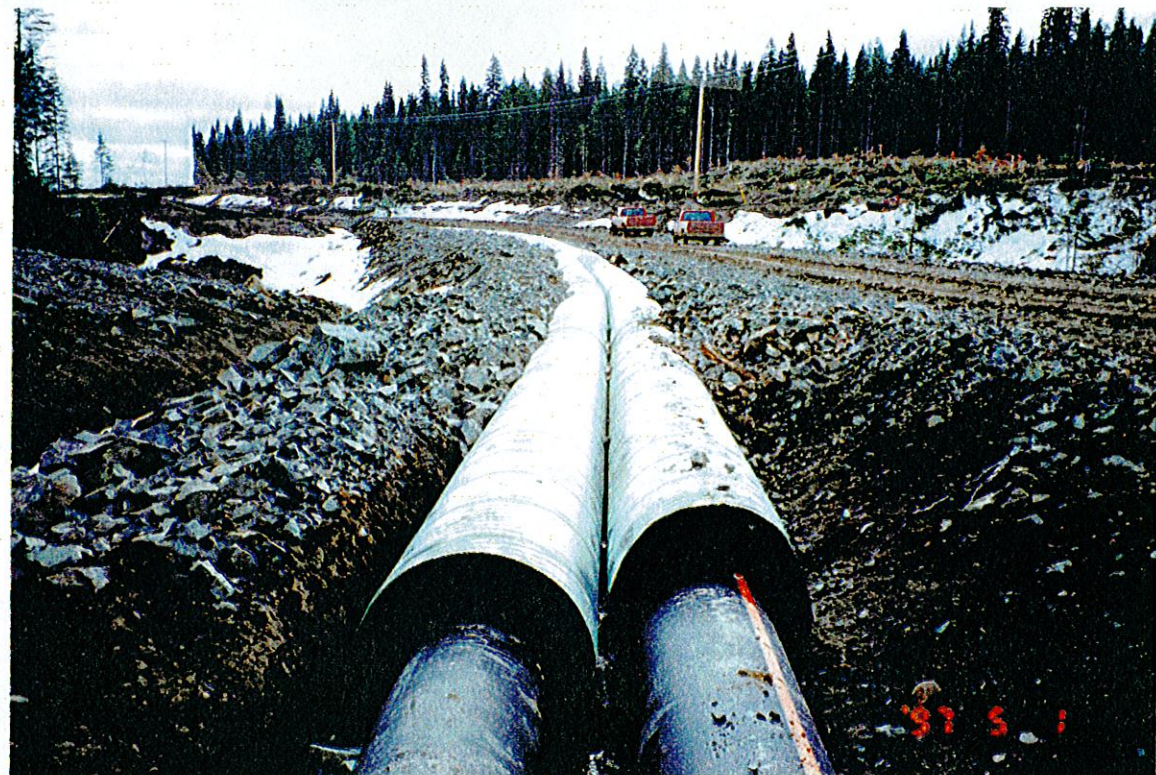
- (13) • The fill slopes look good, with no signs of instability.
- (14) • Dirty water is entering Bootjack Creek just before pipe arch

Photo No. 13 - Bootjack Creek Crossing; looking towards TSF. CSP sleeves around HDPE pipelines. Fill slopes look stable.

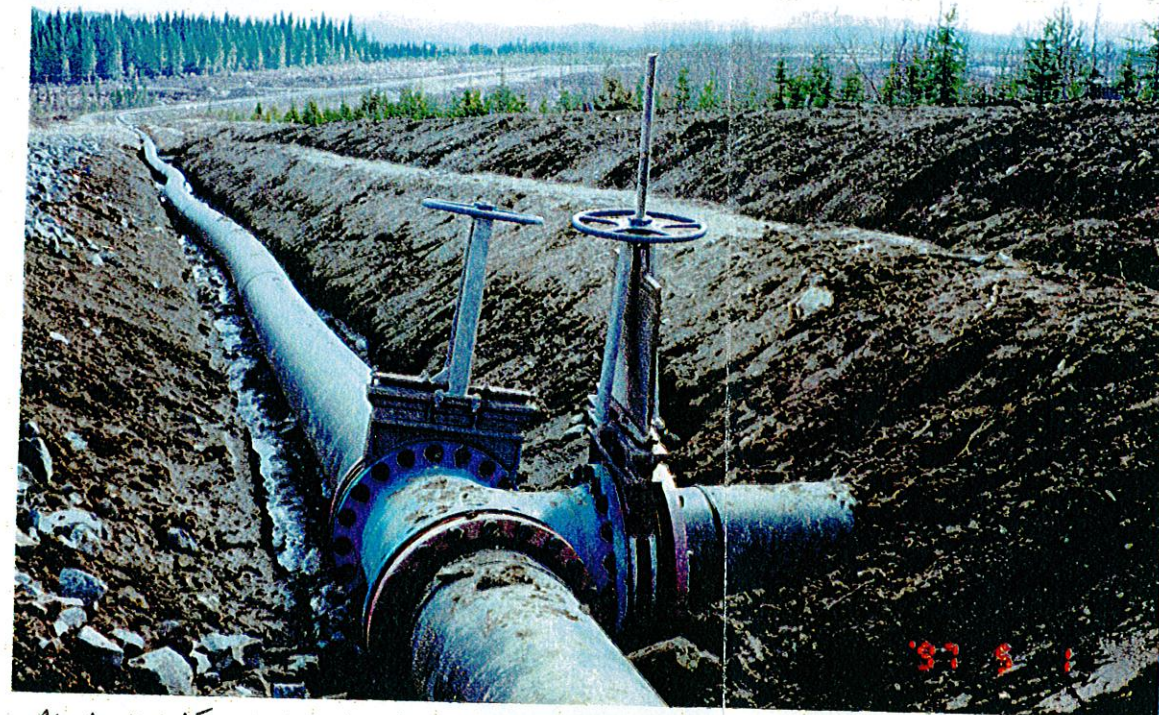
- (15, 16) • Mark 1a is installed, with high flows from the Southeast Sediment Pond and Millsite Sump.
- (16) • The discharge channel at Mark 1a is too flat at the start and may sand up if tailings are discharged. MPMC are planning to extend the HDPE pipe from the Mark 1a valve to a steeper, more open area.
- (20) • The Polley Lake pipeline continues to pump water at a maximum rate of 5400 US gpm. MPMC are planning to pump 2 more weeks. The access road is very soft and is not trafficable.

Photo No. 15 - Mark 1a dump valve at top of TSF.

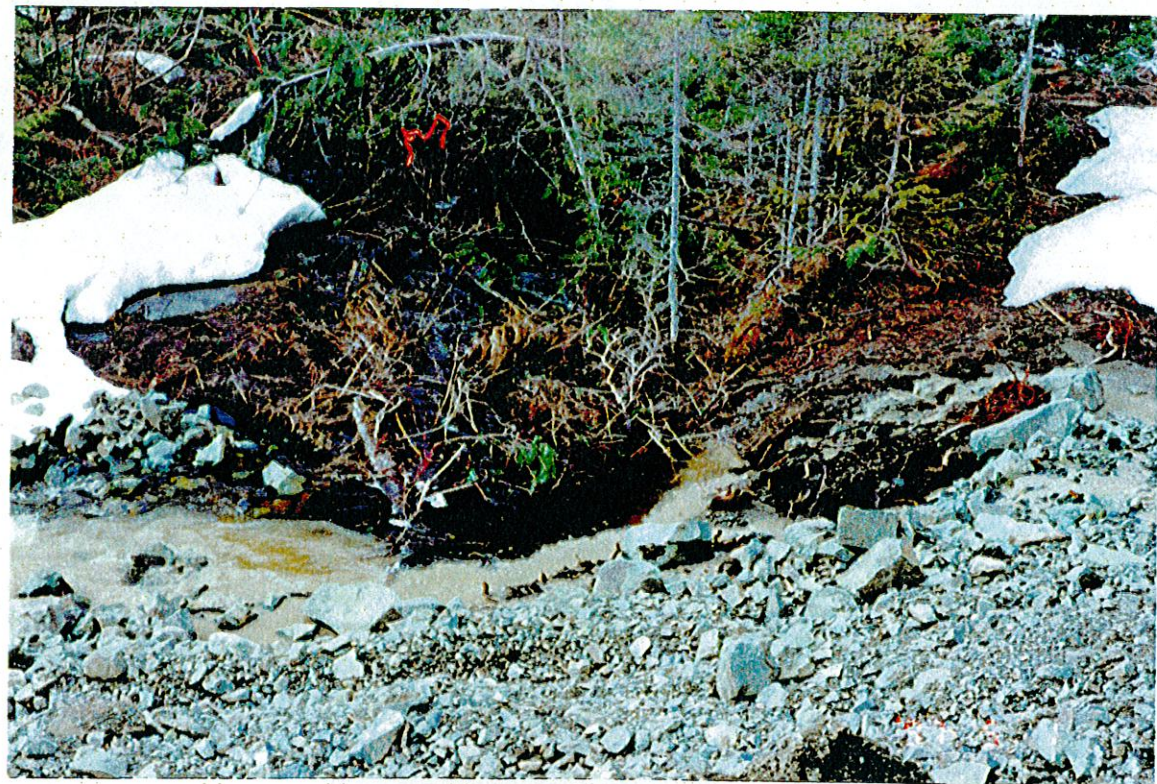
culvert (from road construction). This is being fixed by MPMC who are installing rock for erosion protection in ditch.

Photo No. 14 - Dirty water from road construction entering Bootjack creek just upstream of crossing.

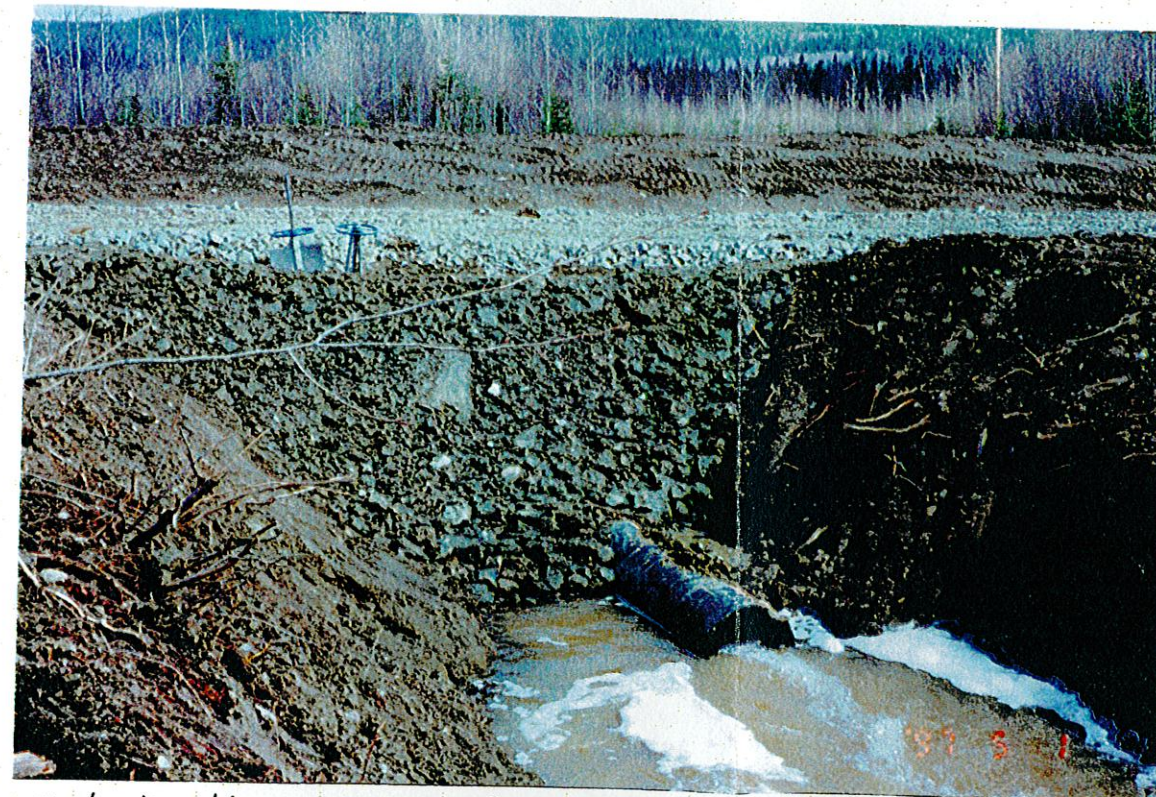
Photo No. 16 - Outflow from Mark 1a dump valve (SESP, Millsite flows). Channel needs work to avoid sanding. MPMC planning to extend pipe.

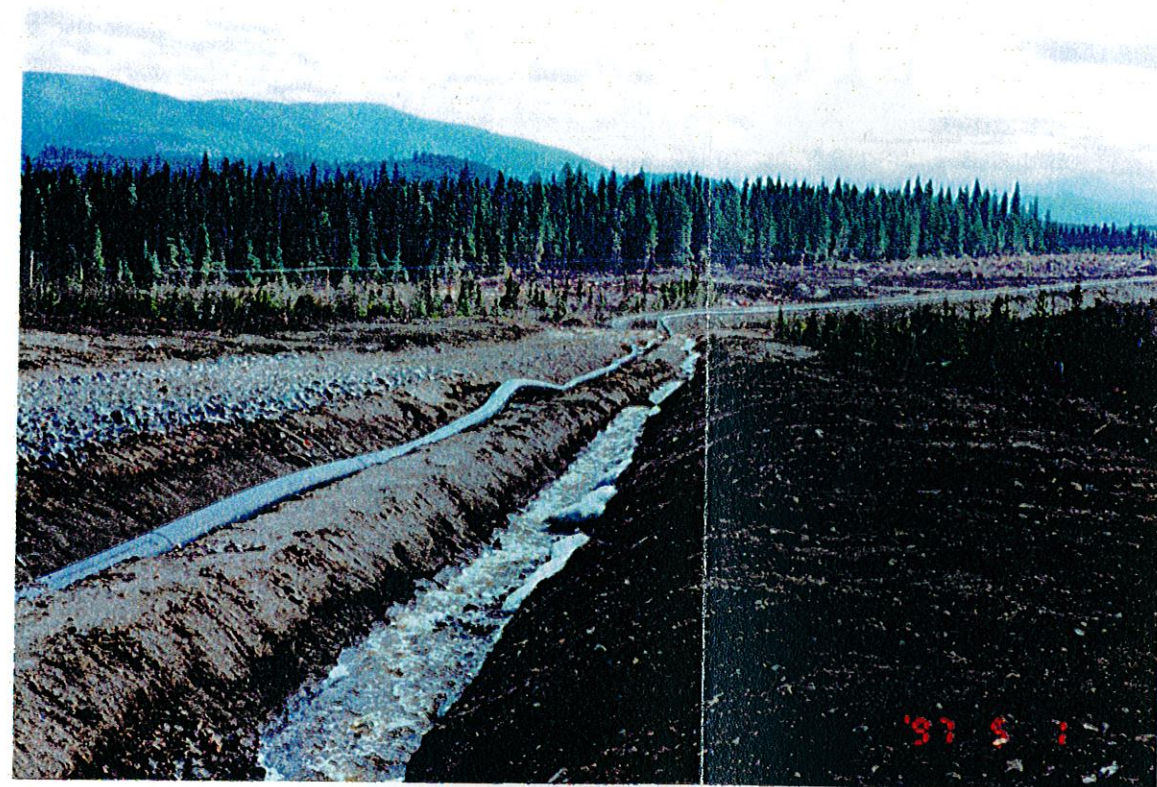
Photo No. 19 - Tailings line looking towards Perimeter Embankment. High spot is above cross drain culvert. Runoff flows are from direct catchment above TSF.

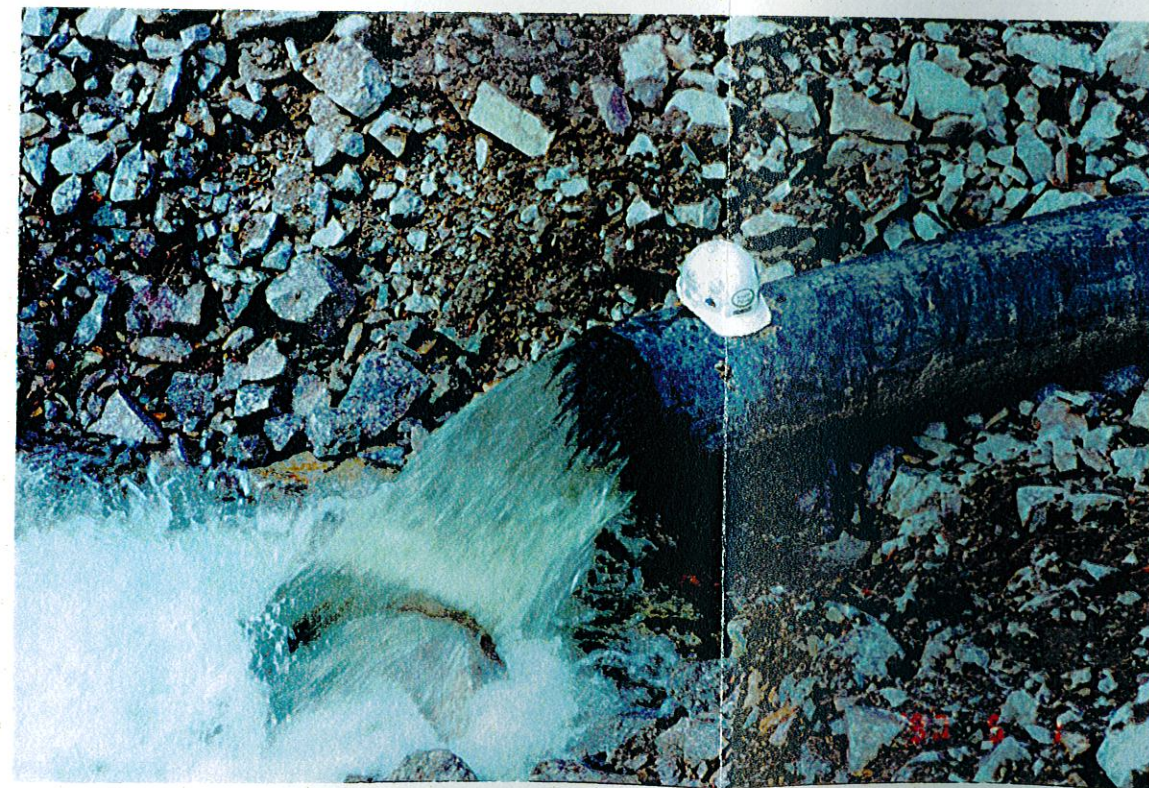
Photo No. 20 - Outflow from Bailey Lake Pumping system (5400 USGPM.)

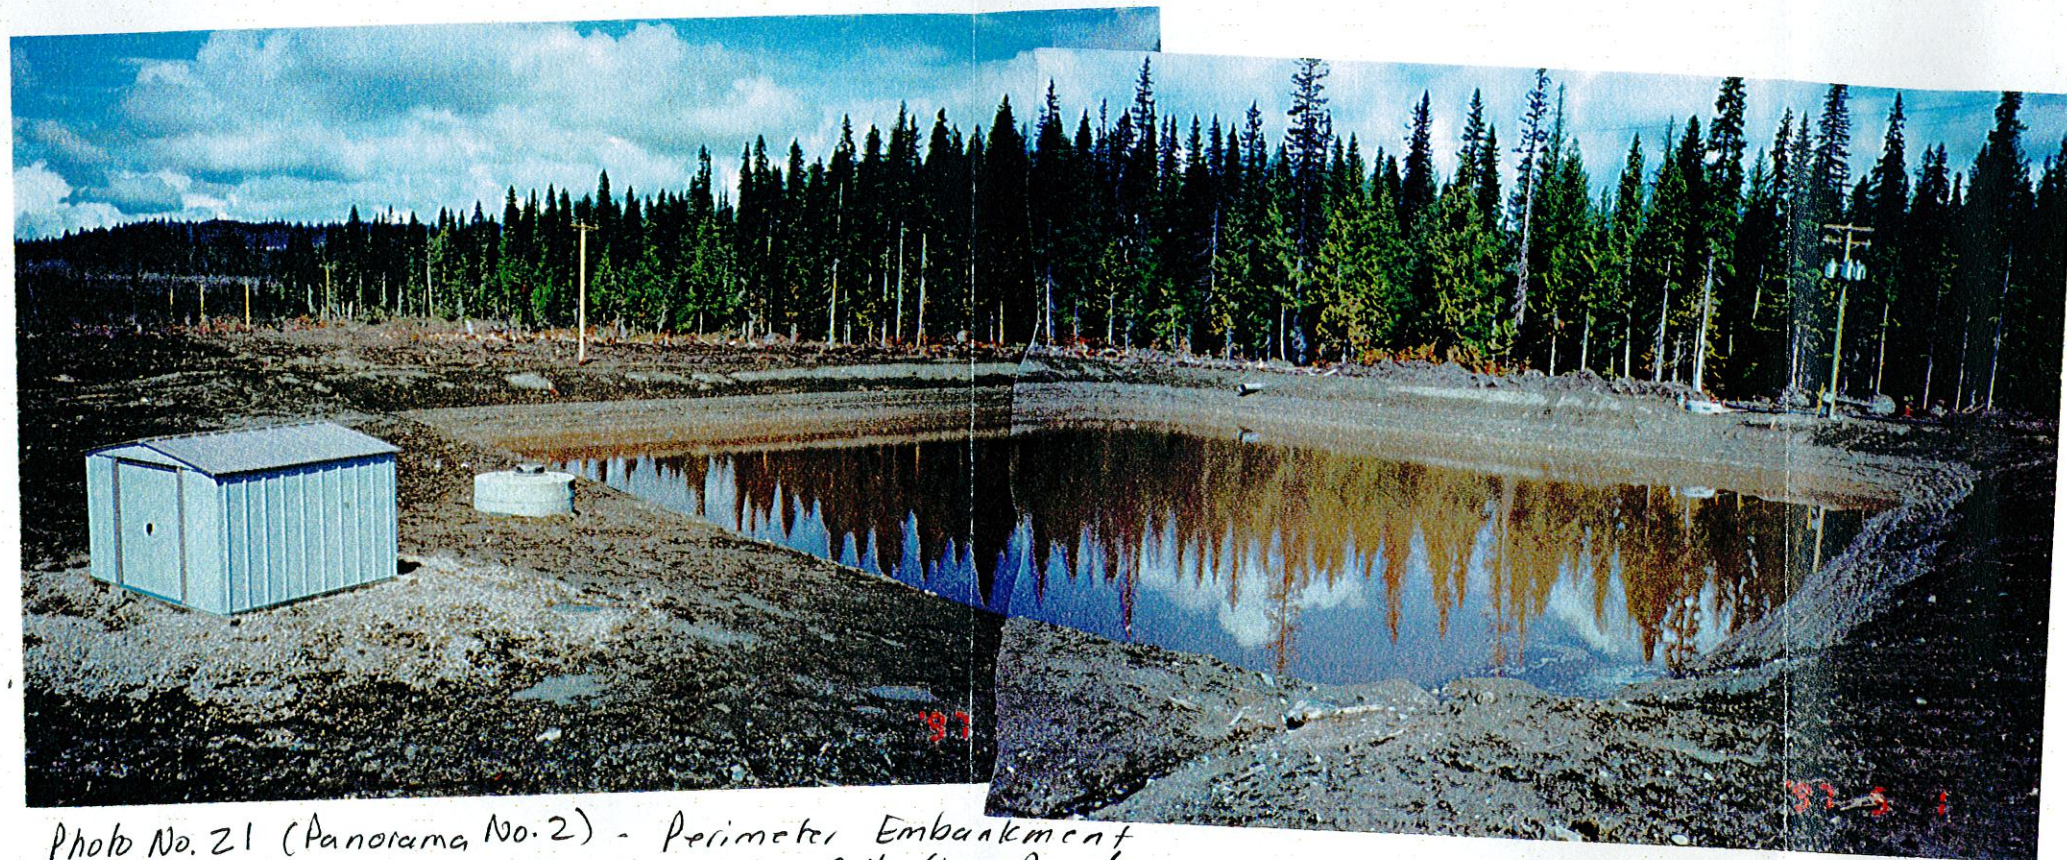
- (21, 22) • The Seepage Collection Pond (PESCP) looks good. The current water level is El.928 approx. The seepage recycle pump is working and discharging local runoff back into the TSF. The pipeline is buried 1m through the fill.
- The downstream area has some ponded water and extensive areas are very soft, with fill over buried snow. This will need to be removed to stripped original ground surface for Stage II construction. The soil is especially soft at the SCP

Photo No. 21 (Panorama No. 2) - Perimeter Embankment
seepage Collection Pond.
Power poles to seepage Recycle sump on RHS.

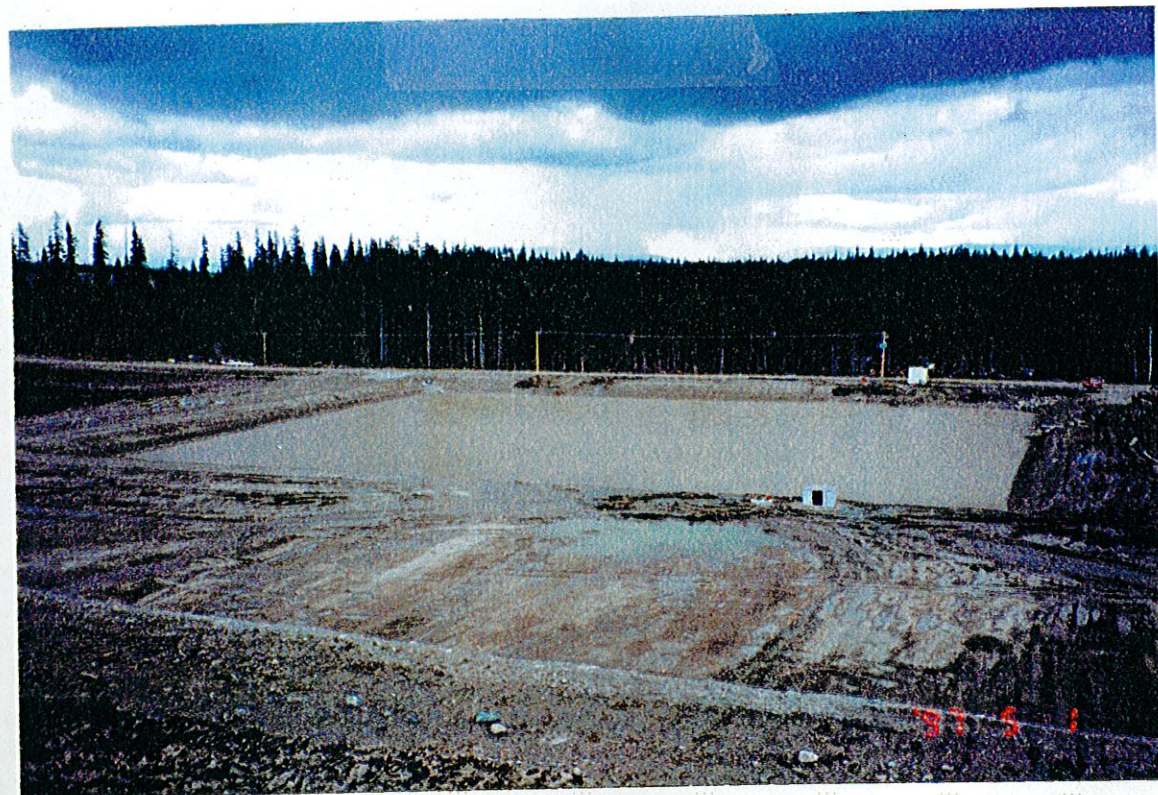
- (23) • Flows in the drain monitoring sump are low and clear.
- (23) • The current water level at the Seepage Collection Pond (MESCP) is approx. El. 909.3. The outlet pipe at the drain monitoring sump is still plugged and the sump is being pumped out. The plug will be removed as the 2 or 3 pumps in the seepage recycle sump are now keeping up with inflows.

- (23) • Runoff from additional areas downstream of the Main Embankment is being diverted to the MESCP. MPMC should provide an estimate/sketch of all areas diverted into the MESCP so that any additional flows can be included in the water balance.

Photo No. 23 - Main Embankment Seepage Collection Pond (MESCP).
Power poles to seepage recycle pump on KITS.
Additional catchment of embankment diverted
to MESCP.
