**MOUNT POLLEY MINING CORPORATION
MOUNT POLLEY PROJECT
TAILINGS STORAGE FACILITY
AND ANCILLARY FEATURES**

**MAY 1, 1997 SITE INSPECTION
(REF. NO. 1627/4)**

SUBJECT: Site Inspection (May 1, 1997)

MOUNT POLLEY
SITE INSPECTION - MAY 1, 1997

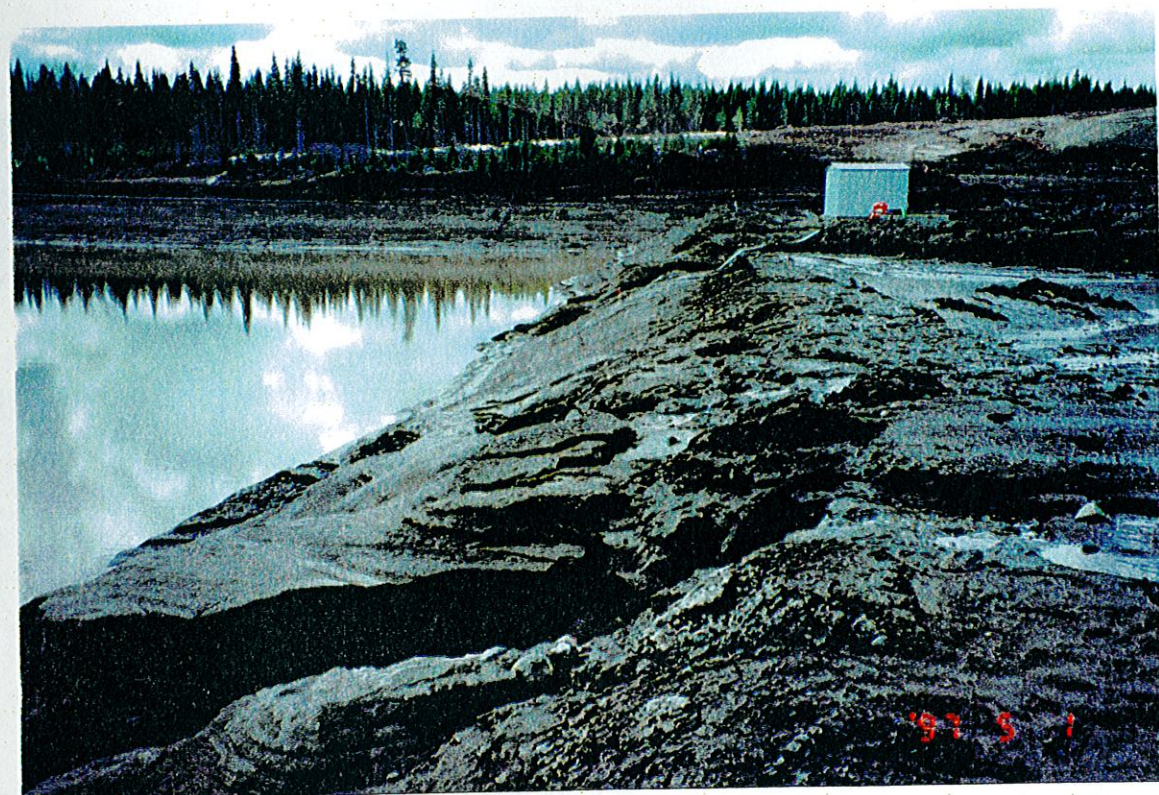
- (24) • There is a slight flow from one of the Toe Drain Main Conveyance Pipes (right side). MPMC should confirm why.
- (24) • There is extensive erosion where runoff has entered the north side of the MESCP. This should be repaired by placing more fill (crushed rock is acceptable) in the eroded area. Suitable storm runoff control measures (a runoff channel) should be incorporated to minimize the possibility of future erosion.

Photo No. 24 - Erosion at NE corner of MESCP (may have been
caused during pumping in October).

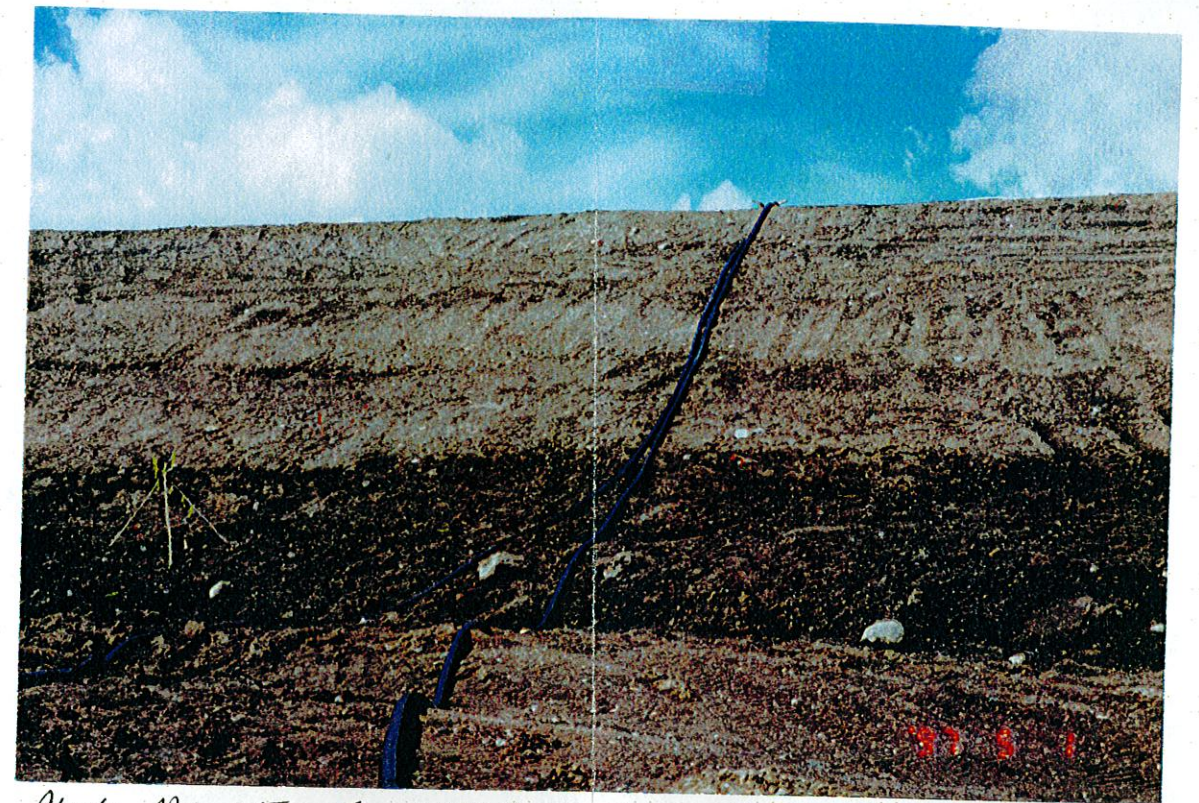
- (25, 26) • There are 2 seepage recycle pipes that return water to the TSF. One pipe is buried 1 m deep in the embankment fill and

the other is on the crest. The ends of the pipes should be pulled out of the water as the pond level rises inside the TSF.

- The area downstream of the MESCP/ Bootjack-Morehead connector road (the old creek bed) should be re-graded and re-vegetated.
- (25) • There is a damp spot on the downstream face of the embankment fill at the location of the seepage recycle pipes (Ch. 19+25). It appears to be related to the presence of wet "unsuitable" material piled against the downstream toe of the embankment. The damp material has small surficial slumps and is also cracking. This dampness and cracking is evident at many places on the downstream face.

- (25, 30, 31, 32, 33, 34) • The pile of wet "unsuitable" fill included snow and ice from clearing of the Stage 1a El. 920 Zone B crest. The result is that the overbuilt area is unstable, with loose fill and cracking evident. Moisture is being absorbed by drier fill above the "unsuitable" fill piles, resulting in more slumping and cracking. Some cracks may be as high as El. 918 m. This "unsuitable" fill is continuous below the Stage 1a crest and slumping and cracking are especially obvious where the "unsuitable" fill piles are larger. There are occasional seeps coming out of the melting unsuitable fill piles. These seeps are believed to be the result of melting snow and ice in the "unsuitable" fill piles. All "unsuitable" material should be removed and the downstream slope redressed over the area as described above.

Photo No. 25 - Two HDPE lines from seepage recycle pump. Note
damp spot approx. halfway up 144 pipes. Also,
note wet (darker) material at bottom.

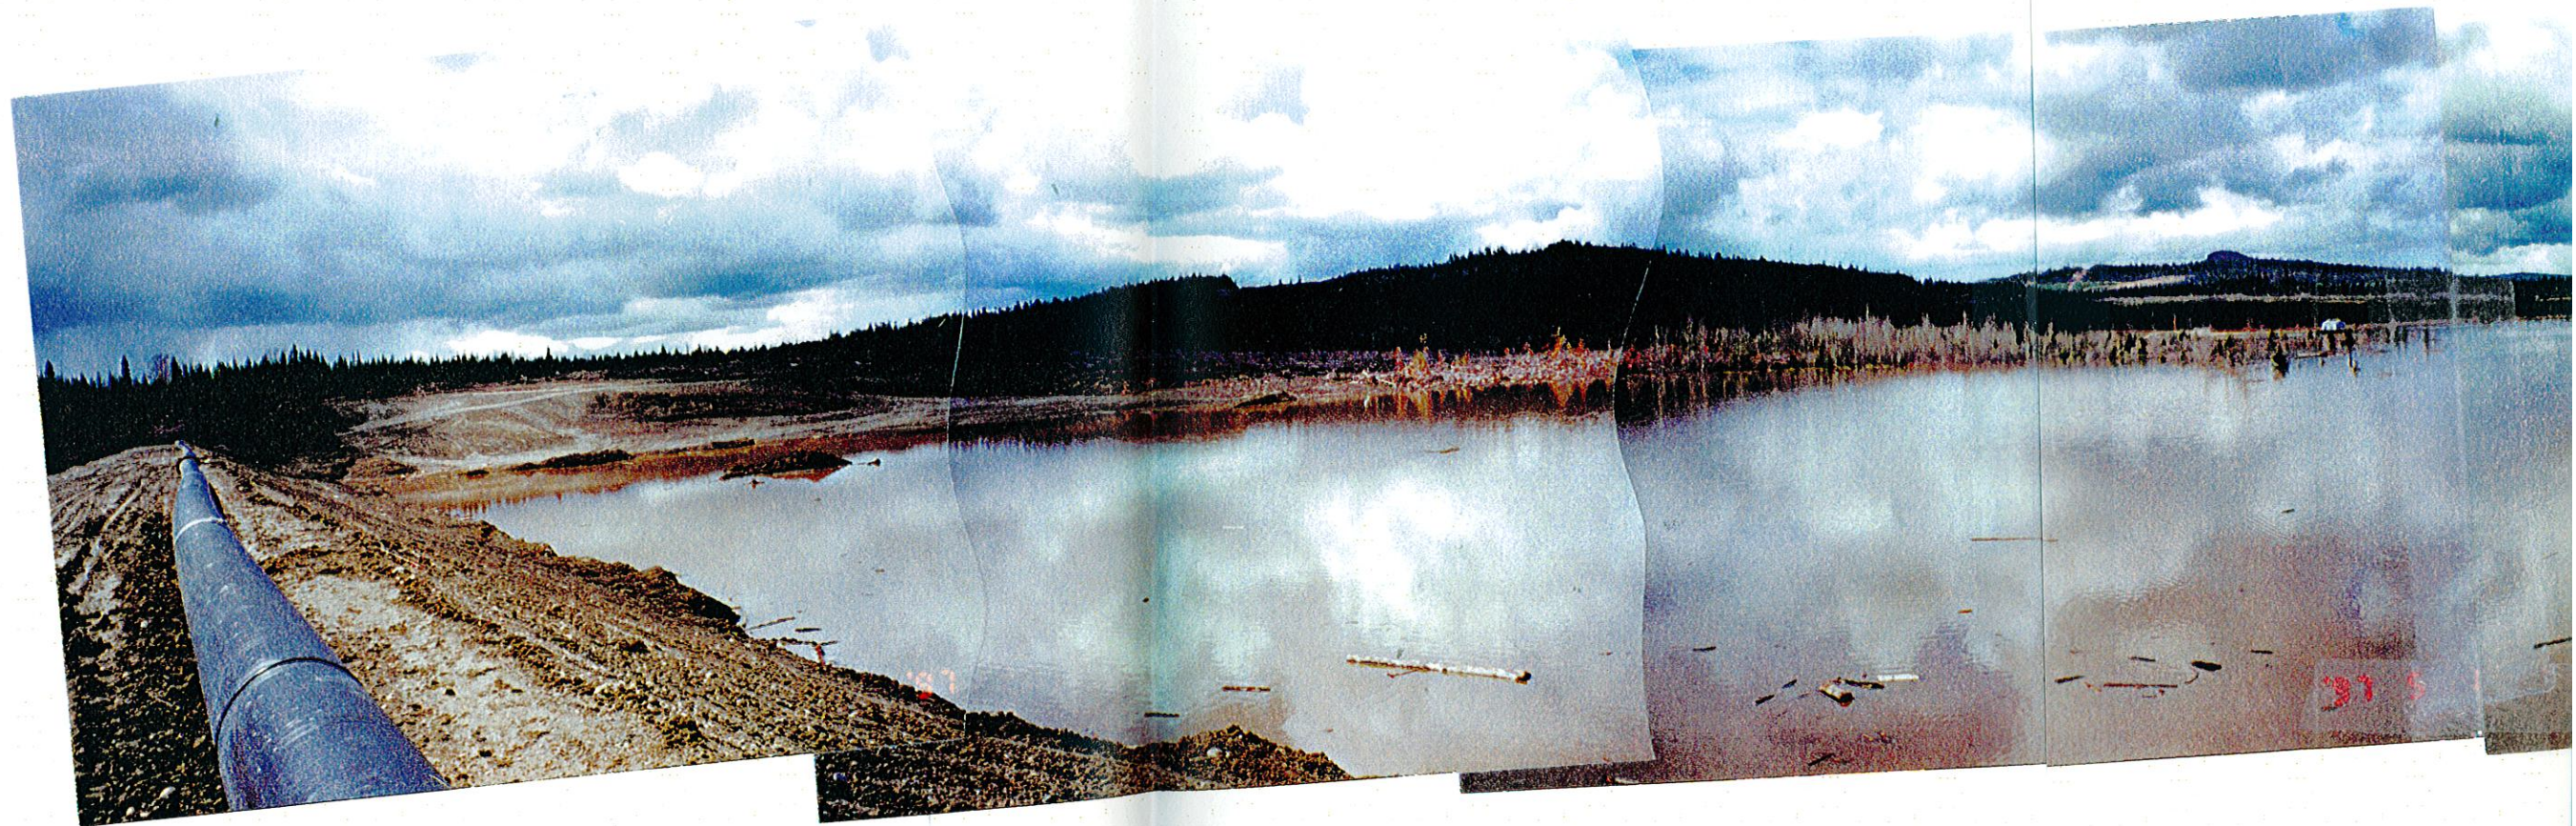
- (27) • Nine (9) six inch spigots are being set up (3 sections x 3 spigots/section). Only 5 or 6 spigots should be operated at start-up. The front 3 or 4 spigots should be turned off (by clamping the material handling hose or installing a blind flange) and discharge should always be out of the spigots starting from the downstream end of the movable discharge section. The optimum number of spigots will be determined during operations.

- (27) • The movable discharge section is set up at the right abutment (Ch. 16+00 to 19+00). It should be moved to the deepest part of the basin (Ch 19+50 to 21+50) as soon as a beach develops at the right abutment.

Photo. No. 27 (Pamotawa No. 3)
 View looking U/S from Main Embankment.
 Pond El approx El. 925m. Note spigots
 set up on LHS (ch. 16100 to ch. 19100).

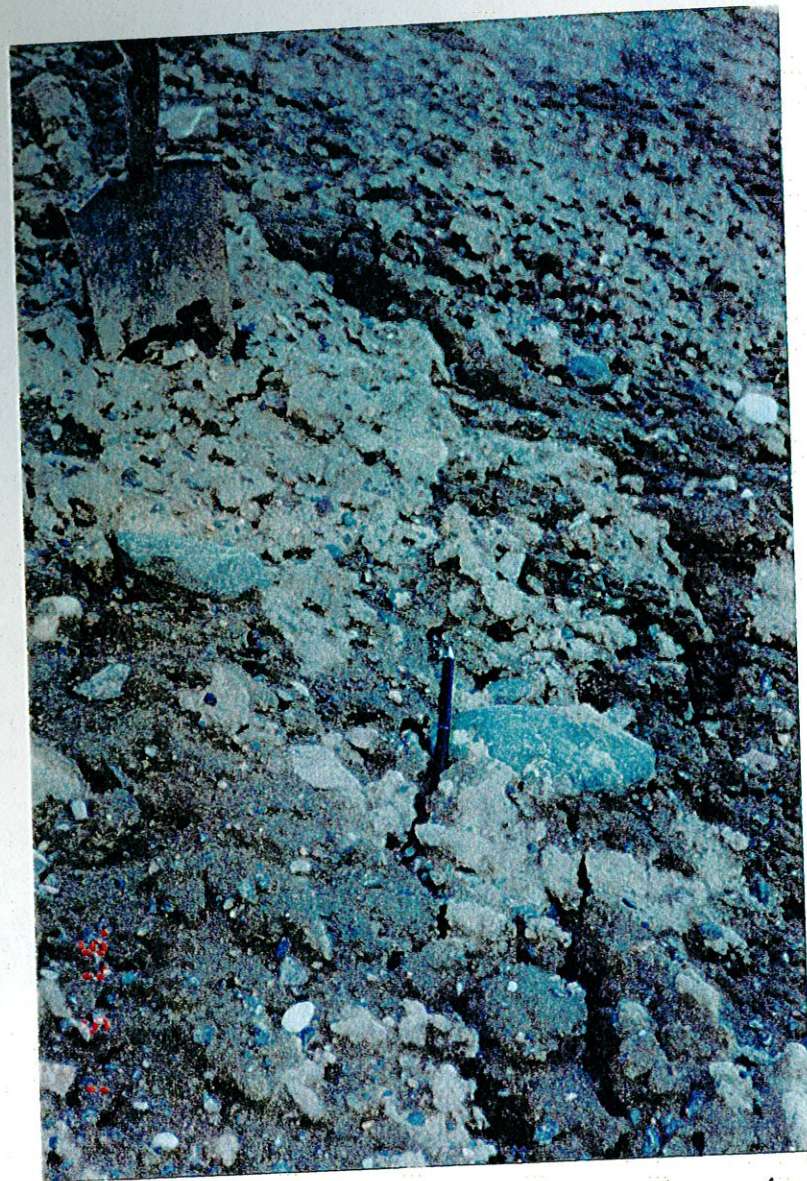
Photo No. 30 - Cracks along downstream toe due to presence of wet or unsuitable material.

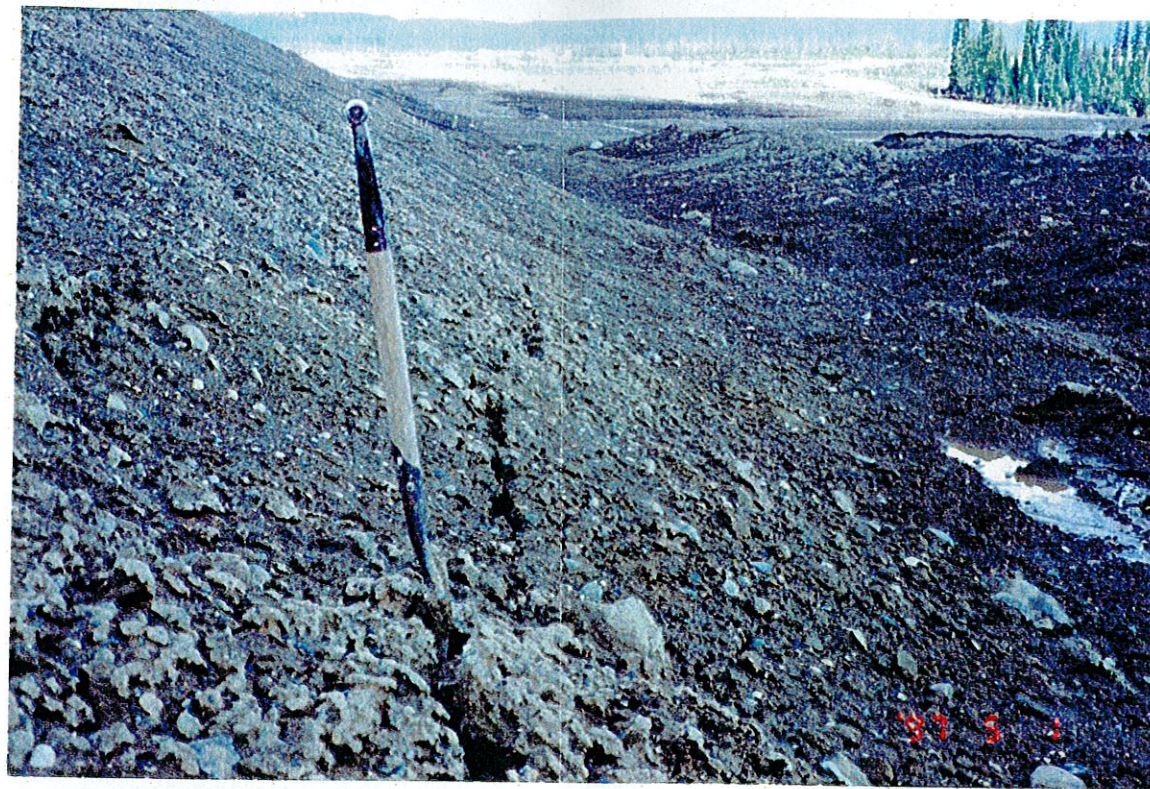
Photo No. 31 - Cracking at downstream toe, towards right abutment.

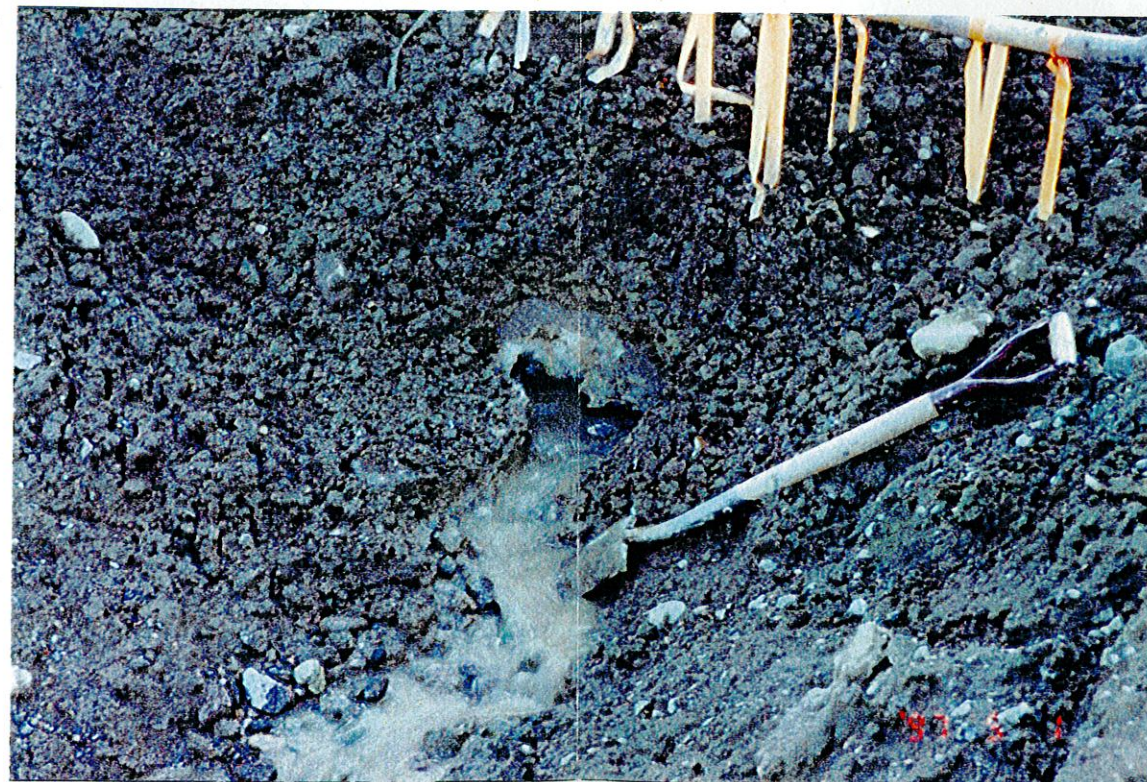
Photo No. 32 - Water from pipe of wet or unsuitable material. Note snow and ice.

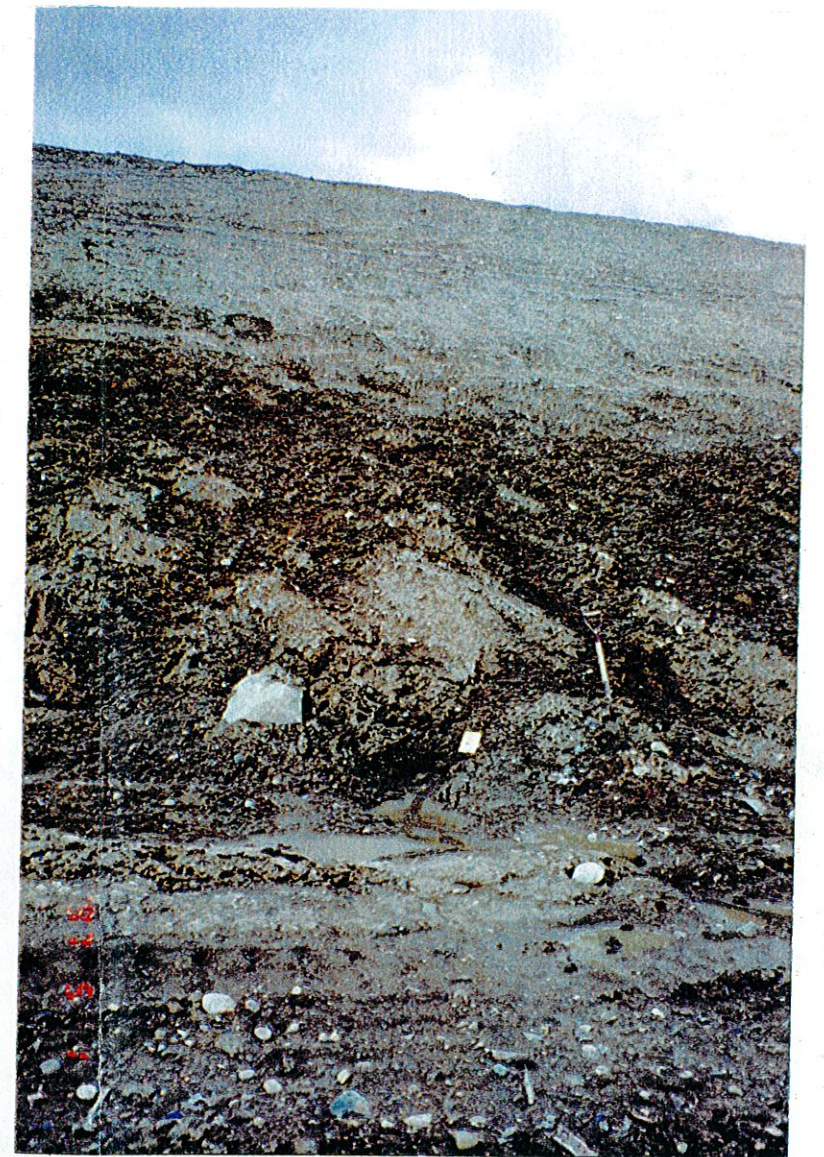
Photo No. 33 - Spring from base of unsuitable fill.

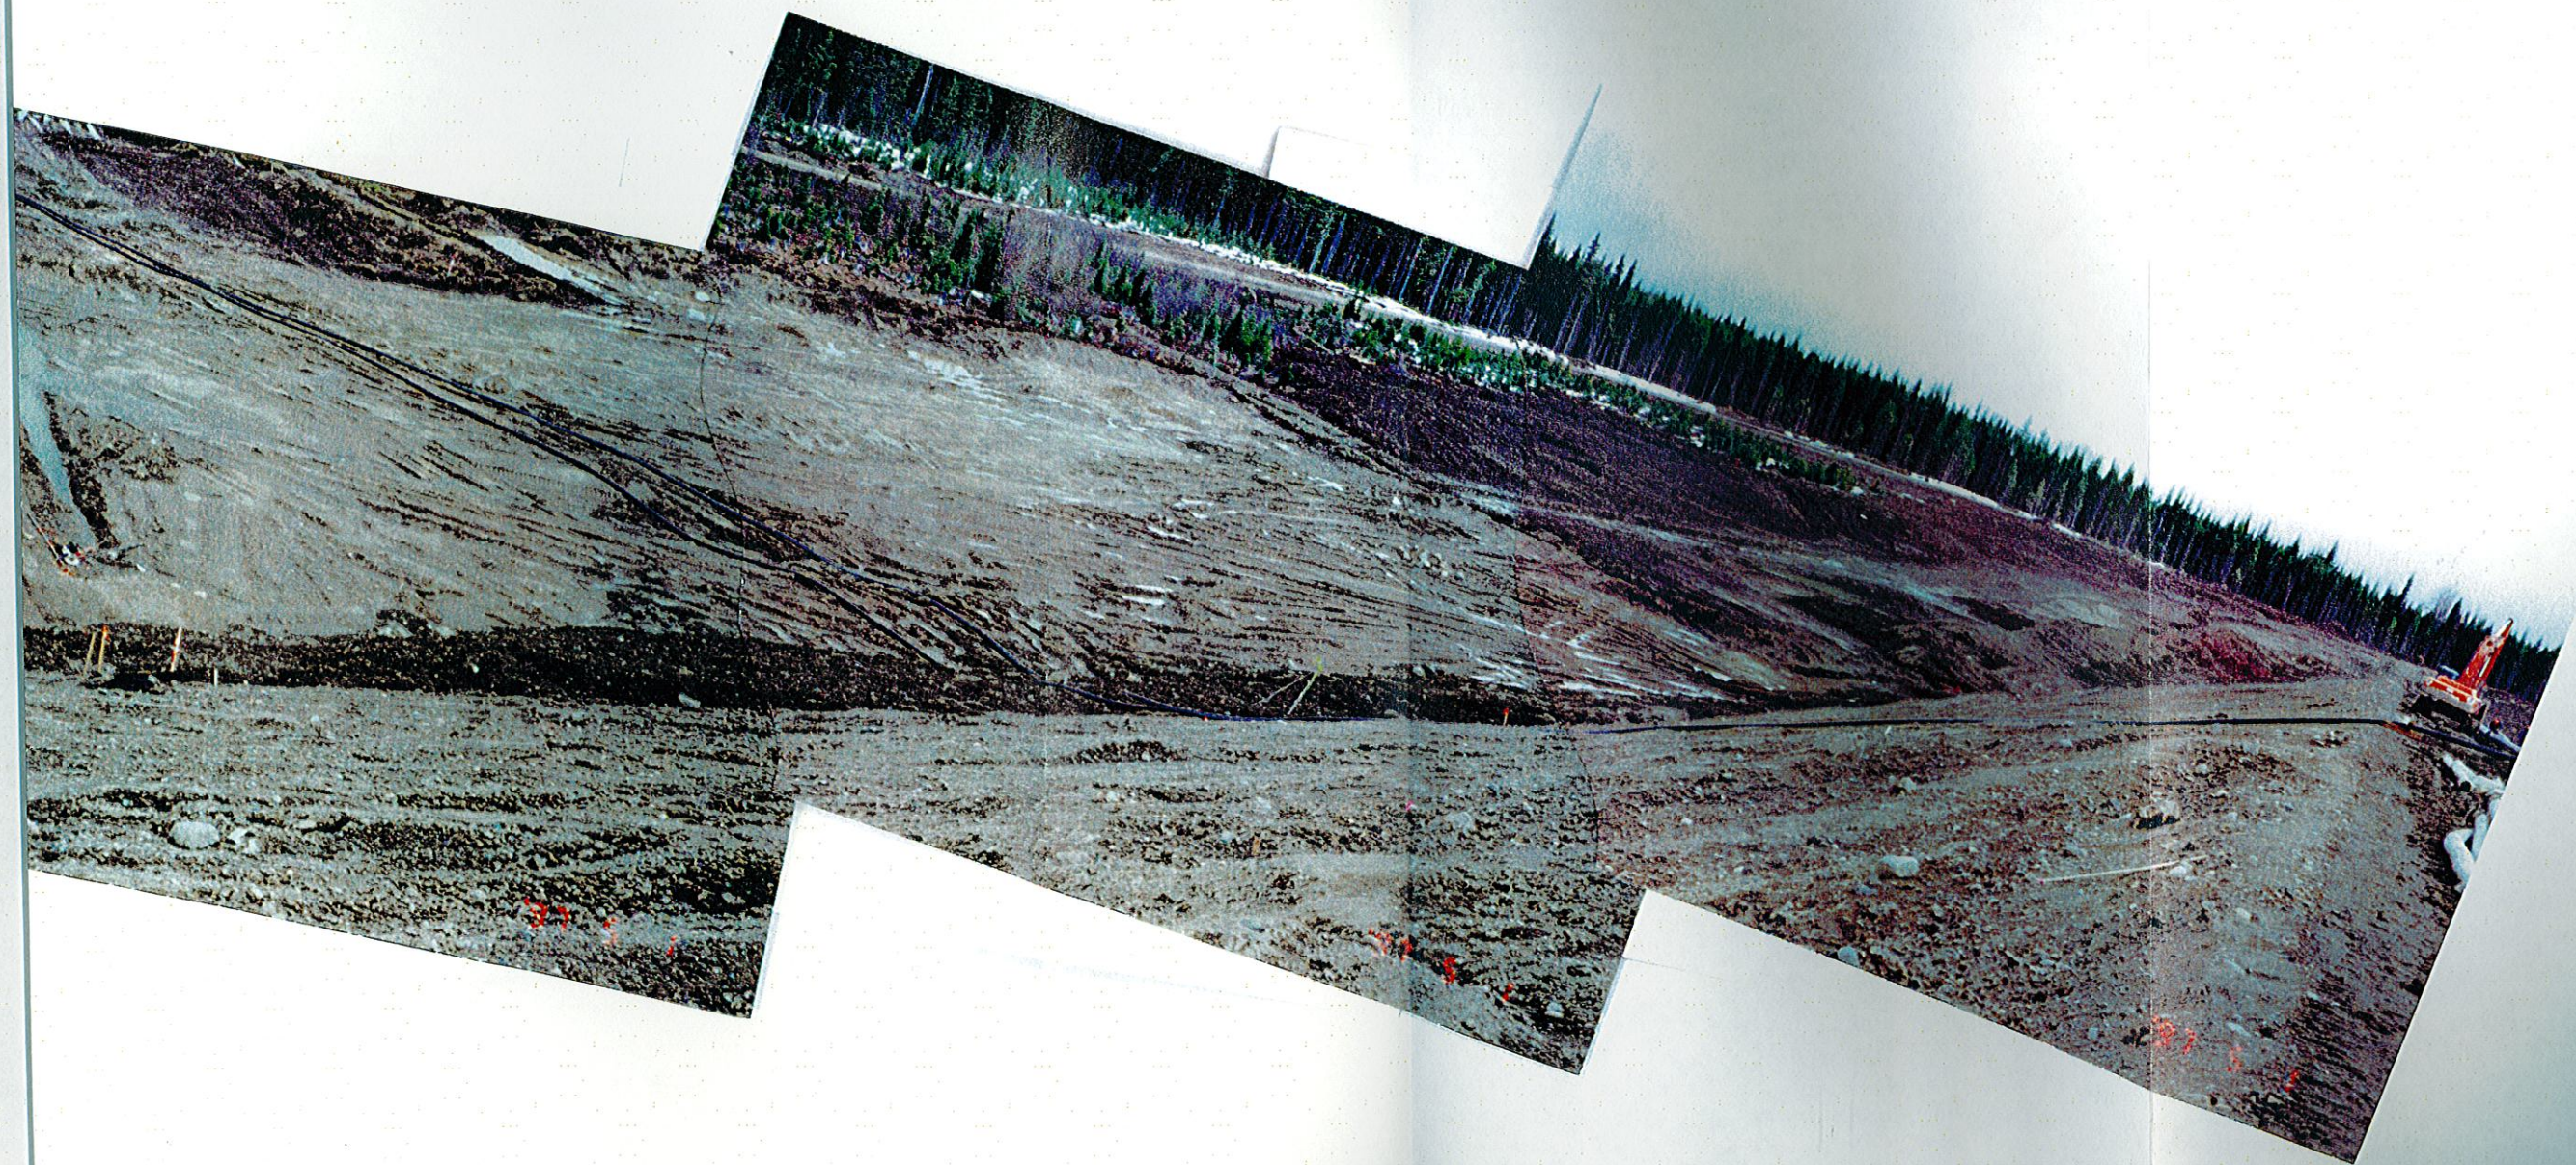
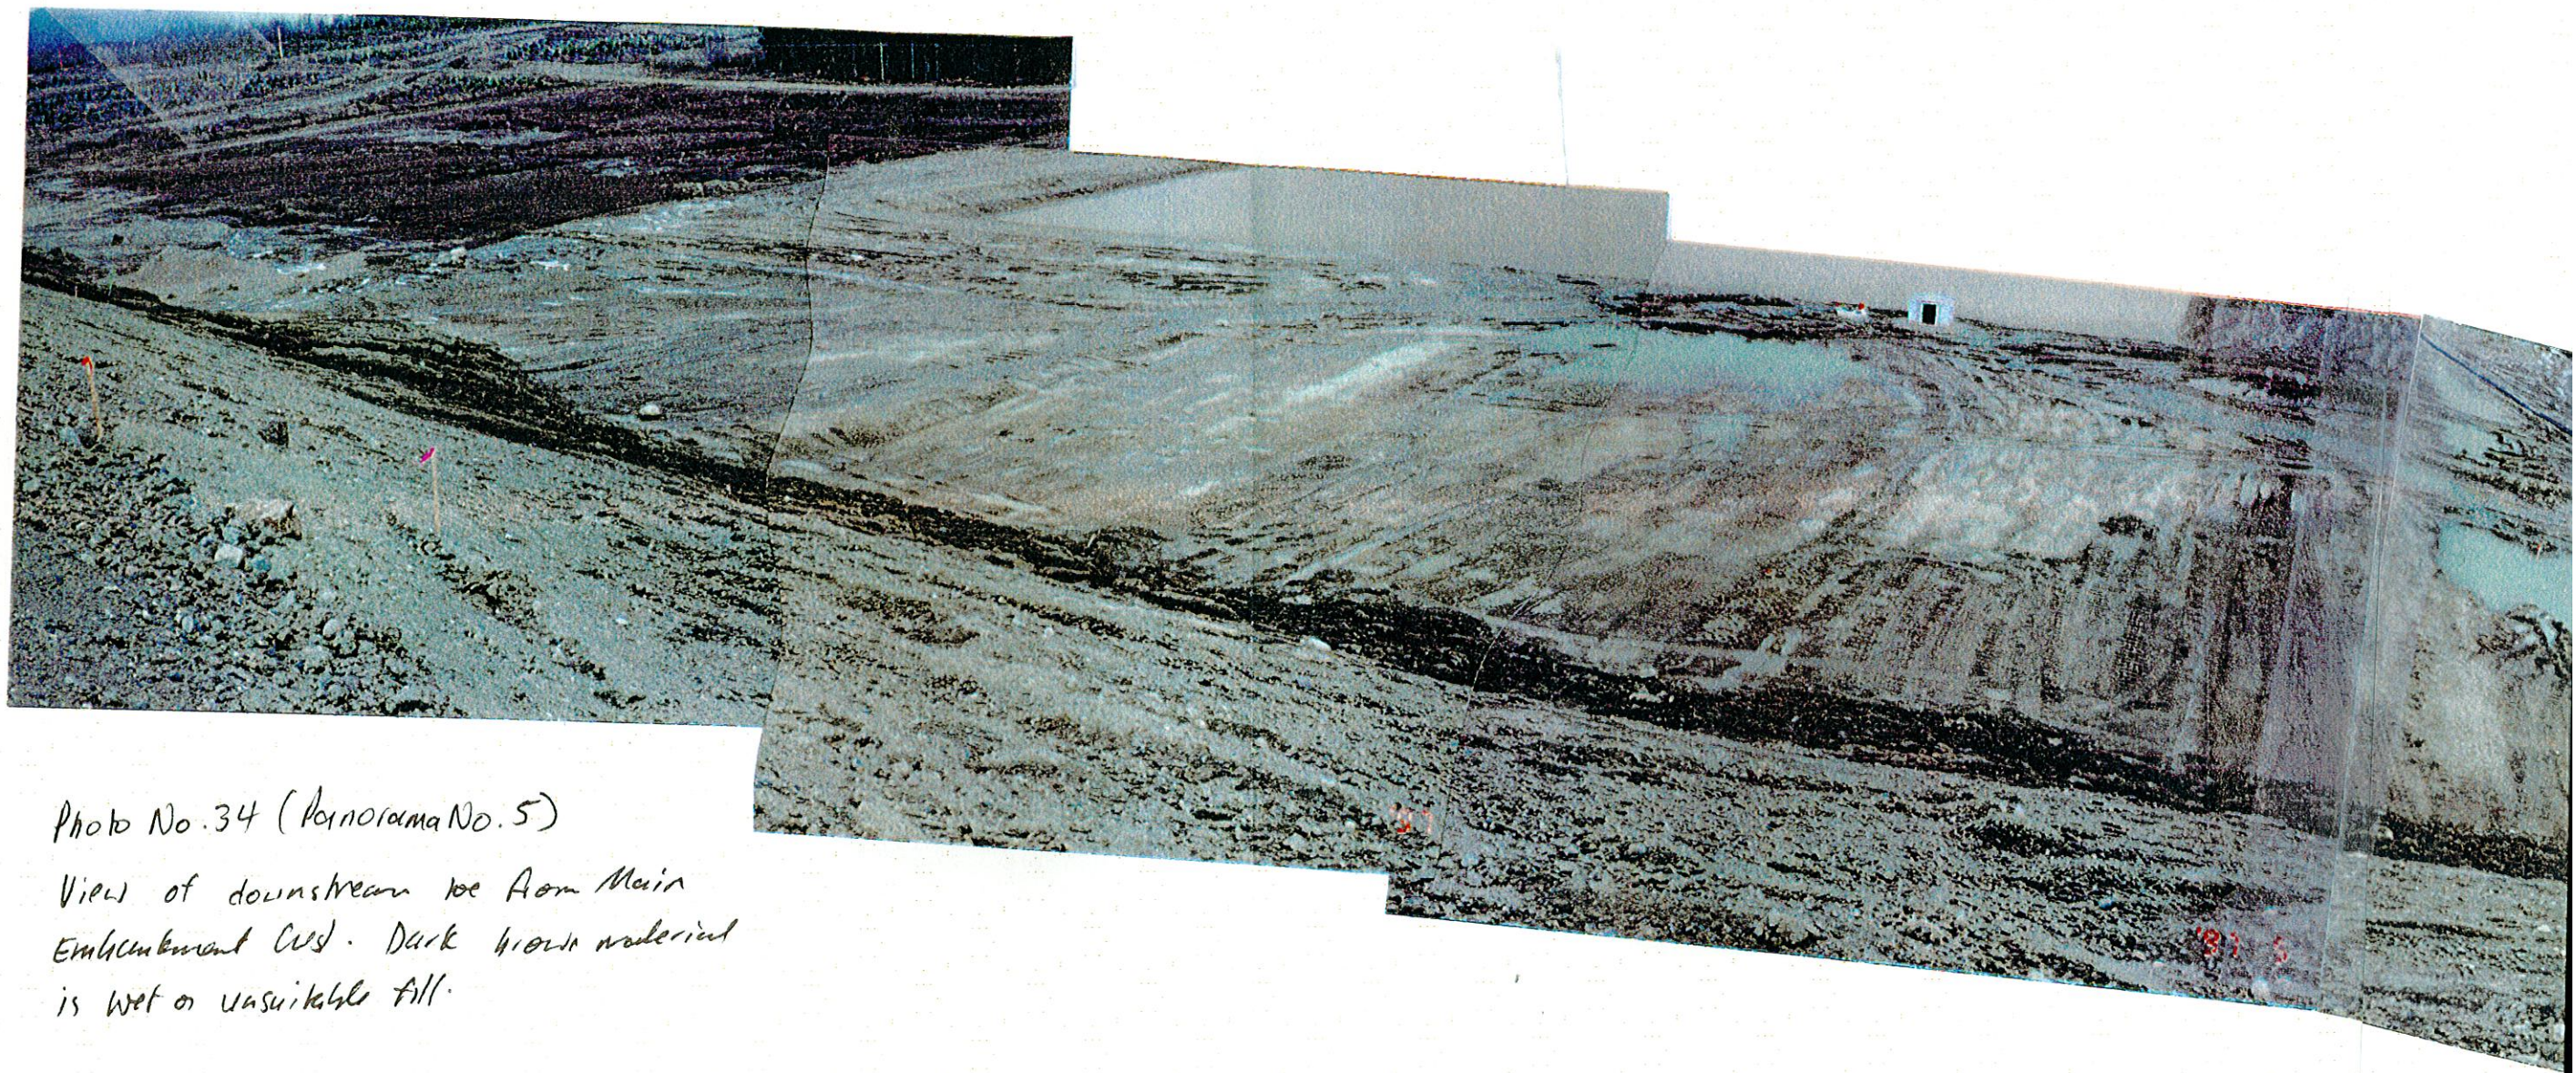
Photo No. 34 (Panorama No. 5)

View of downstream ice from Main
Embankment Cut. Dark brown material
is wet or unsuitable fill.
