**MOUNT POLLEY MINING CORPORATION
MOUNT POLLEY MINE
TAILINGS STORAGE FACILITY**

**1998 ANNUAL INSPECTION REPORT
(REF. NO. 10162/9-5)**

JUNE 26, 1998

Knight Piésold Ltd.
CONSULTING ENGINEERS

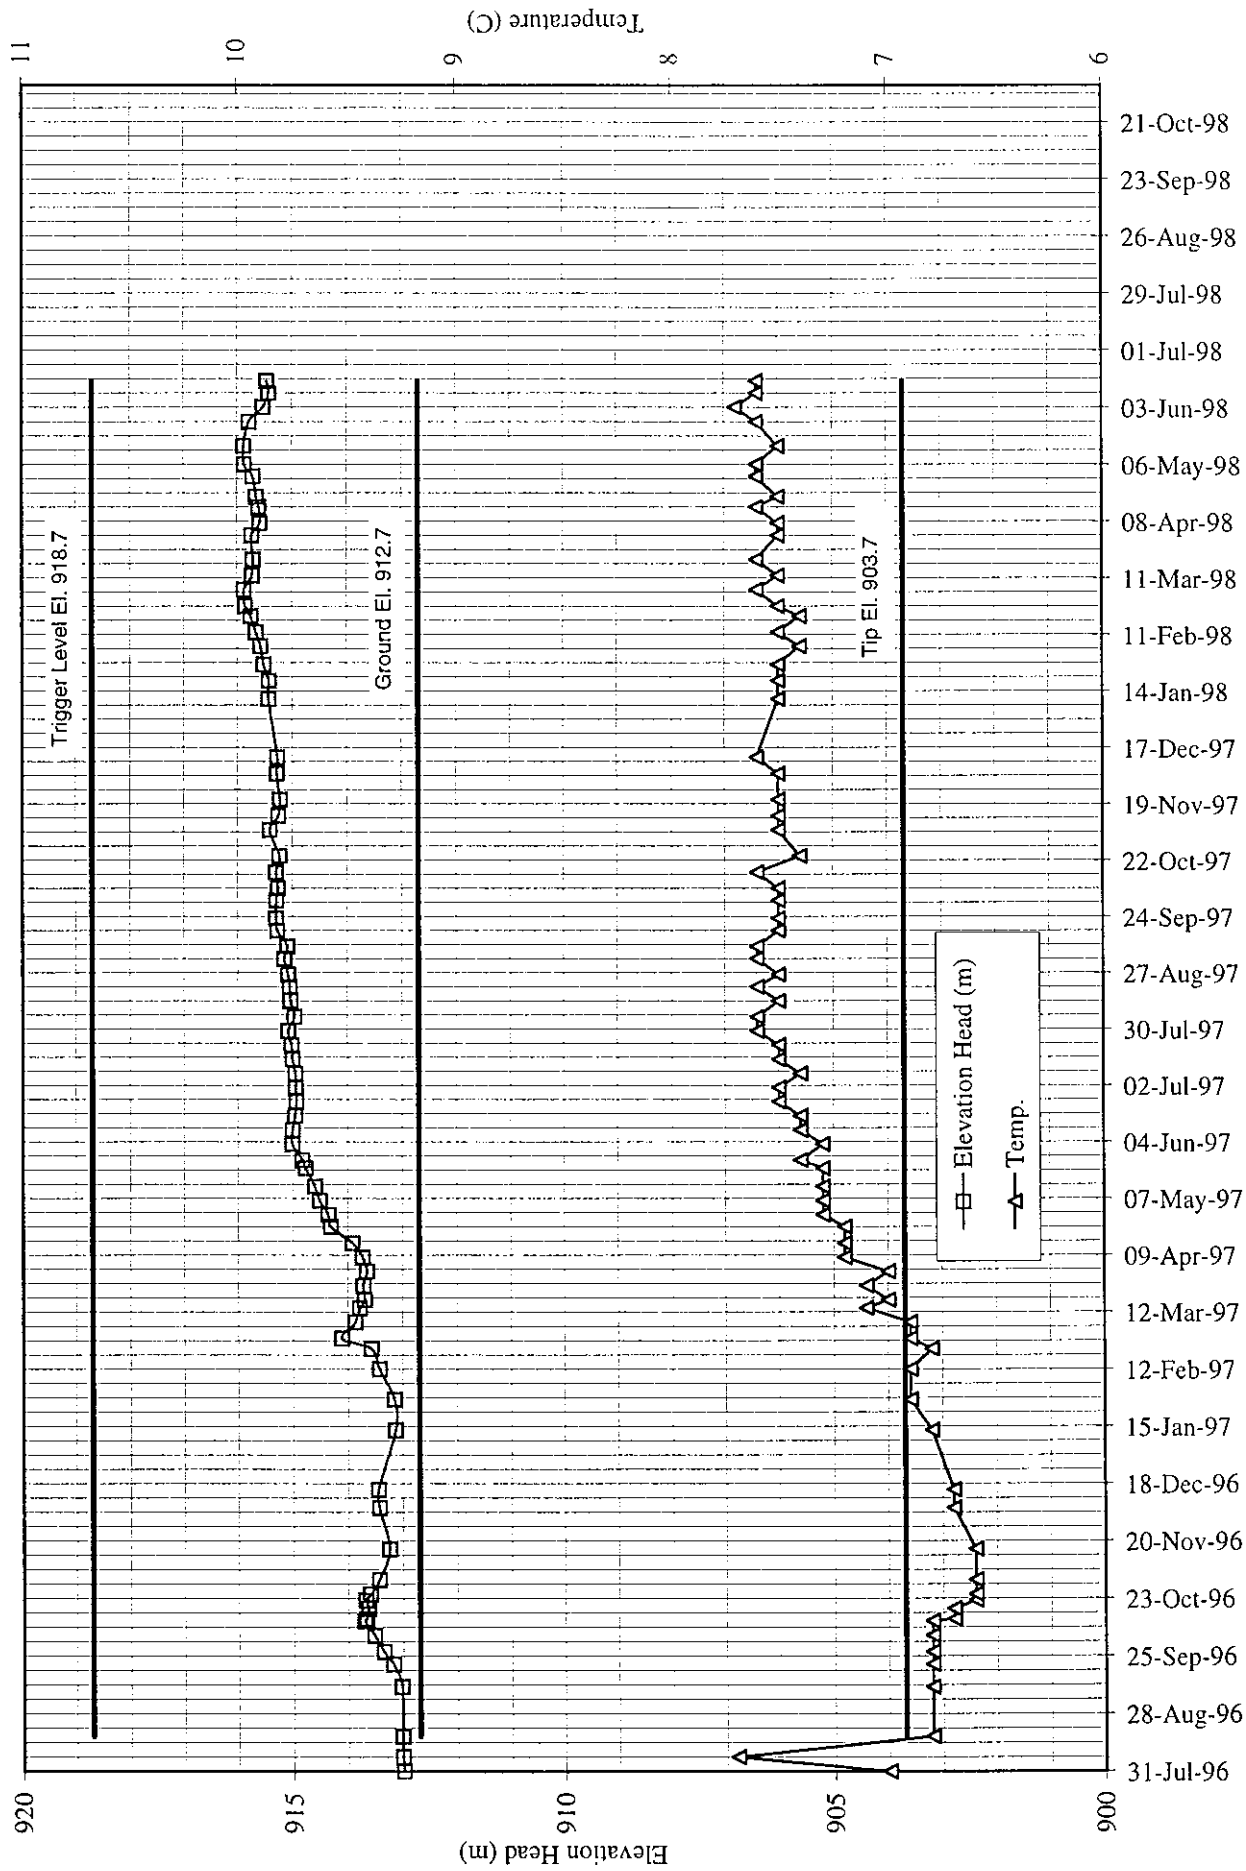
FIGURE 2.5

- A2-PE2-01 is 9.0 m below ground (El. 903.68 m). The recorded pore pressure was 9.51 m after installation (El. 913.19 m), artesian by 0.51 m. The pore pressure has slowly and steadily increased by 2.2 m. The current pore pressure is 11.78 m (El. 915.46 m) and is therefore artesian (relative to original ground) by 2.79 m.
- A2-PE2-02 is 2.9 m below ground (El. 909.77 m). The recorded pore pressure was 1.95 m after installation (El. 911.72). The current pore pressure is 2.03 m (El. 911.80 m). Only minor fluctuations have been observed and no artesian pore pressures have developed.
- A2-PE2-06, 07, and 08 will soon be installed in drillholes.

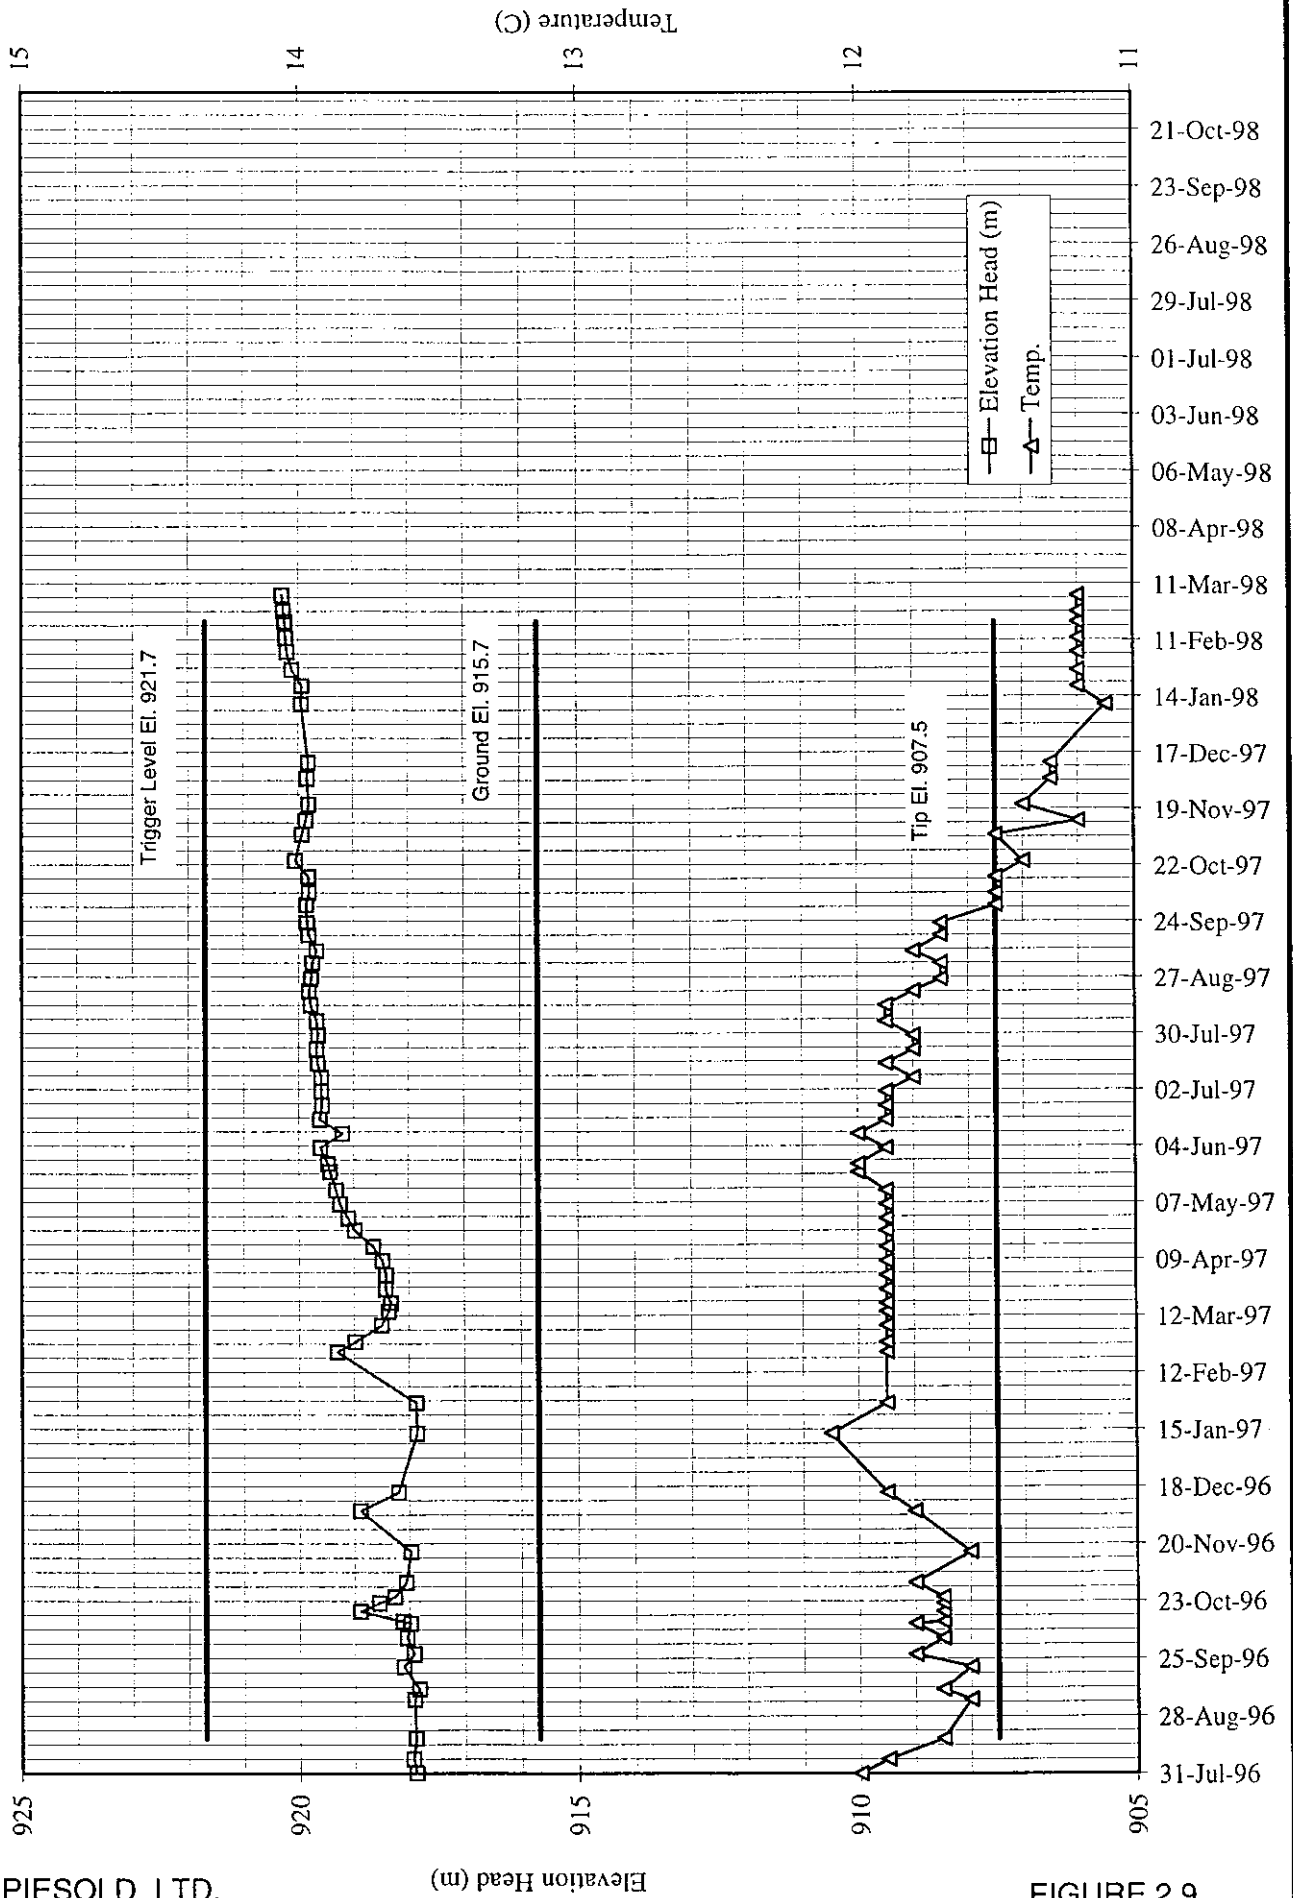
FIGURE 2.9

- C2-PE2-01 is 8.2 m below ground (El. 907.48 m). The recorded pore pressure was 10.59 m after installation (El. 918.07 m), artesian by 2.36 m. The pore pressure slowly and steadily increased by about 2.23 m to an artesian condition of 4.60 m before the piezometer stopped working.
- C2-PE2-02 is 5.2 m below ground (El. 910.53 m). The recorded pore pressure was 5.56 m after installation (El. 916.09 m), artesian by 0.38 m. The pore pressure has increased by 0.63 m to 6.19 m (El. 916.72 m) and is now artesian (relative to original ground) by 1.00 m.
- C2-PE2-06, 07 and 08 will soon be installed in drillholes.

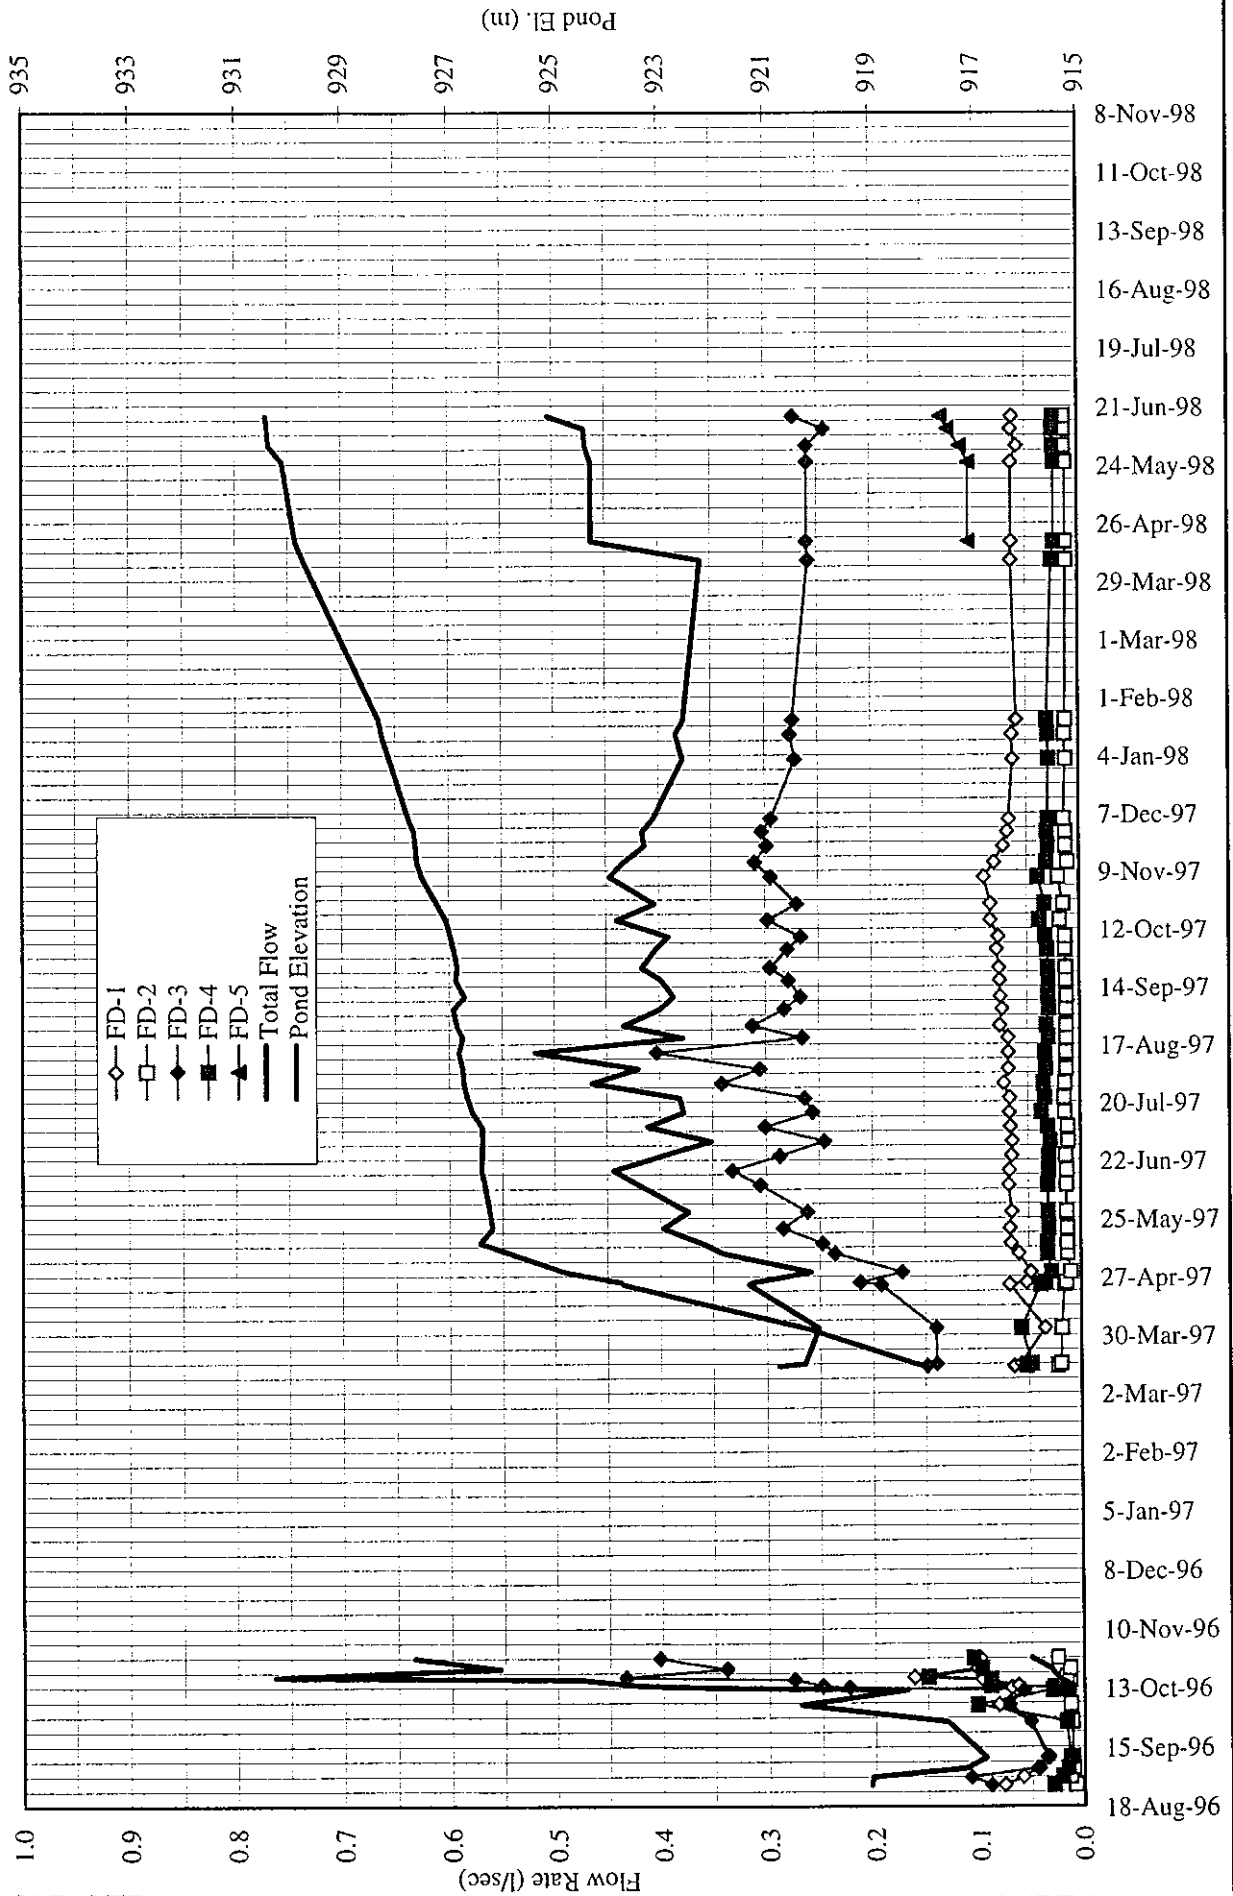
FIGURE 2.11

The foundation drain flow rates were last recorded June 16, 1998, after the installation of six Pressure Relief Wells in FD-5. A summary of the flow rates to date is presented on Table 2.4 and is shown graphically on Figure 2.11. The total flow rate is currently about 0.50 l/sec (30 l/min), an increase of about 0.14 l/sec (8.4 l/min) since FD-5 was installed. It should be noted that the flow rates were increasing from the time that the Stage 1B embankment was completed until August 1997, when tailings discharge from the Main Embankment was well established and the basin was being blanketed with tailings. It should also be noted that the flow rates from FD-5 increased by about 1.5 l/min when the 1998 Pressure Relief Wells were installed.

and are well below the predicted flow rate of 1.1 l/sec (not including baseline flows), as determined by seepage analyses for the Main Embankment foundation drains (see "Report on On-Going Construction Requirements, Ref. No. 10162/9-3).

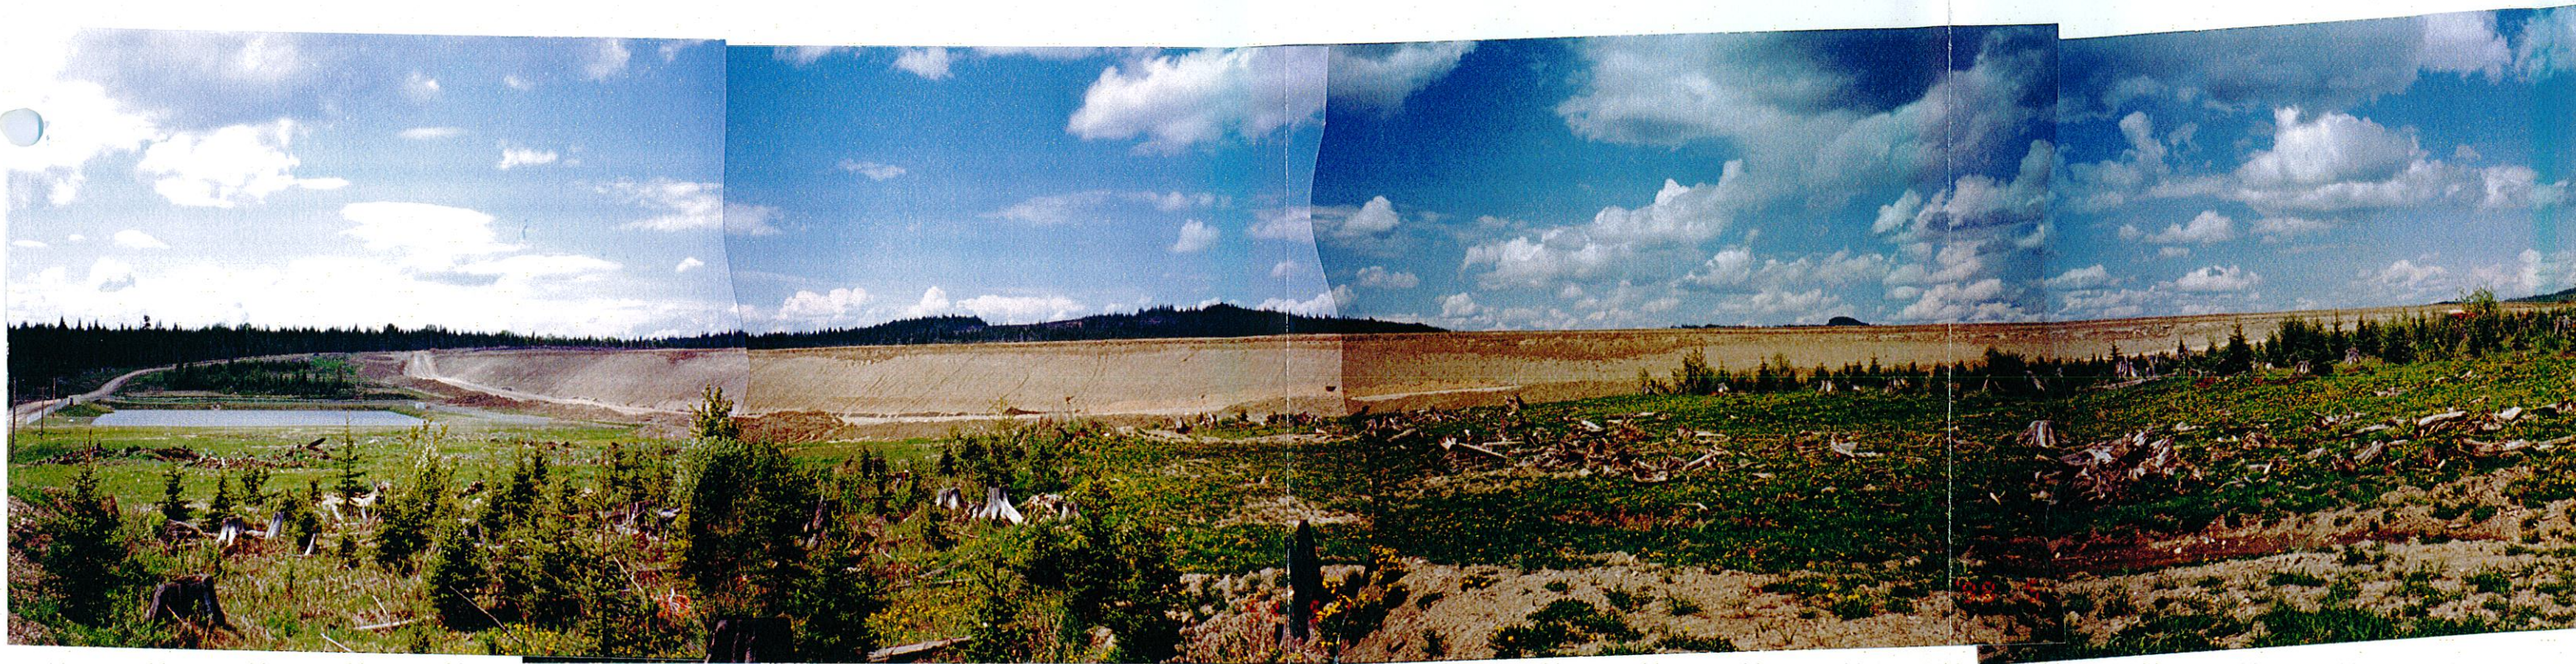
Main Embankment. View looking north, from Bootjack - Morehead Connector Road east of the Seepage Collection Pond. Photo taken near end of construction and only outstanding work is dressing of downstream slope. Note Seepage Collection Pond on left. Zone T material now provides good access to entire Tailings Storage Facility.

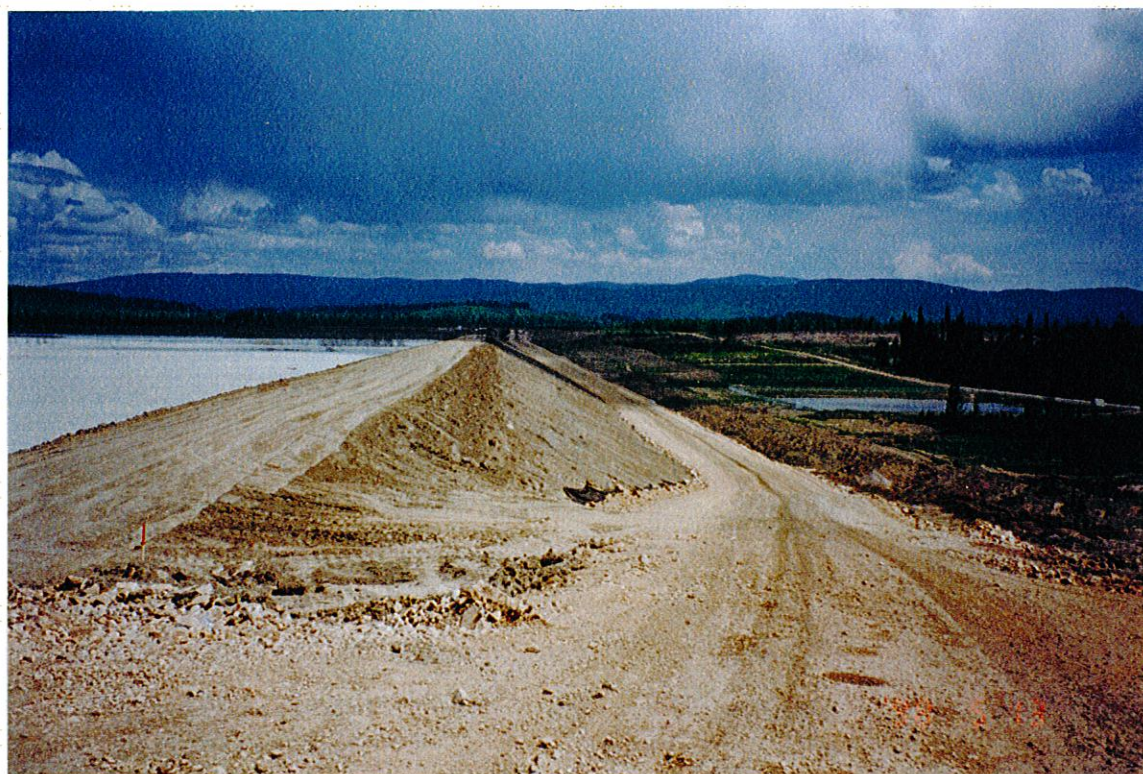
Main Embankment View looking east, from right abutment. Note Zone T material with filter fabric extending up to Stage 2A crest at right abutment.

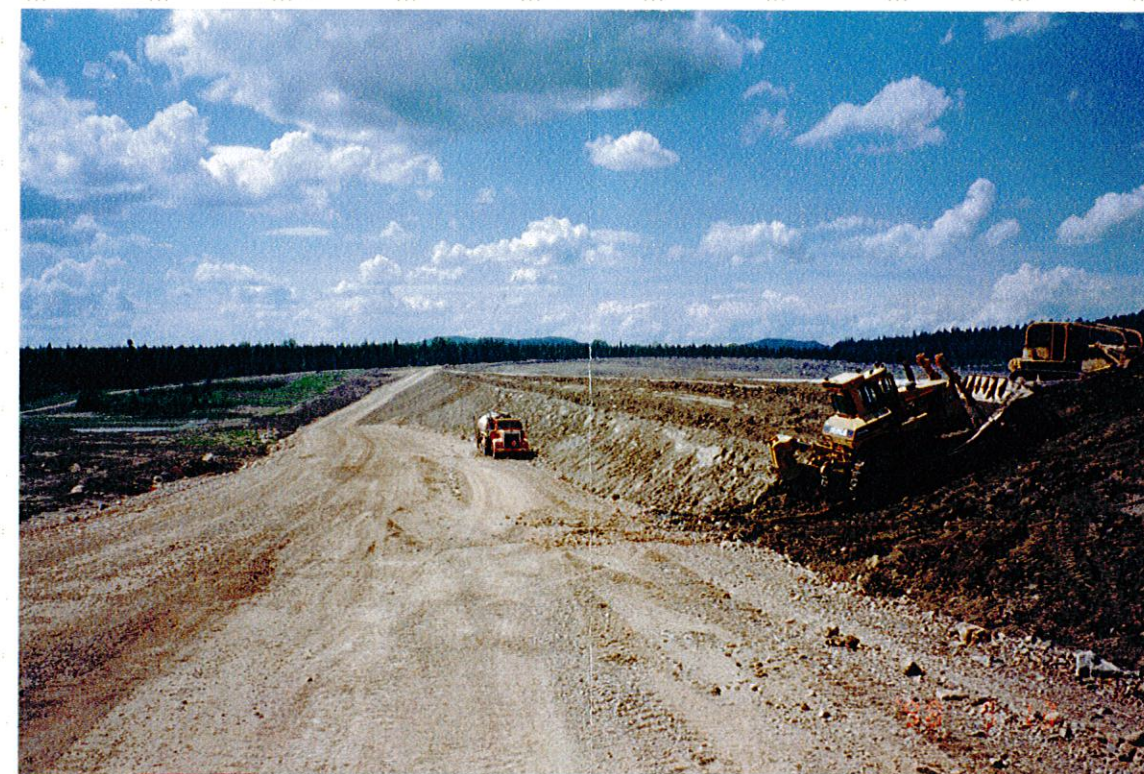
Main Embankment View looking west from left abutment. Final dressing of downstream slope.

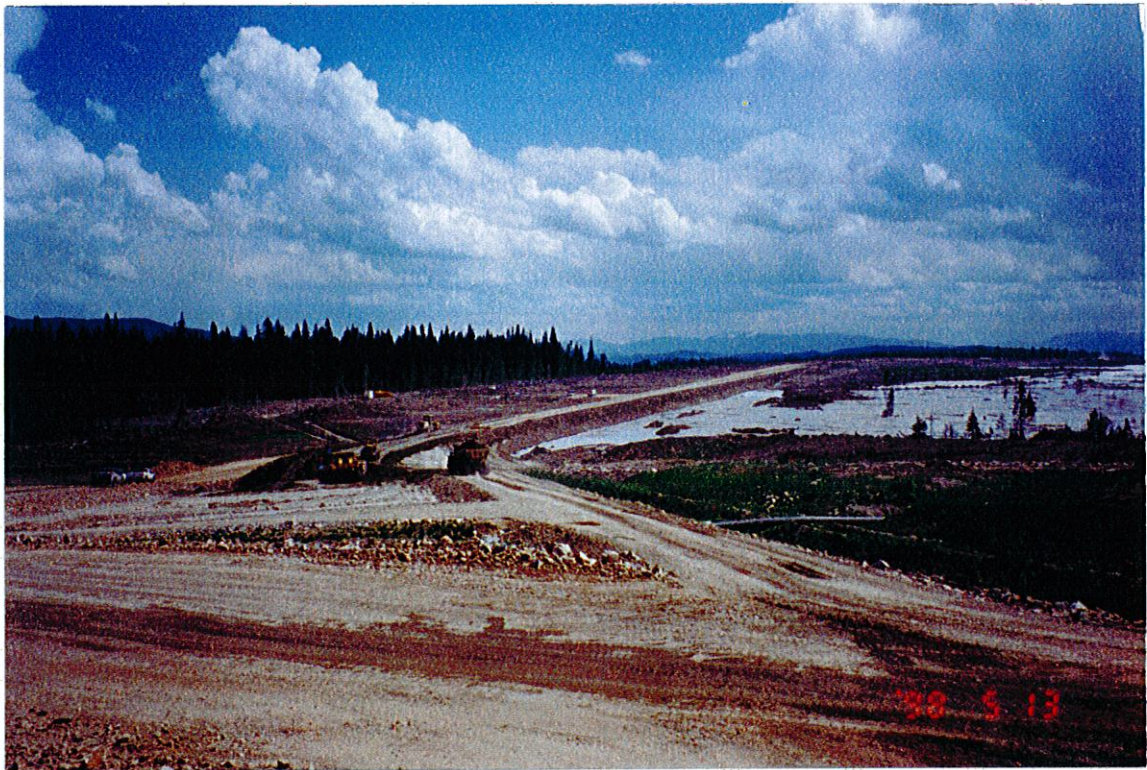
Perimeter Embankment from Left Abutment, end of Stage 2A Construction. Tailings discharge is through M1A dump valve. Note tailings beach development.

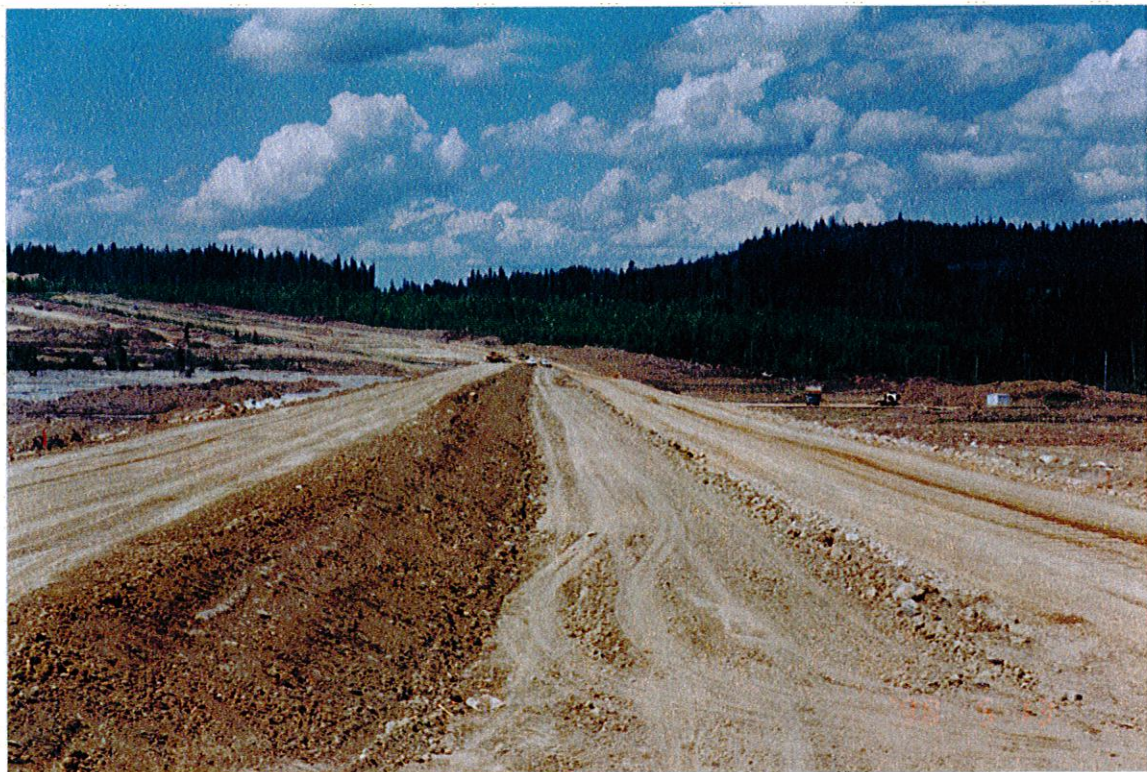
Perimeter Embankment from near right abutment. Note bench left on downstream side for construction of Longitudinal Drain in Stage 2B Construction.

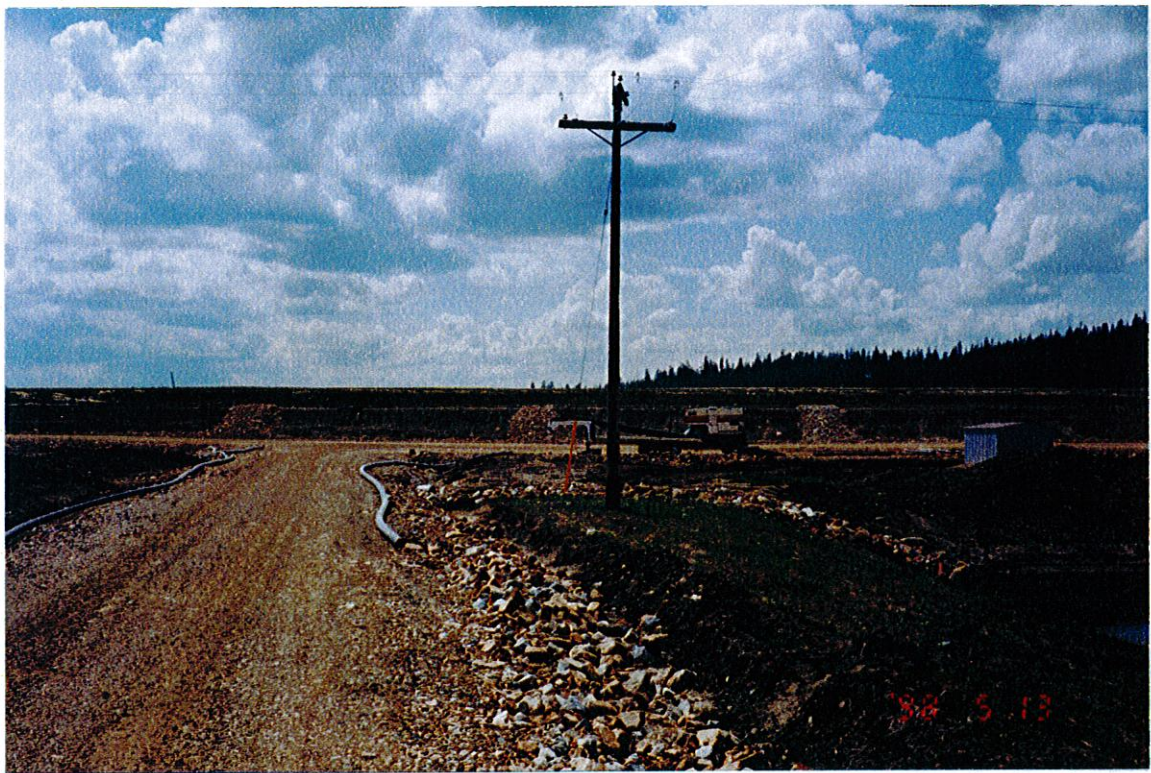
No uncontrolled seepage through the embankments was observed. A trace amount of seepage (estimated less than 1 l/min) was observed from Main Embankment Outlet Drains. The Longitudinal Drain is set in foundation soils above El. 919 m along the left abutment and therefore acts as a foundation drain in this area. Mount Polley is currently preparing weirs that will allow the

Perimeter Embankment. Looking upstream from access road on east side on Seepage Collection Pond. Note Outlet Drains going up face of embankment.

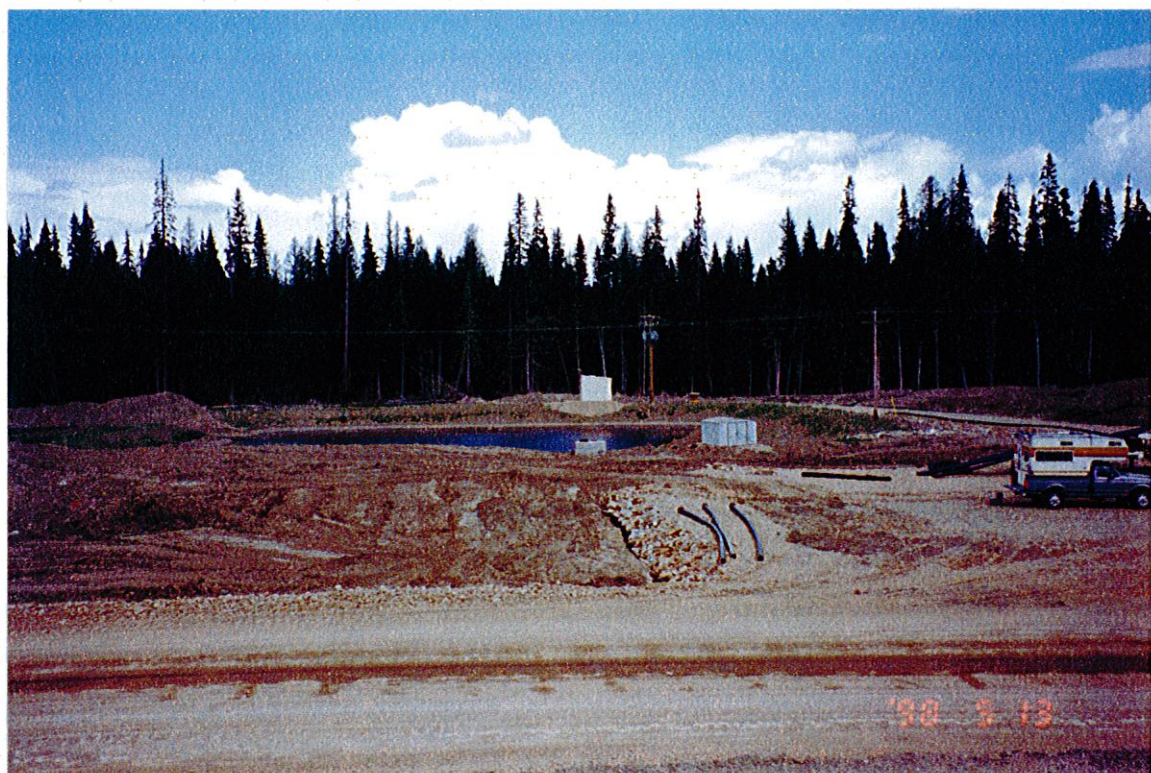
Perimeter Embankment. Looking downstream to Seepage Collection Pond. Note grading of area. Zone T platform was extended to final downstream toe.

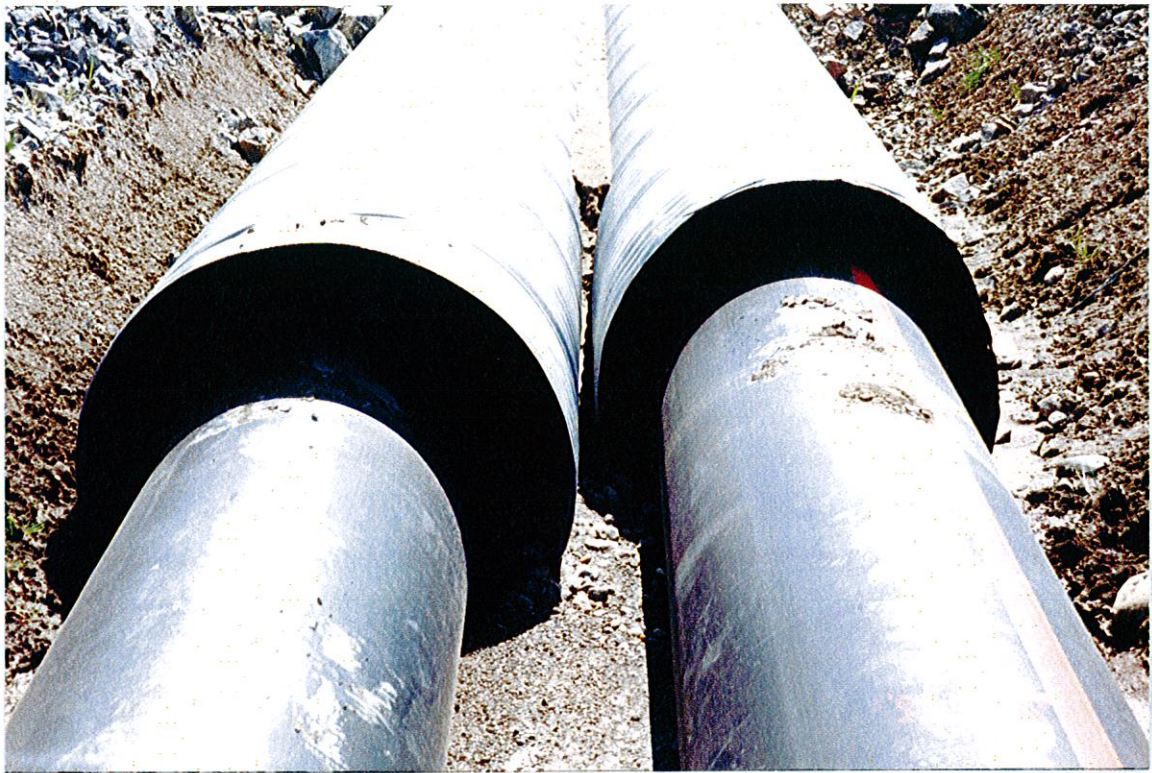
The channel section from the T2 Dropbox to the Tailings Storage Facility is in good condition. The pipelines are sleeved in 900 mm corrugated steel pipe (CSP) culverts within the pipeline containment channel at the Bootjack Creek Crossing. The sleeves provide backup spill containment over this area. An inspection of the pipelines and sleeves at the Bootjack Creek Crossing indicated that tailings have previously reached the sleeves, as a small amount of tailings is present in the upstream side of the culverts. This was caused by tailings backing up at the T2 Dropbox, flowing into the T2 Overflow Pond and then travelling down the pipeline containment channel. No solids escaped from the pipe containment channel. Since the modifications to the Dropbox in October, 1997 no backups have occurred. In the event that tailings do reach the Bootjack Creek Crossing in the future, the CSP sleeves must be flushed to ensure that there is a clear pathway for tailings to get past the crossing, without spilling into Bootjack Creek.

Pipeline Containment Channel. Upstream end of pipeline sleeves at Bootjack Creek Crossing. Note tailings at bottom of sleeves.

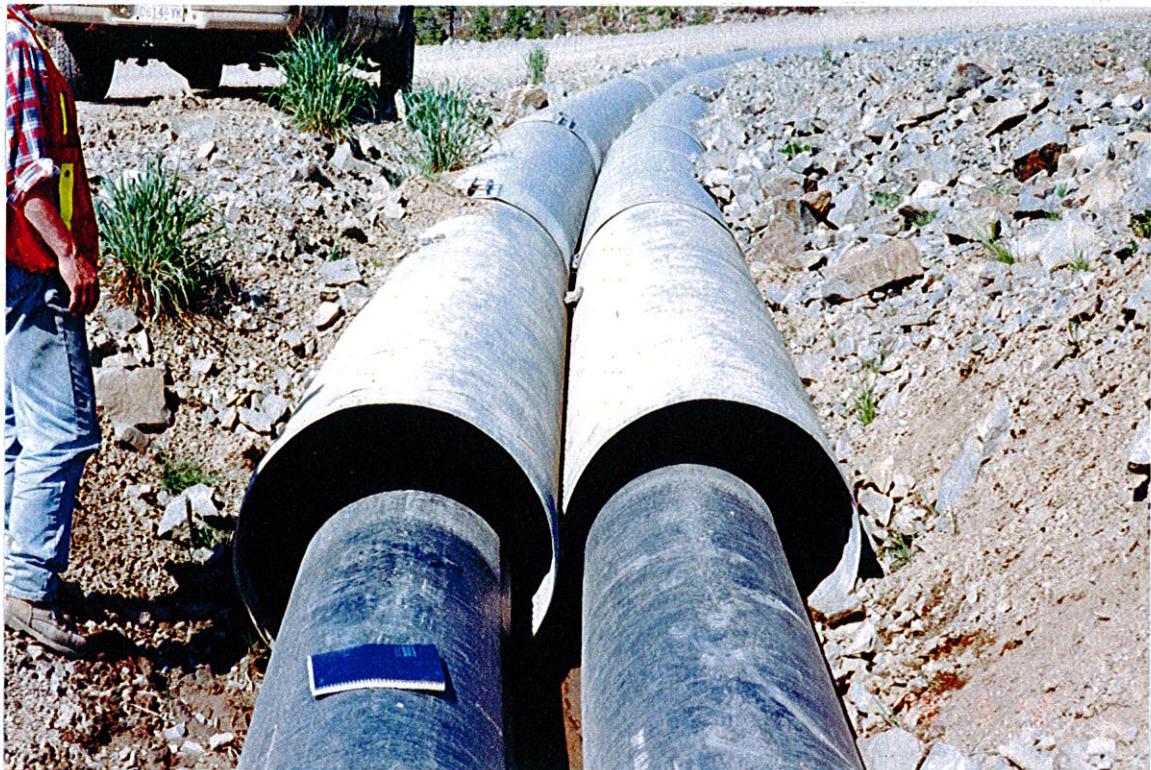
Pipeline Containment Channel. Downstream end of pipeline sleeves at Bootjack Creek Crossing. Note minor amount of tailings at bottom of sleeves.

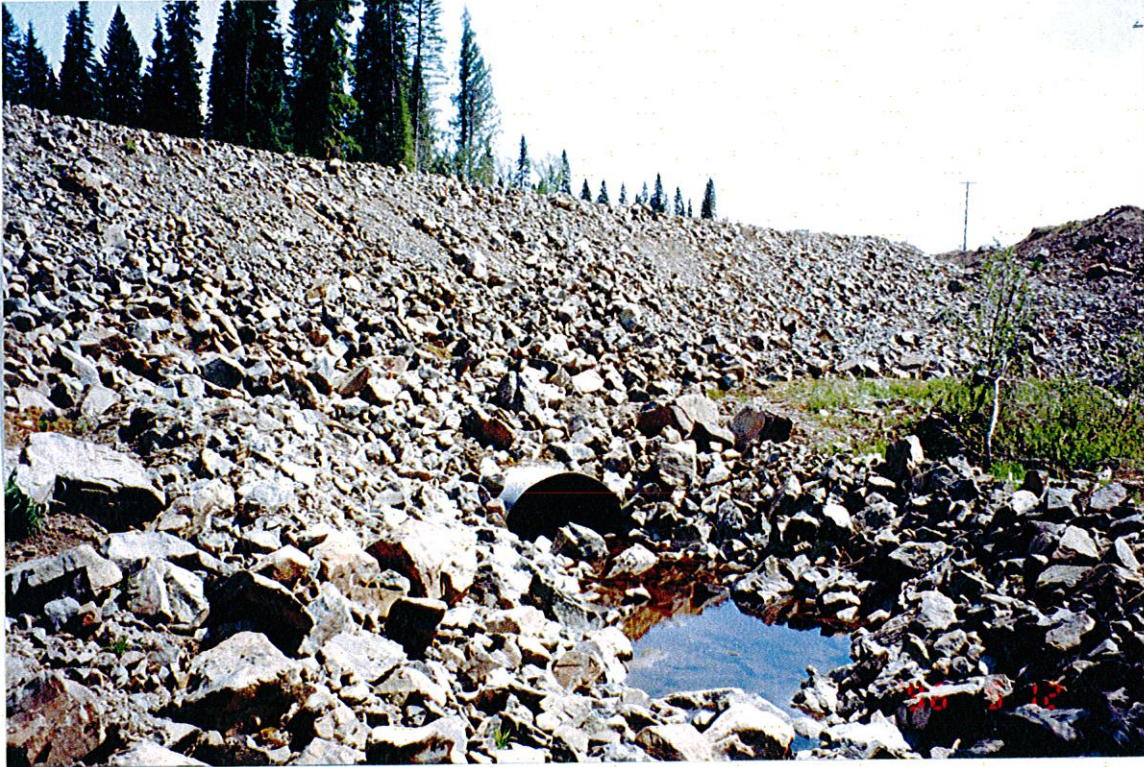
may be removed. The pipe arch culvert appears to be in good condition, with no significant deflections observed.

Bootjack Creek Culvert. Upstream side.

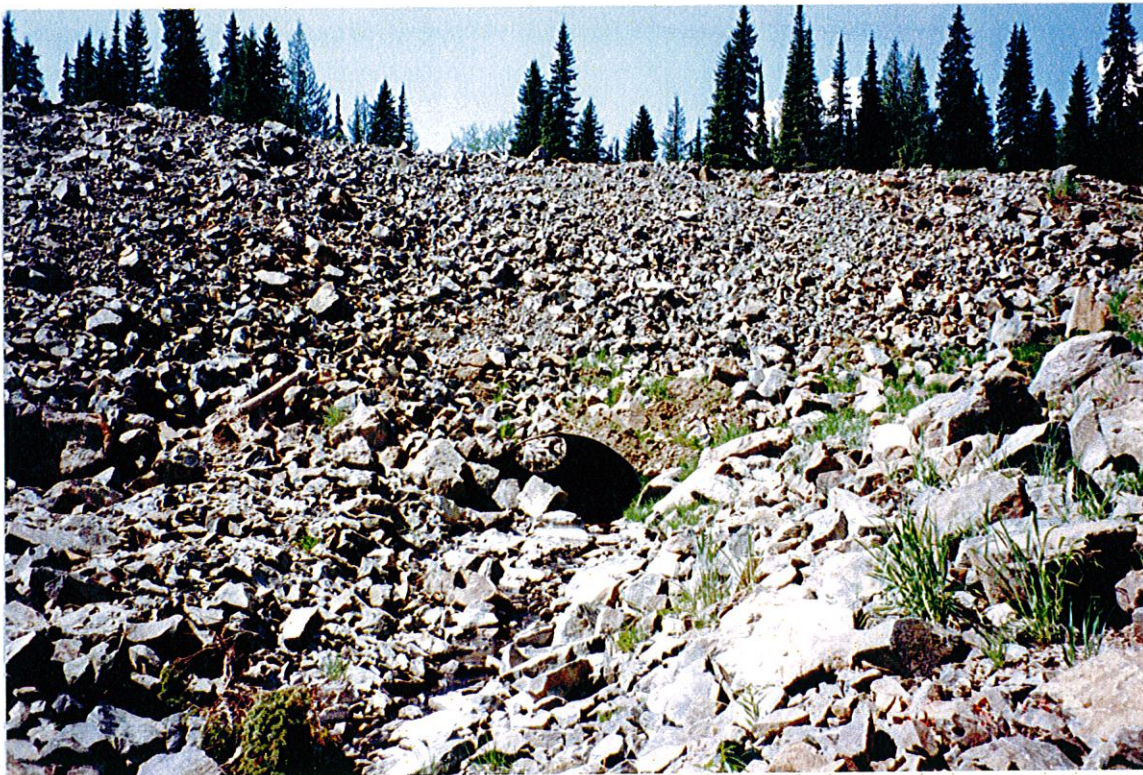
Bootjack Creek Culvert. Downstream side.

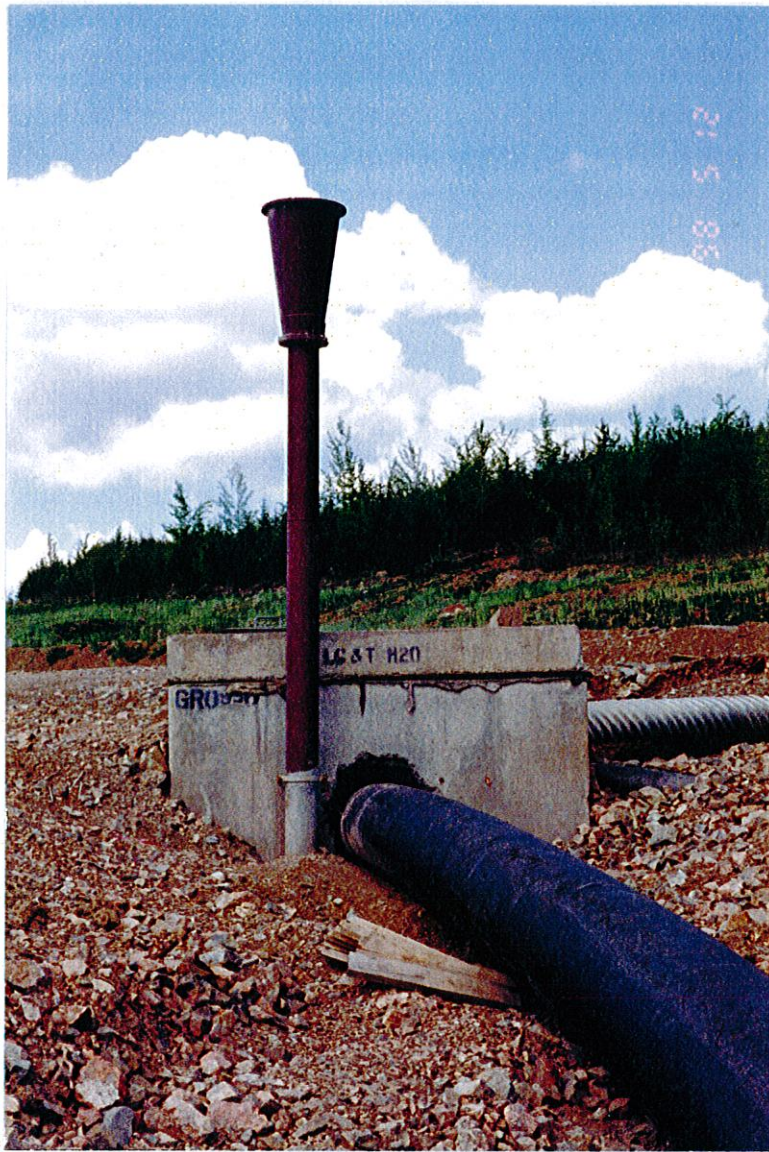
Tailings Pipeline System.
Revised T2 Dropbox. Tailings Pipeline now extends all the way from the Mill to the Tailings Storage Facility. T2 Dropbox provides surge protection and is connected to the pipeline by a bifurcation.

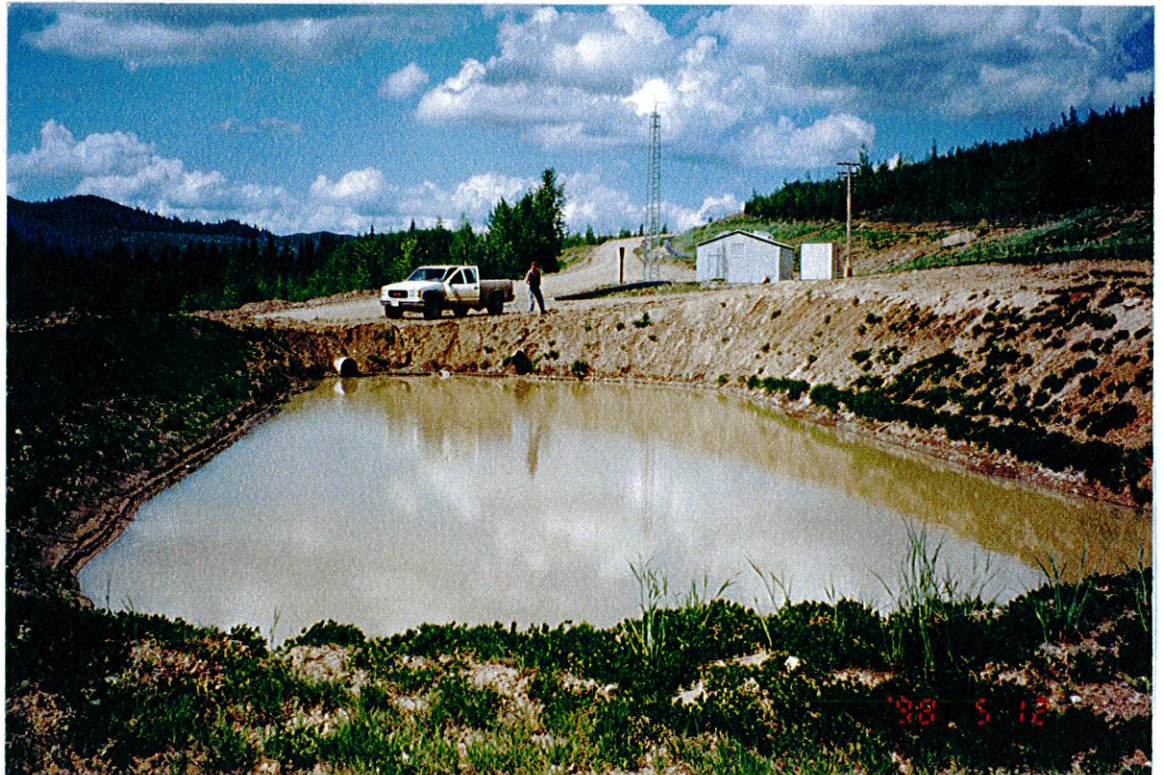
Tailings Pipeline System.
Full T2 Overflow Pond (water).

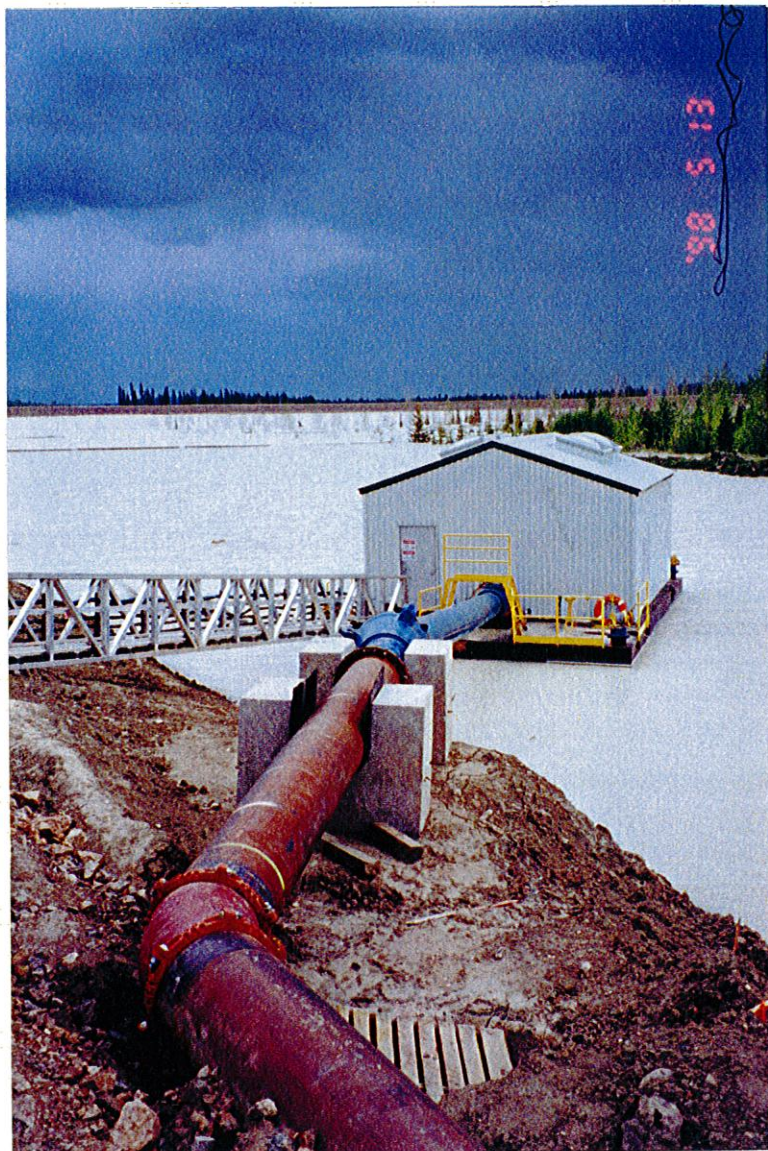
Reclaim Pipeline System. Reclaim Barge and Channel. Note 35 degree elbow added and barge alignment changed.
