**MOUNT POLLEY MINING CORPORATION
MOUNT POLLEY MINE
TAILINGS STORAGE FACILITY**

**1998 ANNUAL INSPECTION REPORT
(REF. NO. 10162/9-5)**

JUNE 26, 1998

Knight Piésold Ltd.
CONSULTING ENGINEERS

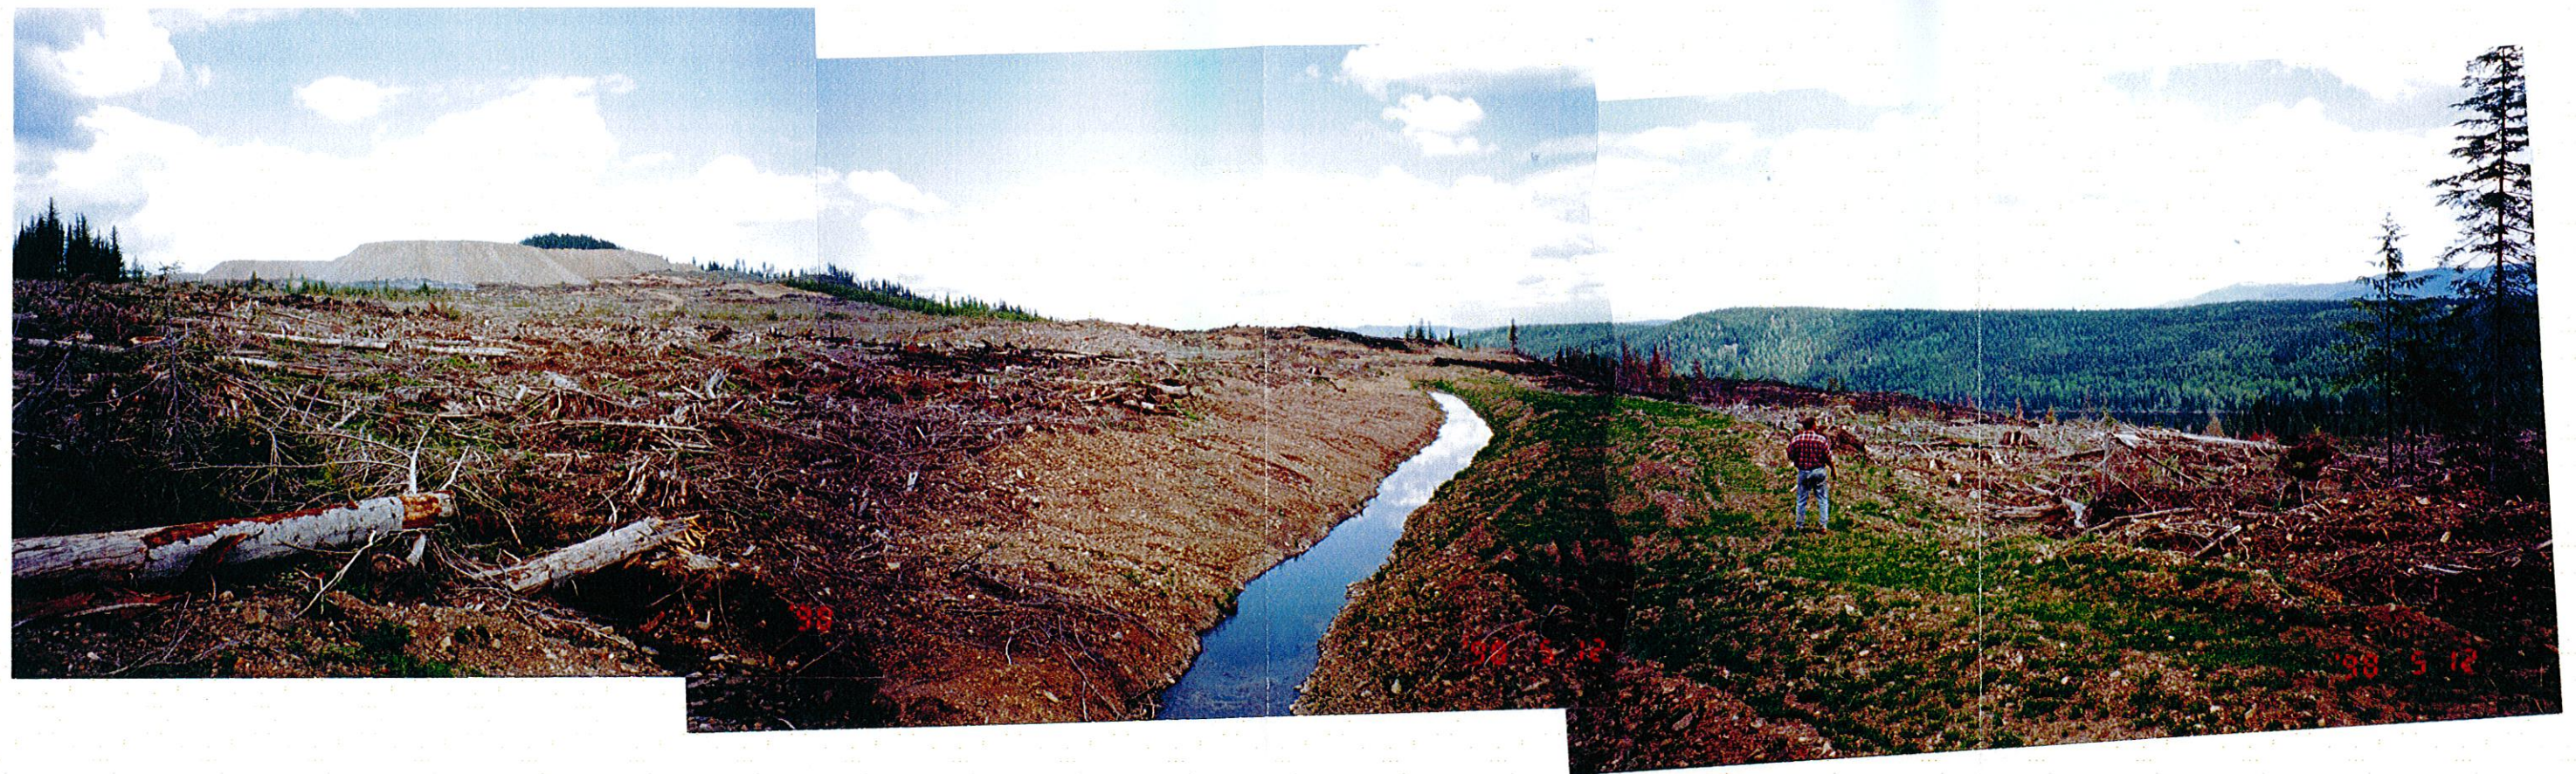
Southeast Sediment Pond - Runoff collection ditch, looking north. Note Mine waste dump to left and Polley Lake to right. Ditch is clear of obstructions.

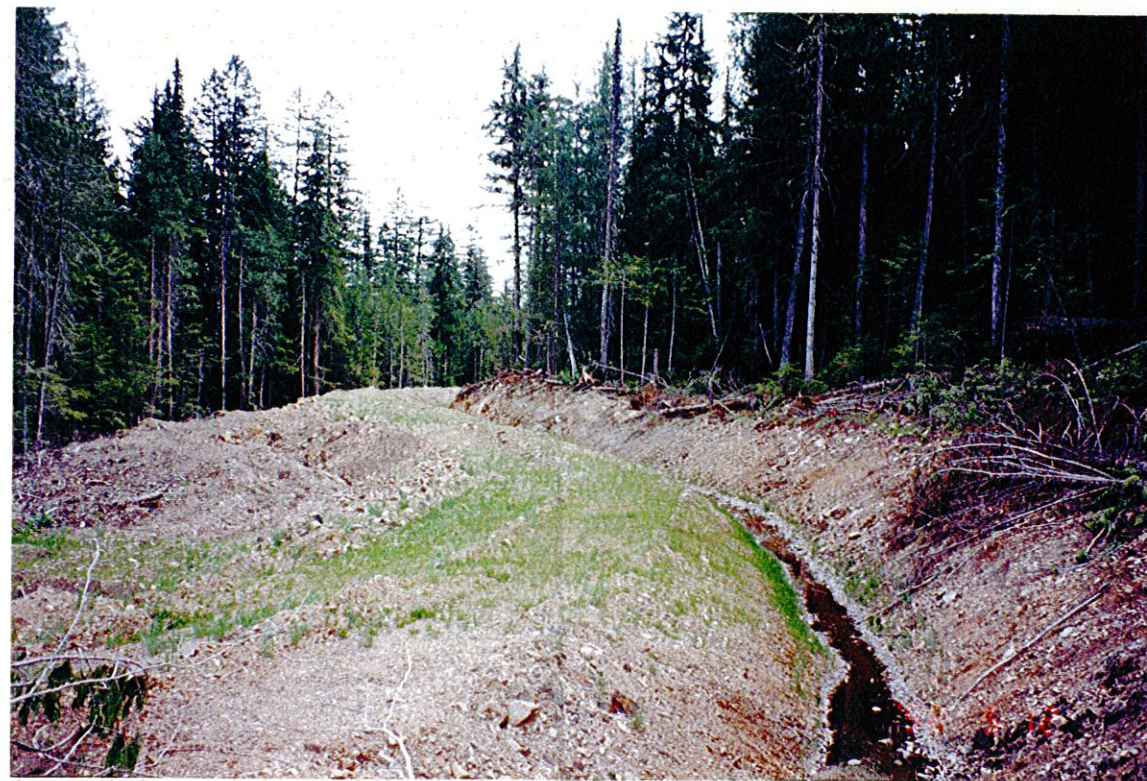
Southeast Sediment Pond - Runoff collection ditch, looking south. Ditch is clear of obstructions.

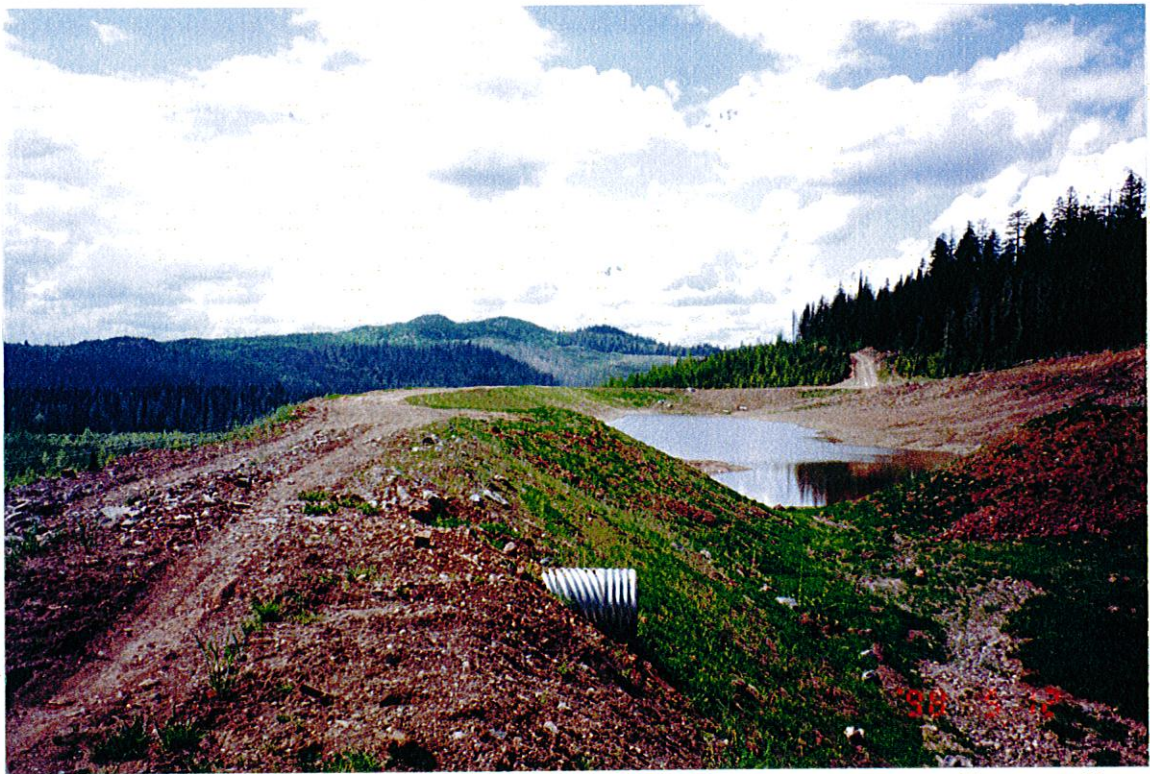
Southeast Sediment Pond. Looking west, from end of runoff collection ditch to the manhole sump. Note low water level and overflow culvert in foreground.

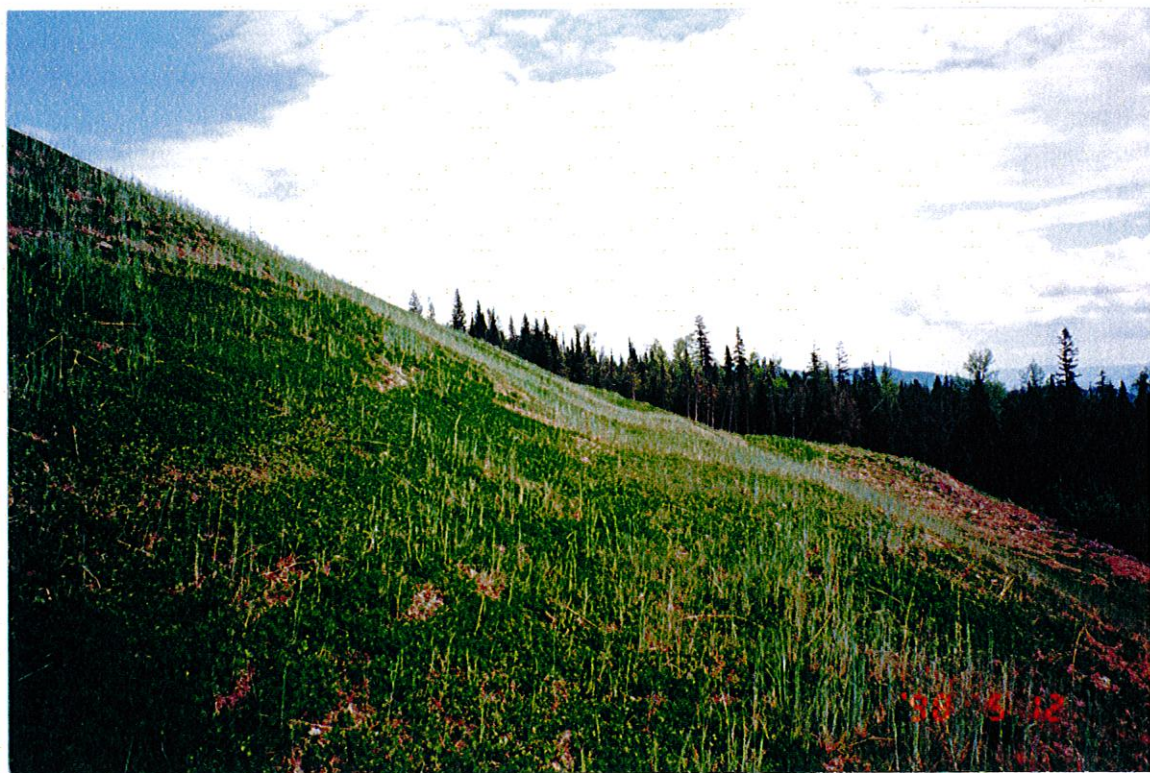
Southeast Sediment Pond. Downstream fill slope looking east. Note dry stable slope and well established re-vegetation.

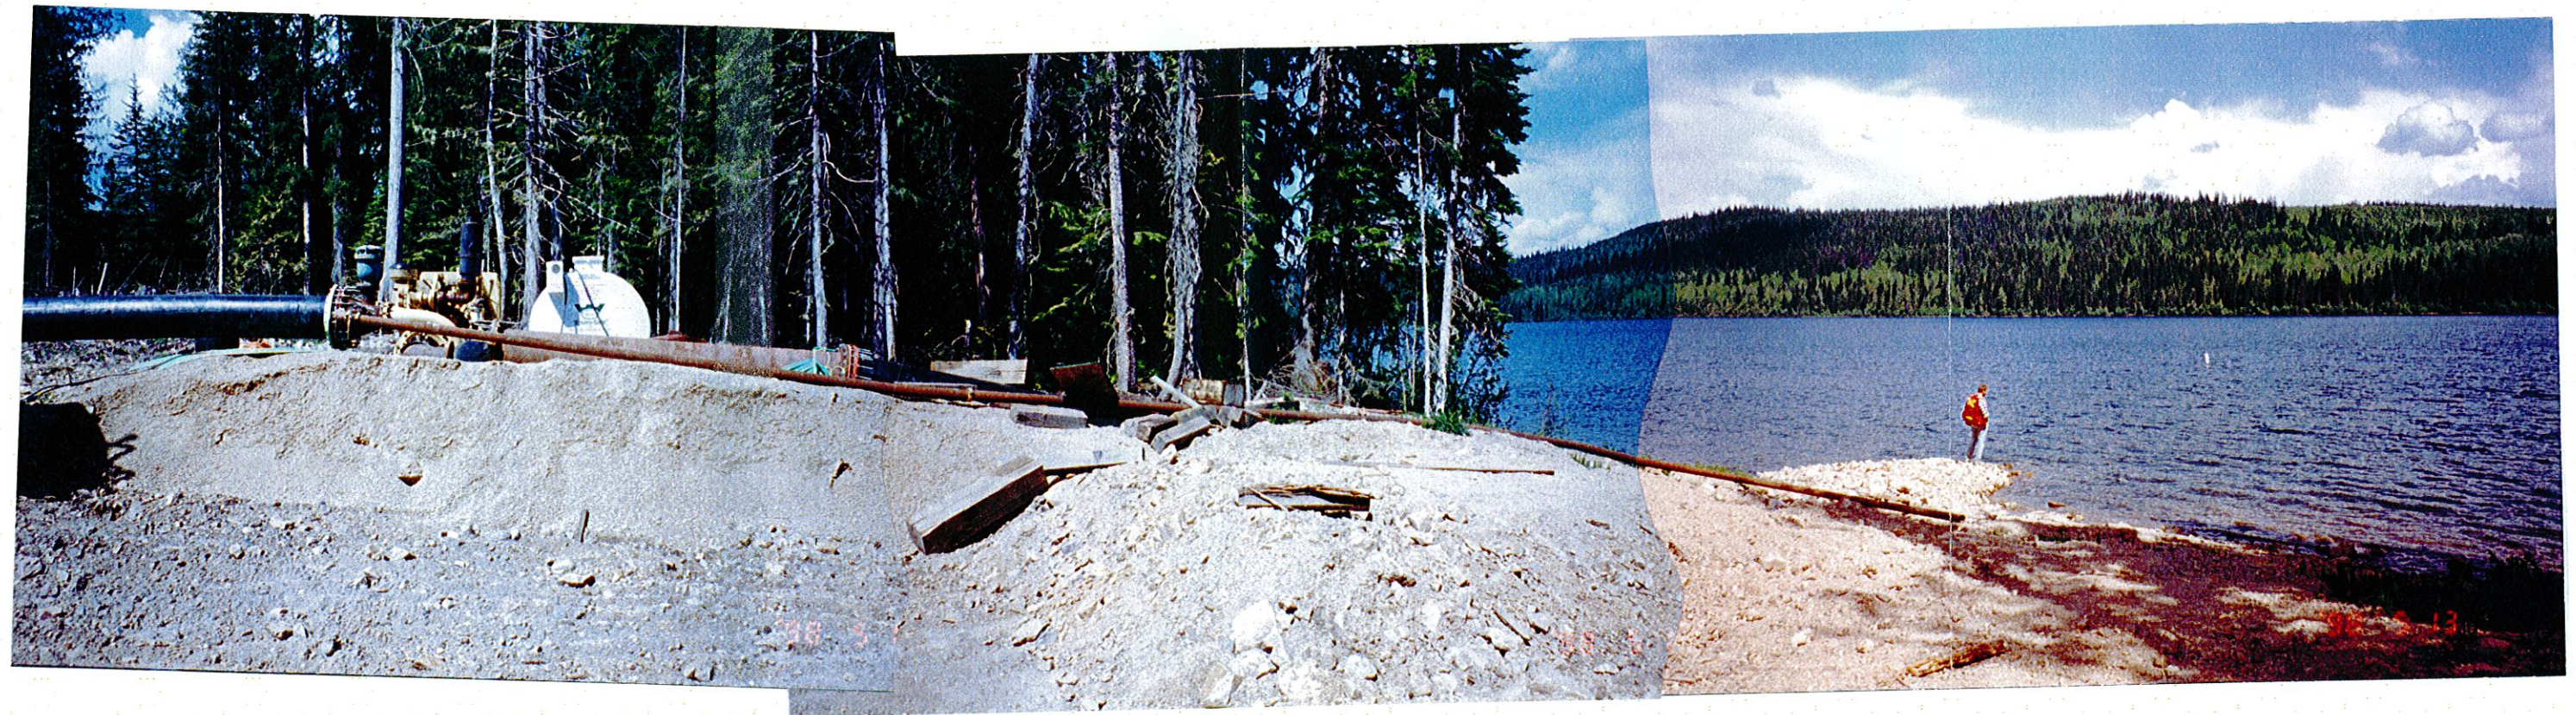
Polley Lake Pumping System. Intake Area. Note float on Polley Lake. Float is attached to the intake.

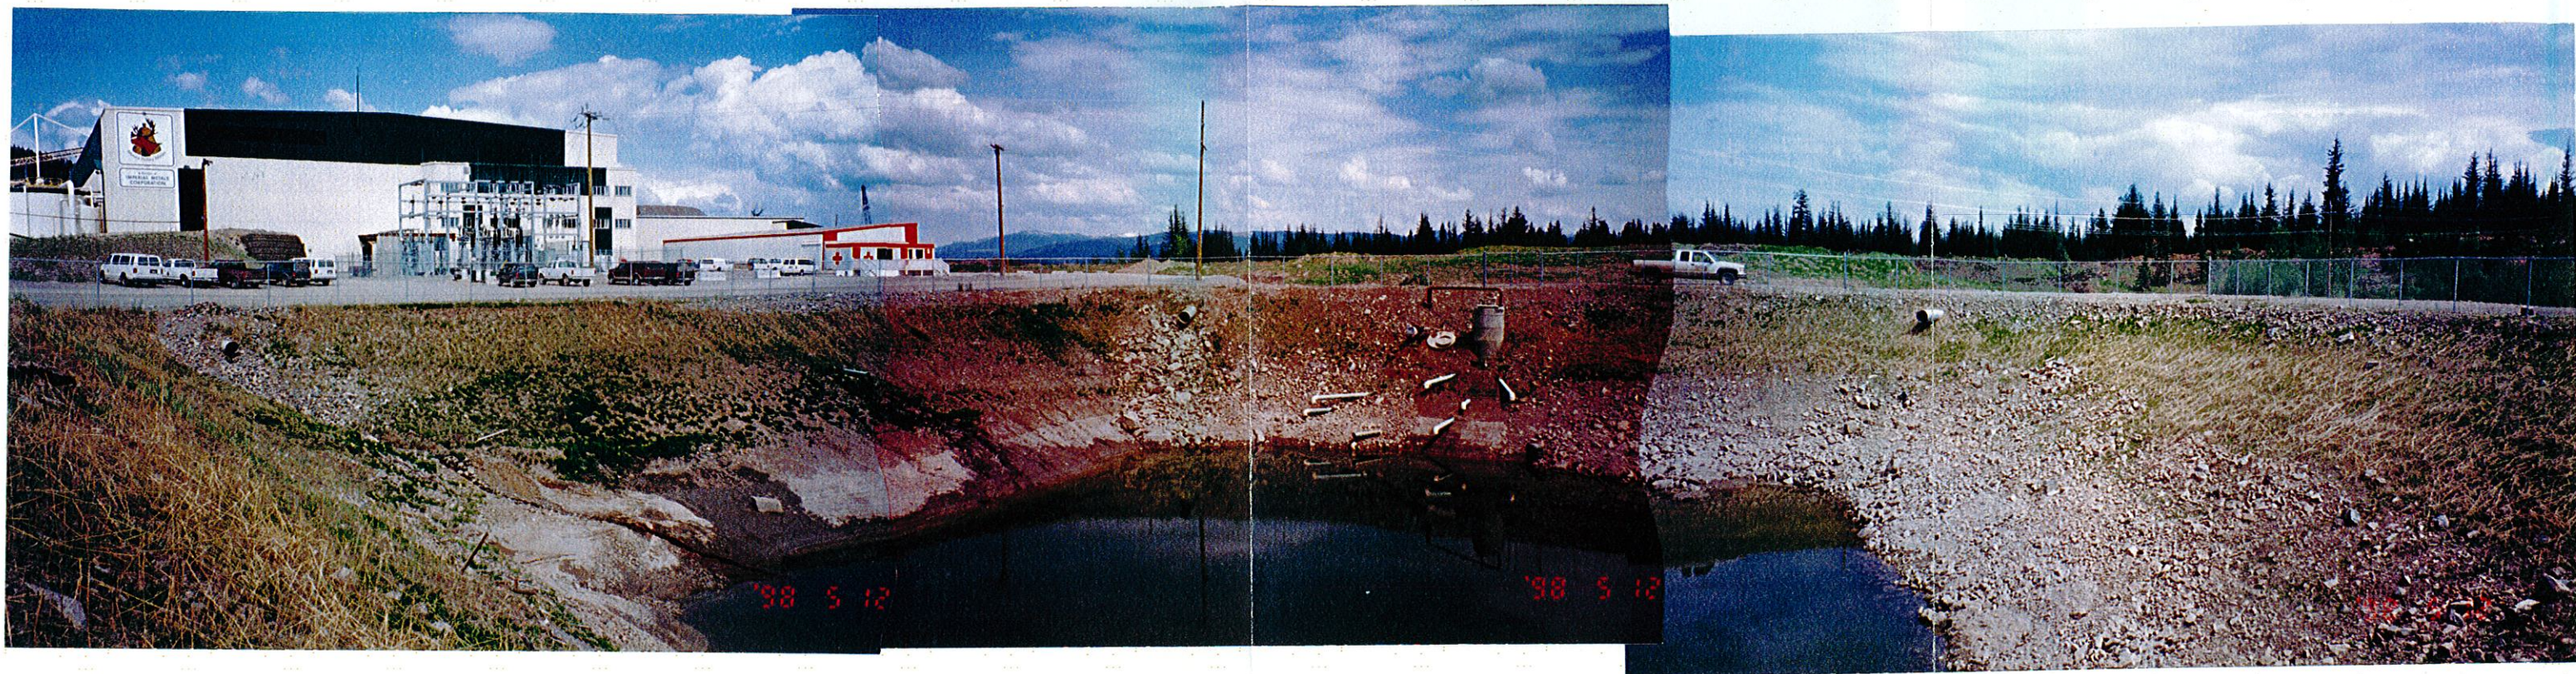
Millsite Sump. Note low water level and stable inner slopes.

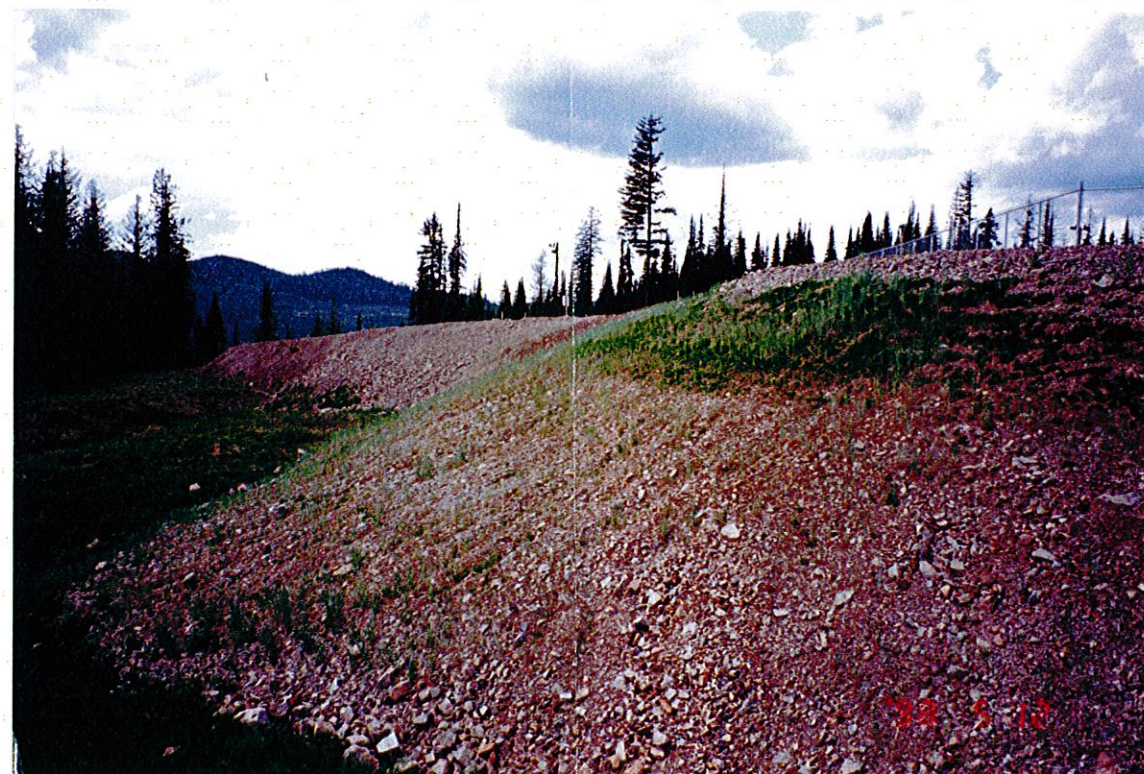
Millsite Sump. View of south slope, looking west. Slope was repaired and is stable. No seepage observed.

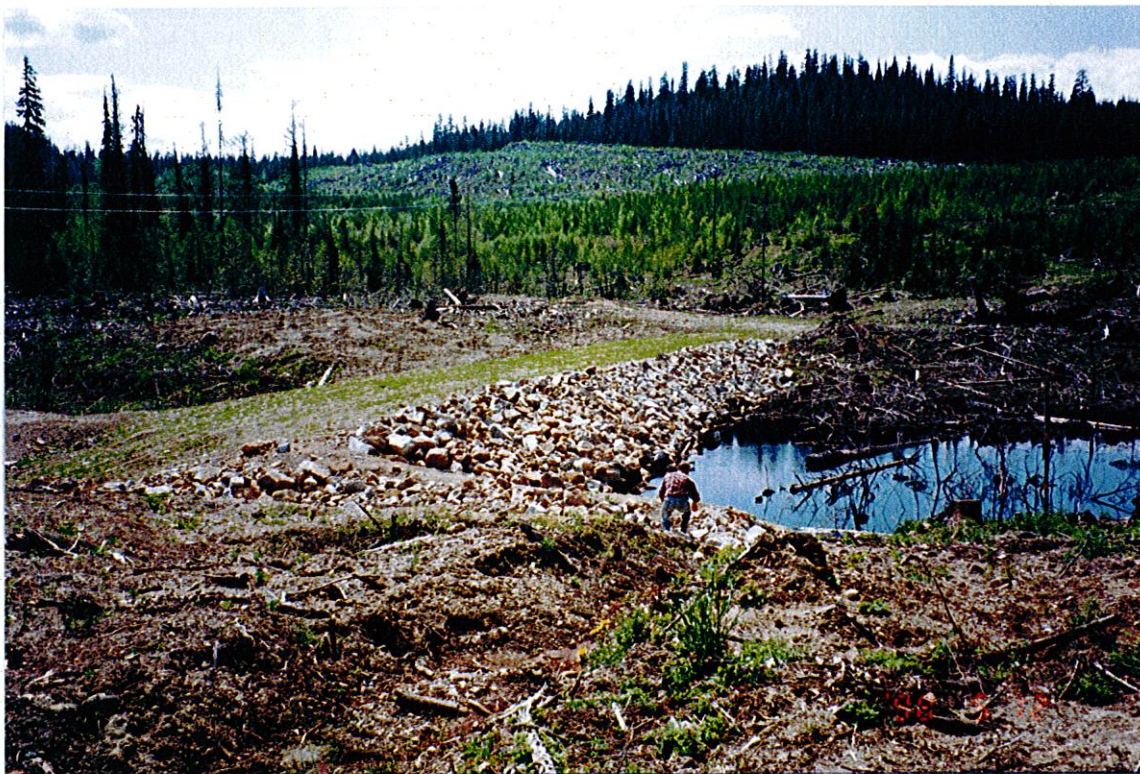
Southeast Bootjack Dam. View of upstream face of embankment, looking southwest. Ponded water is now seeping through old dam back into Bootjack Lake.

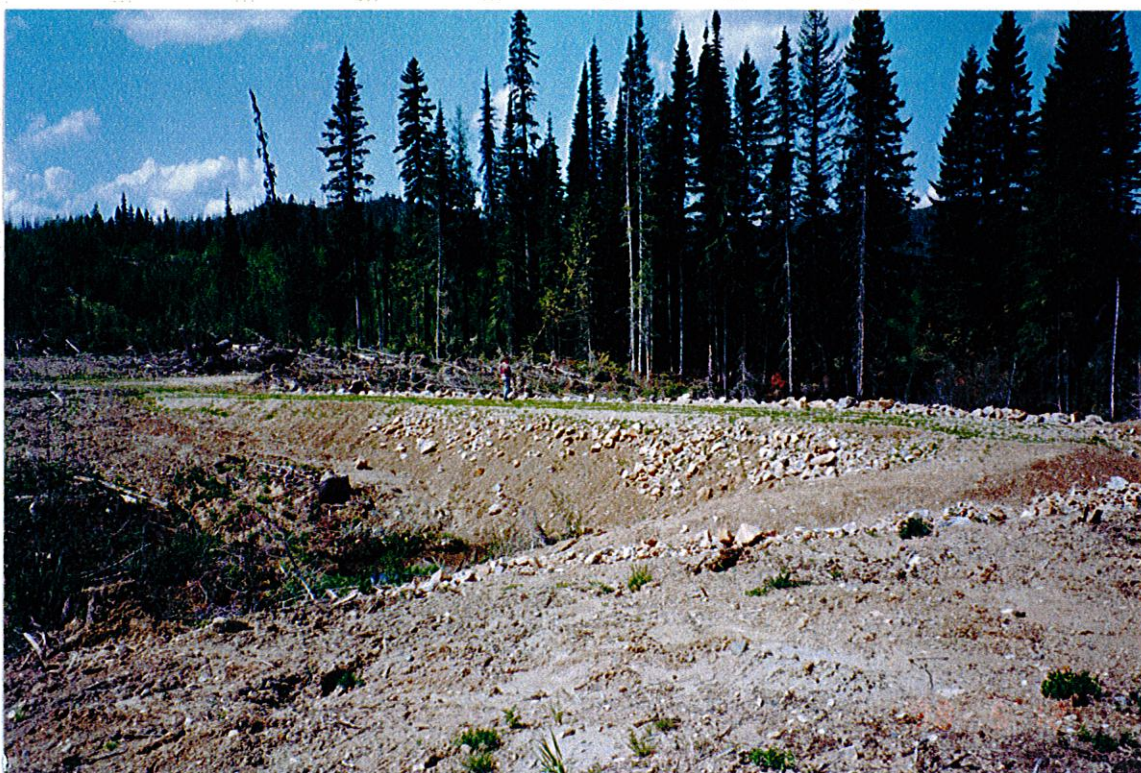
South Bootjack Dam. View of downstream face of embankment, looking northeast. Spillway in foreground is clear of obstructions.
