**MOUNT POLLEY MINING CORPORATION  
MOUNT POLLEY MINE**

**REPORT ON  
1999 ANNUAL INSPECTION  
(REF. NO. 11162/13-9)**

***Knight Piésold Ltd.***

**TAILINGS STORAGE FACILITY**

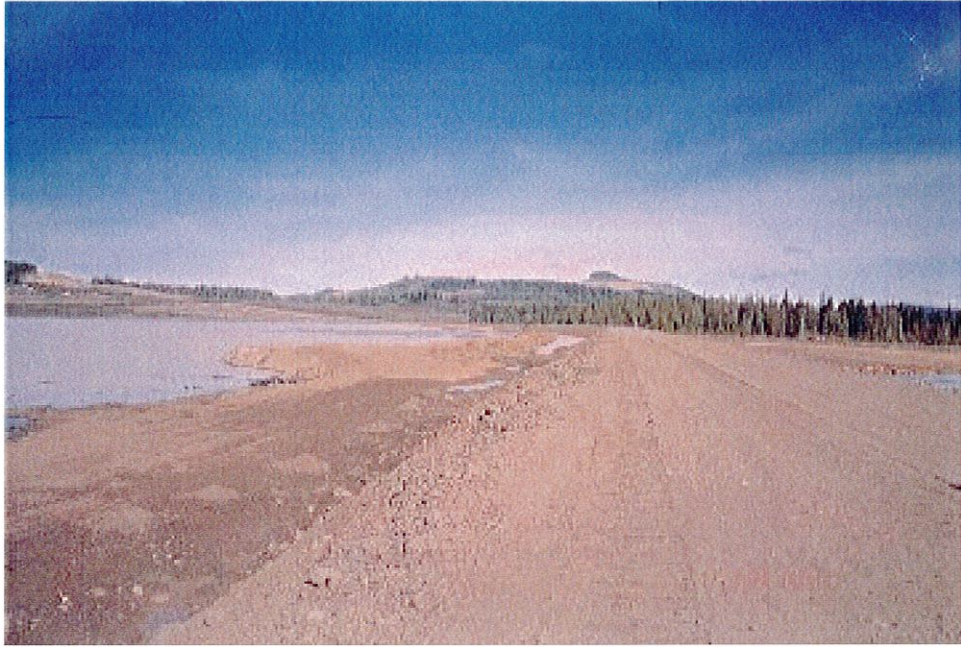
**Photo No. 3:** Perimeter Embankment, looking north from right abutment.

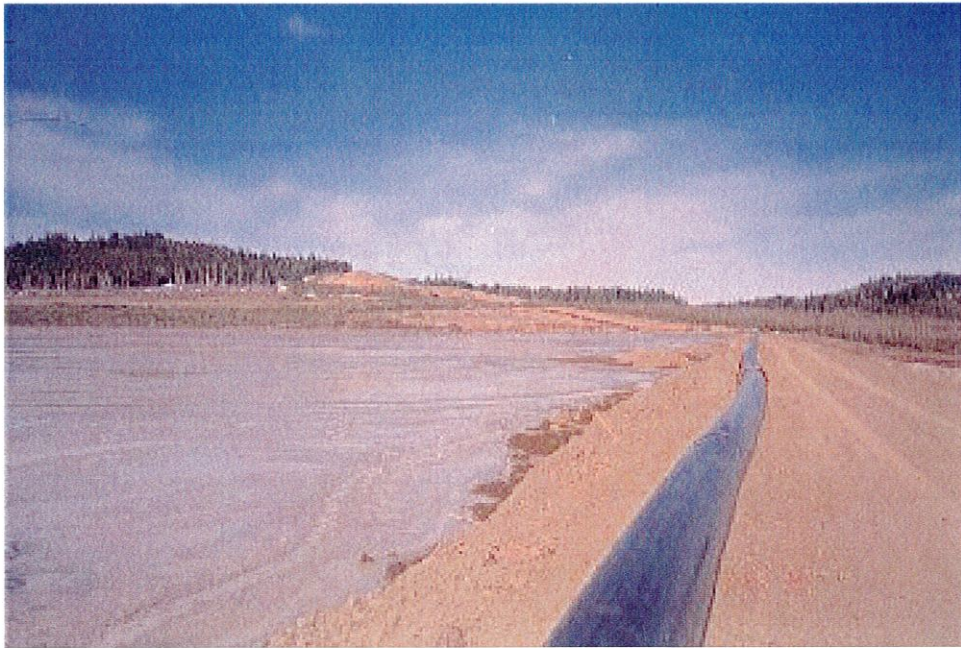
**Photo No. 4:** Perimeter Embankment, near CH 37+20 looking north. Note tailings beach development in northeast corner of the tailings impoundment.

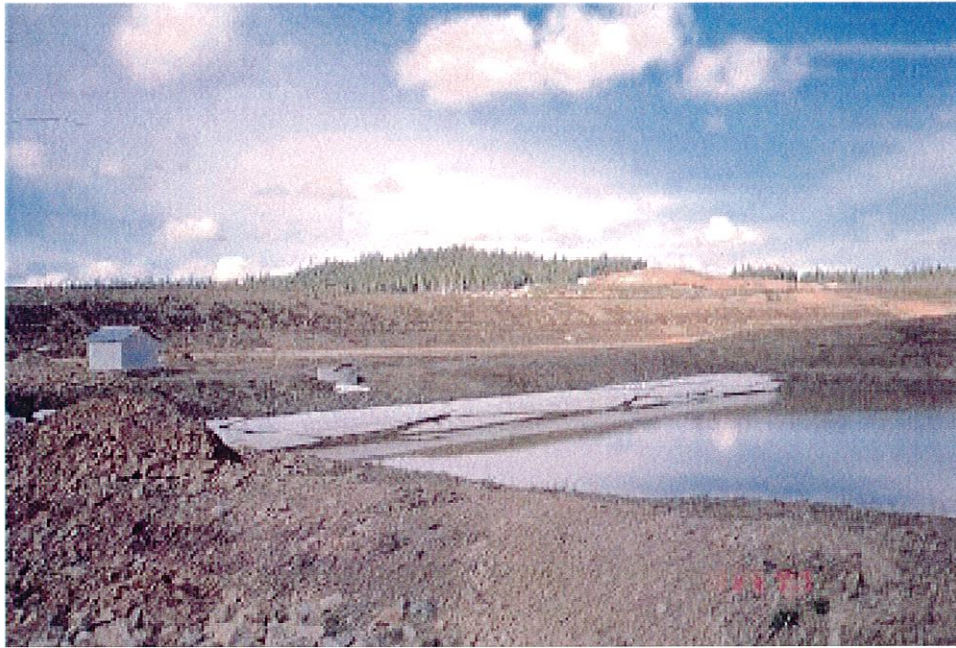
**Photo No. 5:** Perimeter Embankment and Seepage Collection Pond.

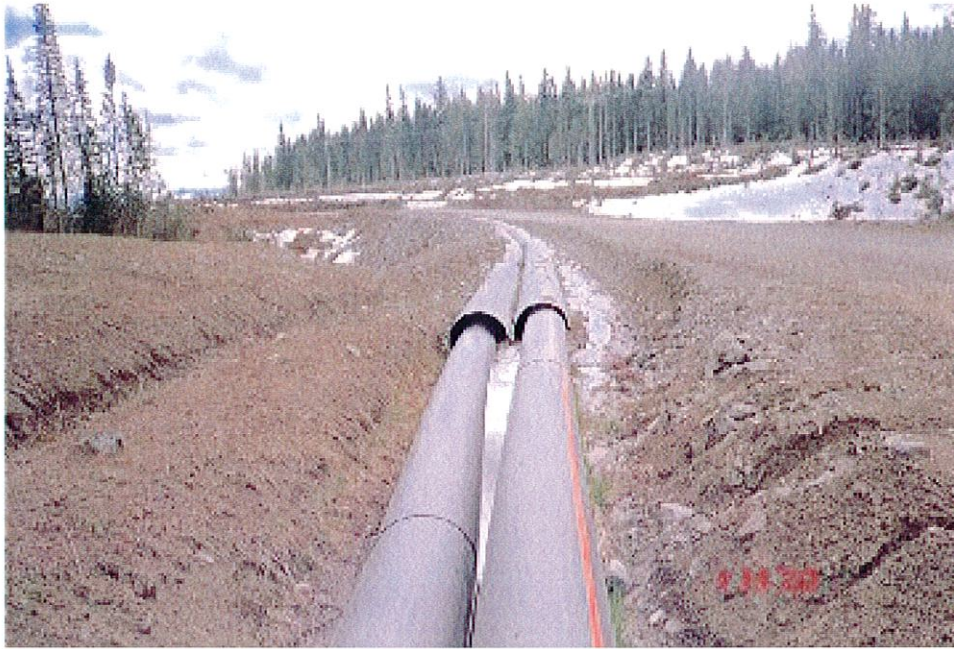
The pipelines are sleeved in 900-mm corrugated steel pipe (CSP) culverts within the pipeline containment channel at the Bootjack Creek Crossing. The sleeves provide backup spill containment over this area. An inspection of the pipelines and sleeves at the Bootjack Creek Crossing indicated that tailings had previously reached the sleeves, as a small amount of tailings is present in the upstream side of the culverts. This was caused by tailings backing up at the T2 Drop Box, flowing into the T2 Overflow Pond and then travelling down the pipeline containment channel. No solids escaped from the pipe containment channel. In the event that tailings reach the Bootjack Creek Crossing in the future, the CSP sleeves must be flushed to ensure that there is a clear pathway for tailings to get past the crossing, without spilling into Bootjack Creek.

**Photo No. 9:** Pipeline Containment Channel. Upstream end of pipeline sleeves at Bootjack Creek Crossing. Minor amount of tailings at the bottoms of the sleeves.

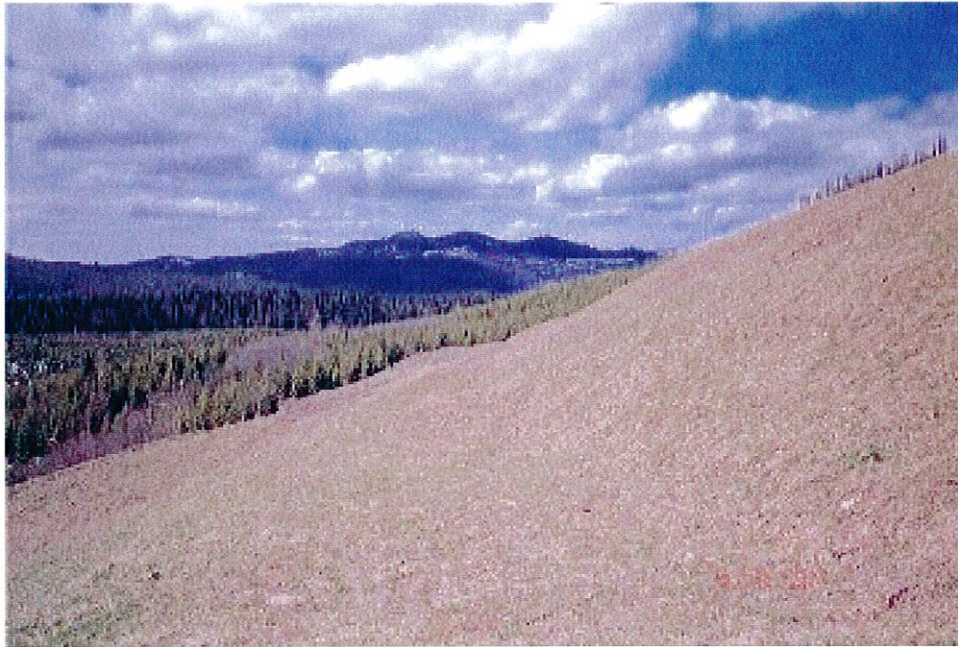
**Photo No. 15:** Southeast Sediment Pond. Downstream fill slope looking west. Slope is dry and stable and vegetation is well established.

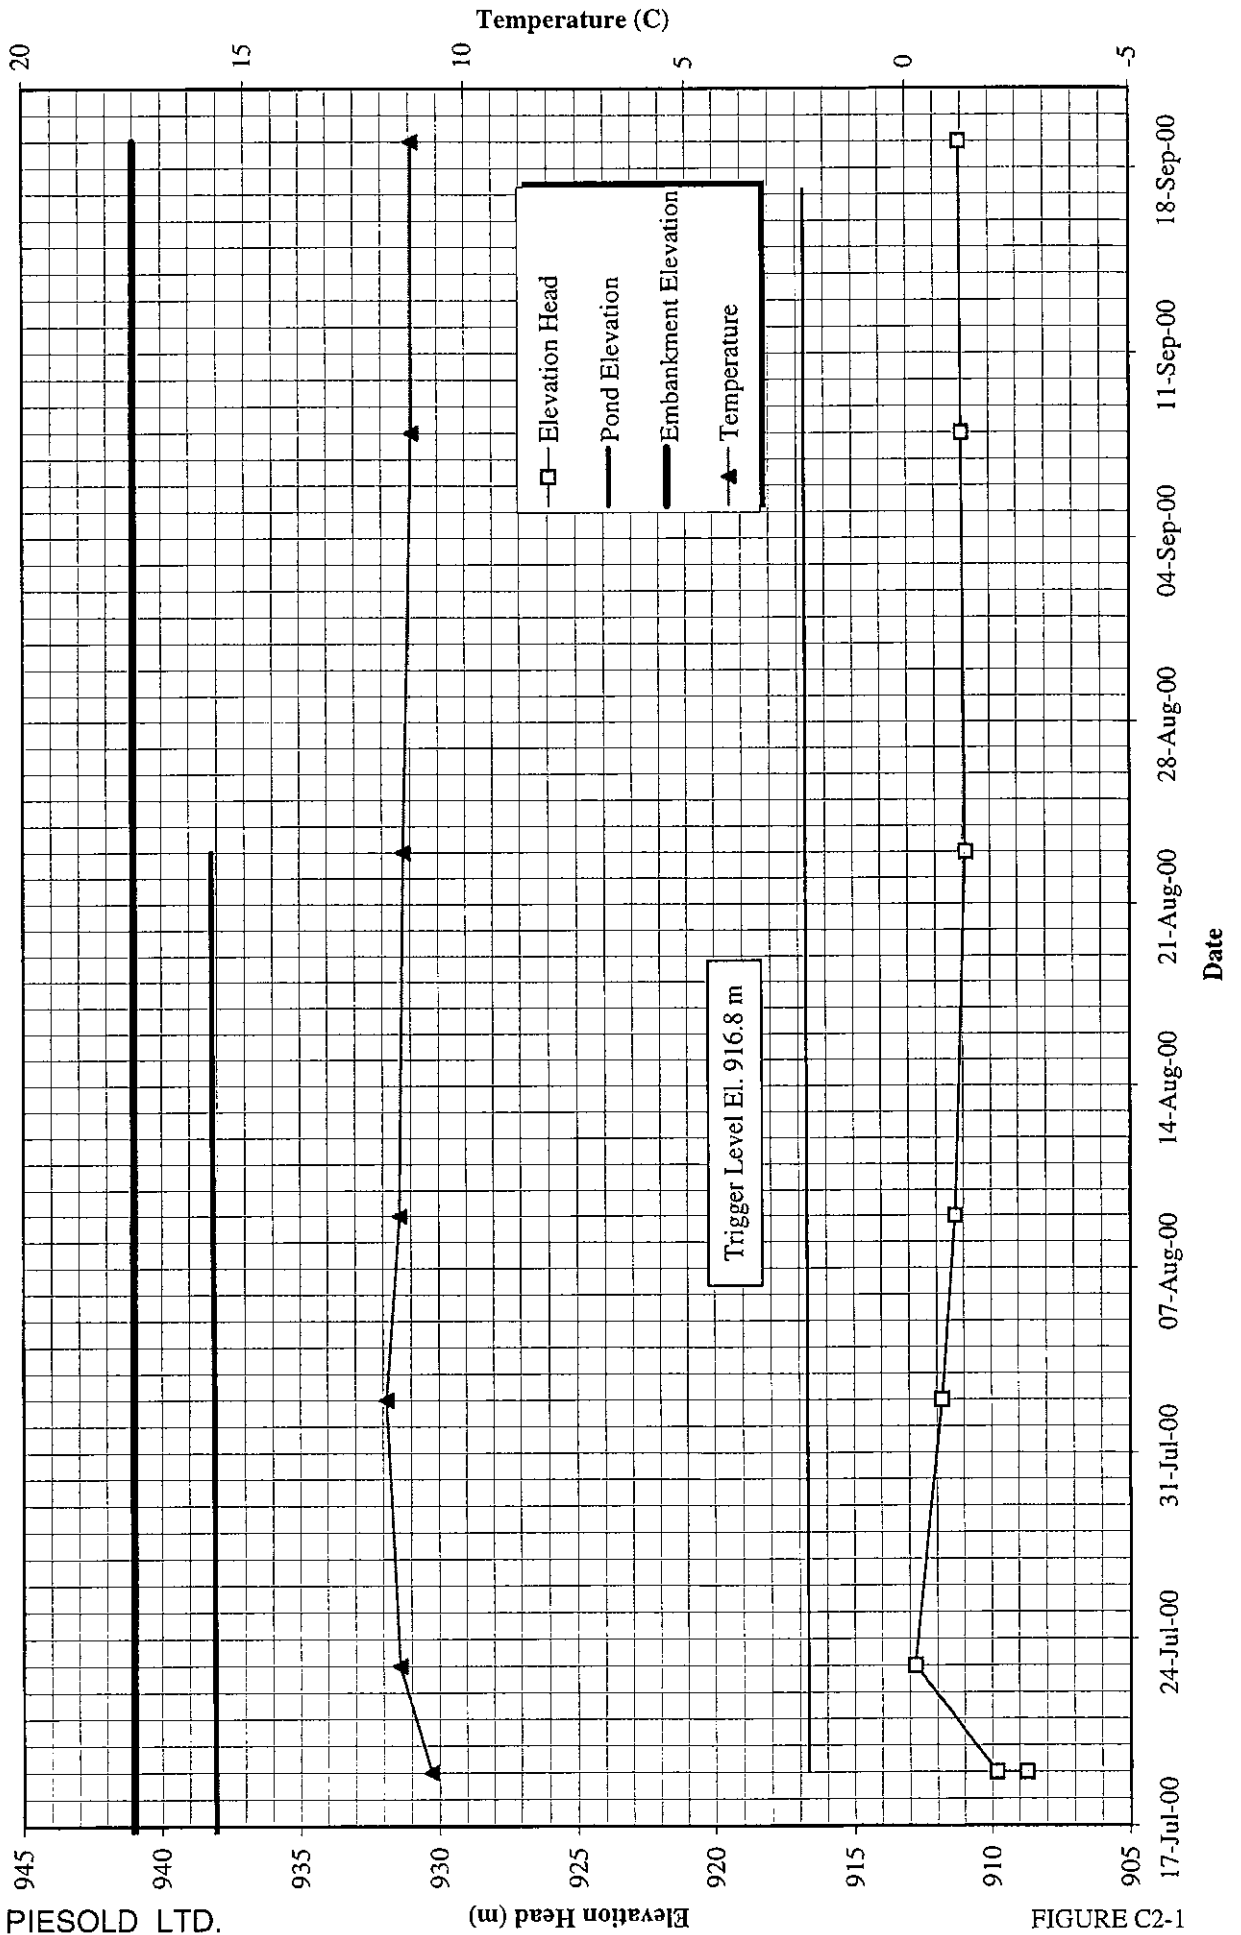
FIGURE C2-1

A total of 16 piezometers had been installed in the embankment foundations at the time of the inspection. Twelve remained in operation. No unexpected high pore pressure increases were observed during the monitoring period. The highest water level indicated by the foundation piezometers was an artesian level of 3.7 m, recorded in A2-PE2-01. Piezometers A2-PE2-02,

**MOUNT POLLEY MINING CORPORATION**  
**MOUNT POLLEY PROJECT**  
**PIEZOMETER A2-PE2-01**  
 (Foundation Piezometer El. 903.7 m)

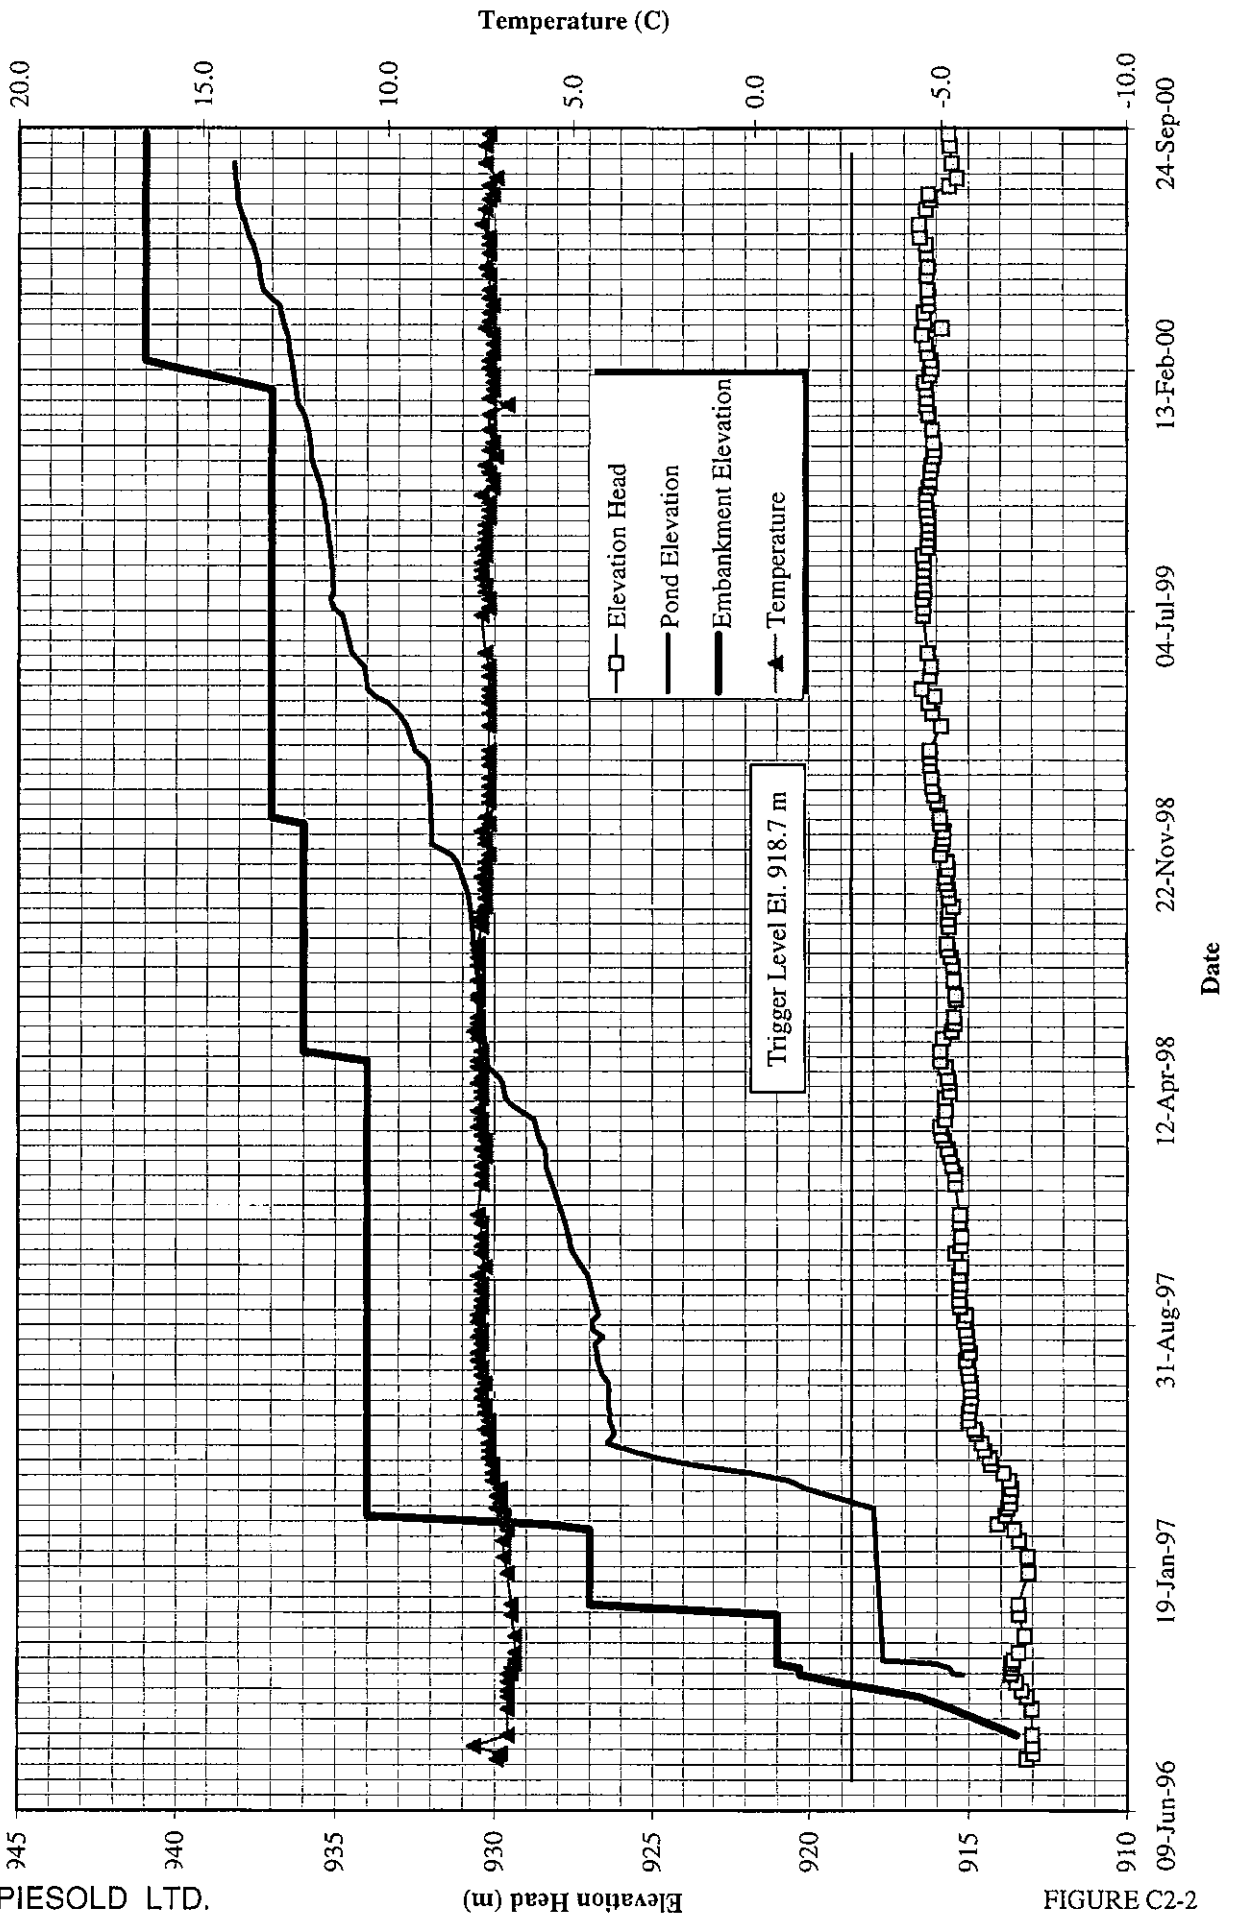
FIGURE C2-2

A2-PE2-06, A2-PE2-07 and B2-PE2-02 indicated artesian pressures of approximately 3.0 m. Although these levels were high, none had reached the foundation piezometer trigger levels of 6.0 m artesian pressure (relative to original ground). The trigger levels are based on embankment stability analyses. These values, if exceeded, will require investigations and contingency or remedial actions to be taken.

**MOUNT POLLEY MINING CORPORATION**  
**MOUNT POLLEY MINE**  
**PIEZOMETER A2-PE2-02**  
 (Foundation Piezometer El. 909.8 m)

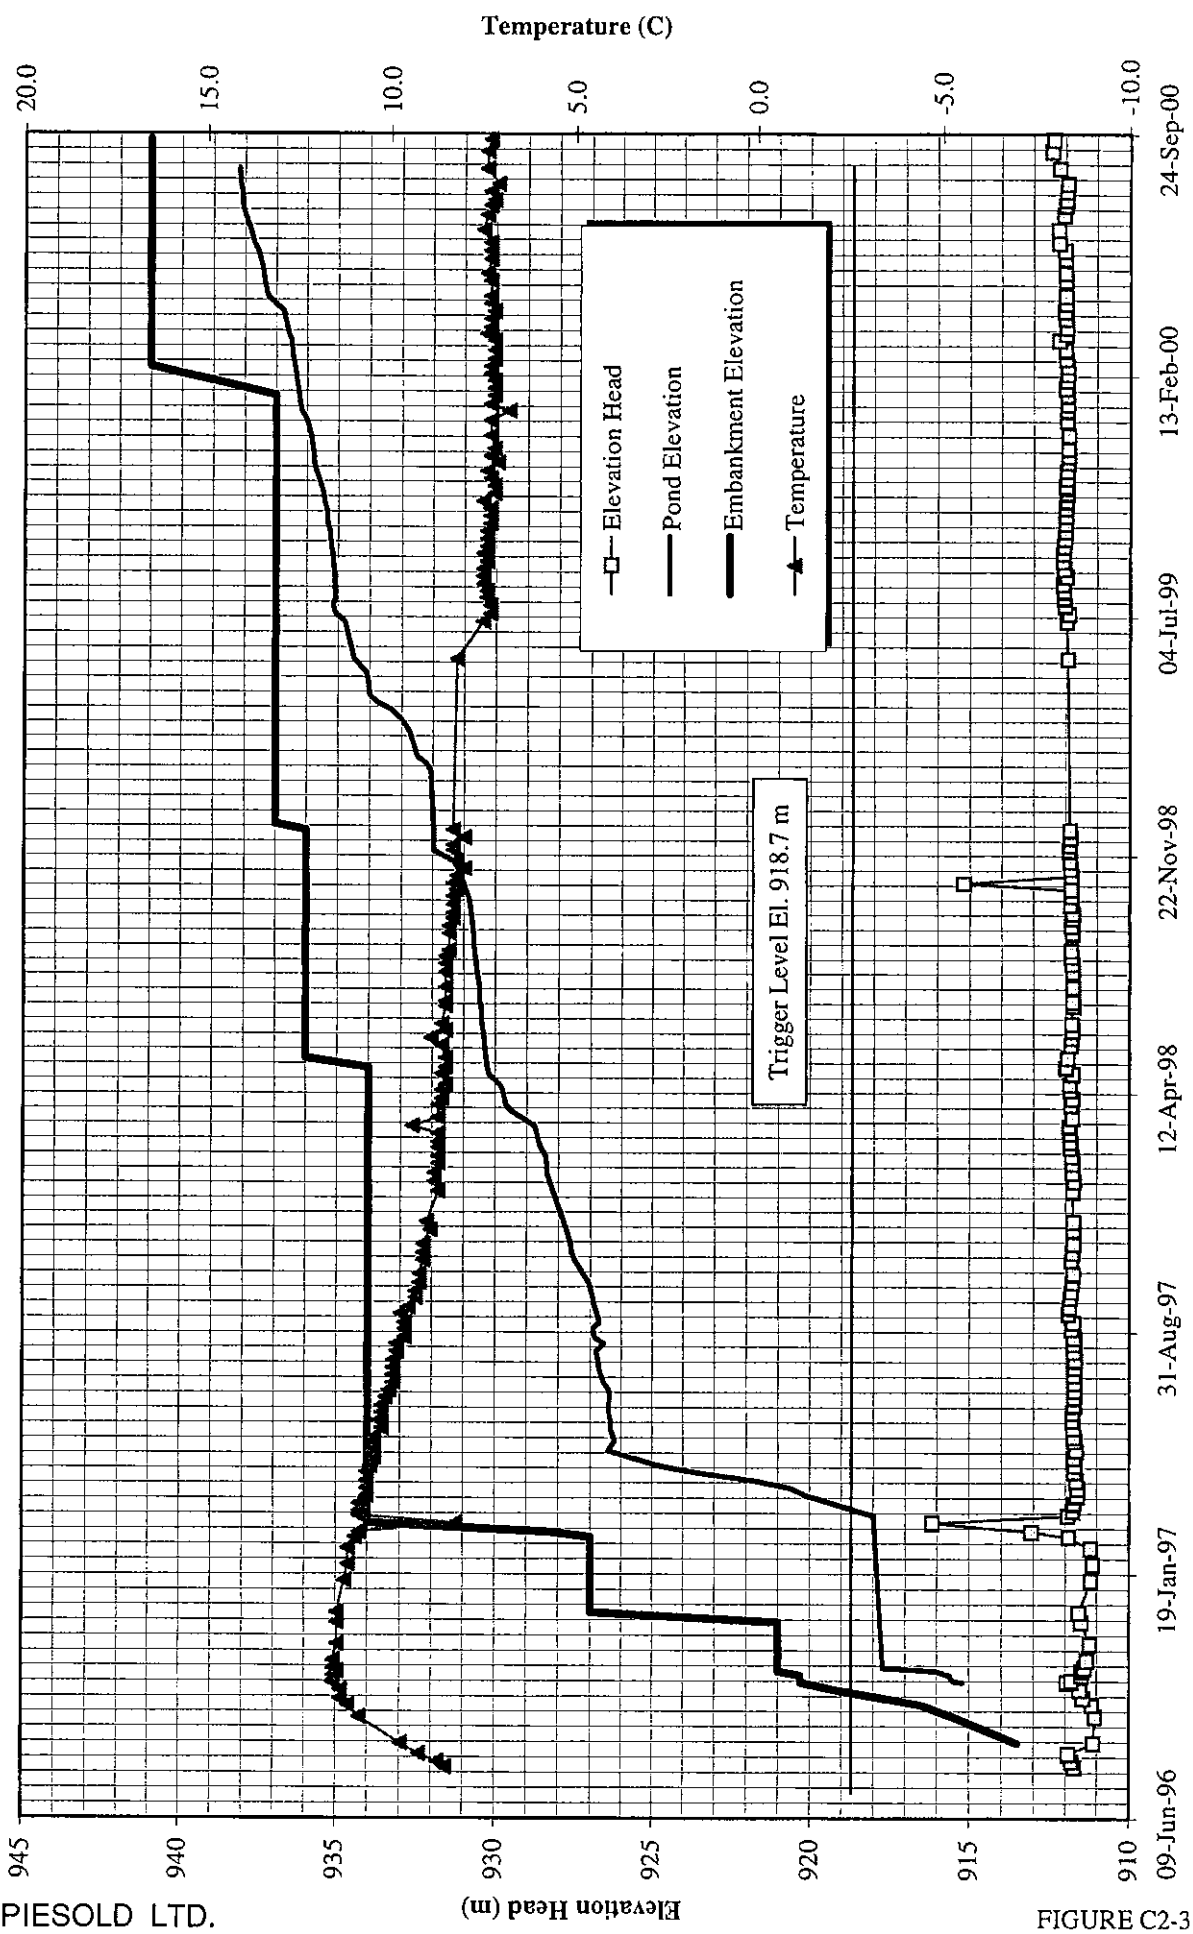
FIGURE C2-3

**MOUNT POLLEY MINING CORPORATION**  
**MOUNT POLLEY MINE**  
**PIEZOMETER A2-PE2-06**  
**(Foundation Piezometer El. 898.0 m)**

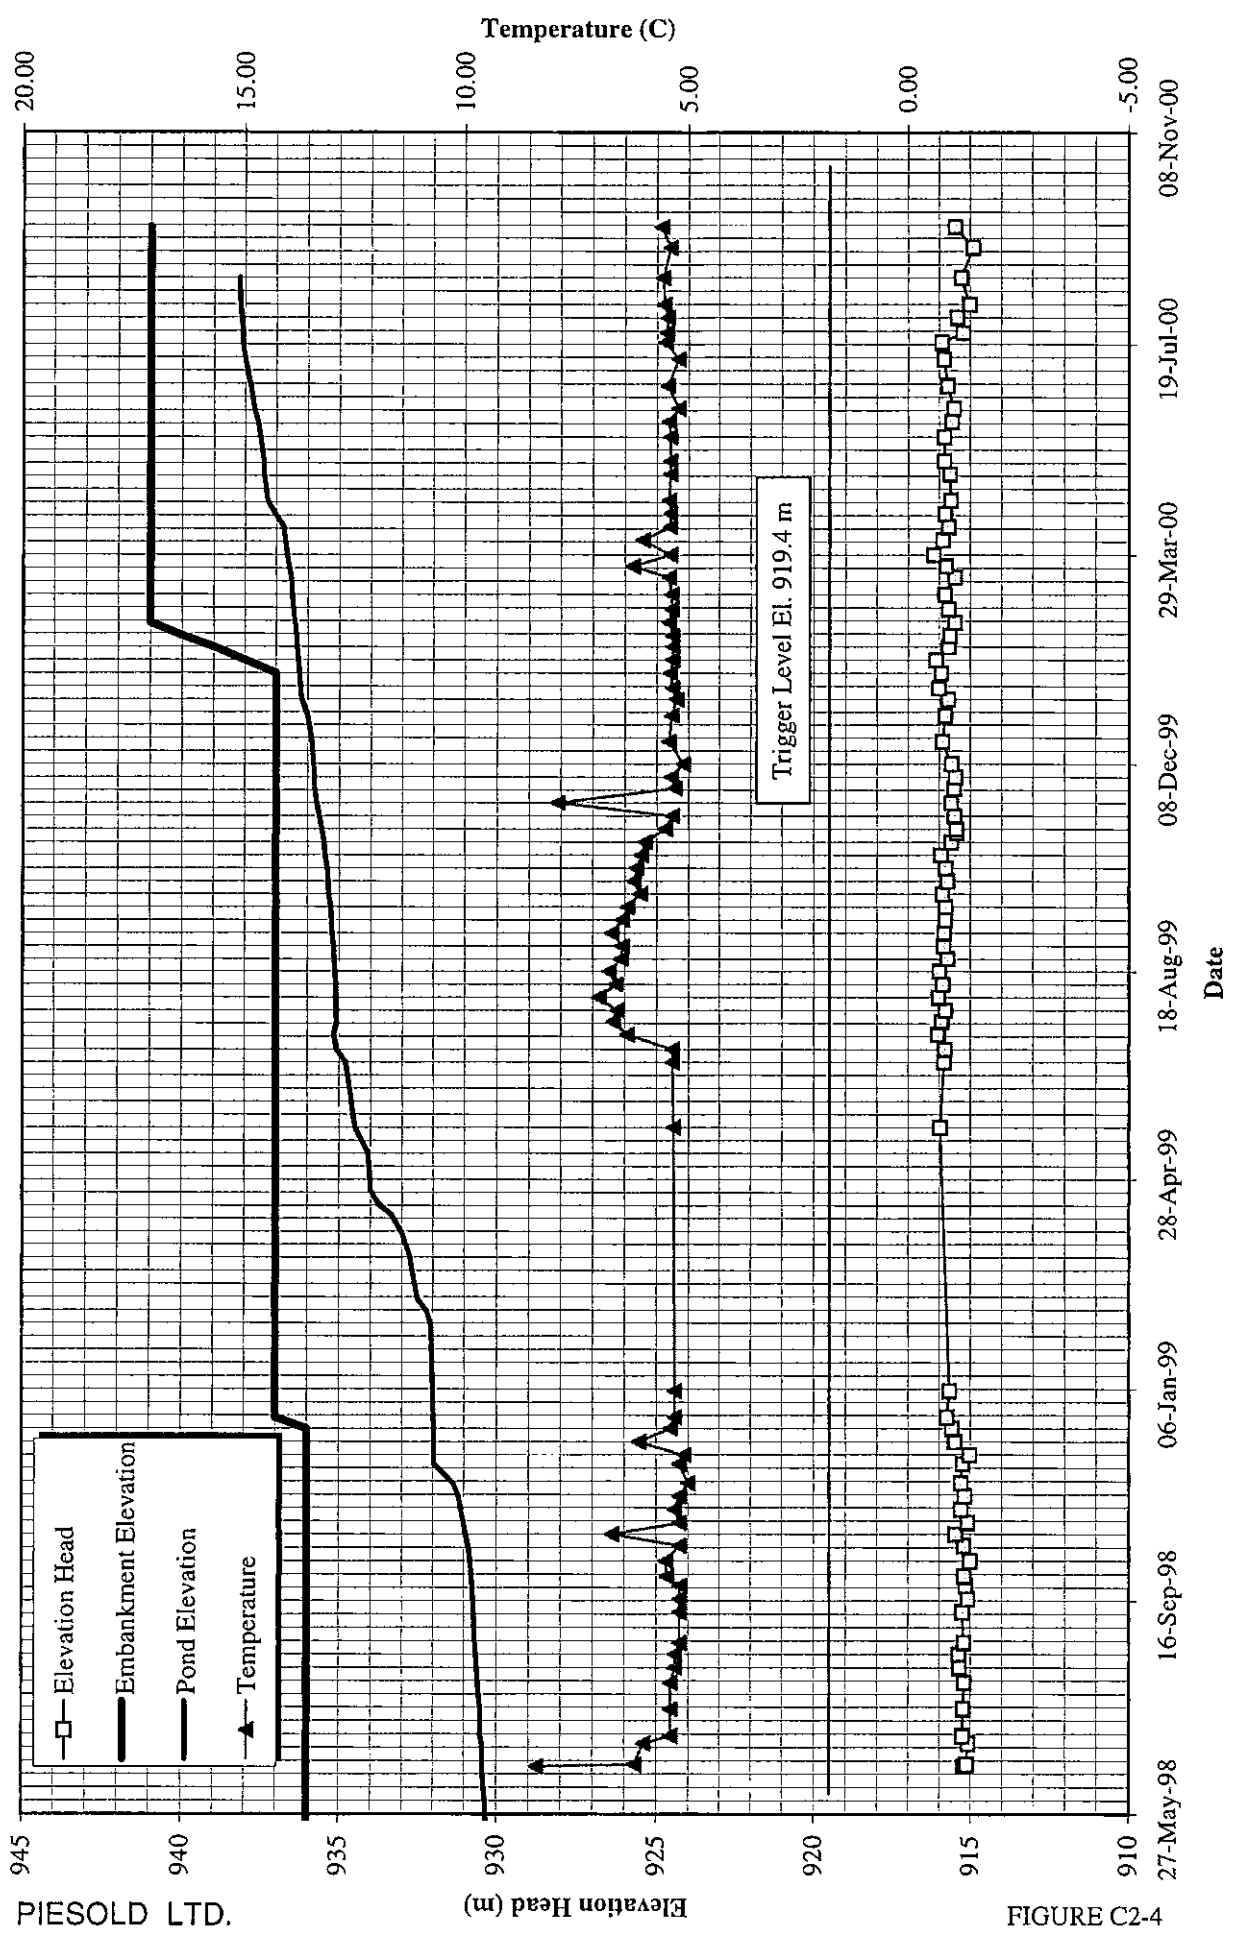
FIGURE C2-4

**MOUNT POLLEY MINING CORPORATION**  
**MOUNT POLLEY MINE**  
**PIEZOMETER A2-PE2-07**  
 (Foundation Piezometer El. 902.8 m)
