**MOUNT POLLEY MINING CORPORATION  
MOUNT POLLEY MINE**

**REPORT ON  
2000 AND 2001 ANNUAL INSPECTION  
(REF. NO. 11162/14-2)**

**TAILINGS STORAGE FACILITY**

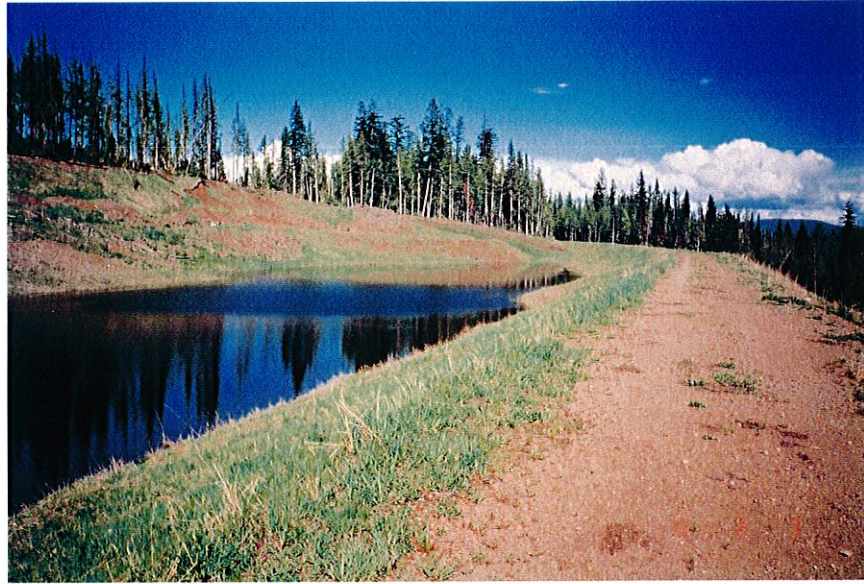
**PHOTO 1:** Southeast Sediment Pond – Looking East

Seeps were observed in the northwest fill slope of the Southeast Sediment Pond embankment. Seeps have been observed in this area since 1997. Additional seeps were observed further east and in an area where waste material and a topsoil pile is located. All seepage was observed to be clear, indicating that no erosion of fill materials was occurring. The seeps are likely attributed to an elevated groundwater table, which is temporarily higher during the freshet season. Tension cracks at the waste and topsoil pile have been reported in the past; however, no further signs of instability were observed during the inspection. The vegetation on the slopes of the waste dump and topsoil pile were observed to be well established.

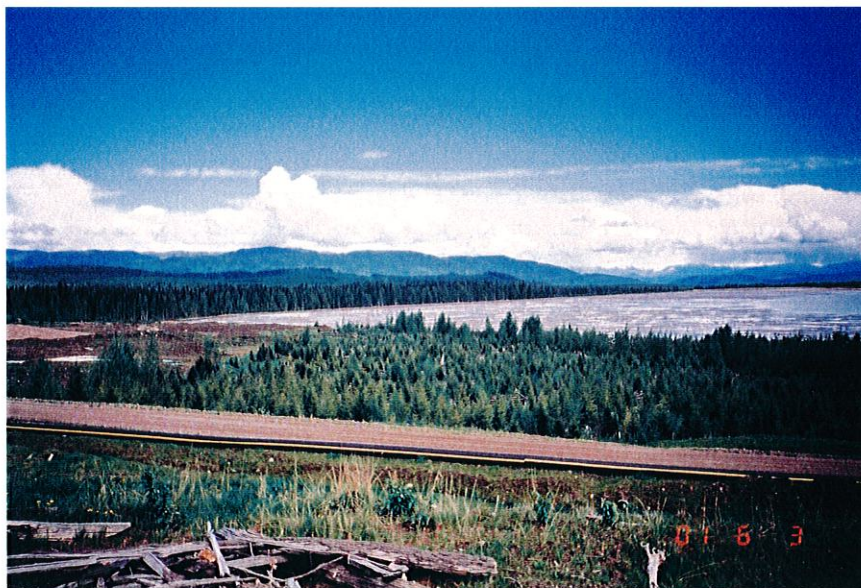
**PHOTO 8:** Perimeter Embankment Left Abutment and Reclaim Line – Looking East

Some seepage was observed at the left abutment of the Perimeter Embankment, but the source of this seepage is water from a ditch adjacent to the Polley Lake pipeline access road. It is believed that this water originates from rainfall and local runoff from the surrounding area. The culvert that transfers water under the road and into the ditch to the Perimeter Embankment Seepage Collection Pond is slightly elevated and water pools at the inlet. This causes the seepage which exits at the base of the embankment but seeps back into the Zone T road and the ditch at Setting Out Point S7. The observed flow rate is very low and the water is clear. The area below the embankment at this location is scheduled to be covered with material during Stage 3B Construction.

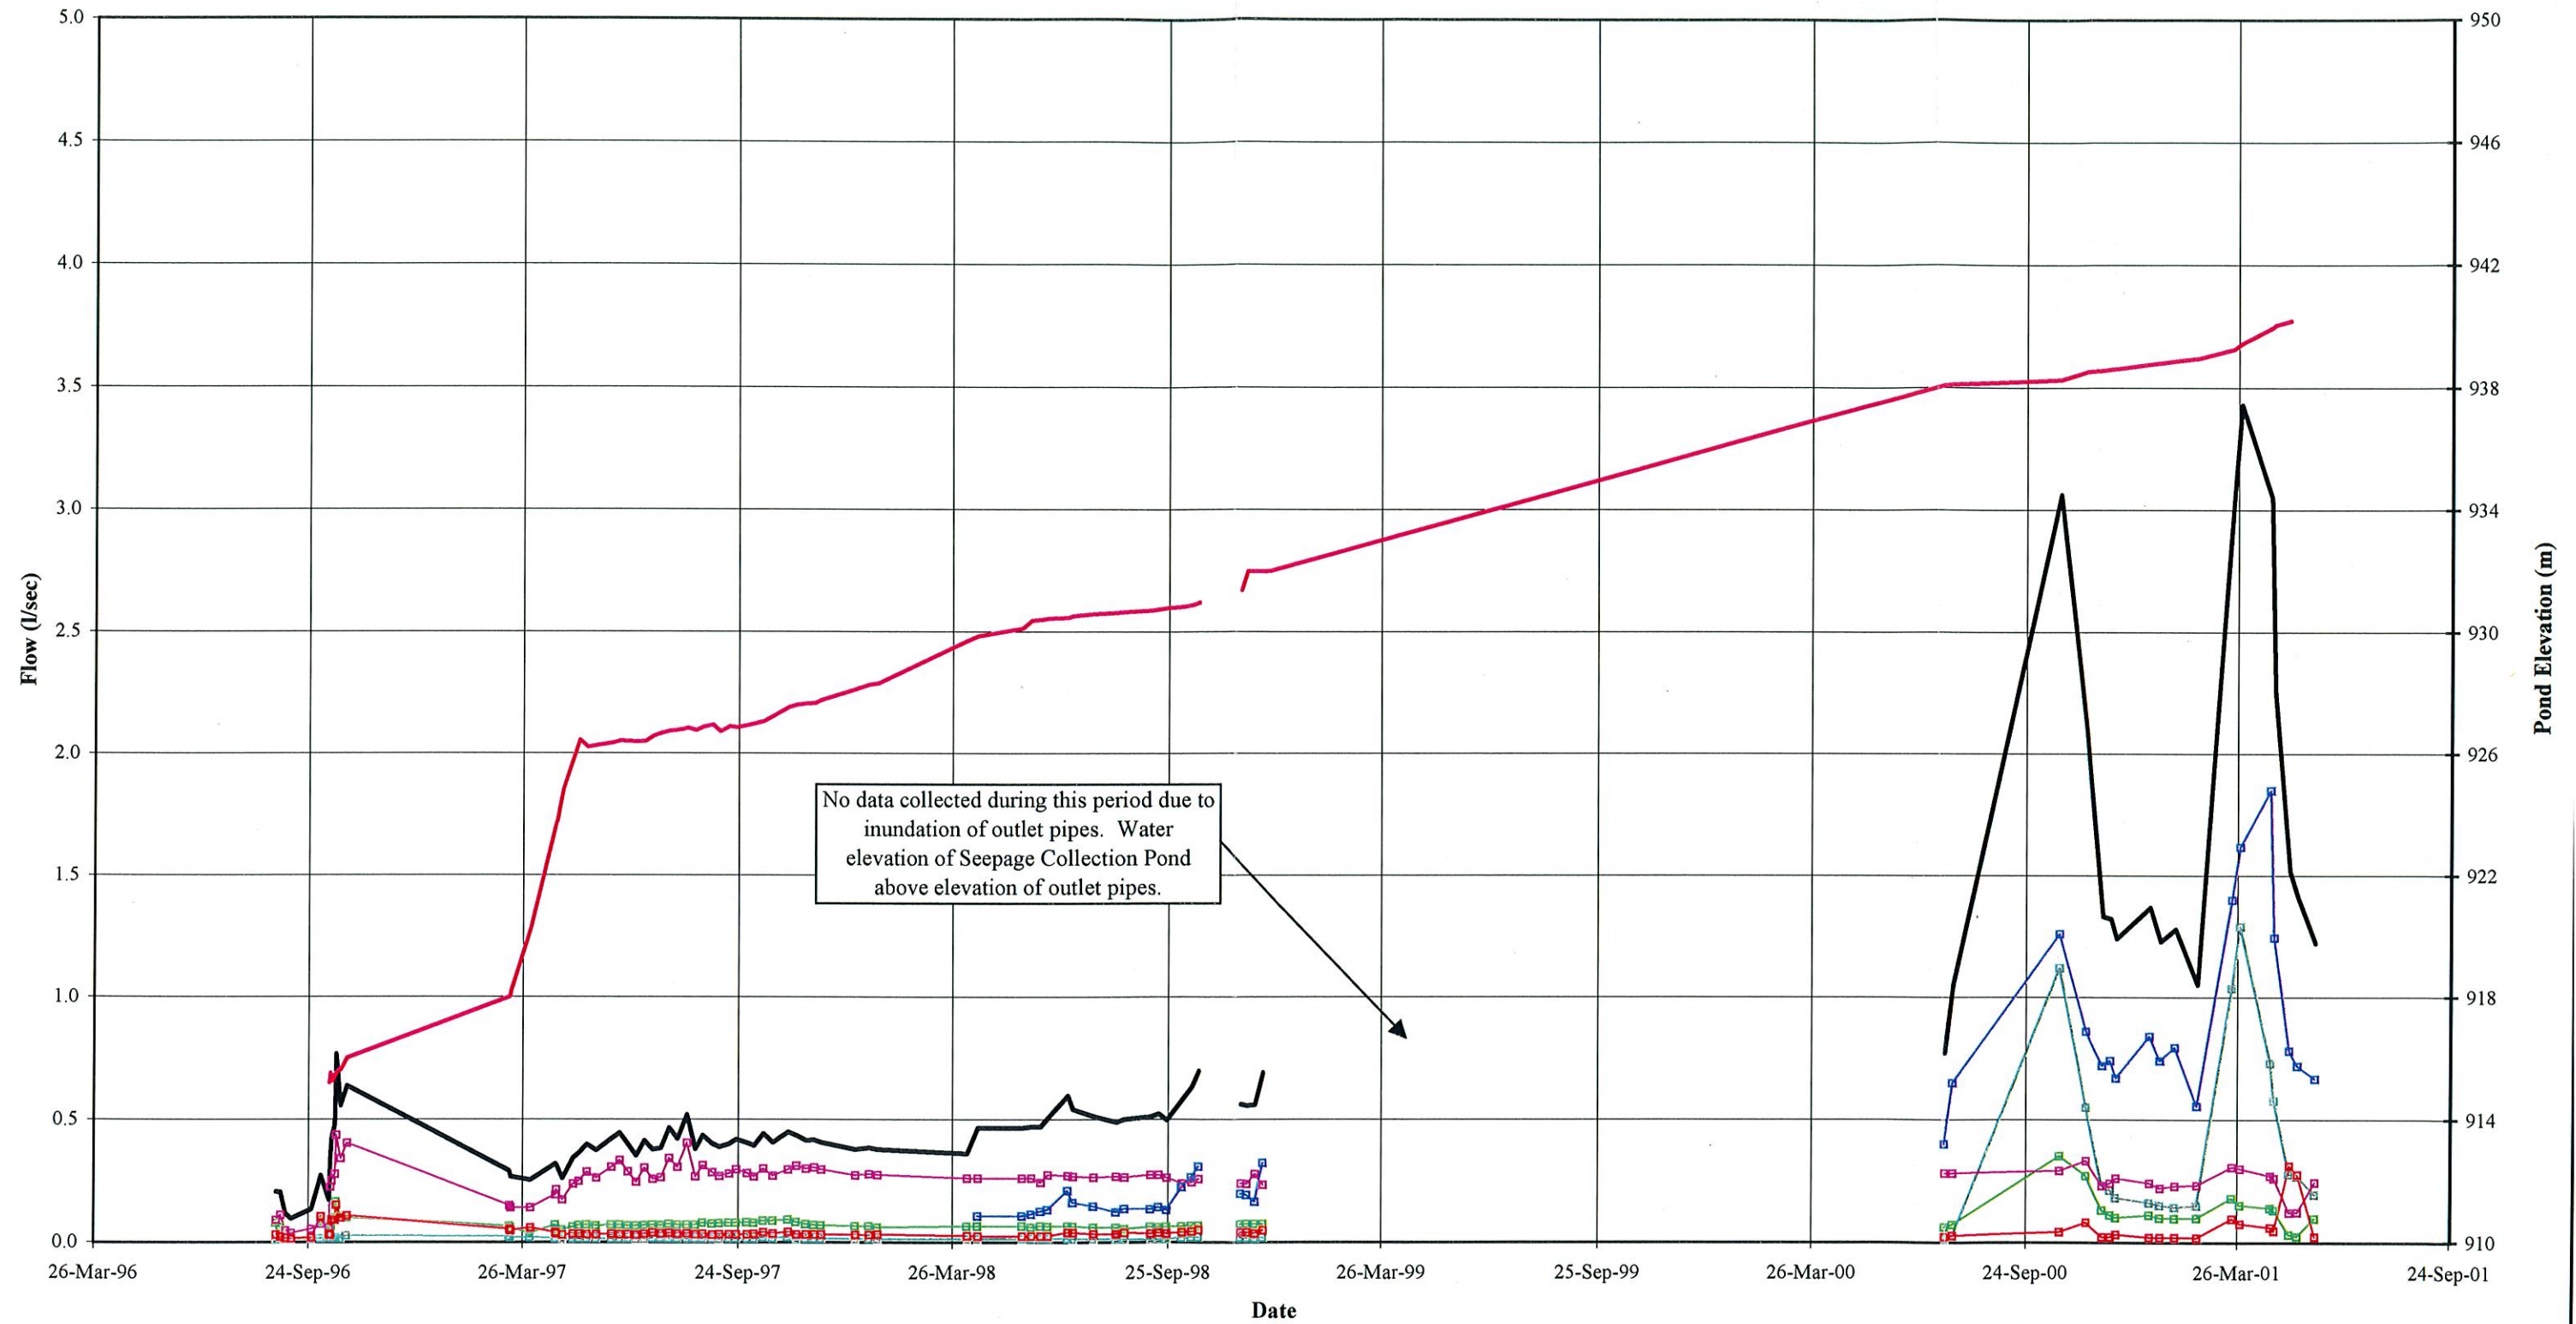
MOUNT POLLEY MINING CORPORATION		
MOUNT POLLEY MINE		
TAILINGS STORAGE FACILITY MAIN EMBANKMENT FOUNDATION DRAIN FLOWS		
PROJECT NO. 11162/14	REF. NO. 2	REV. 0
<b>Knight Piésold</b> CONSULTING		
FIGURE C-2

There is a large gap in the foundation drain data from the end of 1998 to the summer of 2000. This was a result of the water level in the SCP being higher than the outlet elevations of the foundation drains. MPMC experienced problems with the pump at the SCP; therefore, the SCP water level was maintained at a slightly elevated level which flooded the drains. As a result, the flows exiting the drains could not be monitored.

The flow measurements increased dramatically in the fall of 2000 once the pumping system became operational. This was likely due to water backing up in the foundation drain gravel during the period of high water elevations at the SCP. This water then re-entered the SCP as the elevation in the pond was lowered.

A second increase in flows was seen during the spring freshet of 2001, especially in FD-2 and FD-5. These two drains have been extended and now are exposed against rockfill. As a result, these two drains intercept local runoff from snowmelt and rainfall events. FD-5 was again extended in the fall of 2000 to intercept a groundwater seep observed in the foundation materials at the right abutment of the Main Embankment. These events likely explain the increase in flows over this period.
