MOUNT POLLEY MINING CORPORATION
MOUNT POLLEY MINE

TAILINGS STORAGE FACILITY
REPORT ON 2002 ANNUAL INSPECTION
(REF. NO. VA101-00001/3-1)

EXECUTIVE SUMMARY

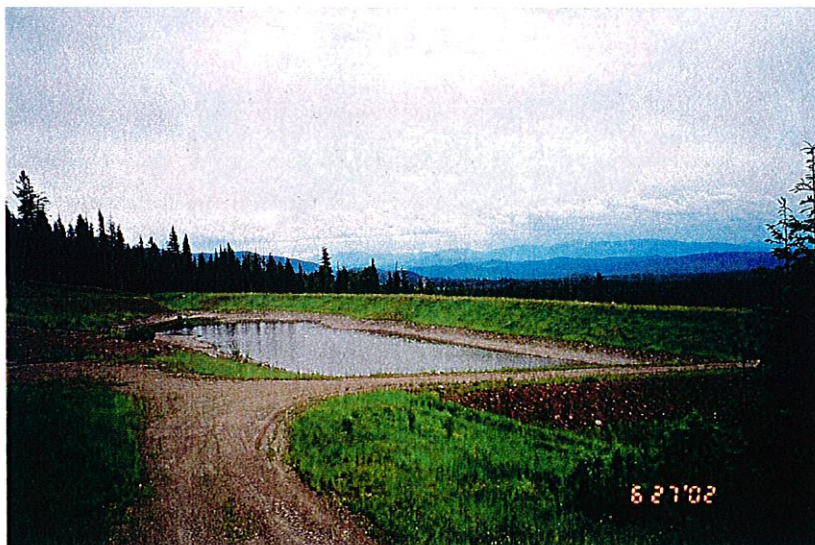
PHOTO 1: Southeast Sediment Control Pond

The Tailings and Reclaim Pipeline System, Southeast Sediment Pond, Millsite Sump, and South Bootjack Dam were all observed to be in good condition and operating normally. No issues were identified.

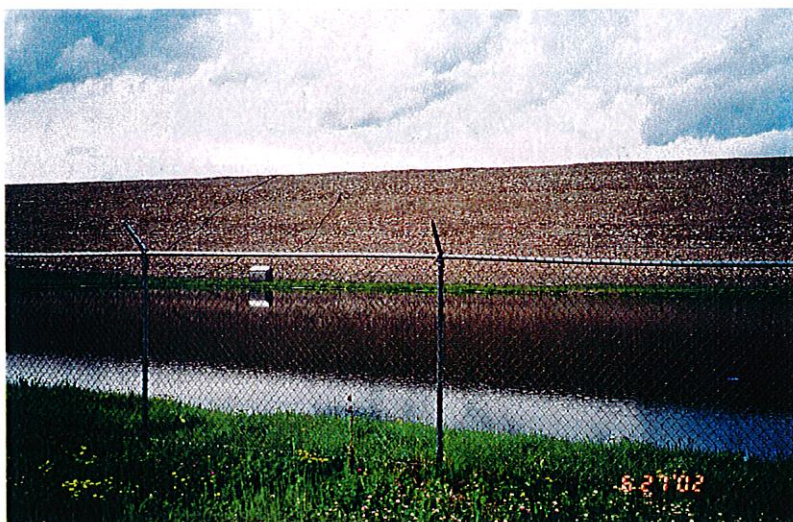
PHOTO 3: Main Embankment and Seepage Collection Pond

- No signs of instability were observed in the embankment fill slopes.
- The seepage collection ponds were observed to be in good condition with no observed erosion activity.
- No unexpected or uncontrolled seepage was observed from the embankments including fill slope and foundations.
- All perimeter surface water diversion ditches were unobstructed and those that were flowing, had clear water.
- No problems were observed or reported regarding wind blown dustings from the tailings beaches.

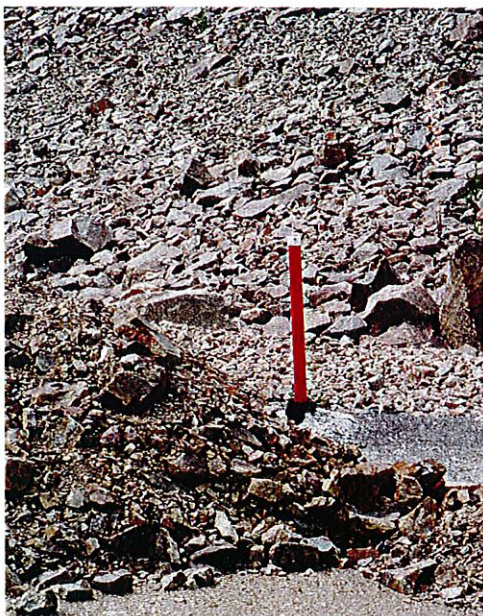
PHOTO 9: Slope Inclinometer at toe of Main Embankment

- Piezometer data indicated that the embankments are performing as designed.
- Aside from the initial reading, only one slope inclinometer reading is currently available. It is recommended that monitoring with the inclinometer probe be undertaken annually and that a 'poor-boy' monitoring rod should be constructed for use monthly, during the care and maintenance period.

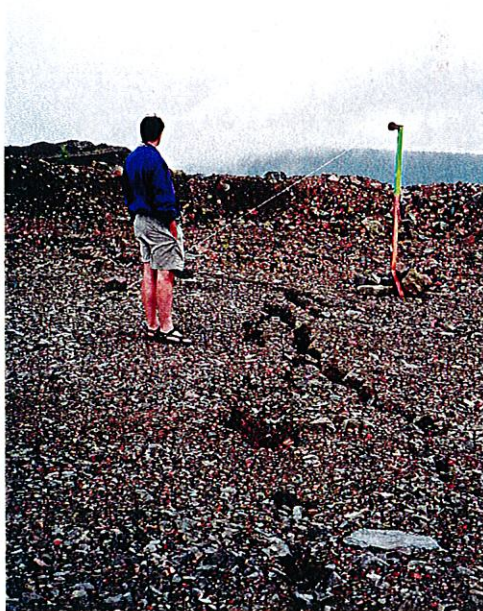
PHOTO 10: Tension cracks along east side of Waste Dump

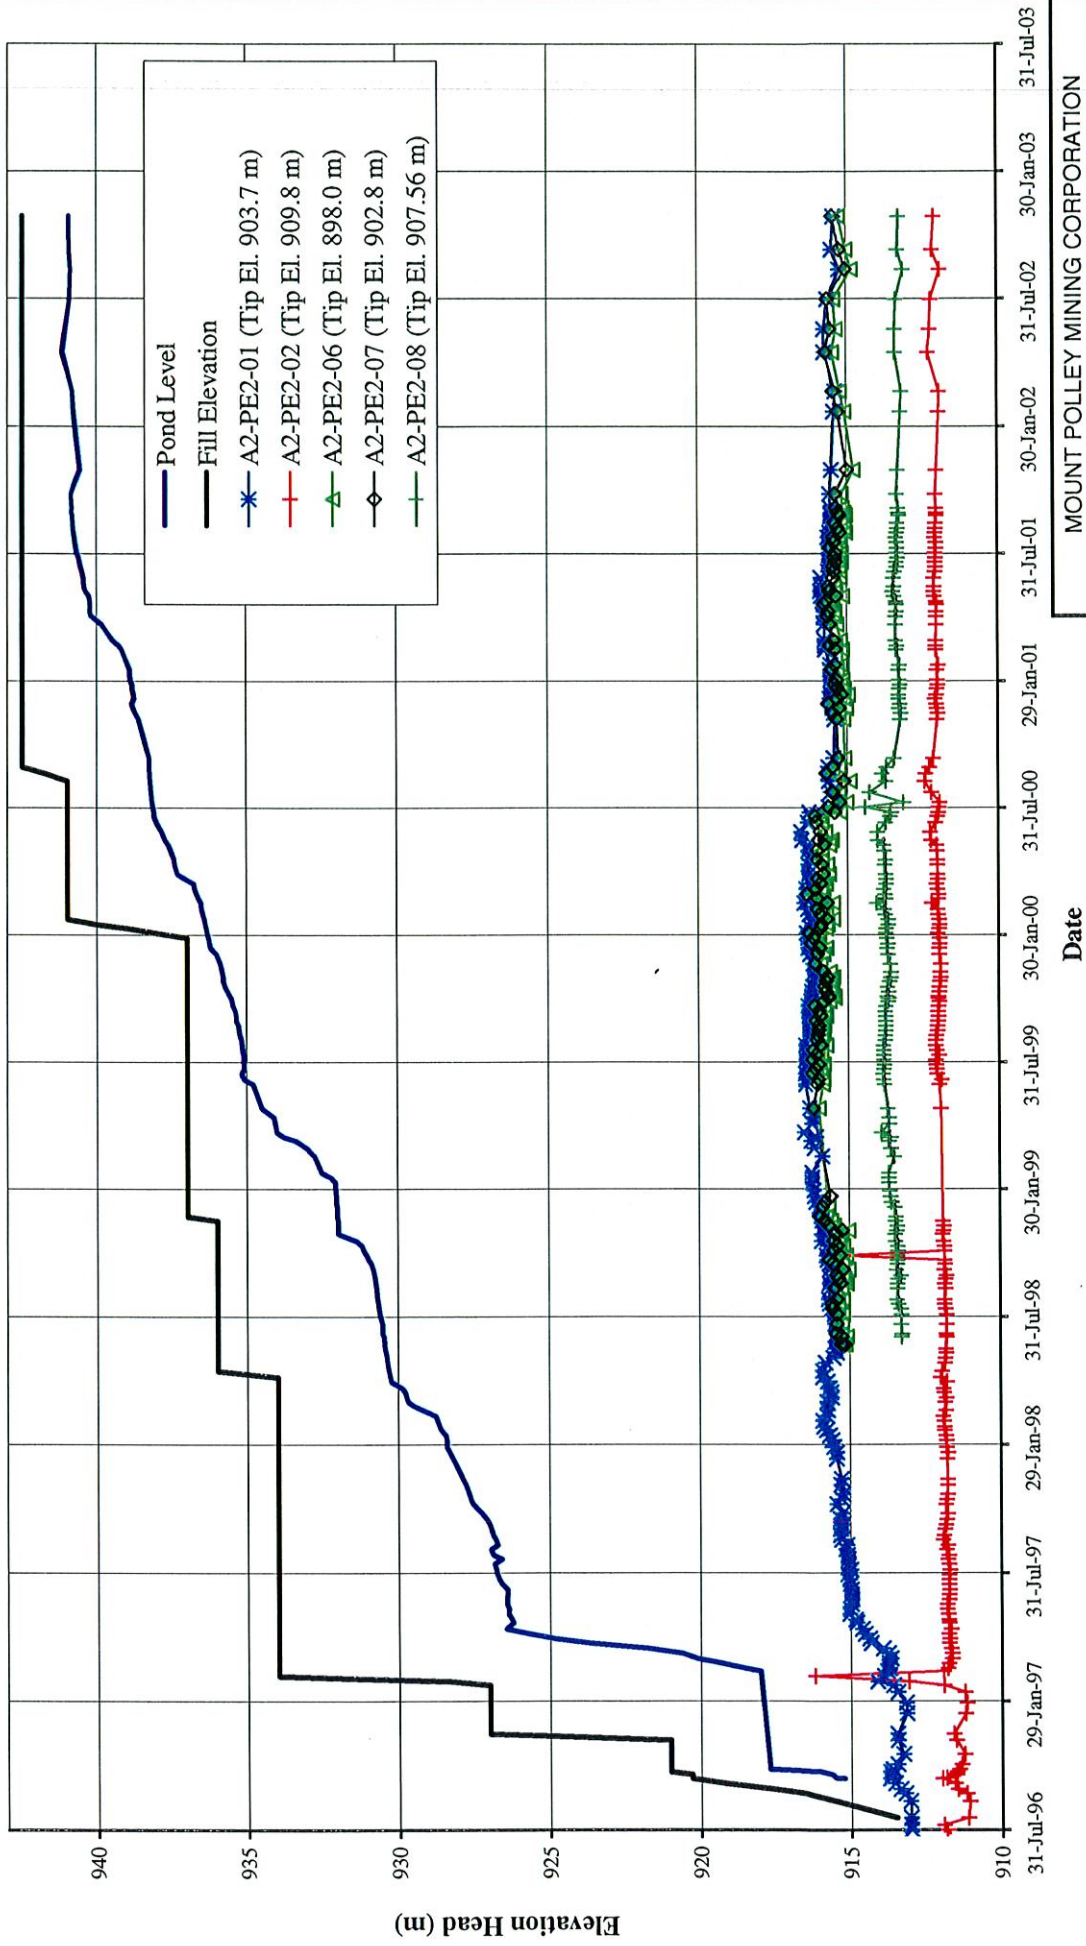
MOUNT POLLEY MINING CORPORATION	
MOUNT POLLEY MINE	
PLANE A FOUNDATION PIEZOMETERS ELEVATION HEAD vs. TIME	
<i>Knight Piésold</i> CONSULTING	
PROJECT / ASSIGNMENT	101-1/1
REF. NO.	1
REV.	0
FIGURE B2-1

Artesian conditions are present in the foundation under the Main Embankment. The piezometers in this area are used to monitor the pore pressures and to confirm that they remain below the threshold level of 6 metres above ground level (KP Ref. No. 1162/7-2). No unexpected high pore pressure increases were noted during the reporting period. The table below summarizes the maximum artesian head values (above ground surface level) reached during the reporting period.

Although the highest level recorded is 4.22 m, none have reached the foundation piezometer trigger level of 6.0 m artesian pressure relative to original ground. All stability analyses completed at the Main Embankment (KP Ref. No. 1162/7-2) use an artesian pressure of 6.0 m for the

It has been noted that artesian pressures have typically developed in the deeper piezometers, at elevations below El. 910 m. This corresponds roughly to the top of the glaciolacustrine/glaciofluvial material and these artesian pressures are therefore not unexpected (Planes A, B and C). It should also be noted that no artesian conditions have been encountered at Plane E, where coarser glaciofluvial material is present.

During operation of the mine, a trend that developed was that many of the pore pressures of the foundation piezometers increased slightly over time. This was likely due to tailings deposition and a rising pond level. While in the period of Care and Maintenance, this trend has levelled off, and the foundation piezometer levels have become steady.

- Continue regular monthly monitoring of the vibrating wire piezometers and drain flows (Foundation Drains and Upstream Toe Drain) during the Care and Maintenance period.
