**MOUNT POLLEY MINING CORPORATION
MOUNT POLLEY MINE**

**TAILINGS STORAGE FACILITY
REPORT ON 2004 ANNUAL INSPECTION
(REF. NO. VA101-01/7-1)**

Les Galbraith, P. Eng., of Knight Piésold Ltd. completed an inspection of the Tailings Storage Facility and associated works on August 30 2004.

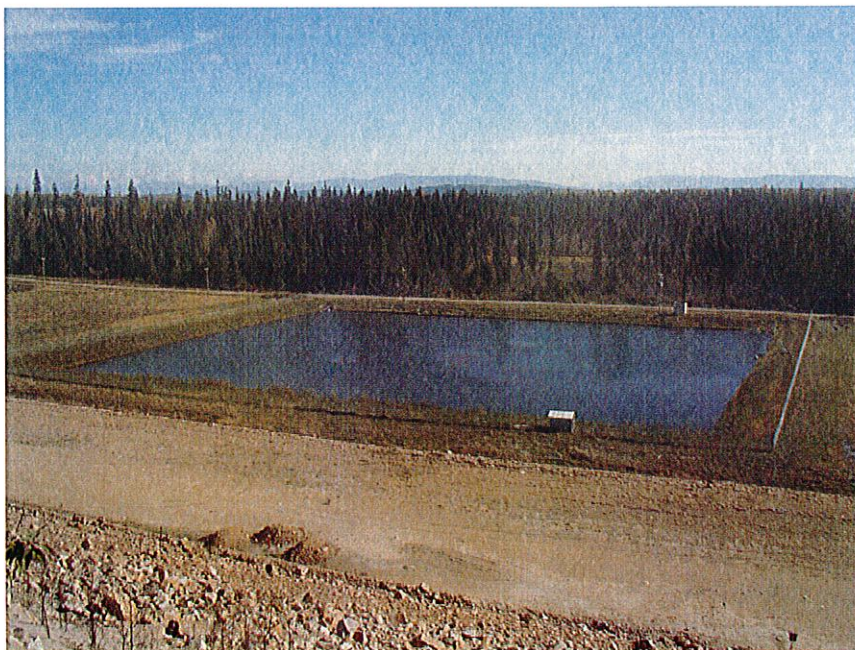
PHOTO 1 – Main Embankment Seepage Collection Pond.

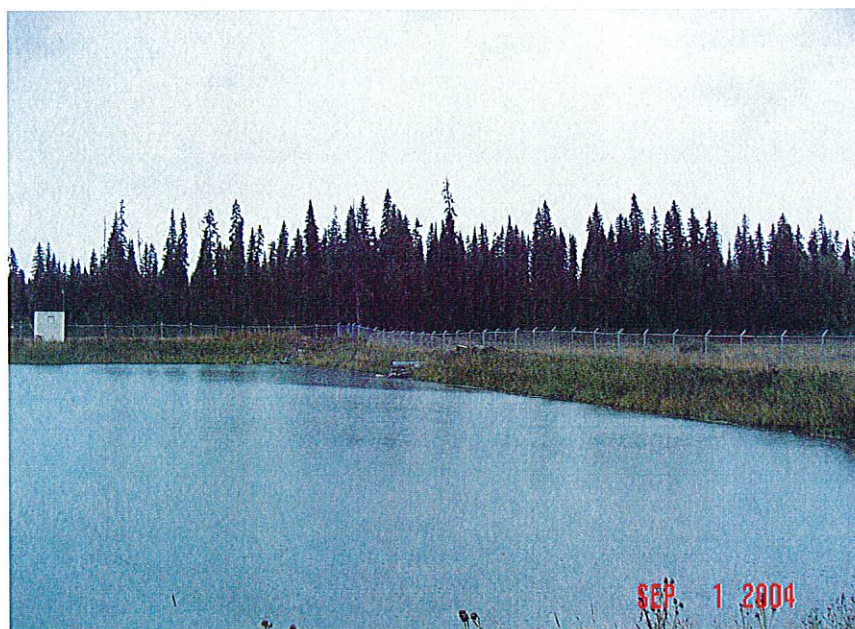
No seepage associated with the embankments was observed during the inspection.

PHOTO 2 – Main Embankment and Seepage Collection Pond.

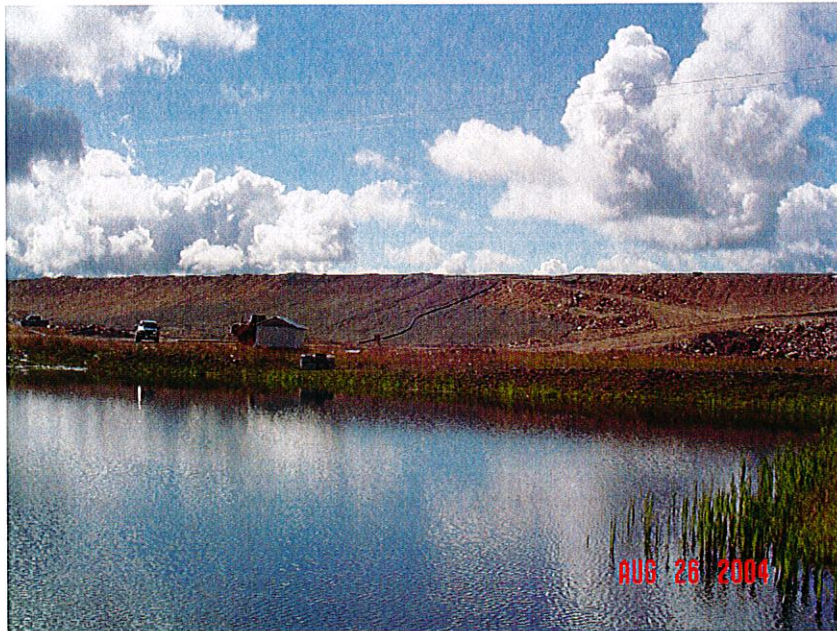
PHOTO 3 – Perimeter Embankment Seepage Collection Pond.

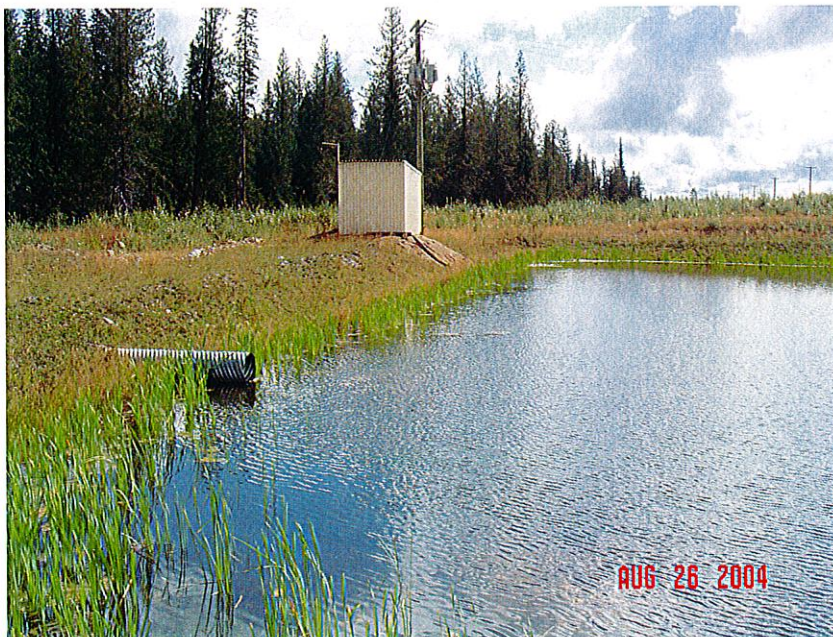
PHOTO 4 – Perimeter Embankment and Seepage Collection Pond.

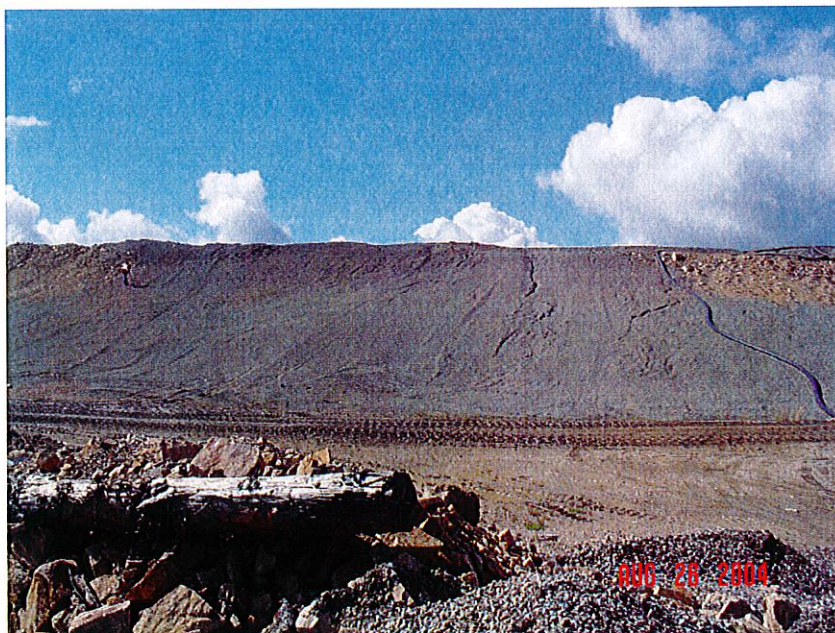
PHOTO 5 – Perimeter Embankment cyclone sand test section before new construction and upgrades.

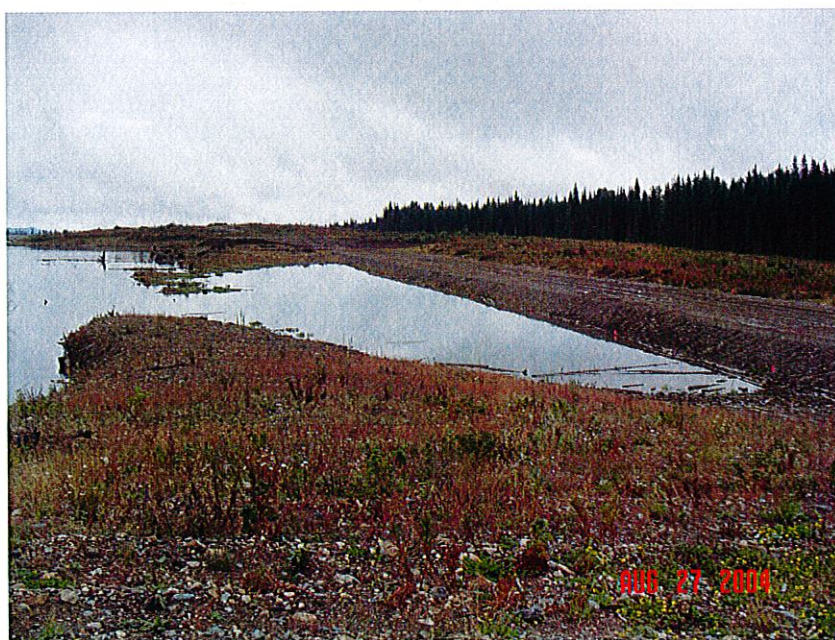
PHOTO 6 – South Embankment.

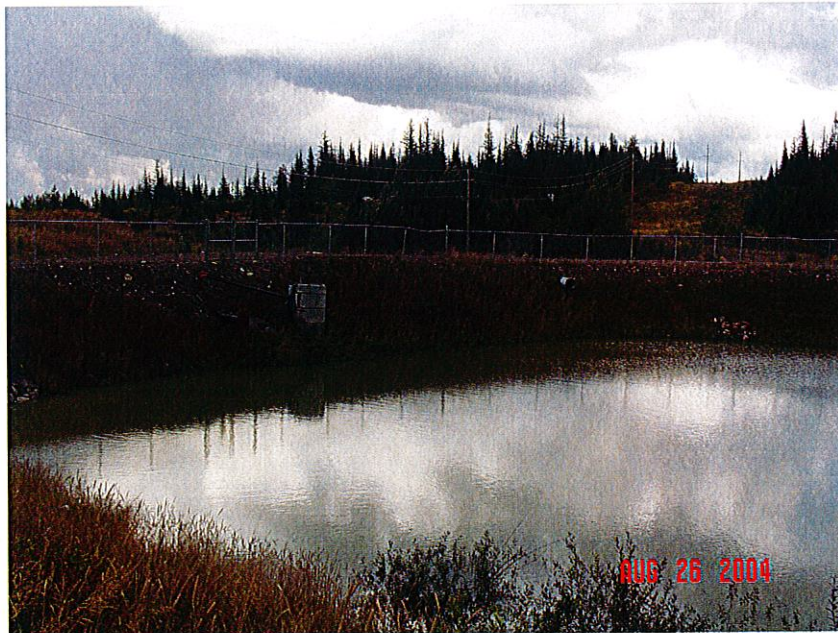
Surface water from the Open Pit and Mill Site Areas is routed into the mill-site sump where it is transferred to the TSF via the tailings pipeline. The embankments at the Millsite Sump were observed to be in good shape, and no cracks, seepage or slumping was noted. The emergency overflow culvert was clear of obstructions, however the spillway was showing signs of erosion and should be repaired. The erosion occurred during an extensive clean-up program at the mill site in preparation for start-up and is unlikely to happen again.

PHOTO 7 – Millsite Sump

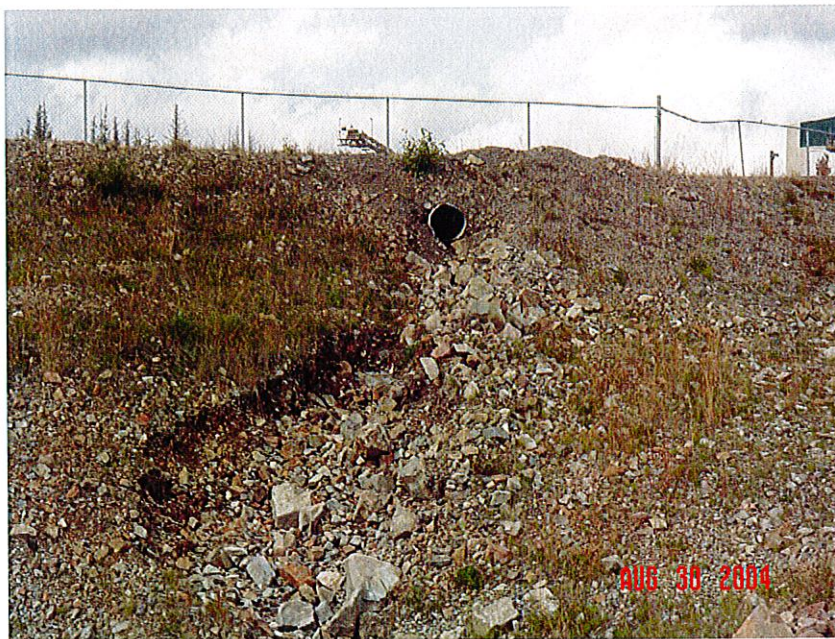
The Southeast Sediment Pond, Millsite Sump, and South Bootjack Dam were observed to be in a good condition with no geotechnical issues outstanding. However the Millsite Sump spillway was showing signs of erosion and should be repaired.

PHOTO 8 – Millsite Sump Spillway showing signs of erosion.

- Repair the spillway at the Millsite Sump.
- Lower the water level in the Main Embankment Drain Monitoring Sump so that the flows from the Foundation and Upstream Toe Drains can be monitored at the required frequency.

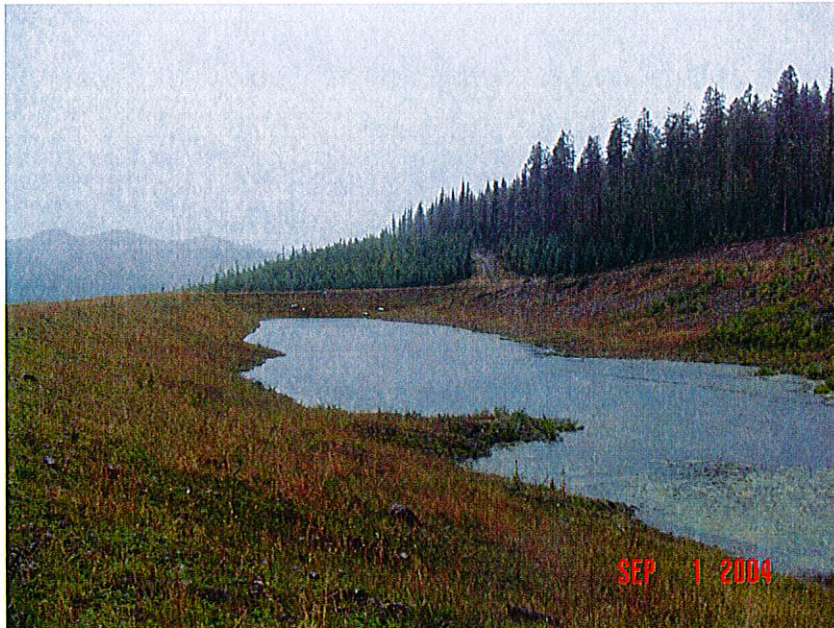
- No seepage was observed for the embankments.
- Water flowing in the ditch was clear.
- The overflow culvert for the pond was clear of obstructions.
- The embankment fill slopes (inside and outside) looked to be in very good shape, with no signs of instability. No cracks were observed on the crest. No seepage or slumping of the slopes was observed.
- Grassy re-vegetation has become well established on the downstream embankment slopes.

PHOTO 9 – Southeast Sediment Collection Pond.

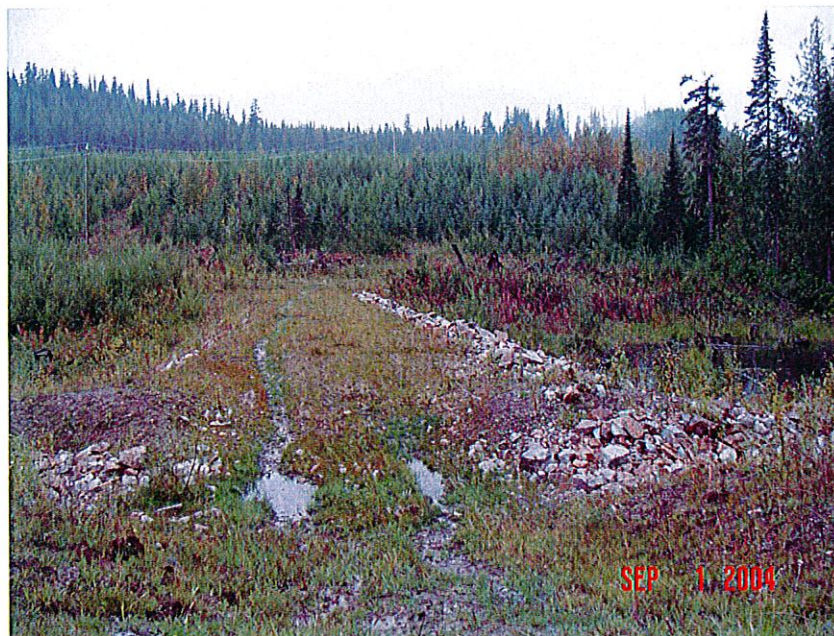
- The water level was low.
- Both upstream and downstream fill slopes were in good condition, with no evidence of seepage or slumping.
- No cracks were observed on the dam crest.
- The spillway contained some minor vegetation, but was generally unobstructed.

PHOTO 10 – South Bootjack Dam.

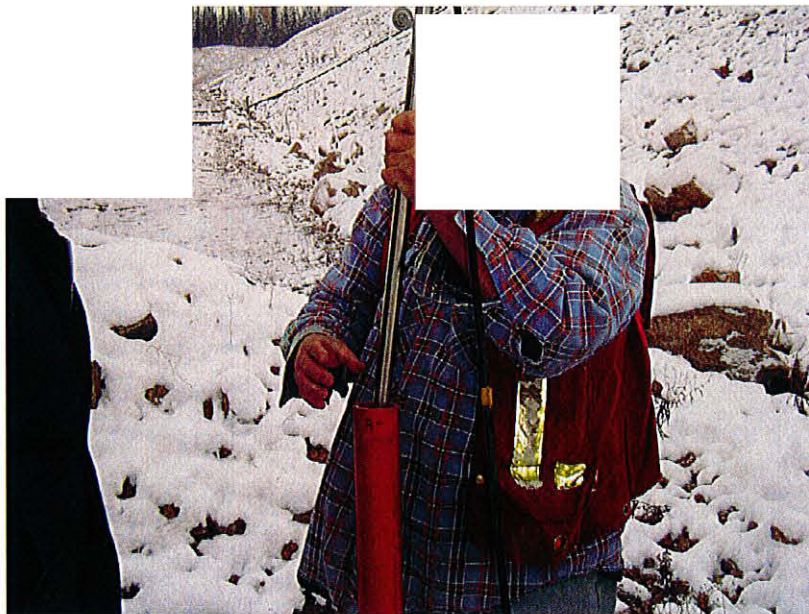
PHOTO 11 – Slope indicator tests.

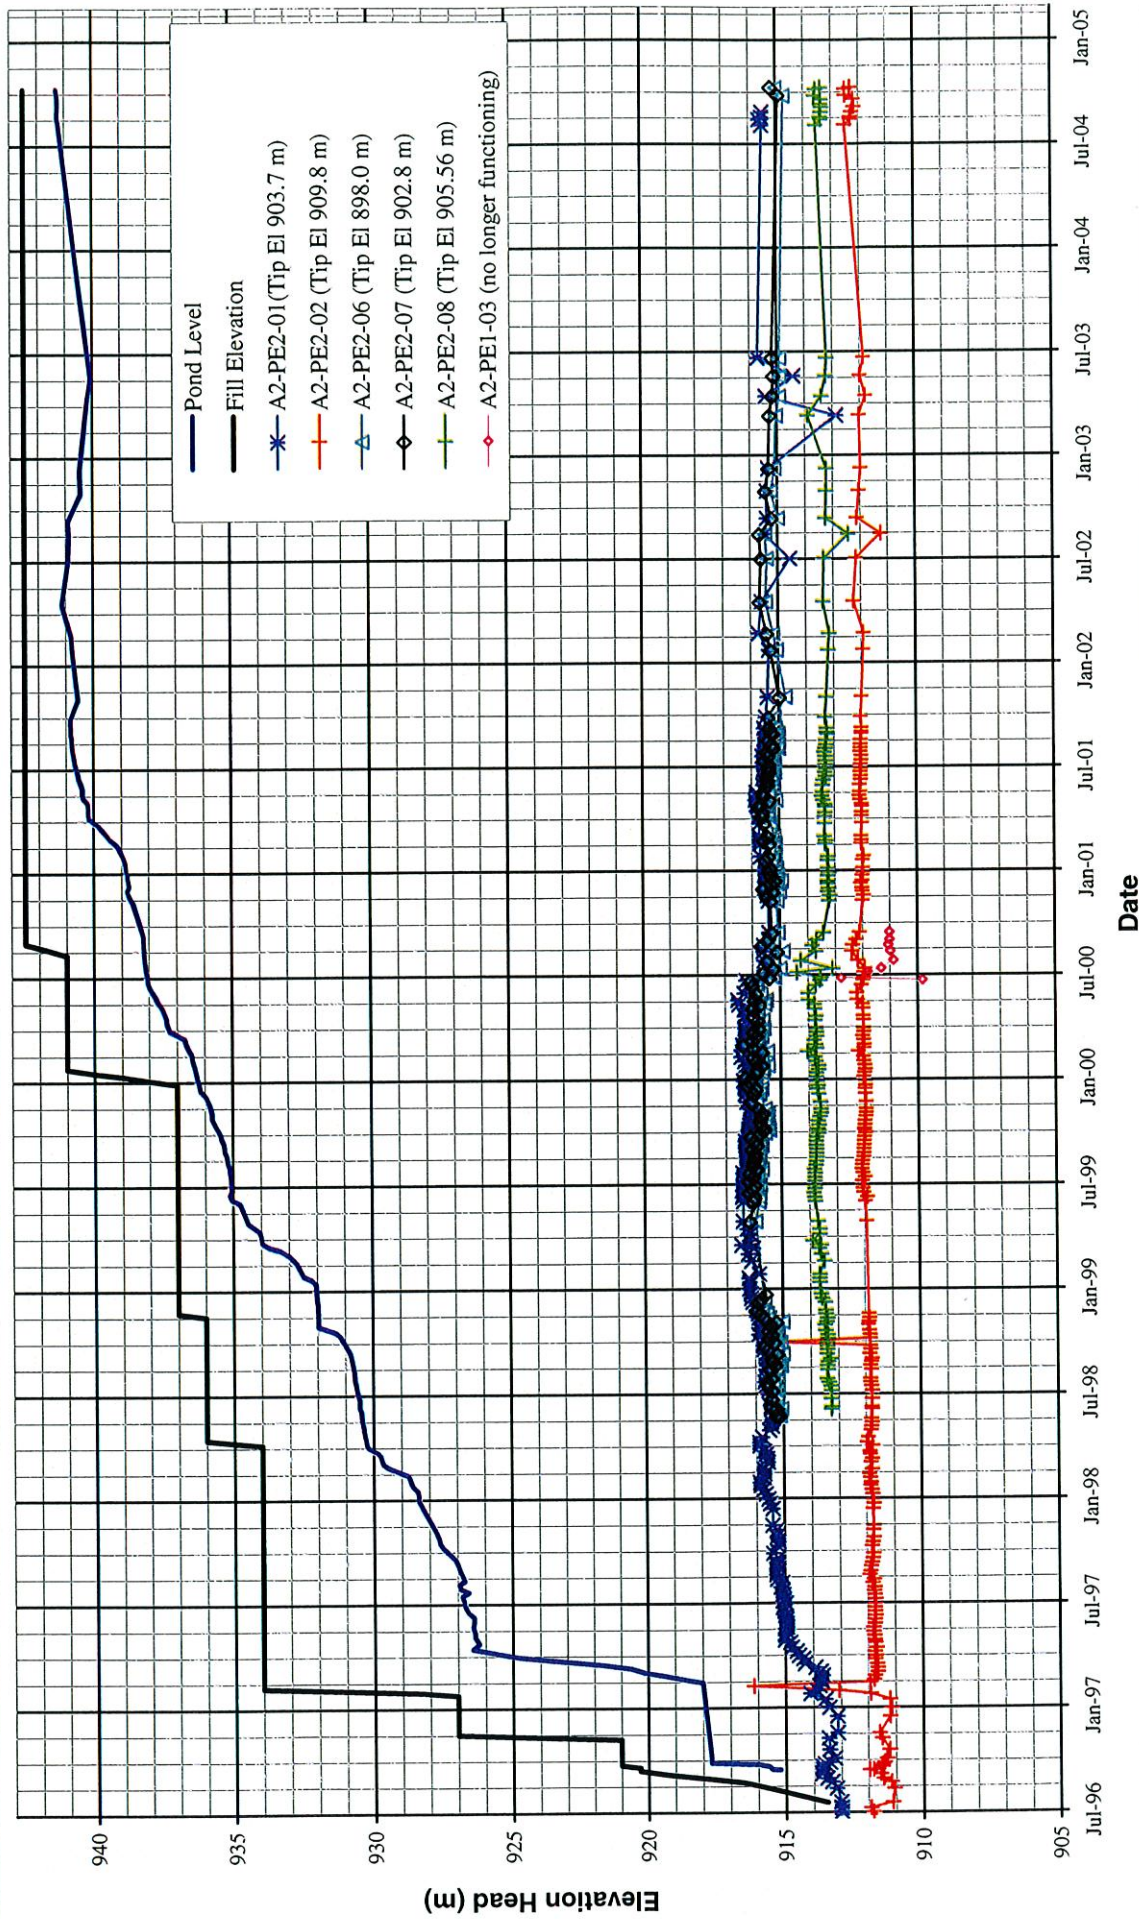
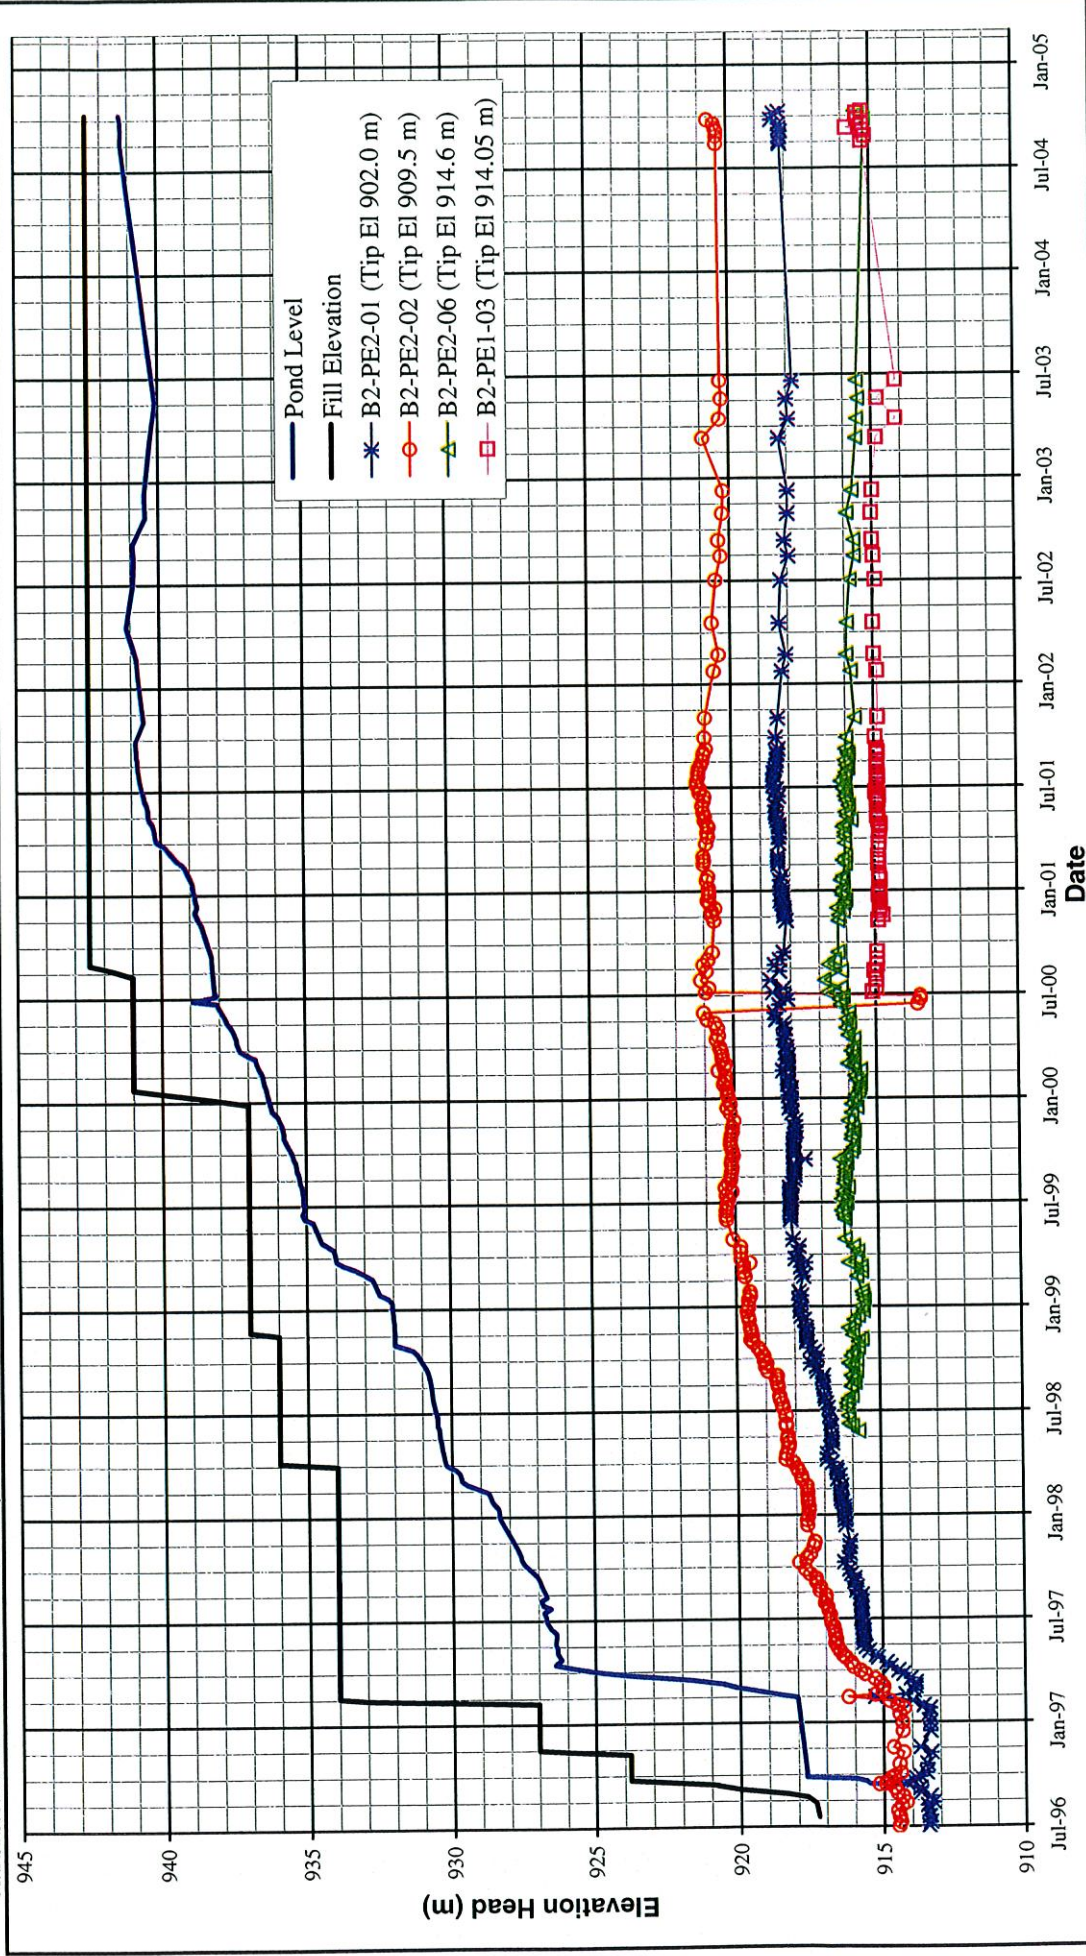
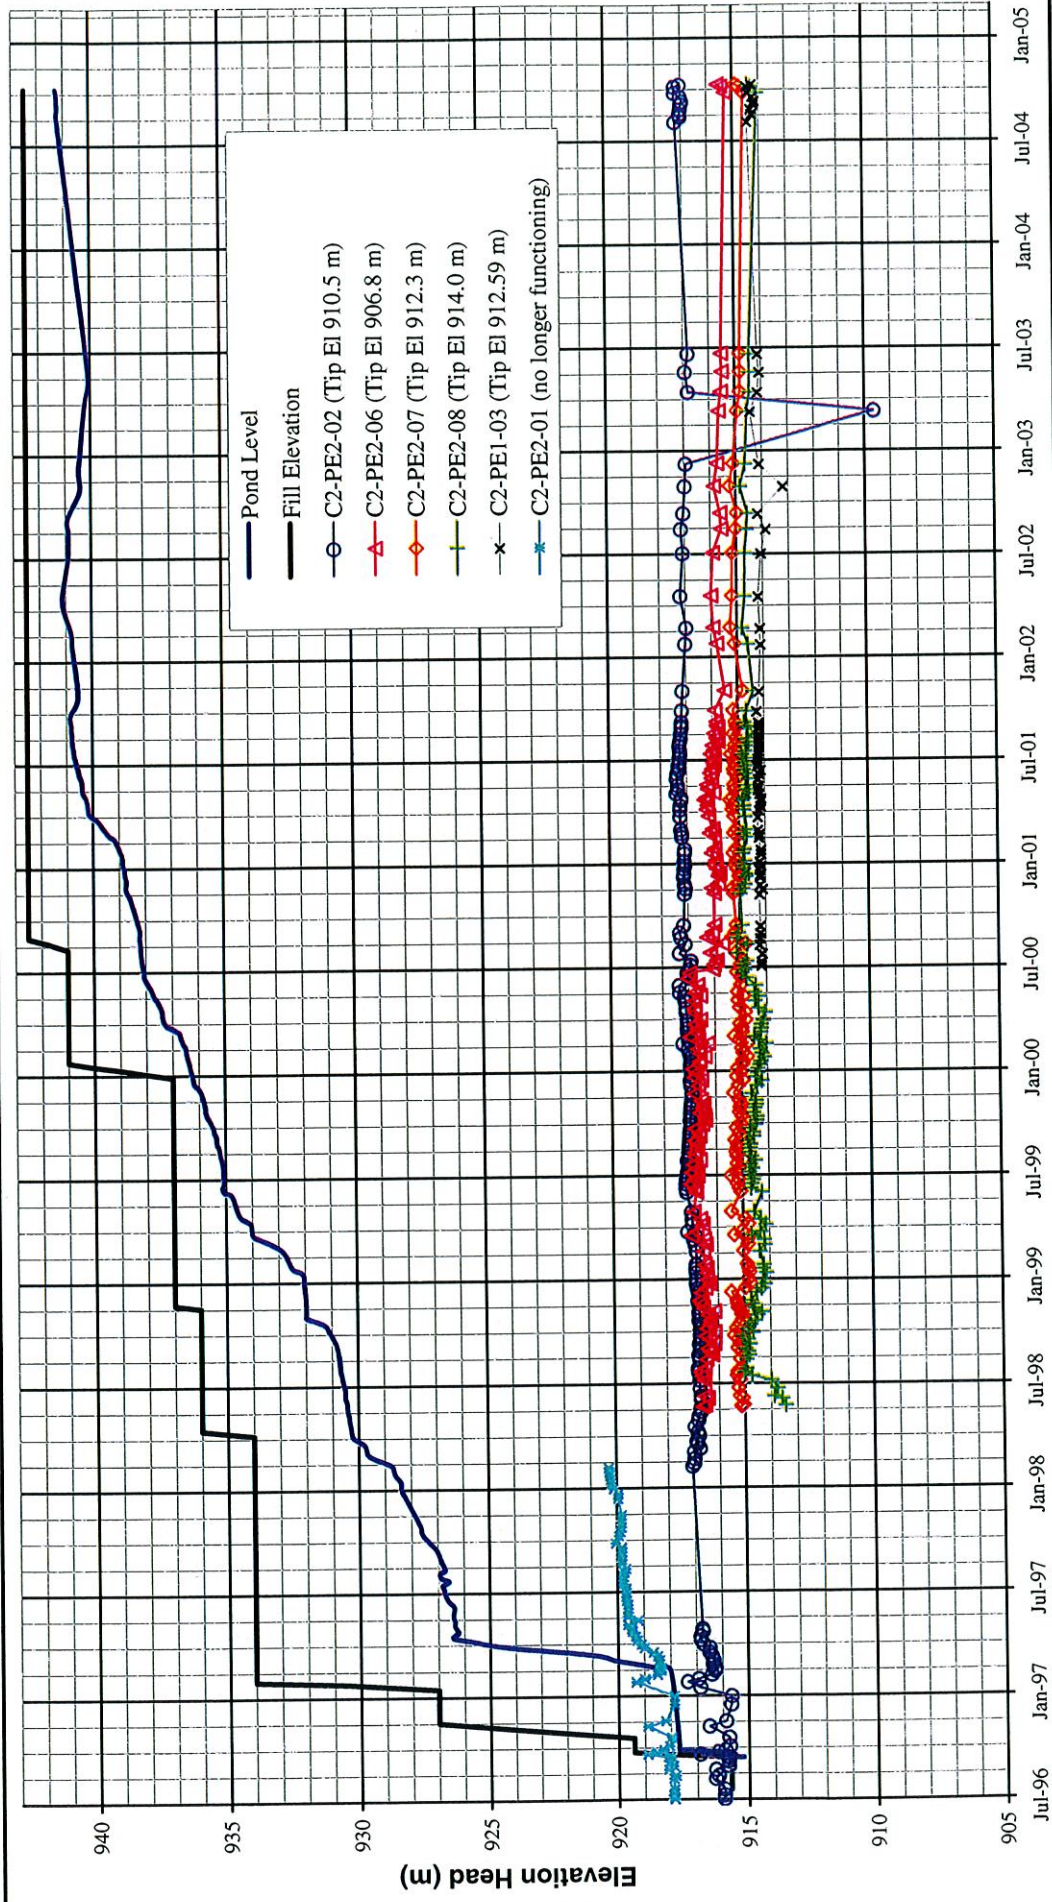
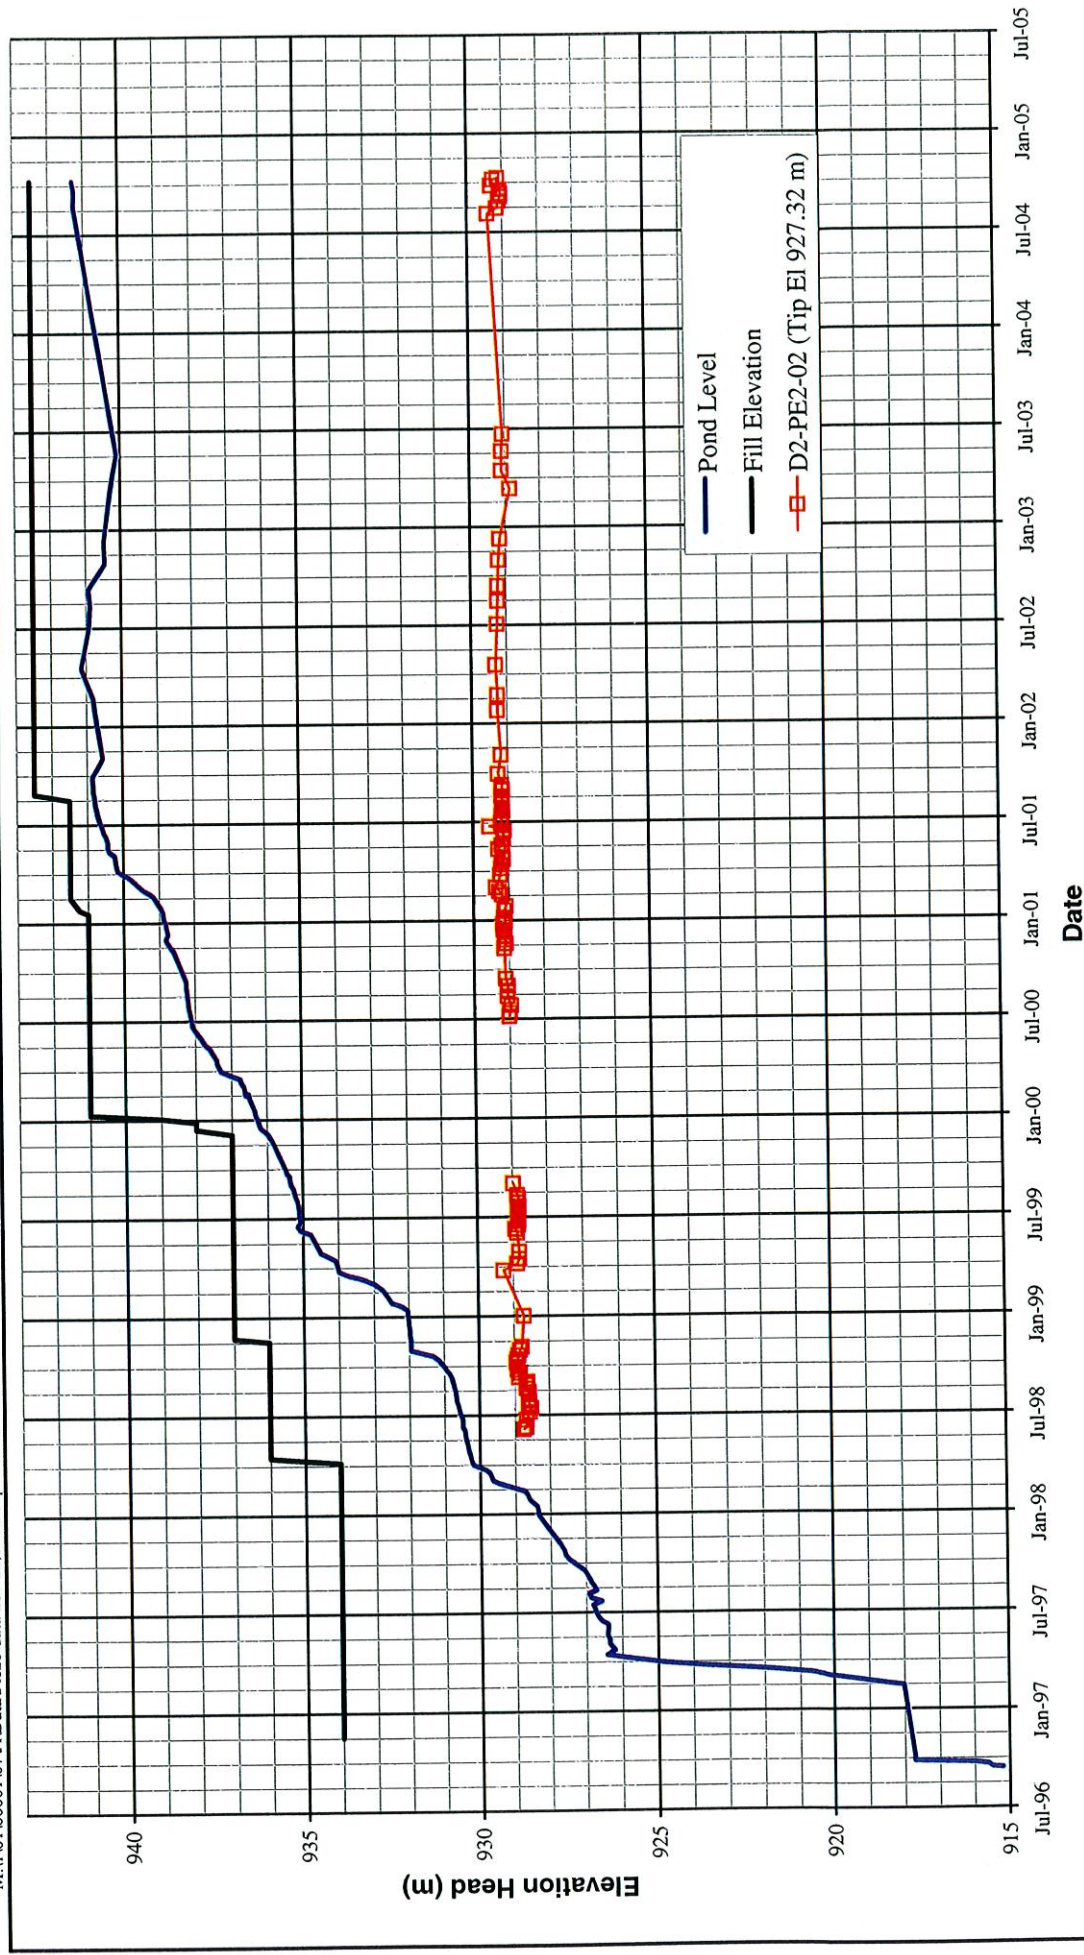
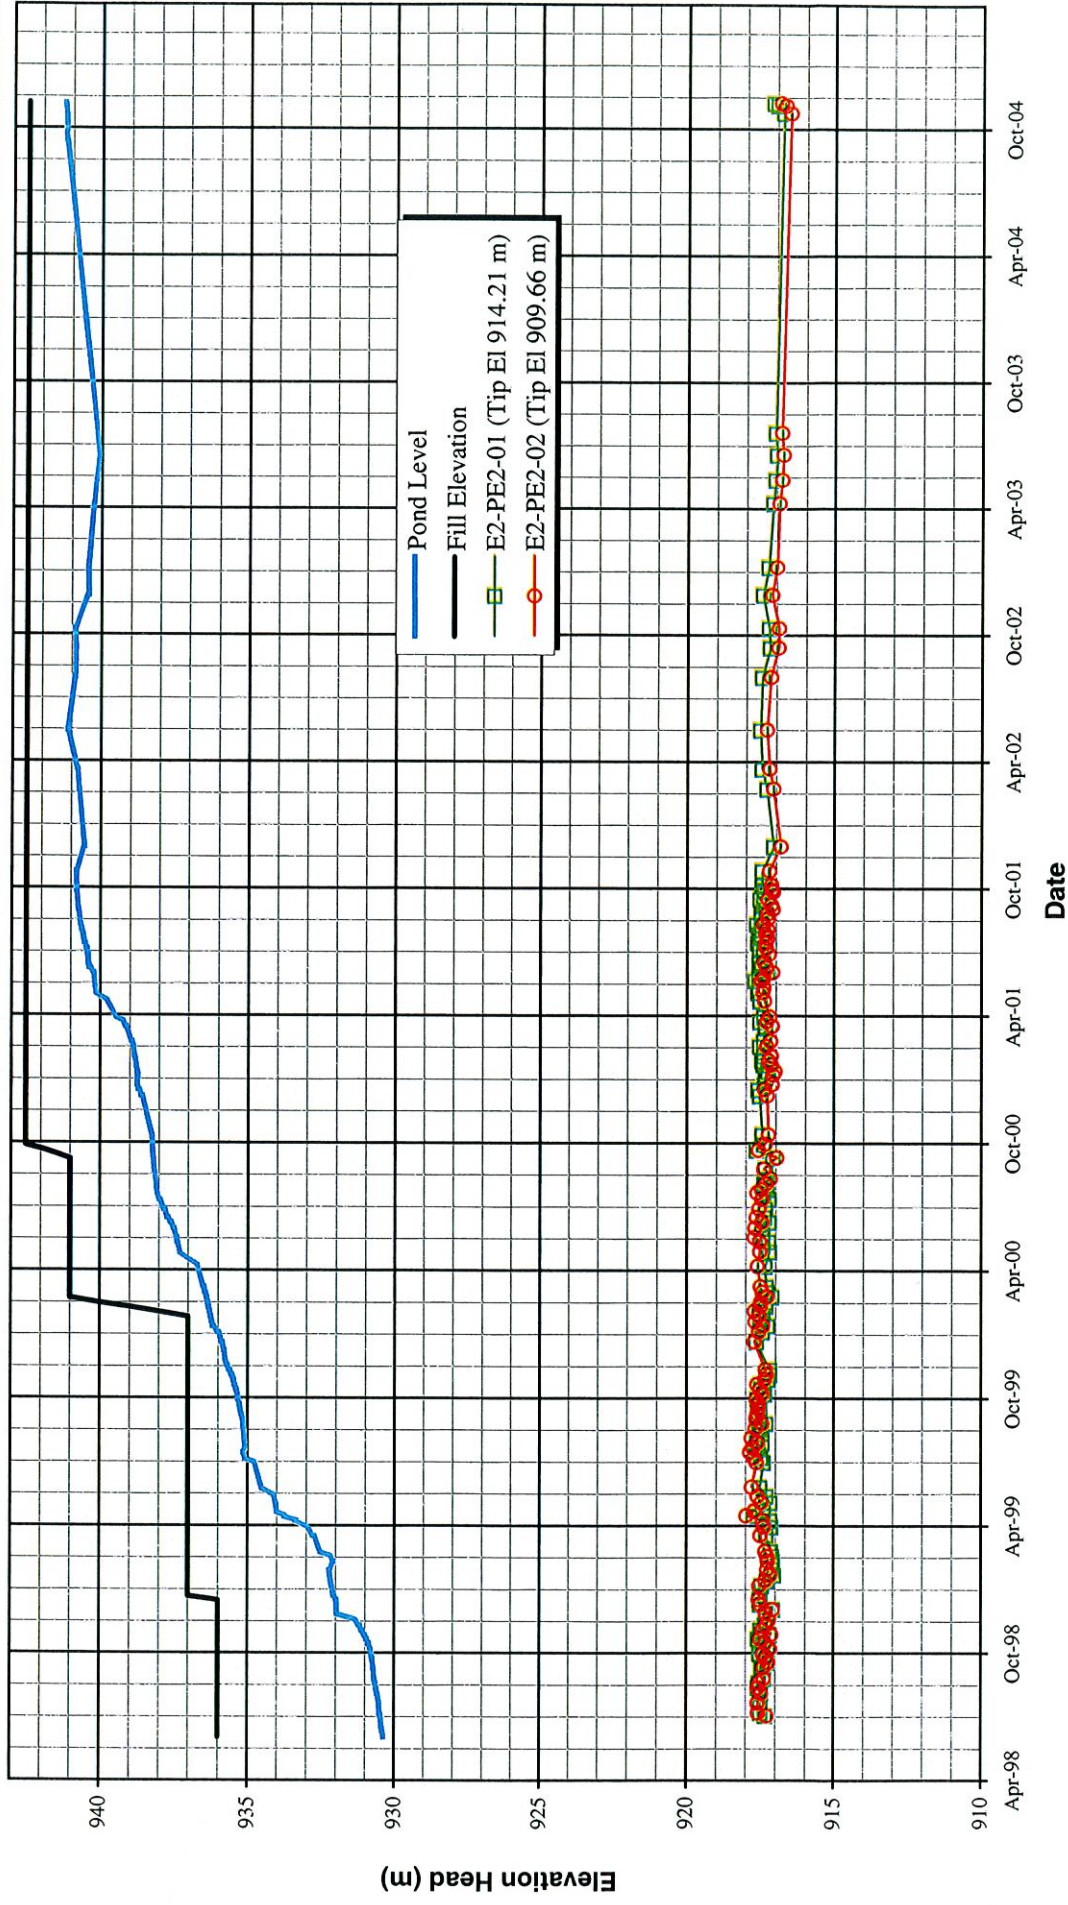
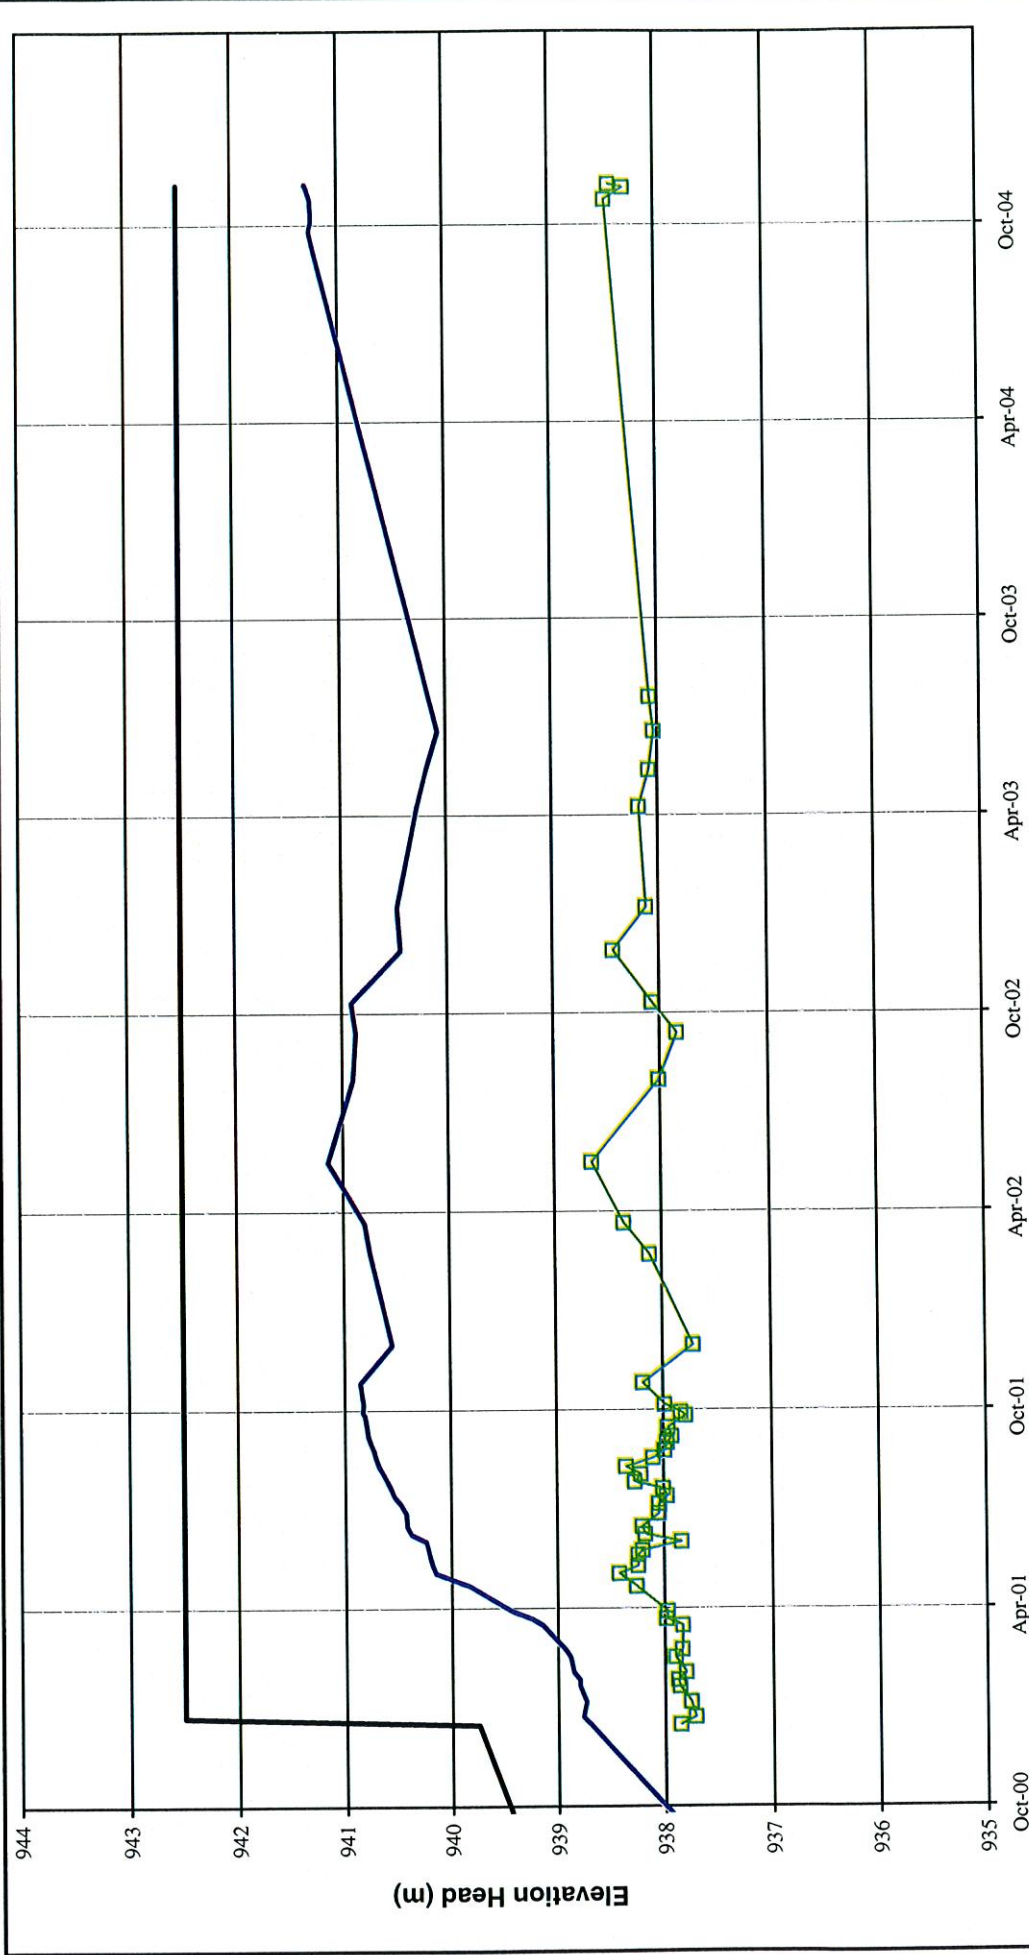
Artesian pressures have remained relatively constant in all the piezometers during the reporting period. No artesian conditions have been encountered at Plane E, where coarser glaciofluvial material is present.

The pore pressures of the foundation piezometers increased slightly over time during previous mine operations. This was likely due to elastic loading of the aquifer and/or seepage recharge from the TSF. However, seepage was minor as evidenced by foundation drain records.

Timeline plots of the embankment foundation piezometers are included in Appendix B2. There are no concerns with the embankment foundation piezometers.
