**MOUNT POLLEY MINING CORPORATION
MOUNT POLLEY MINE**

**TAILINGS STORAGE FACILITY
REPORT ON 2005 ANNUAL INSPECTION
(REF. NO. VA101-01/11-1)**

Rev. No.	Revision	Date	Approved
Rev 0	Issued in Final	May 3, 2006	K.I.B.

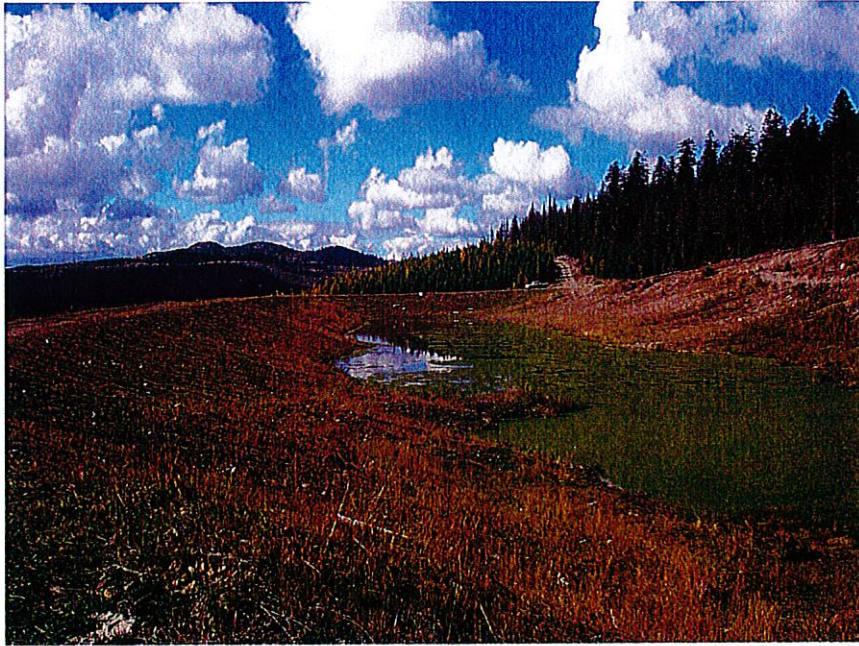
PHOTO 1: Southeast Sediment Control Pond

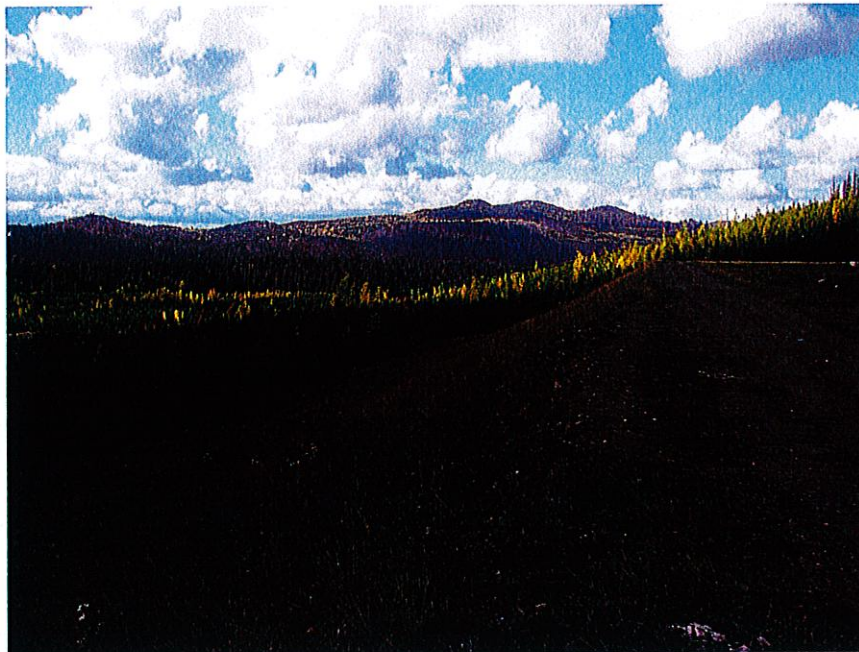
PHOTO 2: Southeast Sediment Control Pond crest and downstream slope.

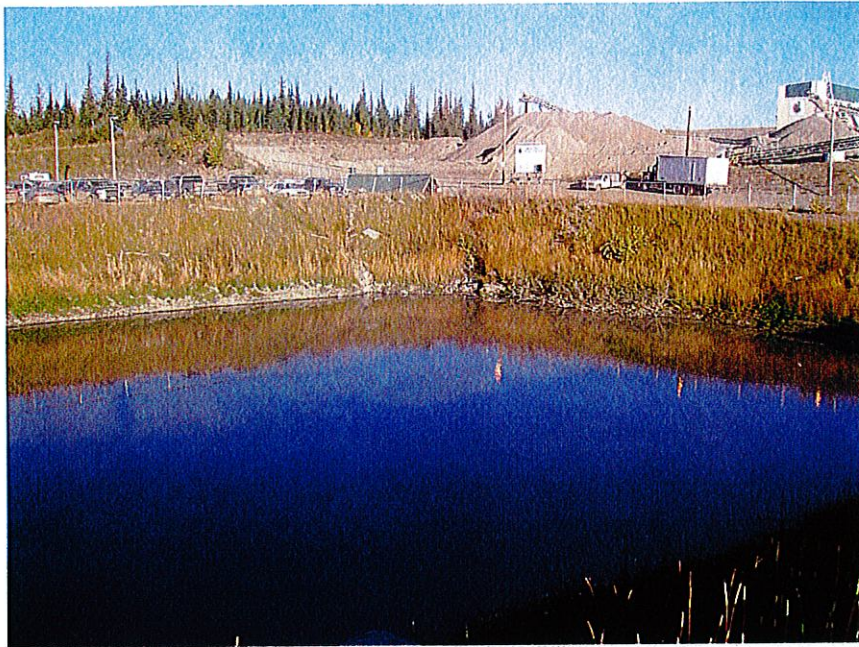
Surface water from the Bell and Cariboo Pits and Mill Site Area is routed into the mill-site sump where it is transferred to the TSF via the tailings pipeline. The embankments at the Millsite Sump were observed to be in good shape, and no cracks, seepage or slumping was noted. The emergency overflow culvert was clear of obstructions, however the spillway showed signs of erosion and should be repaired. The erosion occurred during an extensive clean-up program at the mill site in 2004 prior to start-up and is unlikely to happen again. The repair of the millsite spillway is an outstanding recommendation from the 2004 Annual Inspection Report.

PHOTO 3: Millsite Sump.

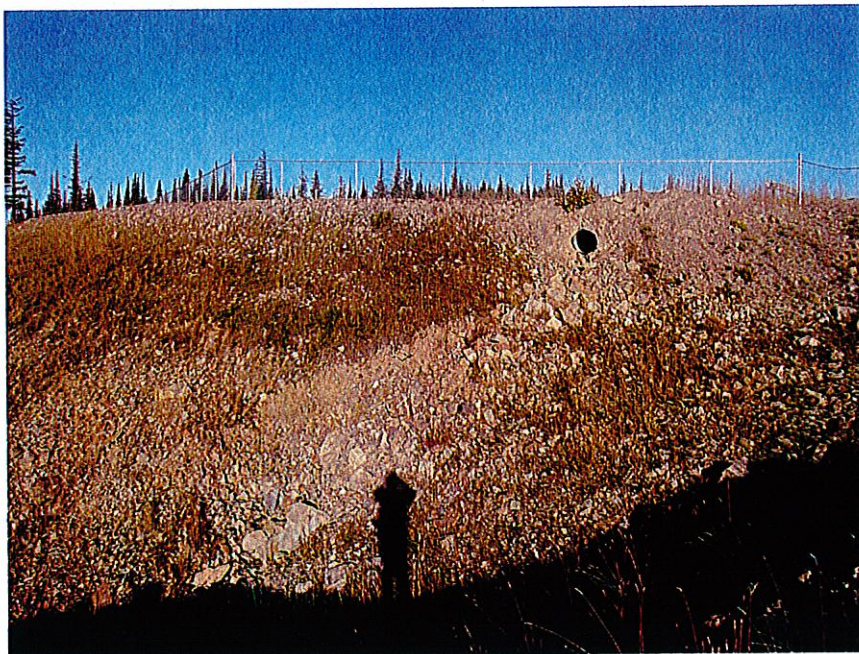
observed to be in a good condition with no geotechnical issues outstanding. However the Millsite Sump spillway was showing signs of erosion and should be repaired.

PHOTO 4: Millsite Sump Spillway showing signs of erosion

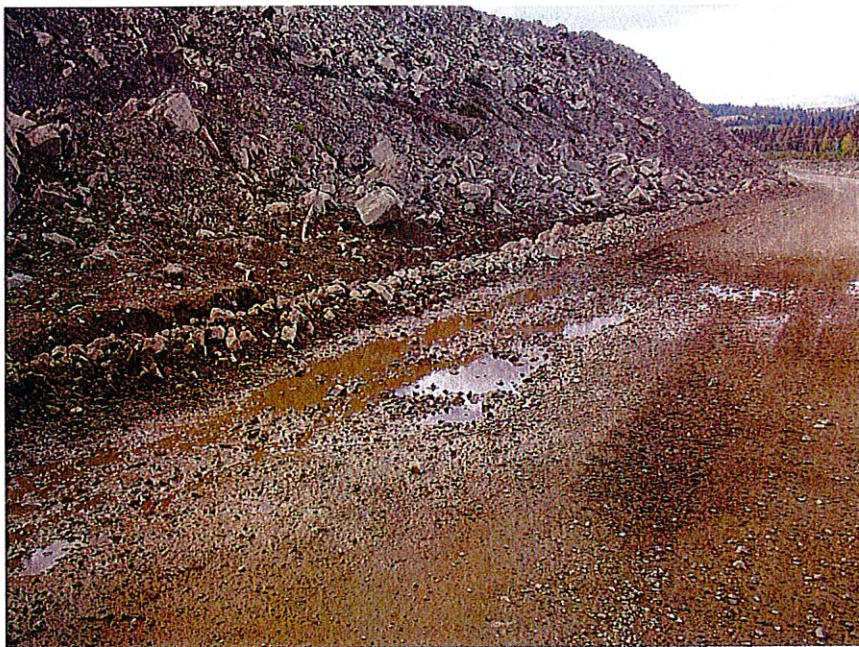
No major unexpected or uncontrolled seepage was observed from the embankments. The small amount of seepage observed at the base of the Perimeter Embankment between chainages 29+00 to 32+00 is being routed to the Perimeter Embankment Seepage Collection Pond.

PHOTO 5: Minor seep at the Perimeter Embankment. Seepage routed to the Perimeter Embankment Seepage Collection Pond.

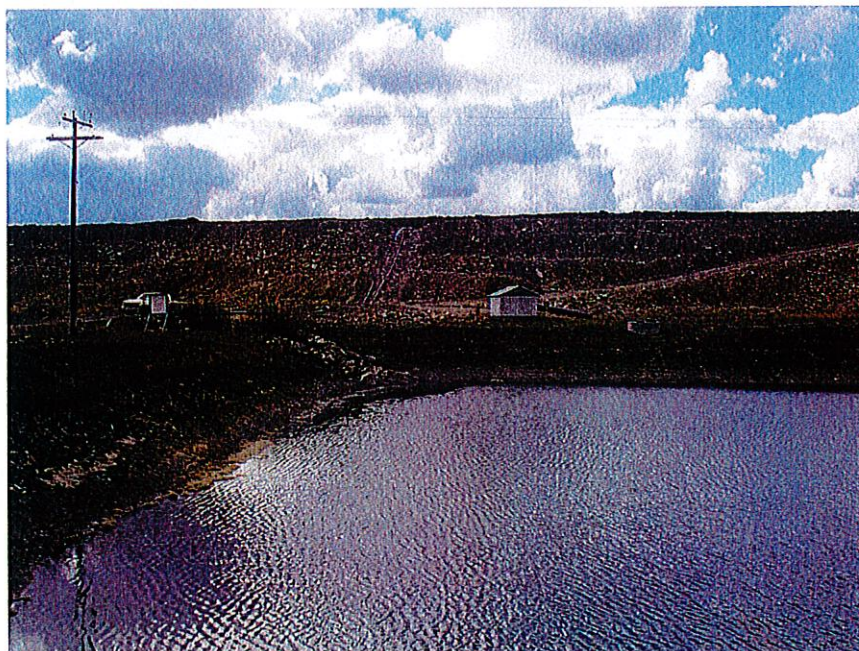
PHOTO 6: Perimeter Embankment with the Perimeter Embankment Seepage Collection Pond in the foreground.

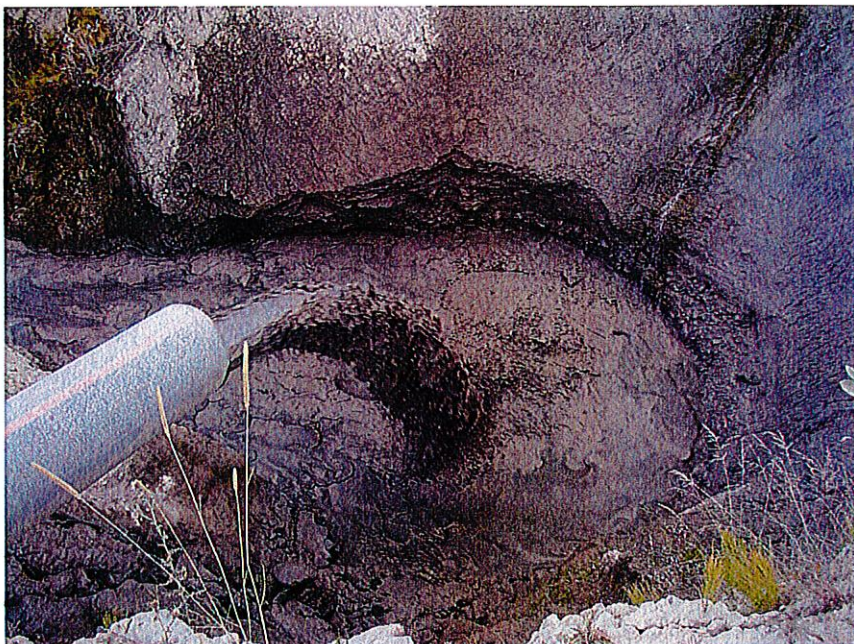
PHOTO 7: Single point discharge into the TSF at the knife gate valve located at the west end of the Perimeter Embankment.

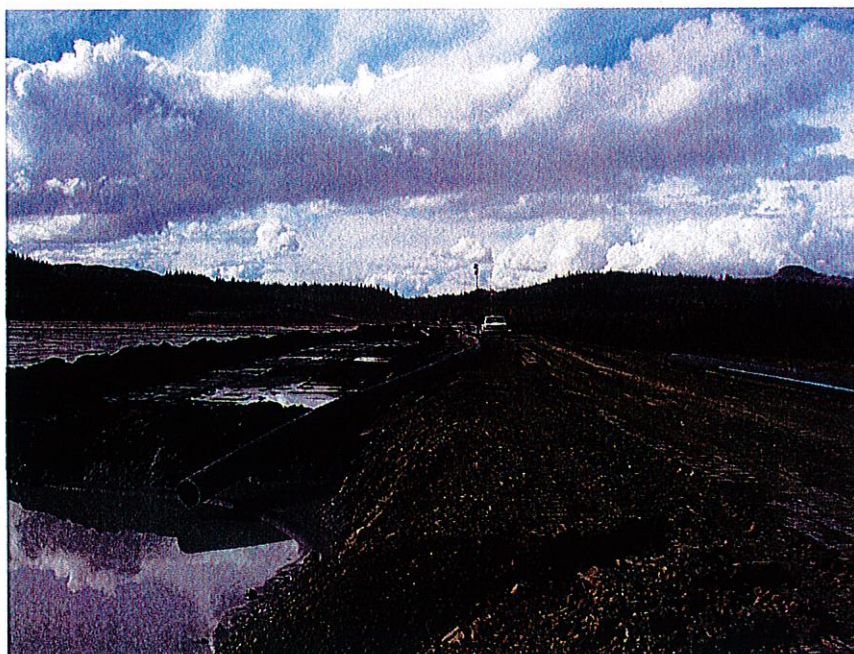
PHOTO 8: Perimeter Embankment. Construction of Zone U using the coarse tailings sand.

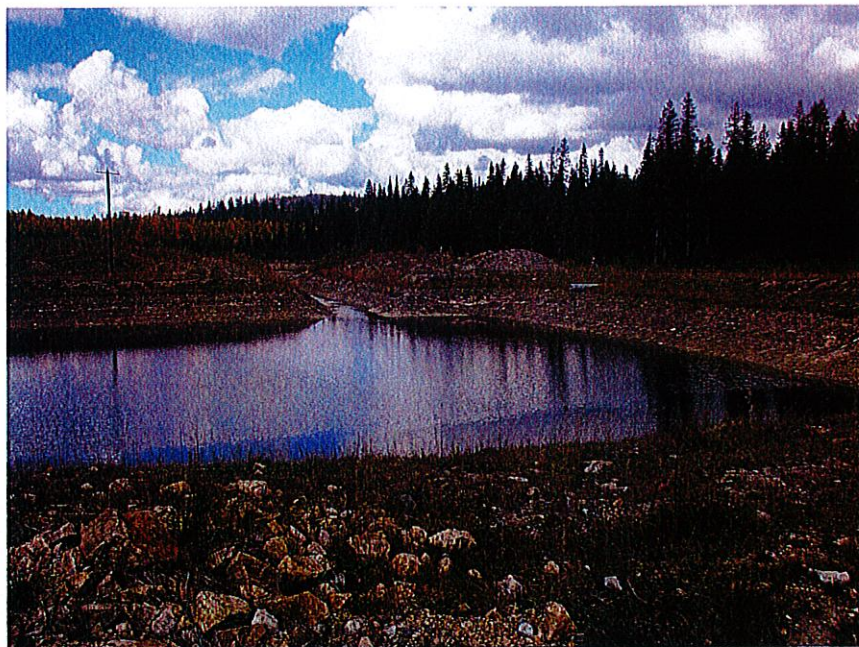
PHOTO 9: Perimeter Embankment seepage collection pond.

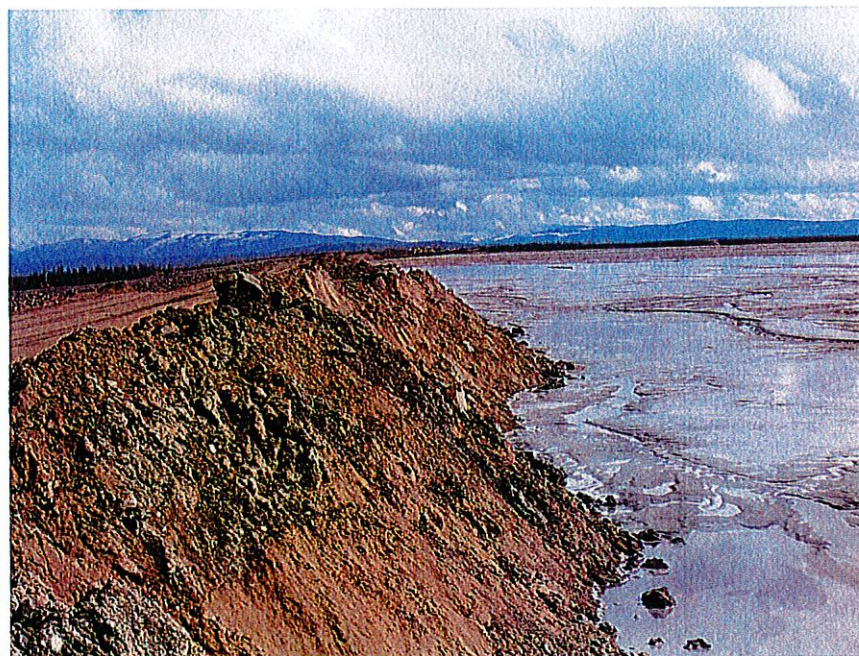
PHOTO 10: Perimeter Embankment. Confining berm used for the construction of the Zone U section using coarse tailings sand.

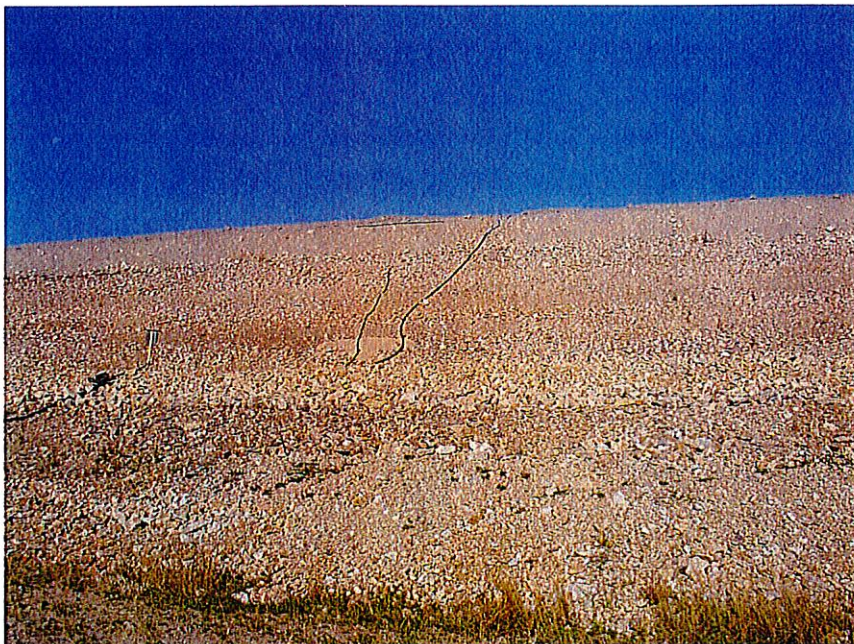
PHOTO 11: Main Embankment downstream slope.

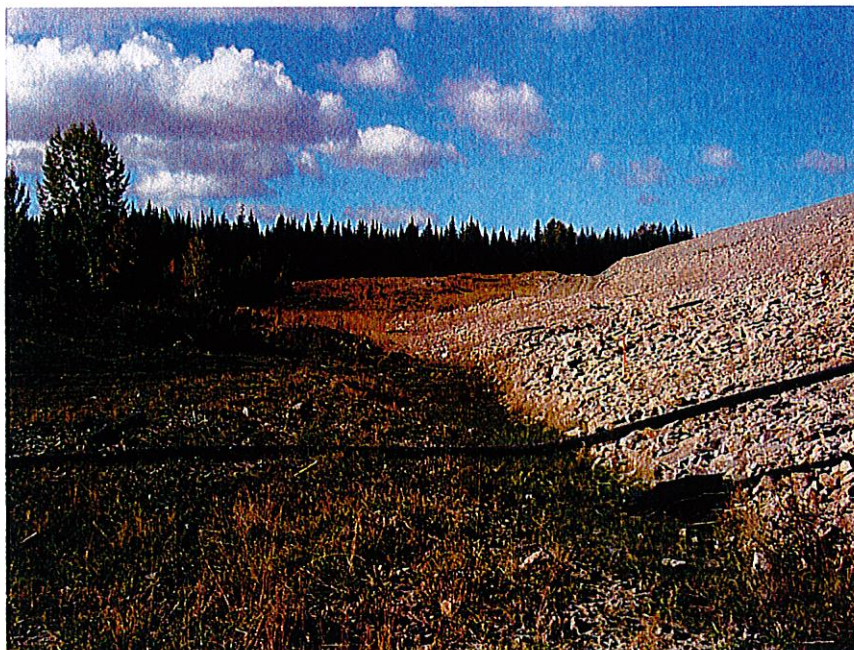
PHOTO 12: Main Embankment downstream toe.

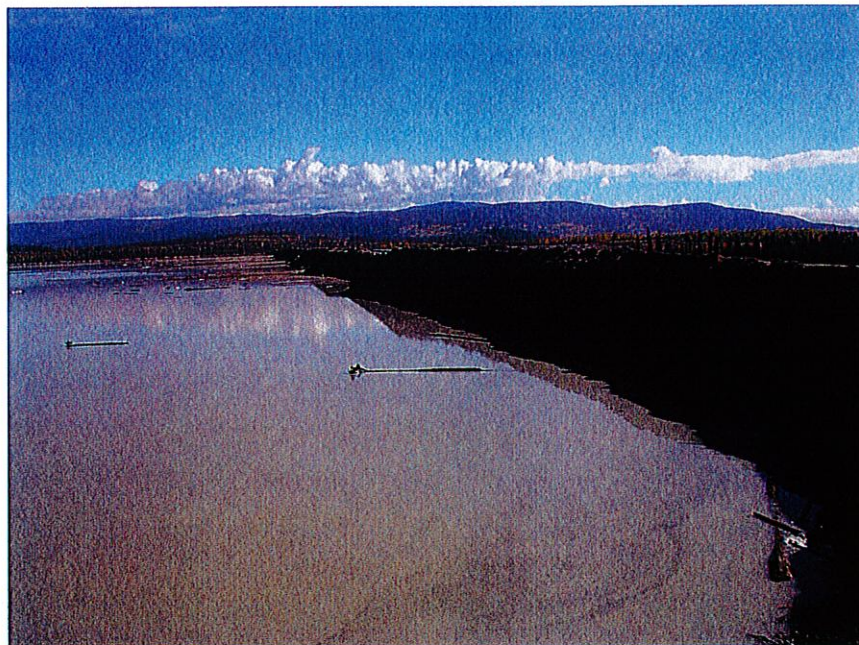
- No signs of instability were observed in the embankment fill slopes.
- The Tailings Pond was against the west end of the Main Embankment (app. chainage 16+00 to 19+00). This was the result of prolonged discharge of tailings from the Perimeter Embankment and from the knife gate valve. The most efficient use of the TSF is made when tailings can be evenly distributed from around the perimeter of the facility. Evenly discharging the tailings from around the facility optimizes the development of

tailings beaches and keeps the supernatant pond clear of the embankments, thereby increasing seepage paths and limiting seepage loss from the facility. Beached tailings, when left to drain and consolidate, form the competent foundation needed for the modified centreline construction of embankment raises.

PHOTO 13: Main Embankment with the tailings pond up against the Zone U material.

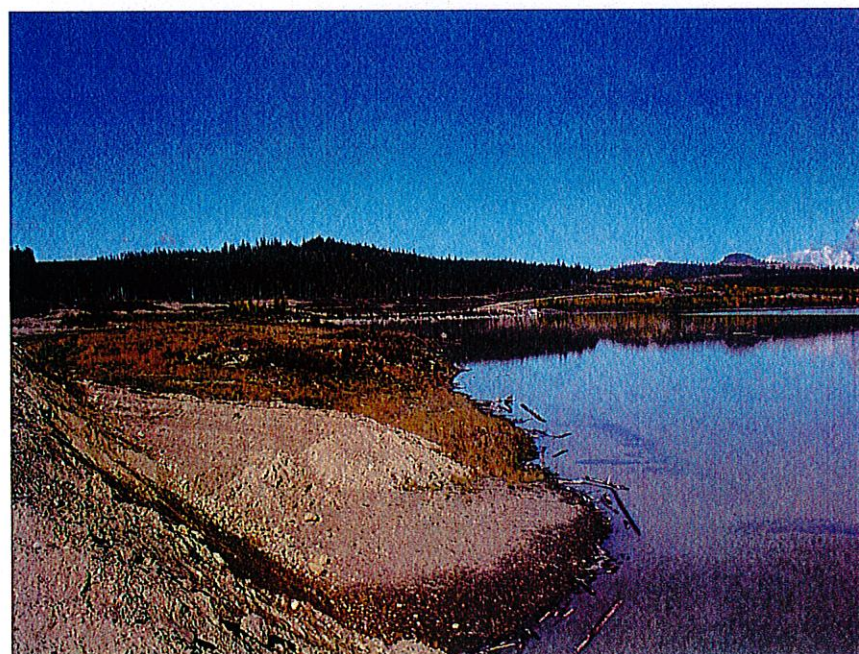
PHOTO 14: Knoll between the Main and South Embankments where the basin liner investigation was required.

- The knoll between the Main and South Embankment should be investigated to ensure that the thickness of the low permeability basin liner is sufficient in this area prior to it being inundated with tailings.
- No major unexpected or uncontrolled seepage was observed from the embankments, including fill slope and foundations. However, a small amount of seepage was observed at the base of the Perimeter Embankment between chainages 29+00 to 32+00. The seepage is likely coming from the internal embankment drain as it exits the TSF within this area. The seepage should be directed to a drainage ditch outside of the ultimate toe of the embankments and routed to the Perimeter Embankment Seepage Collection Pond. This was completed in February 2006.

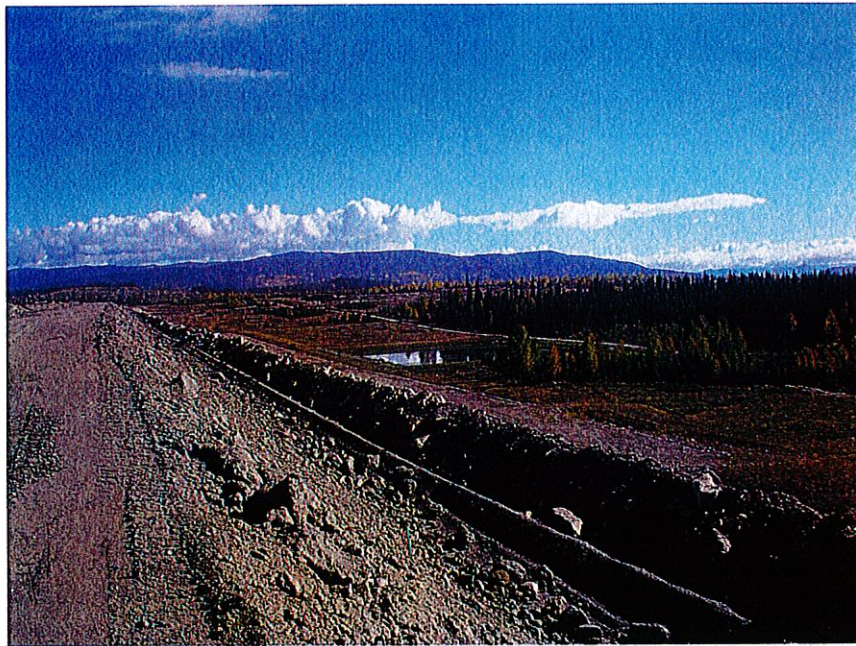
PHOTO 15: Main Embankment crest and the seepage collection pond.

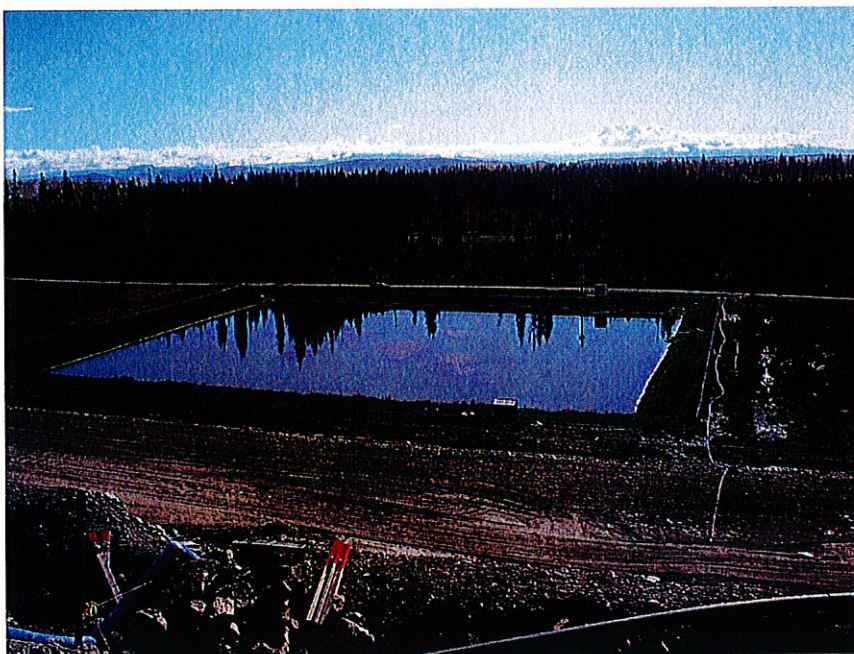
PHOTO 16: Main Embankment seepage collection pond.

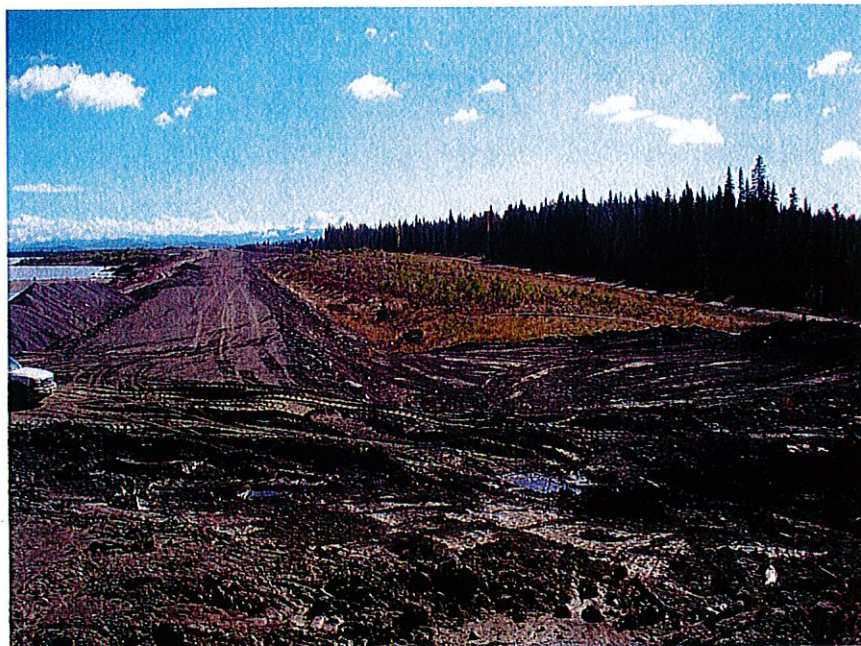
PHOTO 17: South Embankment crest and downstream area.

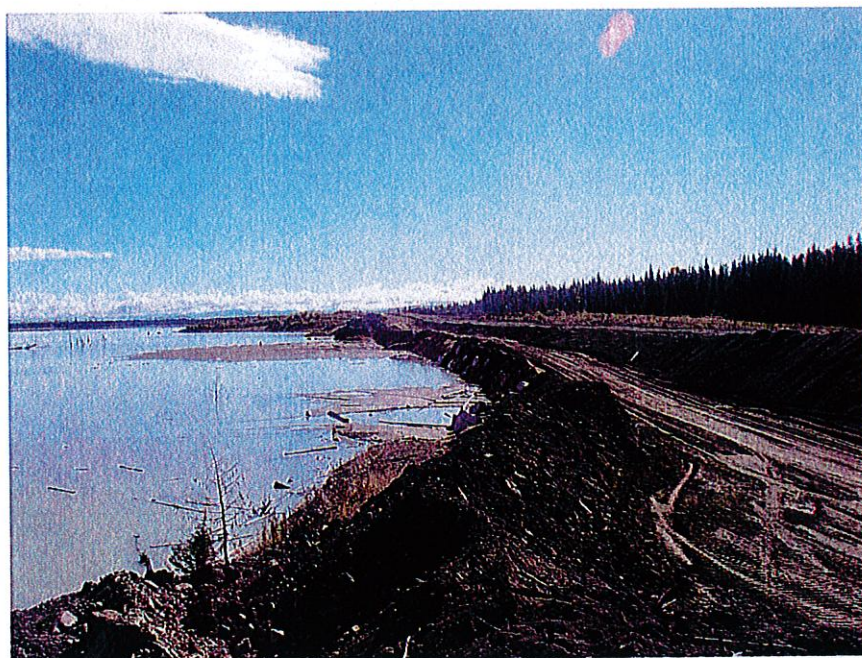
PHOTO 18: South Embankment showing pond up against the Zone U material.

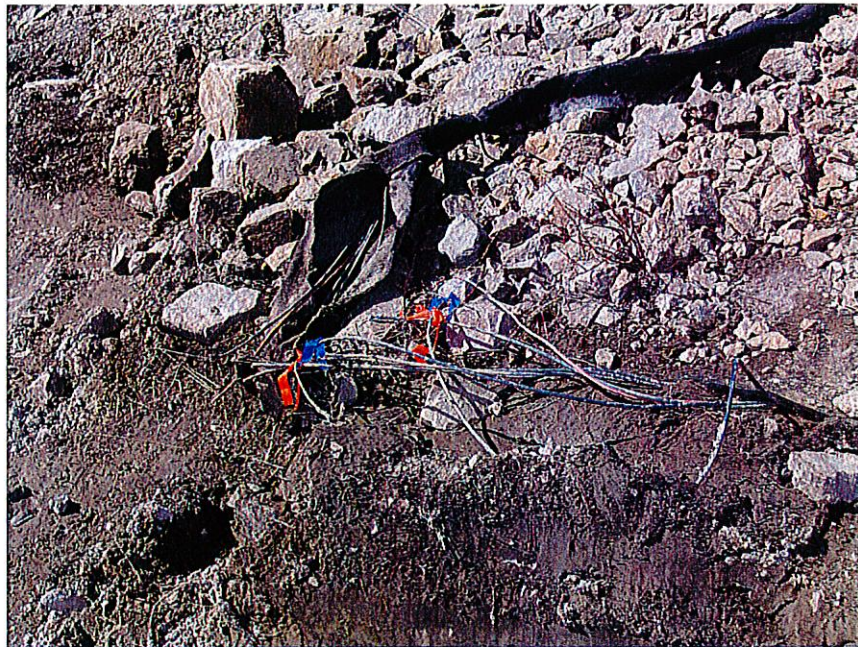
No piezometer data had been collected from Sept 22, 2005 to April 30 2006 due to a malfunctioning readout box connector cable and the accidental destruction or burying of piezometer cables during the Stage 4 construction program. MPMC will update the piezometer records as the damaged cables are repaired and the piezometer data will be further reviewed as part of the Stage 4 Construction Report. There were no concerns with the piezometer collected prior to September 22, 2005.

PHOTO 19: Damaged Piezometer cables at the Main Embankment.

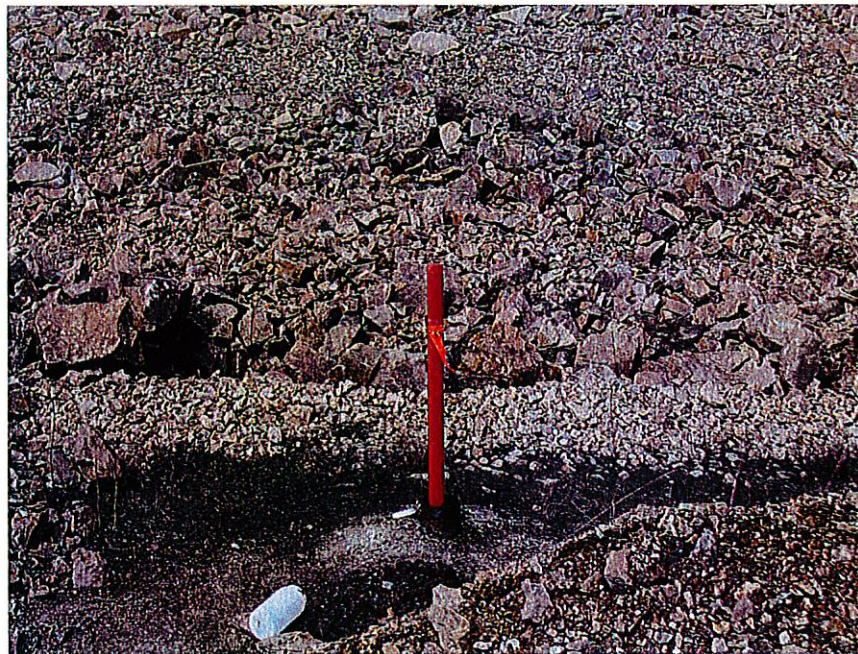
The two slope inclinometers installed at the toe of the Main Embankment in July 2001 were read in March 2006. The results show that there have been no significant deviations in the inclinometers as compared to the installation readings of 2001 and the readings from October 2004.

PHOTO 20: Existing inclinometers at the Main Embankment. These are to be extended during the Stage 5 Construction program.

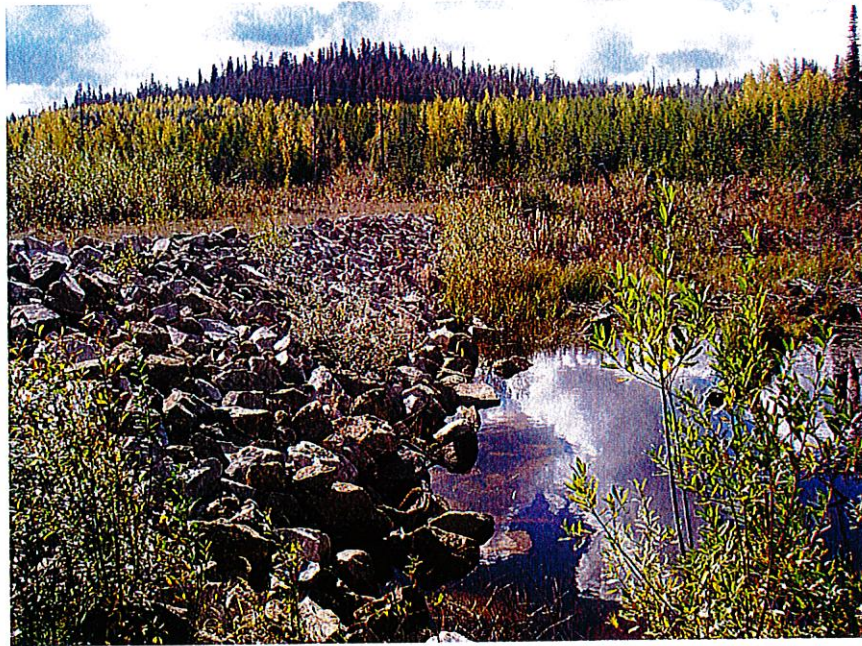
- The water level was low.
- Both upstream and downstream fill slopes were in good condition, with no evidence of seepage or slumping.
- No cracks were observed on the dam crest.
- The spillway contained some minor vegetation, but was generally unobstructed.

PHOTO 21: South Bootjack Dam – Upstream slope.

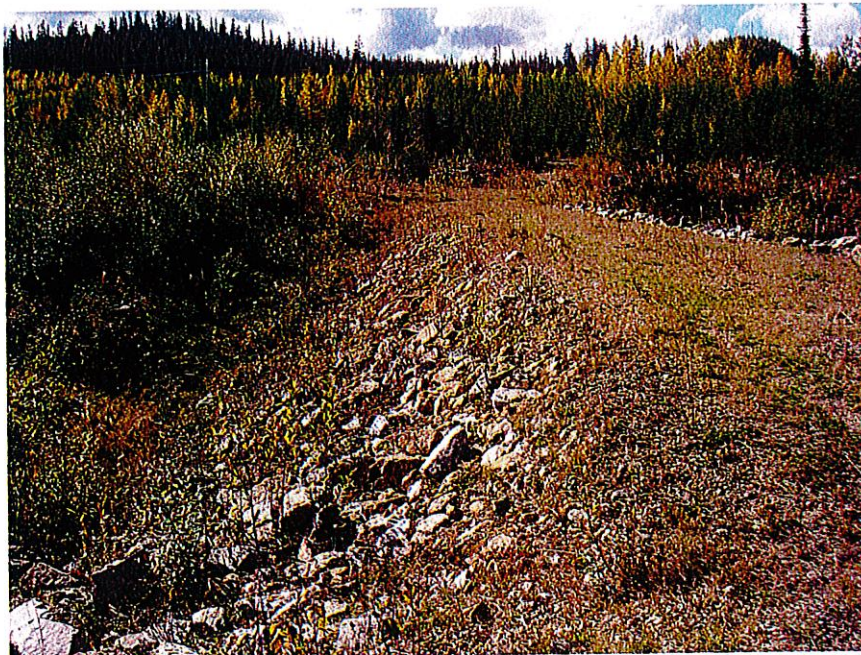
PHOTO 22: South Bootjack Dam – Downstream slope.
