## **FINAL REPORT**

### **DAM SAFETY REVIEW**

**Mount Polley Mine  
Likely, British Columbia**

**December 2006**

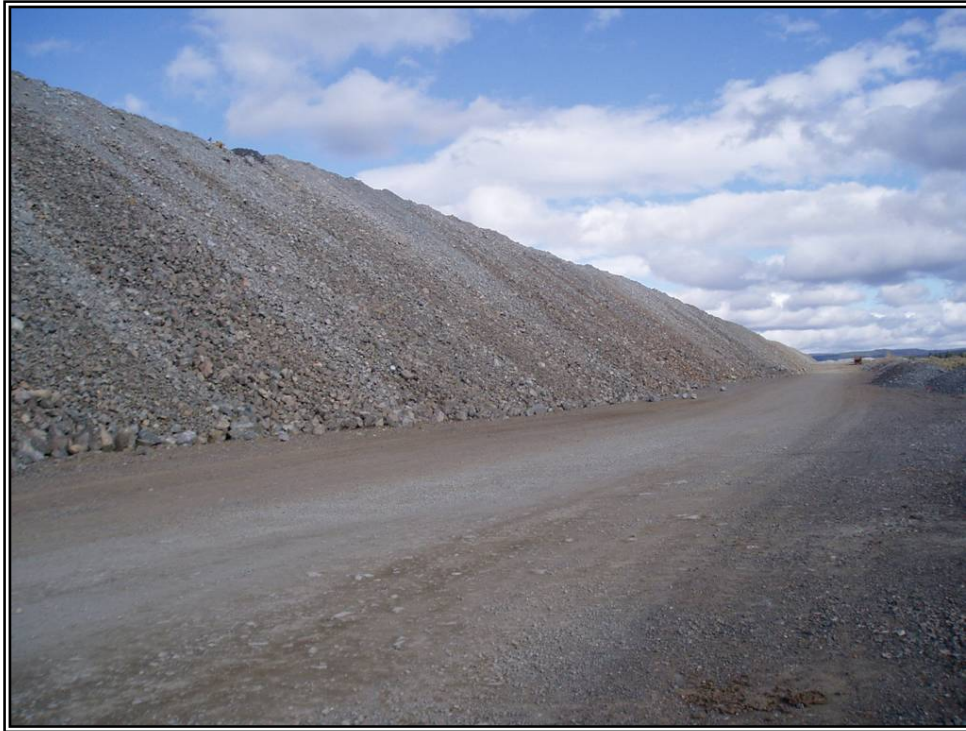
Photo 1: Main Embankment Shell – Looking Northeast

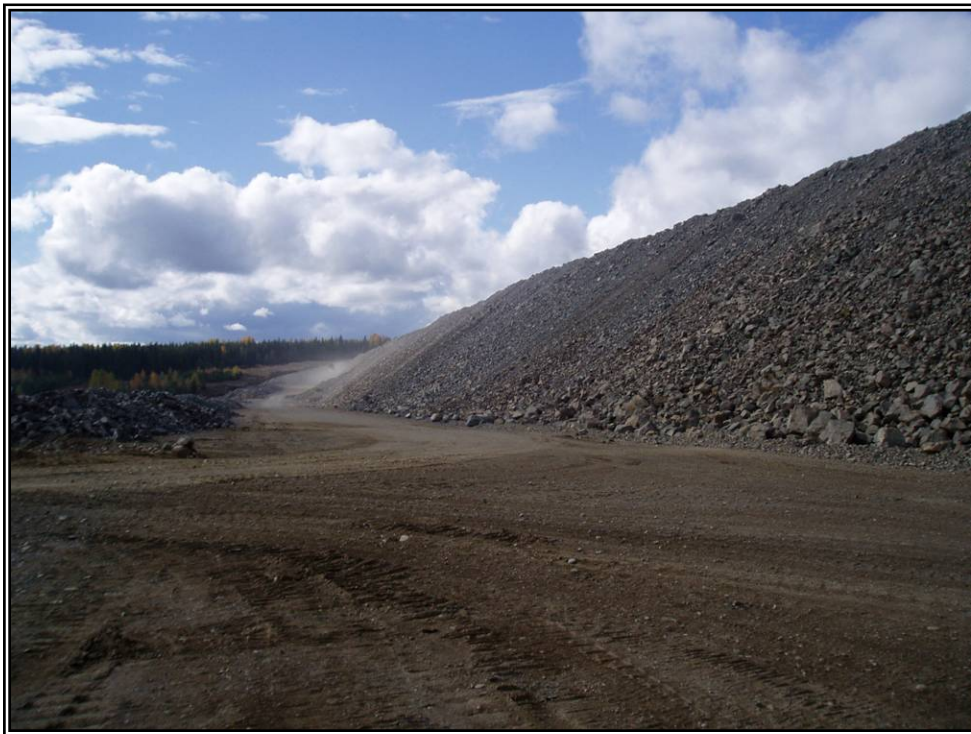
Photo 2: Main Embankment Shell – Looking Southwest

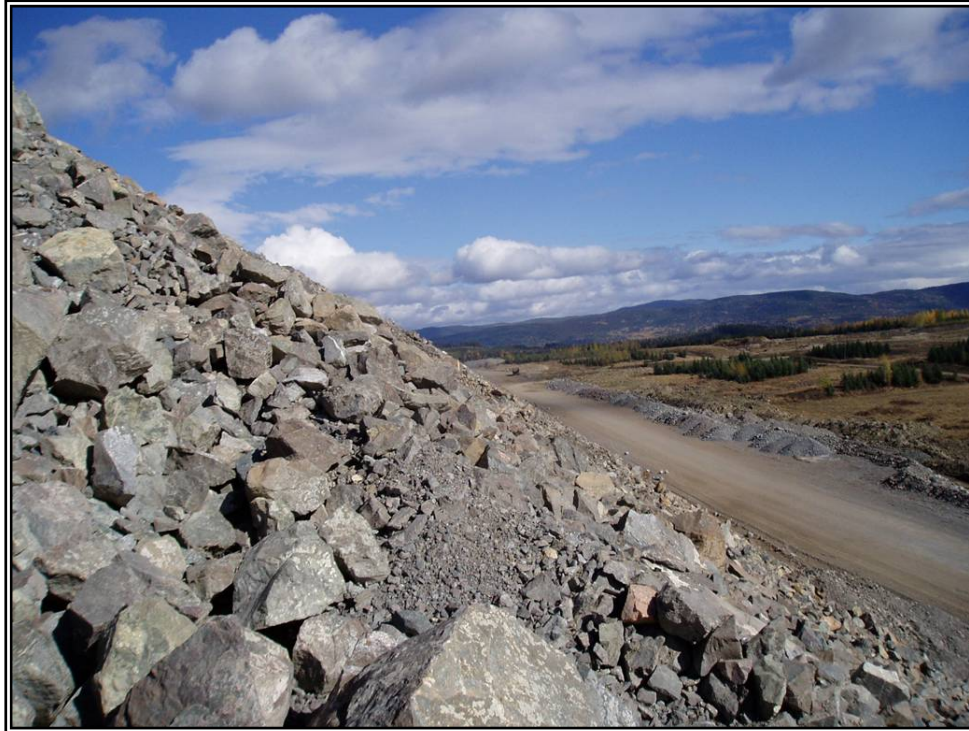
Photo 3: Nature of Main Embankment Rockfill

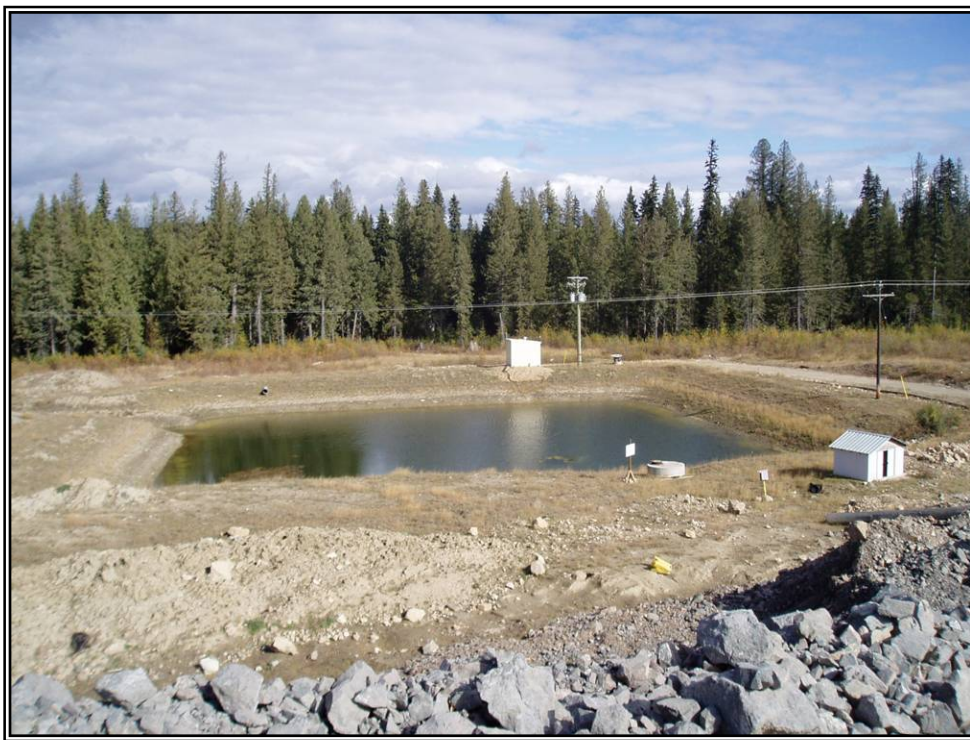
Photo 4: Main Embankment Seepage Collection

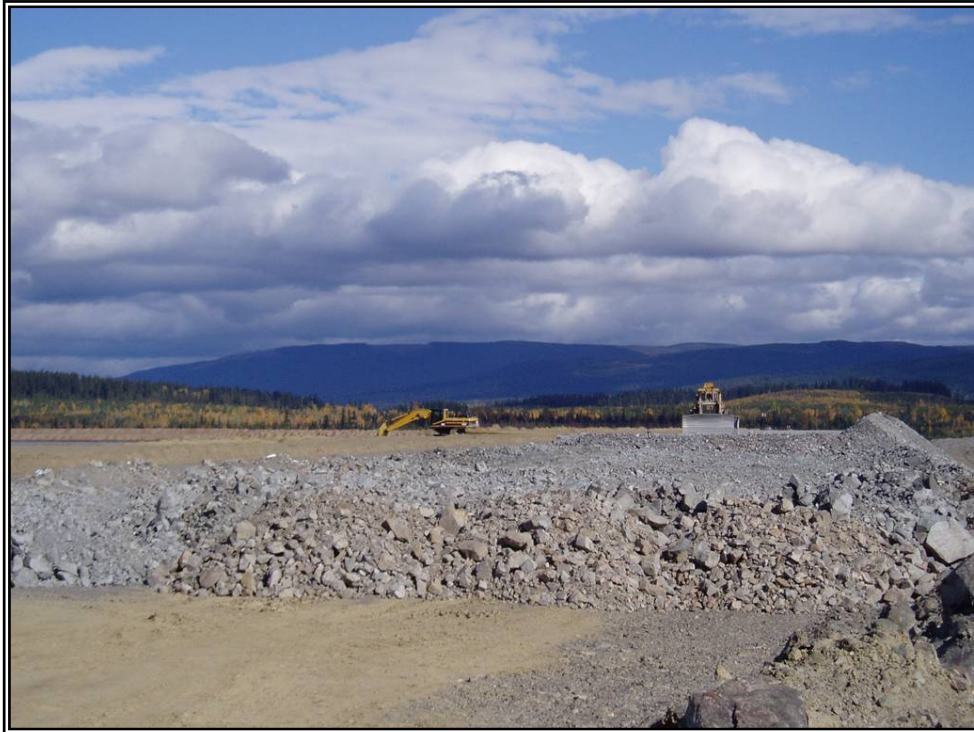
Photo 5: Construction on Main Embankment

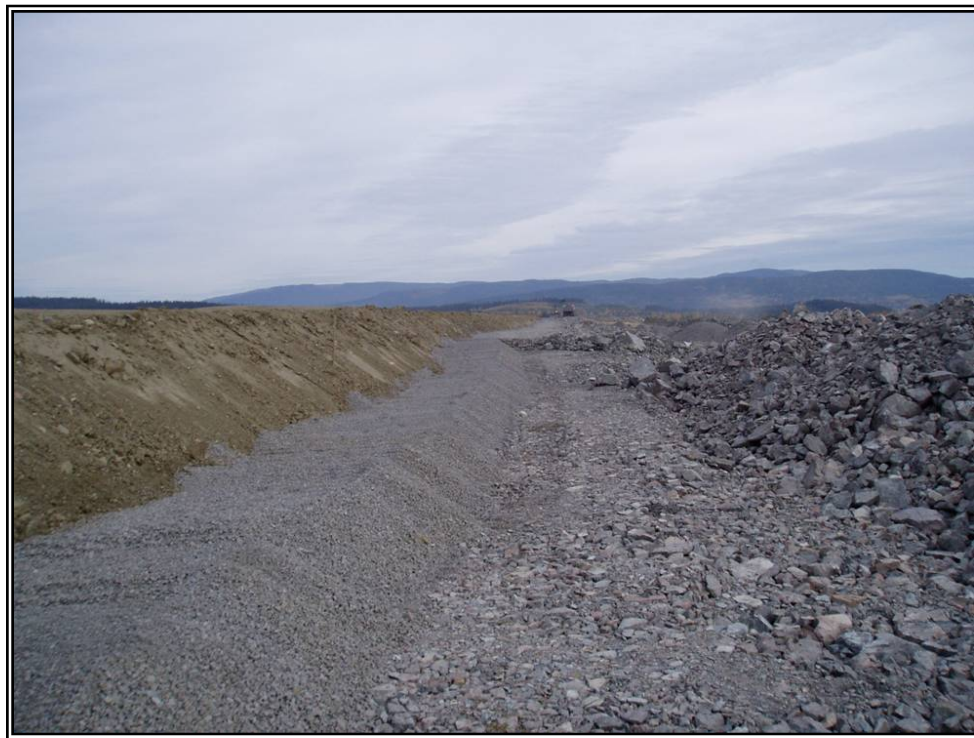
Photo 6: Zones of Main Embankment Dam

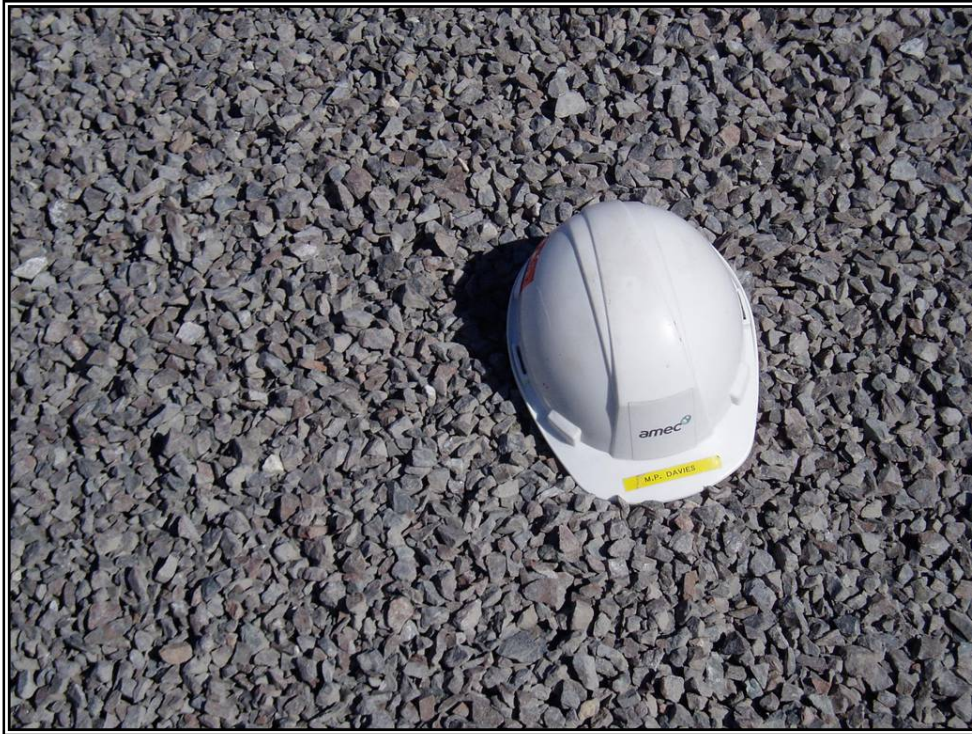
Photo 7: Main Embankment Transition Material

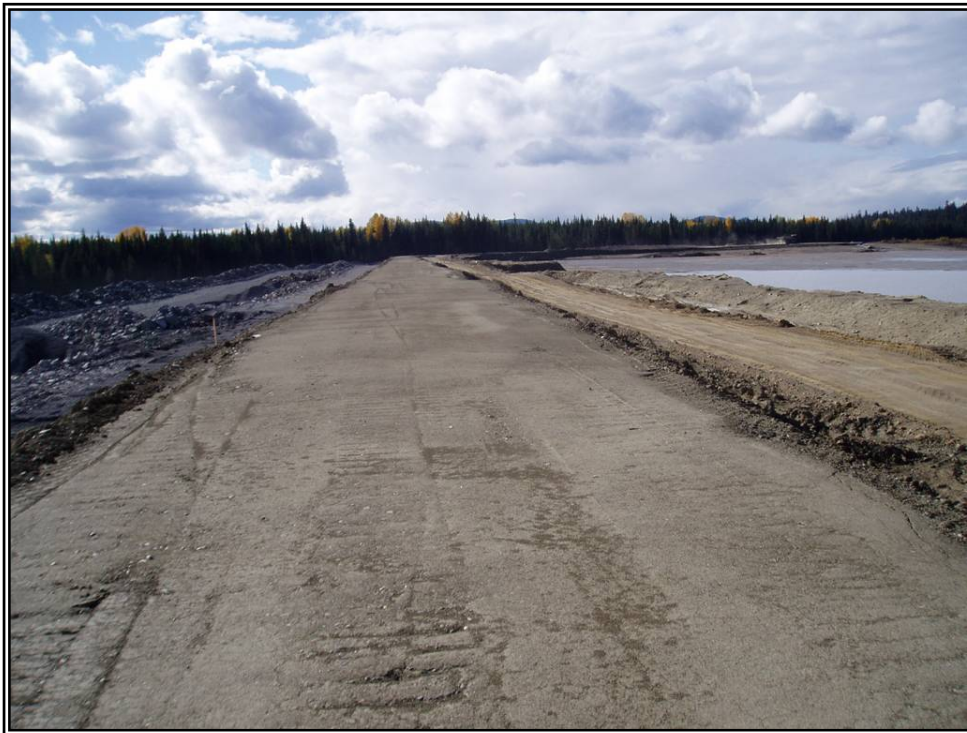
Photo 8: Main Embankment Compacted Core

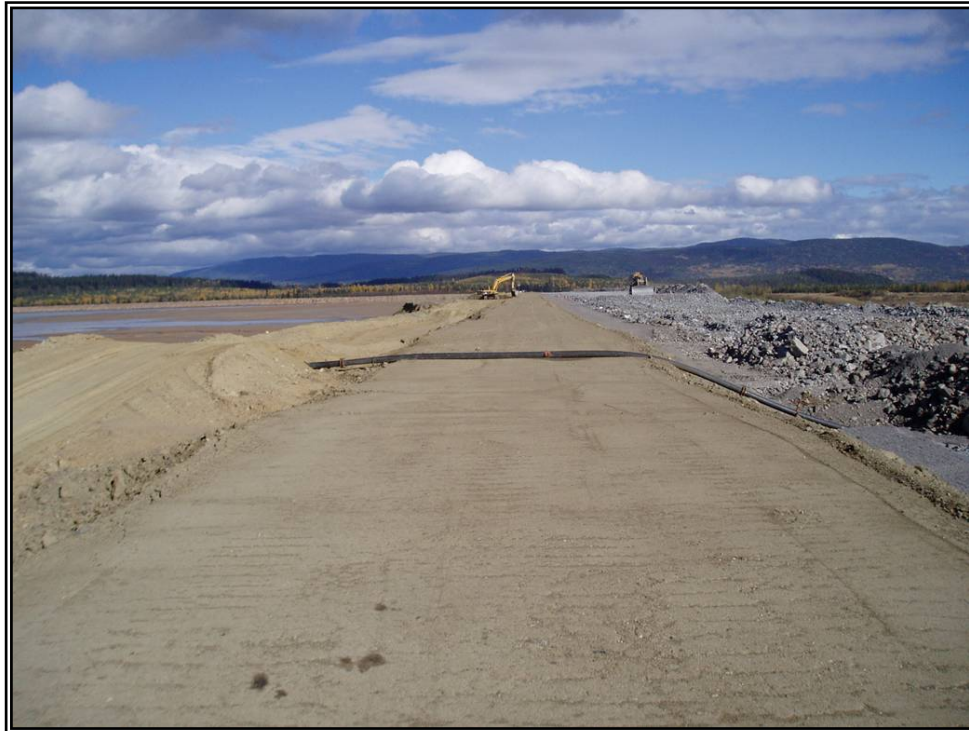
Photo 9: General Photograph of As-Built Robust Core

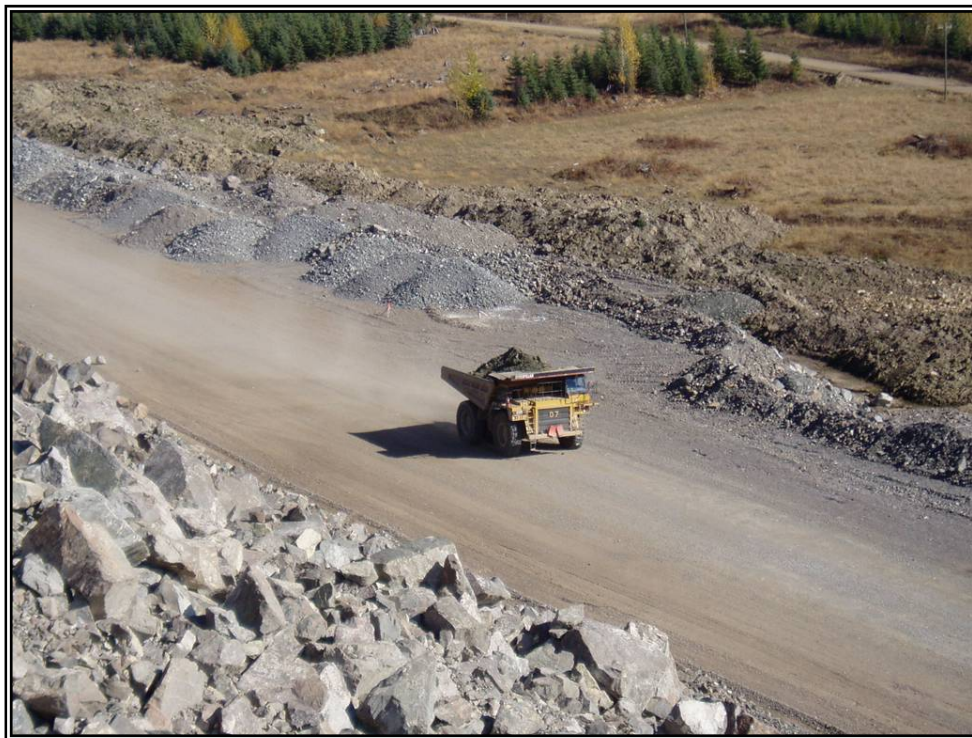
Photo 10: Haulage of Till from Borrow

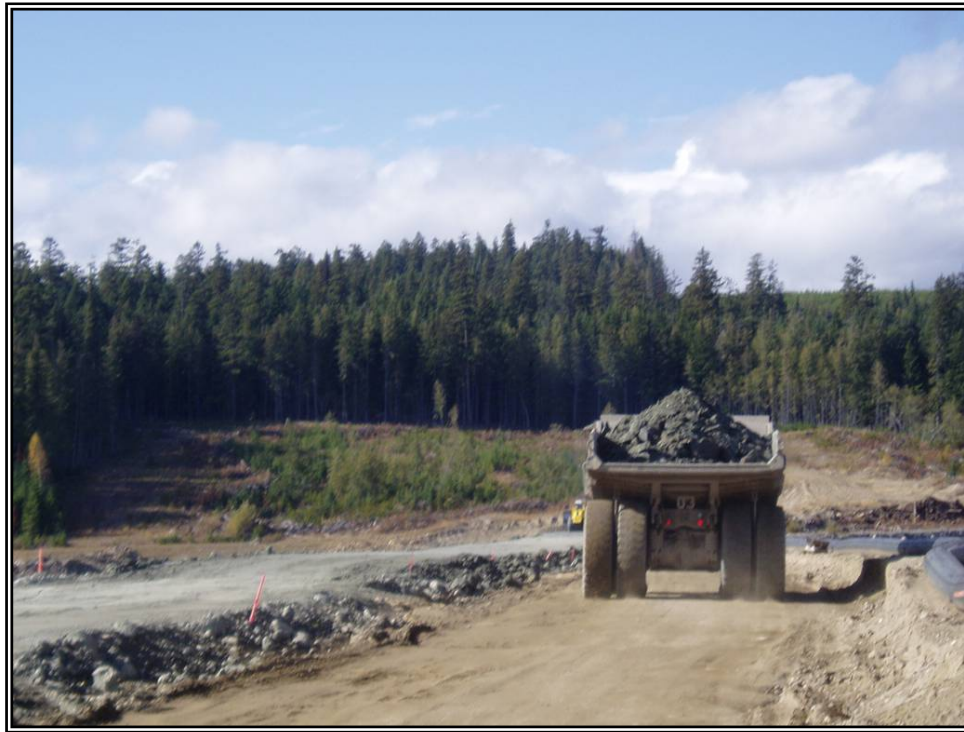
Photo 11: Till Haulage on South Embankment

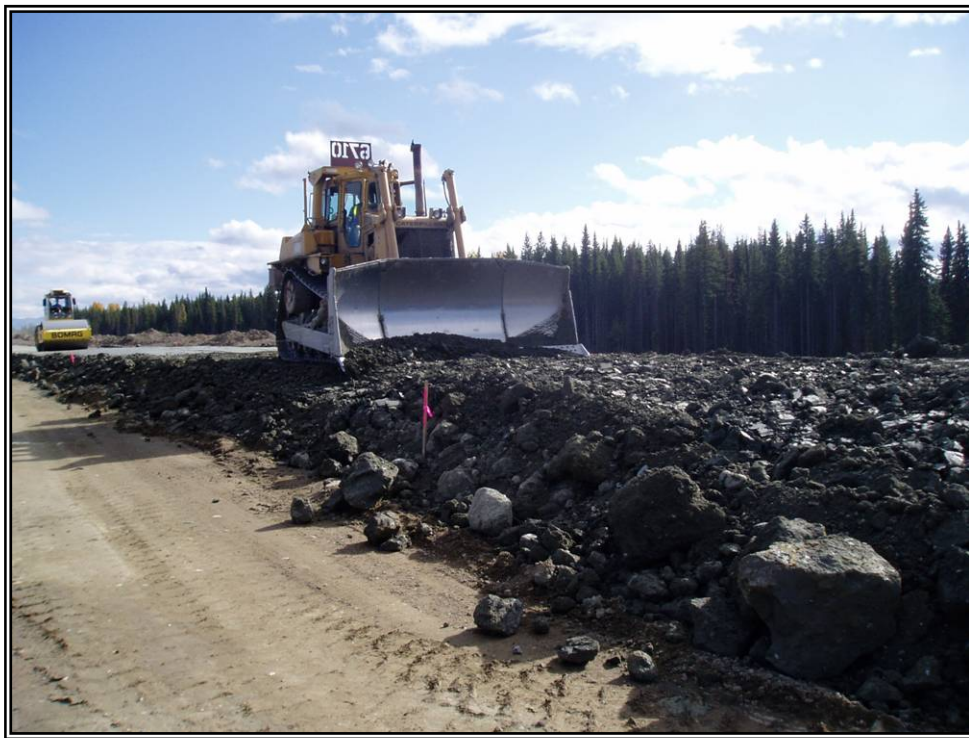
Photo 12: Placement of Till Core – South Embankment

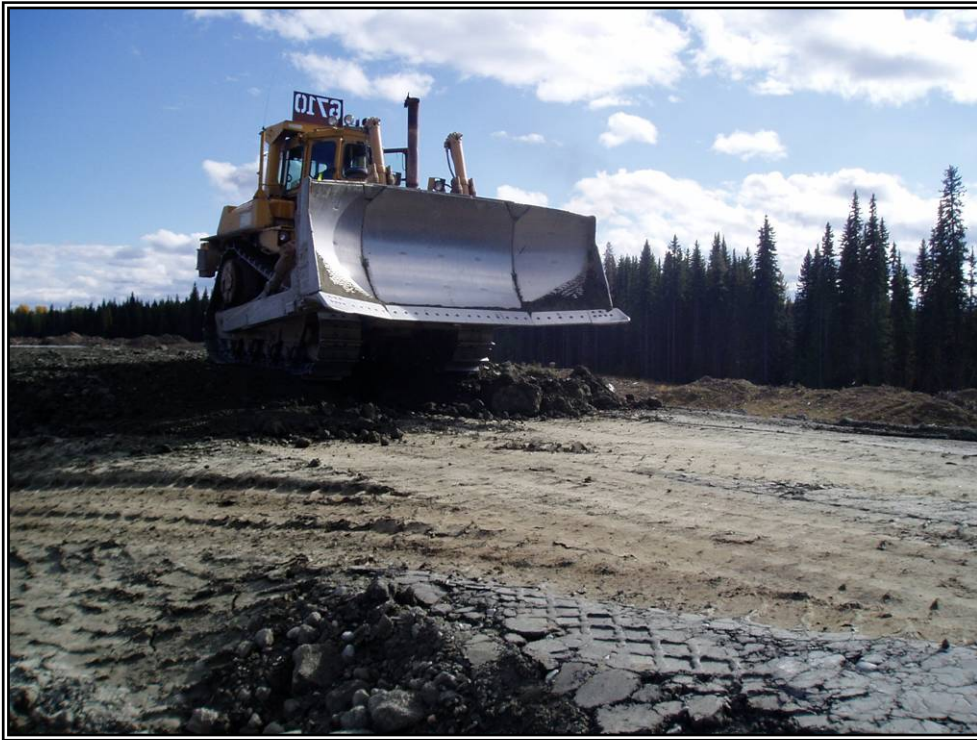
Photo 13: Compacted Till – South Embankment

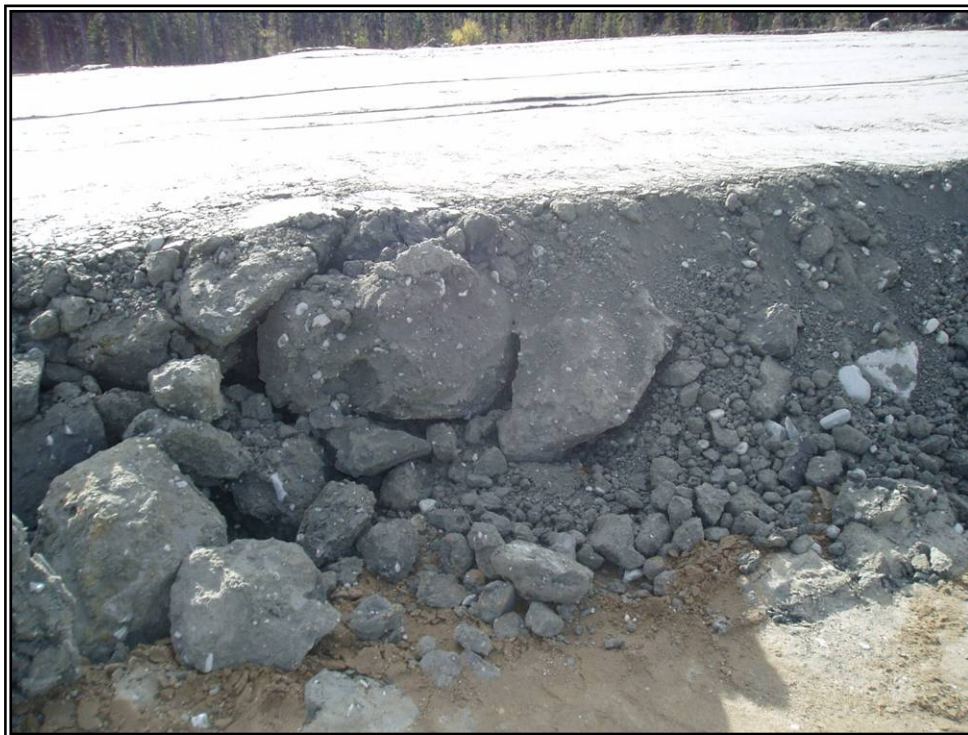
Photo 14: Compacted Till – South Embankment

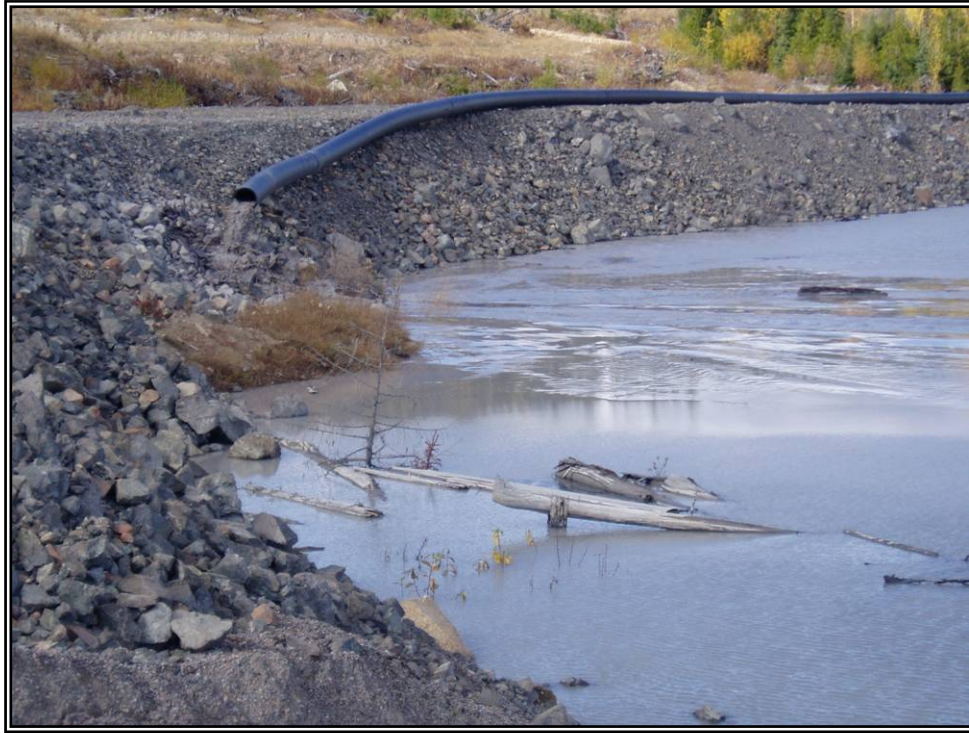
Photo 15: Tailings Overboarding at "Top" of Panel

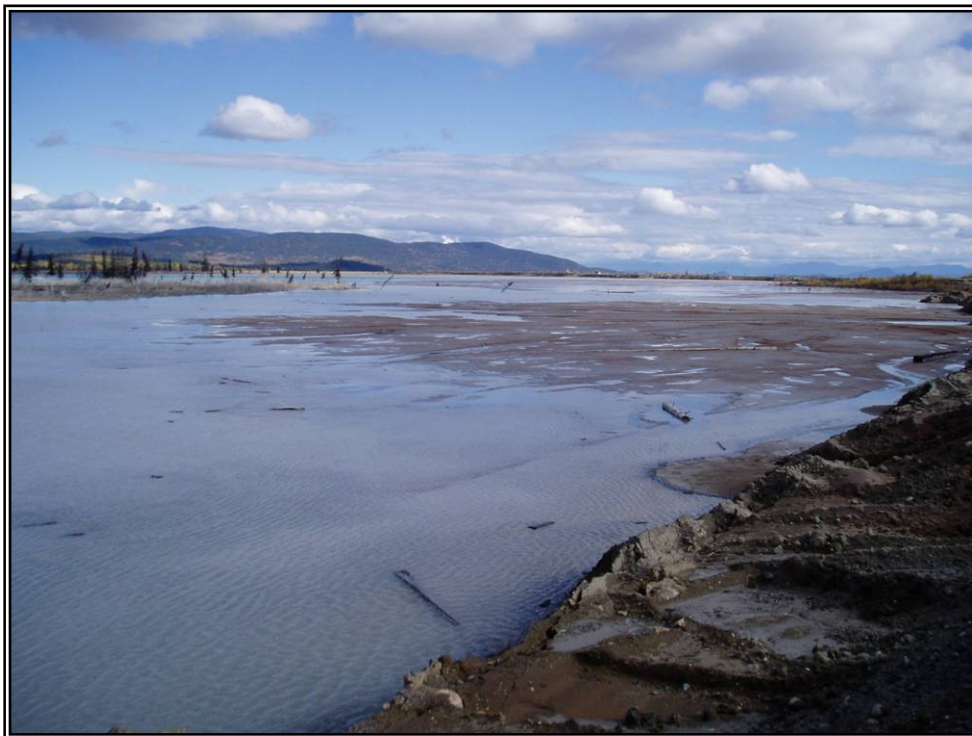
Photo 16: "Beach" Pondward of Deposition Location

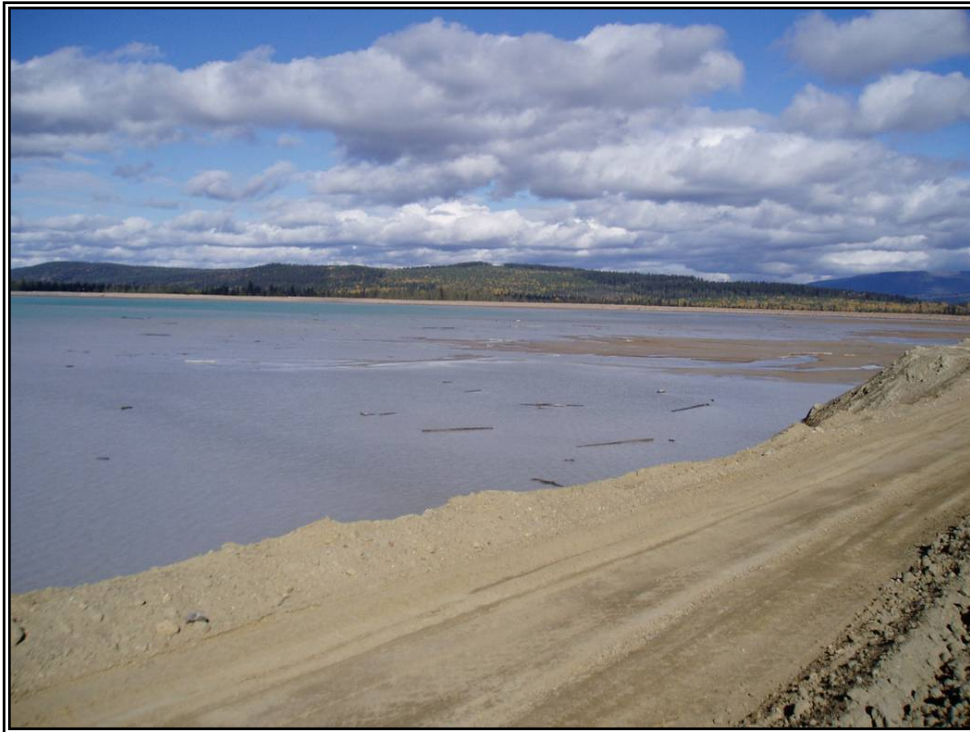
- **Dam Structures** – The three embankment dams all appeared in a good state of repair at the time of the DSR. There was no visual evidence of significant past issues (nor any documented). The lack of a tailings beach and inconsistency with beach profile and the closure concept for the TSF are notable but do not present immediate dam safety concerns. The lack of a beach profile consistent with closure objectives would address the lack of beach against the embankments and, for a number of reasons, should be addressed as soon as possible by the mine to avoid increased costs in this regard in the future. Again, however, dam safety is not a driving reason to address this lack of beach/positive beach profile.

Photo 17: Lack of Established Beach – Perimeter Embankment in Background

There is currently no surface discharge facility (spillway) and one will be required for closure (and is the prime reason why the current beaching practices should be modified to allow effective placement of a spillway). At other similar facilities in British Columbia, where there is no operating spillway, a longer duration PMF event than the 24 hour event has been used with the 24 hour duration being adopted for closure when there will be an appropriate spillway. This approach is recommended for the Mount Polley TSF.

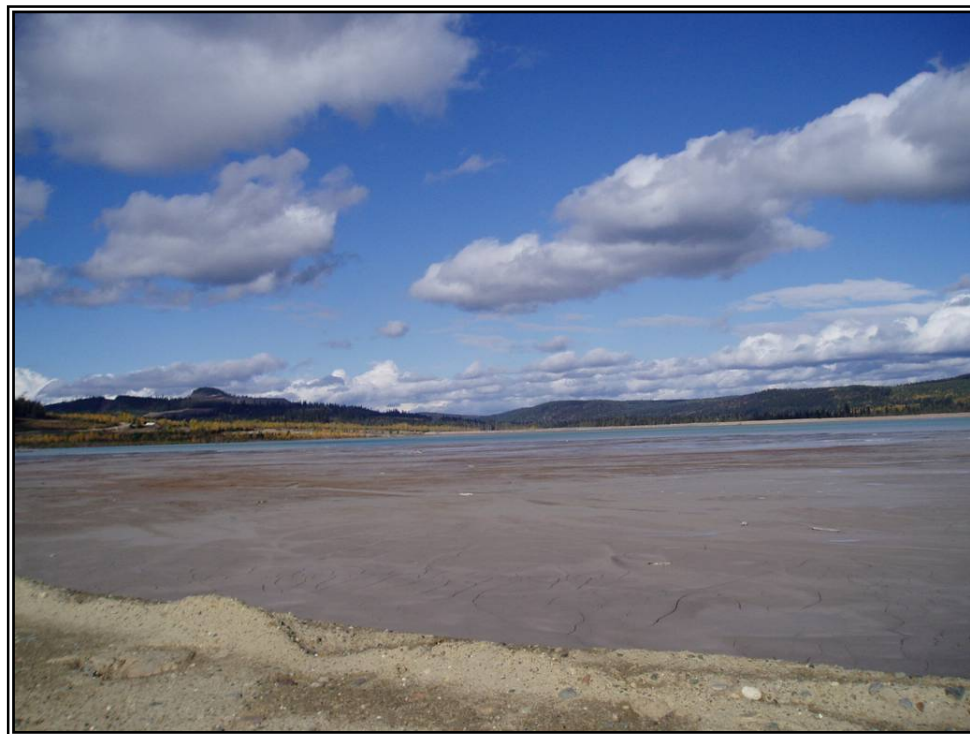
Photo 18: Minor Beach Development along Portion of Main Embankment

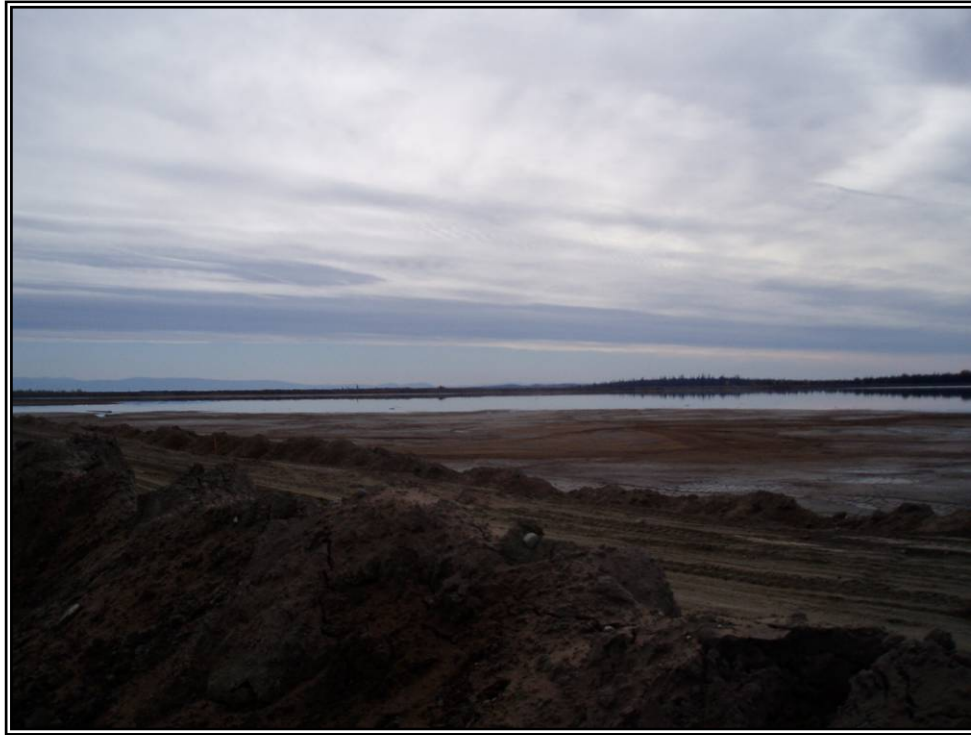
Photo 19: Tailings Pond from Northwest end of Perimeter Embankment

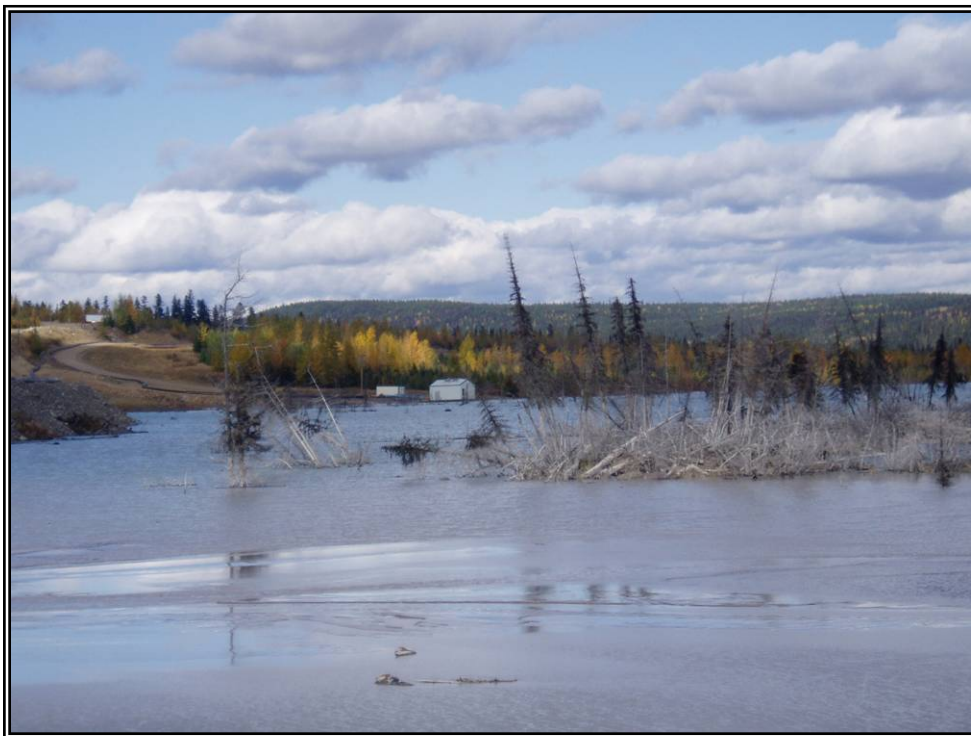
Photo 20: Tailings Water Reclaim Barge Location
