**MOUNT POLLEY MINING CORPORATION  
MOUNT POLLEY MINE**

**TAILINGS STORAGE FACILITY  
REPORT ON 2008 ANNUAL INSPECTION  
(REF. NO. VA101-1/24-1)**

**TAILINGS STORAGE FACILITY  
REPORT ON 2008 ANNUAL INSPECTION  
(REF. NO. VA101-01/24-1)**

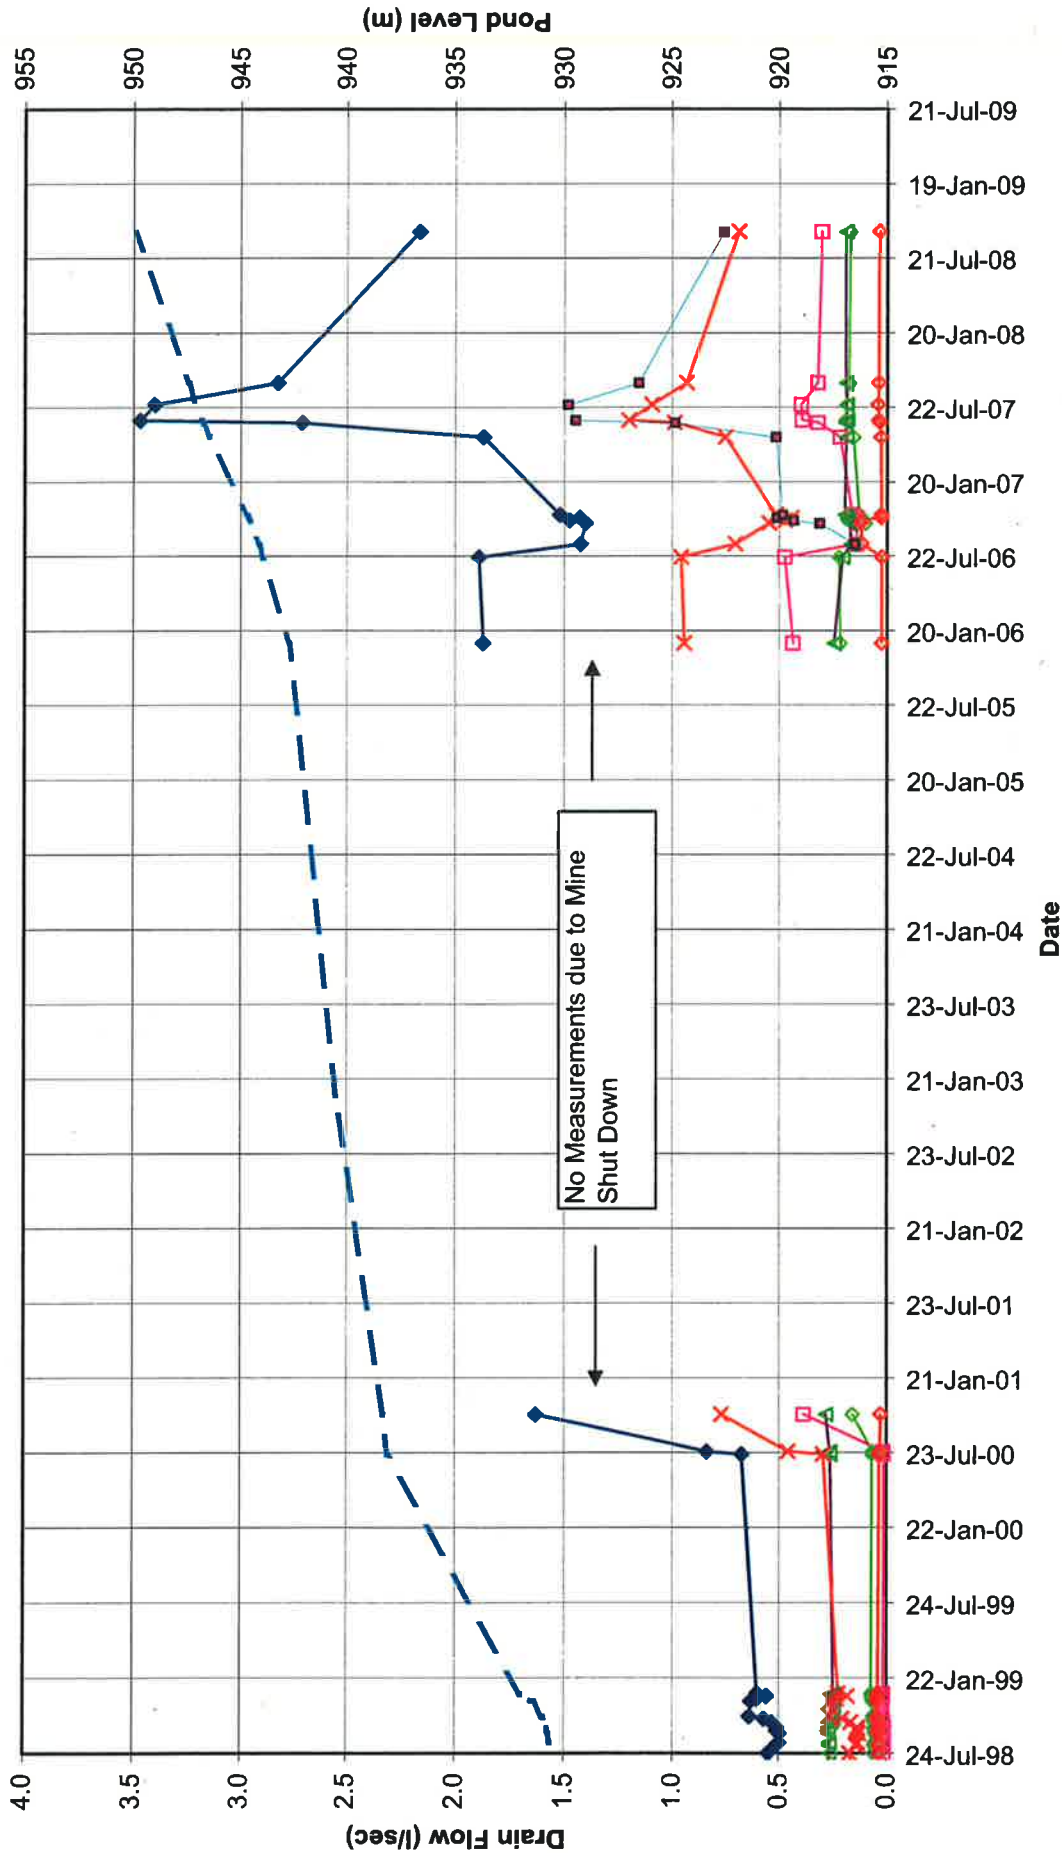
The water from the foundation drains and upstream toe drains is pumped back into the TSF. The flow rates for the foundation drains are shown on Figure 3.1. The flow rates for the upstream toe drains are shown on Figure 3.2. The flows from foundation drains FD-1 to FD-5 have remained fairly constant during the past year at less than 0.4 l/s. The flows at the ME Corner foundation drain have decreased in the last year due to the development of a tailings beach in this area. The flows from the upstream toe drains fluctuate throughout the year in response to the tailings deposition location and the tailings pond location. The flow from the Main Embankment upstream toe drain averaged approximately 11 l/s during 2008 with the flow from the Perimeter upstream toe drain averaging approximately 3 l/s during 2008. The flows from the upstream toe drains have remained relatively constant, with the total flow increasing due to the commissioning of the Perimeter Embankment upstream toe drain. The water flowing from the upstream toe drains was clear.

MOUNT POLLEY MINING CORPORATION	
MOUNT POLLEY MINE	
<b>FOUNDATION DRAIN FLOWS</b>	
<b><i>Knight Piésold</i></b> CONSULTING	
PIA NO. VA101-124	REF NO. 1
<b>FIGURE 3.1</b>	
REV 0	REV 0

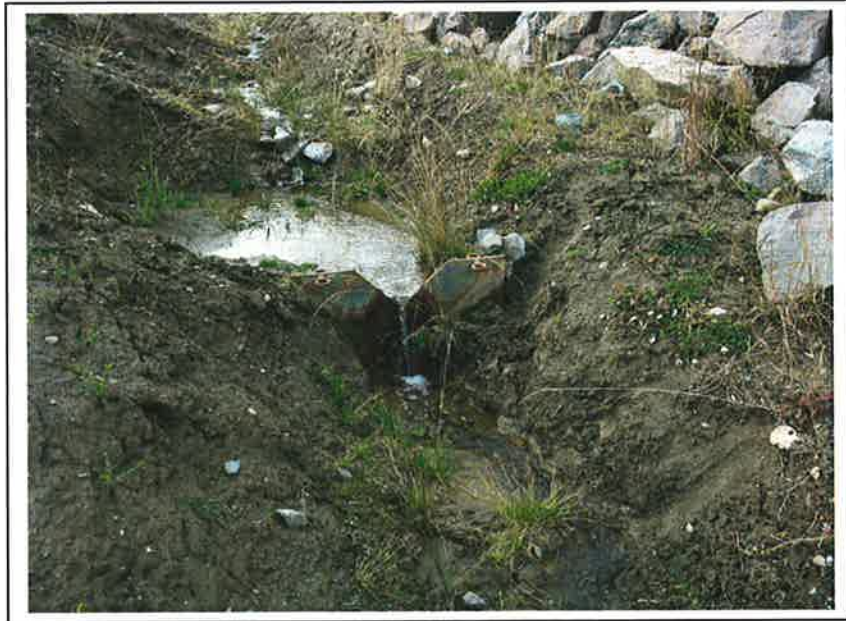
**PHOTO 3** – Main Embankment Foundation Drain flows from the ME/SE Corner.

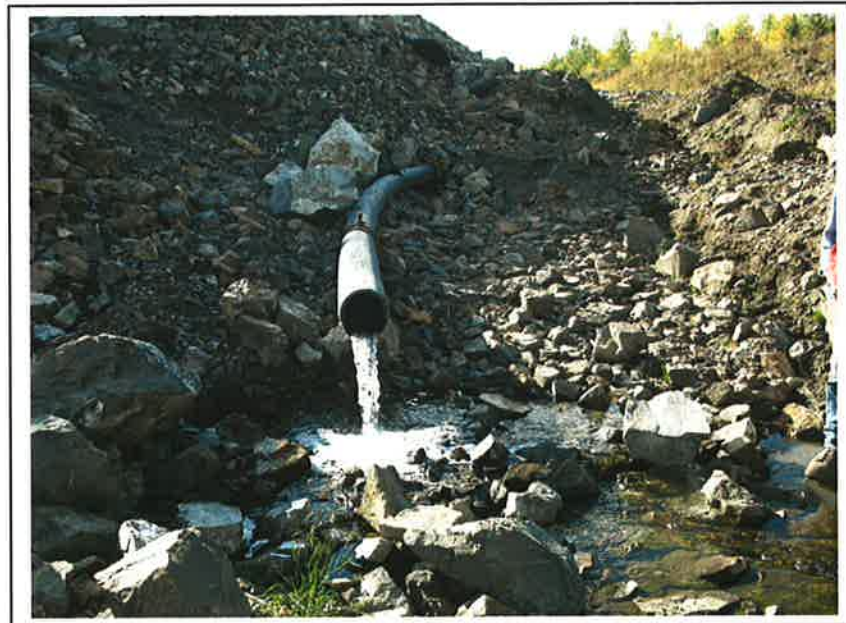
**PHOTO 4** – Perimeter Embankment Toe Drain flow running clear

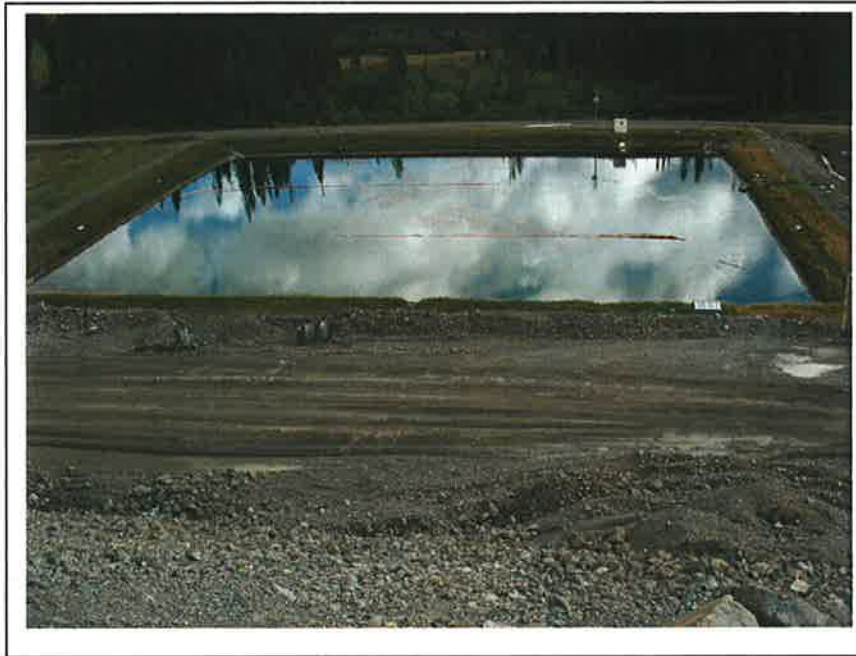
The Main and Perimeter Embankment seepage collection ponds are located immediately downstream of their respective embankments. These ponds were excavated in low permeability glacial till materials in 1996 and collect water from the embankment drain systems and from local runoff. The seepage collection ponds were observed to be in good condition with no observed erosion activity.

**PHOTO 5** – Main Embankment Seepage Pond
